GTSE Service Engineering Vibration Trend Data Analysis Timothy S. Irwin, P.E.

Vibration Trend Analysis Training

This document provides training and guidelines for performing initial trend analysis of changes in a machine's vibration signature.

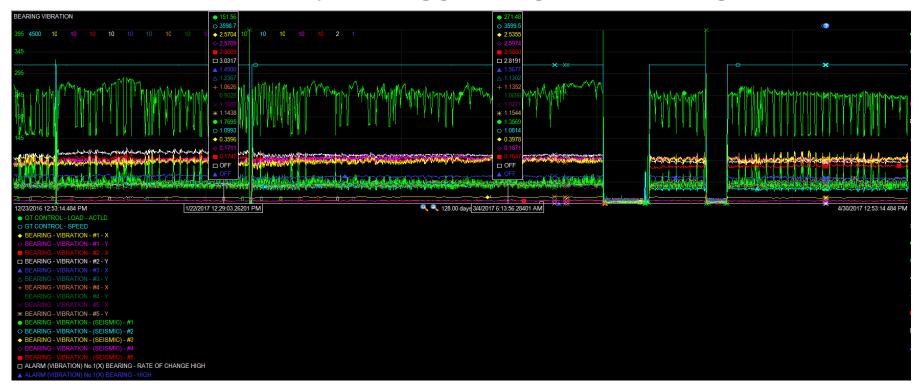
PI Vibration Data Analysis Triggers – gradual change

The trend above provides a general overview of the machine changes over the last four months. The trends on the following pages will provide details on the observations. Over the last four months changes of 0.1 to 0.4 mils are evident on several channels. Initial request was for 30 day trend review.

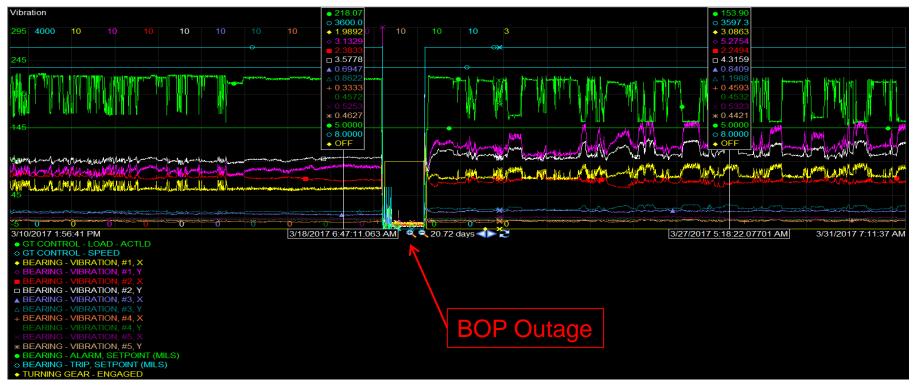
PI Vibration Data Analysis Triggers – changes with load

The above trend plot shows the time frame around the 03/20/17 startup that resulted in higher steady state vibration amplitudes then during the previous operational time frame. Note the changes from pre-shutdown to post shutdown in the #1 and #2 bearing amplitudes and behavior. Initial evaluation request was on 5 mils amplitude during operation

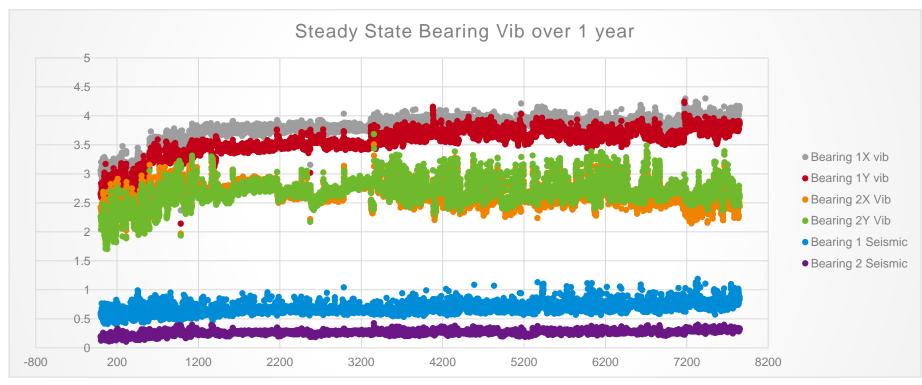
PI Vibration Data Analysis Triggers

The charts above (supplied by the RMC) show that the steady state vibration amplitude levels over the last year had increased. Most of that change occurred within the first 2 months, but there have been additional smaller step changes up as noted above. Initial request was to review the amplitude increase in operational amplitudes

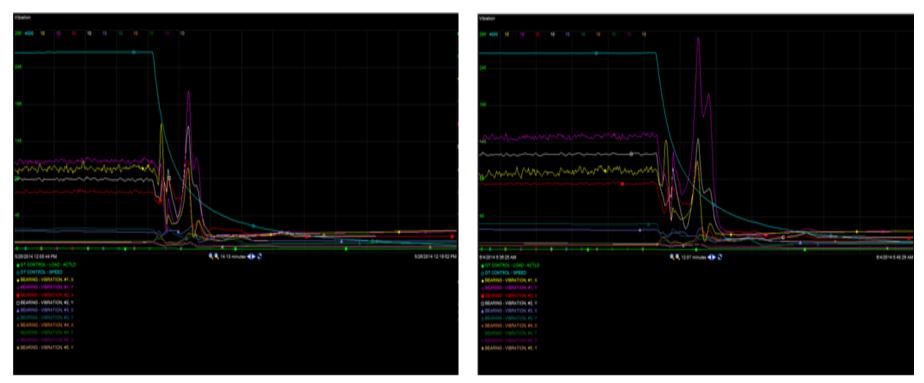
PI Vibration Data Analysis Triggers – changes with load

The above trend plots show the coast downs on 5/26 compared to 6/4 after a CI outage was performed. Initial request was to evaluate the high amplitude levels on the 6/4 coast down.

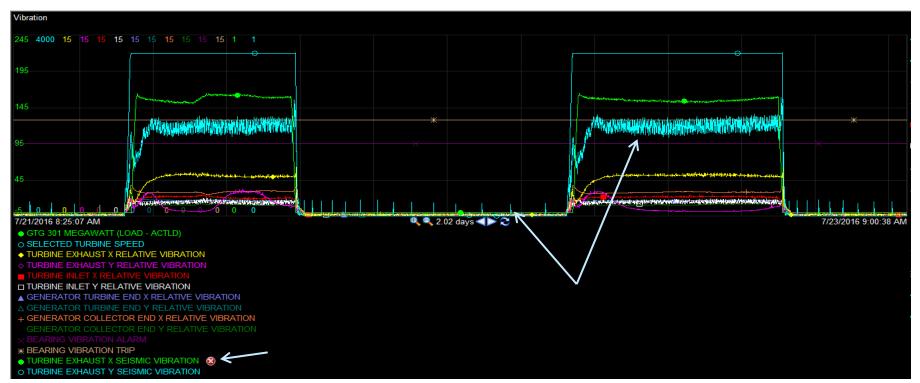
Transducer Errors

The plot above shows two conditions on seismic probes – 'bad' quality signal for one transducer. The other seismic channel shows high vibration levels and a series of spikes when the machine is on turning gear.

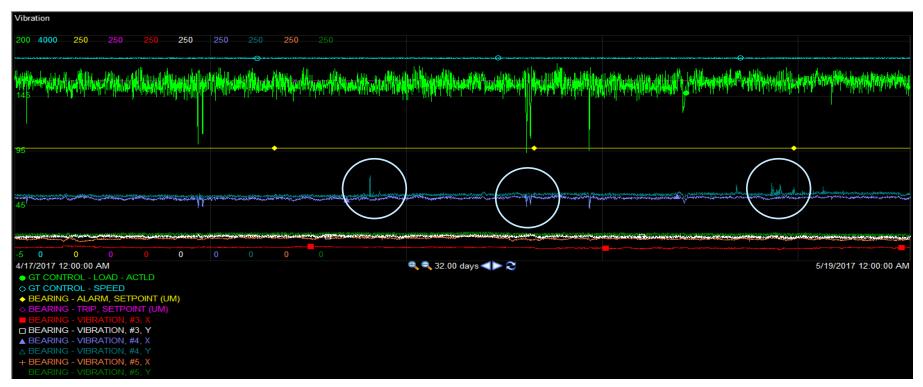
Transducer Errors

The plot above shows spikes and what appears to be noise in two relative vibration channels.

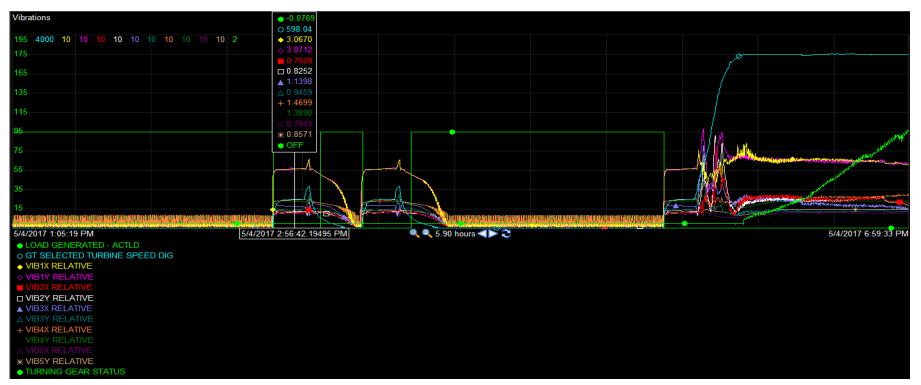
Transducer Errors

The plot above shows actual mechanical runout in a shaft that affects the indicated vibration signal. The cursor is at ~ 600 rpm spin purge for a gas turbine prior to startup. At only 600 rpm the #1 bearing channels are indicating over 3 mils of vibration. It is known that this is an actual mechanical runout in the journal.
