**Installation
Troubleshooting Guide
for
Standard
Steel Doors and Frames**

STEEL DOOR INSTITUTE

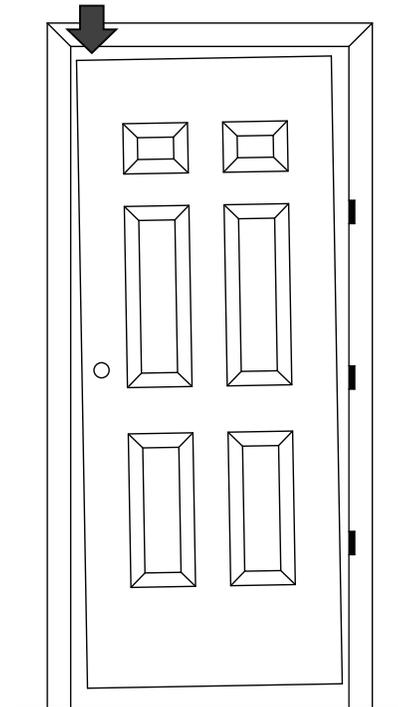
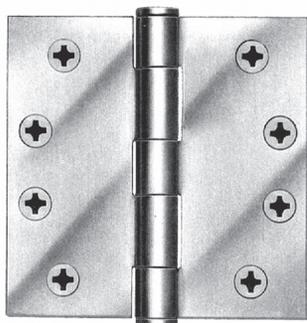
Is door sagging?

Uneven clearances frequently result from improper installation of frames and frame anchors. The condition, characterized by lock edge clearances narrow at the top and wide at the bottom, is called "door sag". The following suggested adjustments may correct the condition

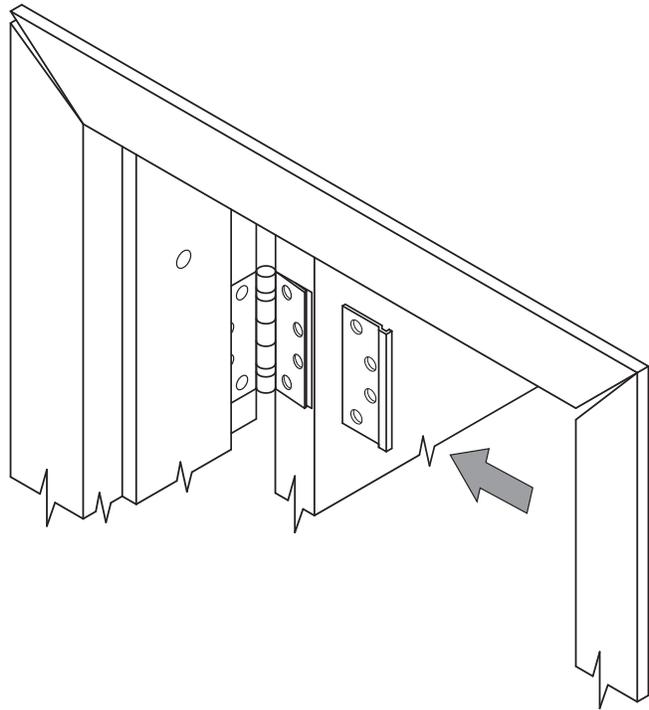
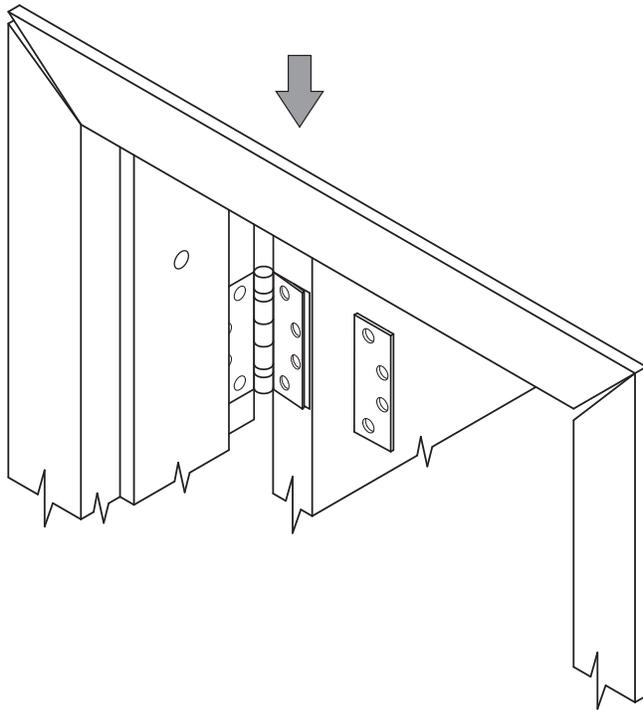
Remove top hinge filler for non-handed doors

The improper clearance condition may be improved by removing the top hinge leaf attached to the door and taking out the filler (hinge filler) from behind the leaf. Once completed, reattach hinge leaf to door. A hinge filler is used on all non-handed doors.

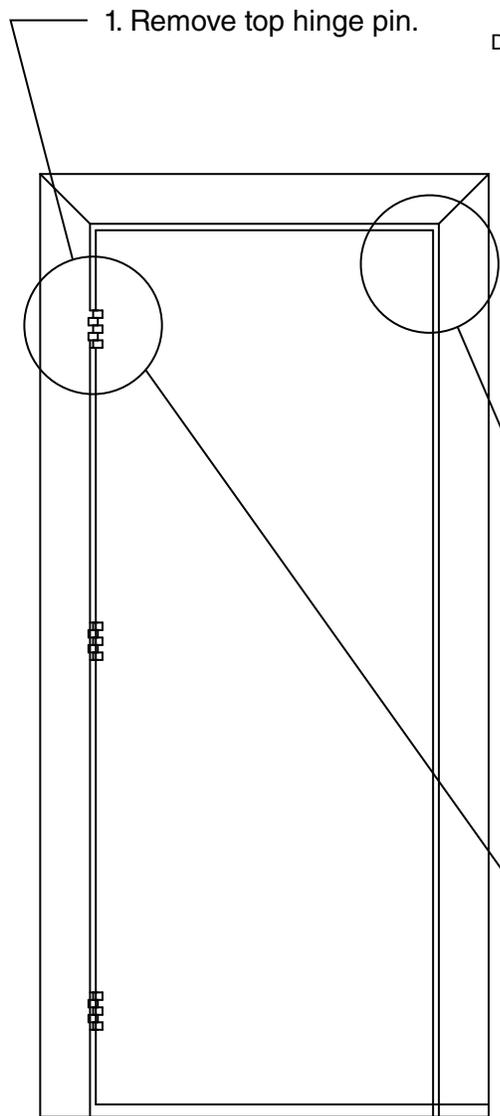
1. Remove top hinge pin.

The following example shows how a hinge leaf can be reswaged to correct minor improper door/frame clearances. This particular method allows the reswaging to be accomplished while the door remains in the opening and the hinge leaves remain on the door and frame. The example shows a top hinge reswaged to correct a sag-type condition. However, any of the hinges can be reswaged in this manner to compensate for conditions opposite to that of a sag condition.

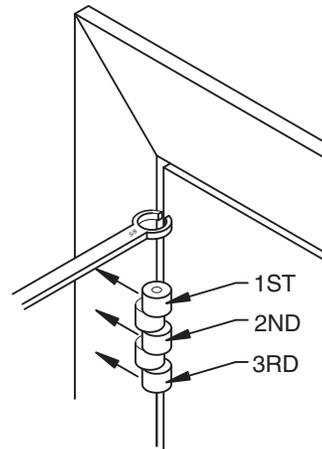
4. Reswage and align hinge knuckles.

As shown, the hinge leaf knuckles on the door move to a new location once the clearance at the strike jamb is set. The hinge leaf knuckles on the frame must now be reswaged (bent) to align with the new location of the hinge leaf knuckles on the door. The simplest way to do this is to use a $\frac{5}{8}$ " – $1\frac{1}{16}$ " tube wrench (a crescent wrench will do as a second choice). Simply slip the tube wrench down around the 1st knuckle and align it with the new location. Once the first knuckle has been aligned, the wrench will now slip down to the 2nd knuckle for alignment. Repeat the process on the third knuckle.

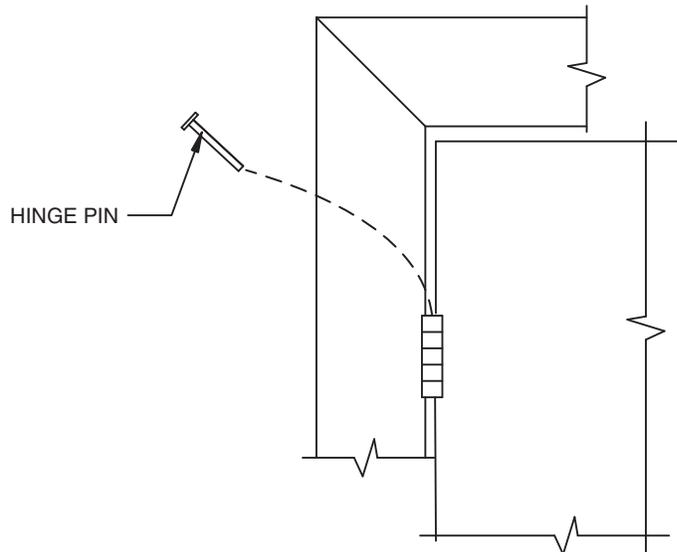
5. Re-insert the hinge pin and remove the screwdriver.

NOTE: As always, caution should be exercised when the hinge leaves are not removed. **Excessive** pressure could damage doors/frames. As an alternate reswaging method, the hinge can be removed and clamped in a vise for reswaging.

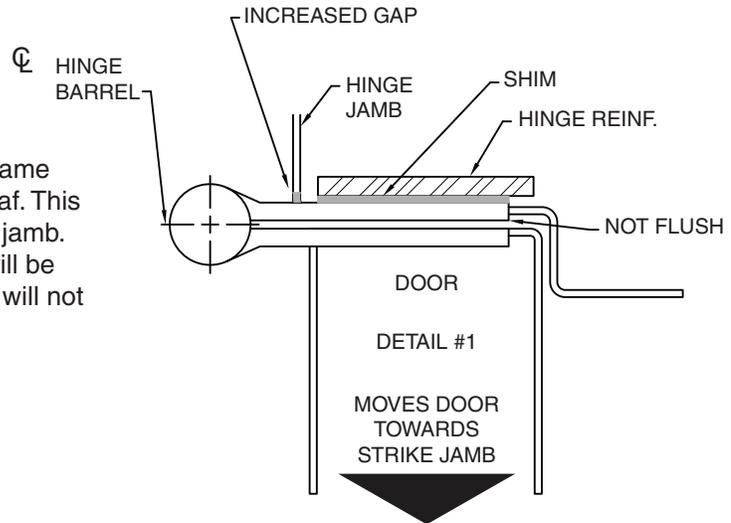
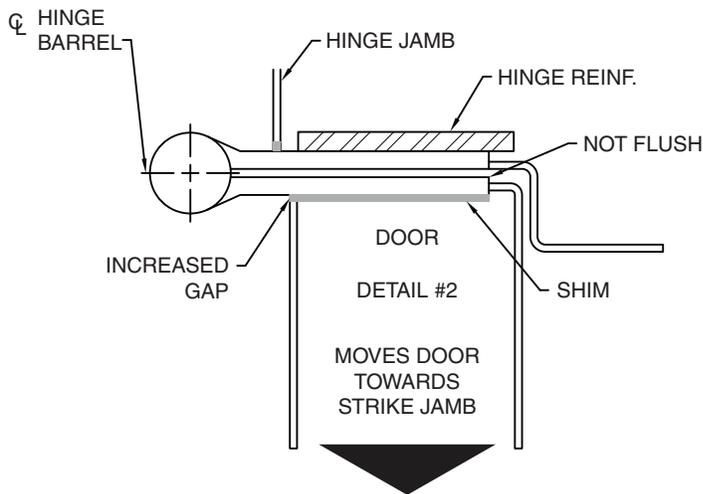
1. A shim can be placed between the frame hinge reinforcement and the hinge leaf. This will move the door towards the strike jamb. However, the hinge notch face gap will be increased and the hinge leaf surface will not be flush with the rabbet surface.

2. A shim can be placed between the door and the hinge leaf. This will also move the door towards the strike jamb. However, an increased gap will be created by the shim and the hinge leaf surface will not be flush with the backset surface on the door.

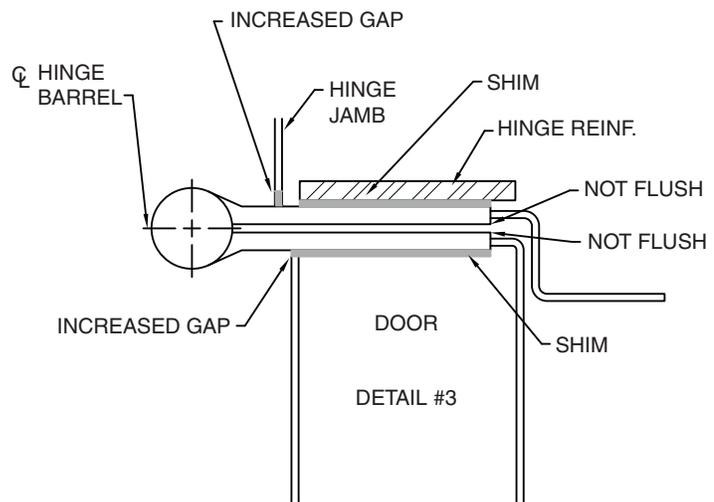
3. To minimize the gaps and the allow the hinge leaf surfaces to remain flush with the rabbet and backset surfaces, two shims, each half the thickness of those used above, could be used.

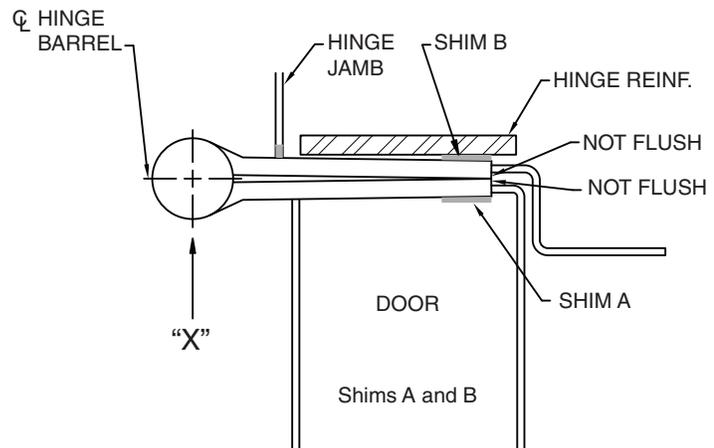
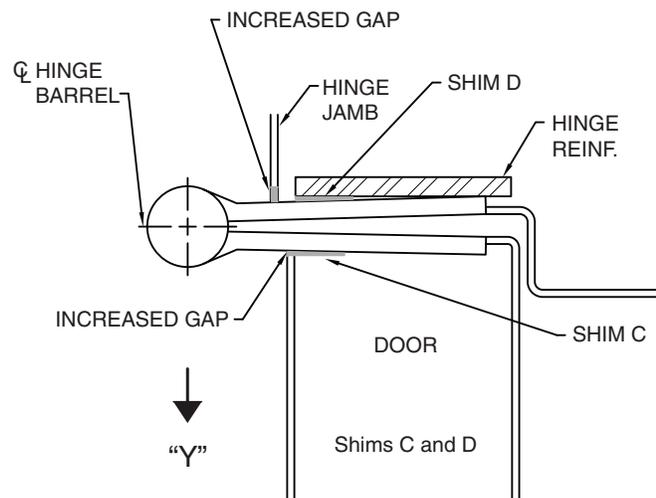
Adjustment of Clearance Between the Door and the Frame May be Accomplished by the Following:

1. Using Shim "A" only, door will be relocated in direction of Arrow "X".
2. Using Shim "B" only, will move both door and centerline of hinge barrel in direction of Arrow "X".
3. Using both Shims "A" and "B" will relocate the door in direction of Arrow "X" by a greater amount than by using Shim "B" alone.
4. Using Shim "C" only, door will be relocated in direction of Arrow "Y".
5. Using Shim "D" only, both door and centerline of hinge barrel will move in direction of Arrow "Y".
6. Using both Shims "C" and "D" will relocate the door in direction of Arrow "Y" by a greater amount than by using either "C" or "D" alone. The centerline of hinge barrel will be relocated the same as by using Shim "D" alone.

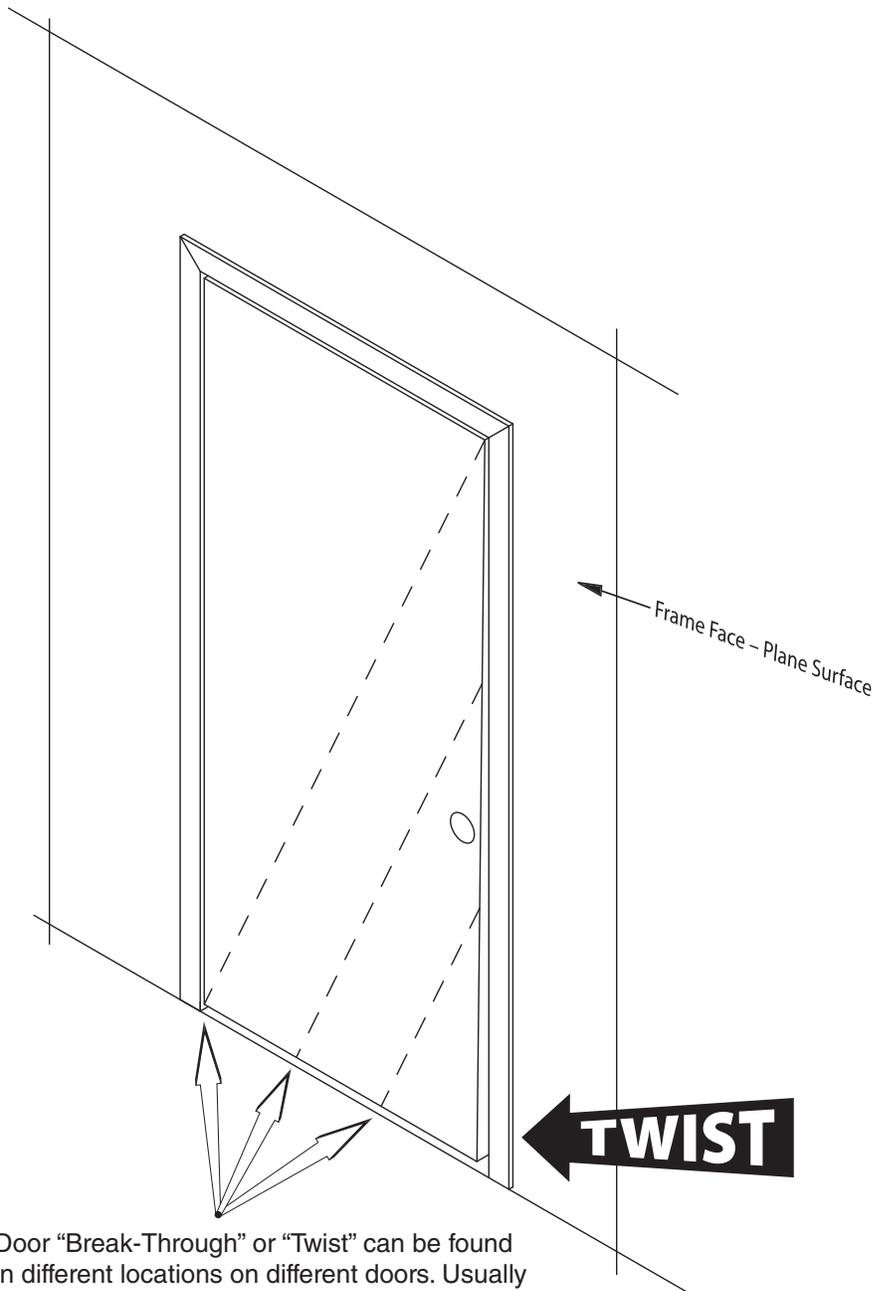
Normal installation results in the plane of the door face being parallel with the plane of the frame face. If the frame is square and plumb, all face surfaces of the frame will be in the same plane. A twisted door will “break through” the frame’s face plane surface. **BE SURE** the frame is square and plumb. If it is not, the problem is probably with the frame installation and **NOT** the door.

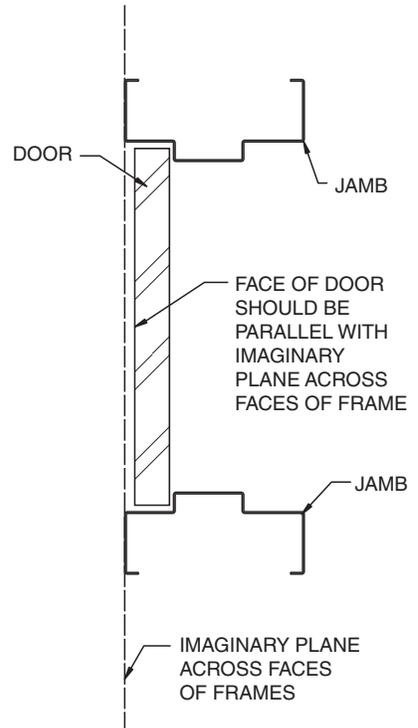
Door “Break-Through” or “Twist” can be found in different locations on different doors. Usually it is found diagonally between opposite lower and upper corners.

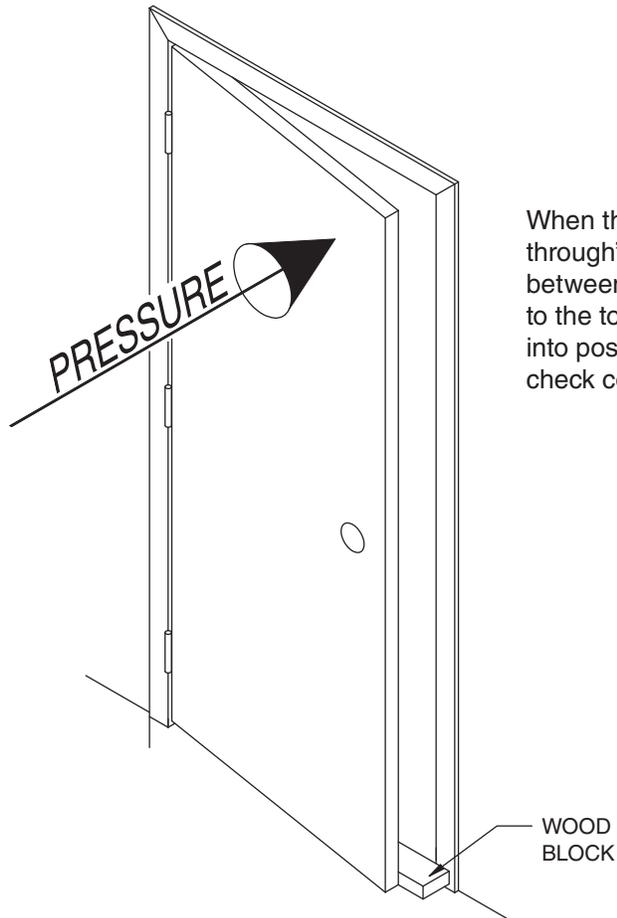
Twisted at Top

When the top lock area of a door is “breaking-through” the plane, place a wood block on floor, between door and frame as shown. Apply pressure to the top lock area as shown to “spring” door back into position. Remove wood block, close door and check condition. Repeat if necessary.

When required, it is possible to “spring” the door back to (or much closer to) its ideal position of being parallel with the plane across the faces of the frame. This can usually be done with the door remaining in the frame. A piece of wood blocking must be placed between the door and frame. Pressure is then applied at the twisted area to “spring” the door. However, caution should be exercised on drywall installations since the frame could possibly work loose from the wall, particularly with slip-on drywall type frames.

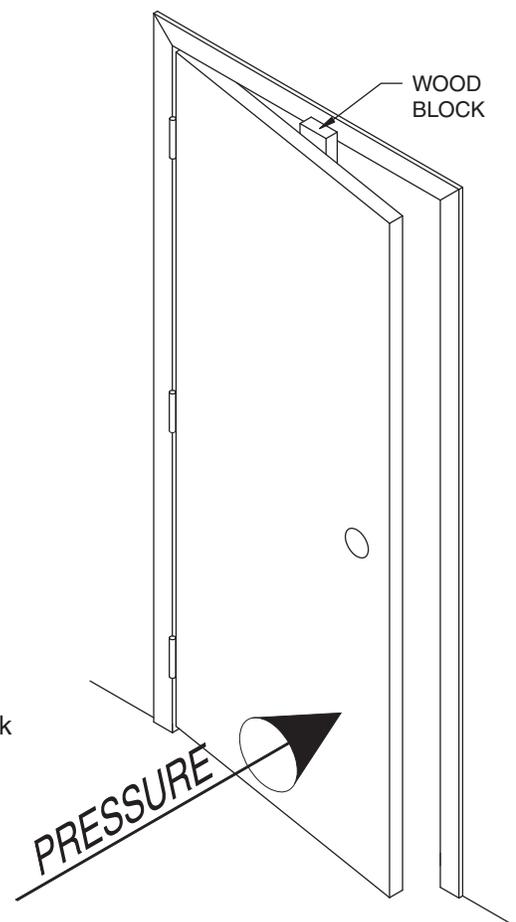
Twisted at Bottom

When the bottom lock area of door is “breaking-through” the plane, place a wood block between frame head and door as shown. Apply pressure to the bottom lock area as shown to “spring” door back into position. Remove wood, close door and check condition. Repeat if necessary.

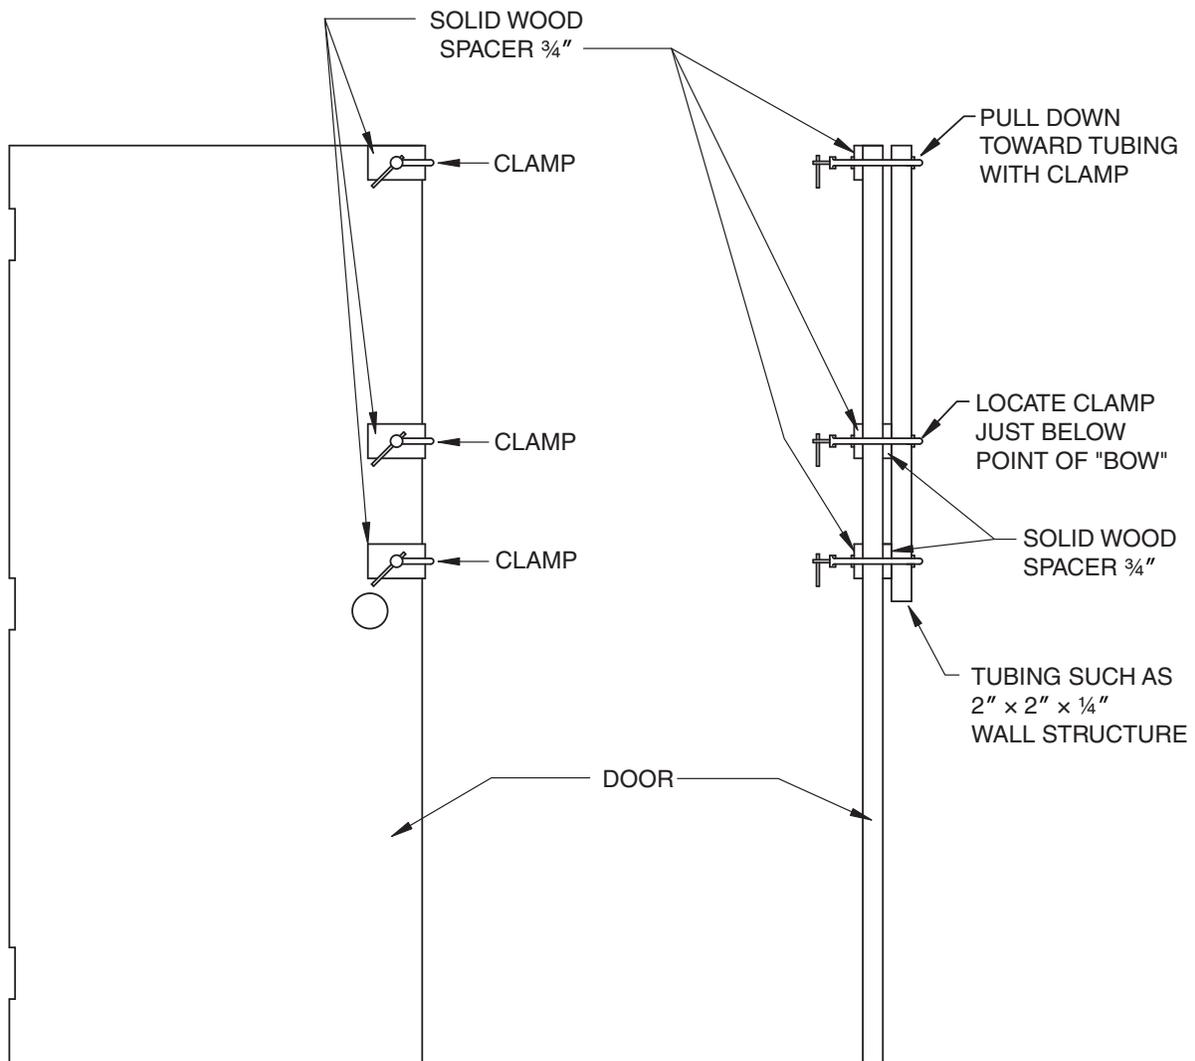
An alternate method can also be used which will allow the door to remain in the opening. This method might be appropriate in drywall installations as previously mentioned. Although the example shown deflects the top half of the door, this method could be used on the bottom half of the door as well.

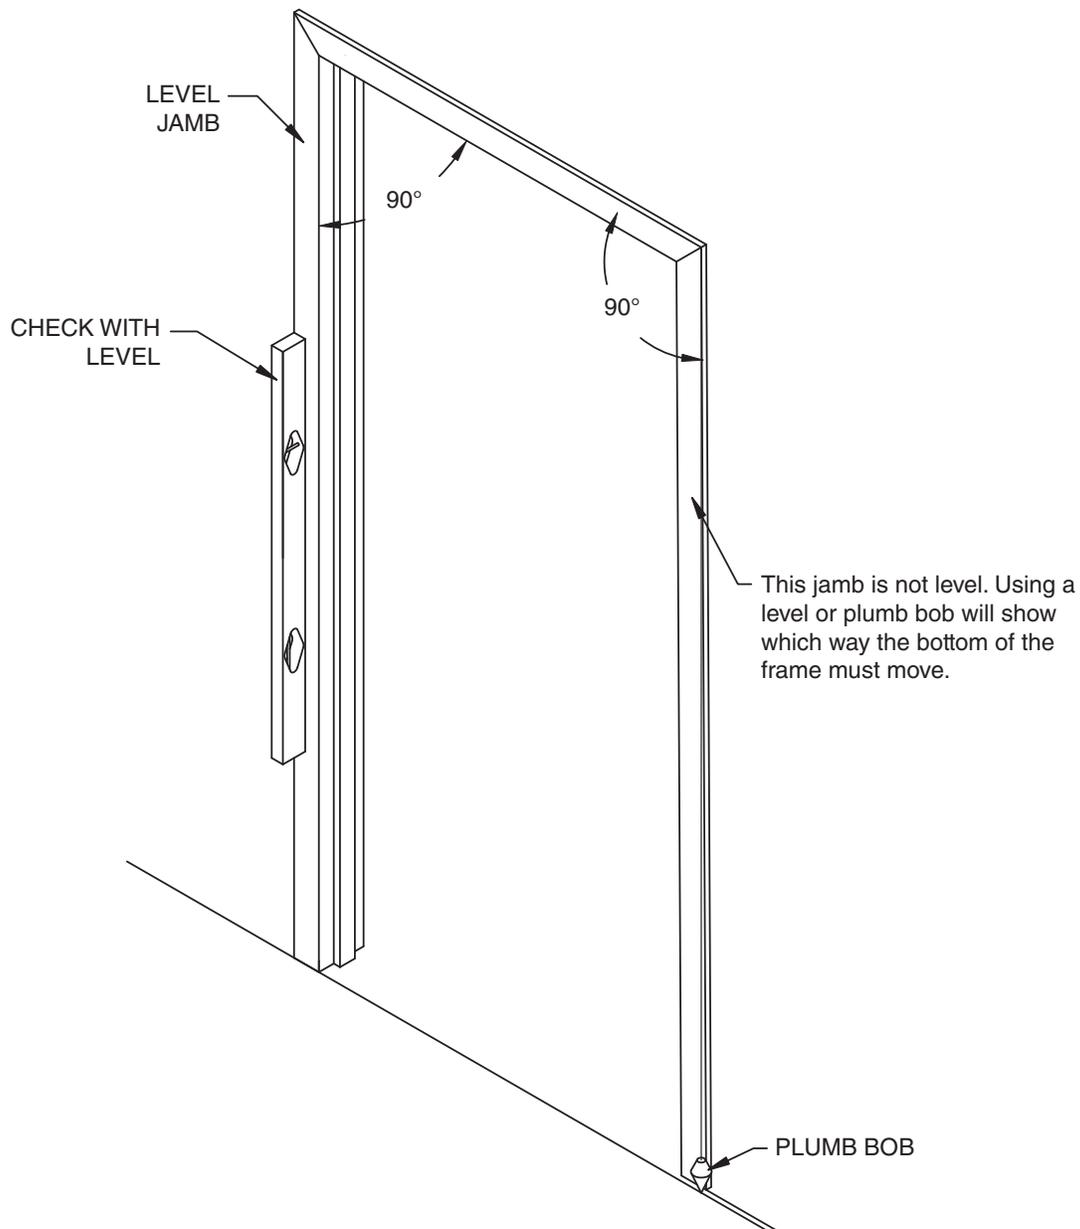
Wall conditions and anchoring methods can cause the frame to be “twisted” in the opening. The two jamb (hinge and strike) faces are not in the same plane as discussed in the twisted door section. This can be checked by using a level and/or plumb bob. Frames do not have adjustments when it comes to “twist”.

The “twist” condition is generally caused by the wall conditions. The frame jamb faces are prevented from being set in the same plane because the walls are out of plane to begin with.

The options available to correct this problem depend, to a large extent, on the wall construction.

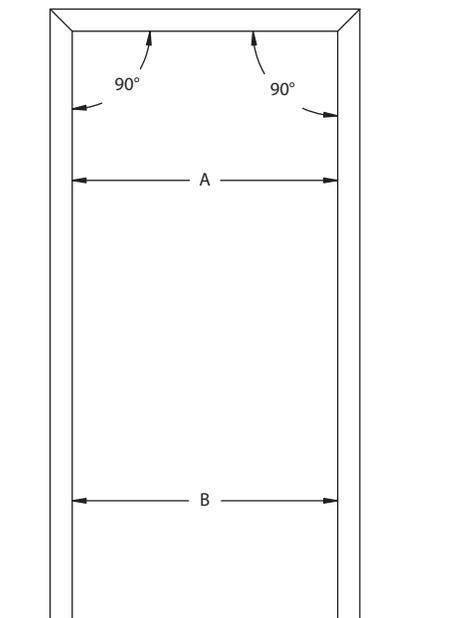
PROPERLY SET FRAME

All corners are 90°. The dimension taken at Point “A” is equal to the dimension checked at Point “B.” Both hinge and strike jambs are plumb and level.

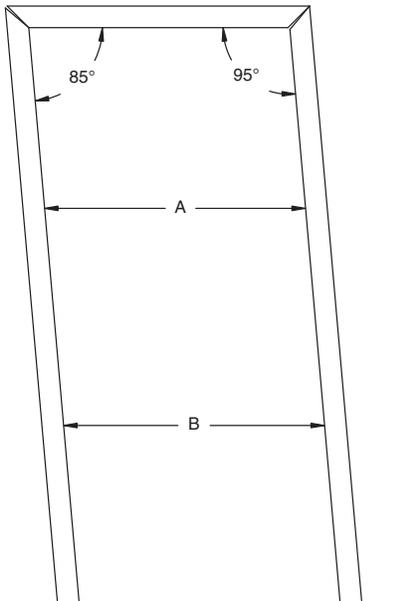
IMPROPERLY SET FRAME (A)

One corner is greater than 90° and one corner is less than 90° . The miters do not properly align with one another and “gaps” are created in the miters which are opposites of one another. The dimension taken at point “A” would remain the same when checked at point “B” if the 90° corners are out of square an equal number of degrees.

This condition can be corrected by adjusting the compression anchors in and/or out of each jamb as required. Loosen the corner clip screws if the frame is so equipped before making adjustments; retighten when finished. The compression anchors must be adjusted (turned) in opposite directions to allow the jambs to move.

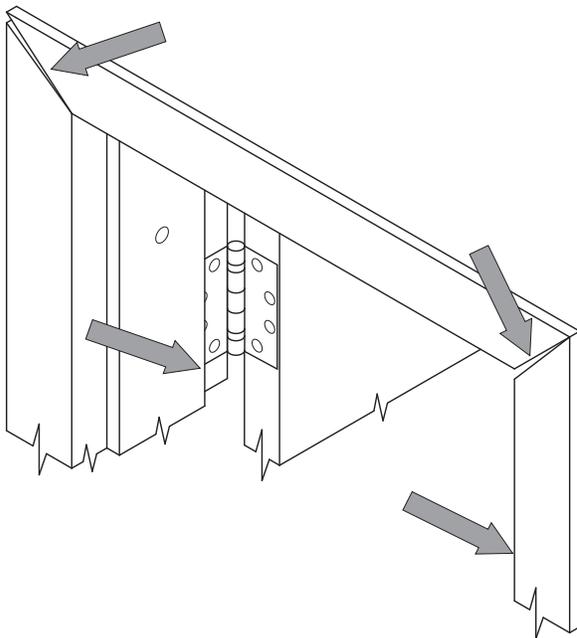
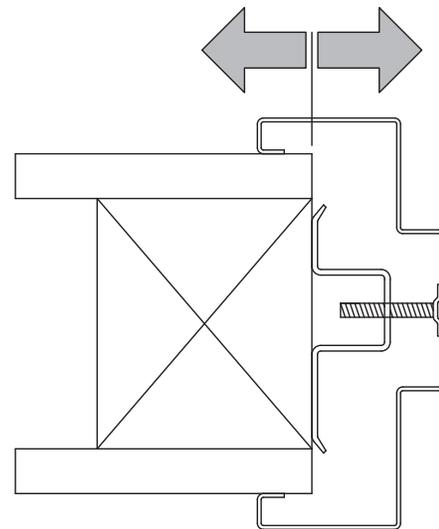
For the illustration shown, the strike jamb compression anchor screw must be turned counterclockwise to retract the compression anchor and give room for the frame to be adjusted back into position using the hinge jamb compression anchor. The hinge jamb compression anchor screw is then turned clockwise to advance the anchor and push the frame towards the room made at the

strike jamb. The frame should be brought into square with the header and the hinge jamb compression anchor. Once this is done, the strike jamb compression anchor screw can be turned clockwise, advancing the anchor snug against the stud. The corner slip screws should then be retightened.

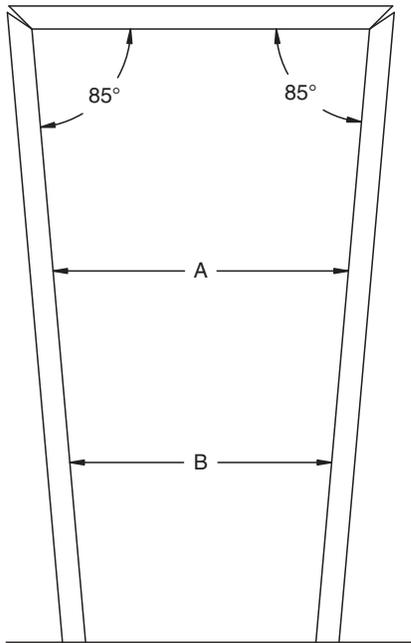
**Jambs Toed In at Sill**

To correct this condition, the sill anchors must be loosened to allow the bottom of each jamb to be moved in and/or out. In the case of the snap-in type sill anchor, the baseboard trim might have to be removed to gain access to the anchors. This type of anchor is generally used because it can be hidden by covering it with the baseboard trim.

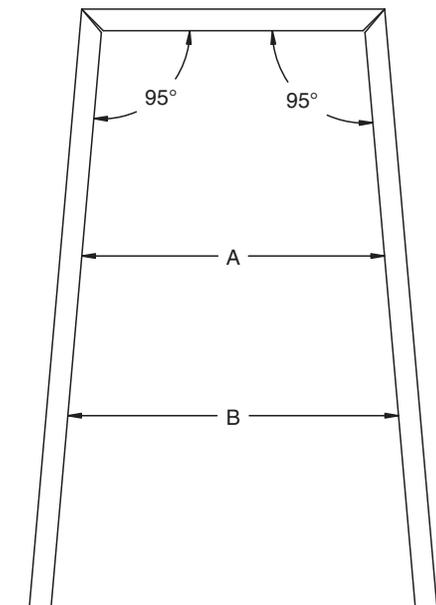
**Jambs Toed Out at Sill**

The corners are both greater than or less than 90° . The miters do not properly align with one another. When the corner is less than 90° the miter will have a gap which increases as it goes towards the return. When the corner is greater than 90° the miter will have a gap, which increases as it goes towards the rabbet. Dimensions taken at point "A" and "B" will not be equal. This condition will always result in dimension "B" being either greater than or less than the nominal opening dimension which would be obtained if checked between jambs along the header.

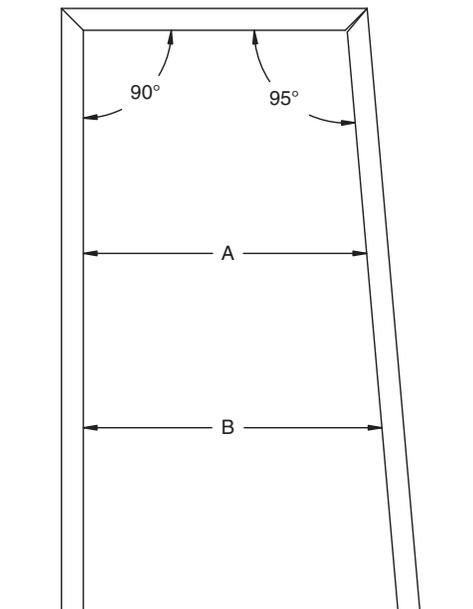
**One Jamb Toed Out**

One corner is properly set at 90° while the other corner is greater or less than 90°. The dimension taken at point "A" will constantly change when checked at various points going towards point "B." The corner miter will not properly align between the header and jamb which is not set at 90°

The jamb which is not 90° to the header must be moved. To correct this condition, the sill anchor must be loosened to allow the bottom of the jamb to be moved in or out as required. In the case of the snap-in type sill anchor, the baseboard trim may have to be removed to gain access to the anchor. This type of anchor is generally used because it can be hidden by covering it with the baseboard trim.

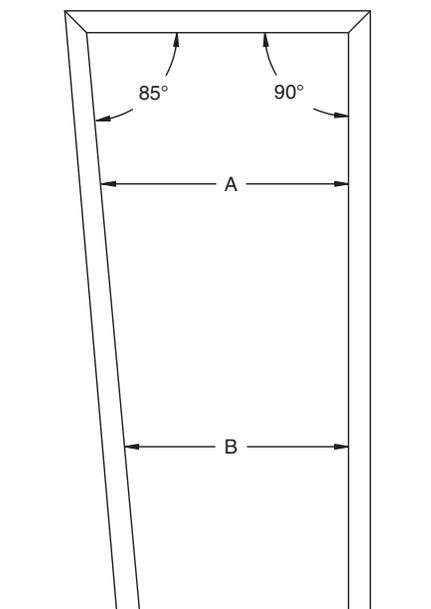
**One Jamb Toed In**

If the jamb is toed in at the sill, the compression anchor may have to be retracted slightly so the sill (base) of the jamb can be pushed out. The jamb should be plumbed, squared with the header and leveled as it is being pushed out into its proper position. The sill anchor should be reset, the compression anchor adjusted and retightened. The baseboard trim should be reattached to the wall if it had been removed.

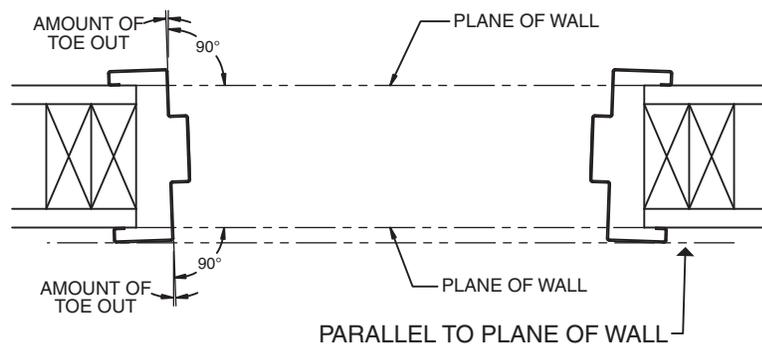
Typical toed-in or out condition

Note that the rabbet surfaces are not 90° to the plane of the wall. This can be checked by placing a straight edge across the face of both jambs.

The straight edge should set flat across both faces at the same time. If the jambs are twisted, a “gap” will be created as shown in the figure to the left.

The below figure shows a condition which can give the impression that the frame is properly installed. Both dimensions “A” and “B” will be equal but the frame will not be square in the opening. Both jambs can be twisted to create a parallelogram. This can be checked by placing a straight edge across the face of both jambs (the straight edge is represented by the dotted line shown below). The straight edge should set flat across both faces at the same time. If the jambs are twisted, a “gap” will be created as shown in the illustration. The “gaps” will be to the same side if a parallelogram was created. The gaps could also be to opposite sides as shown in the Typical Toed In or Out Condition figure on the previous page.

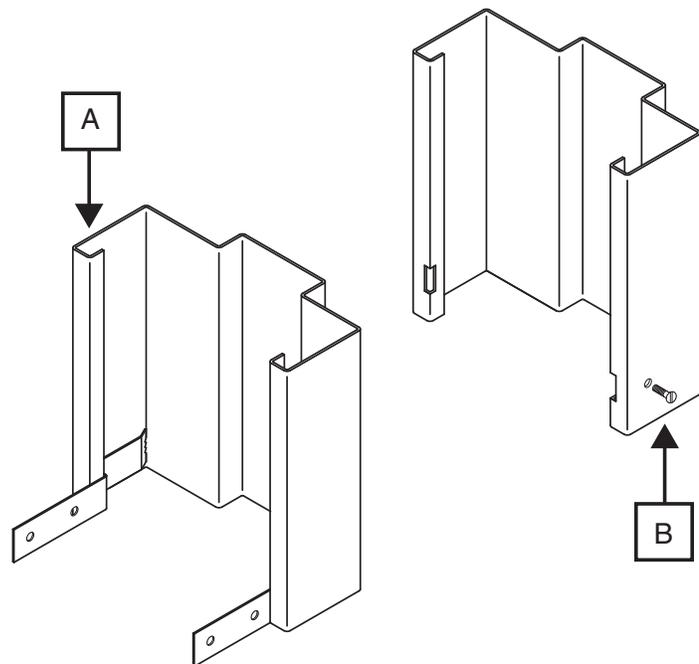
“A” shows an anchor which will be covered up by the baseboard trim. To gain access to this anchor the baseboard trim must first be removed. Next, the nails or screws holding the anchors to the wall must be removed. This will loosen the jamb and allow it to be squared in the opening.

“B” illustrates a screw going through the face of the frame into the wall. This holds the sill of the frame in position. This screw is exposed and is readily accessible. Removing the screw will loosen the jamb and allow it to be “squared-up” in the opening. If both jambs are toed in/out, they both should be “squared-up.” This can be checked by taking measurements as shown below. Both the “A” and “B” dimensions will be the same when the frames are properly set. However, the frame jambs must be plumb, level, and square with the head of the frame.

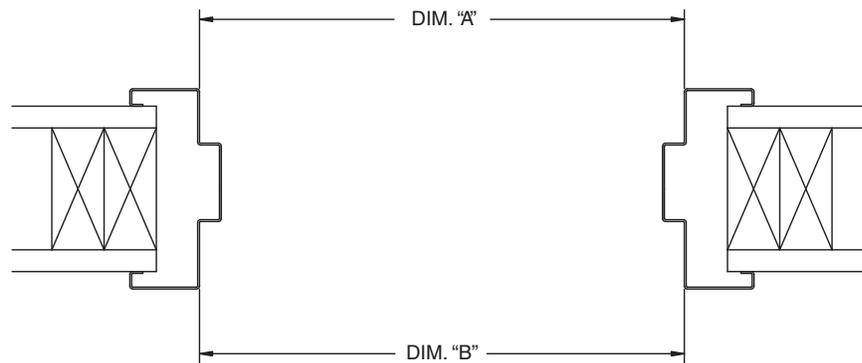
If both jambs are toed in/out, they both should be “squared-up.” This can be checked by taking measurements as shown above. Both the “A” and “B” dimensions will be the same when the frames are properly set.

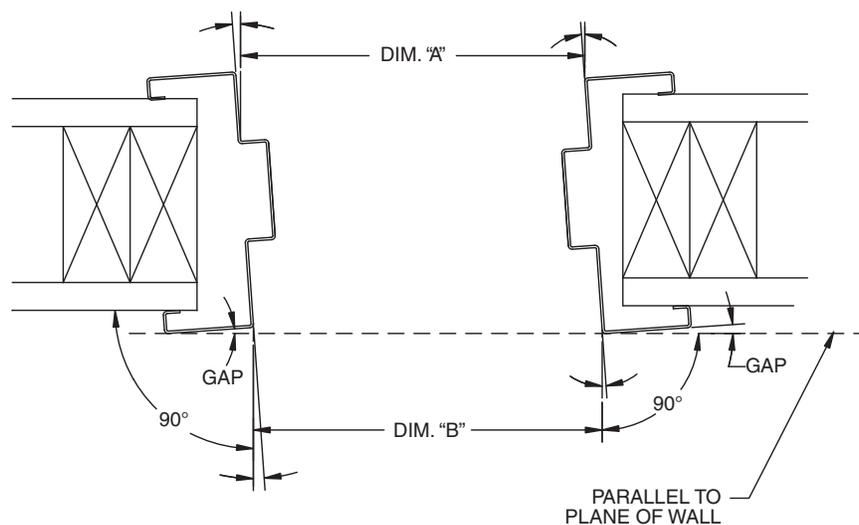
This condition can be corrected as outlined for the other “toe out” or “toe in” examples.

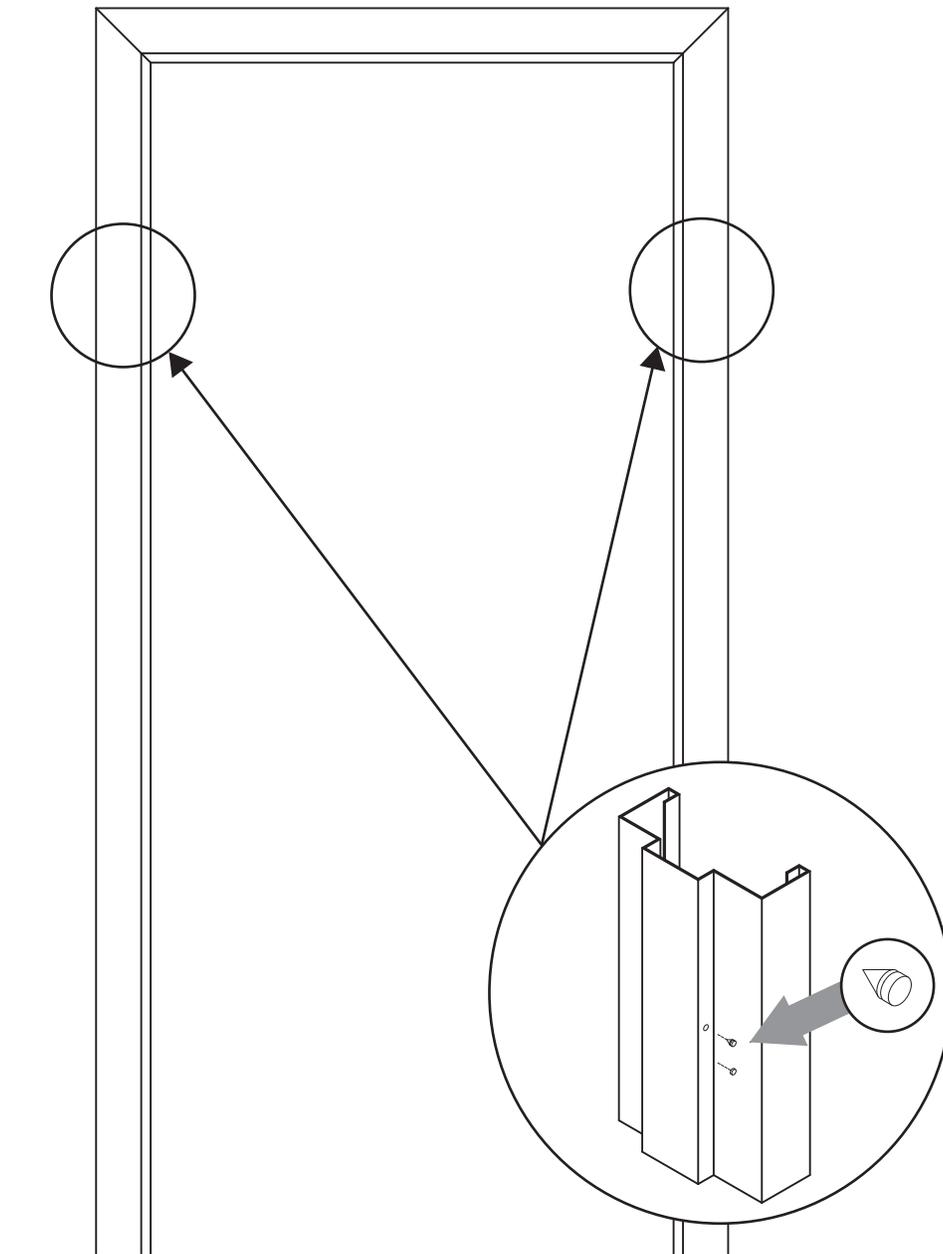
Some manufacturers provide a silencer hole in the frame stop to accept a push-in silencer. A “stick-on” silencer is also available for application to frames without the silencer hole. The silencer acts as a “rubber bumper” which evenly holds the door off the stop at a constant distance. If the door is held off of the stop rather than being allowed to move slightly towards the stop, the latch tube will fit tighter into the strike. Three silencers are placed on the strike jamb, one toward the top of the jamb (nearer the header) and one toward the bottom of the jamb (nearer the sill) and the third near the strike preparation.

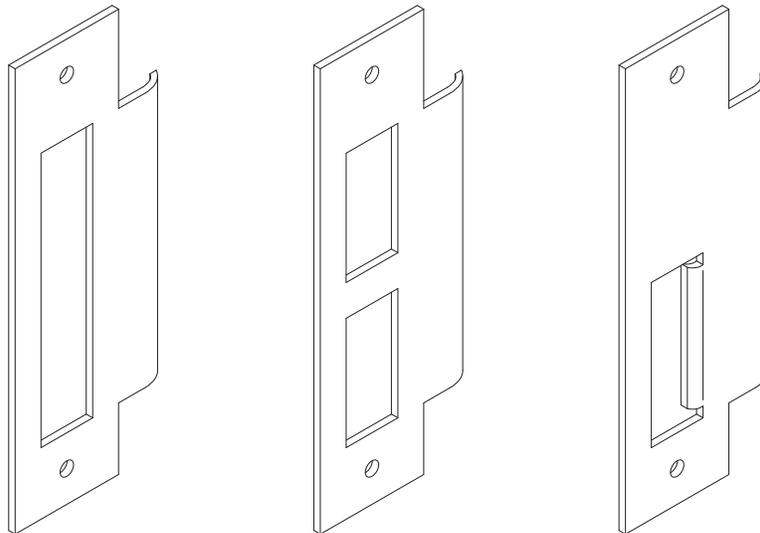
PROPER STRIKE

Is the proper strike plate attached to the frame?

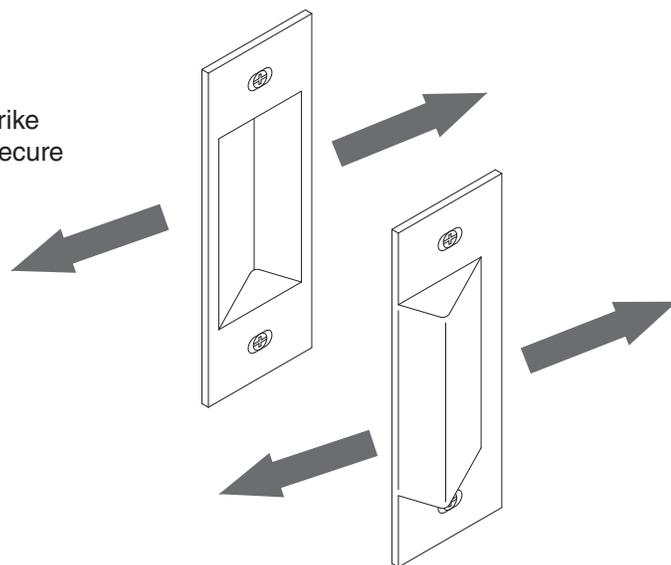
RIM EXIT DEVICES

An adjustable strike plate is provided. Is the strike plate properly adjusted to provide positive and secure latching?

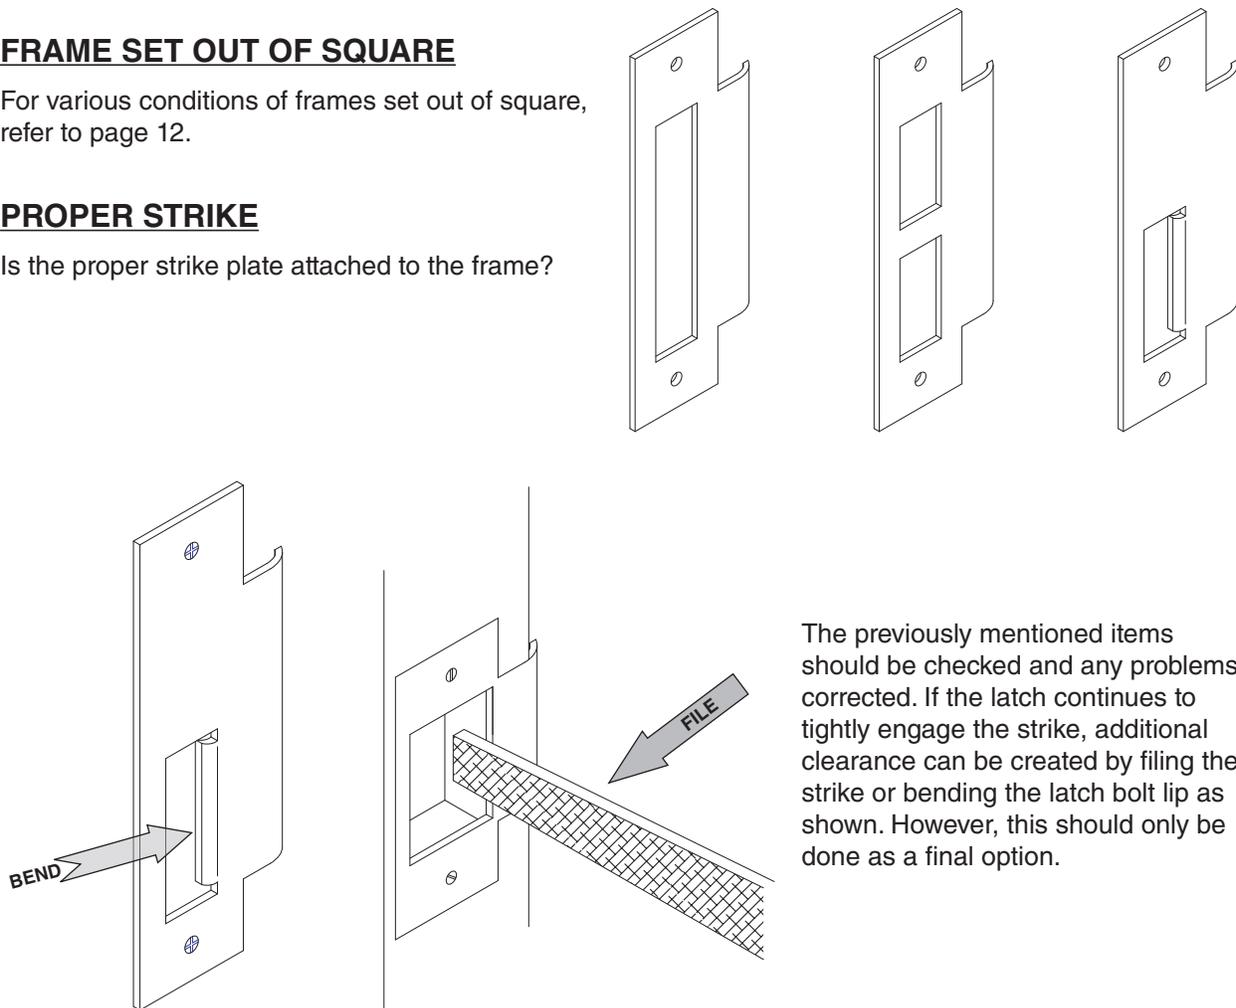
The previously mentioned items should be checked and any problems corrected. If the latch continues to tightly engage the strike, additional clearance can be created by filing the strike or bending the latch bolt lip as shown. However, this should only be done as a final option.

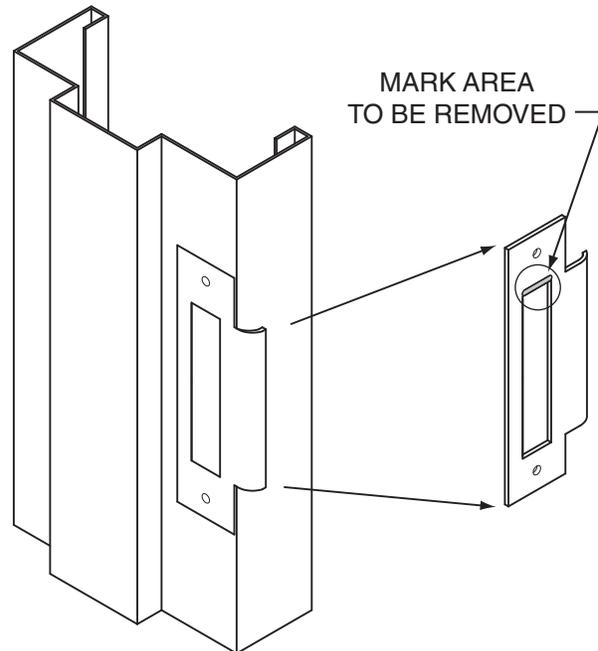
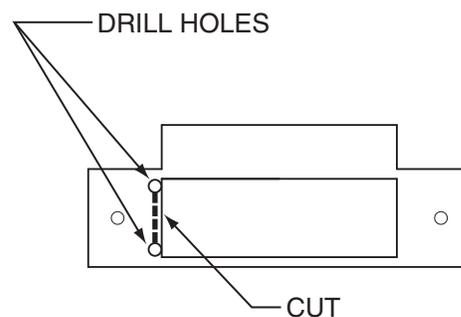
Minor location adjustments usually can be accomplished by altering the strike plate. The strike plate alteration would “extend” the opening to allow the latch tube to properly engage the strike. This is similar to the section “Lock Fits Too Tight in Strike” except that the amount of material removed from the strike is greater. This could compensate for minor mislocation of the strike plate on the frame and/or location of the lockset on the door. These general steps should be followed for modifying the strike plate.

- Mark the area on the strike plate which must be removed.
- Remove strike plate from frame.
- Center punch corners of area to be removed and drill a $\frac{1}{8}$ " diameter hole in each corner.
- Use a saber saw and cut from the existing opening up to the $\frac{1}{8}$ " diameter holes. The remaining material between the two $\frac{1}{8}$ " holes should be filed away.
- Dress off all rough edges and corners with a file. This must be done since any irregular edges or edges with burrs could cause the latch tube to “drag” or “hang up” in the strike plate.
- Reassemble strike plate to frame and check alignment with lockset on door as well as latch tube function in and out of strike plate.

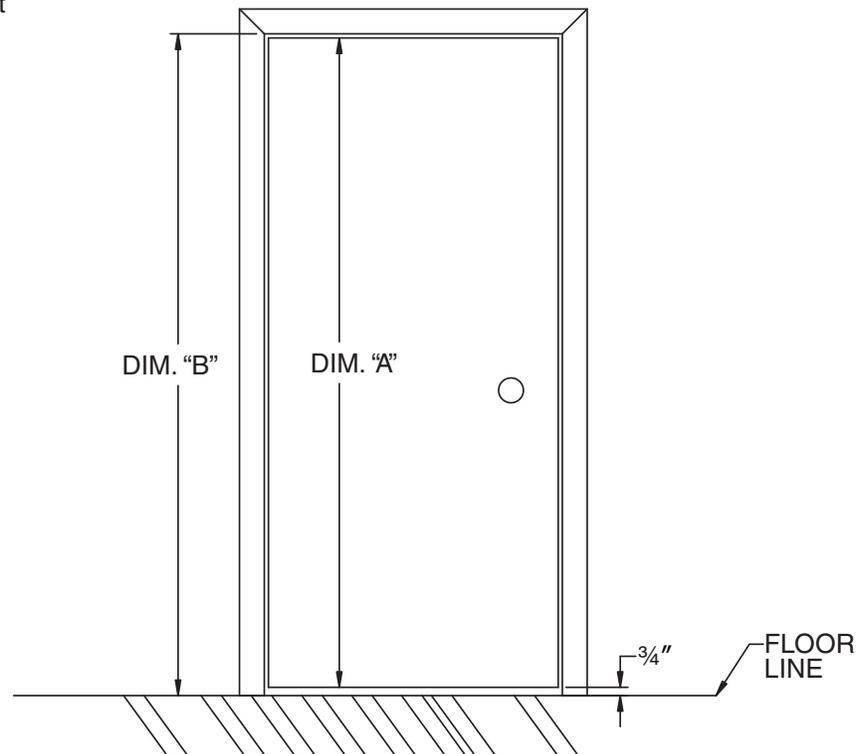
The door height is determined by taking a measurement represented by dimension “A” in the figure. If the door height is “oversize” the clearance at the bottom will be too small.

The frame jamb height (which is the same as the opening height) is determined by taking a measurement represented by dimension “B”. If the jamb height is “undersize,” the clearance at the bottom will be too small.

The bottom of the frame jambs should be set “on” the floor not “in” the floor. In some special cases the jambs can be set “in” the floor but this requires special design consideration and adjustments in door height and jamb heights. If this was not compensated for in the designed heights, the clearance at the bottom could be too small.

The available options for correcting this problem are limited. Frames which are permanently anchored to the wall construction (such as masonry or steel stud) leave few alternatives. The only available “fix” is to trim the bottom of the door, if the door’s construction will permit trimming. As shown in the figure below, the nominal “sill clearance” should be $\frac{3}{4}$ of an inch. The sill clearance is the dimension from the bottom of the door to the bottom of the frame jambs, and $\frac{3}{4}$ ” is a standard industry dimension.
