**Installation
Troubleshooting Guide
for
Standard
Steel Doors and Frames**

STEEL DOOR INSTITUTE

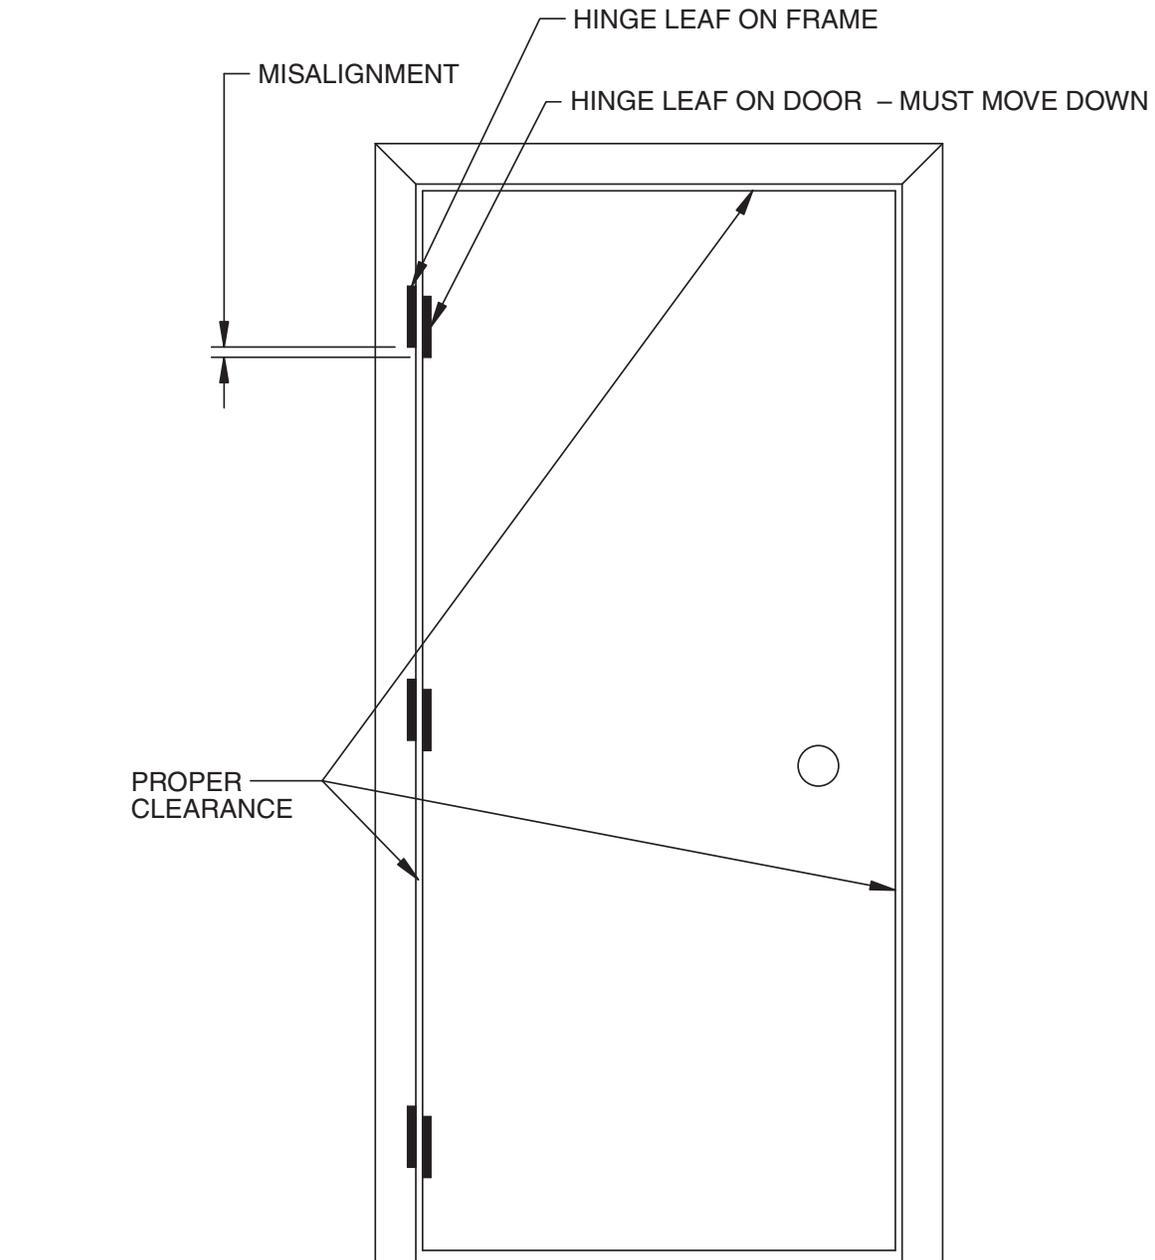
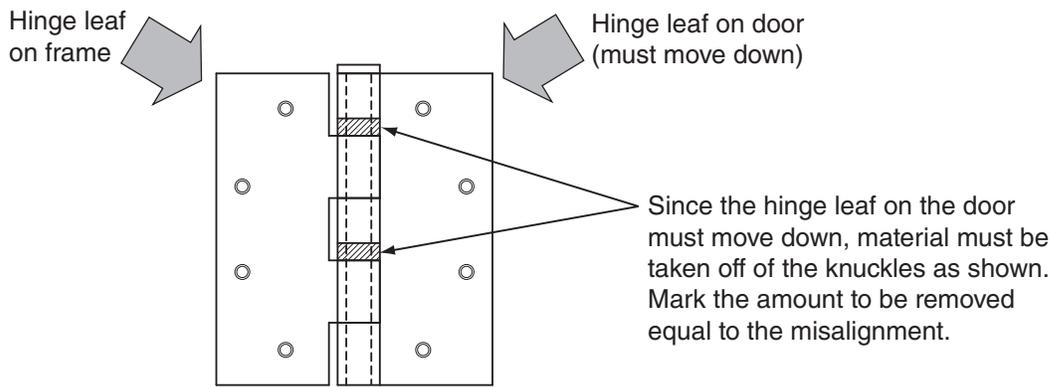
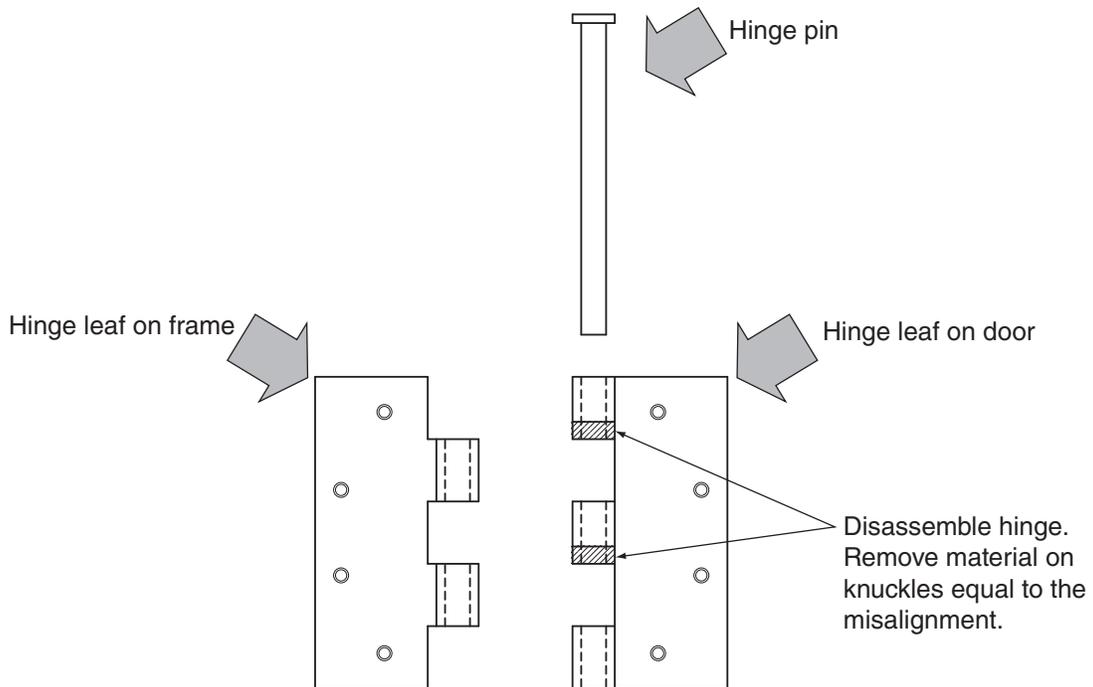
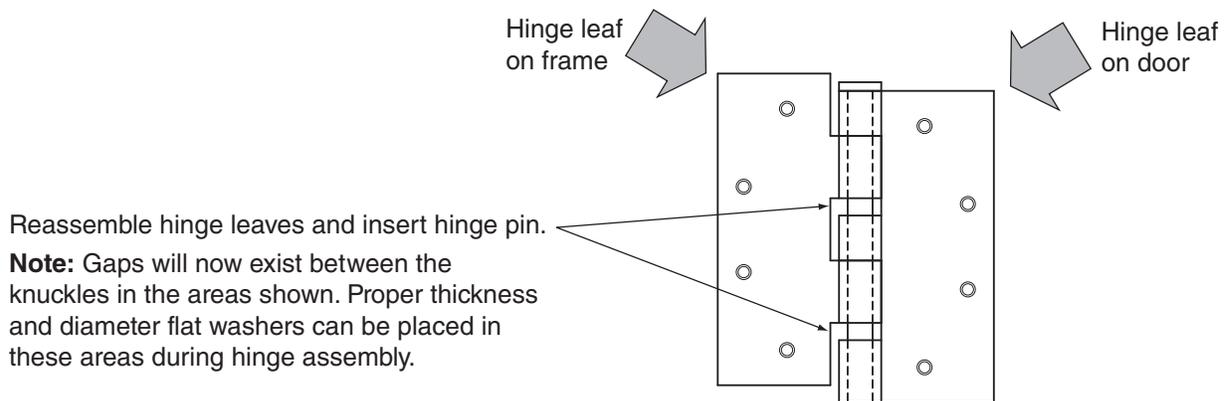
The example shown on the following page reflects the dropping of the hinge leaf which attaches to the door from its relationship to the hinge leaf on the frame. However, by removing material from the opposite end of the knuckles, the door hinge leaf could be raised as well. The frame hinge leaf can also be relocated in similar fashion.

Frame and door hinge misalignment can cause a variety of problems. When misalignment occurs, either the door's hinge locations or frame's hinge locations are slightly off. This can apply to retrofitting existing openings where either the door or frame is being replaced, but not both. When new doors and frames are provided from a single manufacturer, this problem does not exist.

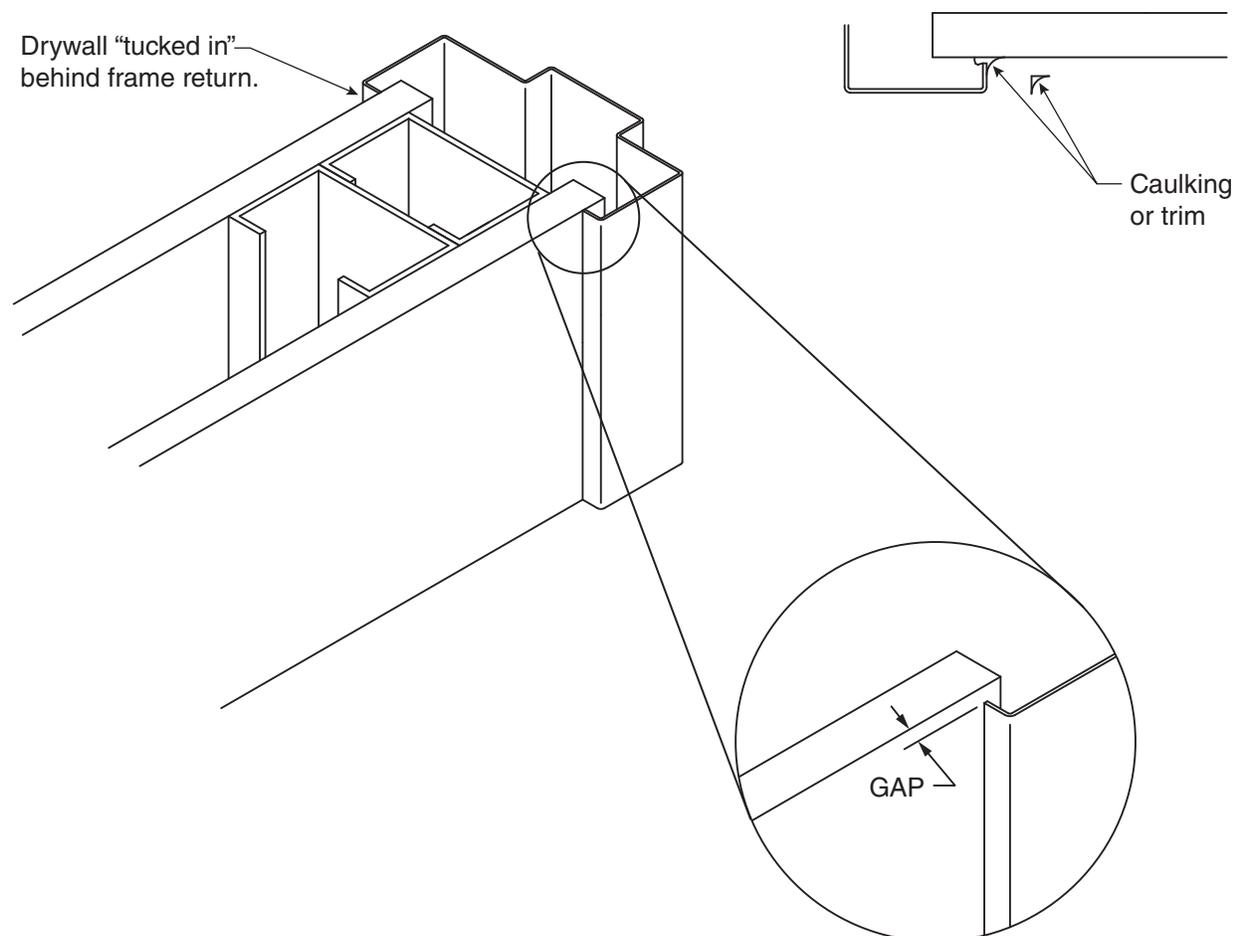
WELDED/SNAP-IN STEEL, OR WOOD STUD ANCHORS

Some frames use welded or snapped-in steel or wood stud anchors. These frames are installed prior to the drywall material being attached to the studs. The drywall can either be "butted-up" against the return of the frame or be "tucked in" behind the return of the frame. Only in the installation where the drywall is "tucked in" behind the return can there be a condition where the frame is loose on the drywall. This gap could be uniform along the entire length (height) of the jamb or could be only in certain areas. Since the frame cannot be removed, the only available options are to caulk the gap or cover it with trim.

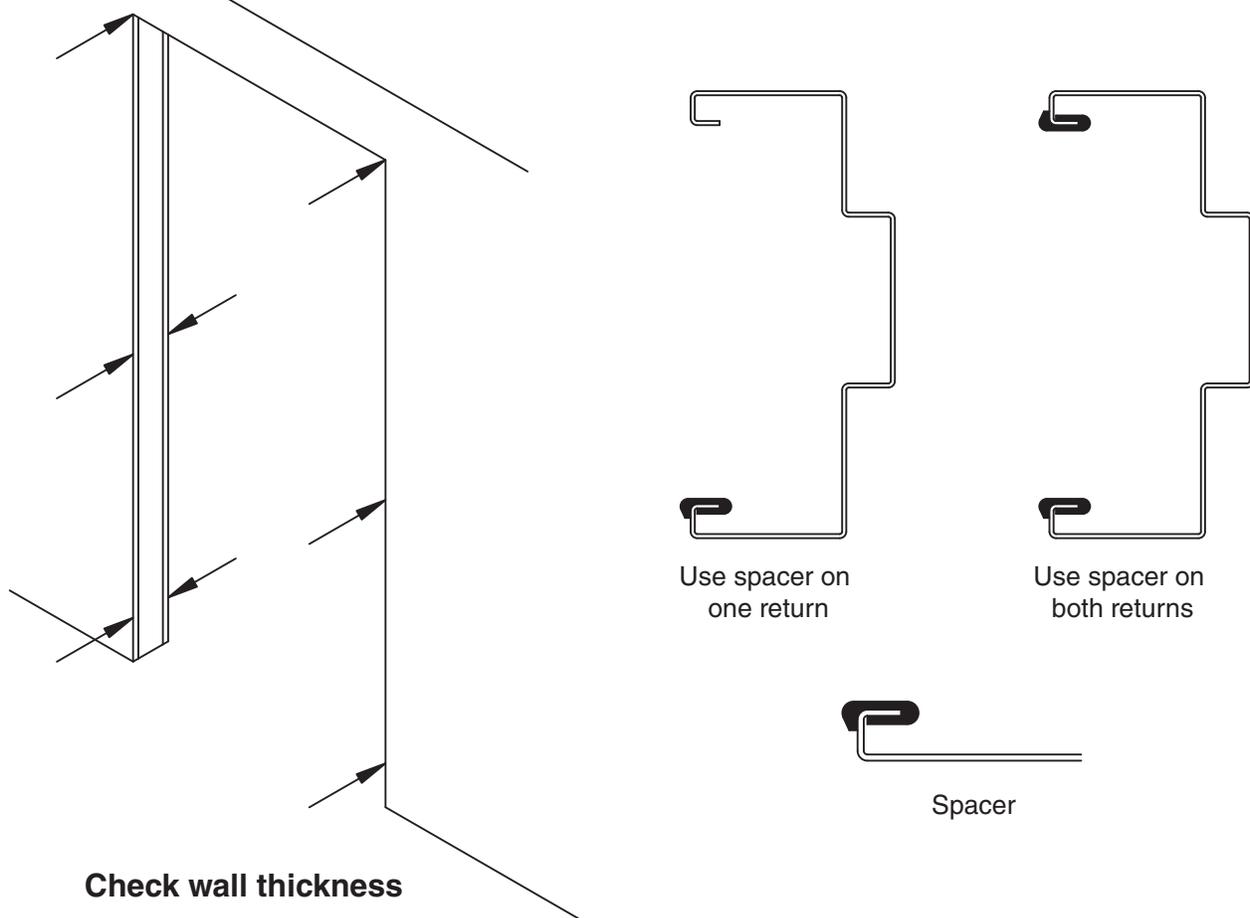
- 1) The first condition is a uniform gap along the entire length (height) of the frame jambs. The frame should be removed from the opening and the wall thickness checked at numerous places around the opening. These measurements should be compared to the job specifications. If the wall thickness is undersize, two options are available.
 - a) If the gap is relatively small, the use of caulking or trim can be considered to cover the gap when the frame is installed.
 - b) If the gap is larger, the use of "spacers" can offset the lacking wall thickness. The use of spacers requires that the frame be removed from the opening, the spacer(s) attached, and the frame reinstalled. The spacers can be used on either one or both of the frame returns which would result in spacers on either one side or both sides of the wall. Spacers are available from the frame manufacturer.

SPACERS ARE NOT TO BE USED ON LABELED FIRE DOOR FRAMES.

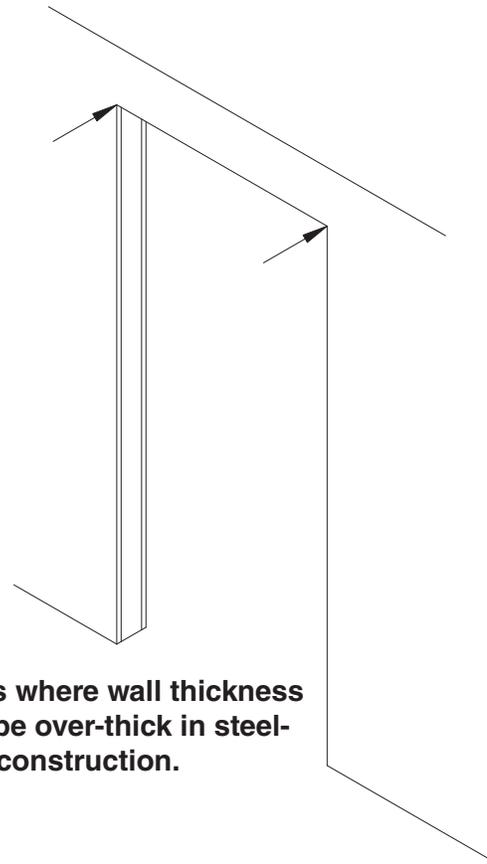
2) The second condition would be a gap that changes along the length (height) of the jamb. This condition is generally found in steel stud construction and results in “over thick” walls in the upper corners of the opening, refer to Figure 5. This is usually a direct result of how the steel stud headers were attached to the vertical steel studs to form the opening. When the wall is oversize (in this area) it will force the header and jamb miters to spread apart and actually open up the throat dimensions to accept the oversize wall. This will cause the corners of the frame to be extremely tight on the wall and as you progress down the jamb, a gap will begin to develop and then gradually disappear closer to the floor, see figure on following page.

Areas where wall thickness may be over-thick in steel-stud construction.

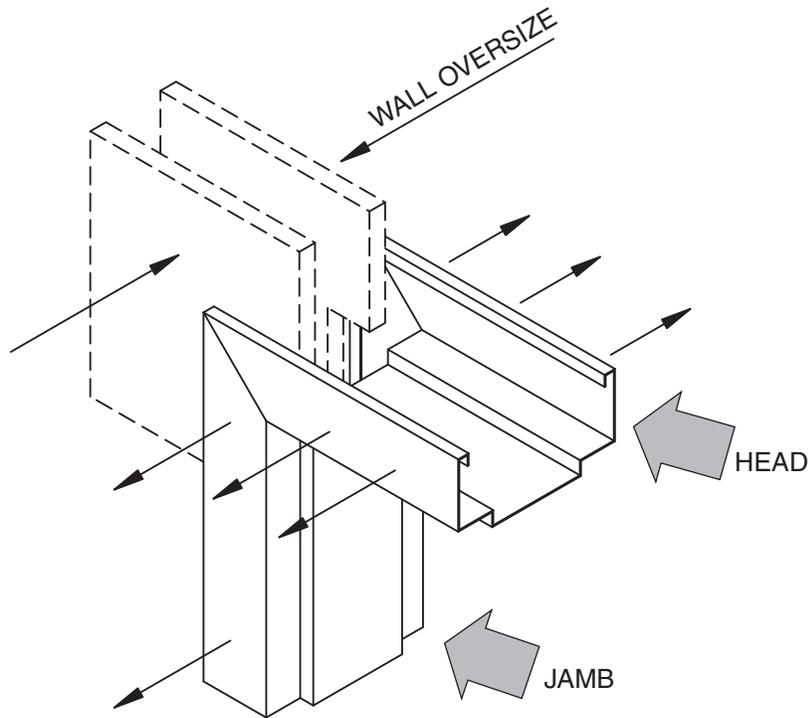
Frame spreads apart with oversize wall.

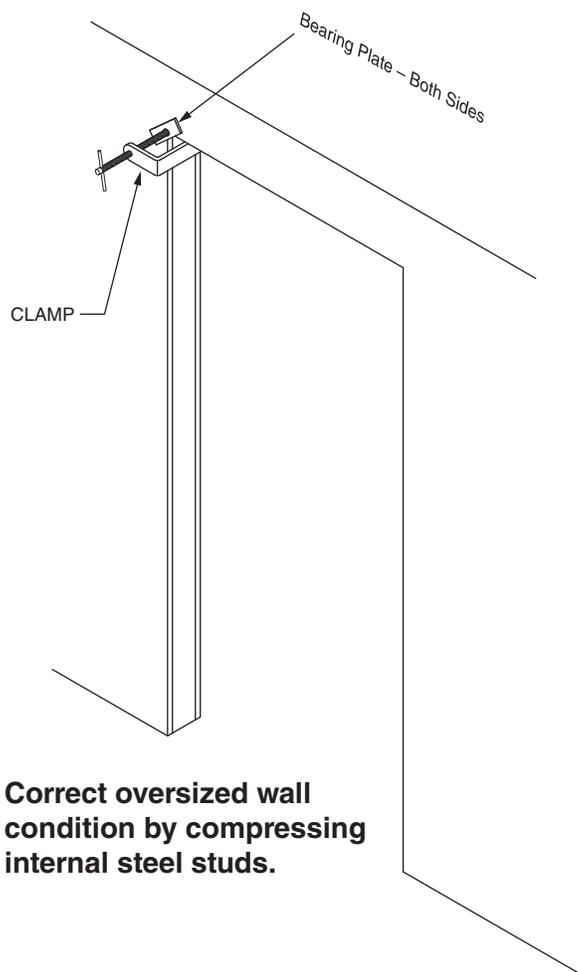
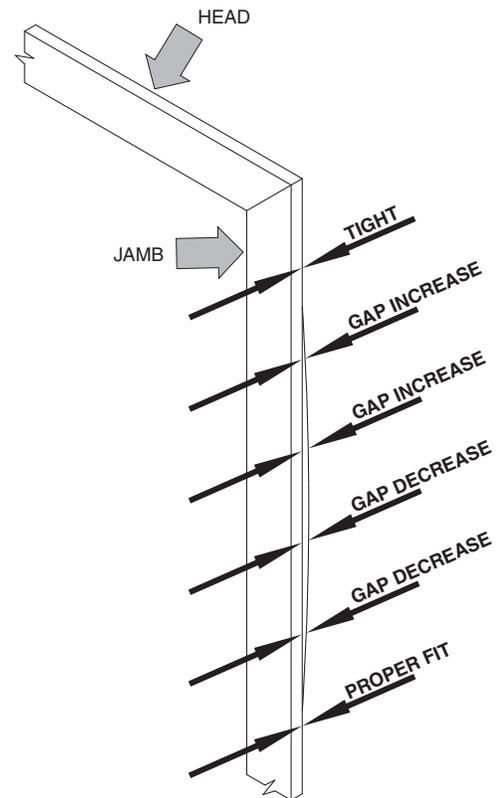
This condition should be reported to the appropriate jobsite personnel. The condition can be corrected by putting a bearing plate on each side of the corner and compressing the internal steel studs with a clamp. However, the responsibility for correcting this condition belongs to the sub-contractor responsible for the actual wall construction.

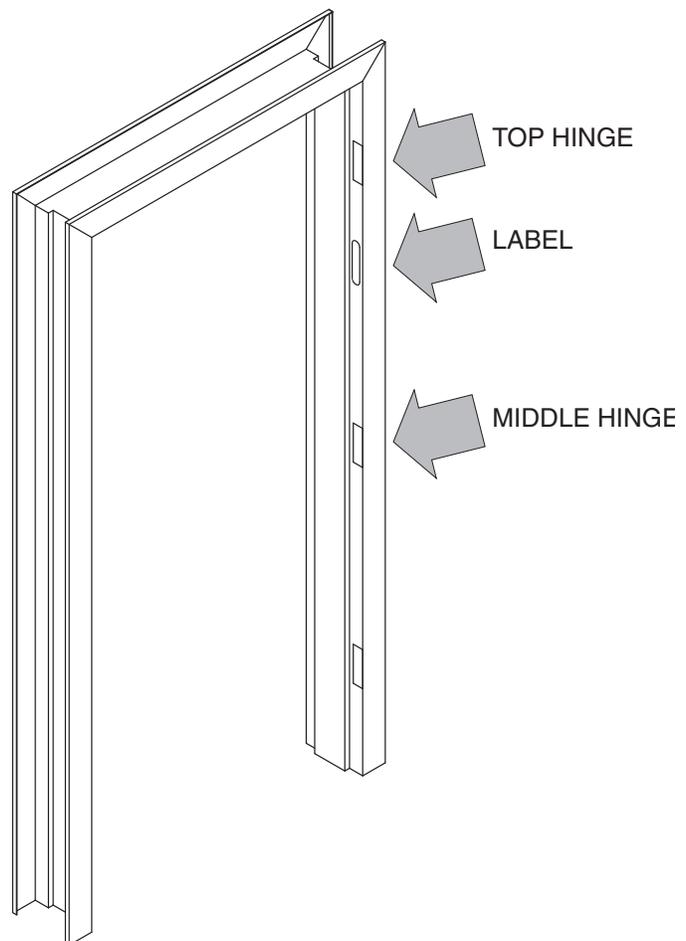
All labels on fire rated frames are located on the hinge jamb between the top and middle hinge (see figure below). It should be noted that some frames have an embossed label, rather than a surface-attached label. The embossed label is stamped into the frame rabbet and can be painted over.

- Borrowed light frames may have labels applied to soffit of frame due to glass and glazing bead location.
- Frames incorporating continuous hinges may have labels applied to soffit or frame head.
- See manufacturer's procedures.

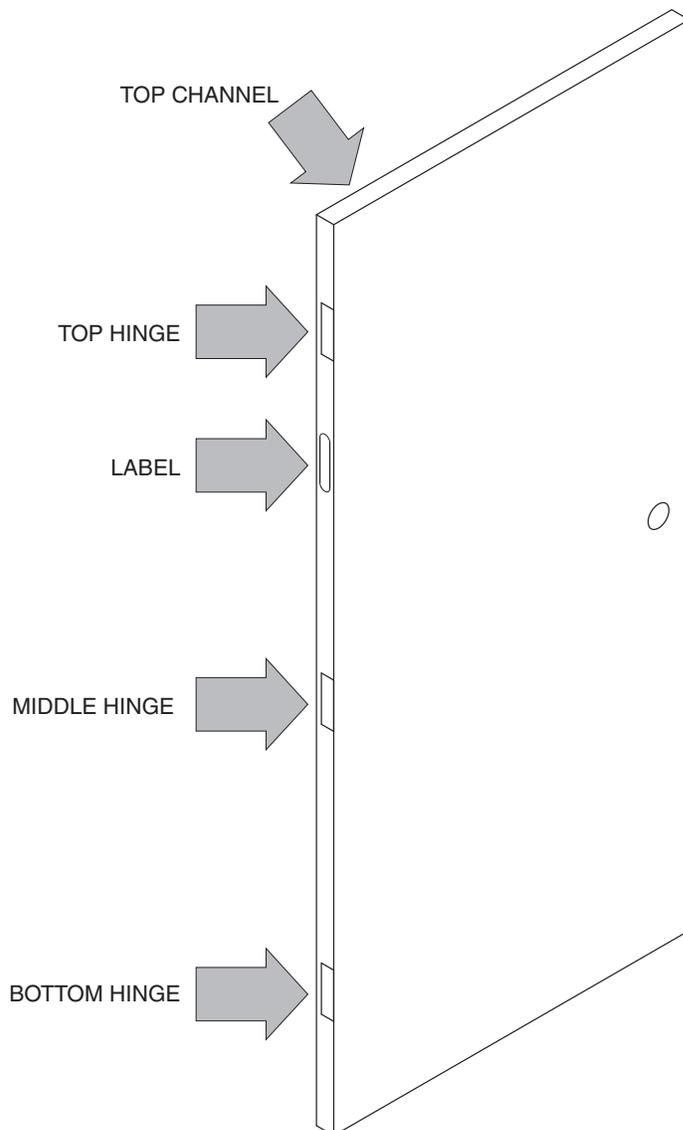
Labels on fire-rated doors are located in one of two places, either between the top and middle hinge, or on the top channel (see figure). Be sure you are looking for the label in the correct location.

- Labeled doors incorporating continuous hinges may have labels placed on the top channel of the door. Check with the individual manufacturer to determine location of label.
- Labeled hollow metal transom panels may need to be removed to verify labeling if fully enclosed by a fixed hollow metal frame.
- See manufacturer's procedures.

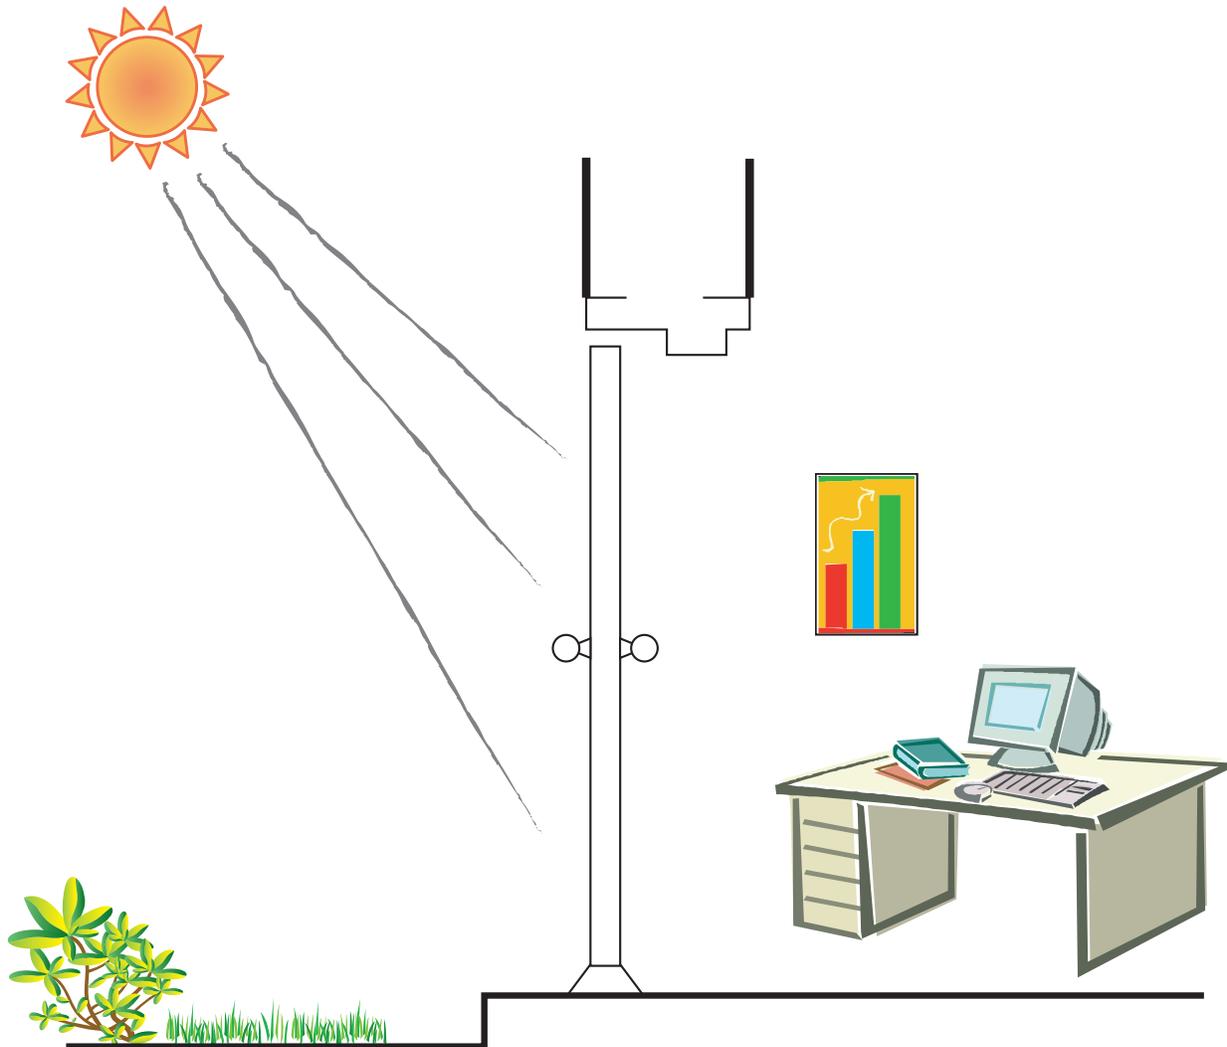
THERMAL BOW

Installers need to be aware of a condition known as Thermal Bow. Thermal Bow is a temporary condition which may occur in metal doors due to the inside-outside temperature differential. This is more common when the direct rays of the sun are on a door surface. This condition is temporary, and to a great extent depends on the door color, door construction, length of exposure, temperature, etc. This condition can often be alleviated by painting the exposed surface a light color. Thermal bow can occur in reverse under extremely cold conditions. Typical symptoms of thermal bow are hardware latching difficulty and door clearance issues.
