## FireFlex FR House Wrap Model Demonstration

February 21<sup>st</sup>, 2022

### 1. House Model Demonstration Purpose:

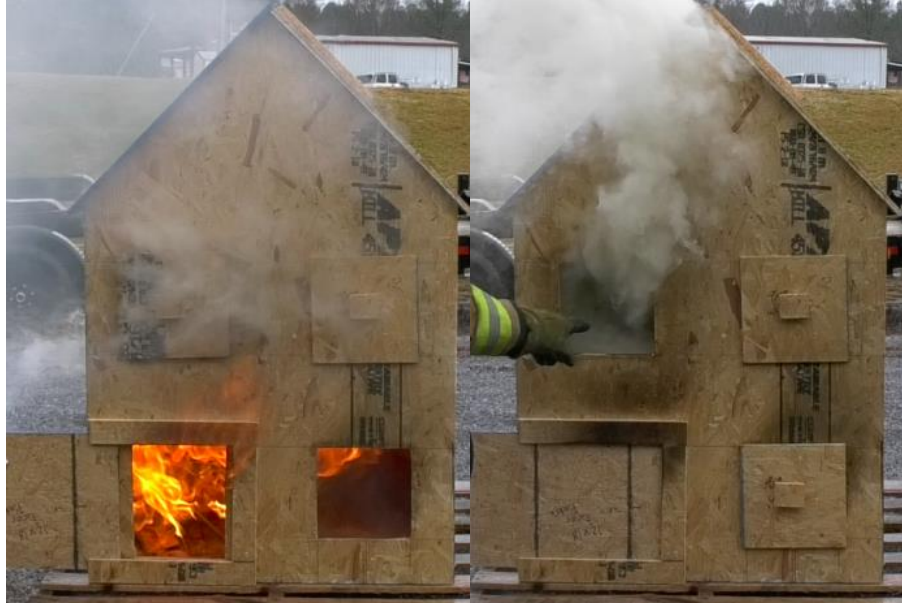
- iii. At **0 h 8 m 49 s** the two 1<sup>st</sup> floor rooms experienced **Flashover Conditions** and the two 2<sup>nd</sup> floor rooms experienced IDLH Conditions
1. NFPA 921 defines flashover as “A transitional phase in the development of a compartment fire in which surfaces exposed to thermal radiation reach its ignition temperature more or less simultaneously and fire spreads rapidly throughout the space resulting in total involvement of the compartment(s)”

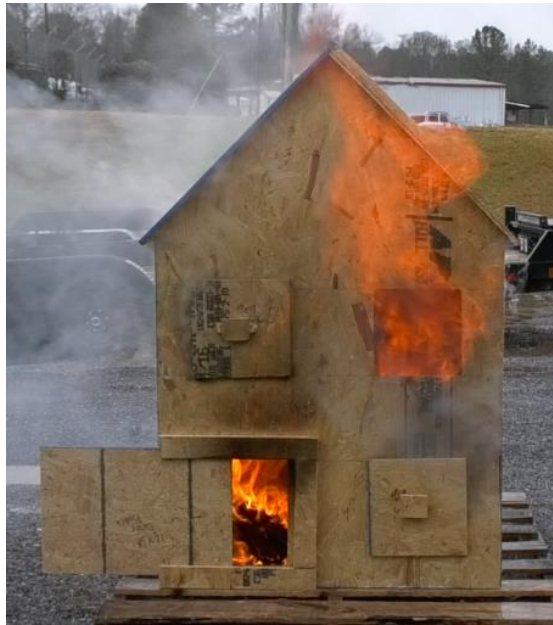
- iv. At **0 h 13 m 27 s** the two 2<sup>nd</sup> floor rooms experienced Flashover Conditions

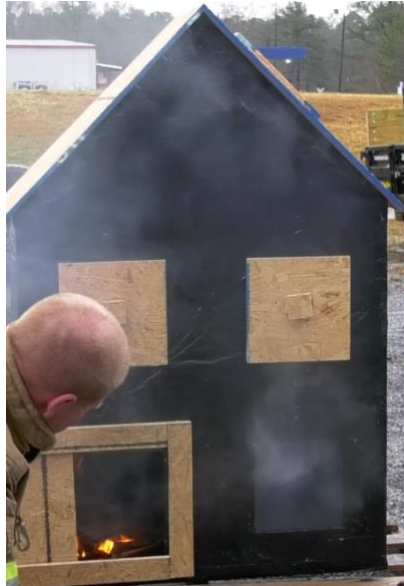
- ii. At 0 h 9 m 33 s conditions in the **ignition room** on the 1<sup>st</sup> floor room reached IDLH conditions

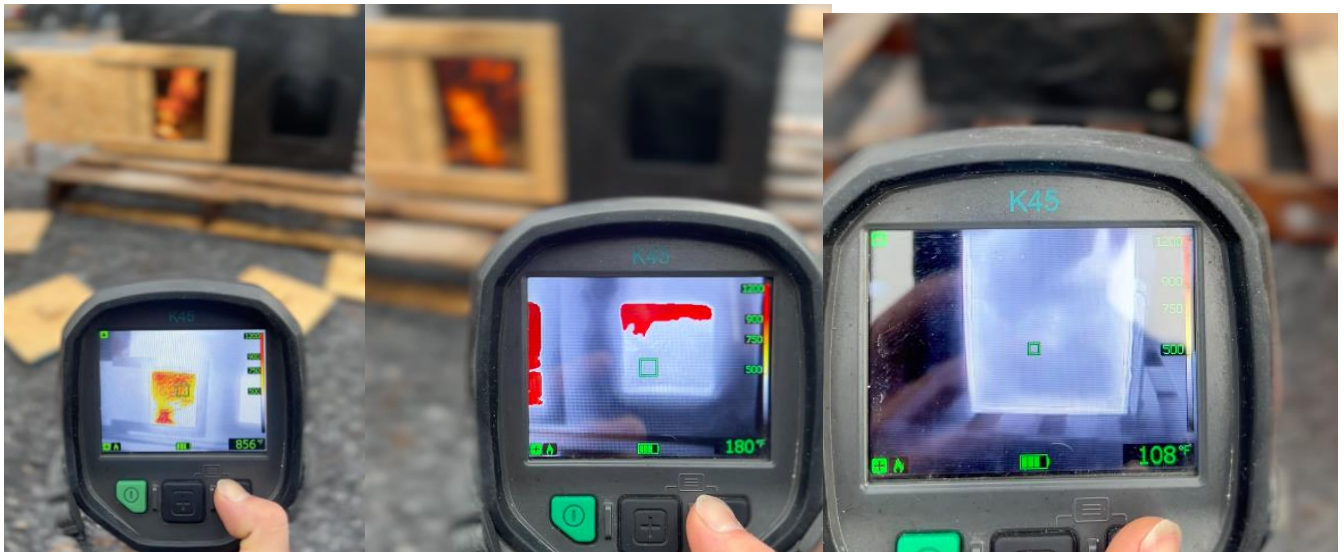
- iii. At 0 h 14 m 32 s difference in temperature between the two 1<sup>st</sup> floor rooms was observed to be 676° F; the difference in temperature between the interior and exterior of the **ignition room** was 748° F

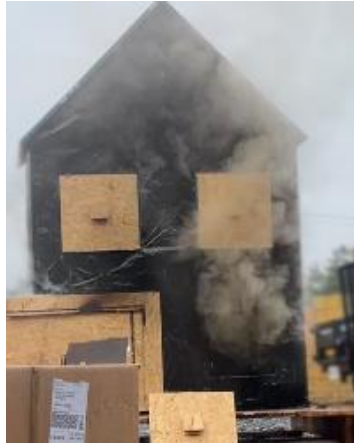
- iv. At 0 h 18 m 51 s the 1<sup>st</sup> floor right room experienced IDLH Conditions

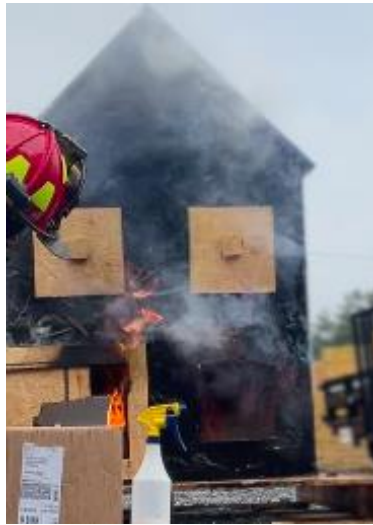
- v. At 0 h 21 m 38 s the 1<sup>st</sup> floor right room experienced Flashover Conditions

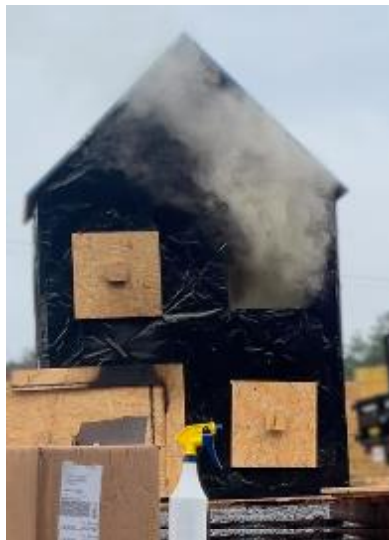
- vi. At 0 h 22 m 52 s the 2<sup>nd</sup> floor right room experienced IDLH conditions

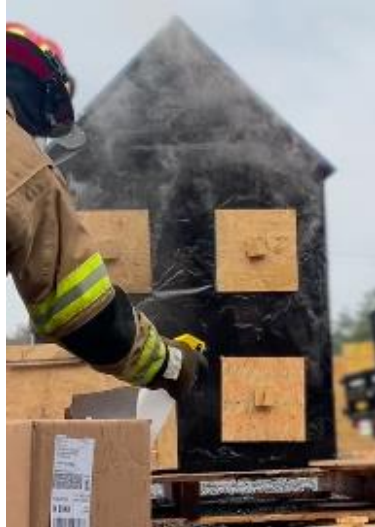
- vii. At 0 h 26 m 47 s the majority of the fire was determined to be out due to covering the openings, no fire extension into the second floor or attic space was observed

1. Water was sprayed on the covers to prevent complete burn-through

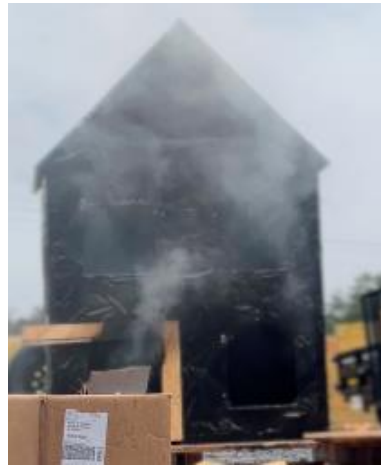
- viii. At 0 h 31 m 33 s the fire was determined to be out completely
