Corrosion Control of Buried Piping

Presented By:
James T Lary
Corrpro
1055 W. Smith Rd.
Medina, OH 44256
Tel. 330-241-6615
email: jlary@corrpro.com
<http://www.corrpro.com>

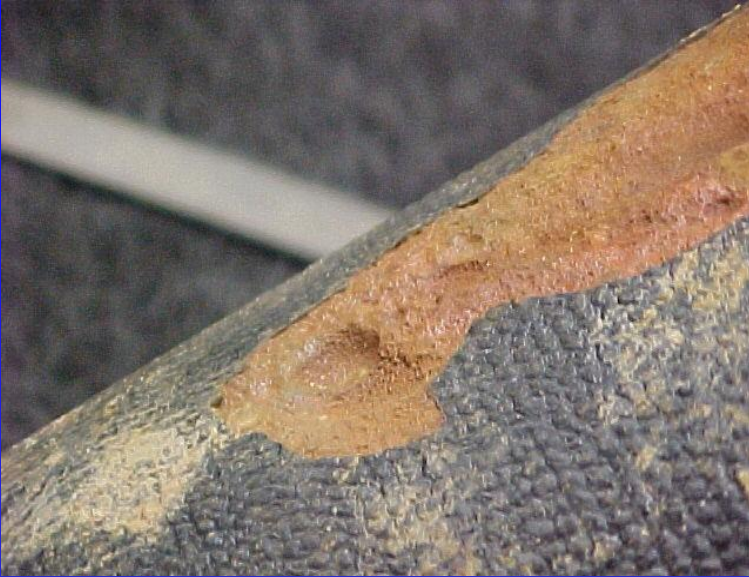
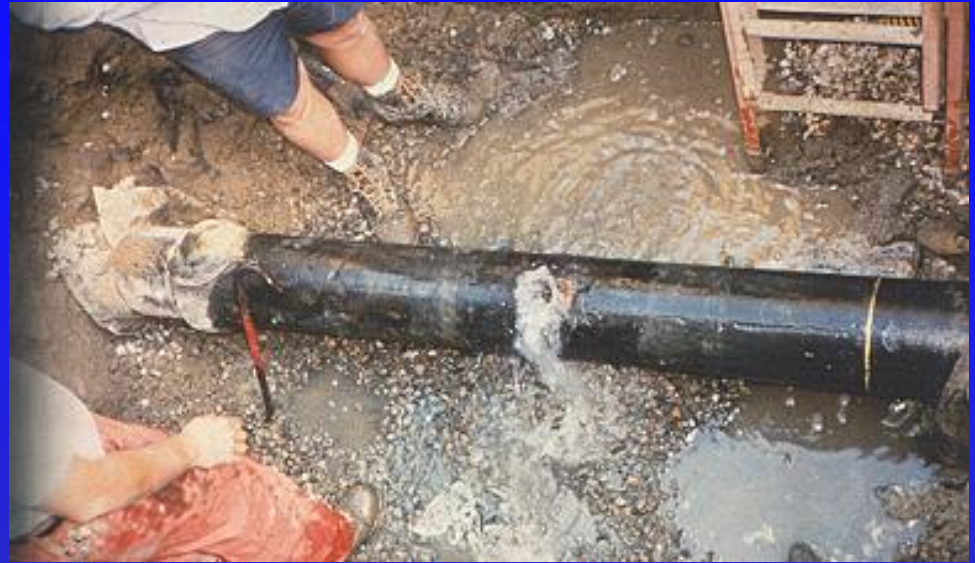
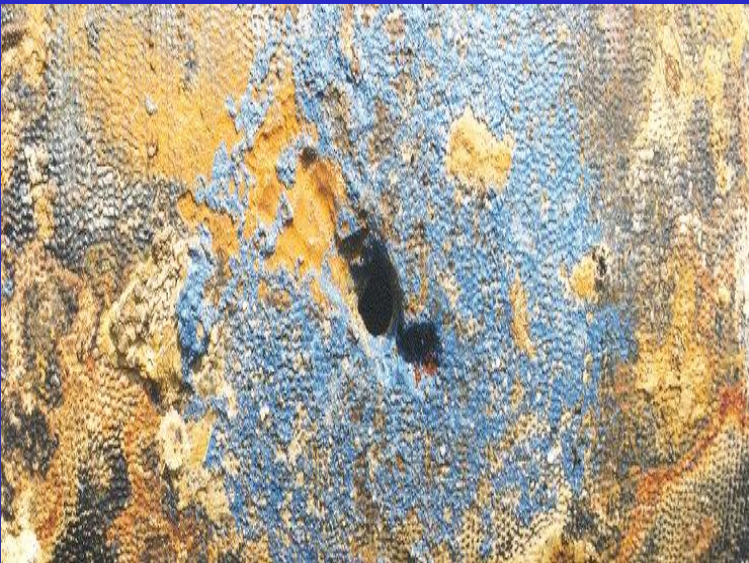
Ductile Iron

Pitting (concentrated) corrosion attack on ductile iron pipe.

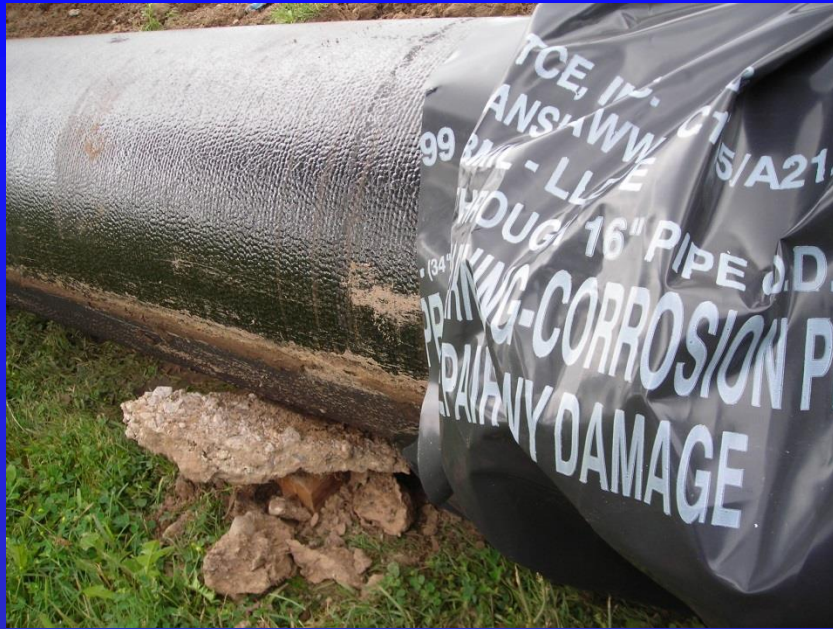
Polyethylene Encasement of Ductile Iron Pipe

- Follow DIPRA installation procedures
- Clean pipe before installing polywrap
- Repair tears or damage to encasement
- Engage an inspector to oversee installation

- Follow manufacture's and AWWA recommendations to insure proper installation of polyethylene encasement.
- In extremely corrosive areas, additional methods (bonding of joints, cathodic protection, may be required).

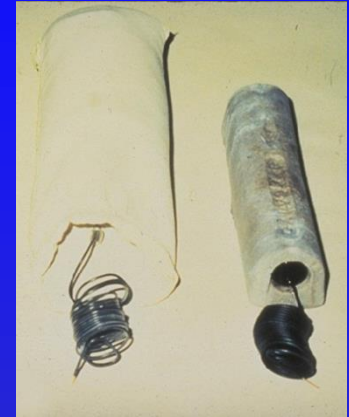
PRACTICAL GALVANIC SERIES

Material	Potential*
Pure Magnesium	-1.75
Zinc	-1.10
Aluminum Alloy	-1.00
Cadmium	-0.80
Mild Steel (New)	-0.70
Mild Steel (Old)	-0.50
Cast/Ductile Iron	-0.50
Stainless Steel	-0.50 to + 0.10
Copper, Brass, Bronze	-0.20
Gold	+0.20
Carbon, Graphite, Coke	+0.30

* Potentials With Respect to Saturated Cu-CuSO₄ Electrode

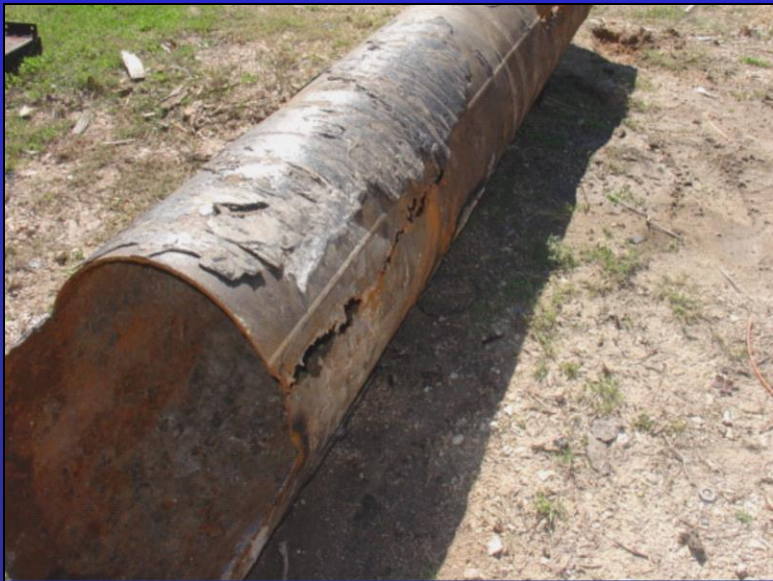
36" Above Ground Crossing

- Failure of force main at above ground crossing
- Crown of pipe attacked by hydrogen sulfide gas

- Failure of force main at above ground crossing
- Crown of pipe attacked by hydrogen sulfide gas

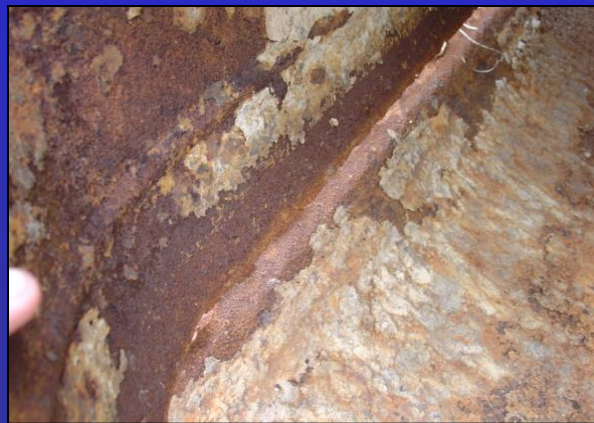
Dual 26" Force Mains

- Internal failures at bottom of pipe
- Failure following loss of internal mortar lining
- Failures concentrated at low areas (dips) in pipeline alignment
- Cause is corrosion under accumulated solids

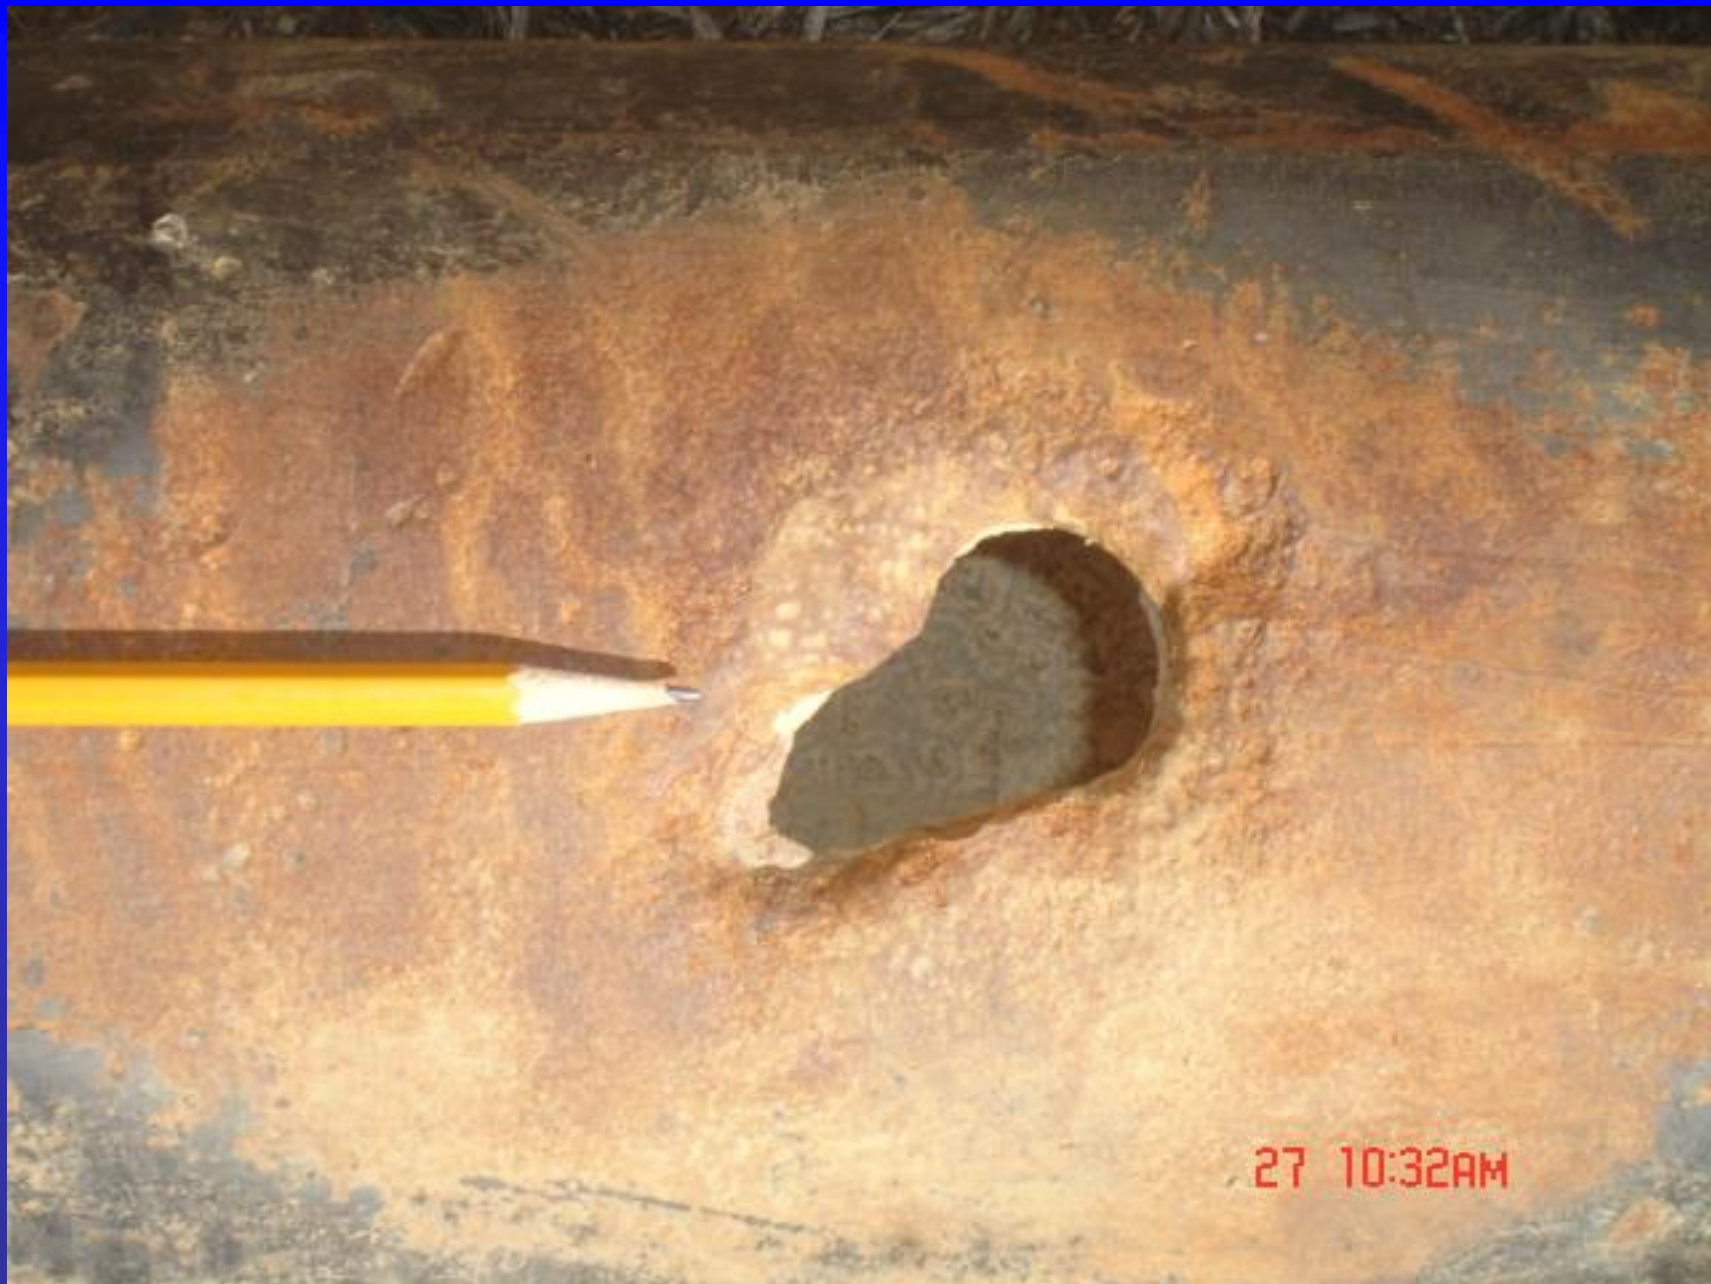
Impressed Current CP System on Oil/Gas Lines can Create Stray Current Problem on Water Lines

Transformer Rectifier

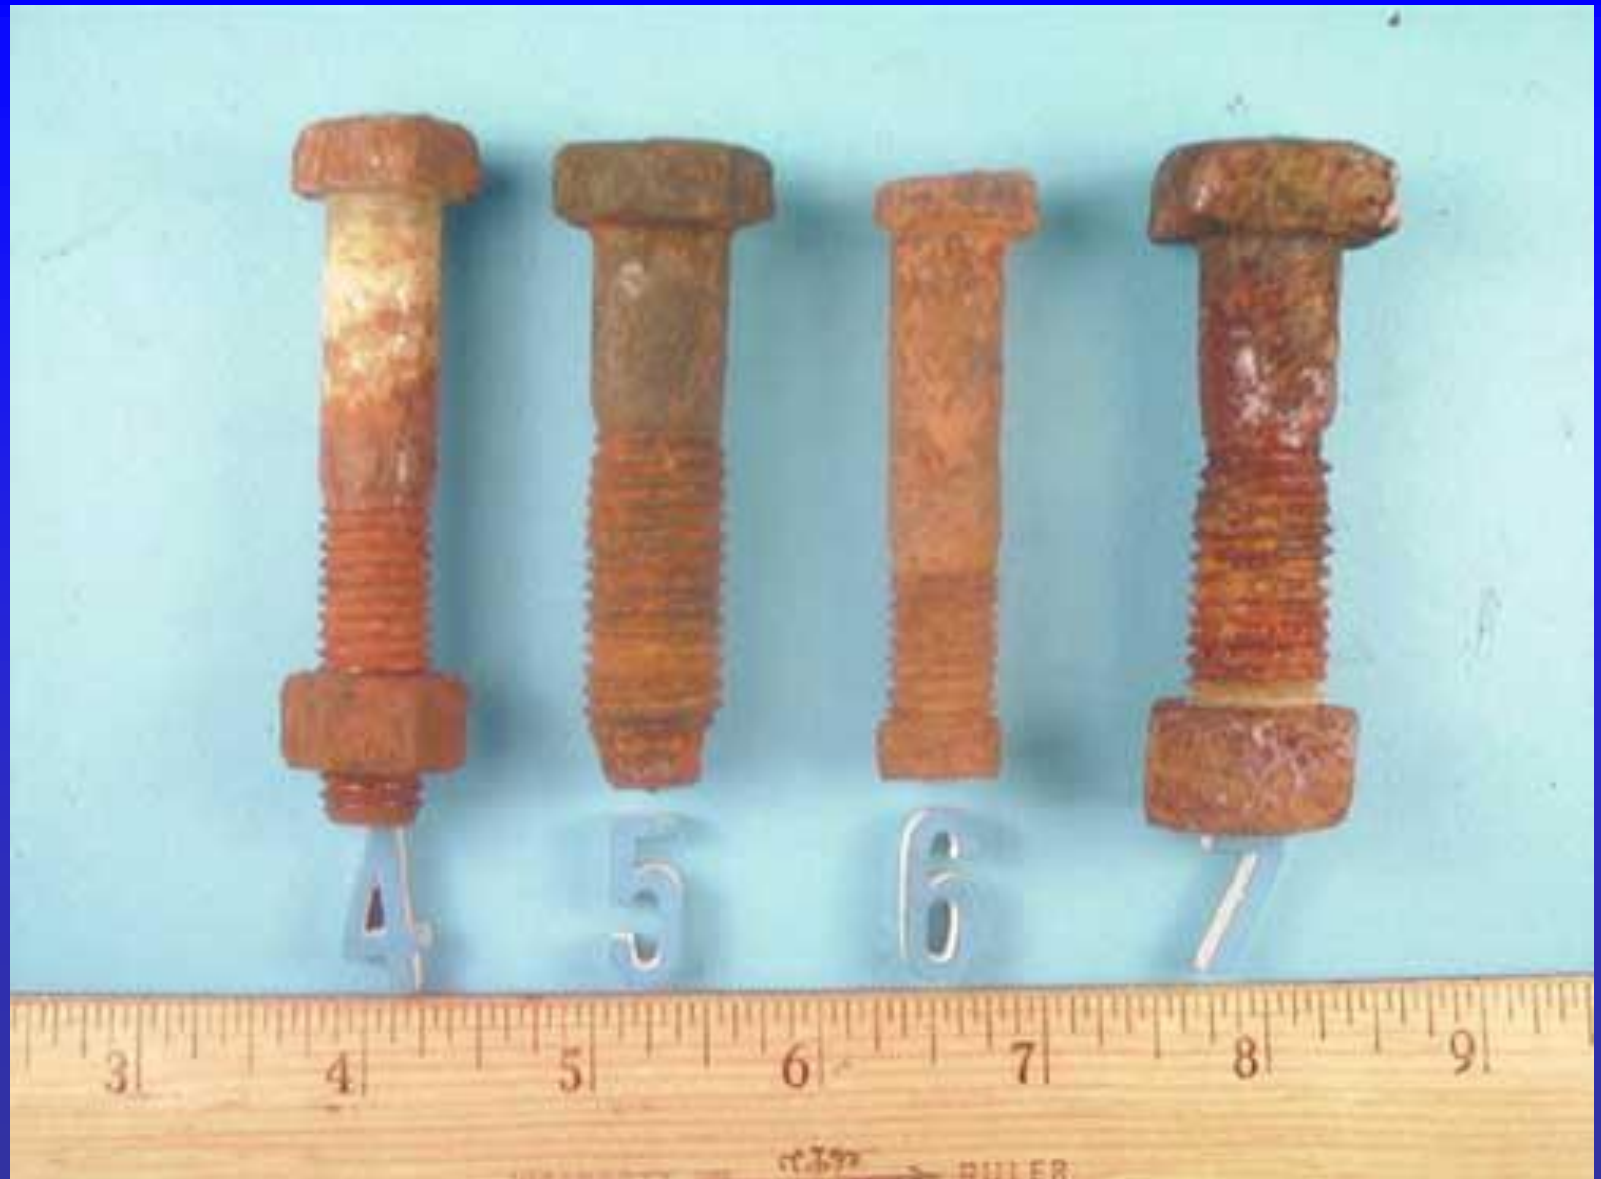
Corrosion is the leading contributor to cast and ductile iron water system breaks!

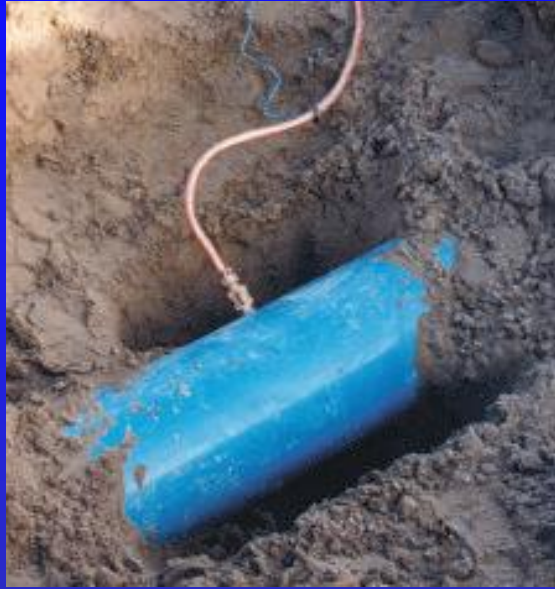
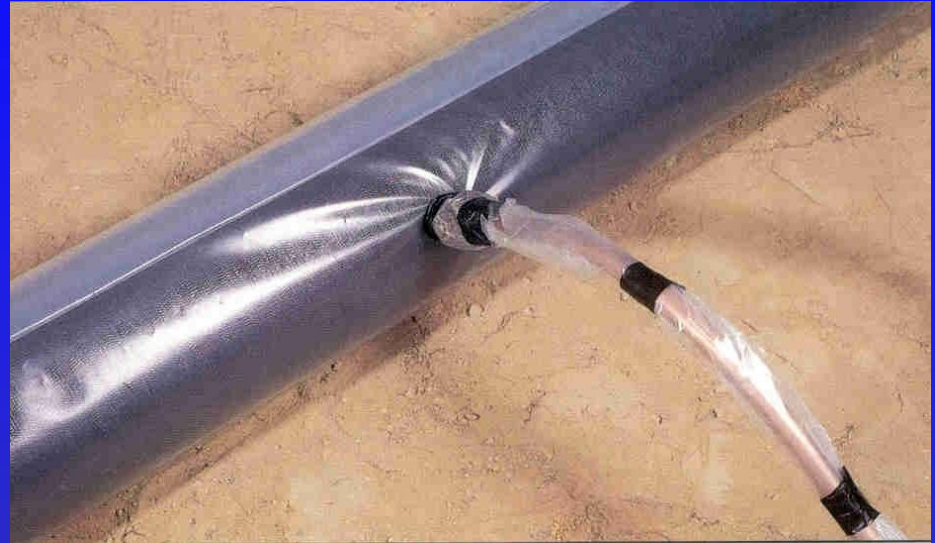
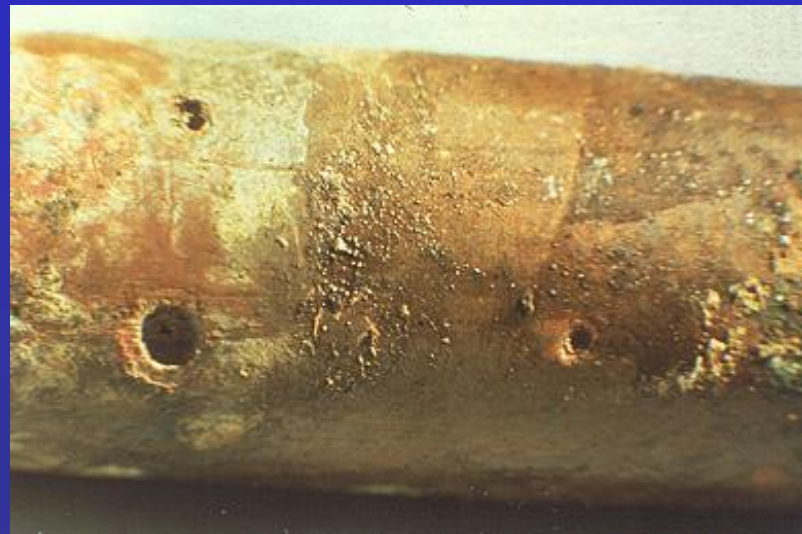
Copper Service Connections

Anode Installation Prevents Corrosion on Copper Service Line

Non metallic or
Polyethylene Encased
Ductile Iron Main

Anode Connection to Line

Anode

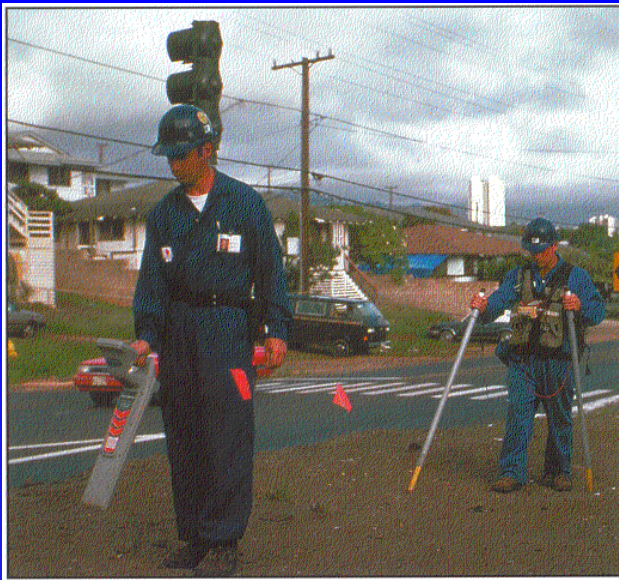
CIS Survey

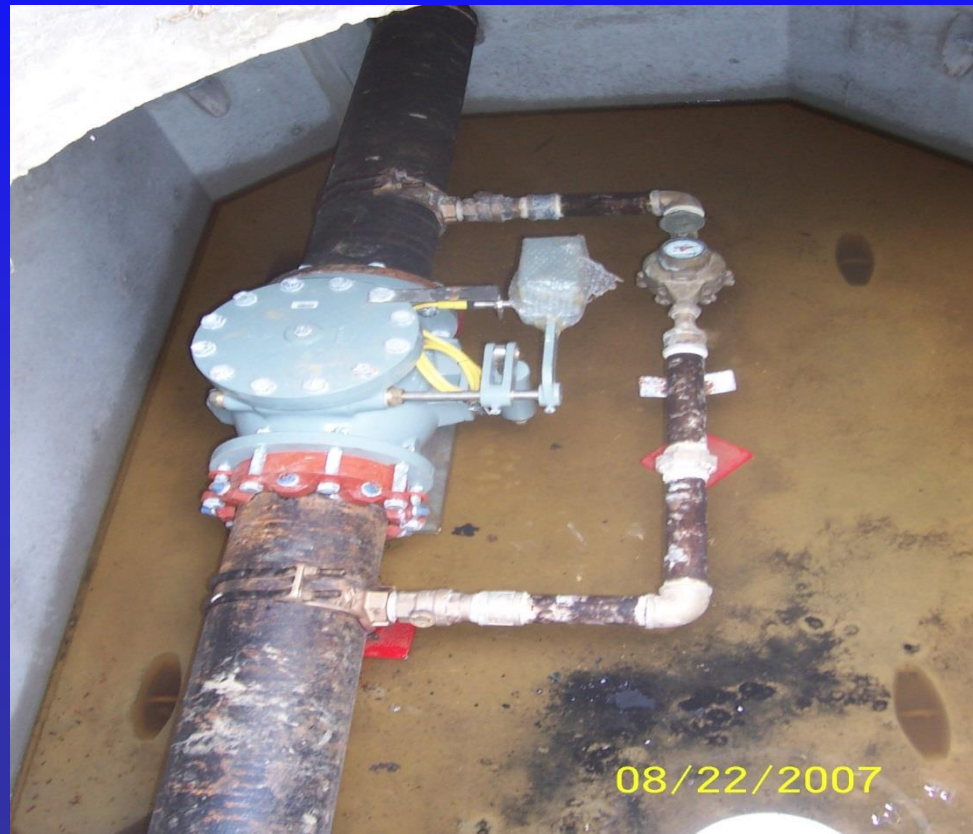
Meter Vaults

(Keep dry if possible)
