# Corrosion Control of Water Systems

**Presented By:**  
**James T Lary**  
**Corrpro**  
**1055 W. Smith Rd.**  
**Medina, OH 44256**  
**Tel. 330-241-6615**  
**email: [jlary@corrpro.com](mailto:jlary@corrpro.com)**  
**<http://www.corrpro.com>**

**corrpro®**

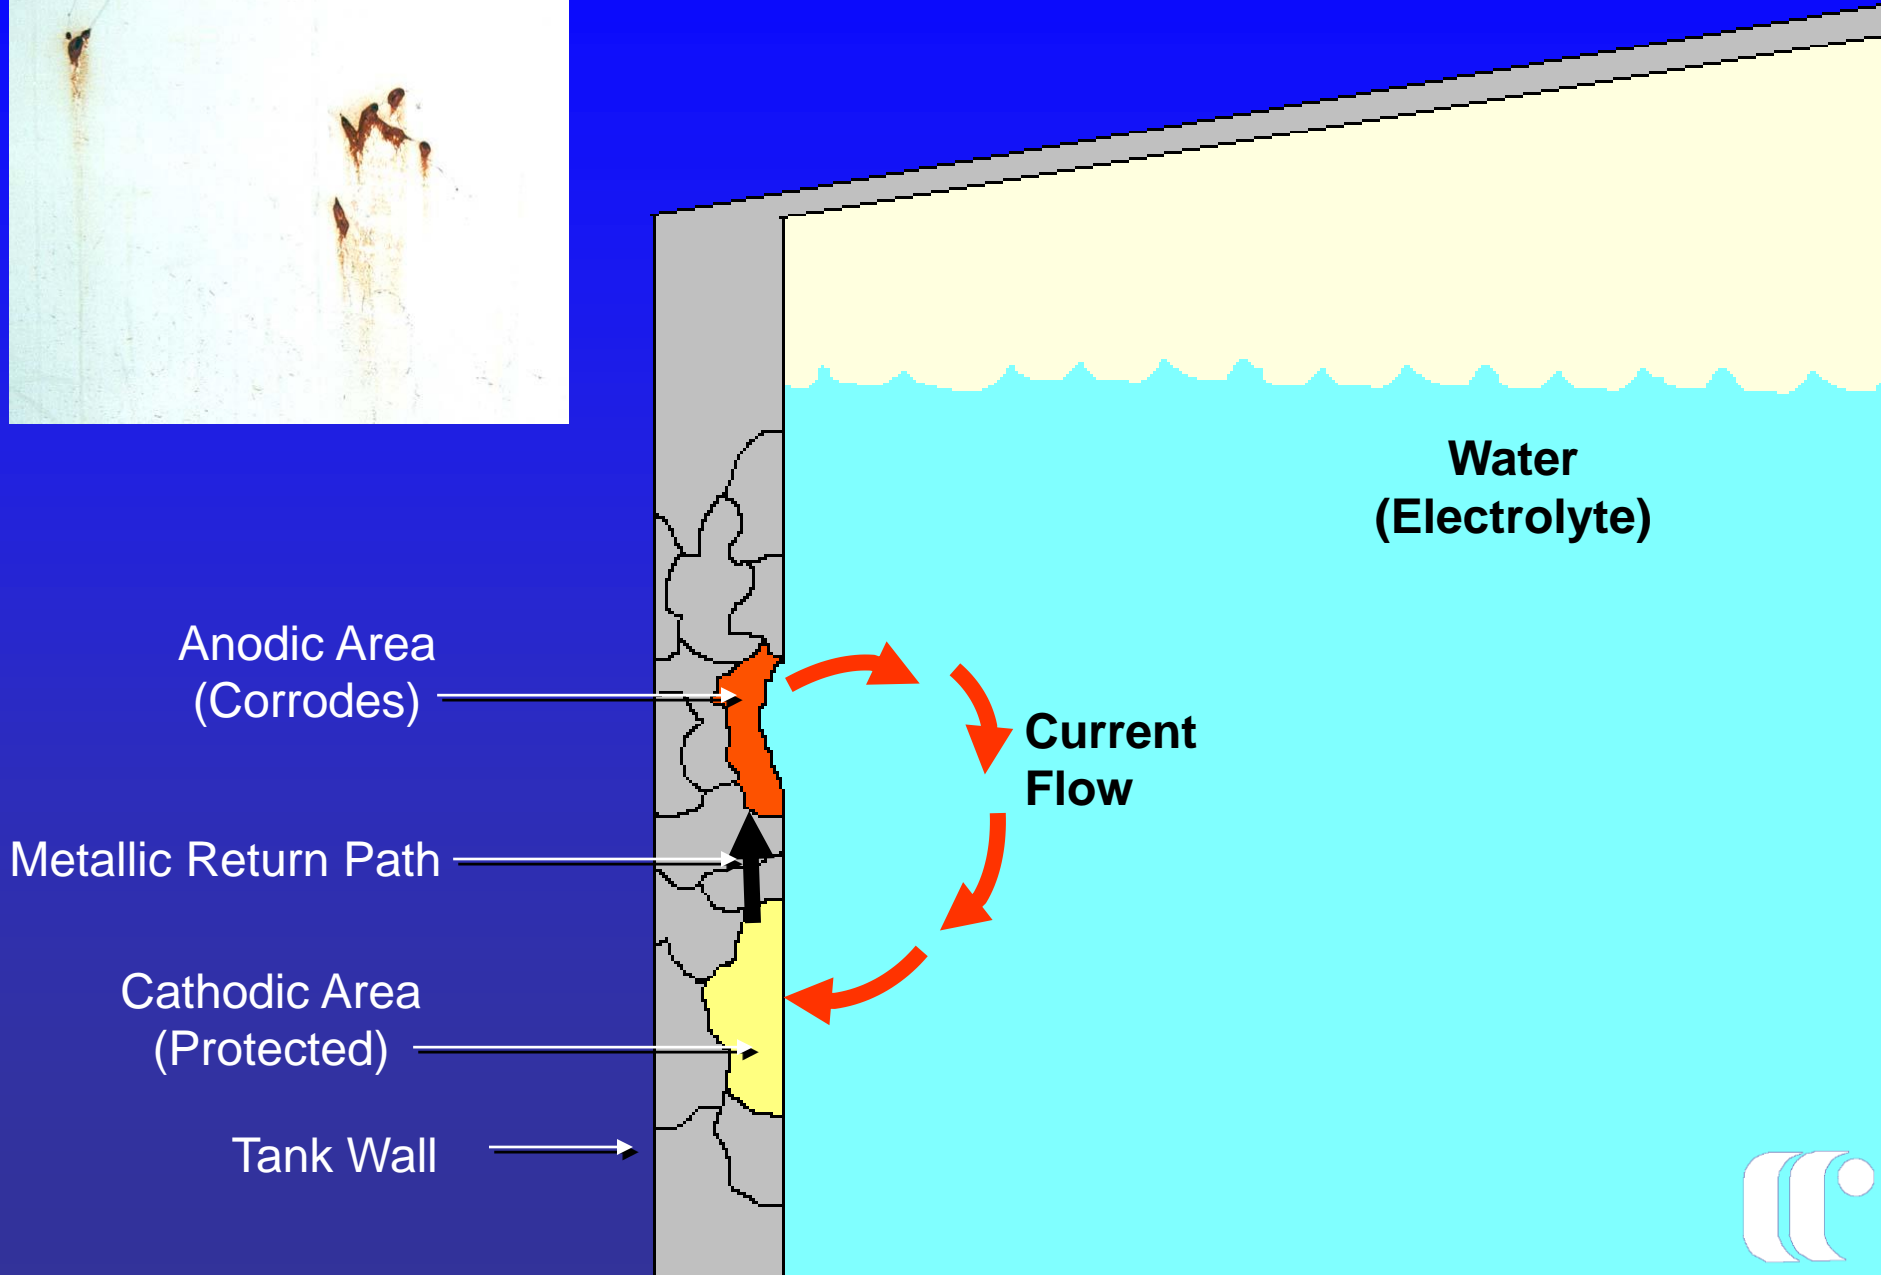
# Corrosion of Metallic Structure

Anodic Area  
(Corrodes)

Metallic Return Path

Current  
Flow

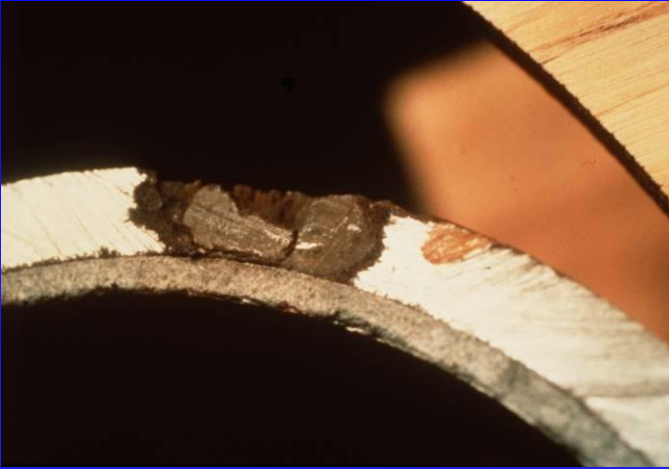
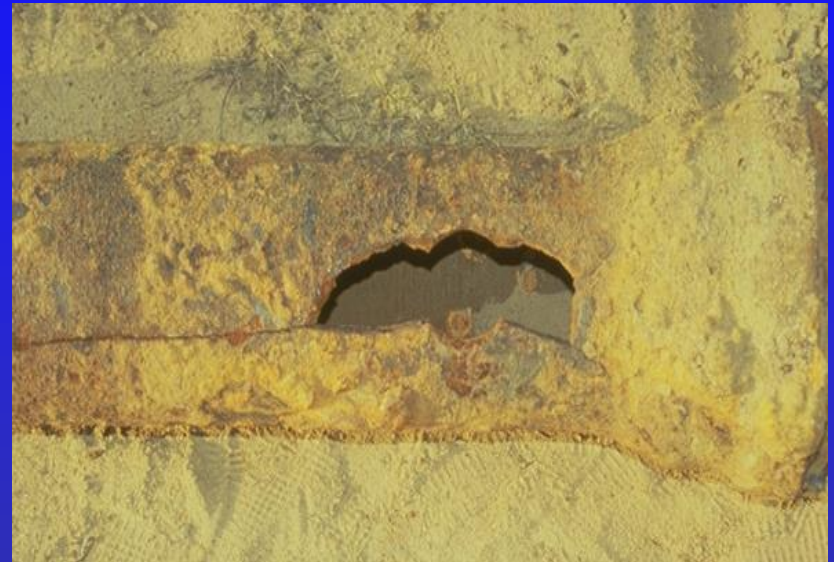
# Cast (Grey) Iron Failures

Graphitization leaves pipe brittle and weakened.

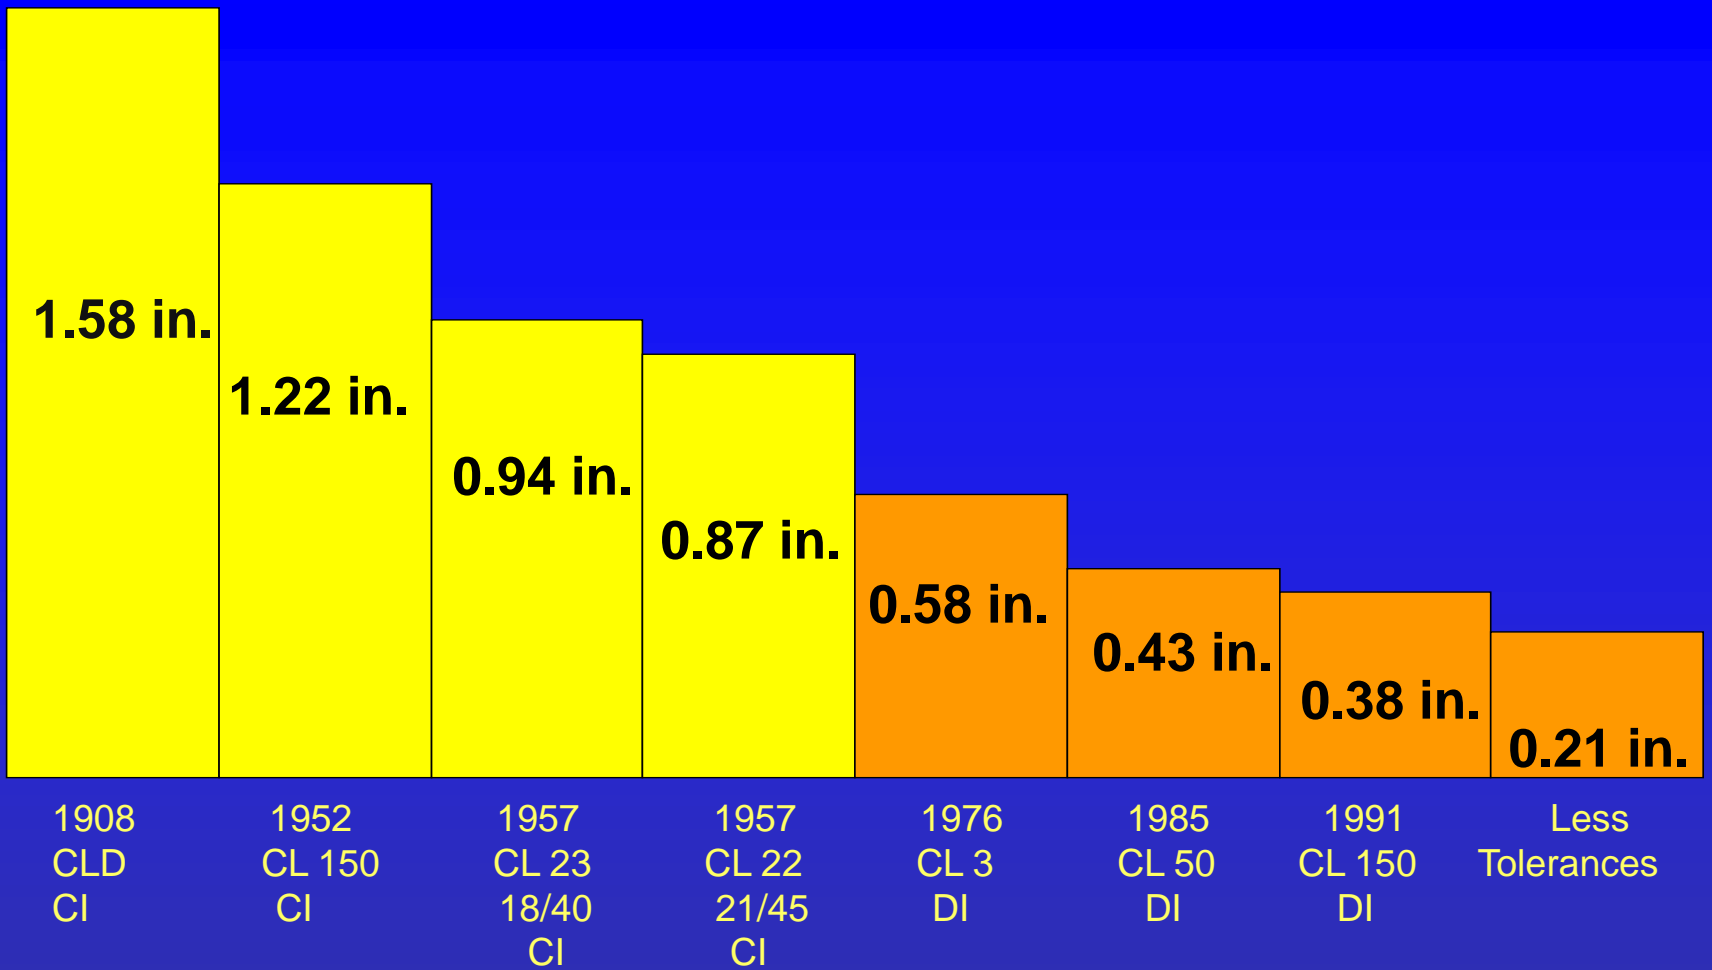
Actual size of AWWA Specification Thickness Reductions for 36-inch Diameter Cast and Ductile Iron Pipe - 1908 to Present (150 PSI Operating pressure)

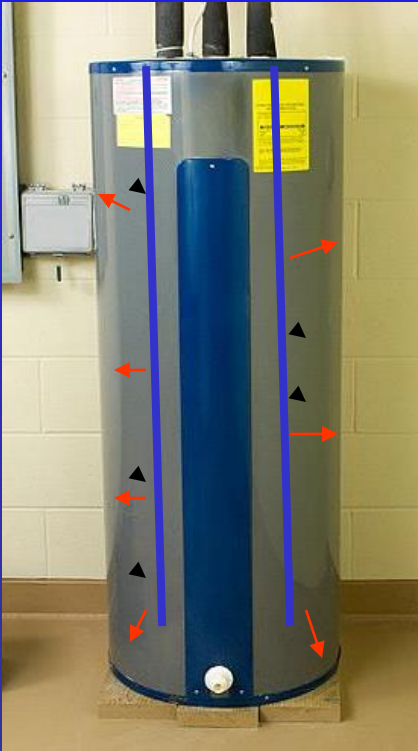
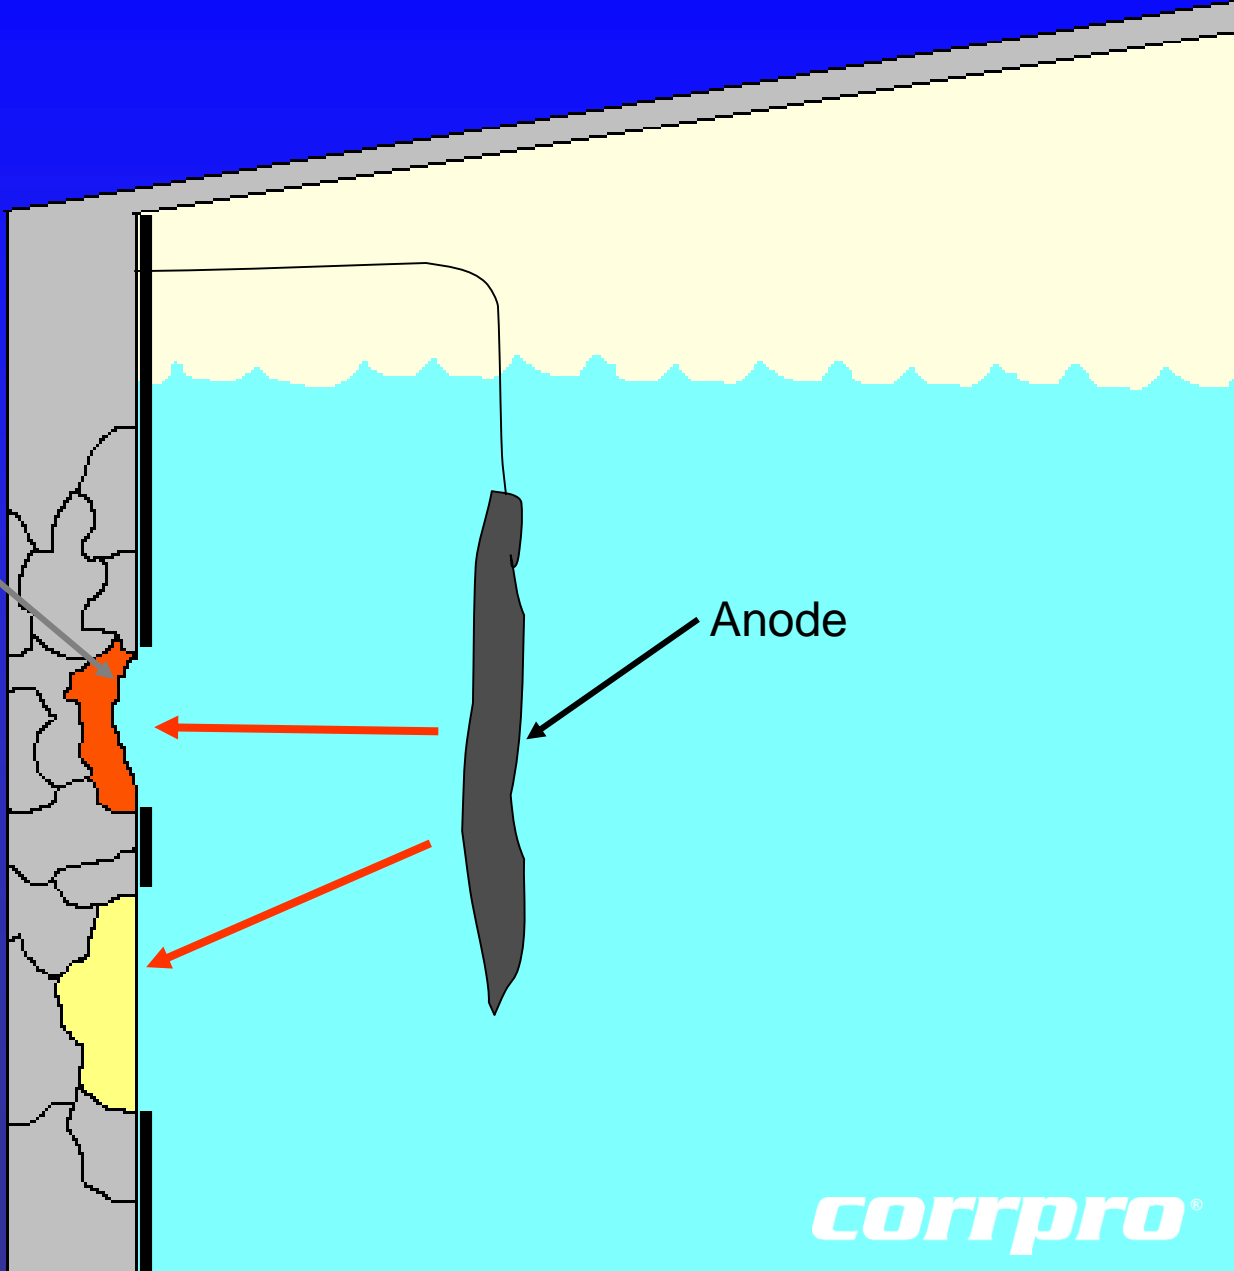
Cathode  
(Protected)

Anode

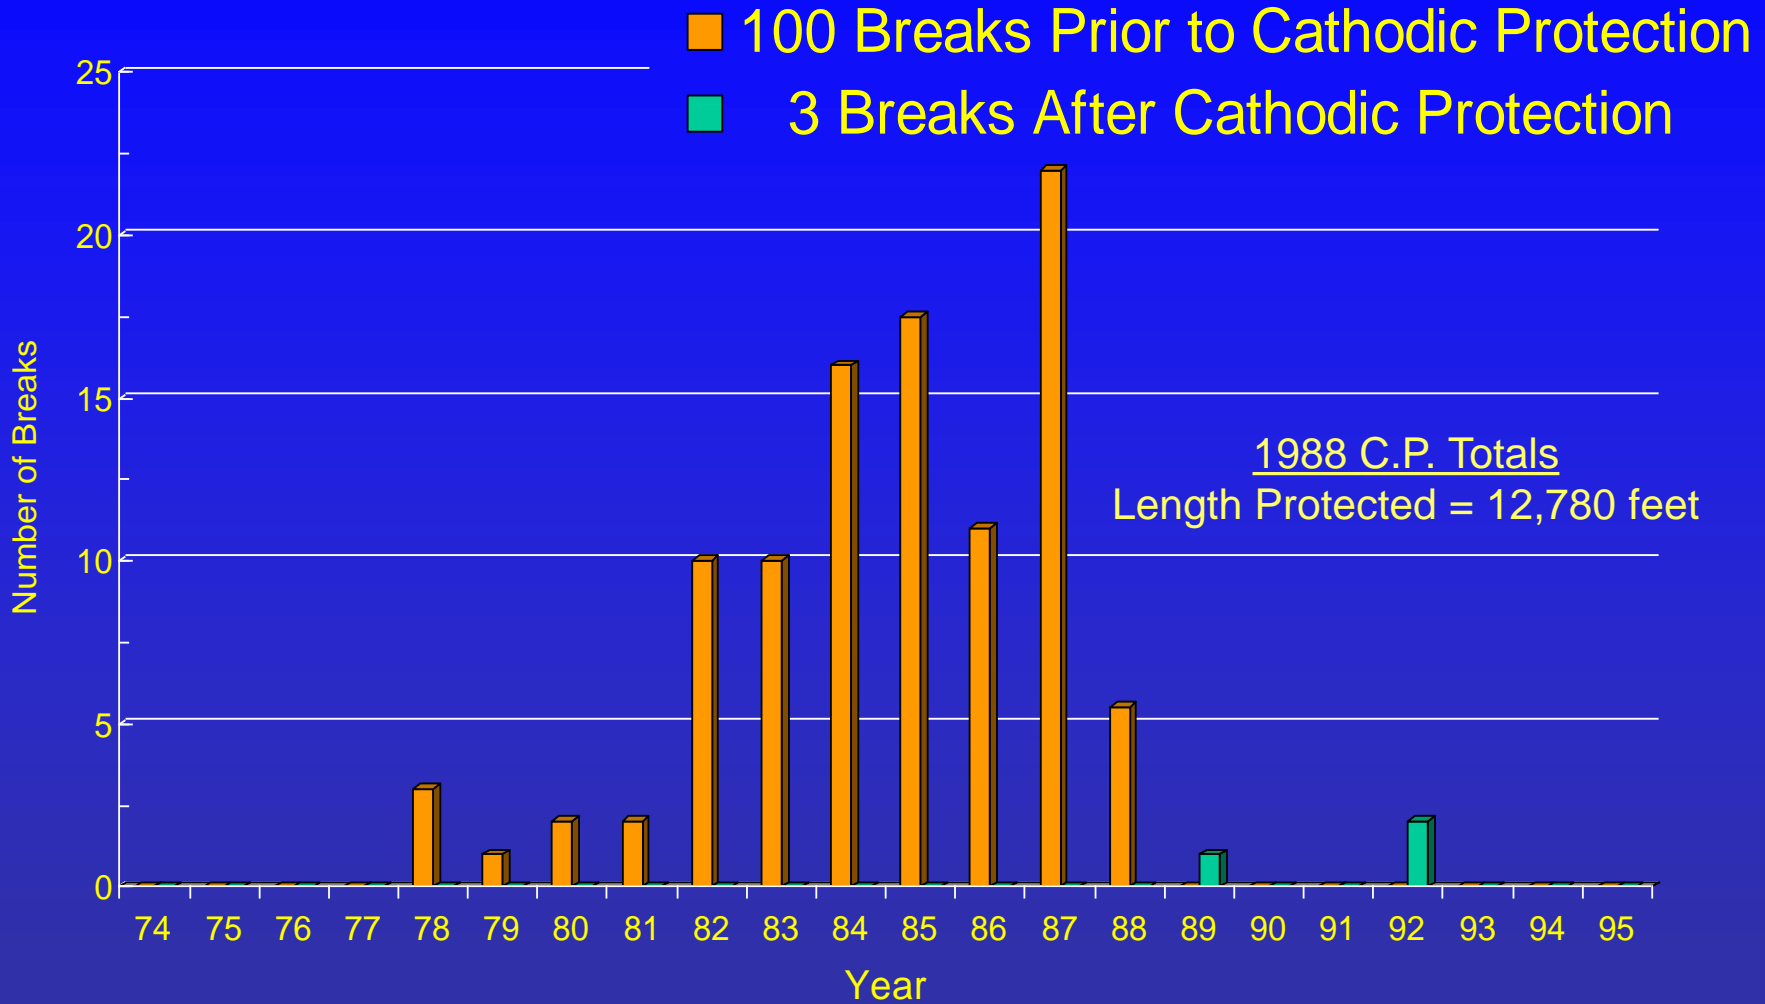
**Break Records for Water Mains Cathodically Protected in 1988**

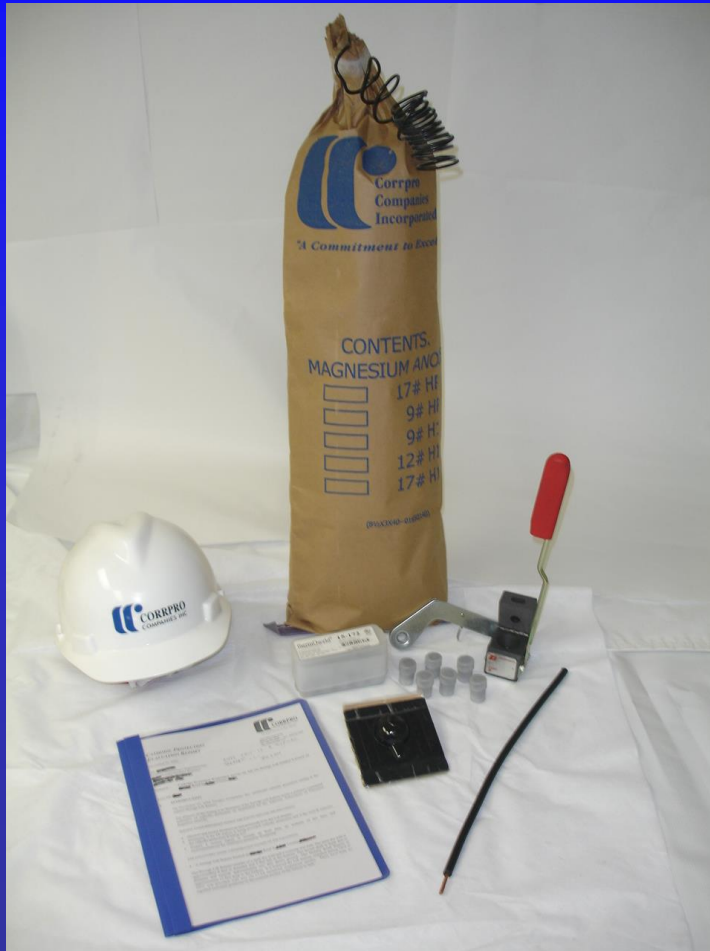
# Water Leak Repair Kit

*Includes:*

**Installation instructions.**

**Cathodic protection components/connection materials suitable for 10 repairs.**

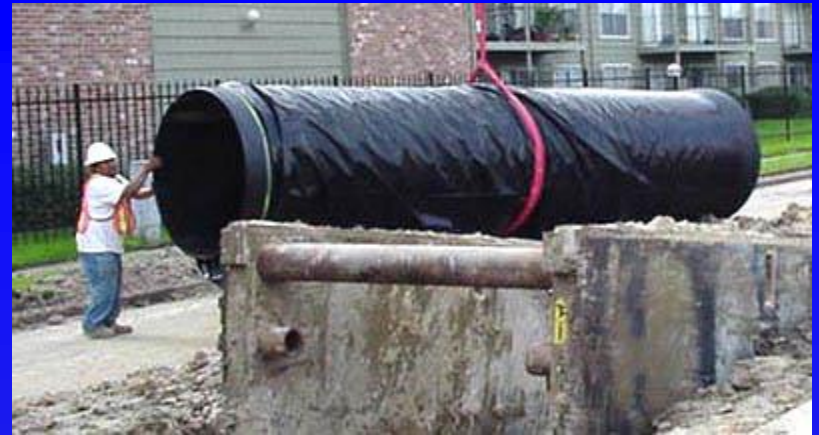
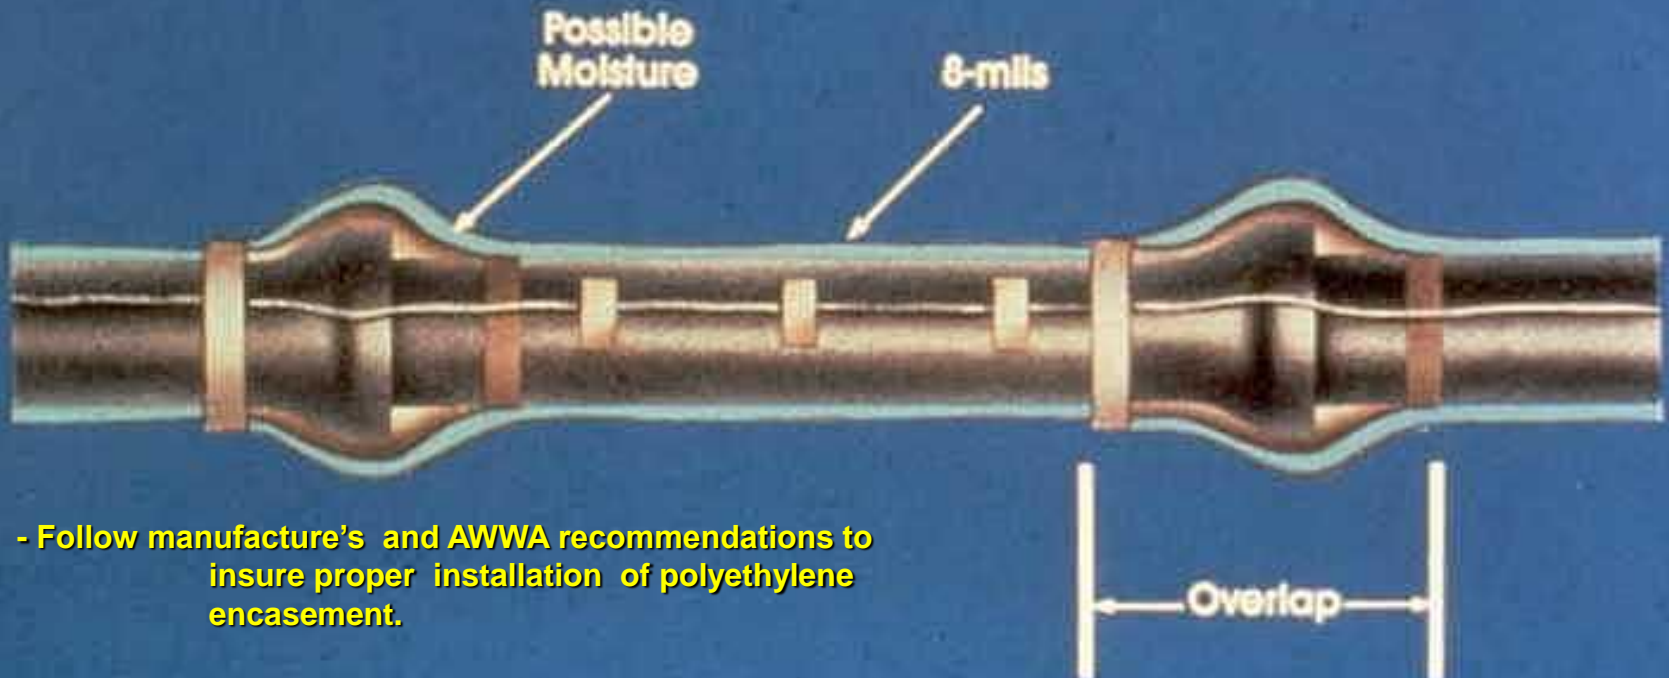
# Polyethylene Encasement

- Follow manufacture's and AWWA recommendations to insure proper installation of polyethylene encasement.
- In extremely corrosive areas, additional methods (bonding of joints, cathodic protection, may be required).

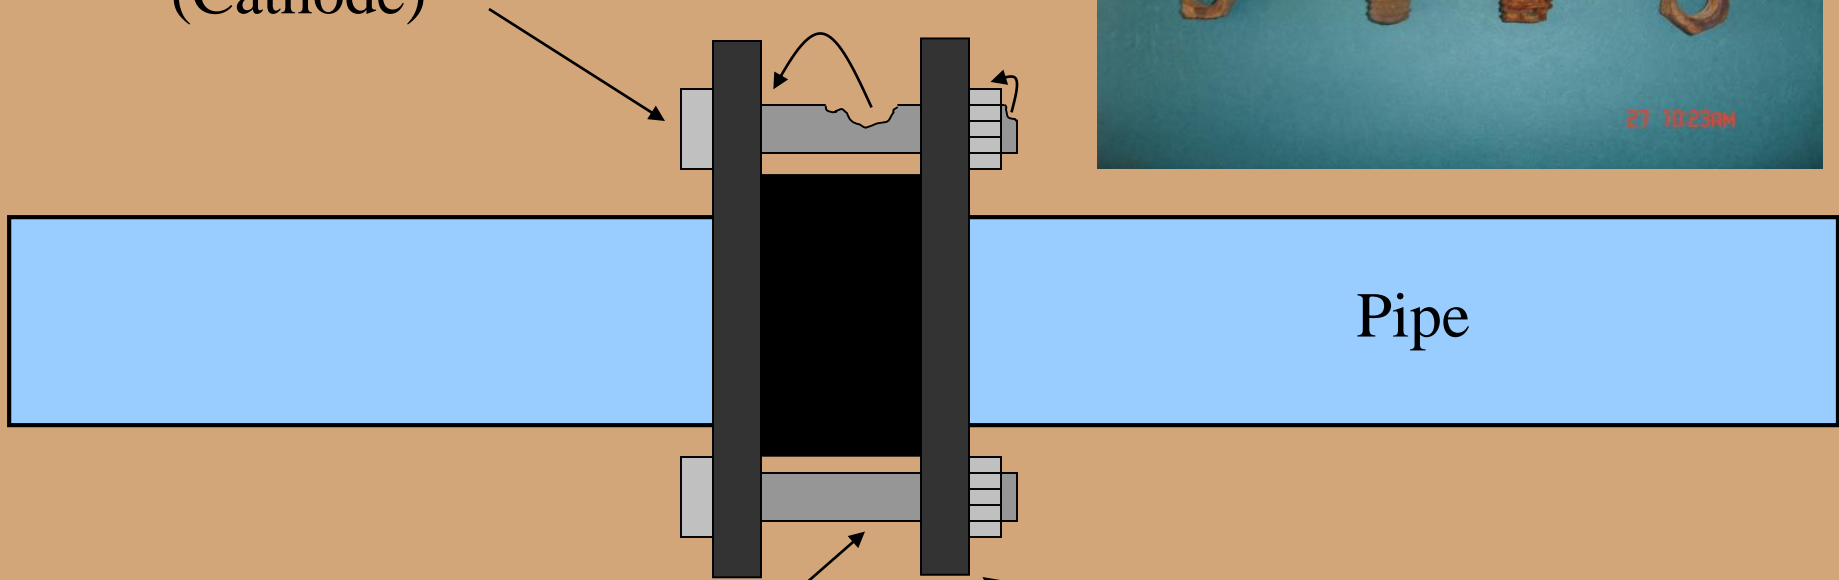
Stress Corrosion

Lower Stress Area  
(Cathode)

Threaded Bolt  
Higher Stress Area  
(Anode)

Metallic Coupling

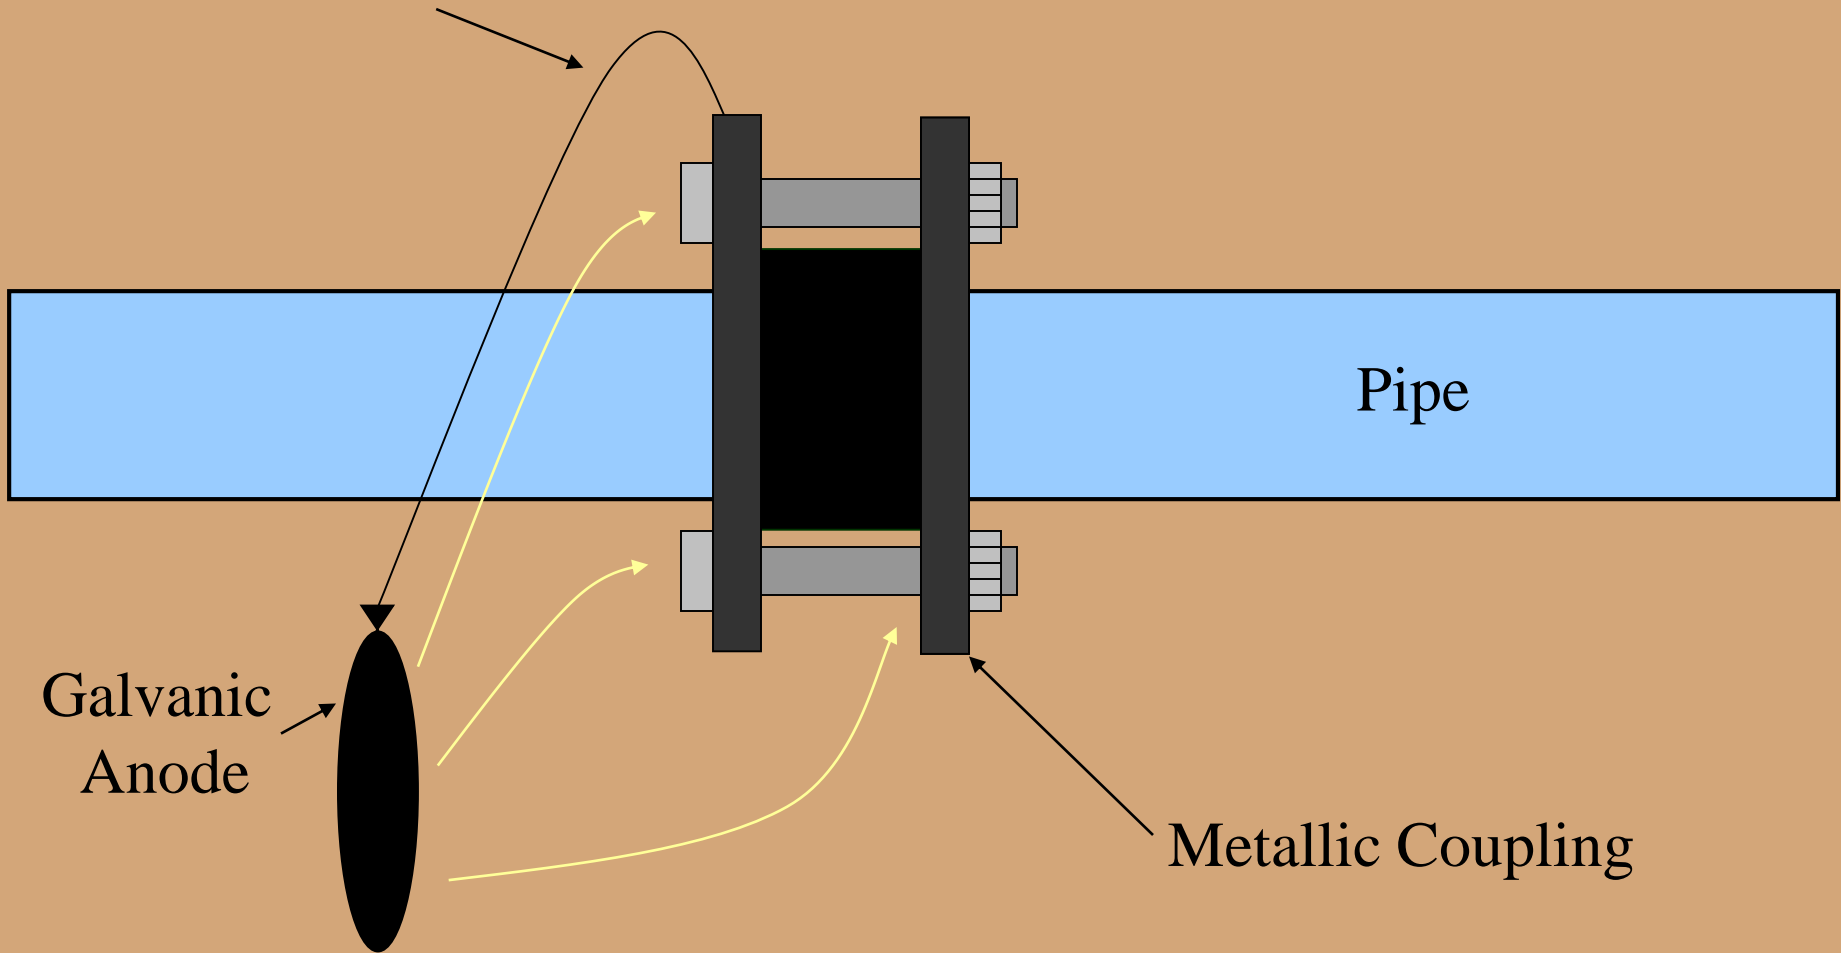
Cathodic Protection of Metallic Fitting

Galvanic Anode

Pipe

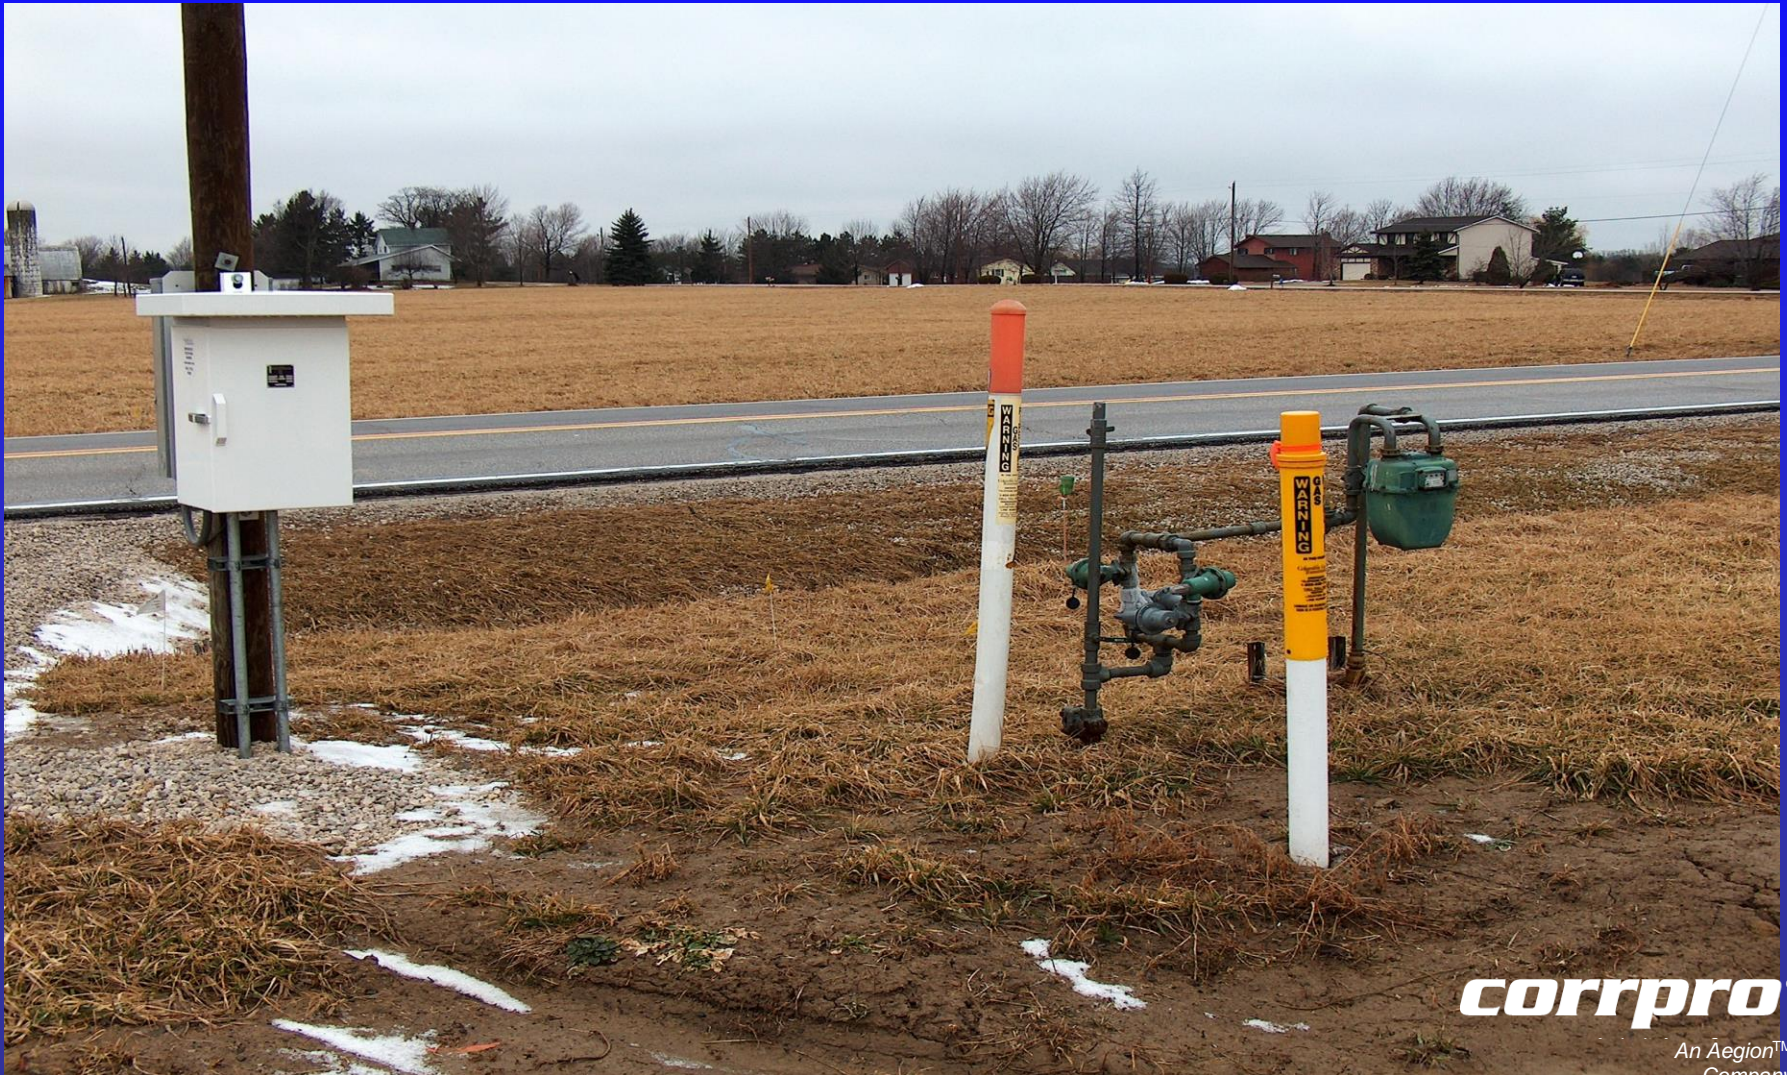
# Impressed Current CP System on Oil/Gas Lines can Create Stray Current Problem on Water Lines

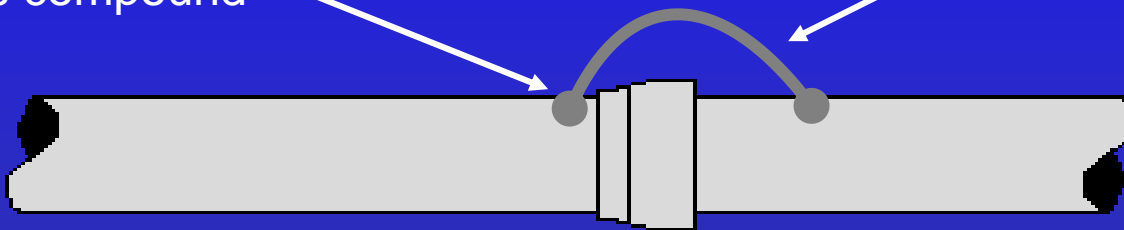
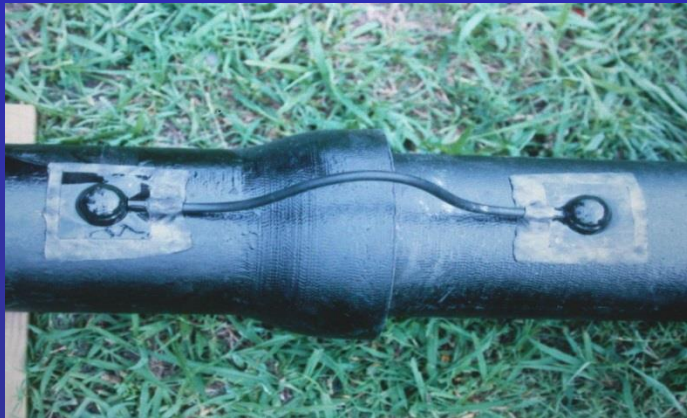
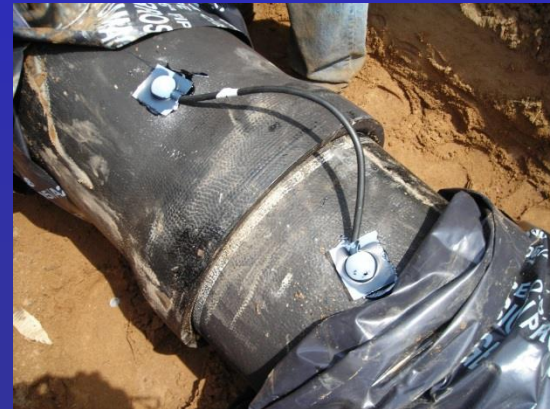
# Stray Current Due to Impressed Current Cathodic Protection System

Thermite brazed connection coated with bitumous compound

Copper wire with direct burial insulation

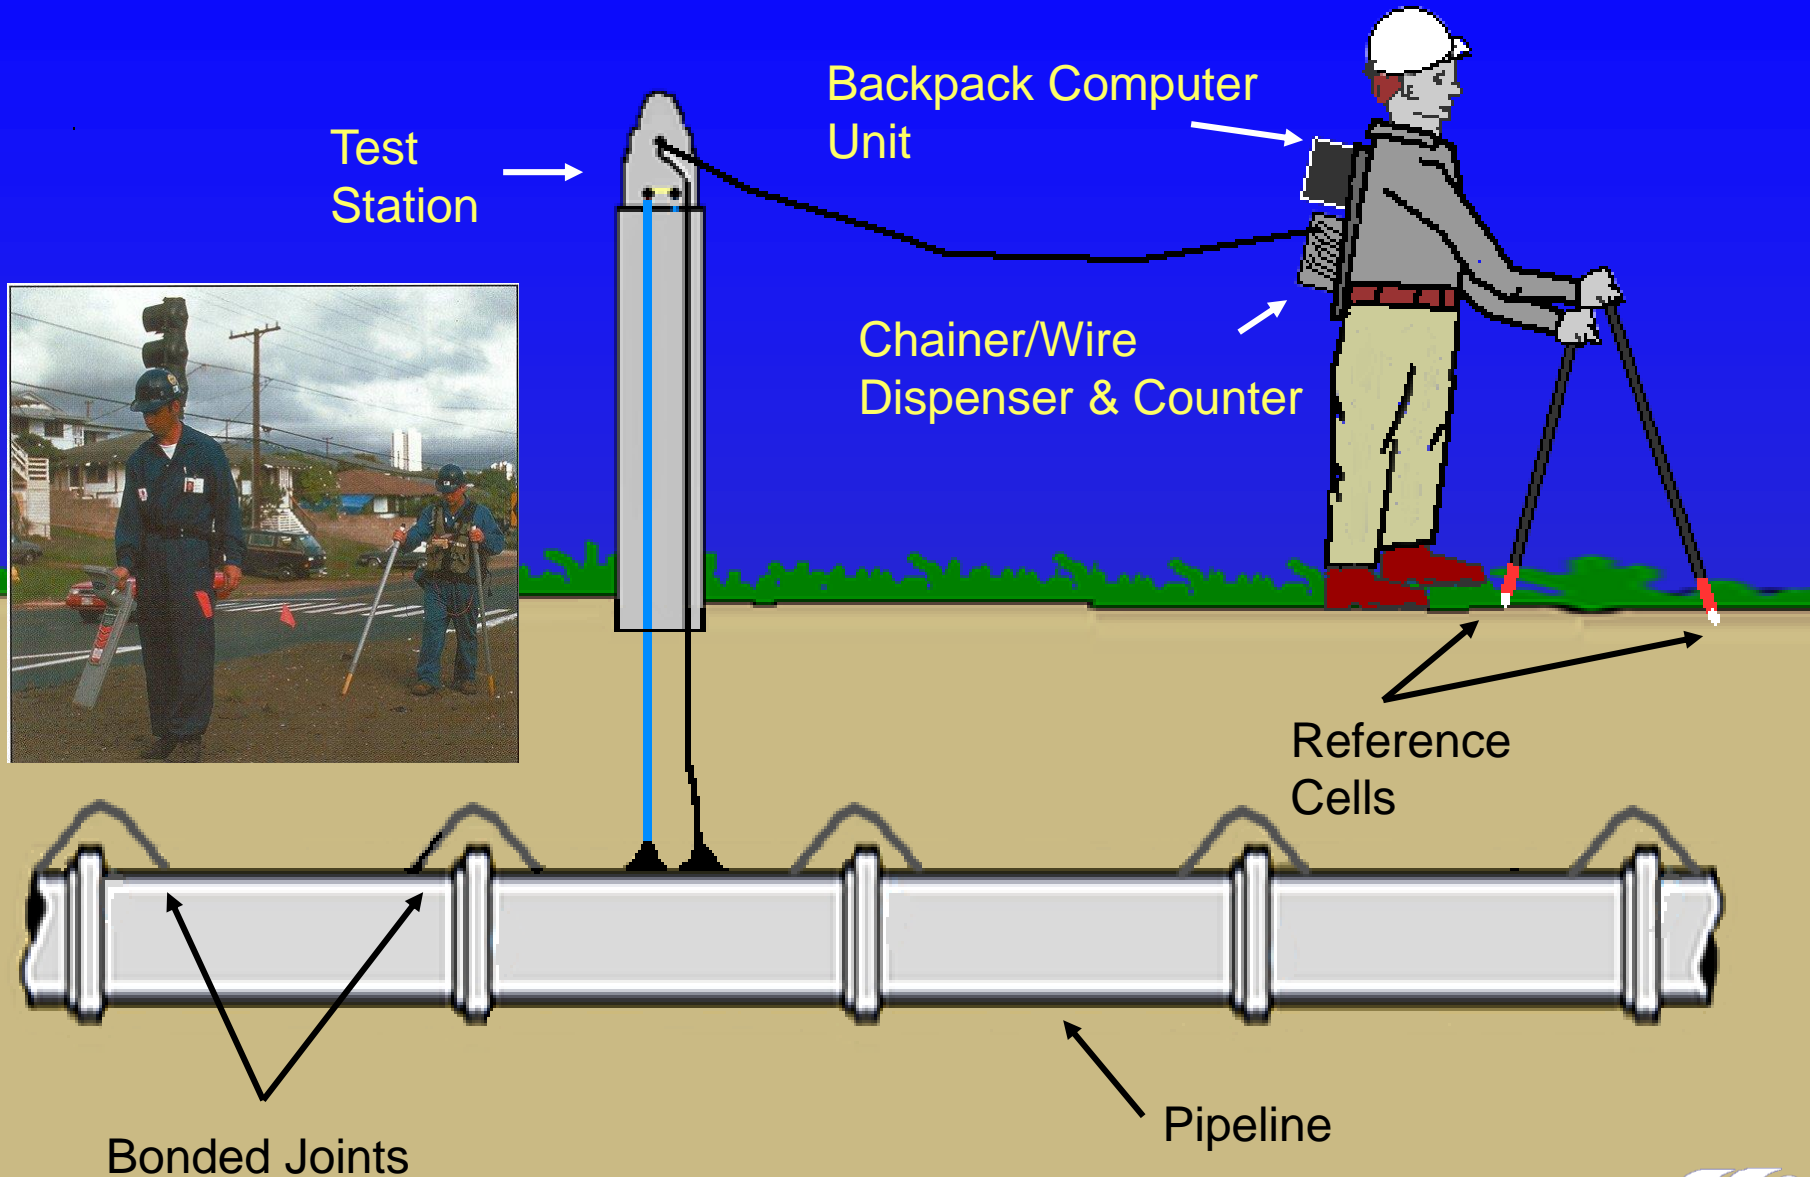
# Computerized Potential Logging Survey

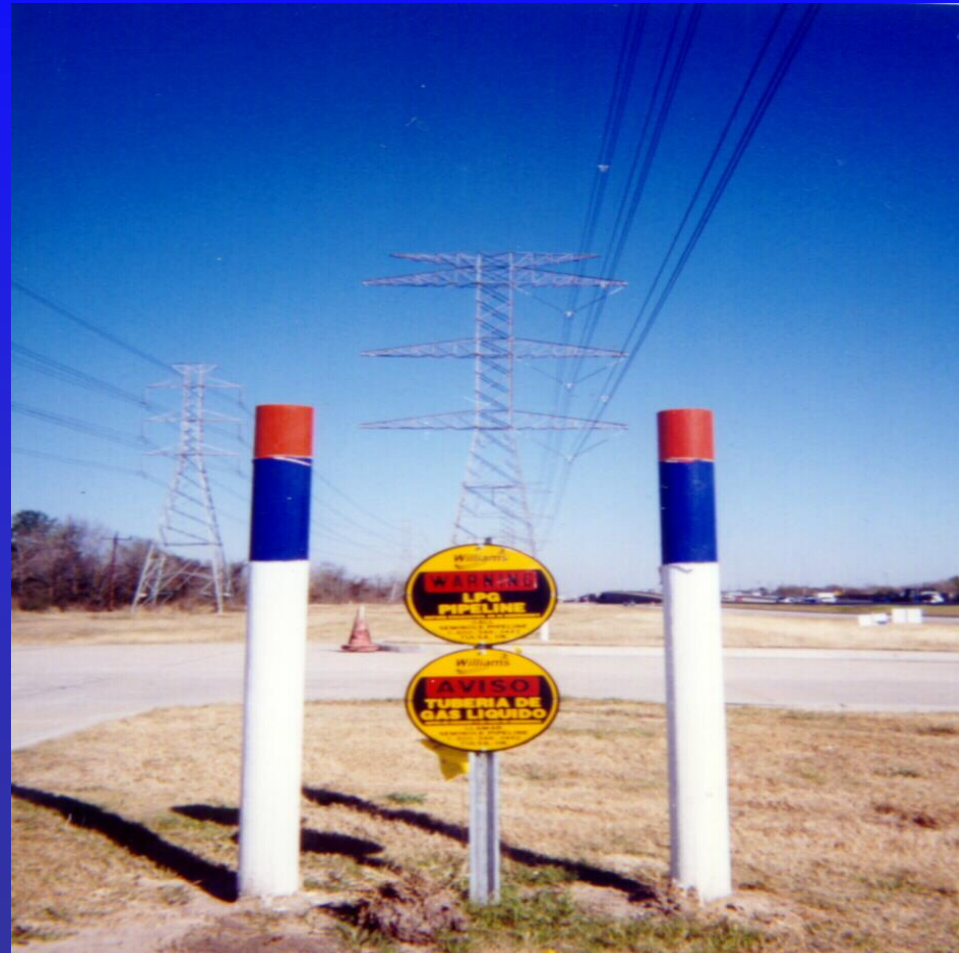
# AC Mitigation

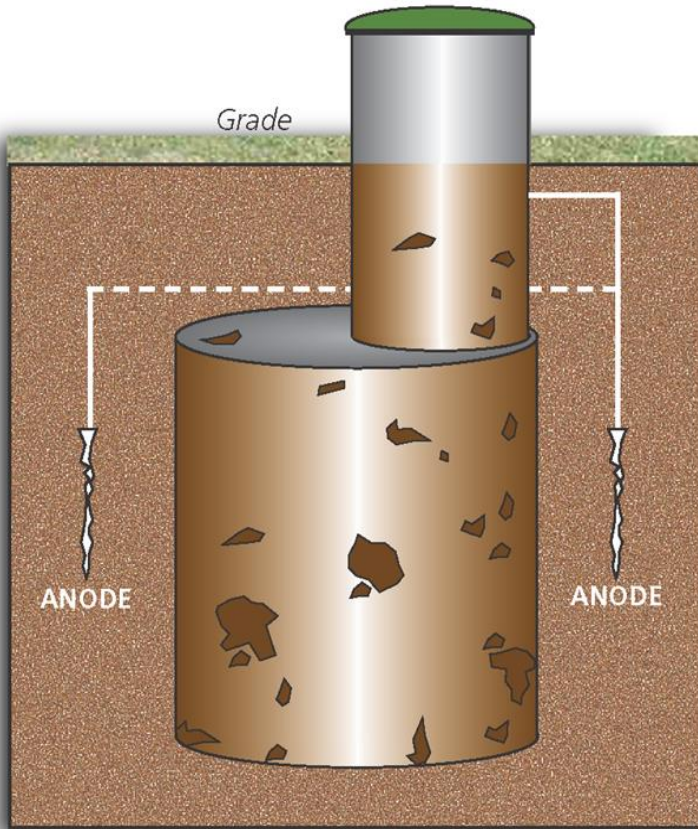
# Depleted & Refurbished Cathodic Protection for Lift Stations

Depleted cathodic protection system allows corrosion to occur.

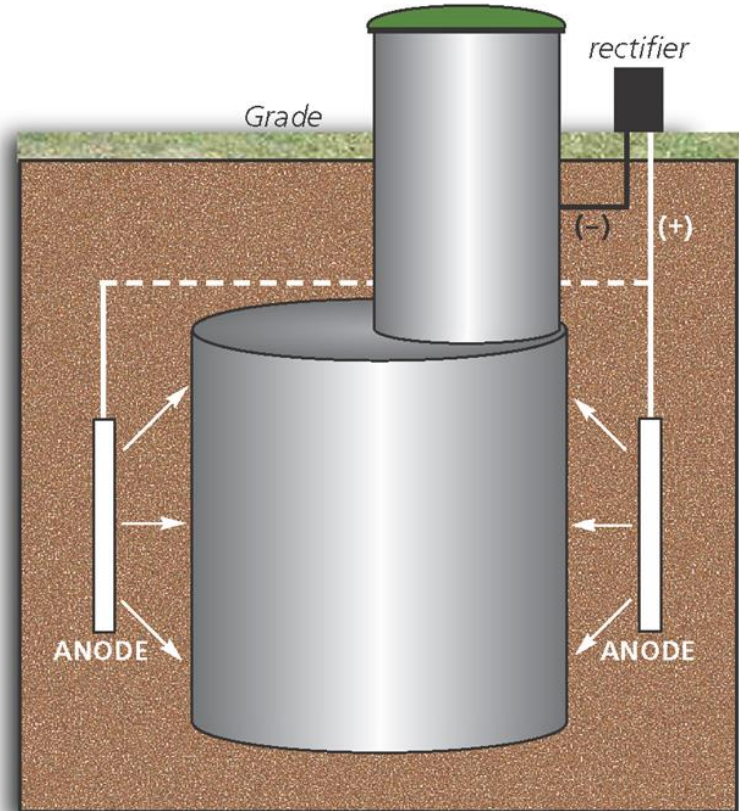
Effective cathodic protection system prevents corrosion and extends life of lift station.

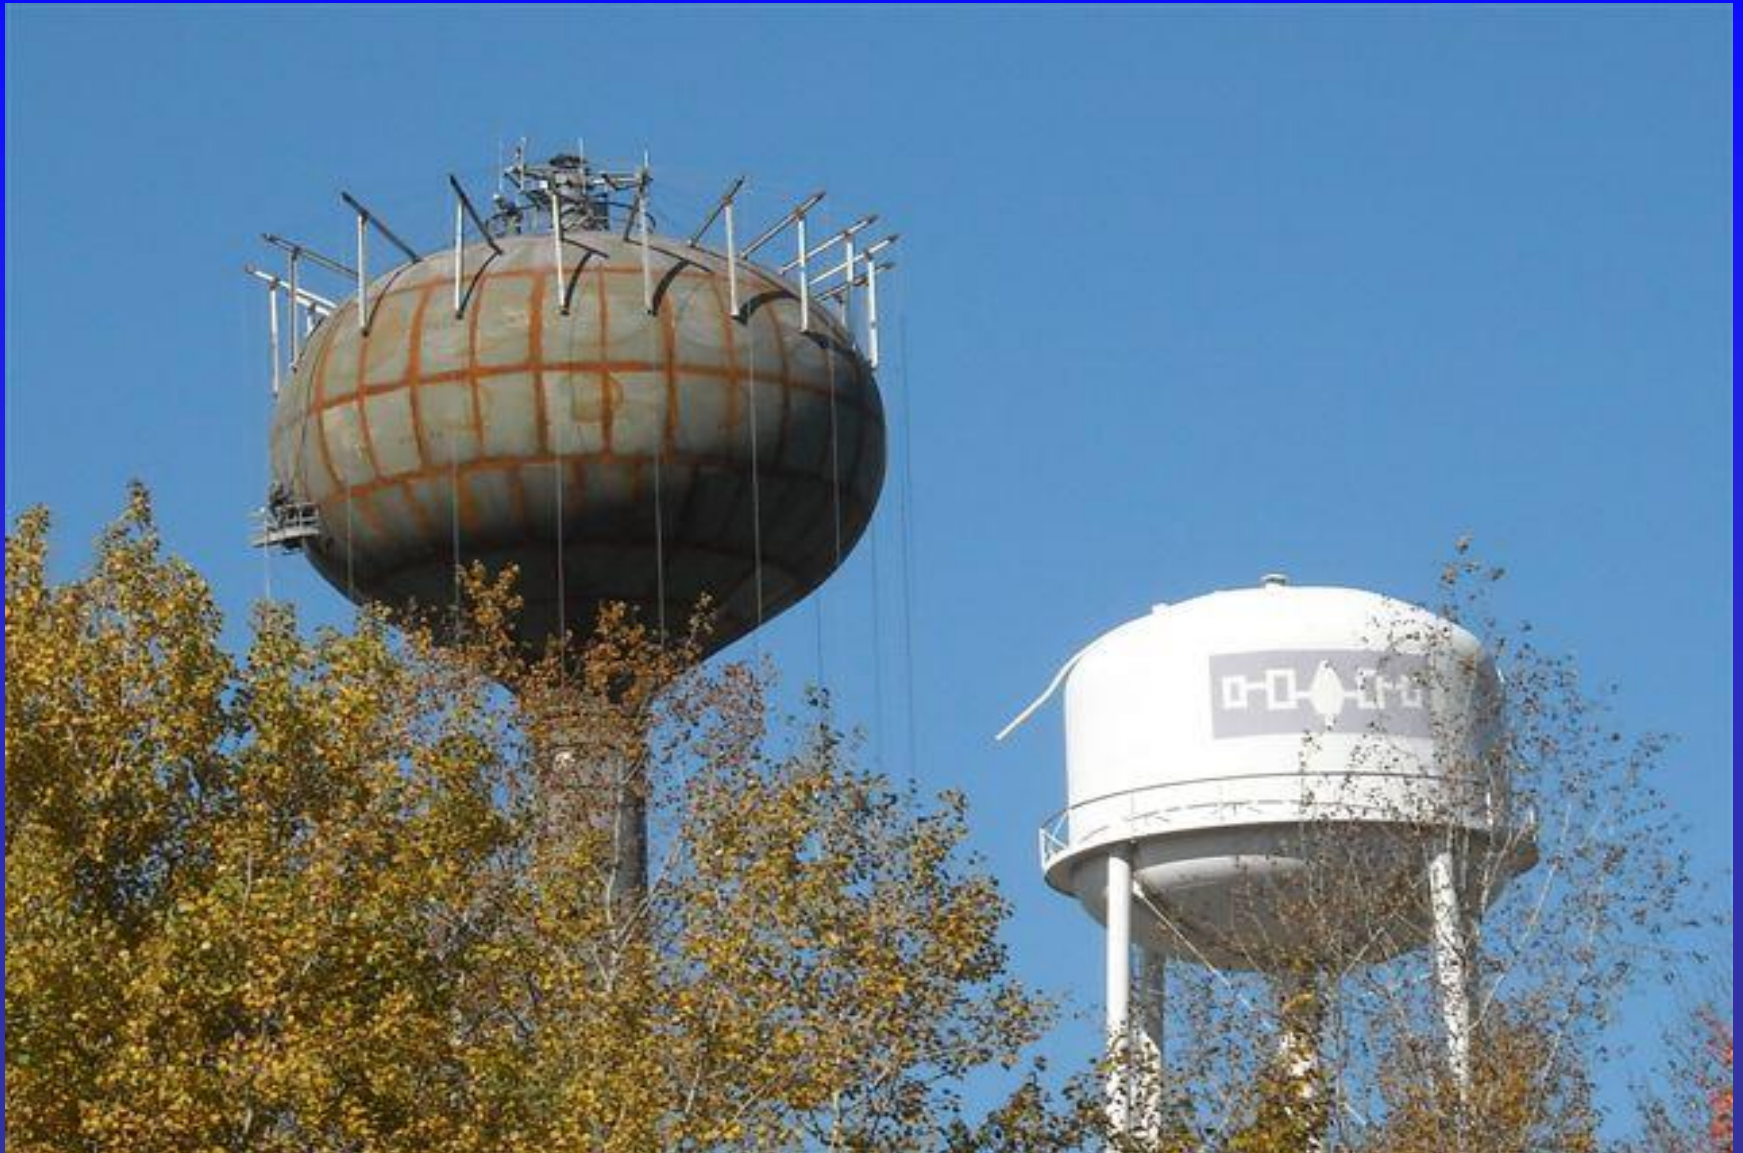
# Horizontally Submerged Cathodic Protection System in Water Storage Tank
