# Corrosion Control of Water Systems

**Presented By:**  
**James T Lary**  
**Corrpro**  
**1055 W. Smith Rd.**  
**Medina, OH 44256**  
**Tel. 330-241-6615**  
**email: [jlary@corrpro.com](mailto:jlary@corrpro.com)**  
**<http://www.corrpro.com>**

**corrpro®**

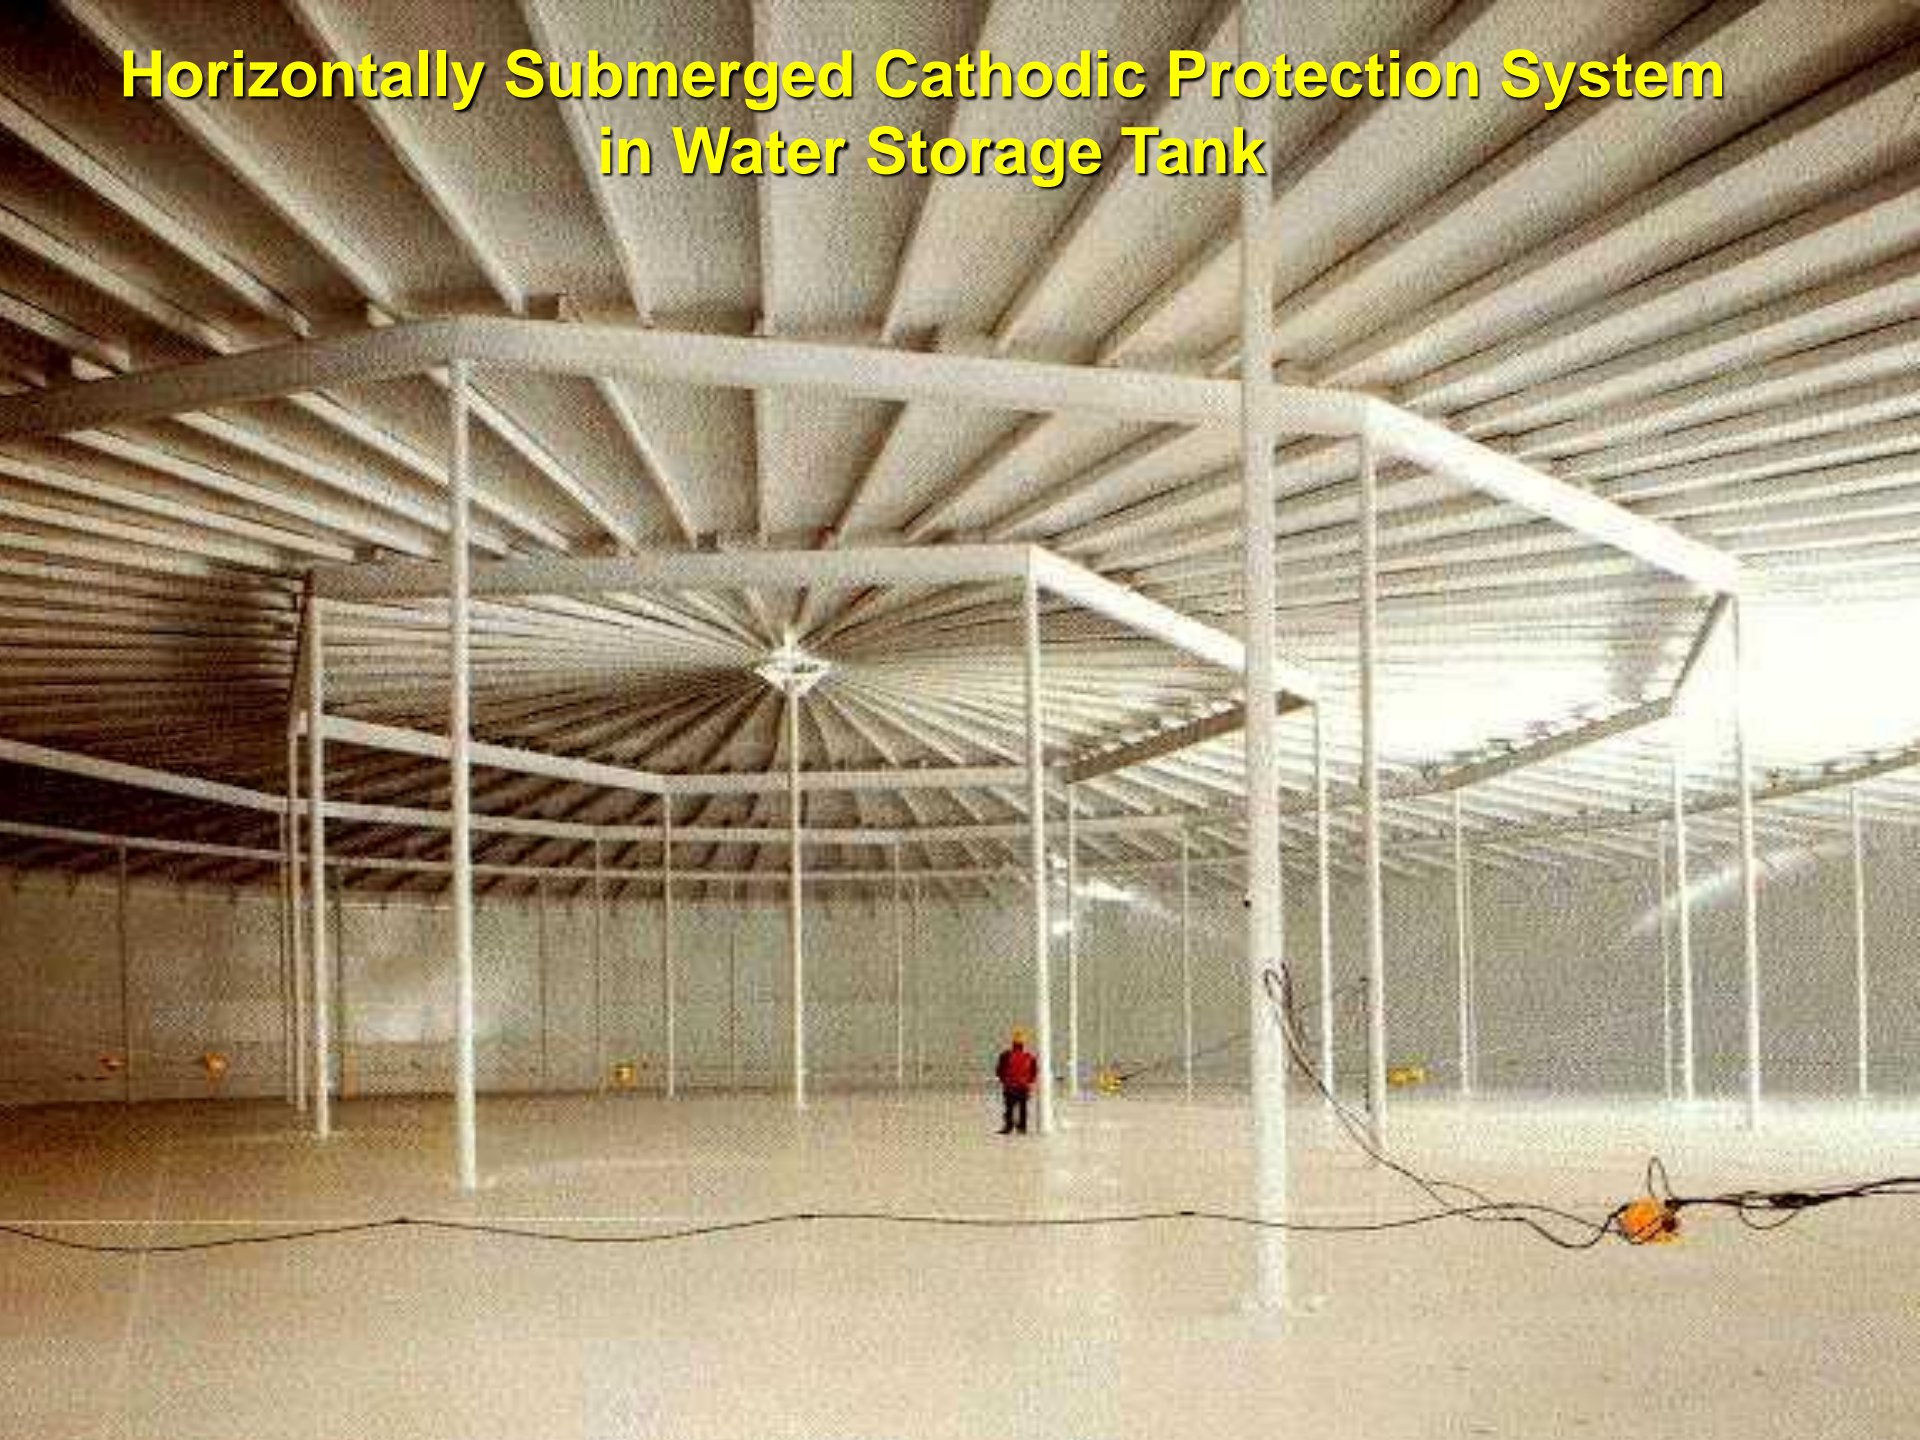
# Vertically Suspended High Silicon Cast Iron Anode String

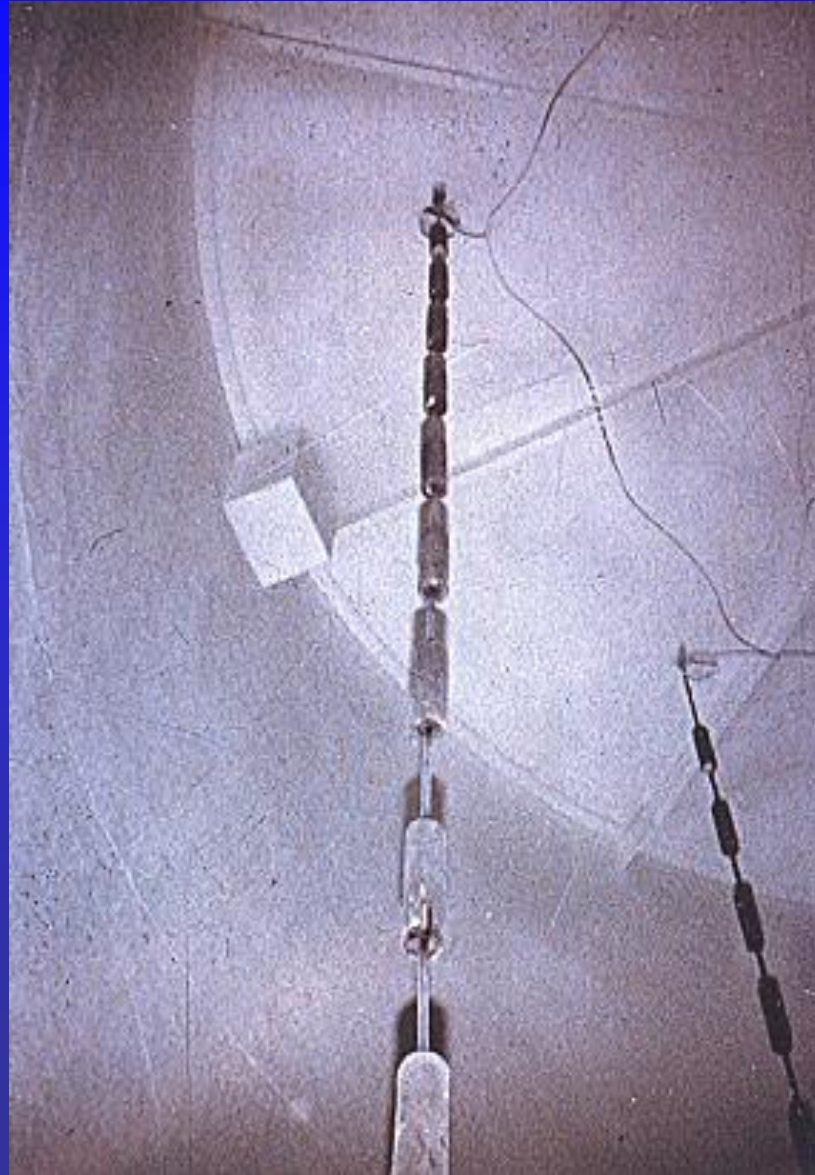
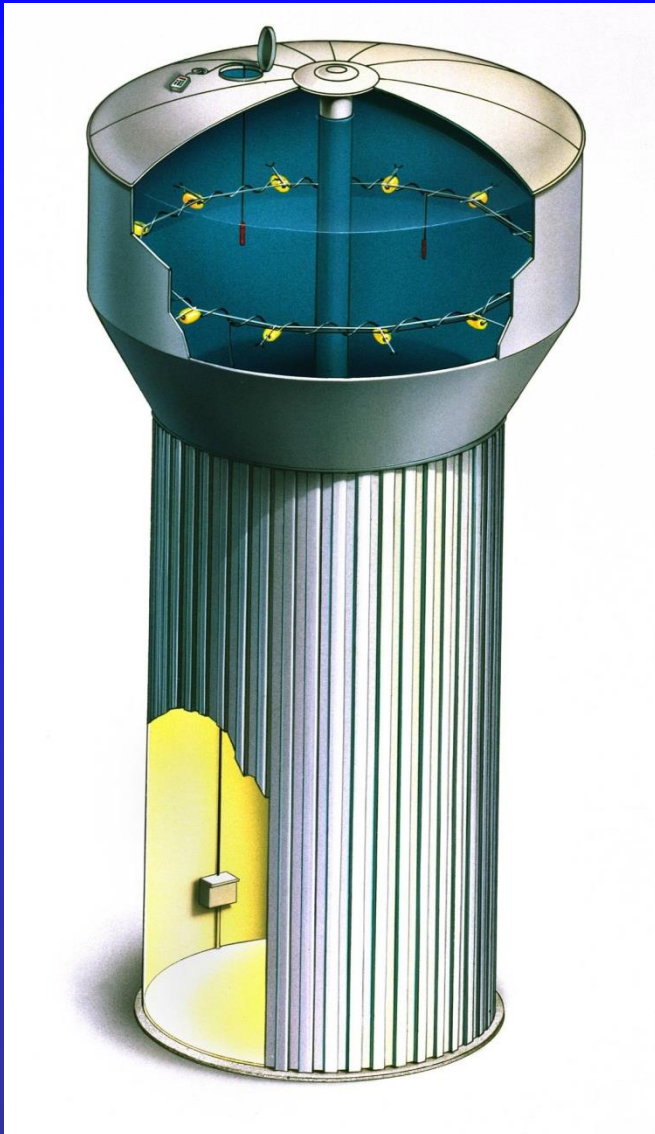
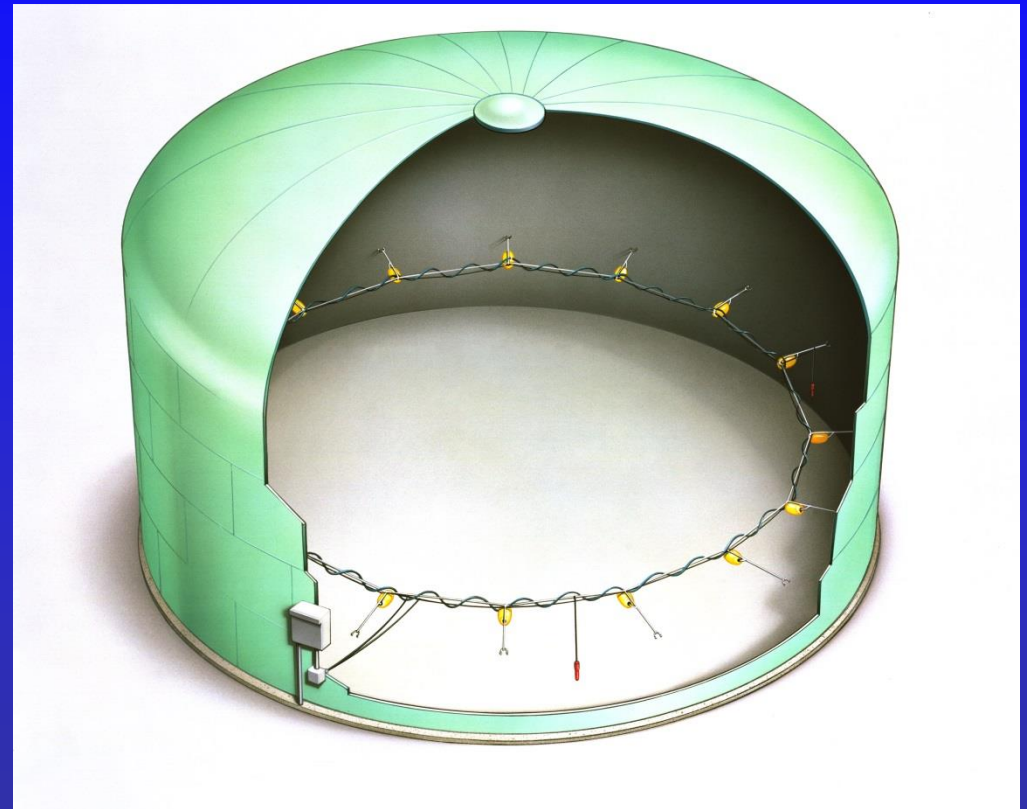
**CP Benefits:** - Triple life of coating  
- Reduce maintenance cost

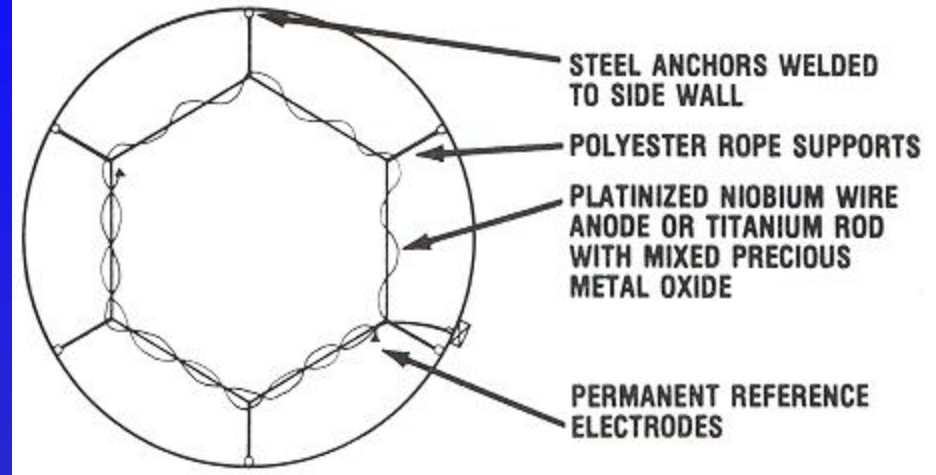
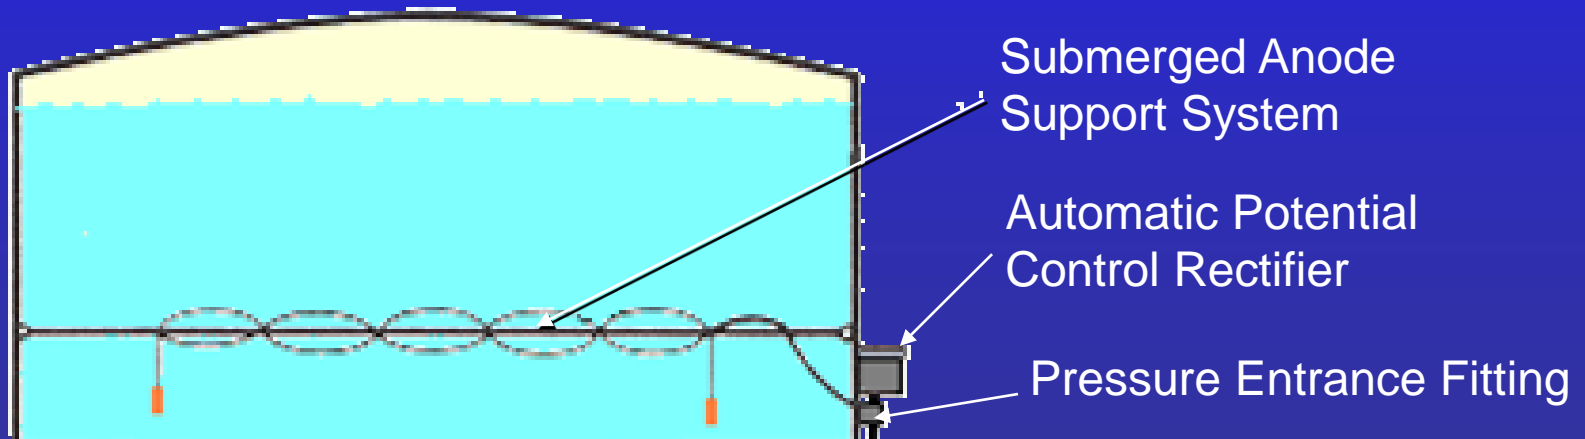
Top View Diagram

# Suspended Horizontal Anode System

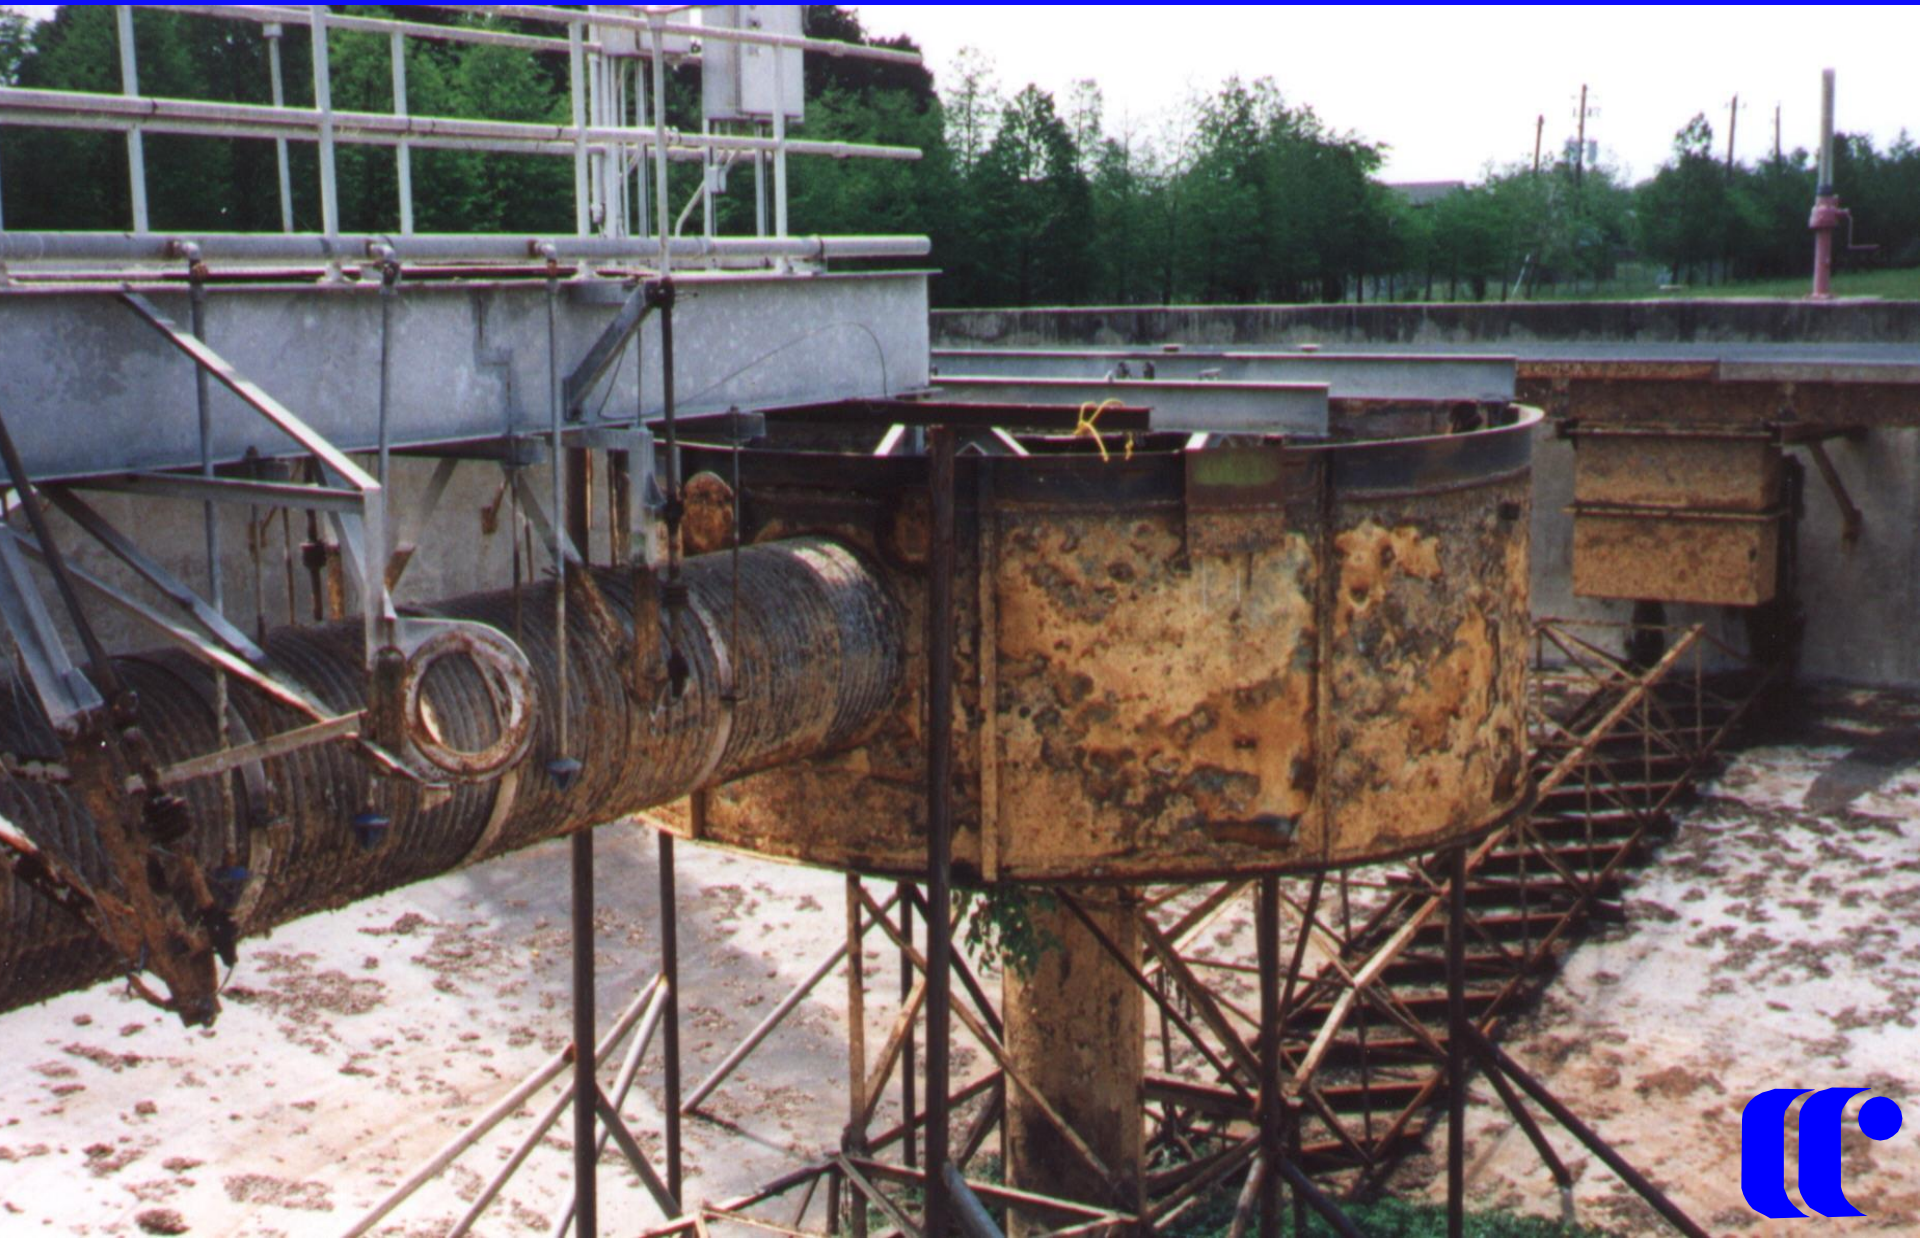
# Corrosion of Clarifier Center Well

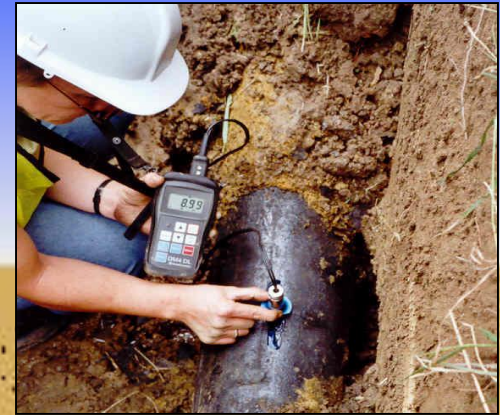
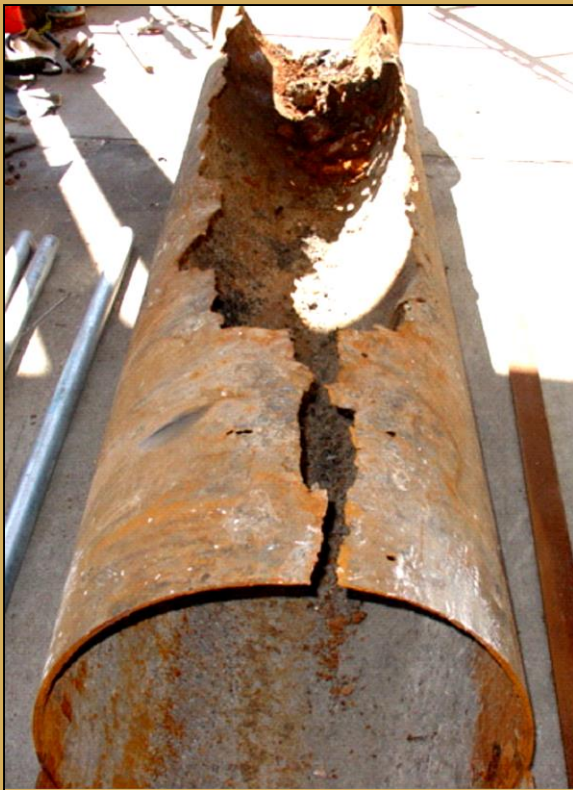
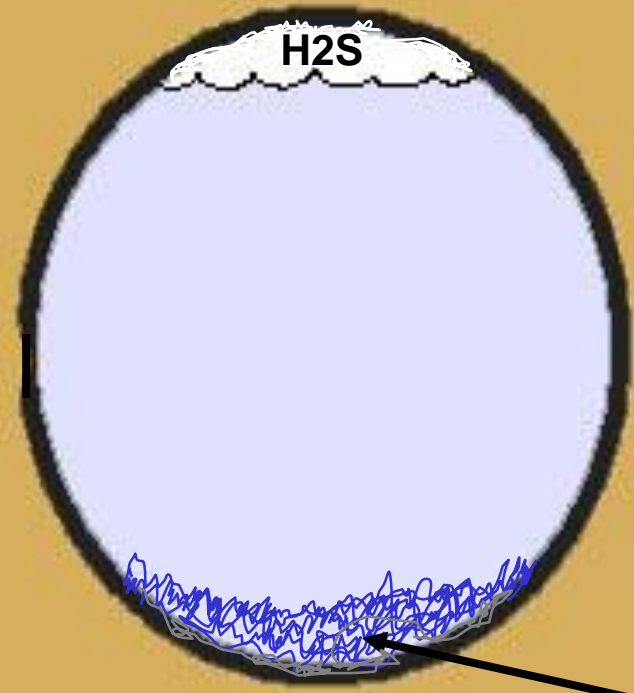
# *Internal Corrosion of Force Mains....*

**Solids  
Buildup**

- Internal failures at bottom of pipe
- Failure following loss of internal mortar lining
- Failures concentrated at low areas (dips) in pipeline alignment
- Cause is corrosion under accumulated solids

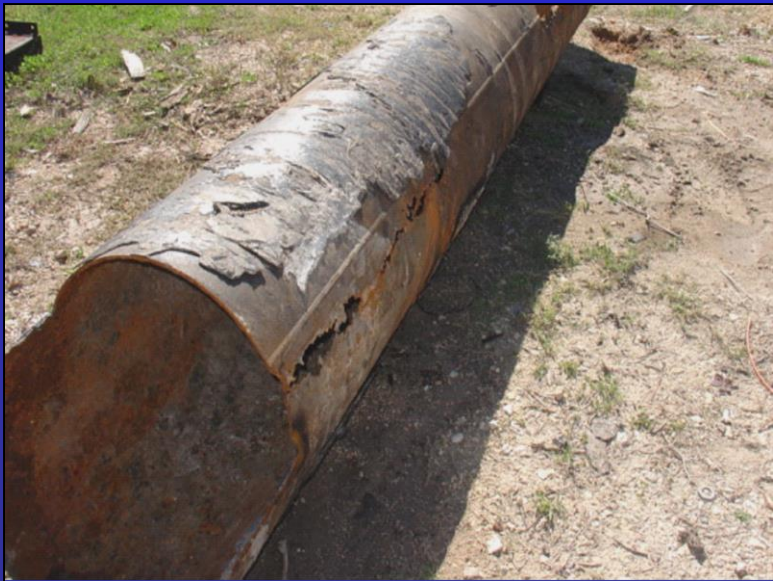
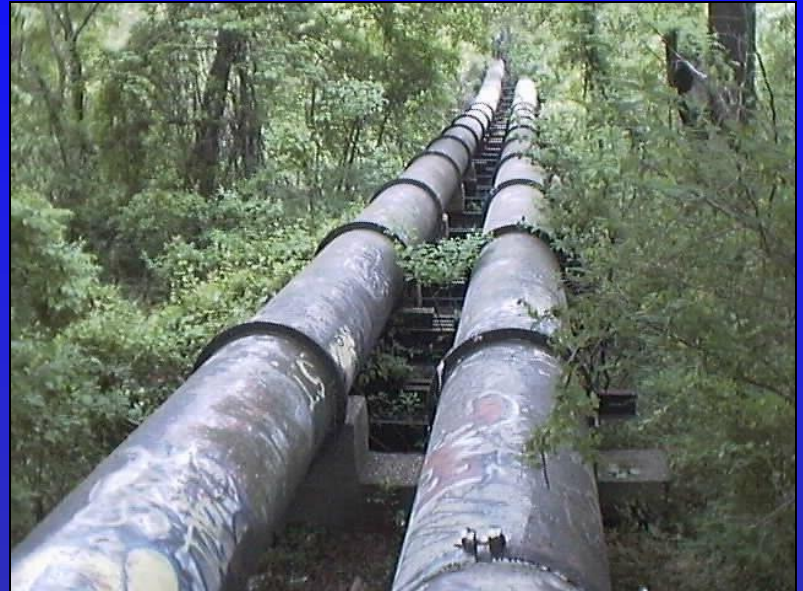
# 36" Above Ground Crossing

- Failure of force main at above ground crossing
- Crown of pipe attacked by hydrogen sulfide gas

- Failure of force main at above ground crossing
- Crown of pipe attacked by hydrogen sulfide gas

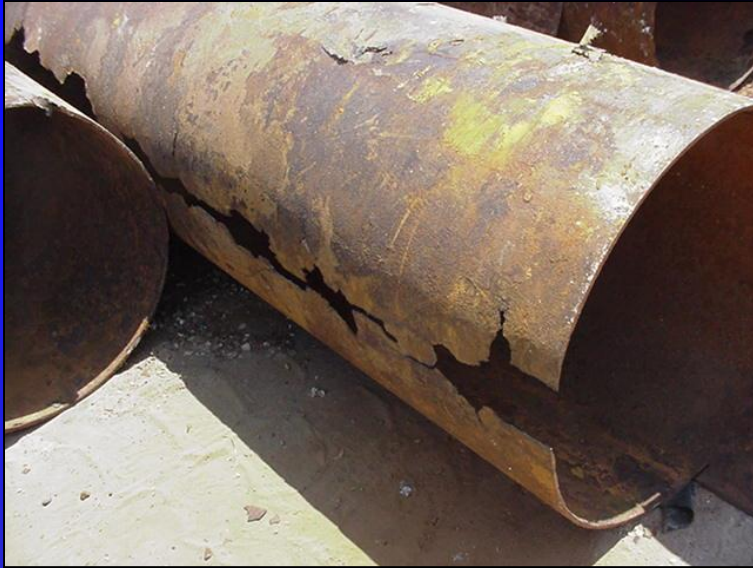
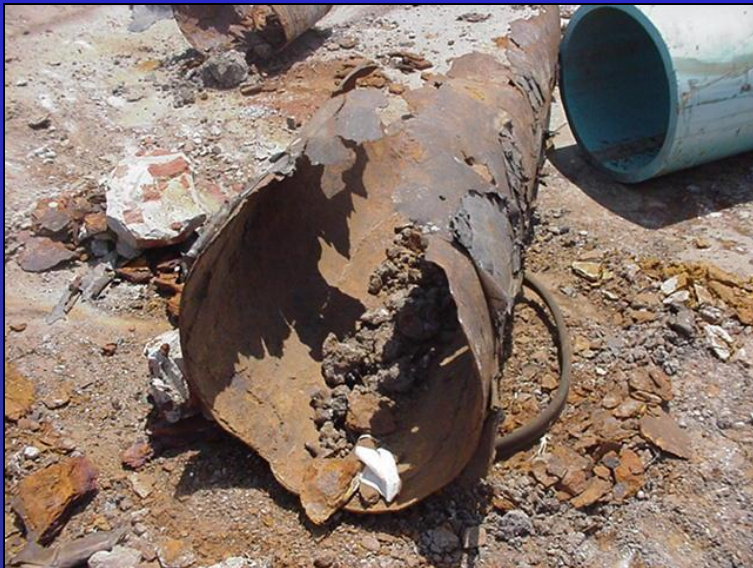
# 24" Ductile Iron Force Main

- Internal failure following loss of internal mortar lining
- Failure was along top of pipe due to formation of hydrogen sulfide gas

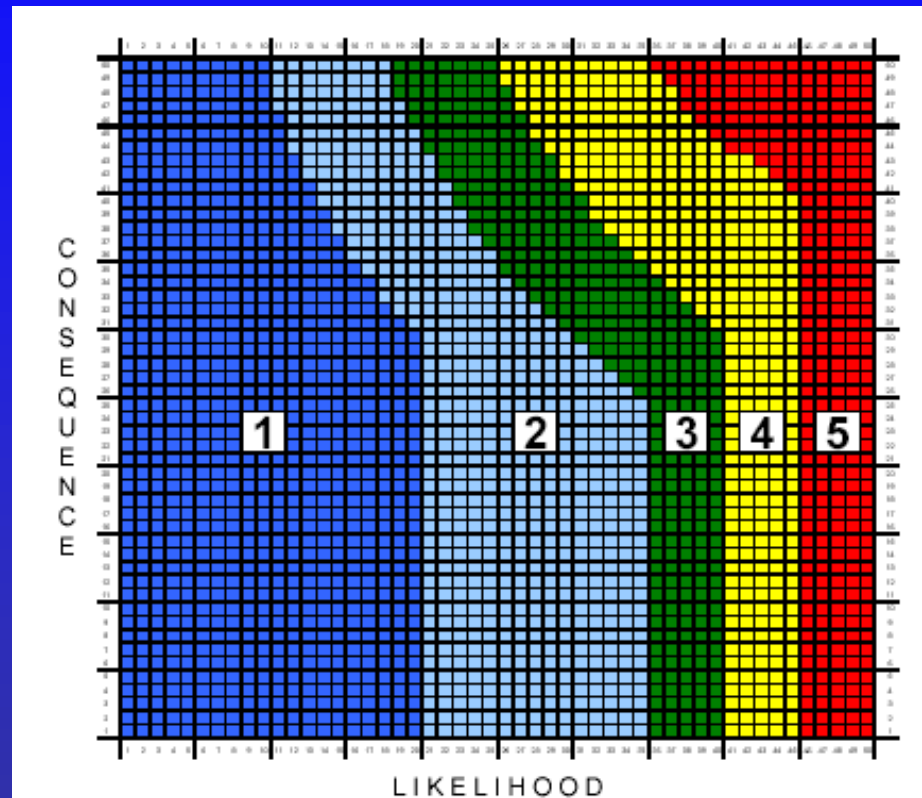
# Design Decision Model

*For Ductile Iron Pipe*

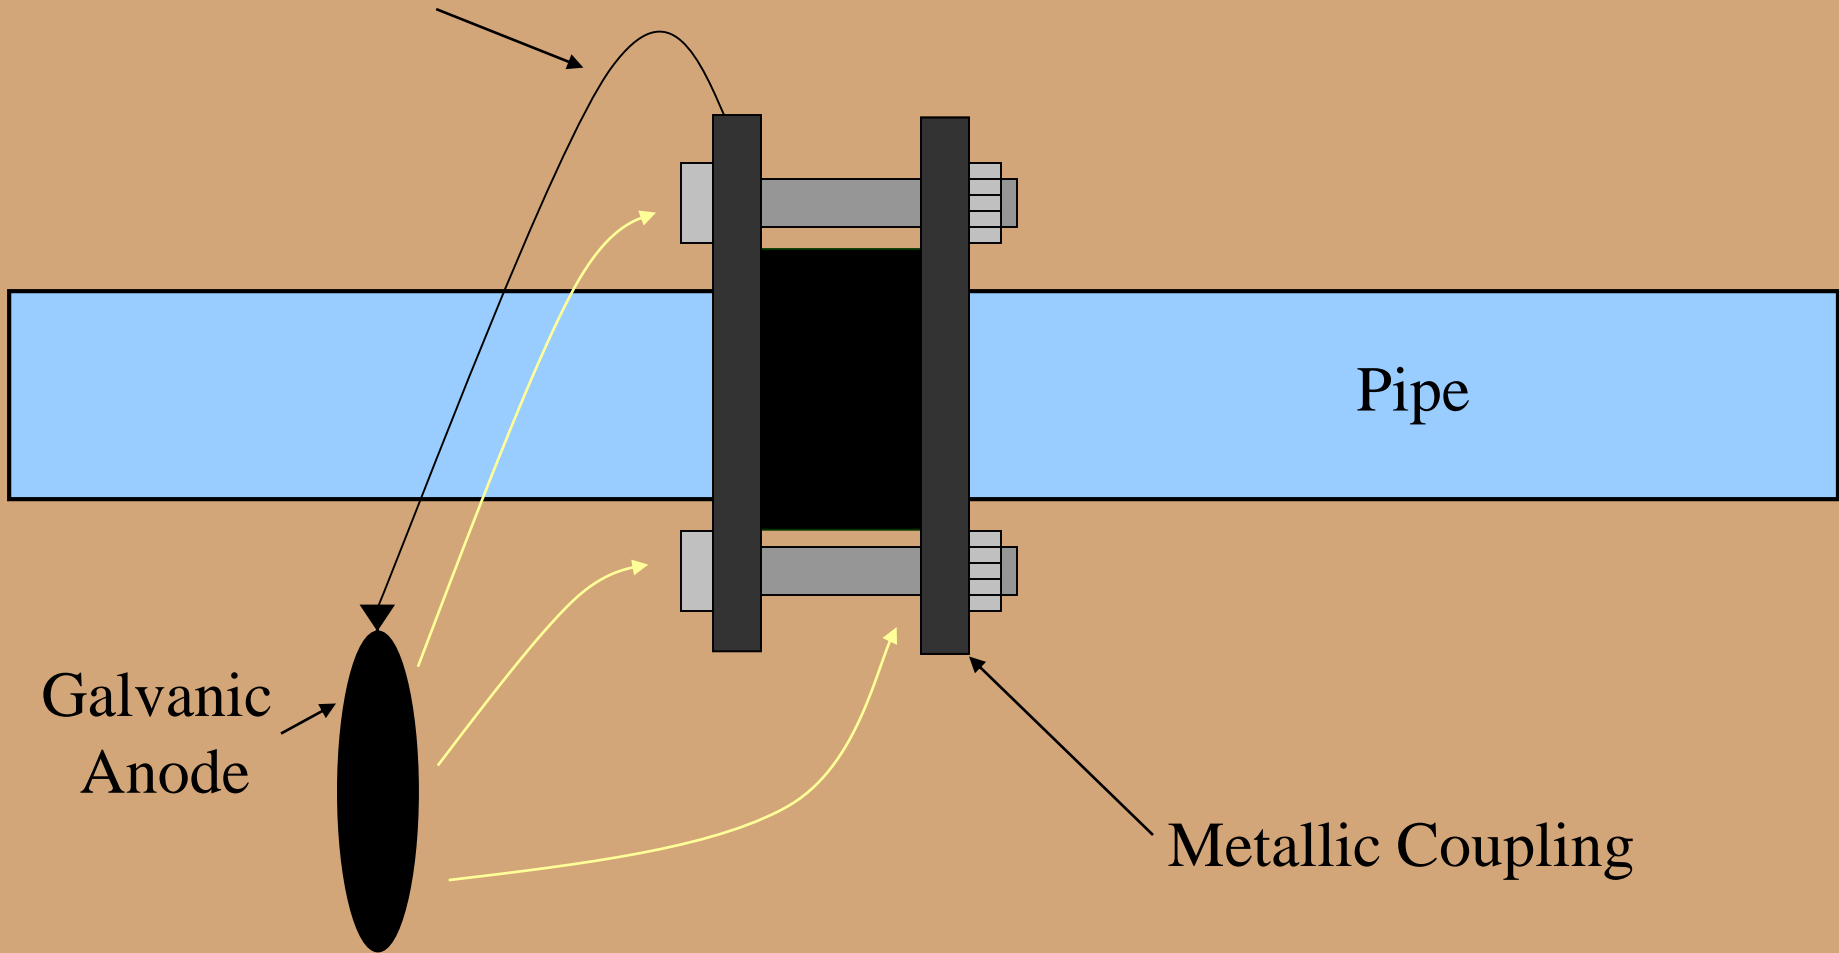
Cathodic Protection of Metallic Fitting

Anode Lead Wire Connection

Galvanic Anode

Pipe

Metallic Coupling

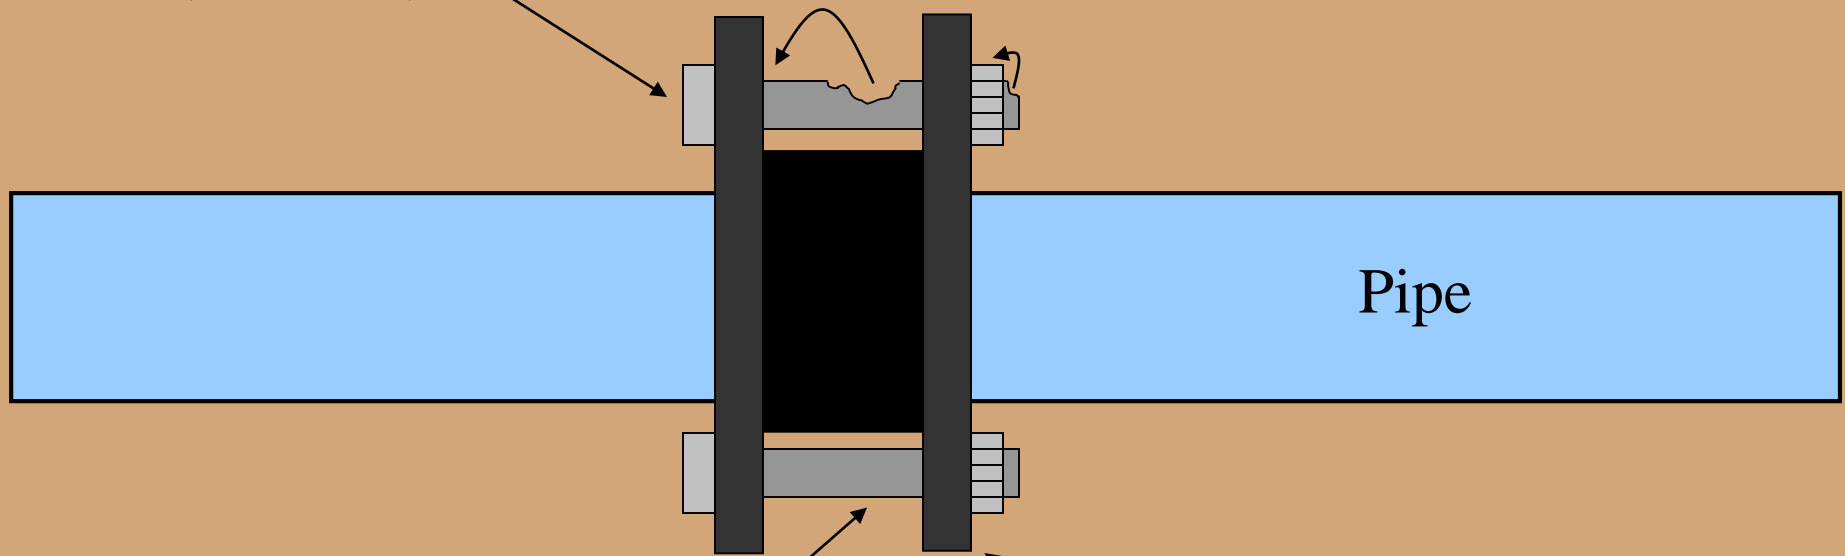
Lower Stress Area  
(Cathode)

Pipe

Threaded Bolt  
Higher Stress Area  
(Anode)

Metallic Coupling

Stress Corrosion

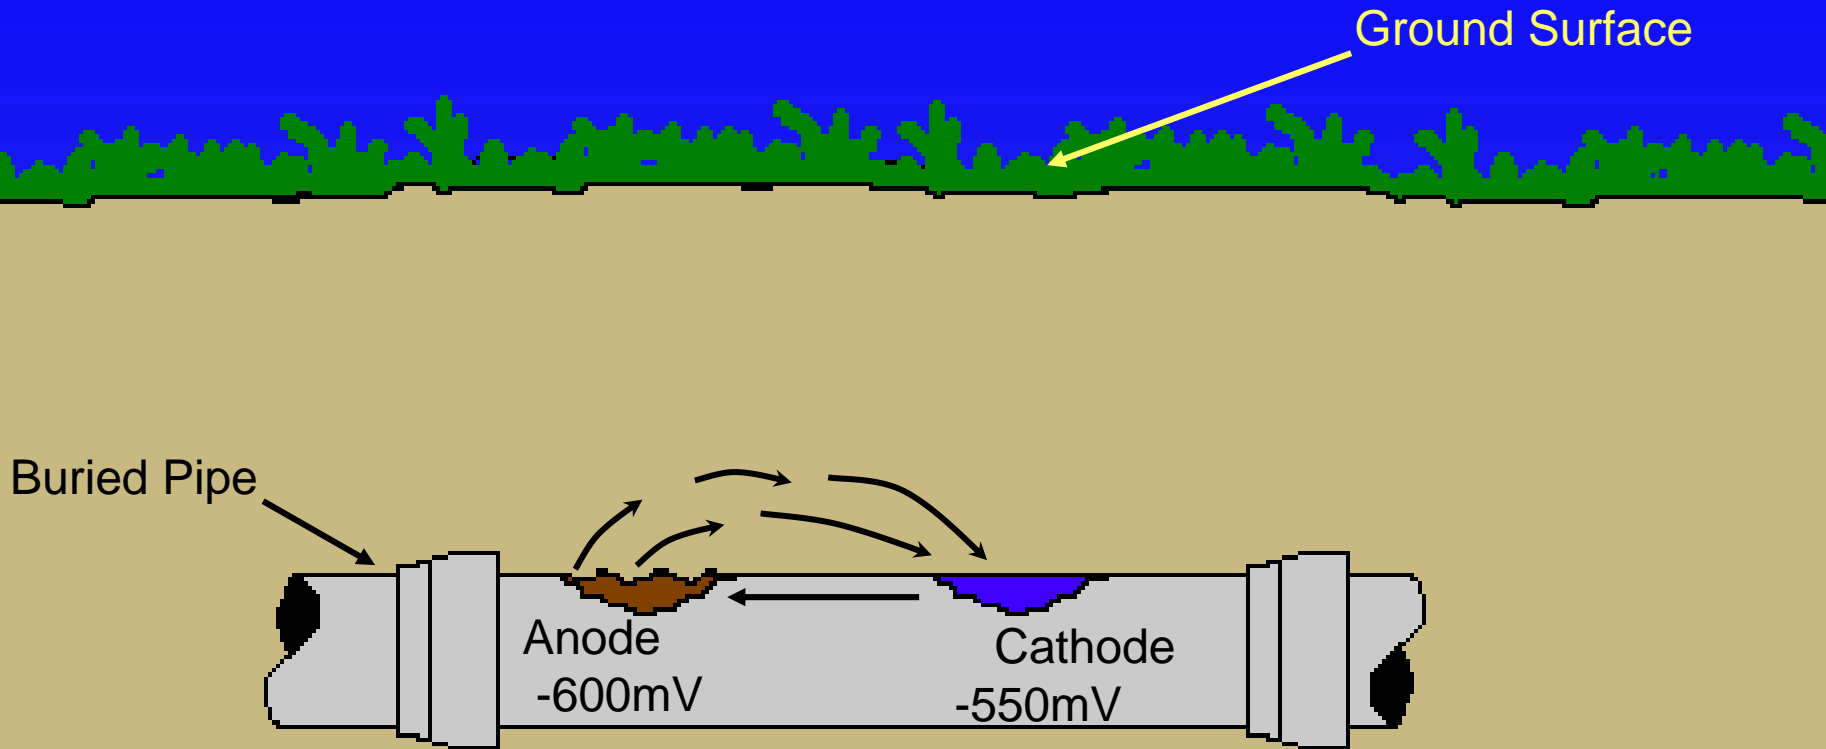
# Basic Corrosion Cell

- 1) Anode
- 2) Cathode
- 3) Electrolyte
- 4) Electrical Connection

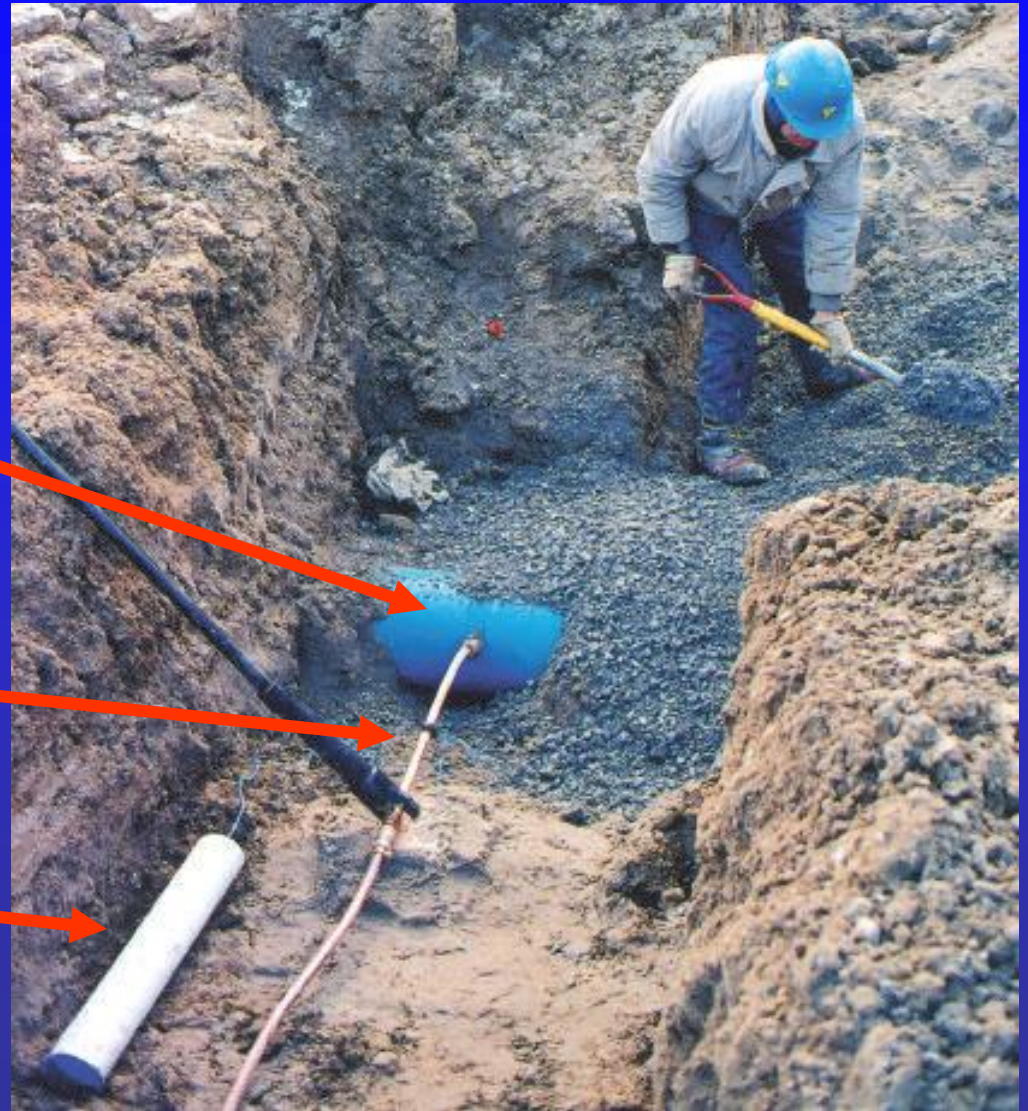
# Anode Installation Prevents Corrosion on Copper Service Line

Non metallic or  
Polyethylene Encased  
Ductile Iron Main

Anode Connection to Line

Anode

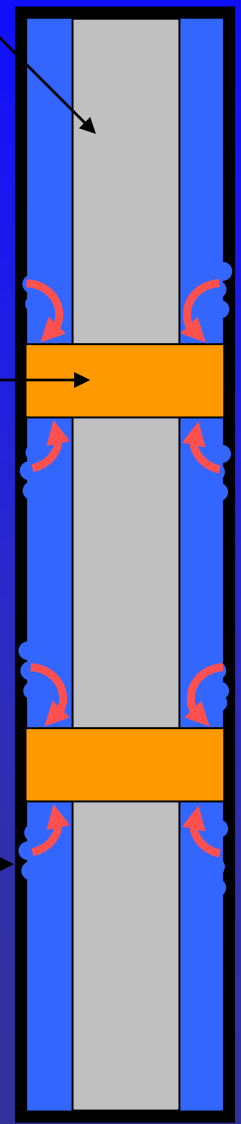
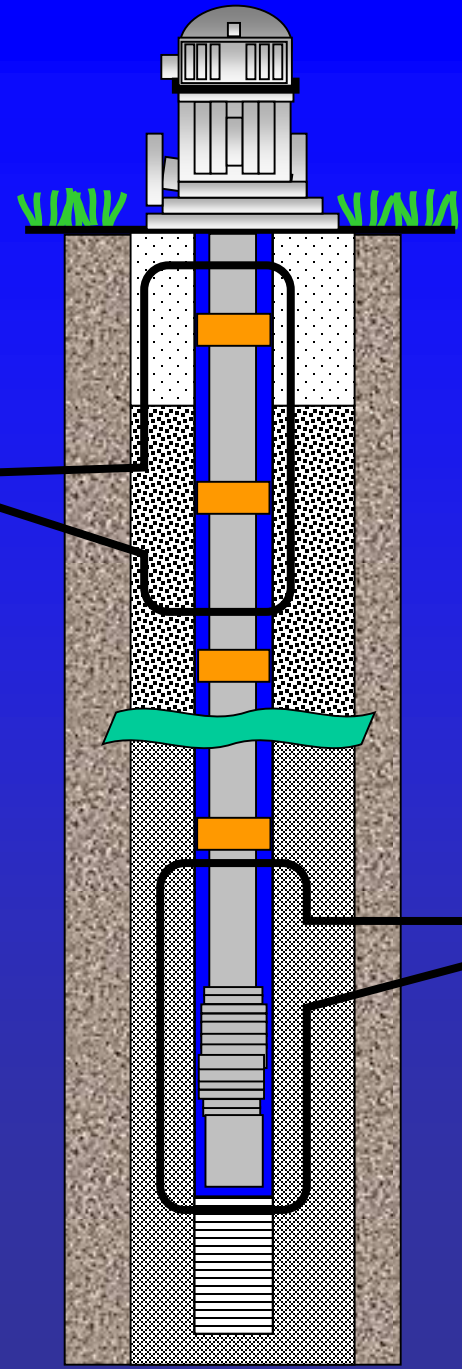
**Stainless Steel Bowl Shaft**

**Bronze Shaft Spacers (Cathode)**

**Mild Steel Column Pipe (Anode - Corrodes)**

**Bowl Shaft (Stainless Steel) Cathode**

**Crown (Steel) Anode**

**Bowls (Cast Iron) Anode**

**Suction Case (Cast Iron) Anode**

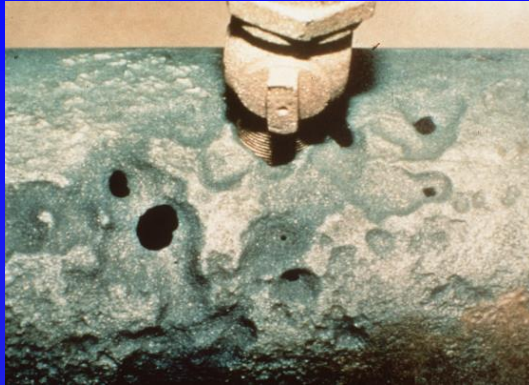
Corrosion of iron when coupled to copper service line.

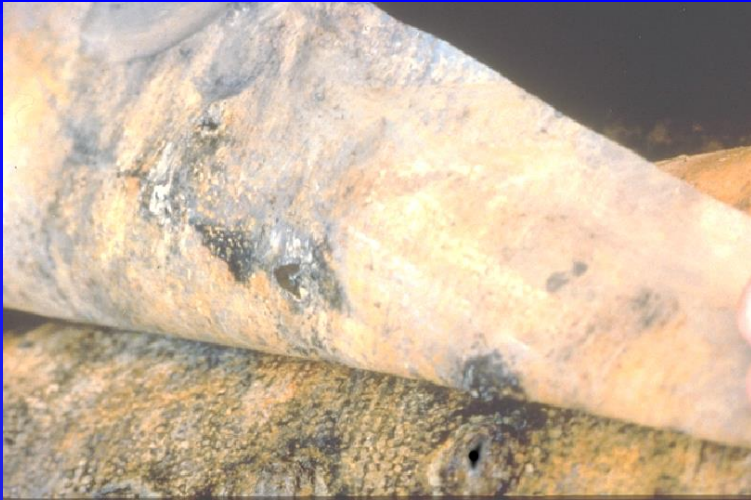
Corrosion on damaged polyethylene encased pipe.

- Follow manufacture's and AWWA recommendations to insure proper installation of polyethylene encasement.
- In extremely corrosive areas, additional methods (bonding of joints, cathodic protection, may be required).

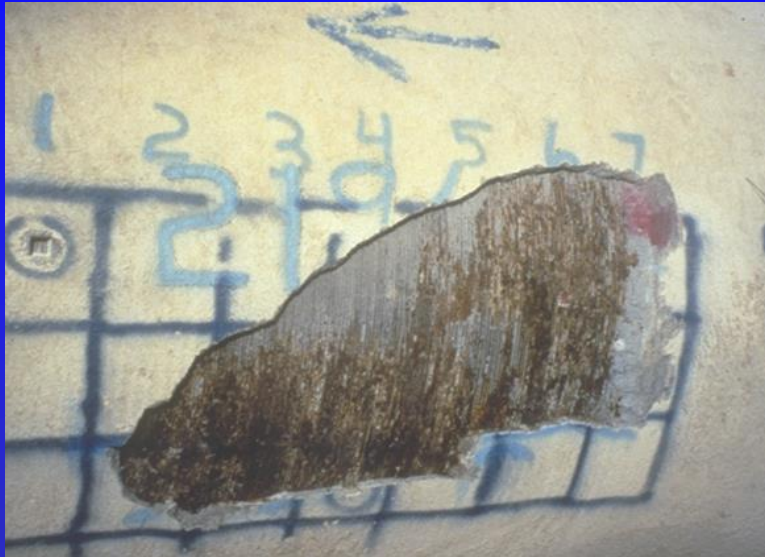
Corrosion of pre-stressed concrete cylinder pipe (P.C.C.P.).

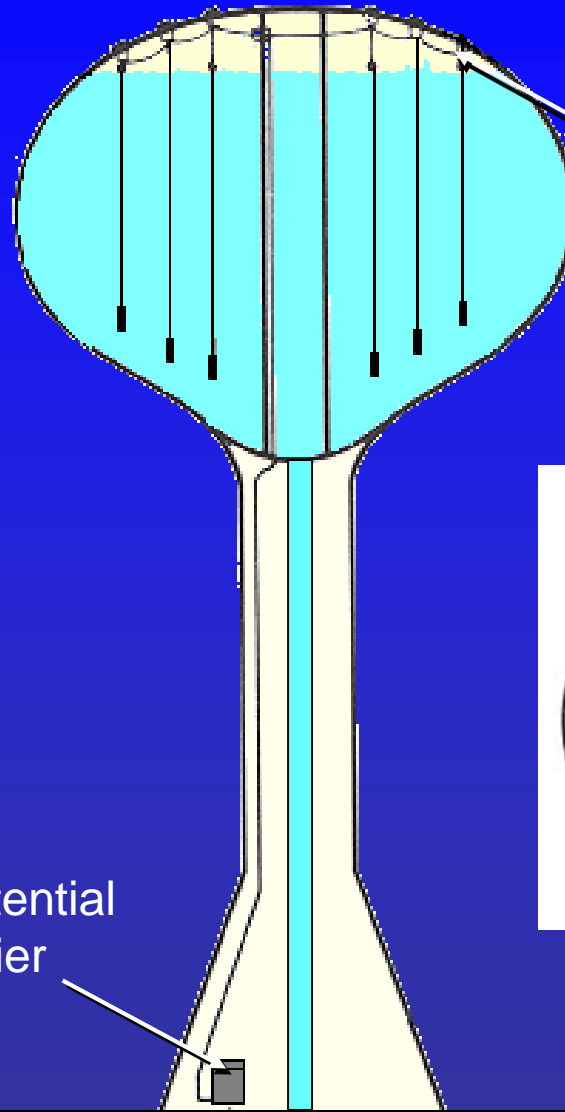
# Suspended Vertical Anode System

Support System Bolted to Roof for Bowl Anodes and Reference Electrodes

Top View Diagram

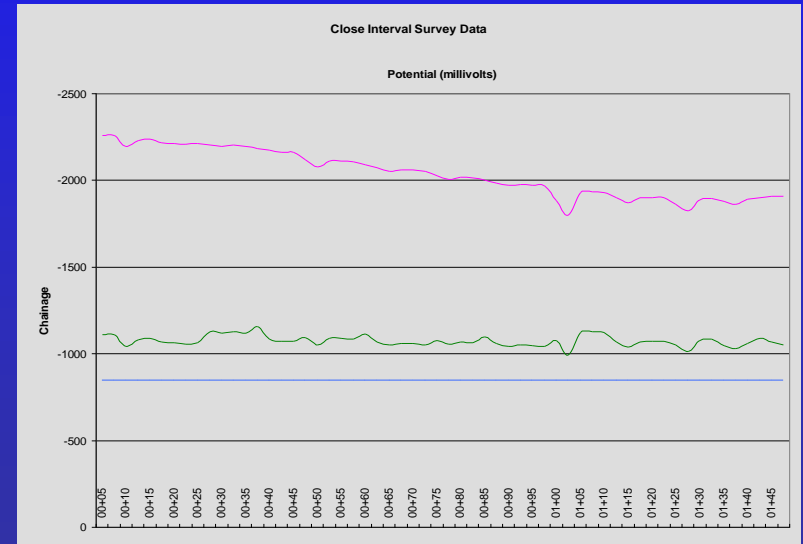
Close Interval Data  
PG/WFA Survey

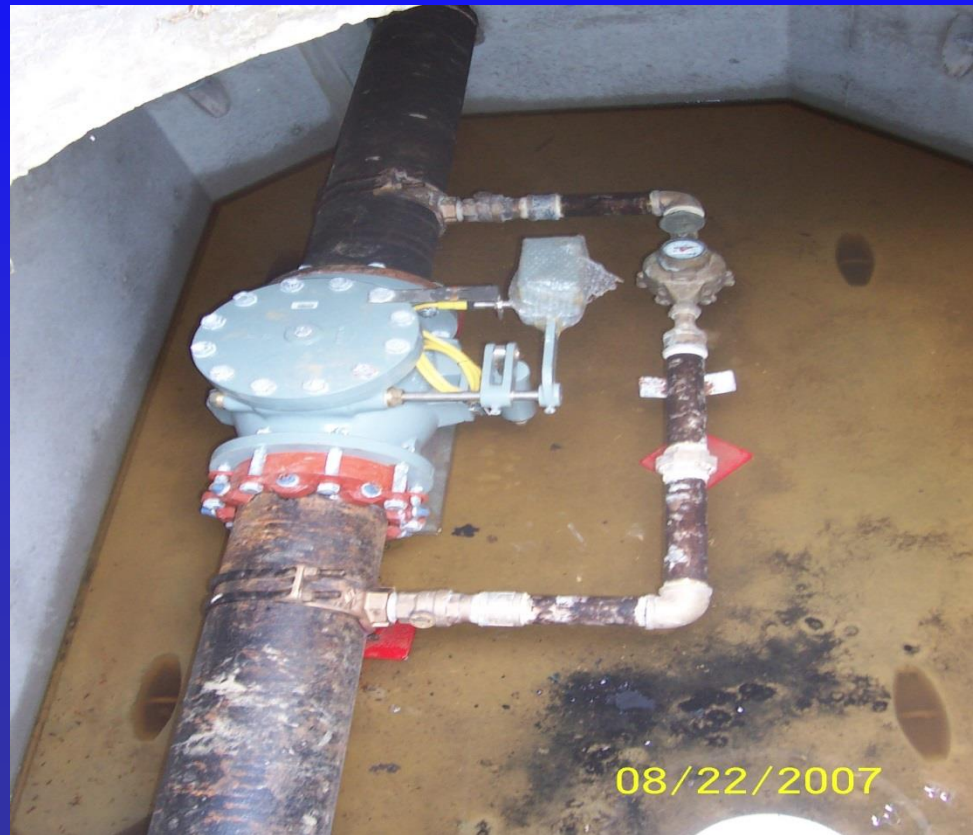
# Meter Vaults

*(Keep dry if possible)*
