Peeling the "I/I Onion"

John W. Swartzbaugh, PE

BURGESS & NIPLE

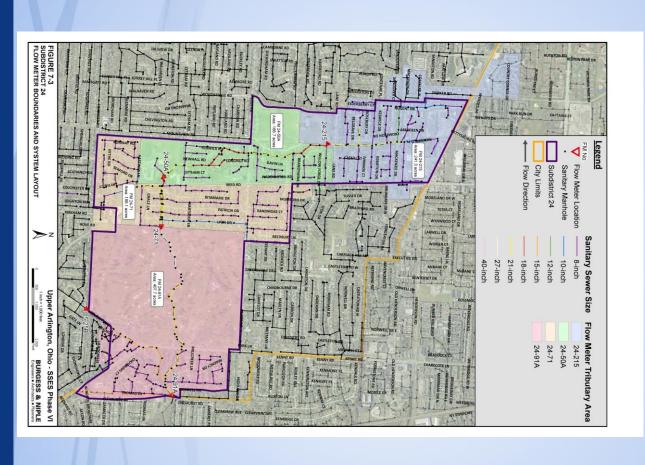
Flow Meter Tributary Area Map

- Select locations with 5,000 to 10,000 feet of Tributary Area
- Use Data Gathering Info to Guide Flow Meter Location Selection
- Install Meters for Baseline Comparison

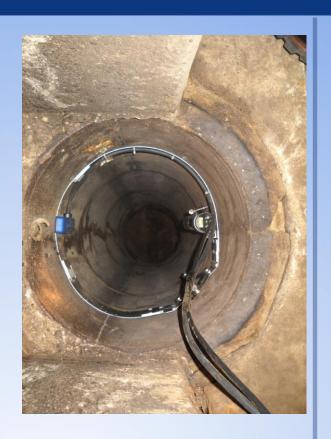
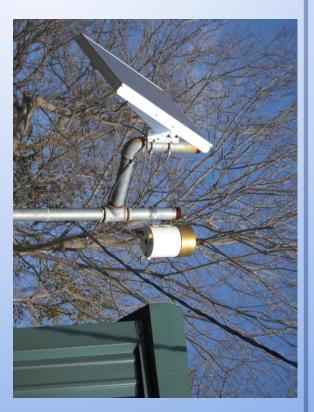
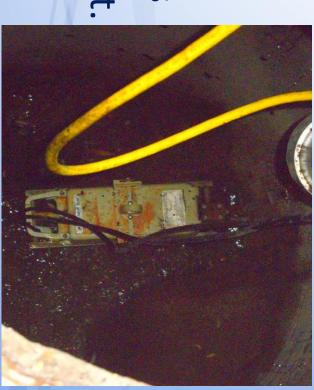
Flow Meter / Rain Gauge Installation

- No Flow Meter is
- Suited for Every Situation
- where they perform at their best. Each have their site conditions

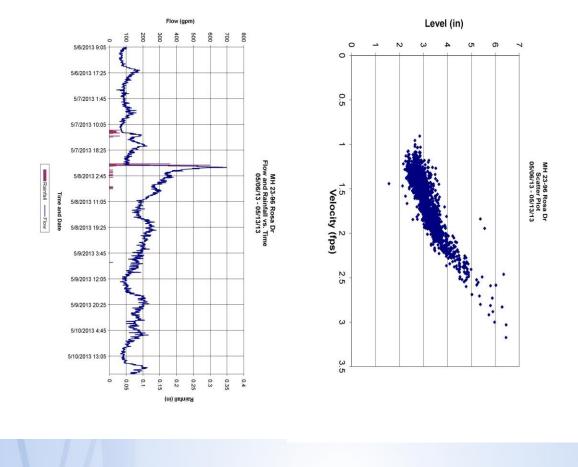
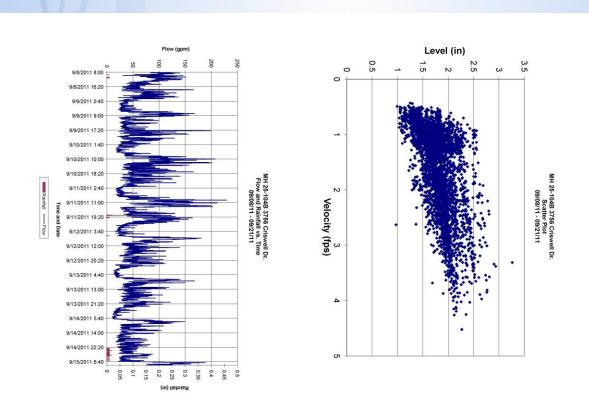
Flow Data QA/QC

- Weekly Downloads Check Batteries!
- At a Minimum Monthly Flow Confirmations
- Level Pressure Transducer Drift
- Debris partially covering velocity sensor
- Weekly Data Processing and QA/QC
- Hydrographs of Flow vs. Rainfall
- Scatter Graph of Velocity vs. Level

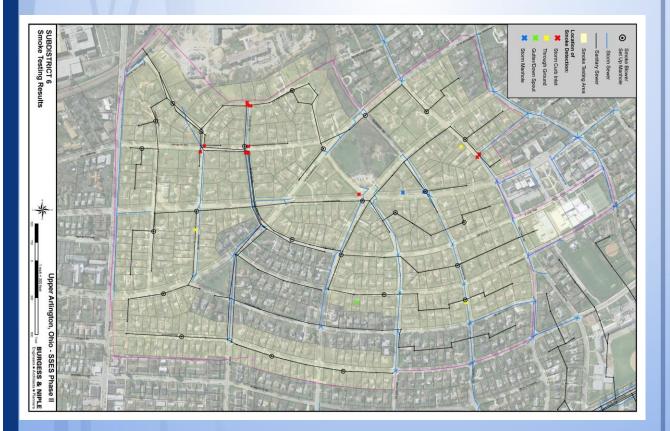
Smoke Testing Data Collection

٥	Silloke Lesting Form		
Project Name:	NEW IBERIA			
Client Name:	NEW IBERIA	Date:	1/21	1/21/2011
Map Grid:	4-5	Technicians:	RC, SS	SS
General Information				
Address:	5085 Reed Road			
Upstream Node Name:	4-23	Downstream Node Name: 4-4	de Name: 4-4	
Line ID:	4-23:4-4			
Cover Information				
USMH Cover Holes?:		USMH Cover Slots?:	ts?:	
Number of Holes/Slots:		Size of Holes/Slots:	ts:	
Ponding?:		Print Correction?:	.,	
Pipe Information				
Pipe Length:	185	Pipe Size:	00	
Surface Cover:	ASPHALT	Smoke_Leak:	5	
Length Smoked:	185	UTSC Code:	N/A	
Comments:	NONE			
Smoke Defect Information	'n			
Line ID	_	Leak Address	Leak Number	Leak Type
4-23:4-4	50	5085 Reed Road	1	MAIN LINE

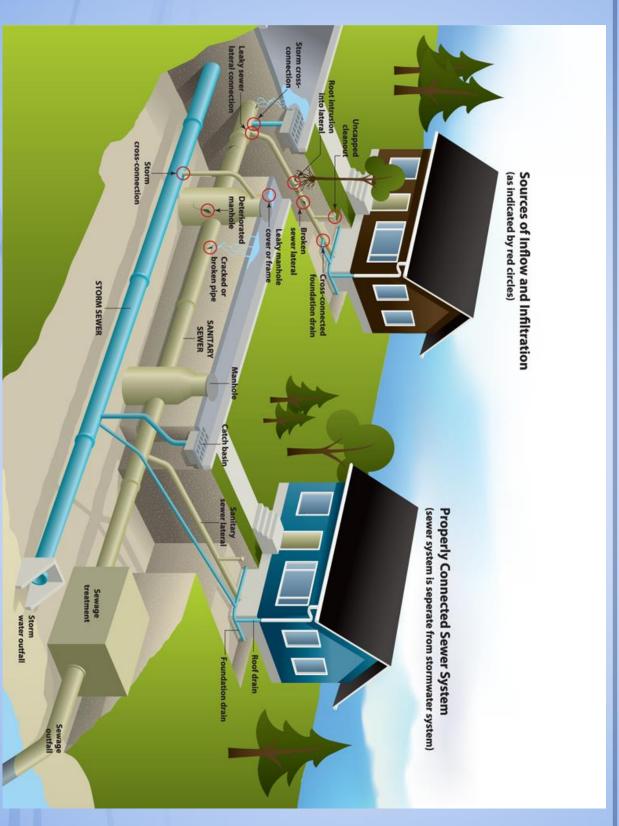
Identification of I/I Pathways

- Determine Storm Sewer Capacity
- Perform Rainfall Simulation to Known Storm Event
- Perform Testing on:
- Manholes
- Parallel Storm and Sanitary Lines
- Perpendicular Storm and Sanitary Lines in close vertical proximity

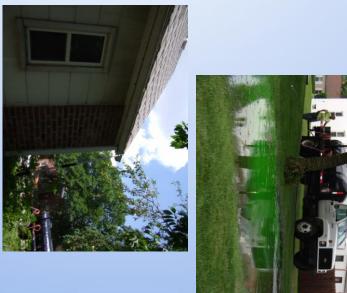
Rain Fall Simulation Locations

- Downspouts
- House Foundations
- Yard / Driveway Drains
- Lateral Locations
- Low Spots or Sunken Sidewalks
- Lower Entry Steps and
 Driveways
