The Latest Innovation in Leak Detection for Gravity and Pressure Sewers

March 23, 2022 – Marietta, OH

**Machine-Intelligent
Infiltration Location & Quantification**

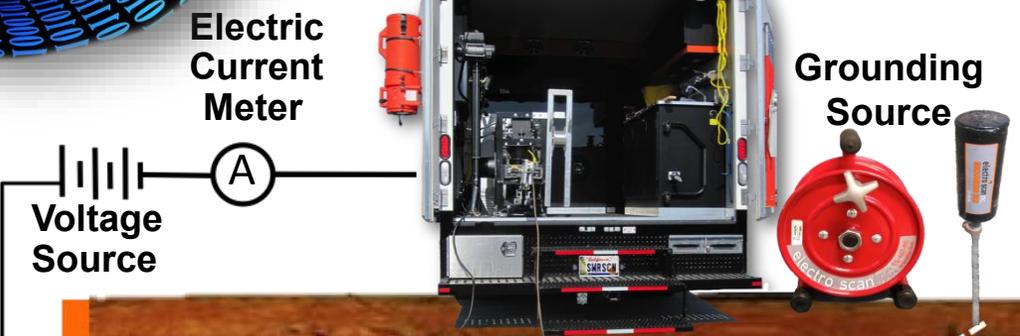
Electro Scan Probe

Resistance = ACP, Brick, CIPP, Concrete, FRP, HDPE, PE, PCCP, PVC, RCP, SRP, VCP

Sliding Funnel Plug

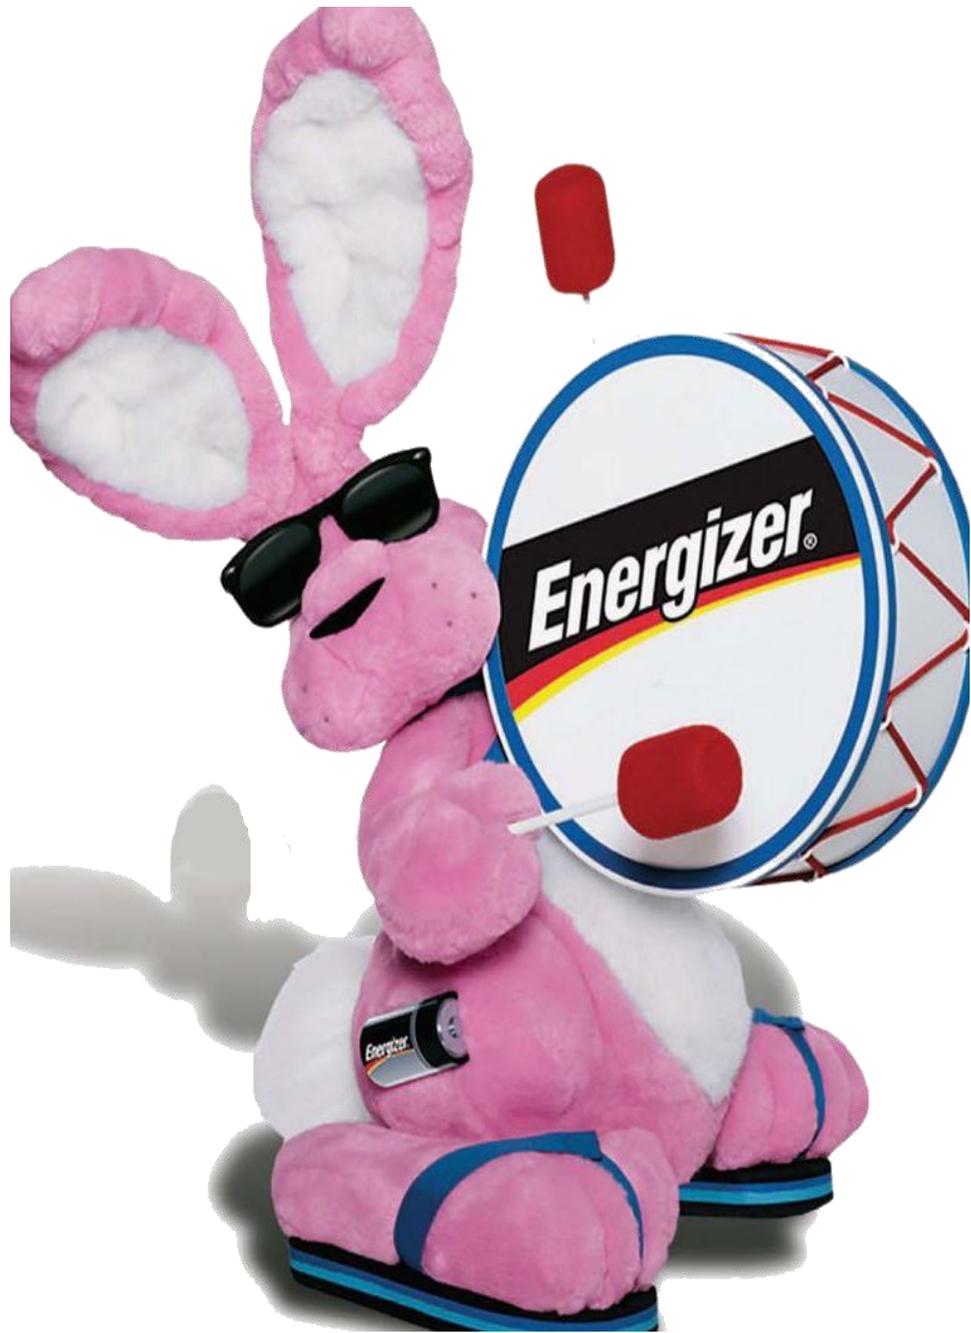
Low Voltage – 40mA

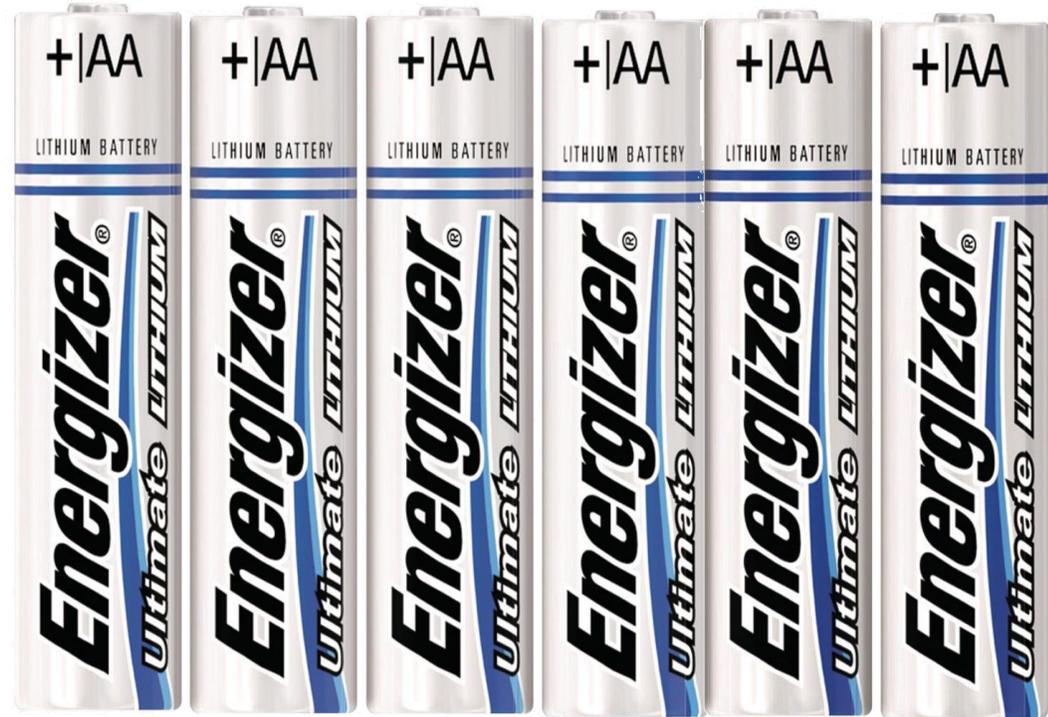
High Frequency

Equipment Uses 24v DC, w/Probe output of 11v AC.

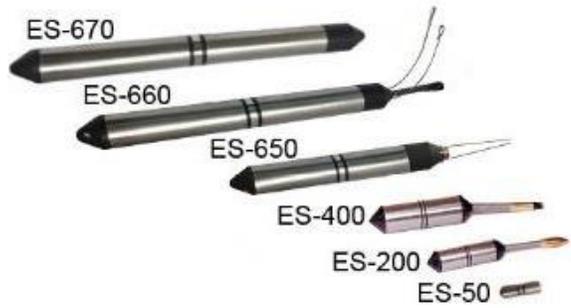
Conductivity Benchmark Testing For Finding Leaks in Plastic Pipe

DEFECTS		LENGTHS	
Large	0	0.00%	
Medium	0	0.00%	
Small	1,100		31.33%
Pinhole	379		6.38%
All Defects	1,479		37.71%

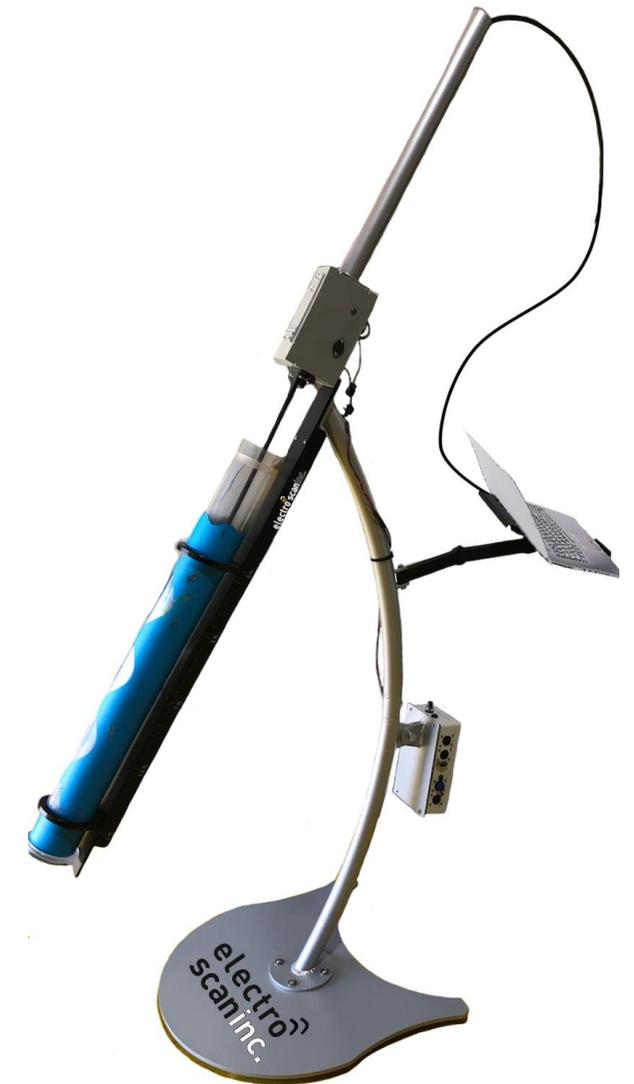
Electro Scan's Use of Ohms Law Provides Unmatched Data Repeatability.

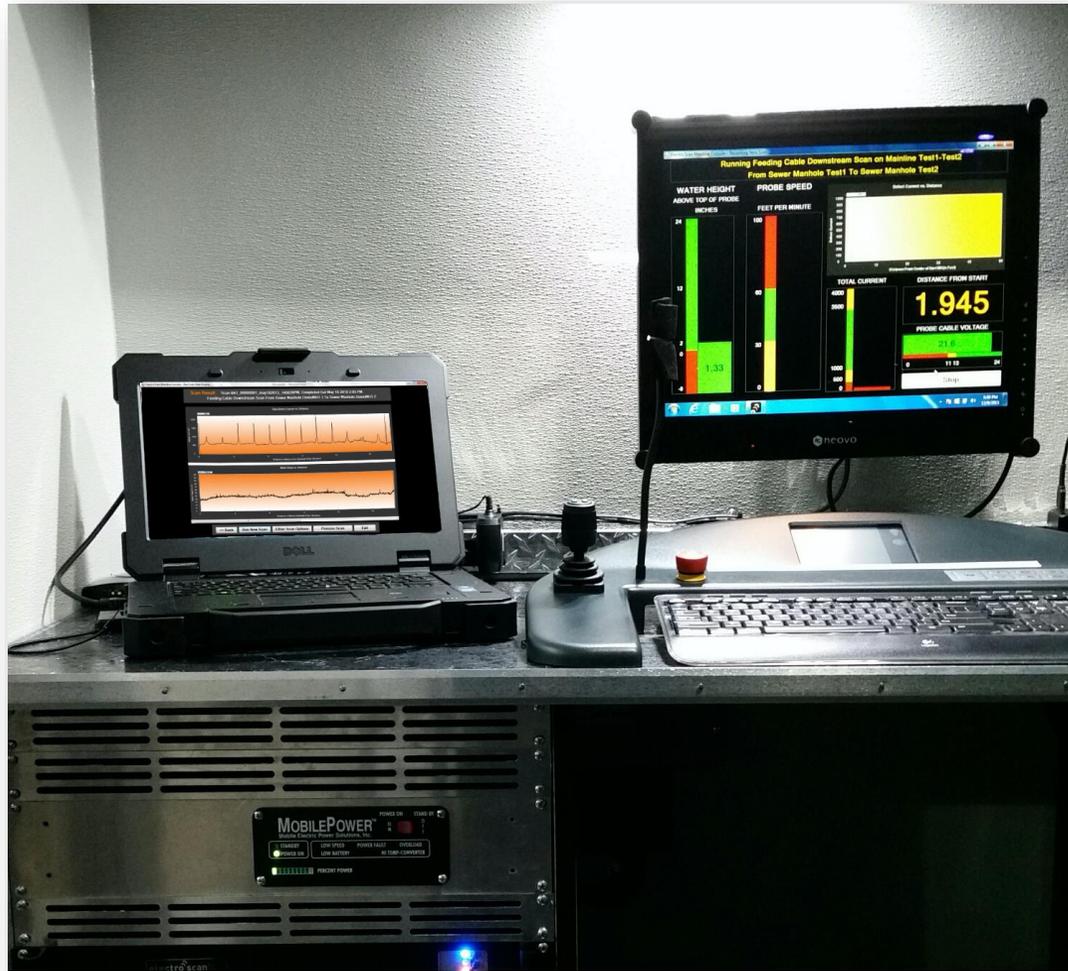
Summary Results

Dual Real-Time Machine-Independent (i.e. NO MANUAL OBSERVATIONS OR CODING) Field Data In-Vehicle Recording.

*All defect flow results are $\pm 30\%$, assuming an avg. groundwater condition of 1ft. head and 1% pipe gradient

84	Mainlines FELL Tested
20,002	Linear Footage
245	Total Pinholes
4,545	Total Defects
5,282	Gallons Per Minute*
7,605,864	Gallons Per Day*
6	Pipes With Less Than 1 GPM
20	Pipes With 1 – 10 GPM
28	Pipes With 10 – 50 GPM
15	Pipes With 50 – 100 GPM
15	Pipes With More Than 100 GPM

As shown in Table 1, Electro Scan inspected 84 pipes or 20,002 linear feet and located a total of 4,300 individual defect locations as well as 245 “pinholes” which contribute an estimated defect flow of 5,282 GPM or 7,605,864 GPD.

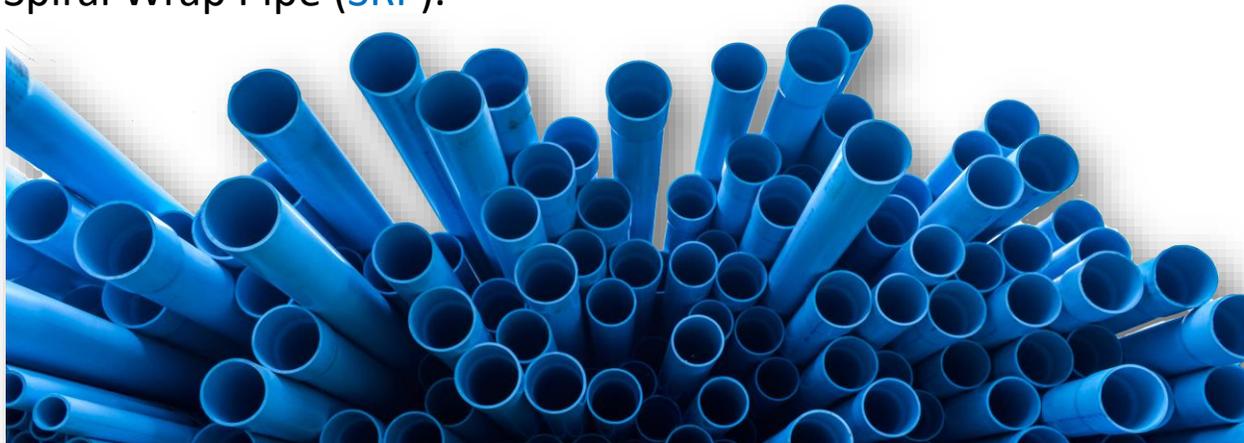
FELL Benchmark Testing of Plastic Pipe (2012) in accordance with ASTM F2550-13 (2018).

Electro Scan is unique in its ability to accurately & consistently locate & measure defects in plastic pipes, including but not limited to Acrylonitrile Butadiene Styrene (ABS), Cured In-Place Pipe (CIPP), Chlorinated Polyvinyl Chloride (CPVC), Fiberglass Reinforced Pipe (FRP), High Density Polyethylene (HDPE), Medium Density Polyethylene (MDPE), Polyethylene (PE), Polypipe (PLP), Polypropylene (PP), Polyvinyl Chloride (PVC), and Spiral Wrap Pipe (SRP).

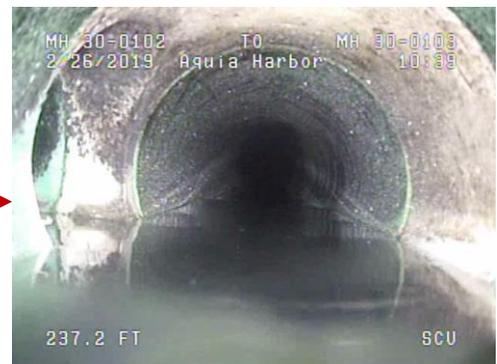
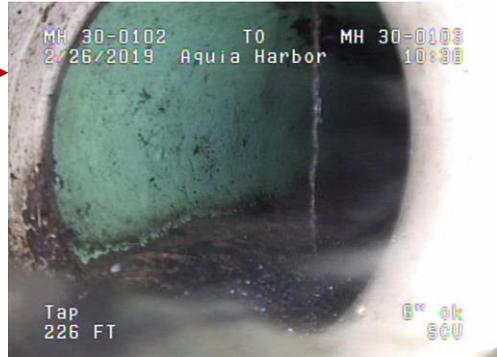
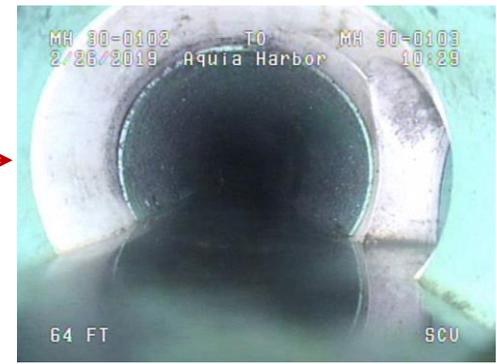
30-0103 – 30-0102

PVC Tap vs. Connection Defect

One (1) Y Connection
One (1) Defective Tap

One (1) Y Connection
One (1) Y Connection

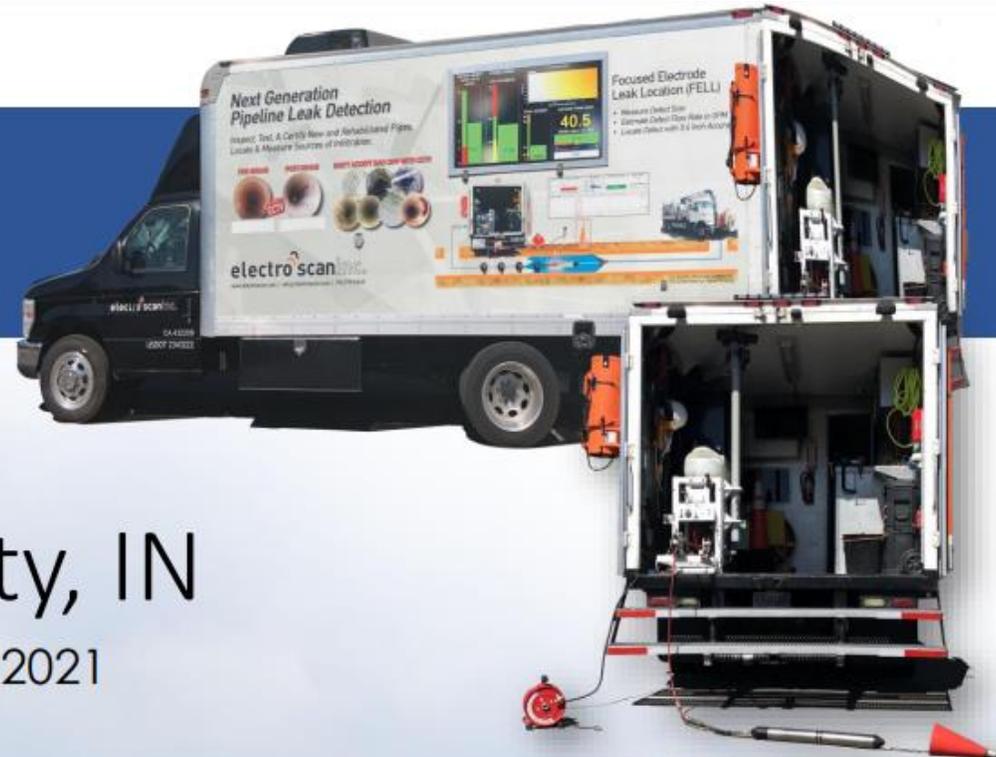
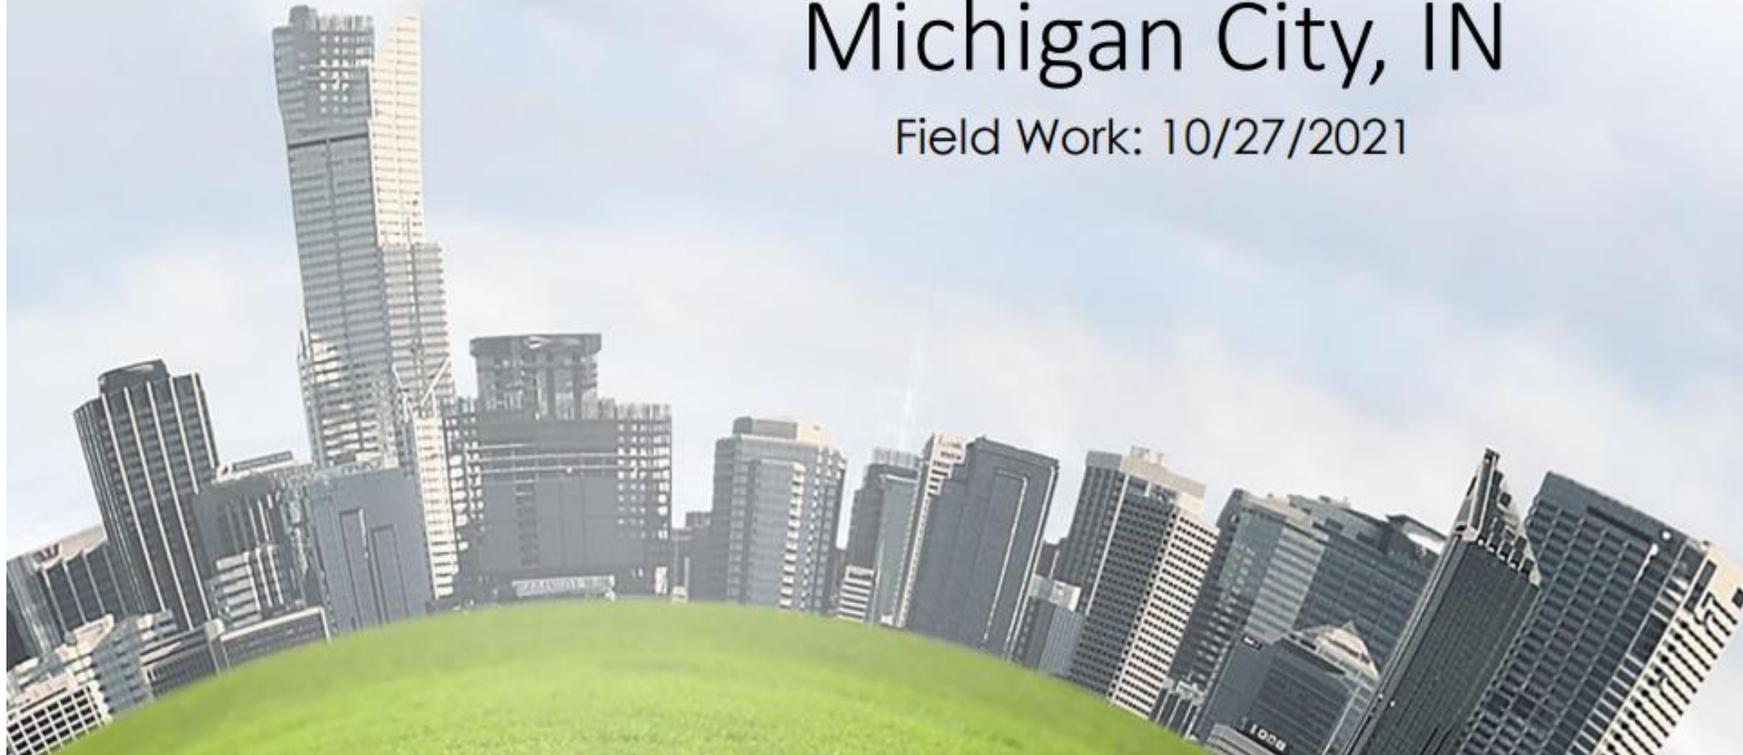
Electro Scan Demo Report

Michigan City, IN

Field Work: 10/27/2021

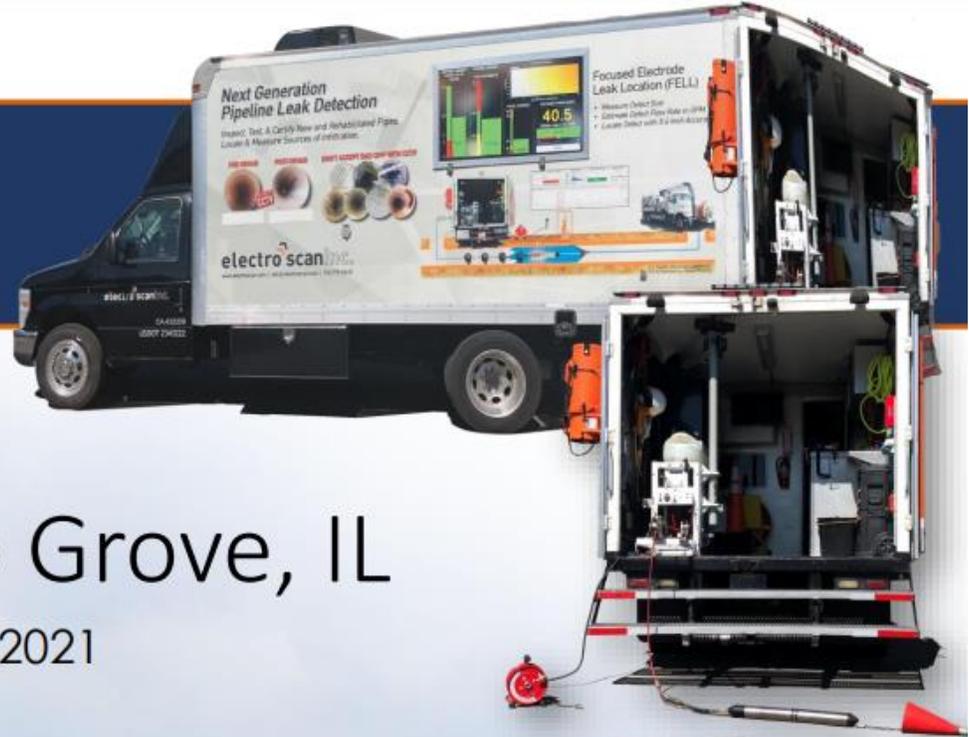
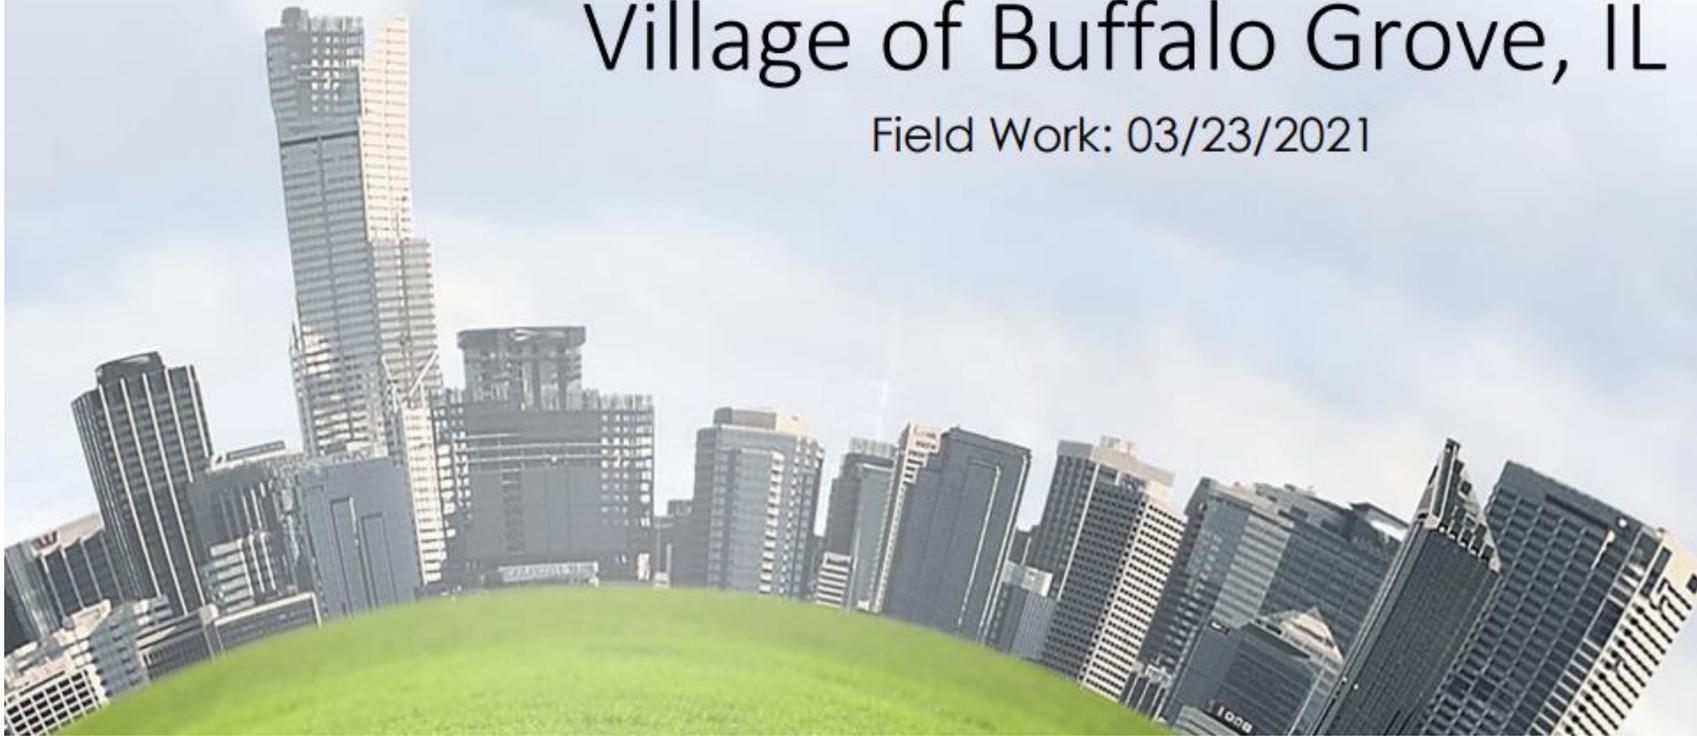
Electro Scan Demo Report

Village of Buffalo Grove, IL

Field Work: 03/23/2021
