Water Storage Tank Asset Management

OTCO Water Distribution Workshop
November 13, 2018

Suez Asset Protection Programs

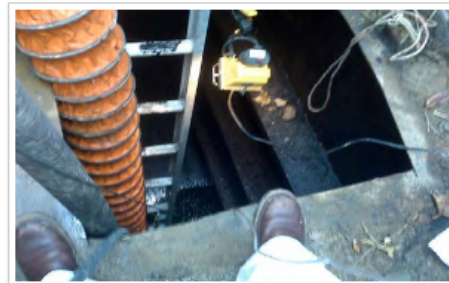
Ventilation hoses provide air and exhaust toxic vapors during confined space entry. A guardrail would also be necessary to protect workers from potential falls.

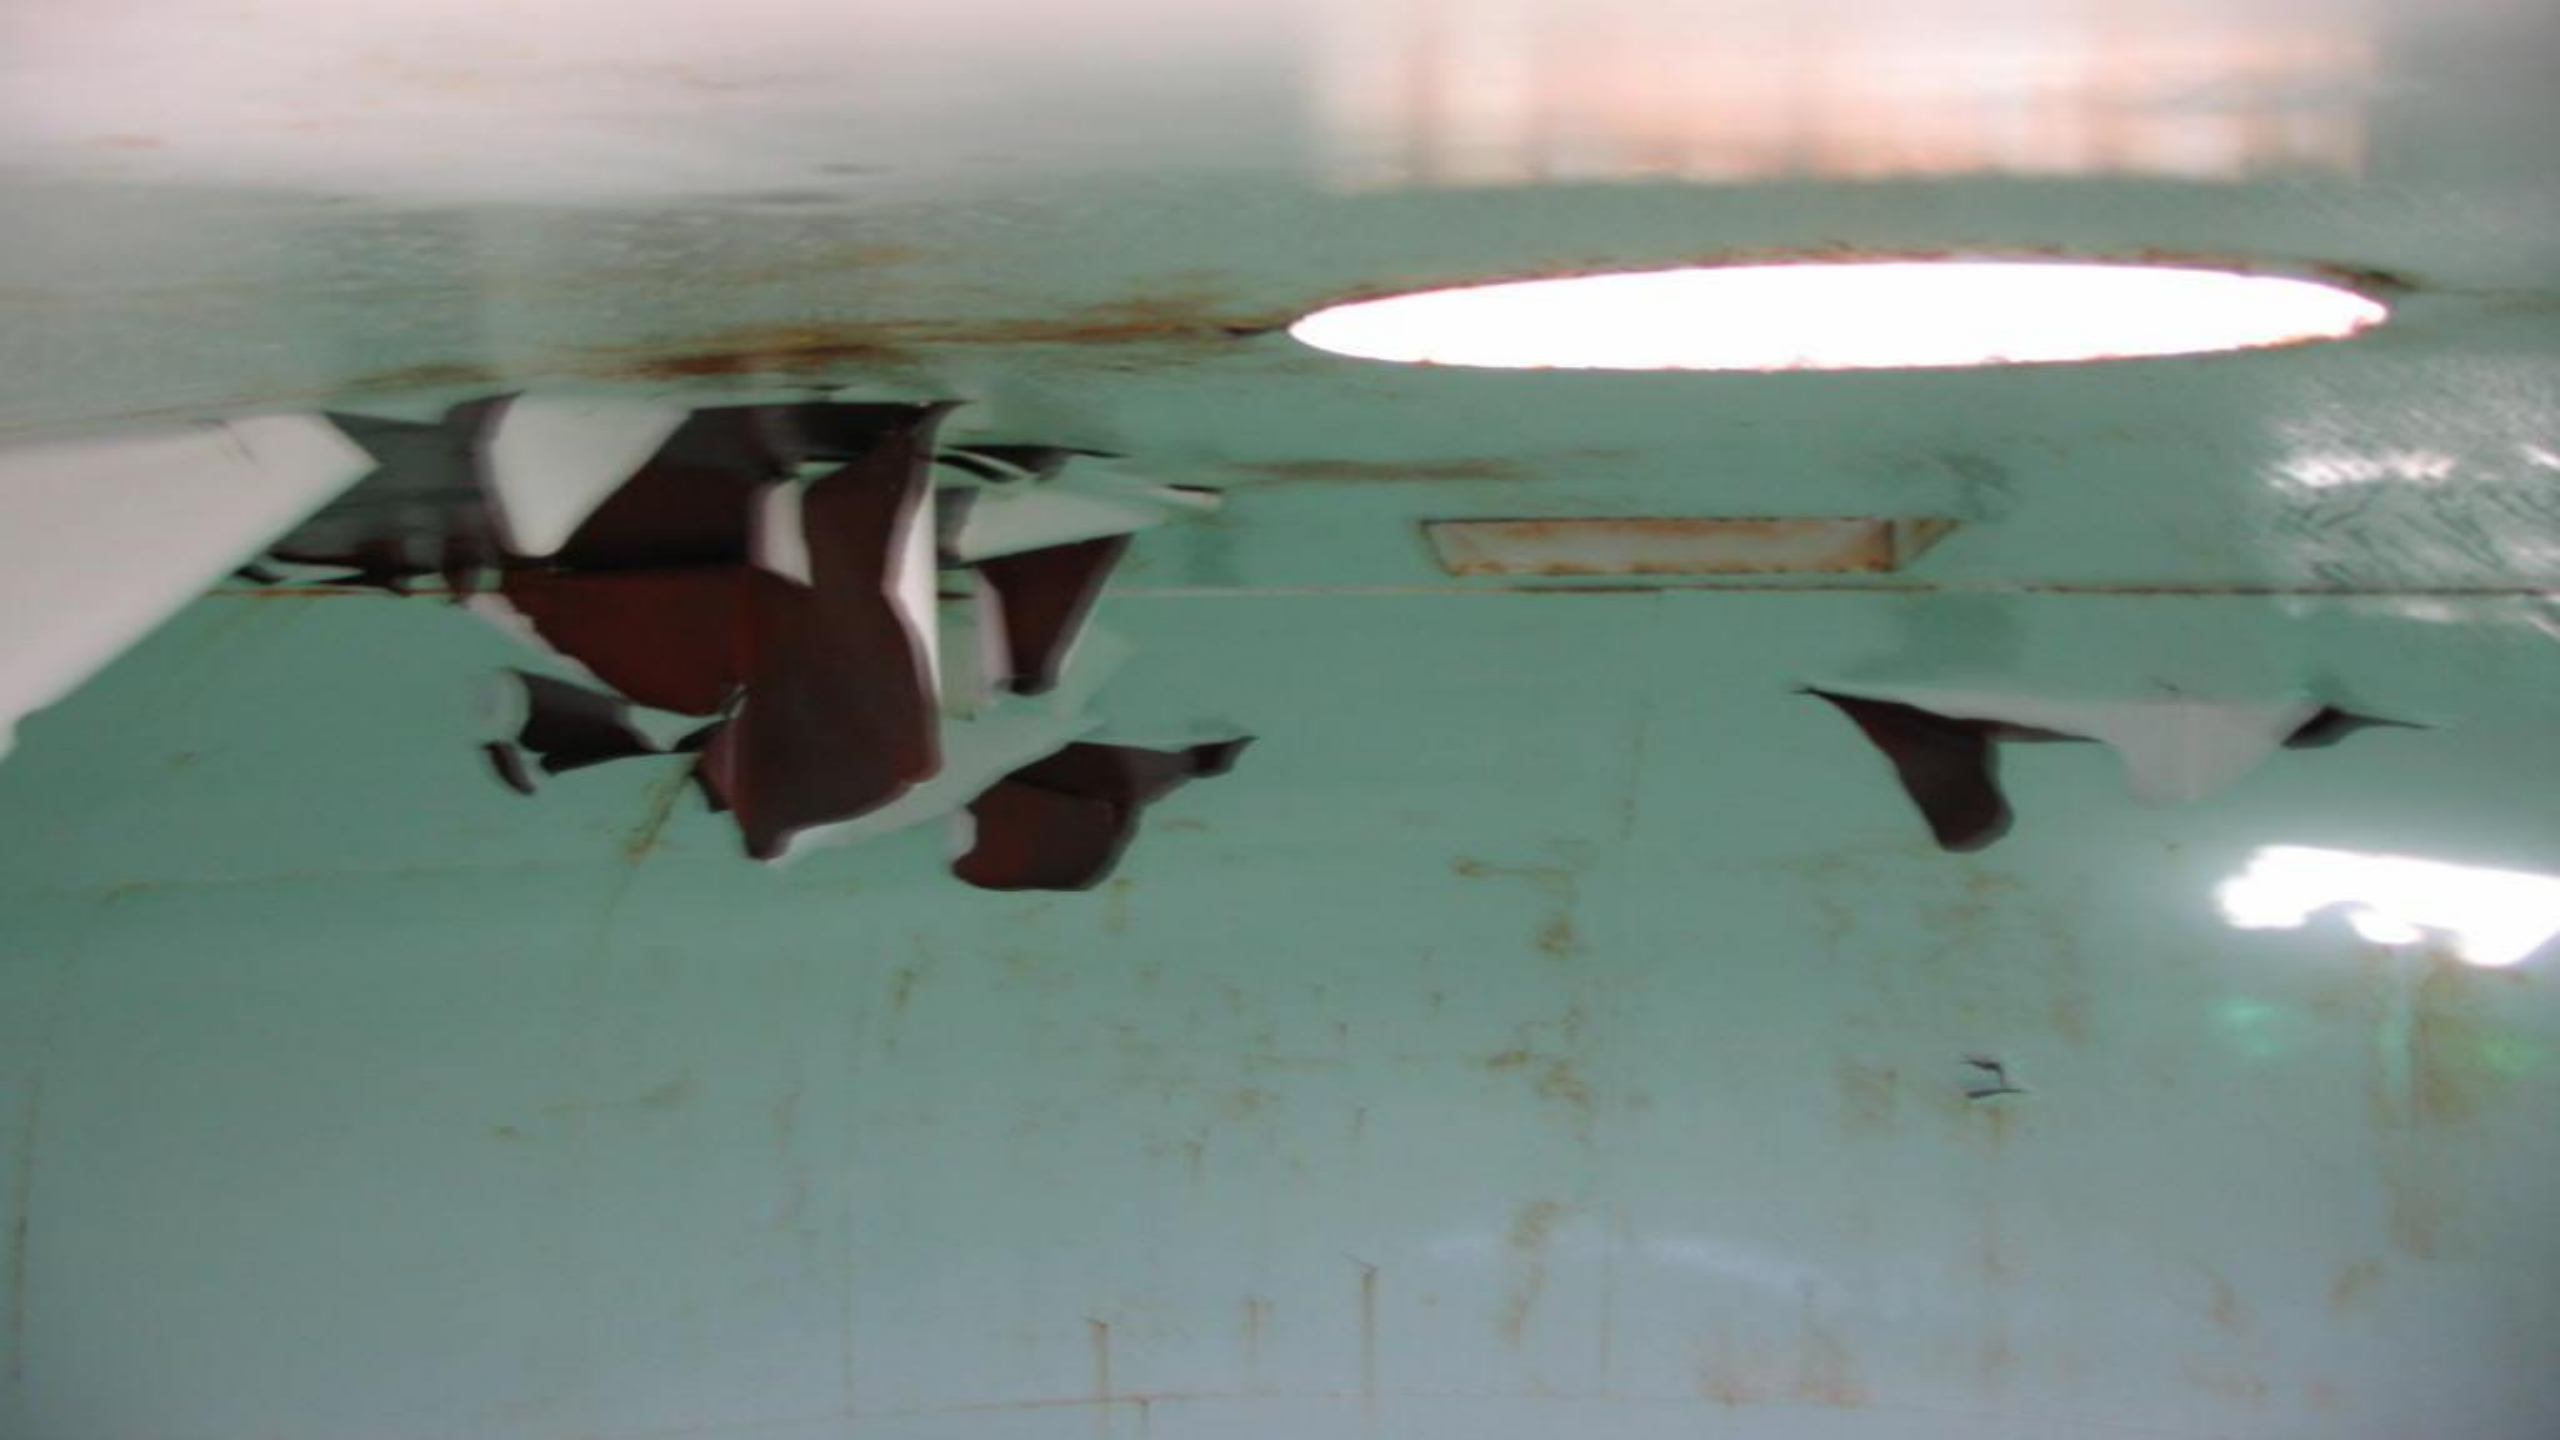
Brand new tank

The image shows a close-up of a white, textured surface, possibly a tank or container. The surface is composed of several rectangular panels separated by recessed lines. A horizontal ledge or edge runs across the middle of the frame. Along this ledge, there are significant signs of rust and discoloration, appearing as brownish-orange streaks and patches. The text "Brand new tank" is overlaid in the center-left area of the image.

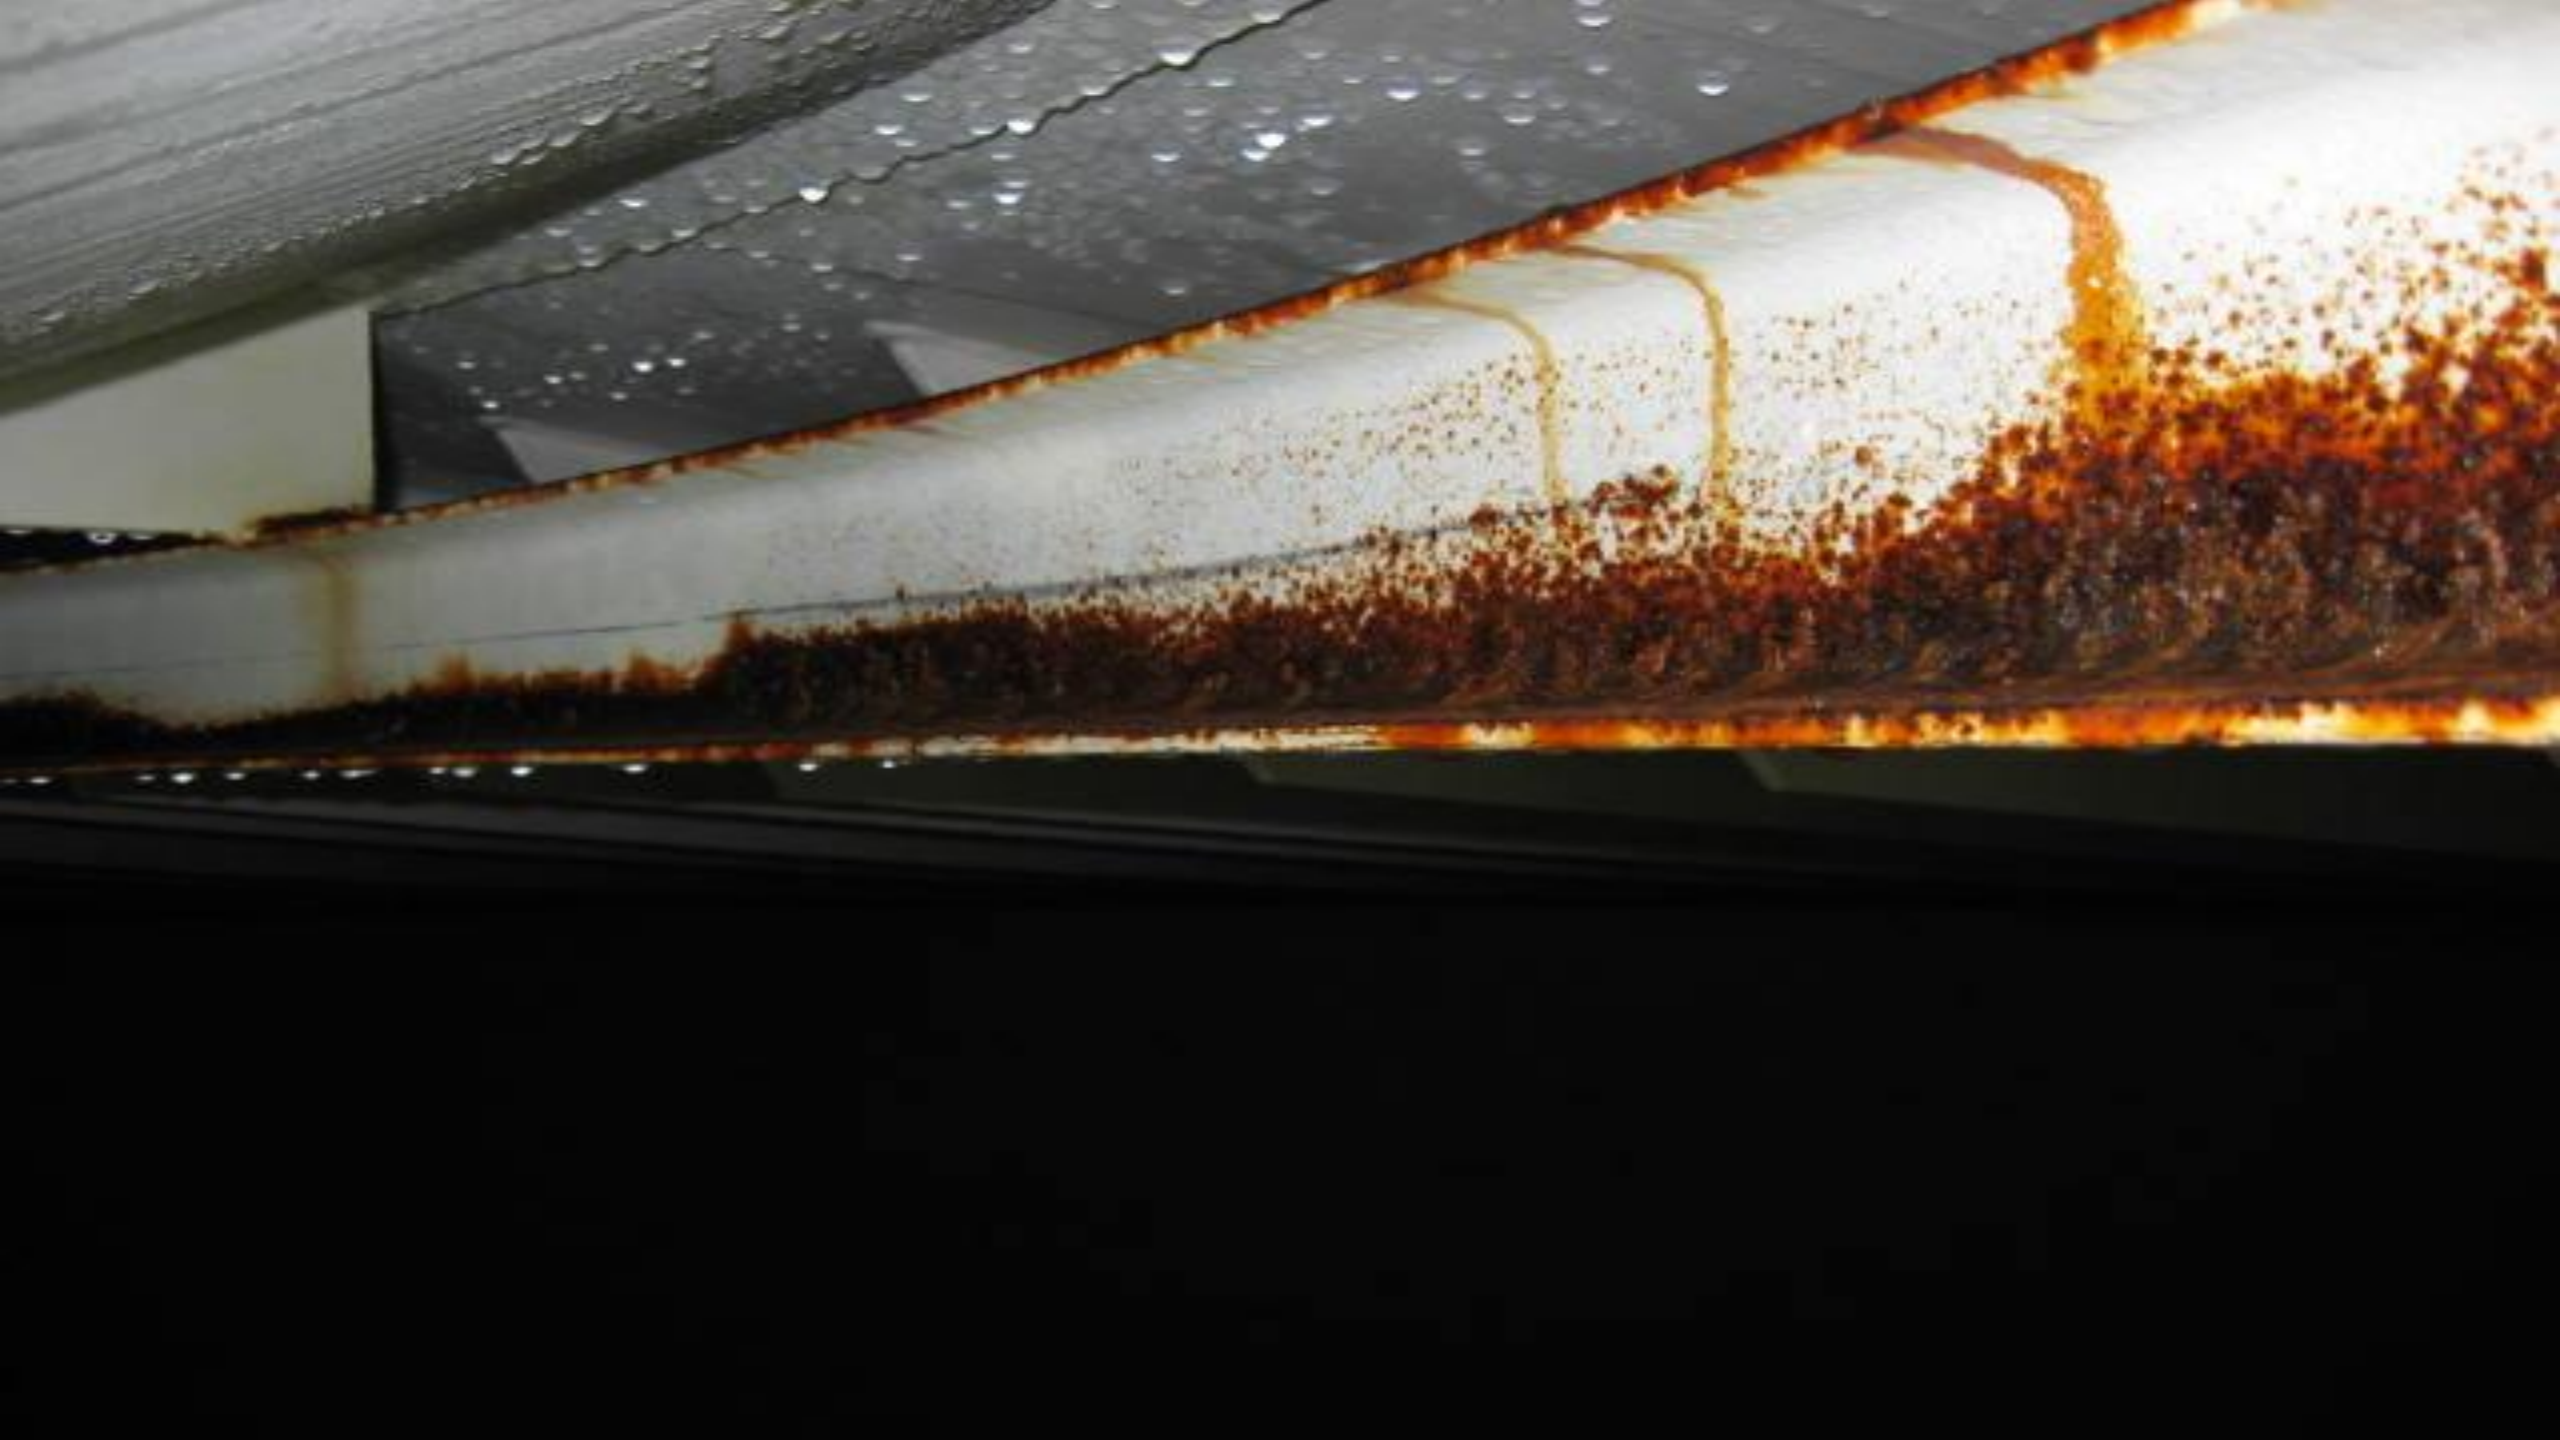
**New paint job
Cohesion issue**

Cohesion failure

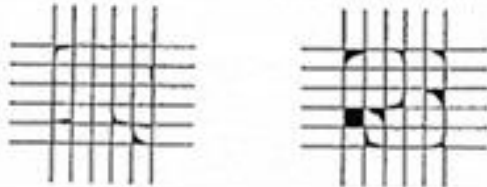
3B	5 - 15%

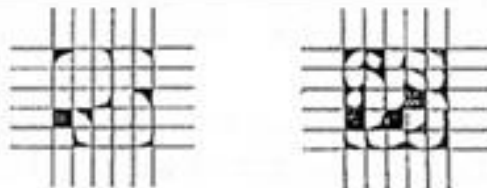
2B	15 - 35%

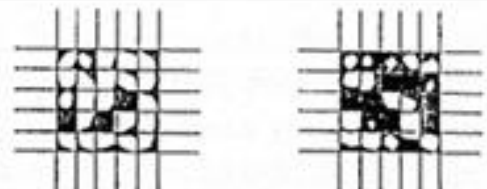
1B	35 - 65%

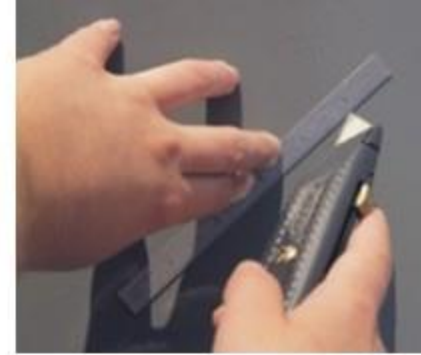
1. Cut "X" mark

3.1 *Test Method A*—An X-cut is made in the film to the substrate, pressure-sensitive tape is applied over the cut and Page No 1 then removed, and adhesion is assessed qualitatively on the 0 to 5 scale.

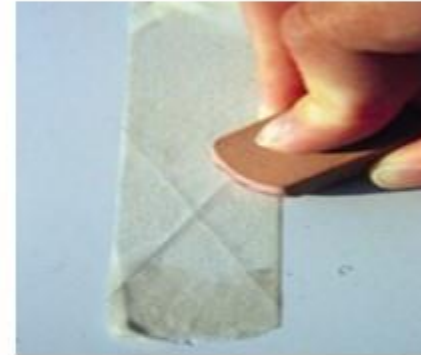
2. Place 25mm wide Transparent Tape.

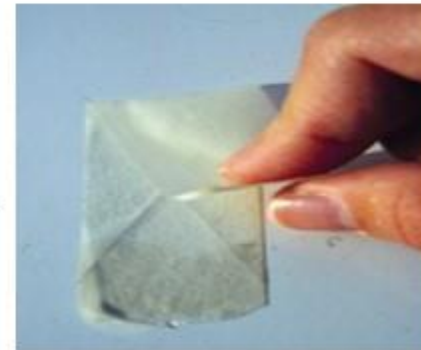
3. Remove the tape quickly.

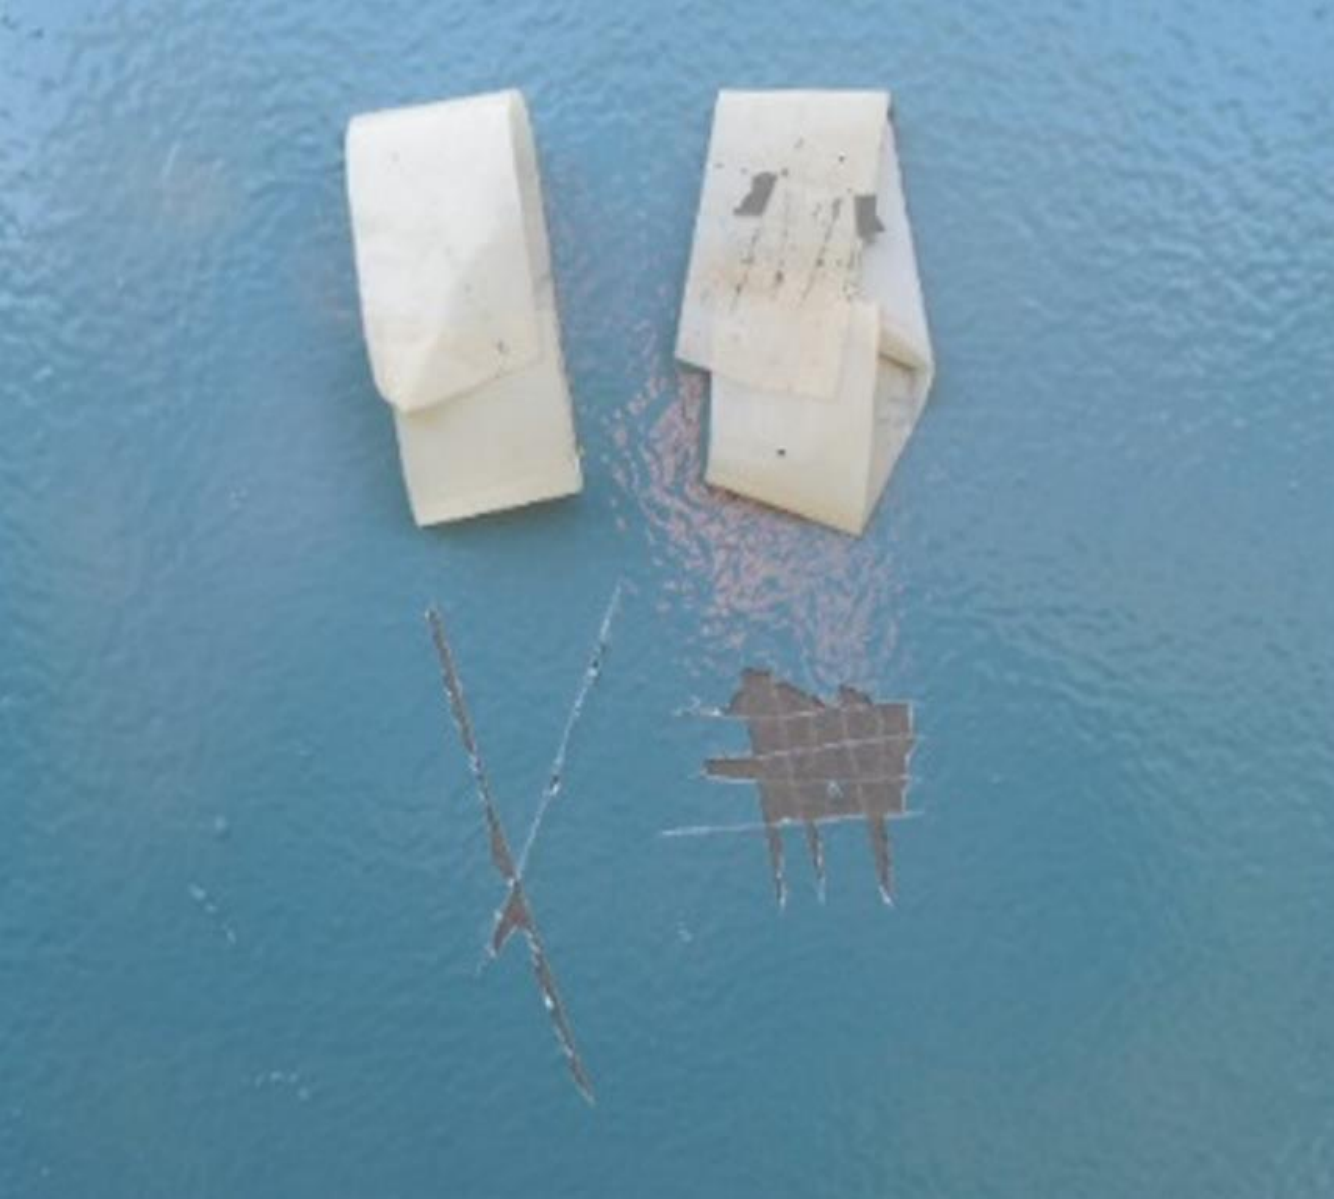
Adhesion failure

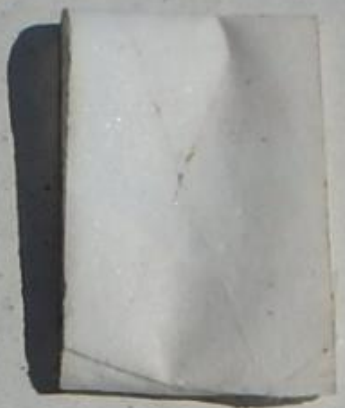
X- Scribe Tape Test – ASTM D 3359

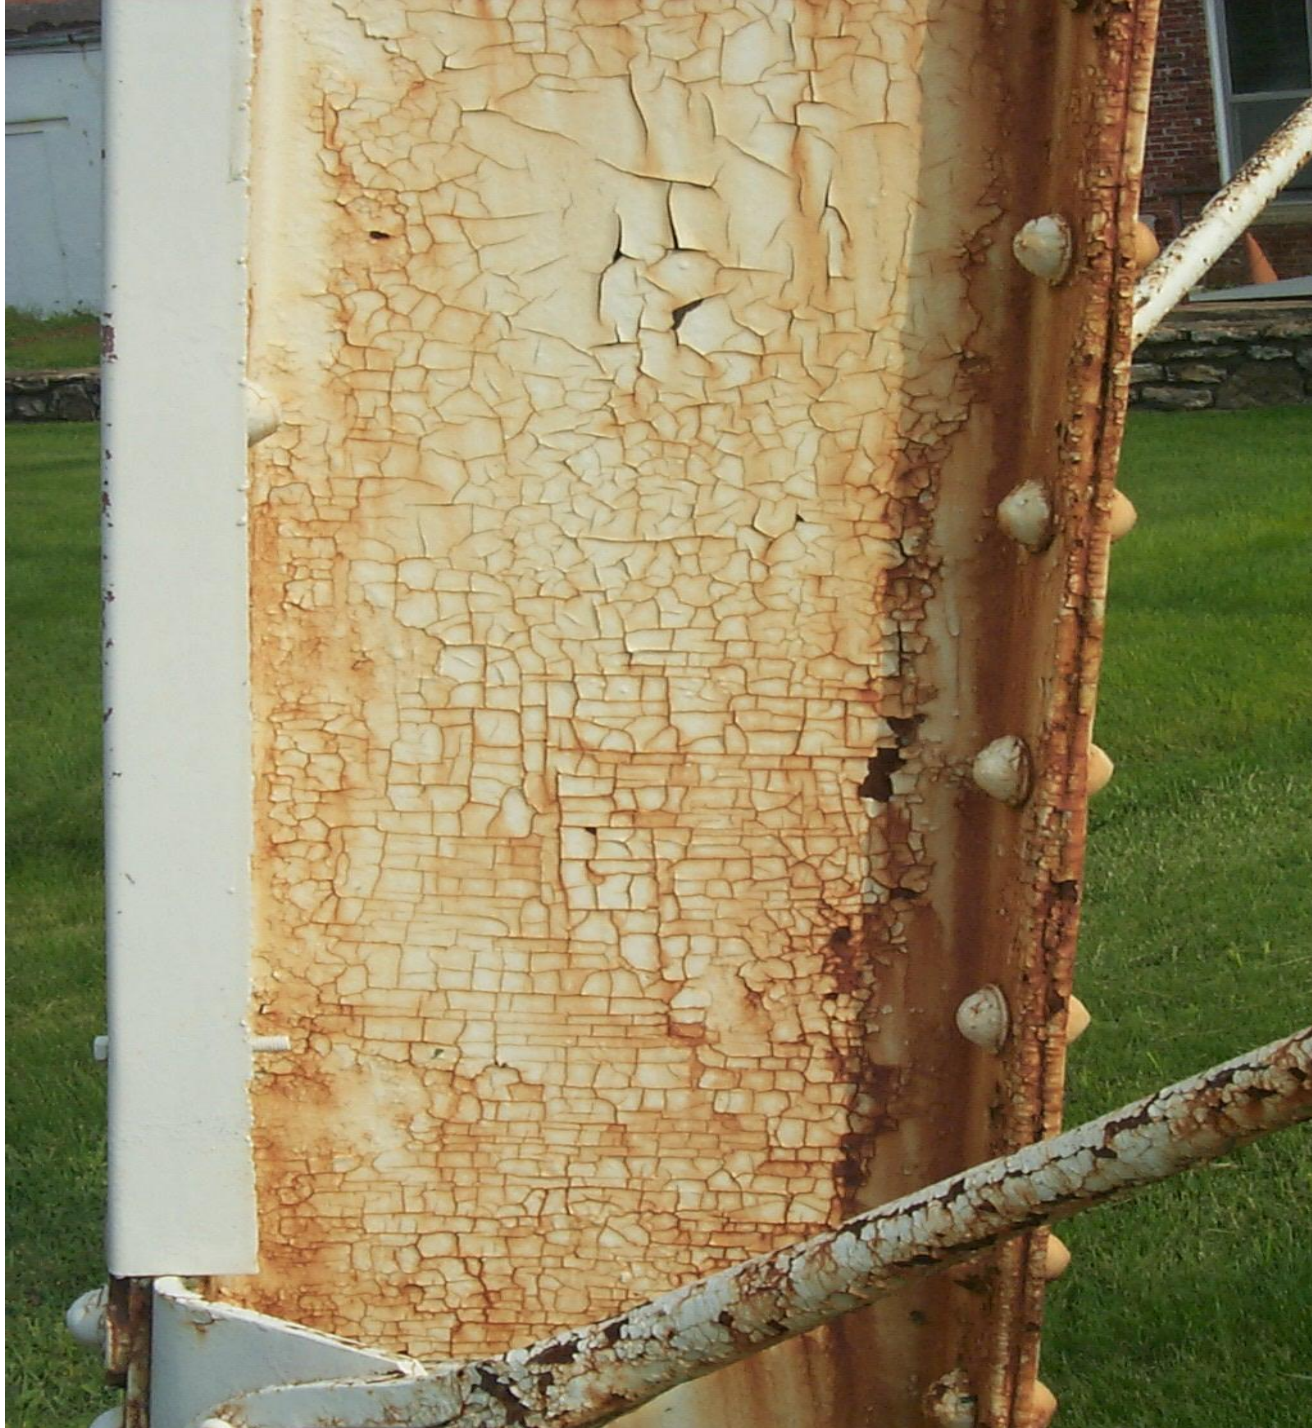
Blasted "profiled" surface

The diagram shows a rectangular block with a highly irregular, jagged top surface, characteristic of a blasted profile. The surface is represented by a complex, wavy line.

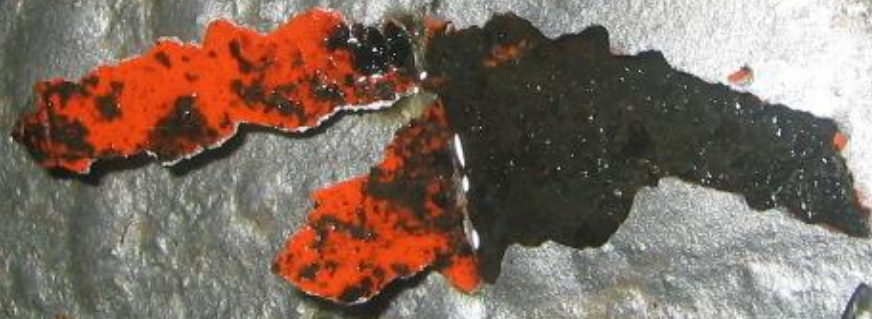
What is this orange stuff???

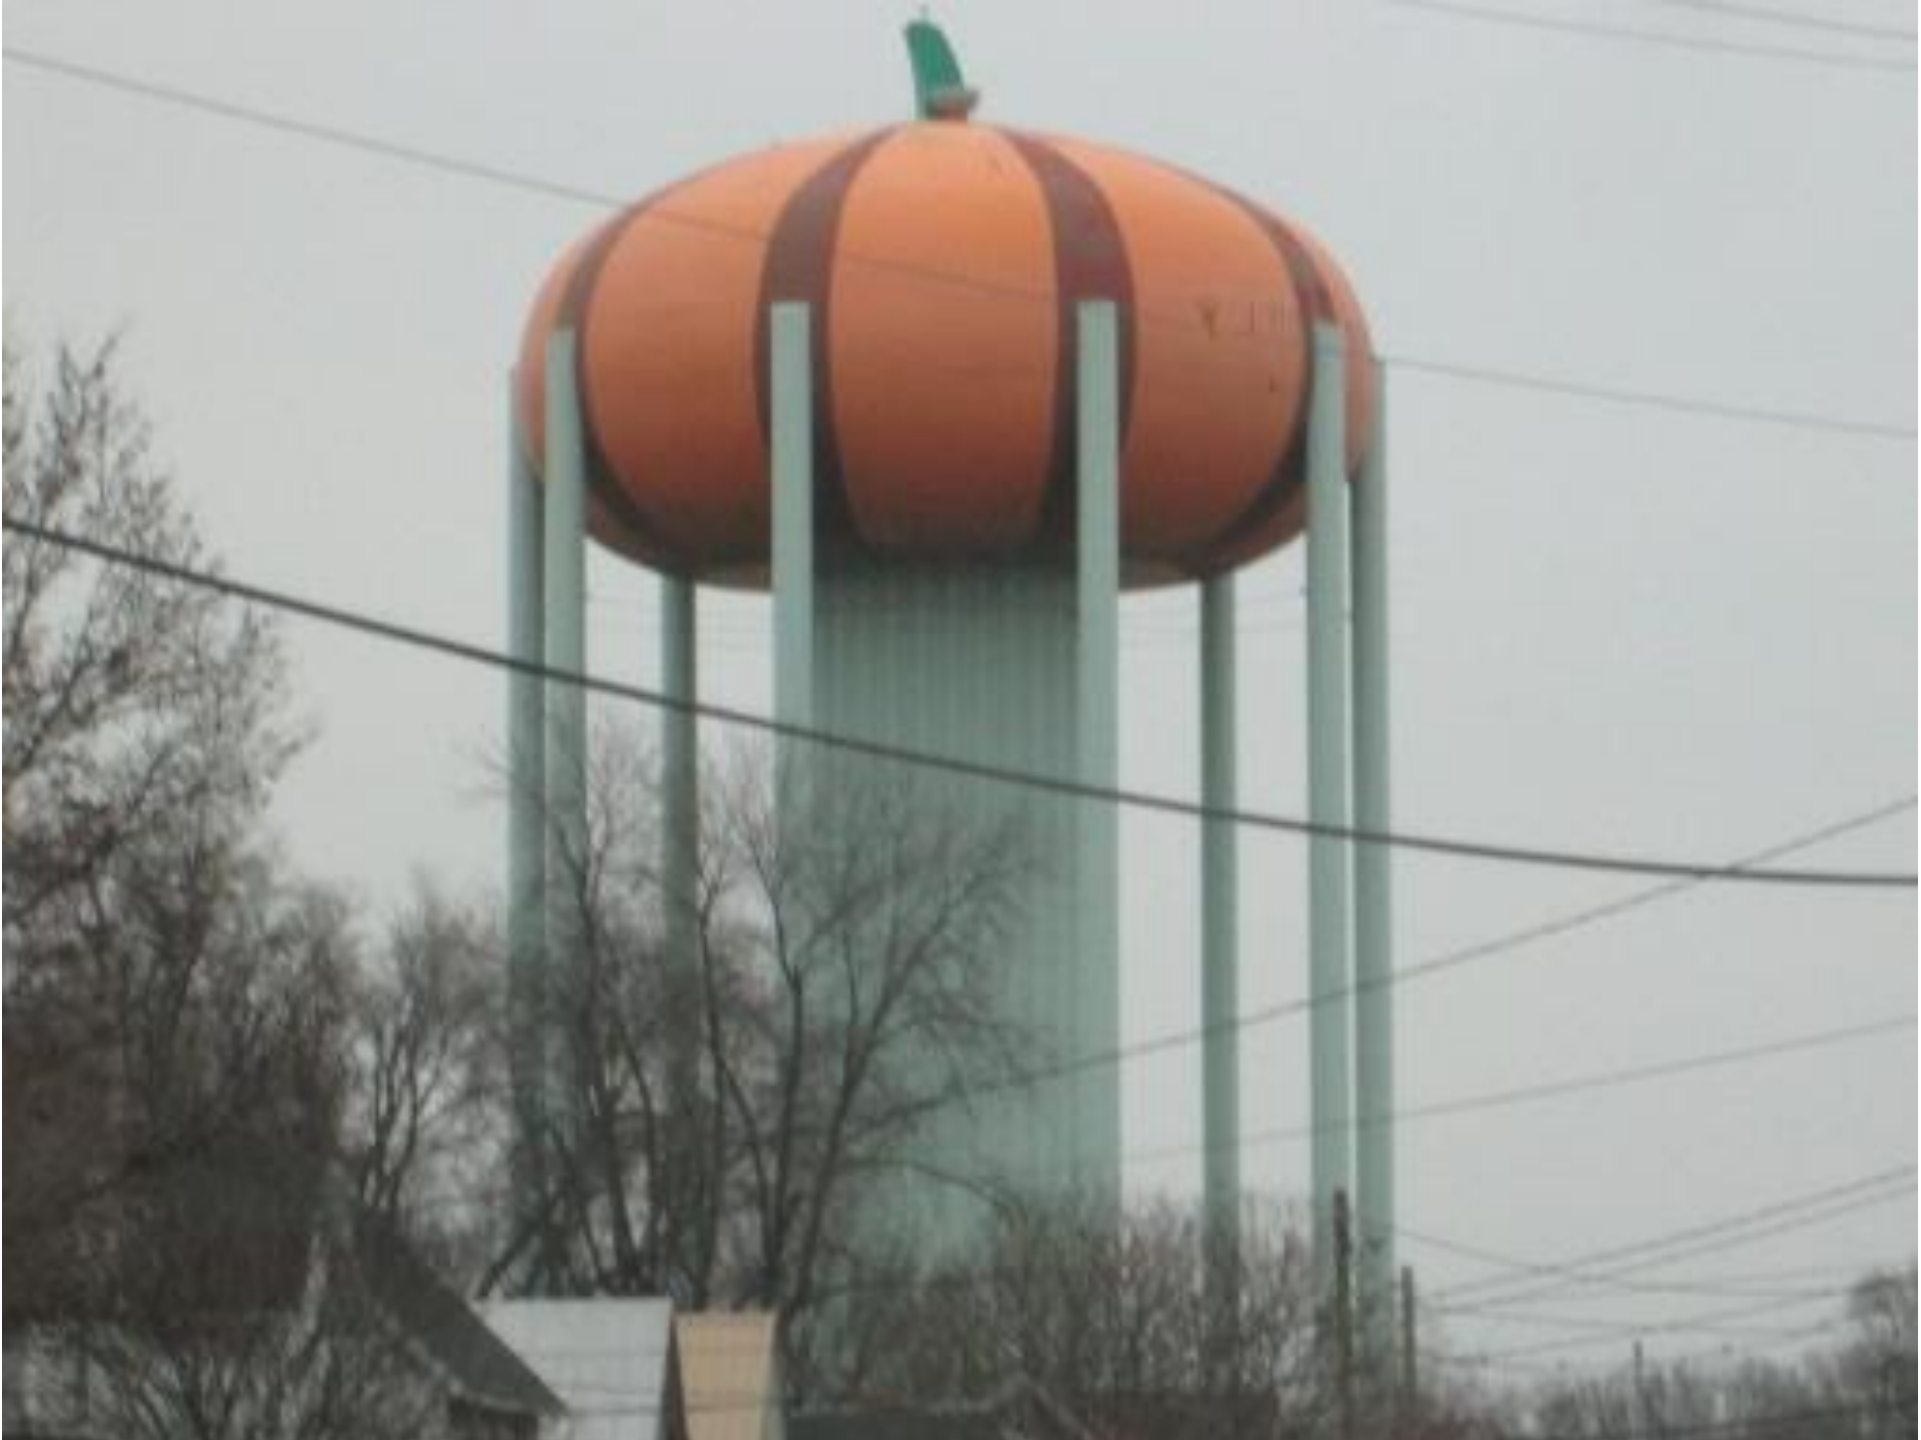
FTIR Generic Topcoat Analysis:

Pigmented Acrylic Polyurethane

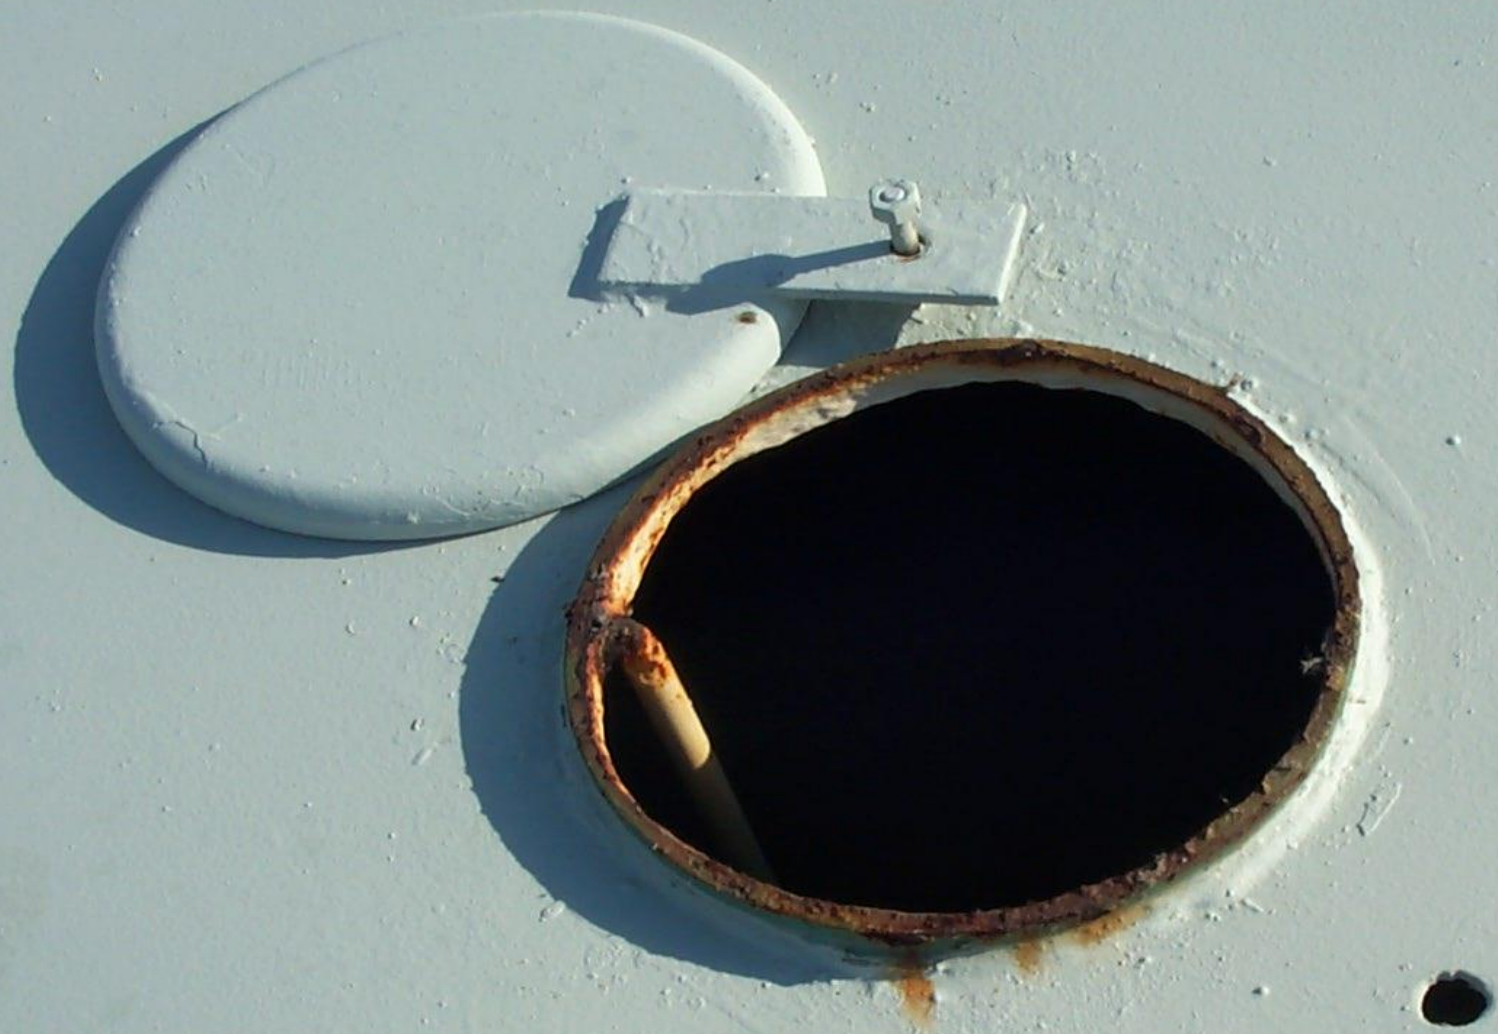
How many things can you find wrong with this picture?
