Water Storage Tank Asset Management

OTCO Water Distribution Workshop
November 13, 2018

Suez Asset Protection Programs

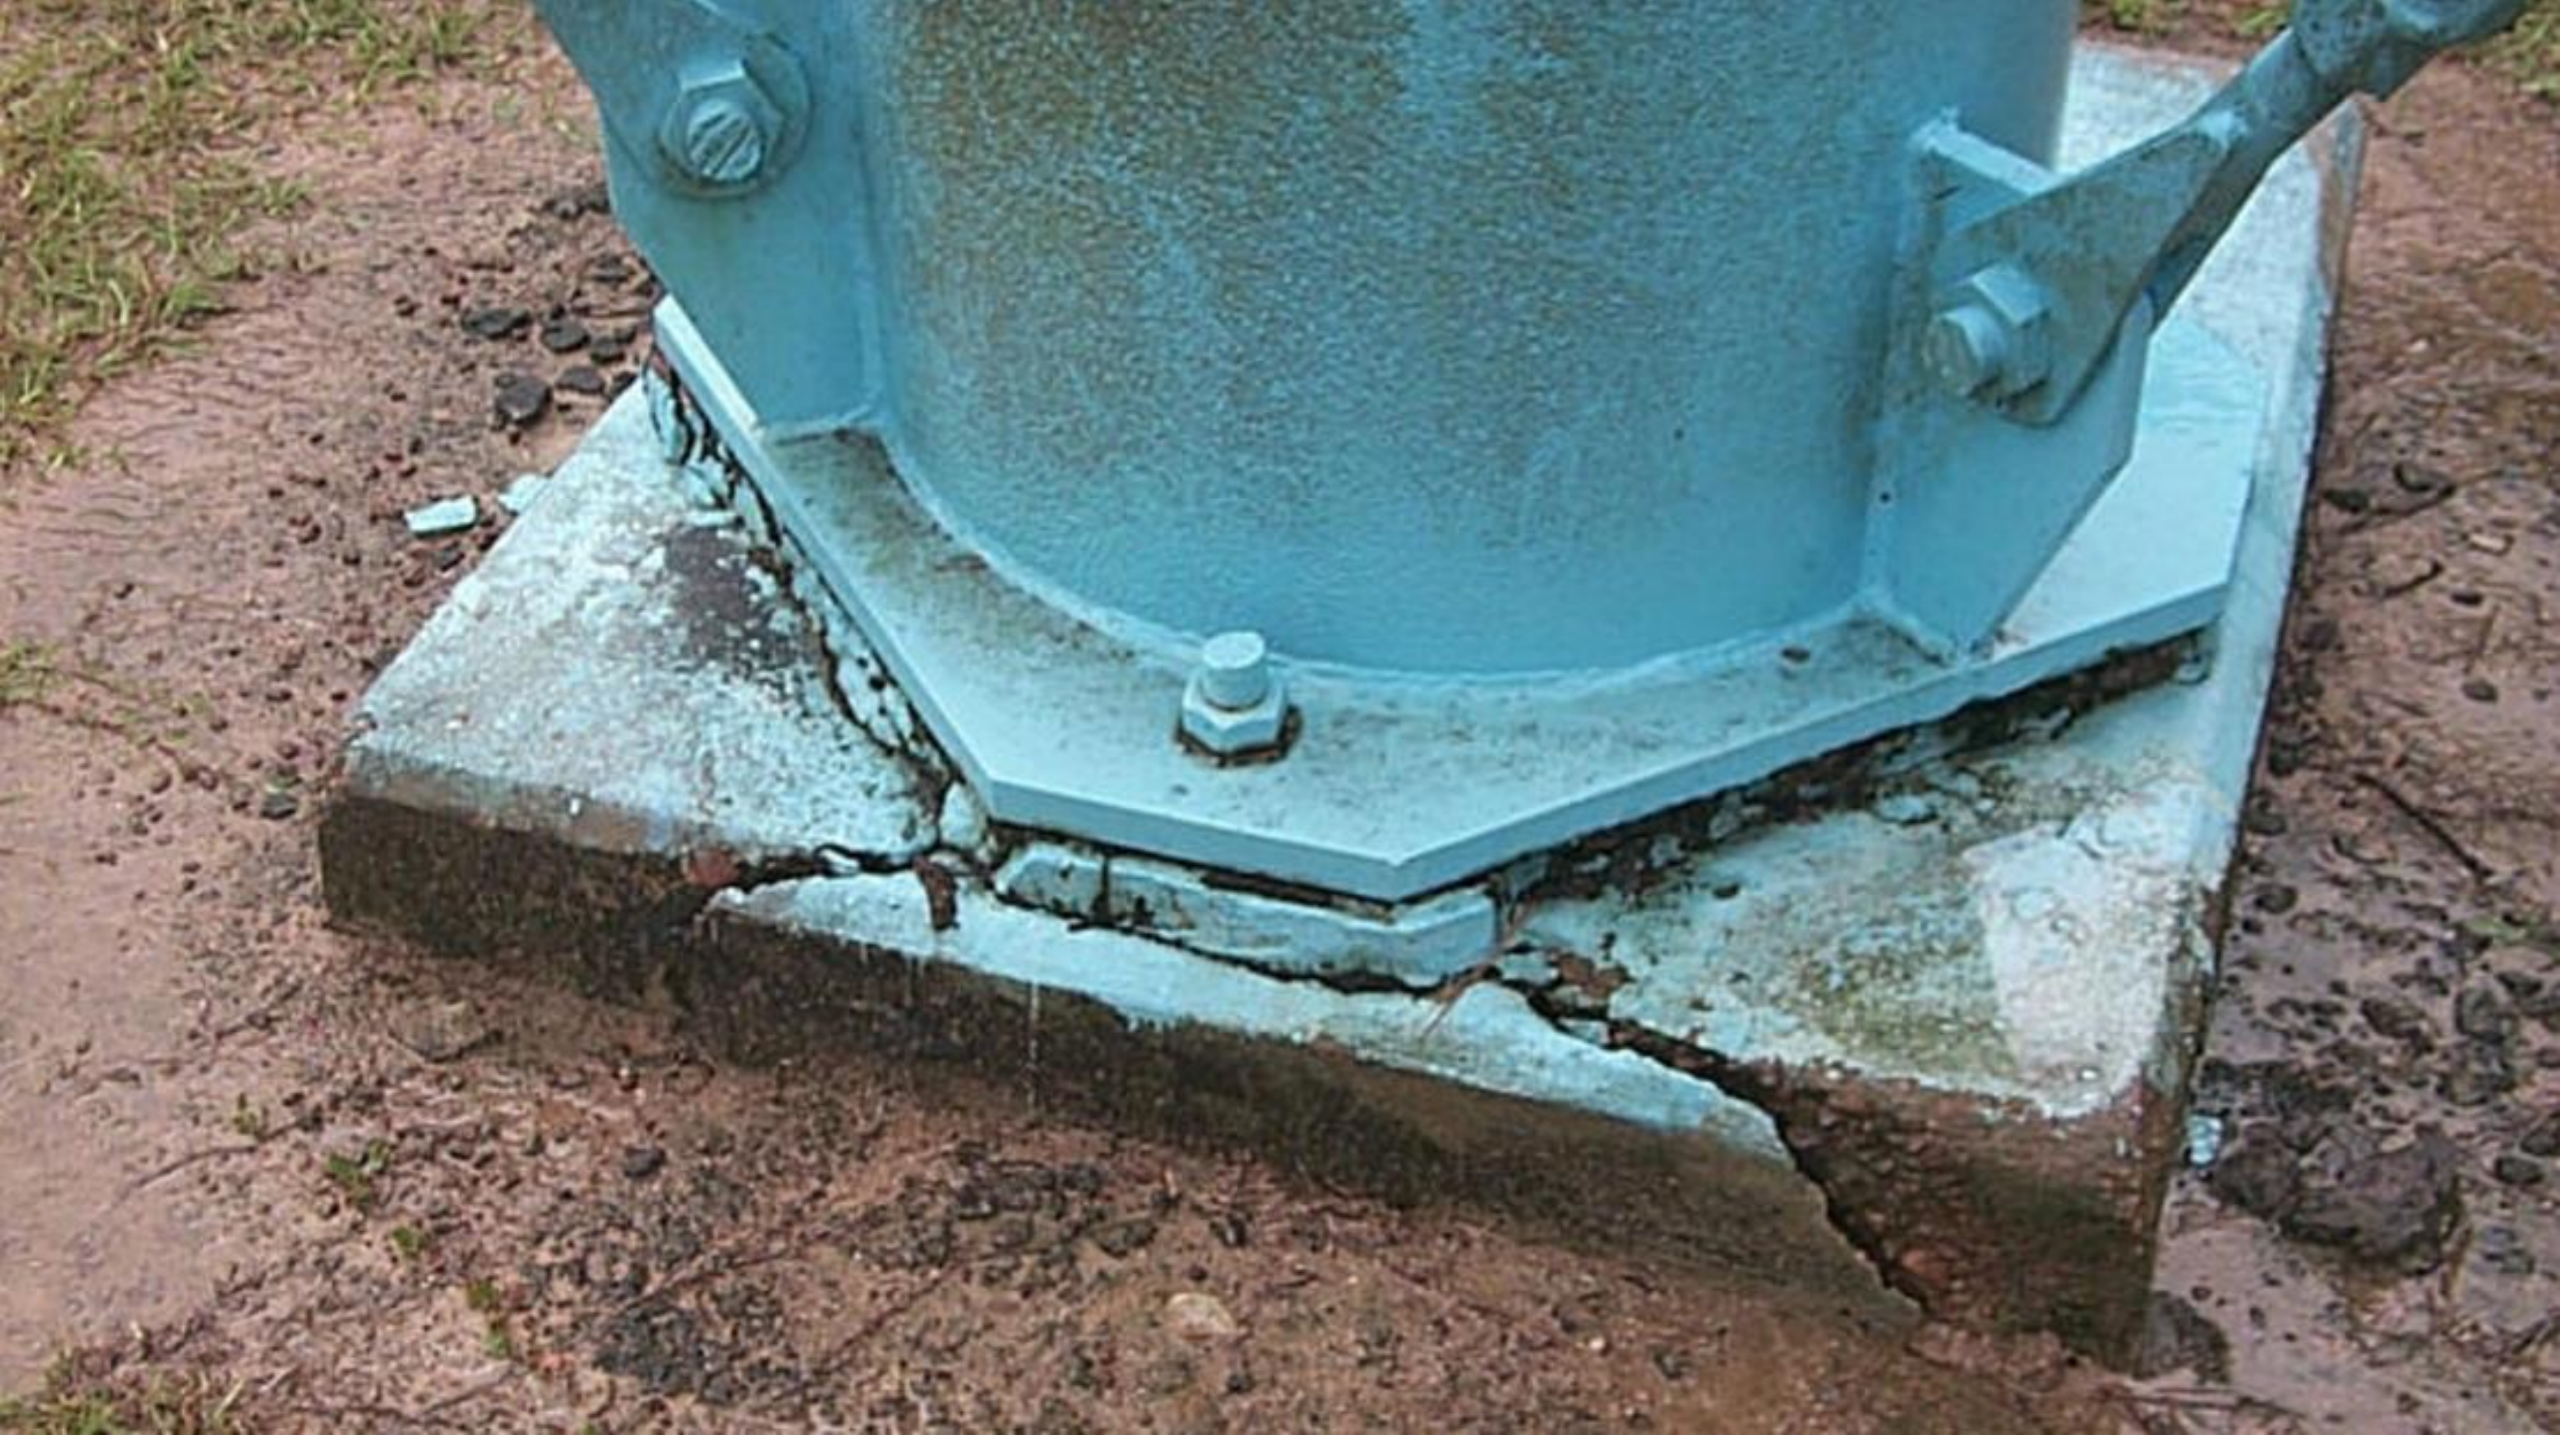
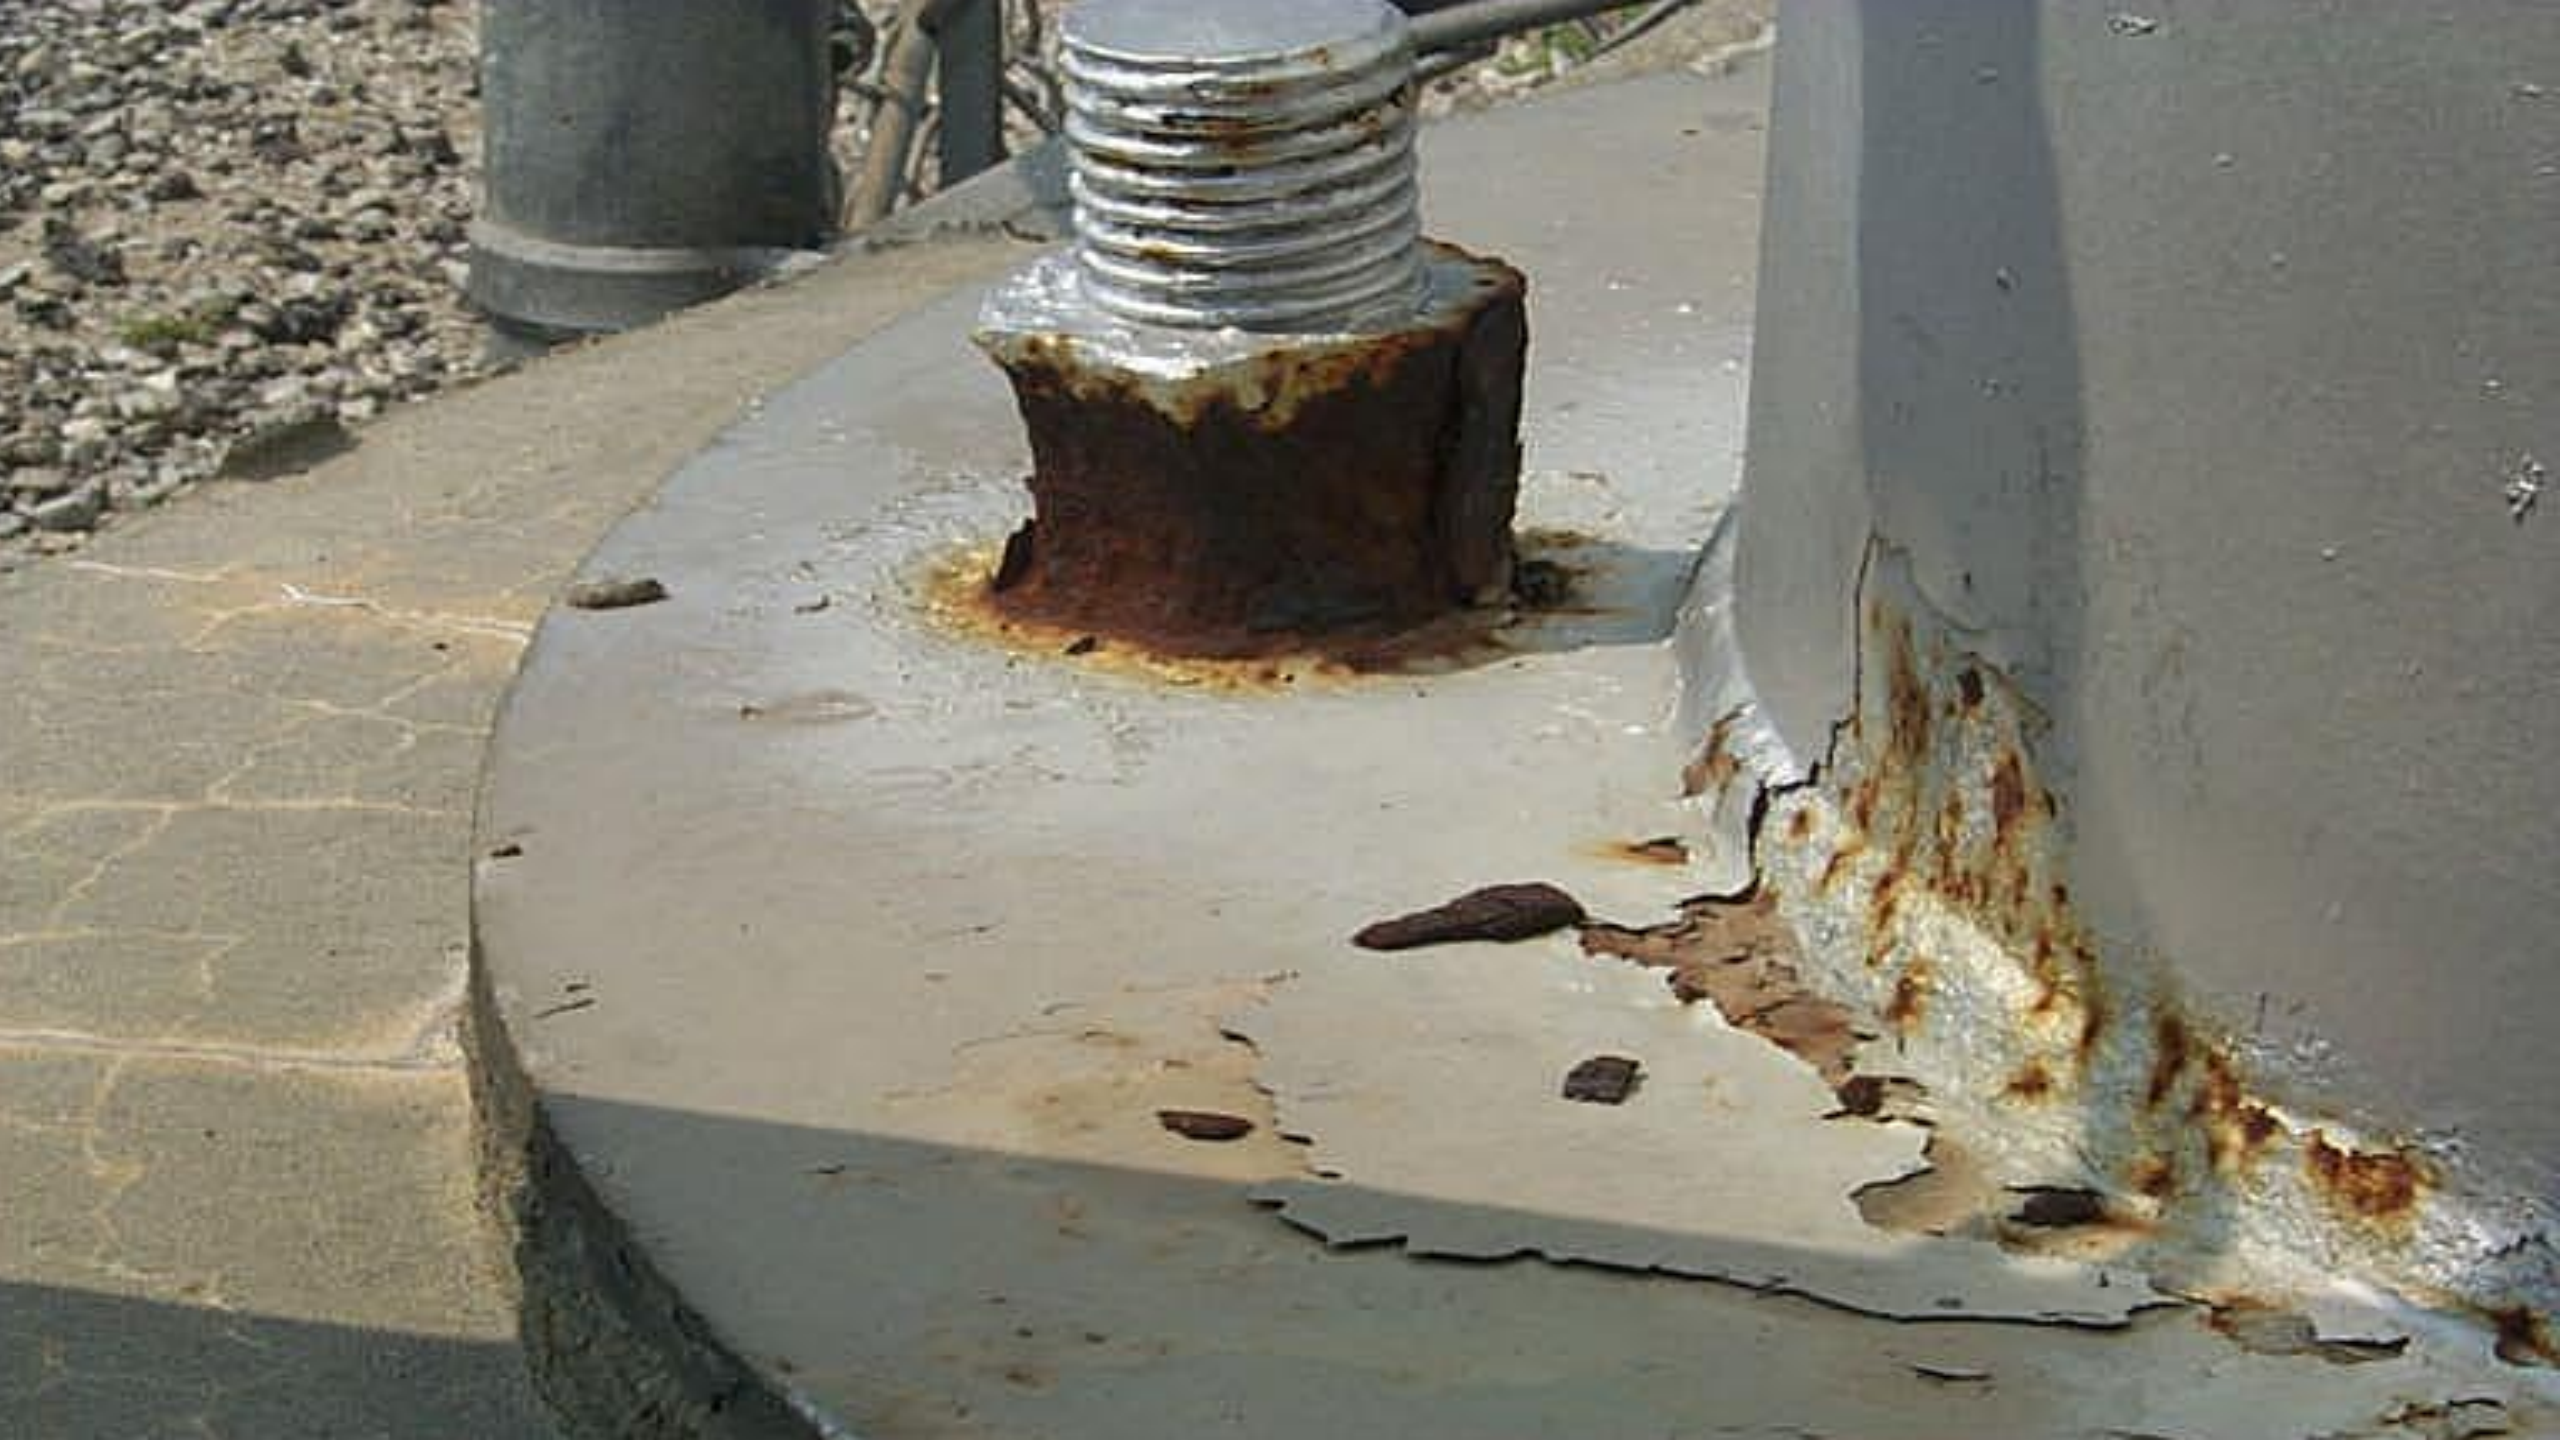
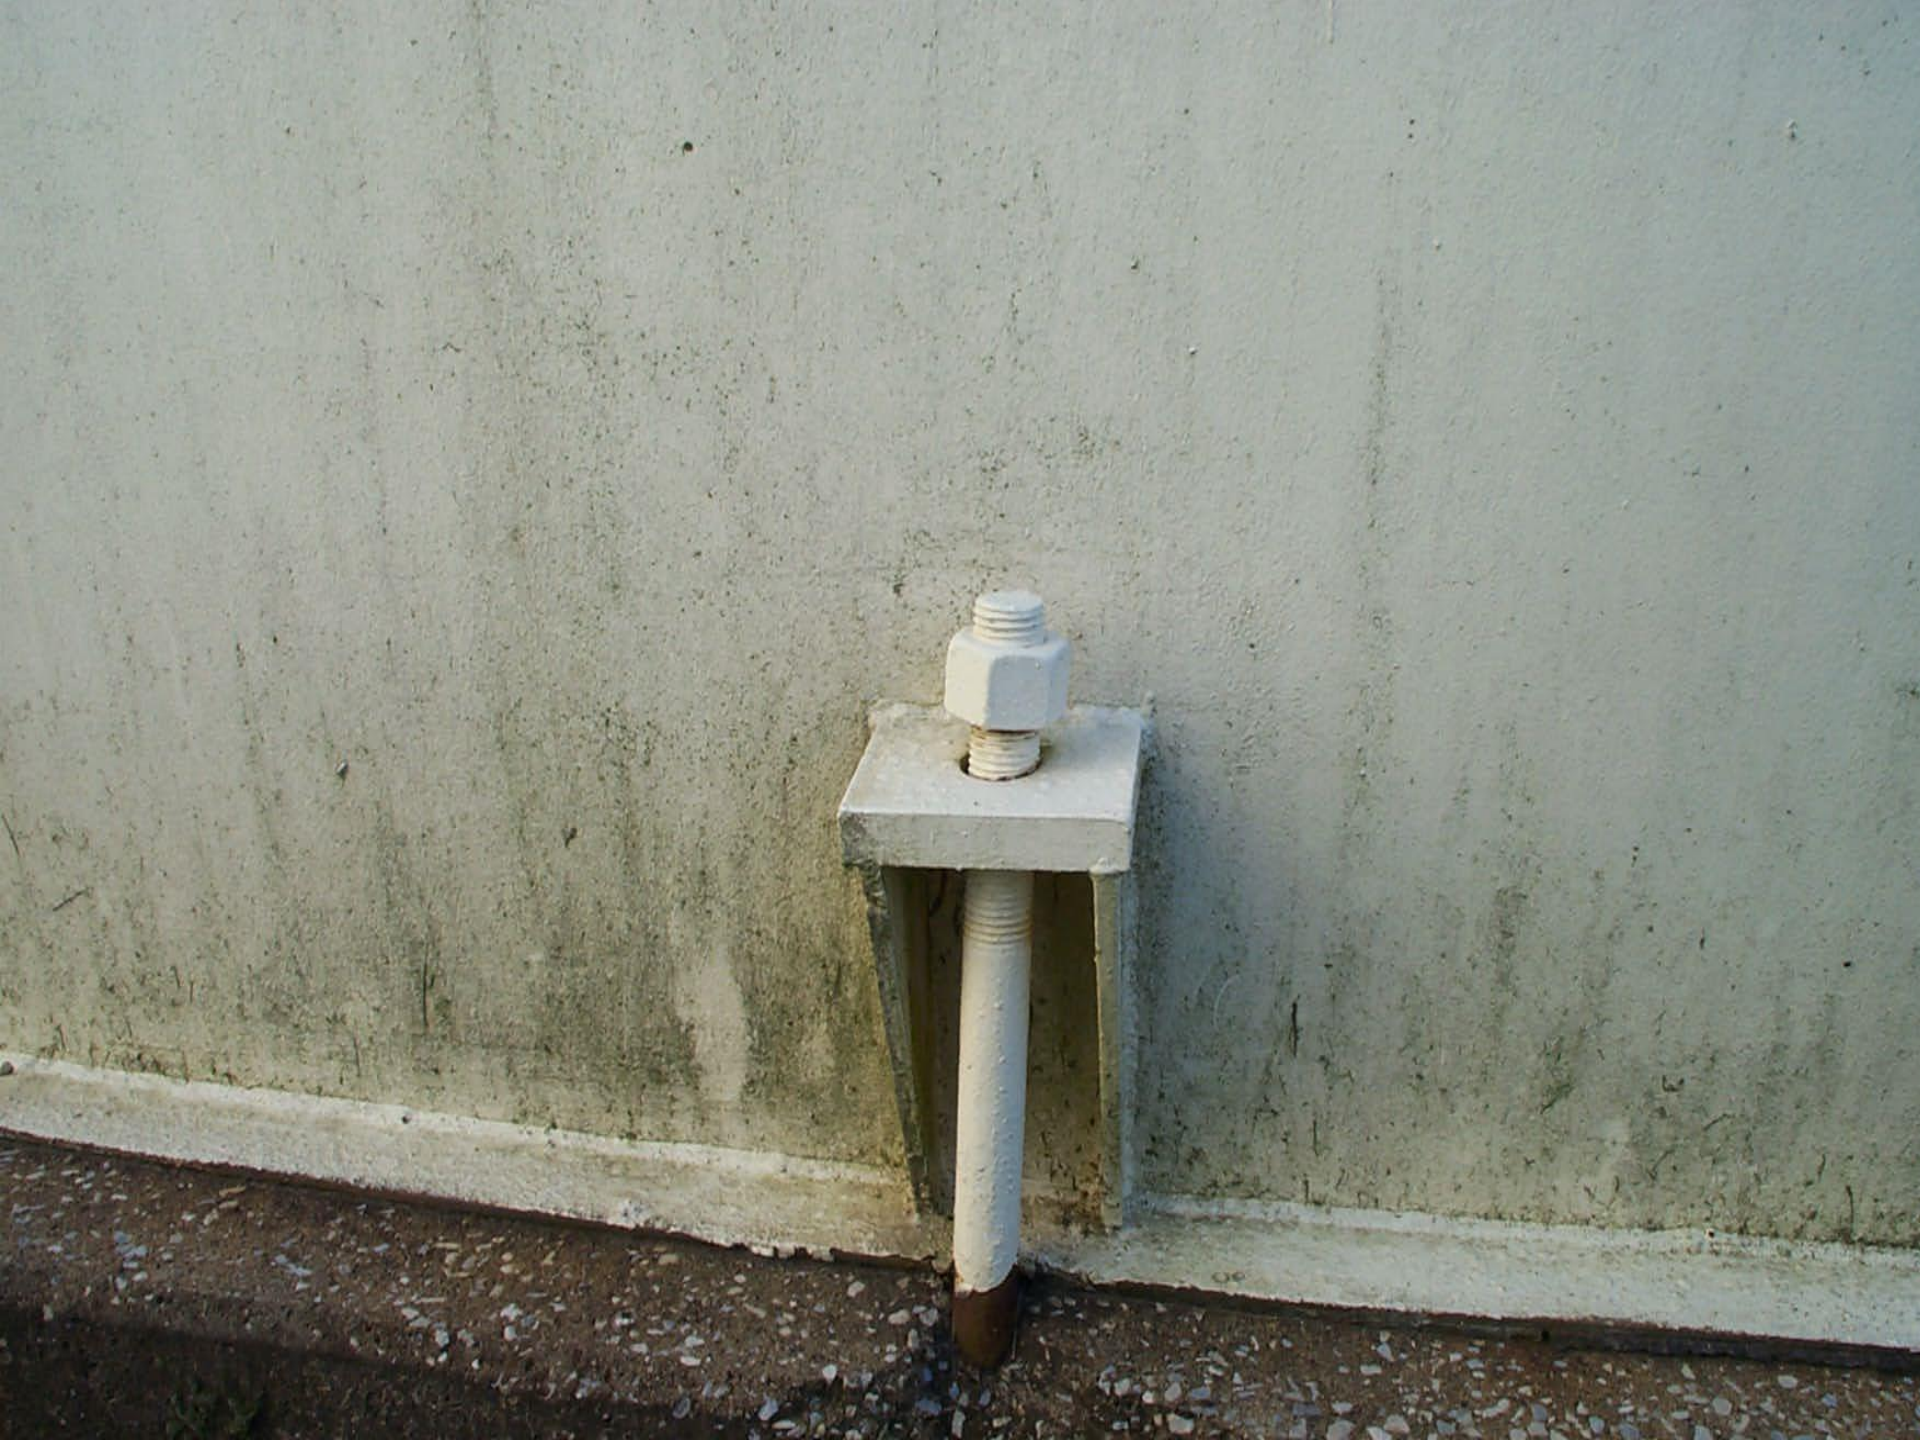
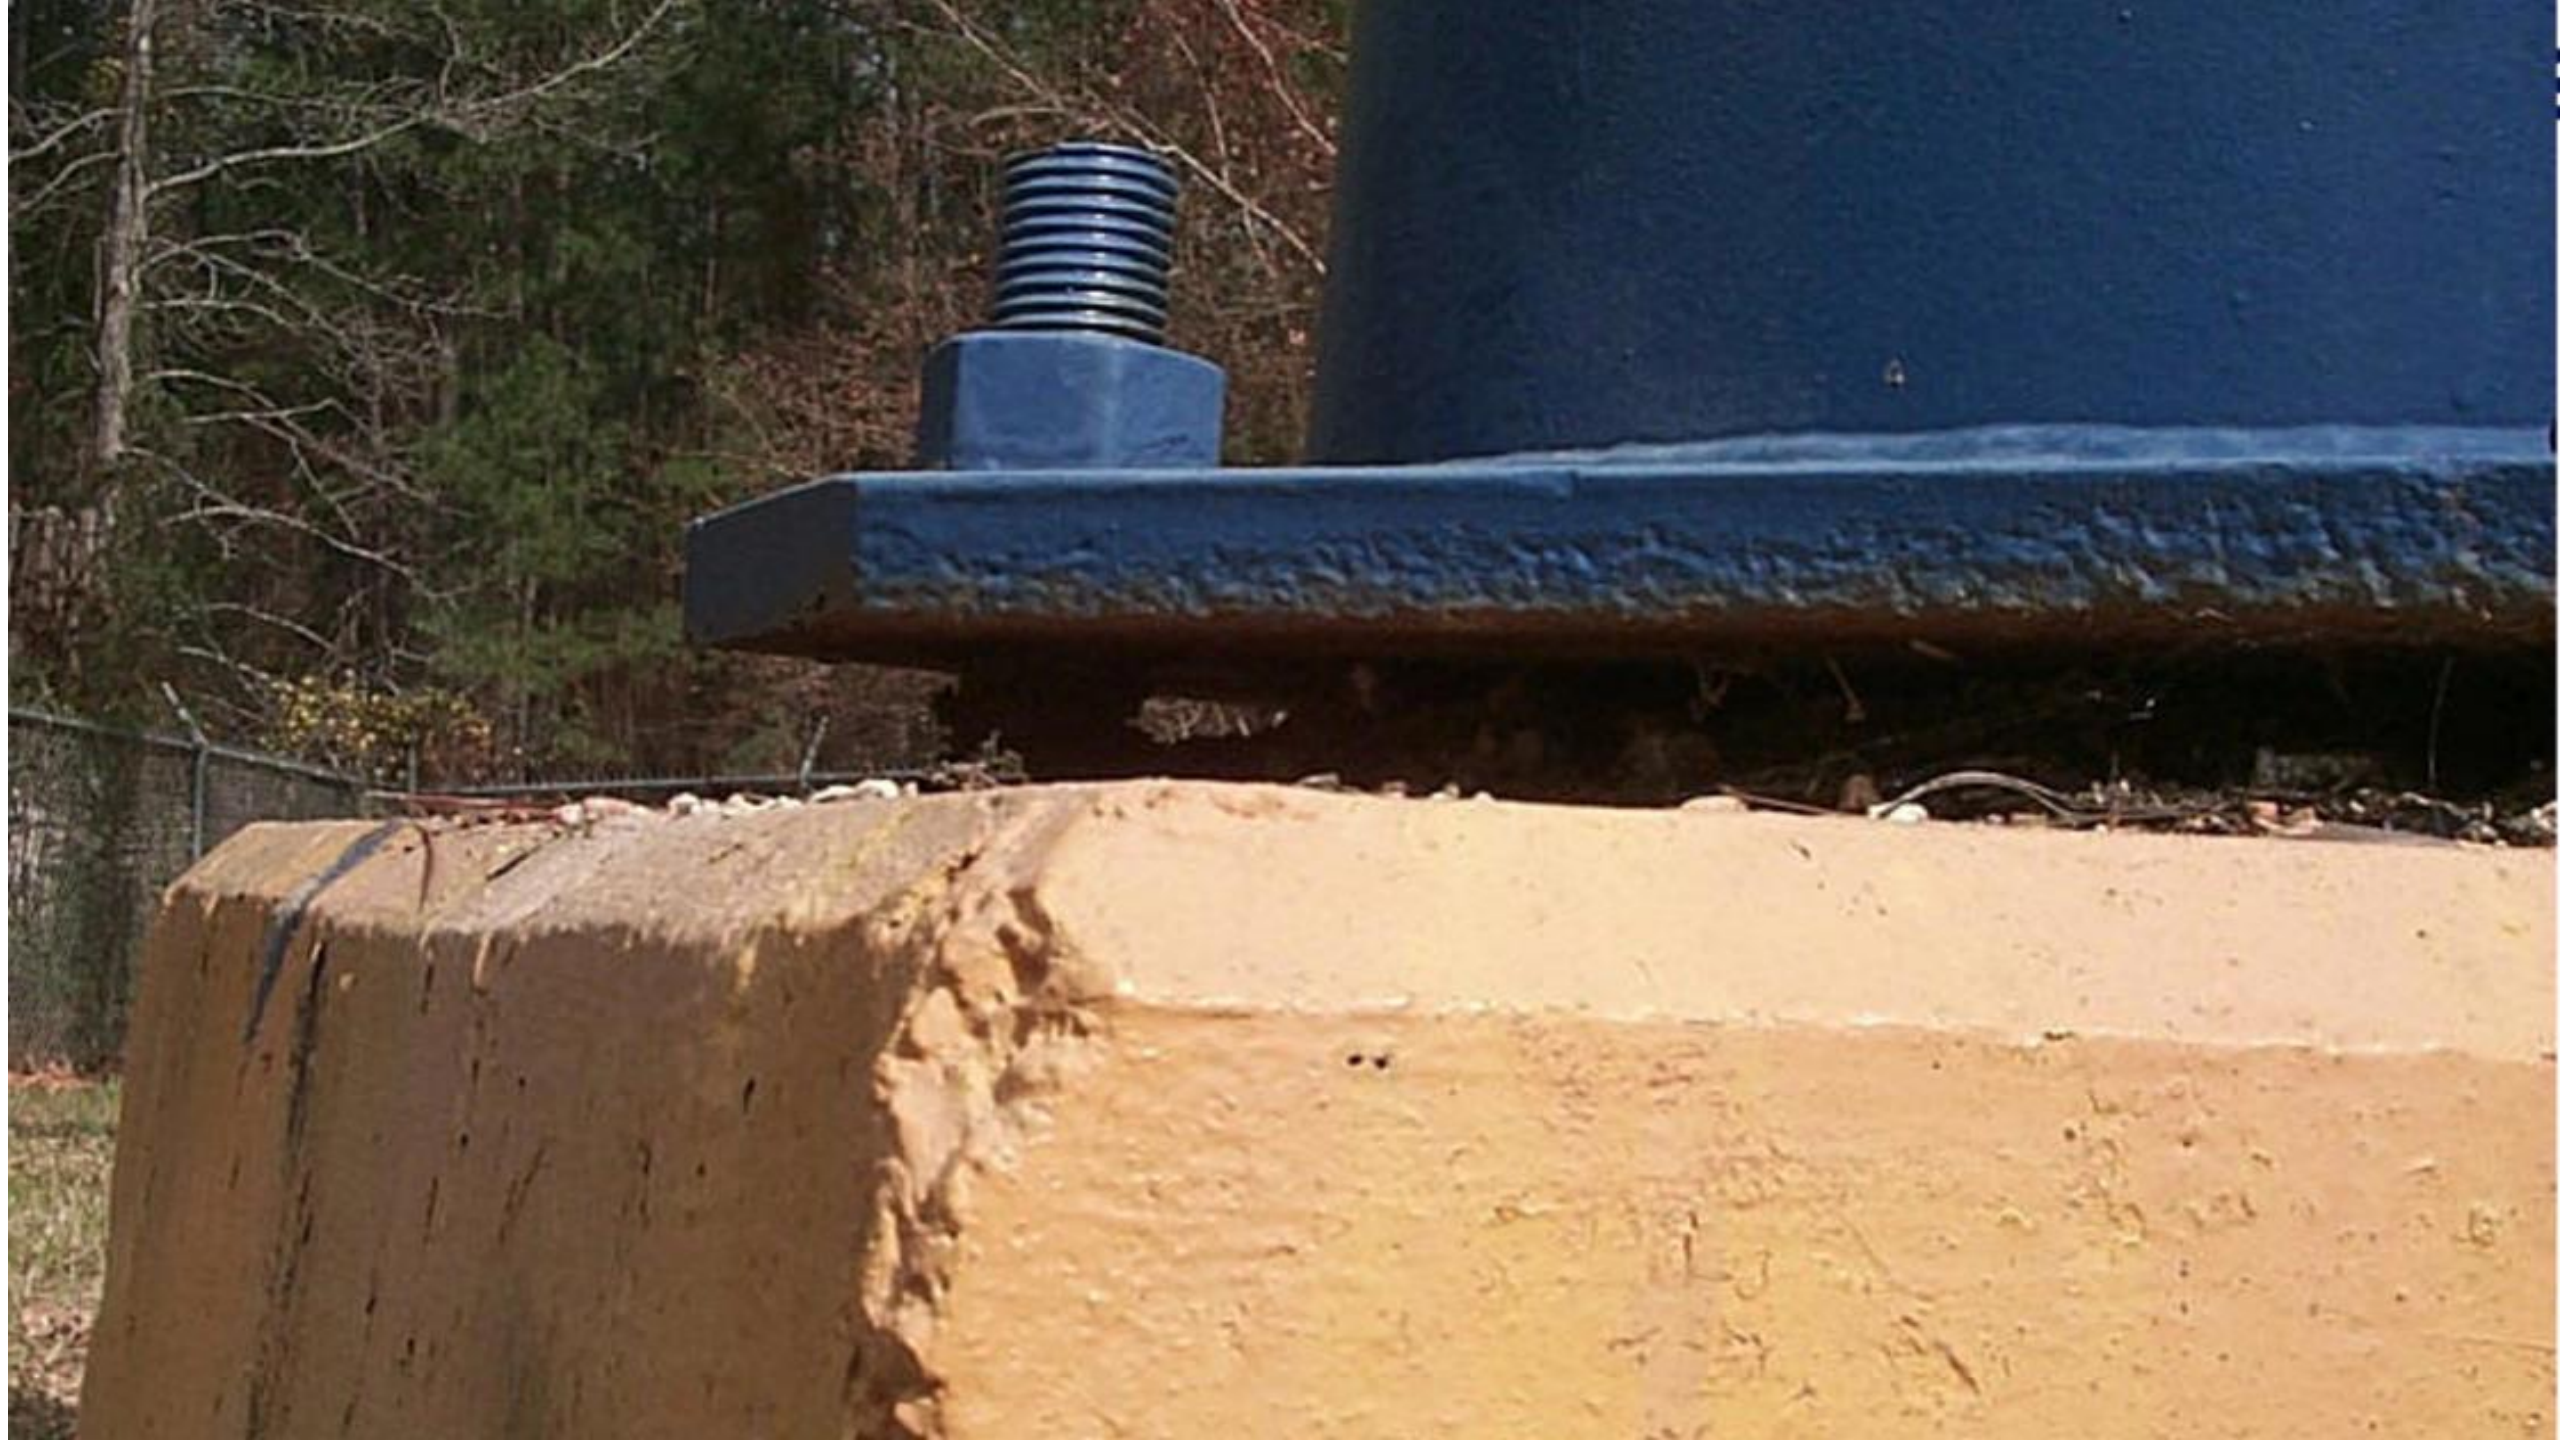
STRUCTURAL CONDITIONS

- Anchor bolts
- Foundations
- Wind rods
- Riser/Shell steel
- Spider rods
- Roof Trusses
- Ladders

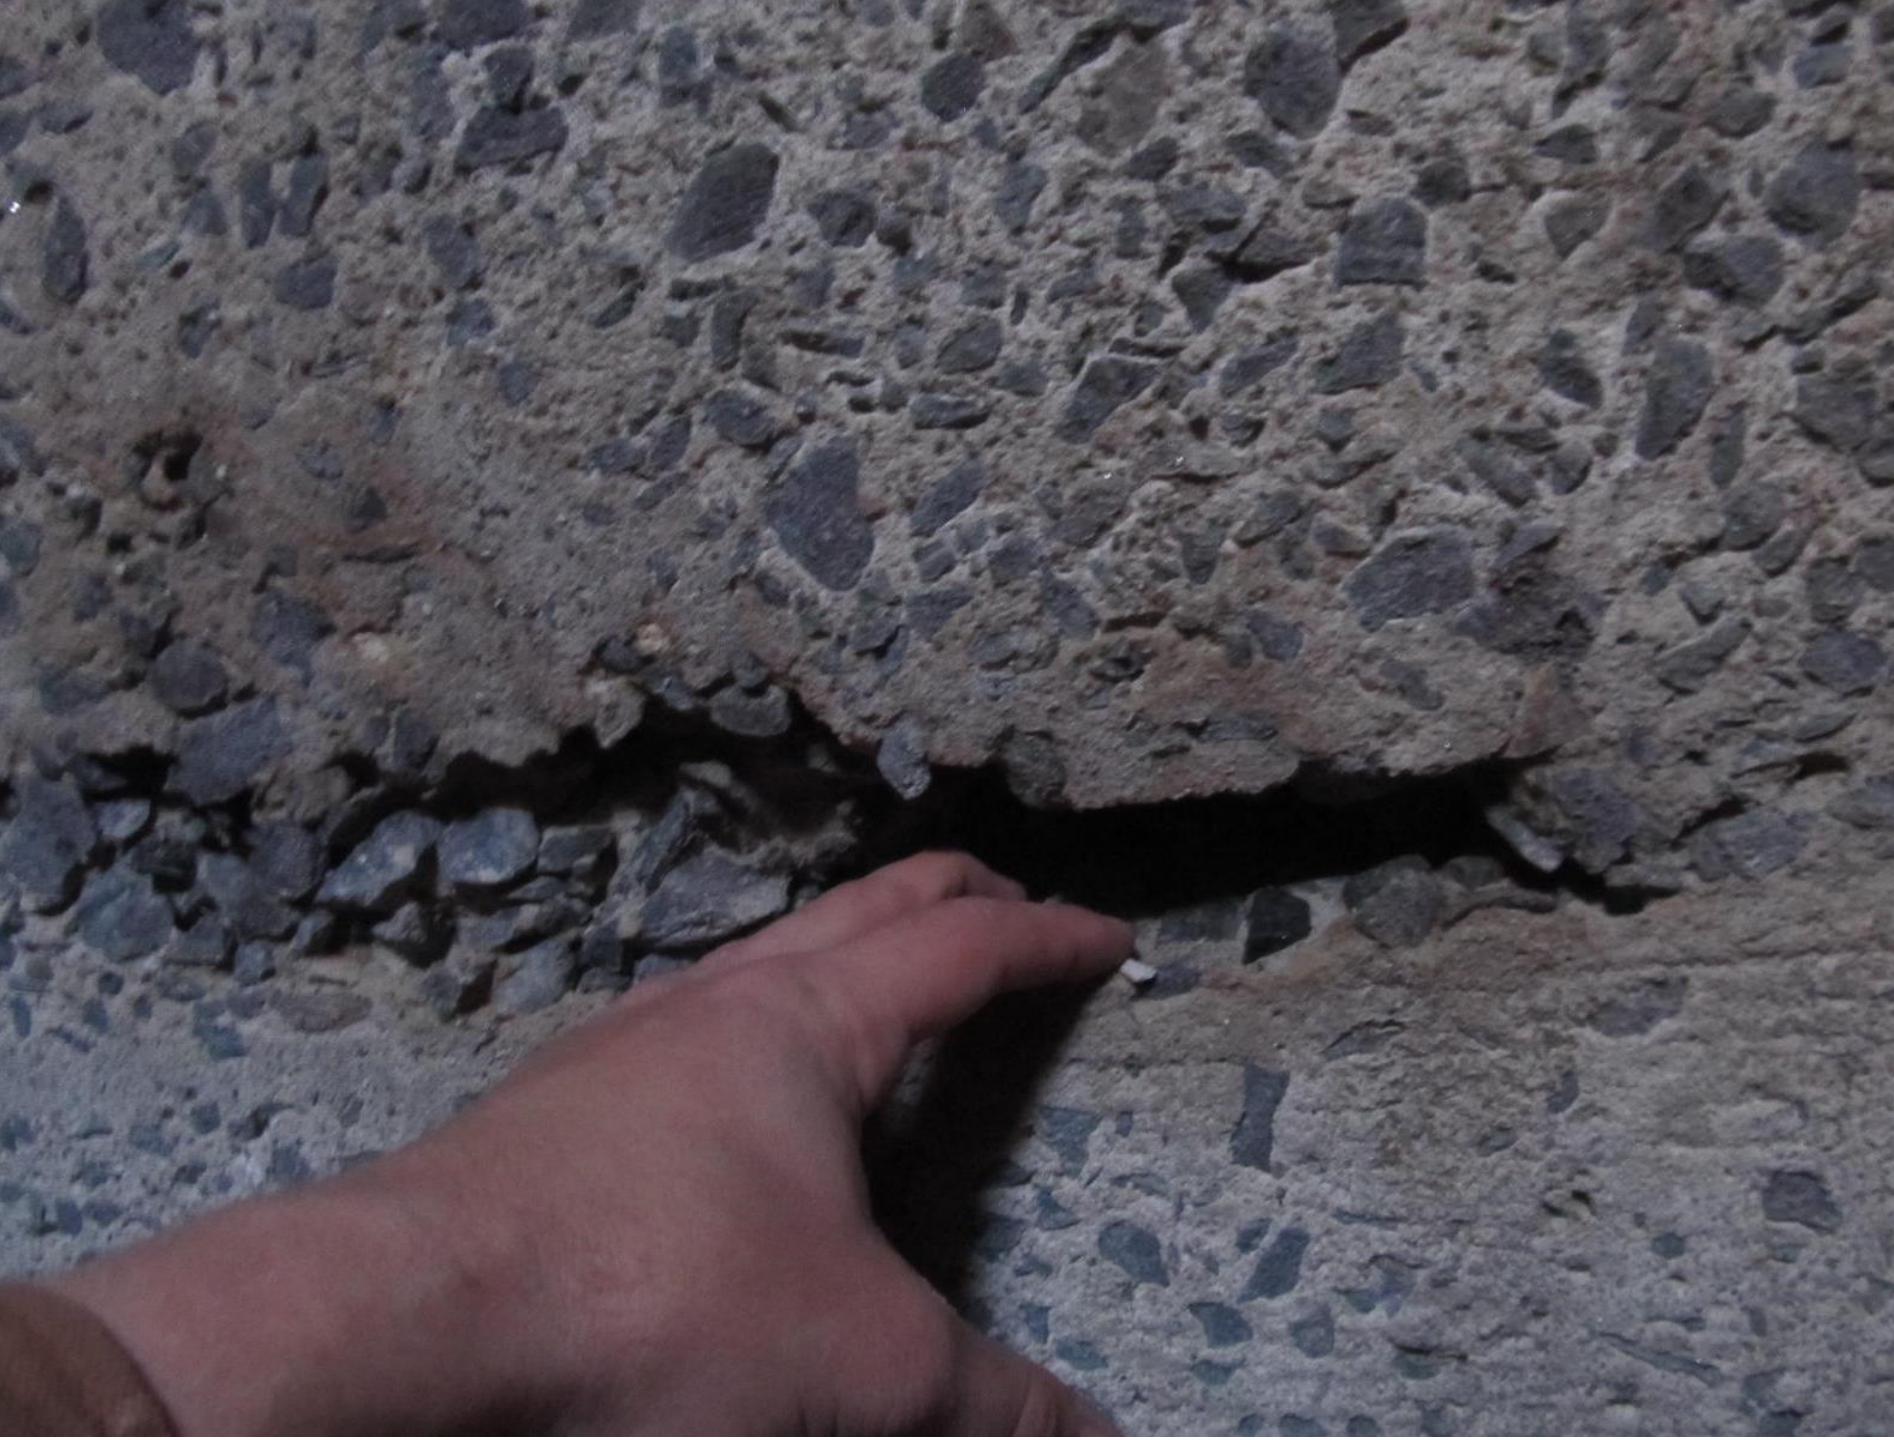
**How about the structural
condition of a Concrete tank?**

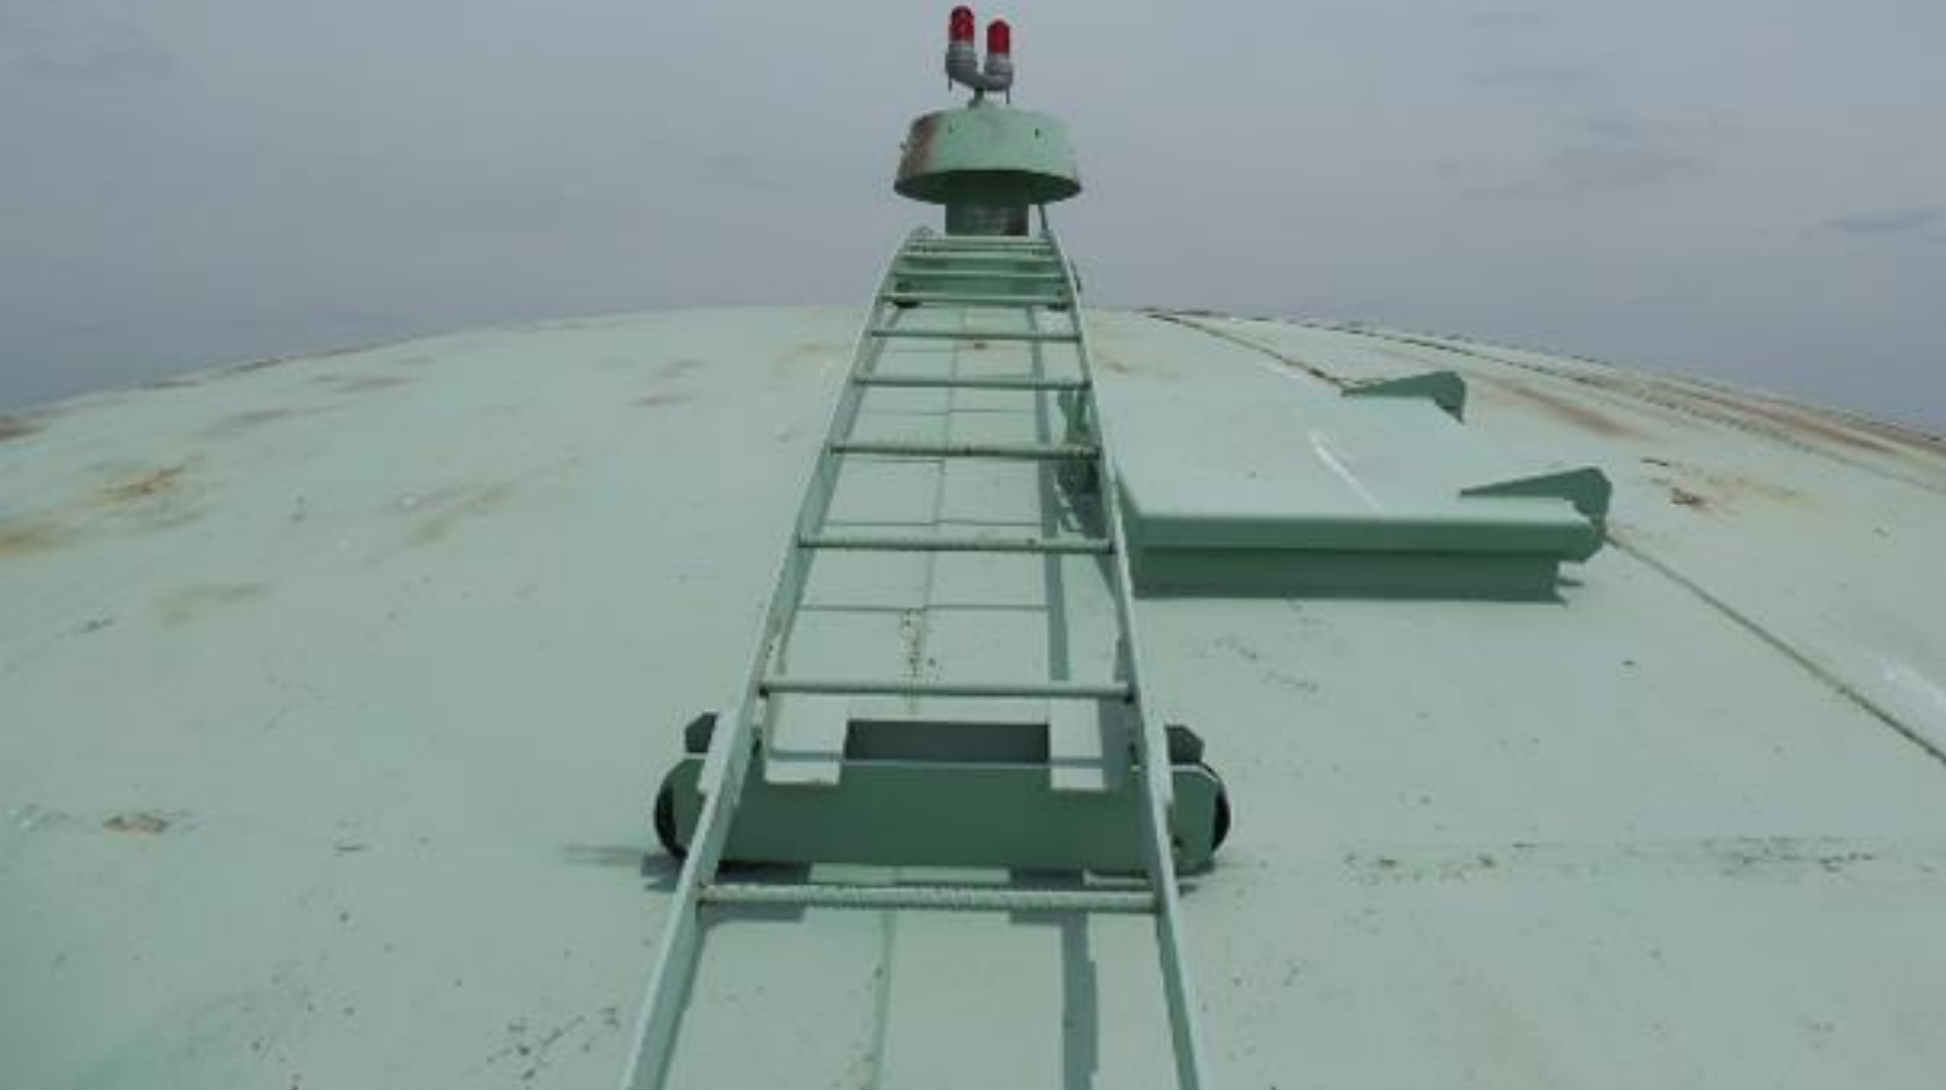
**This ladder looks safe ...
Right??**

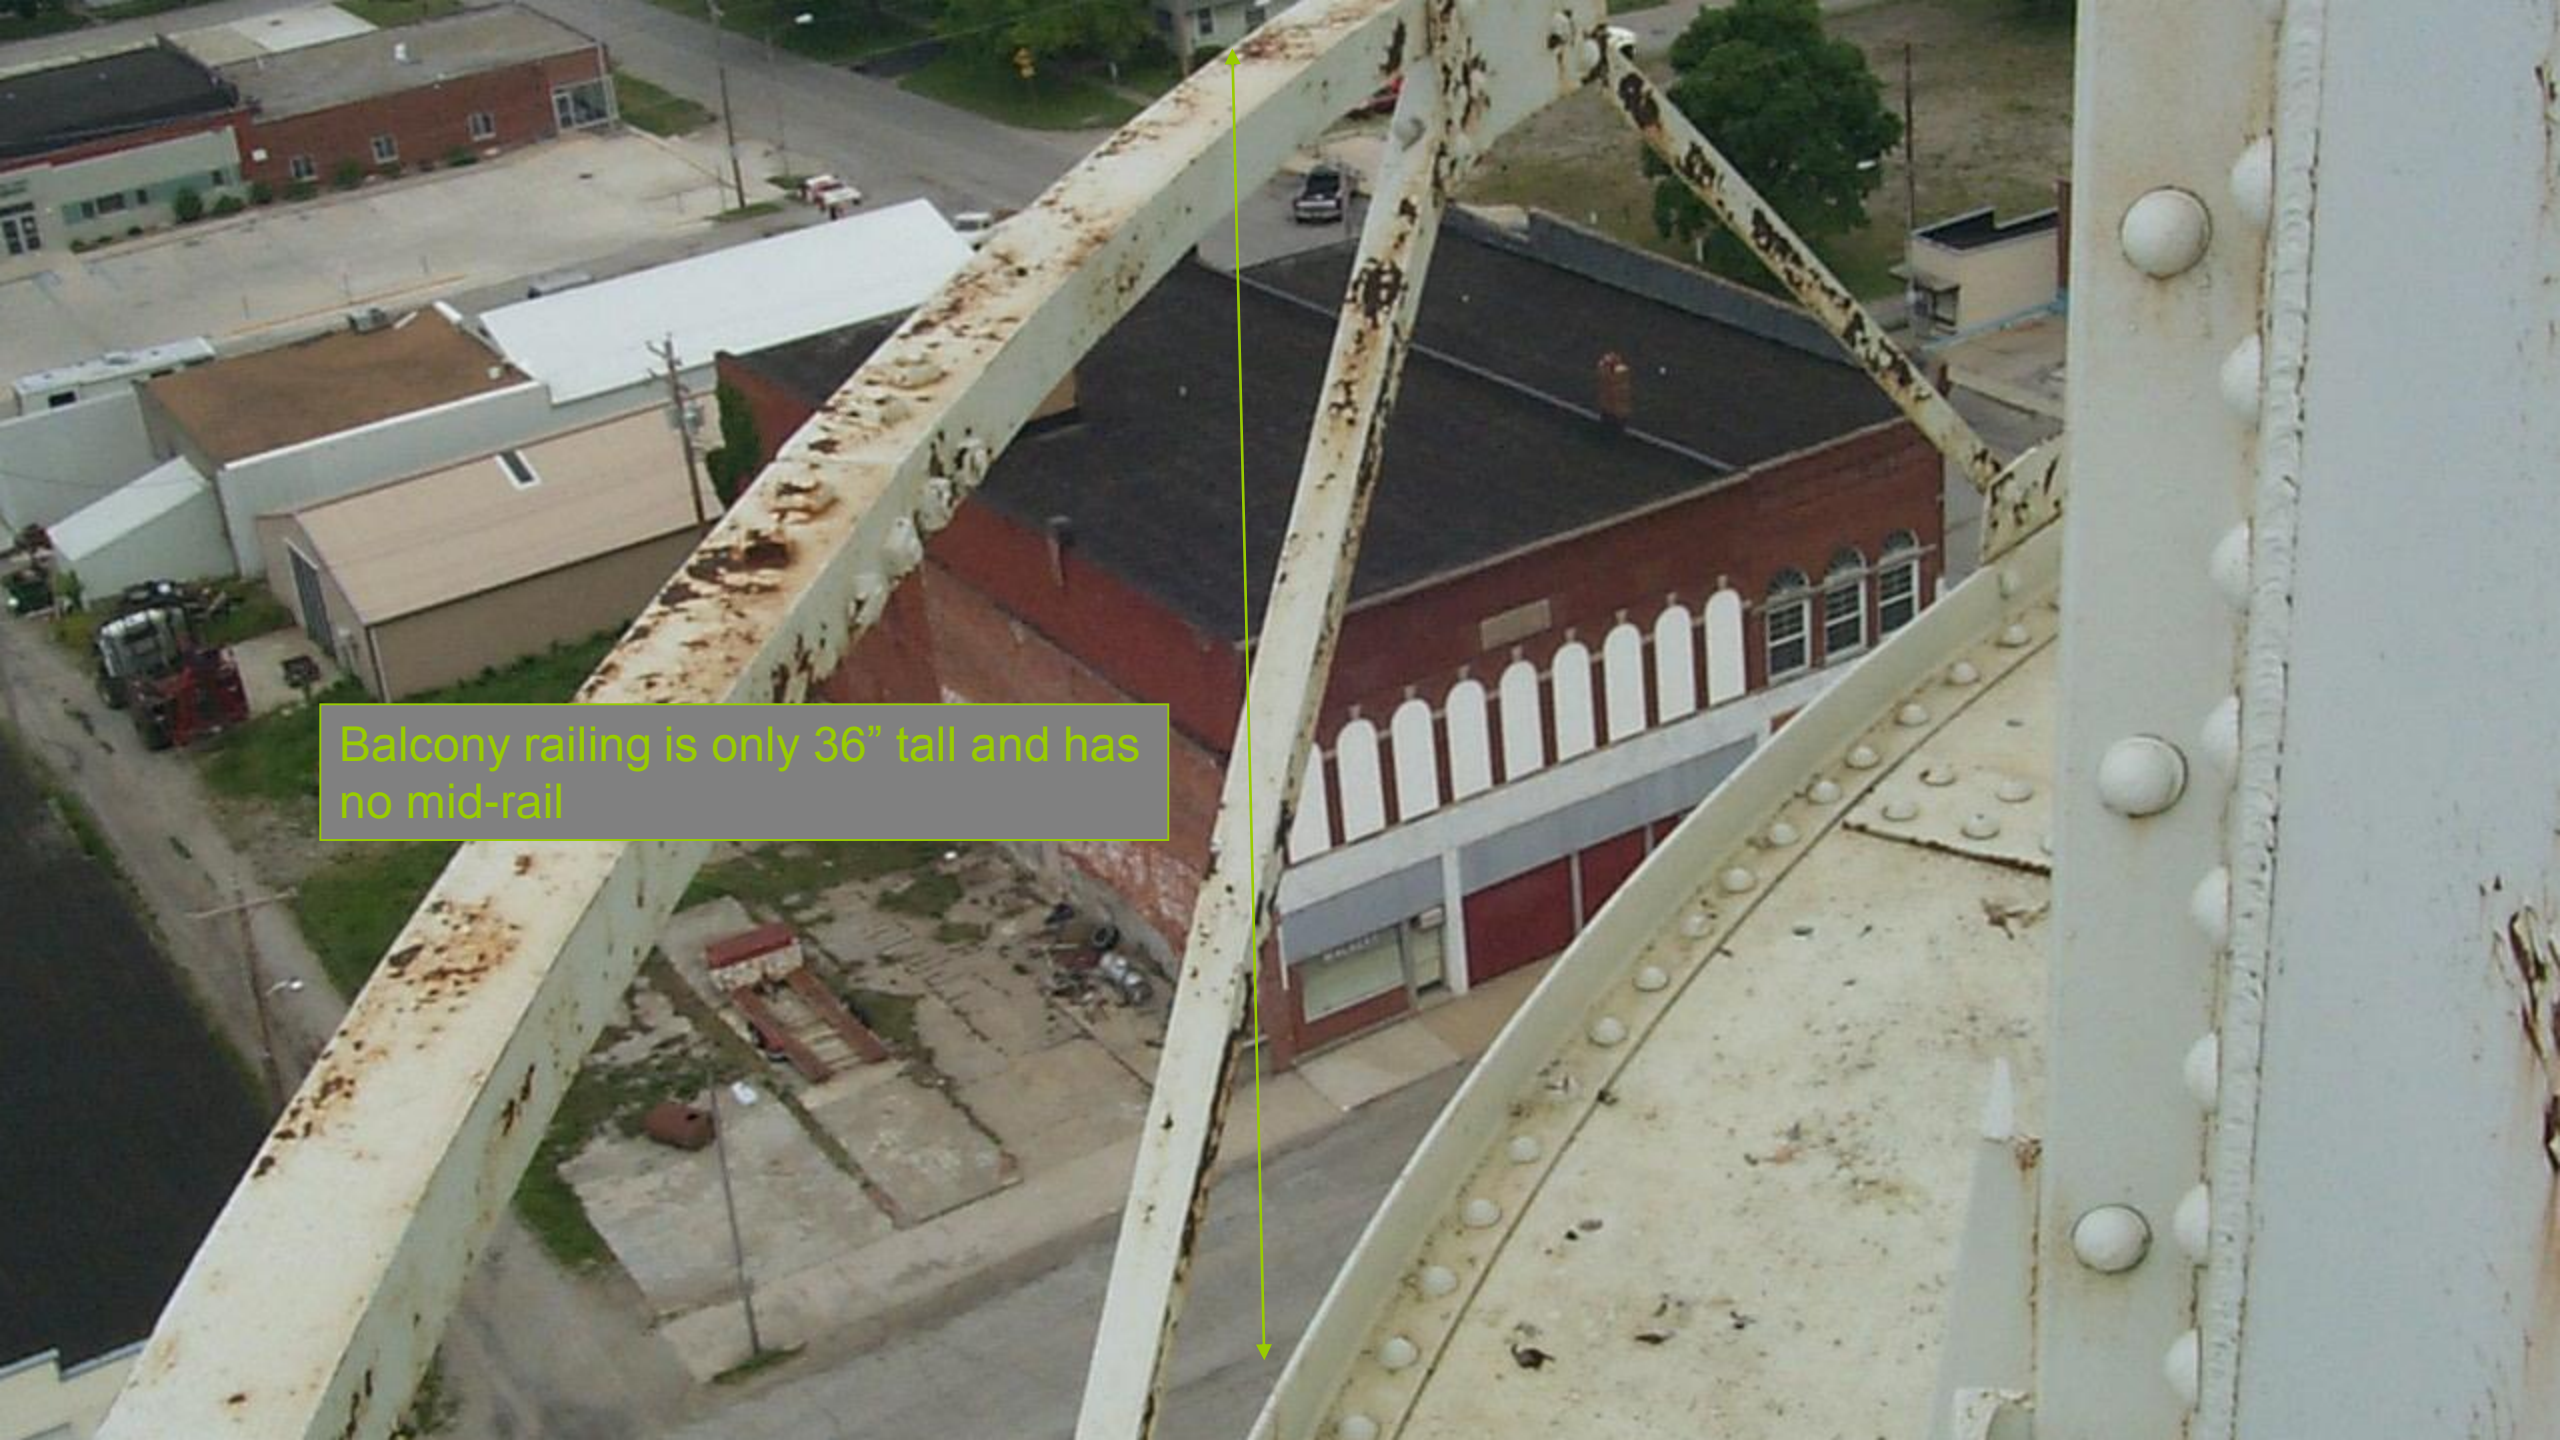
Safety Conditions: Handrail Systems

- 29 CFR 1910.23
- Handrail shall consist
 - Top rail 42” tall (200 lb force)
 - Toe board
 - Intermediate rail
 - No openings greater than 19”
 - 2”x2”x3/8” posts 8’ intervals

Balcony railing is only 36" tall and has no mid-rail
