Water Storage Tank Asset Management

OTCO Water Distribution Workshop
November 13, 2018

Suez Asset Protection Programs

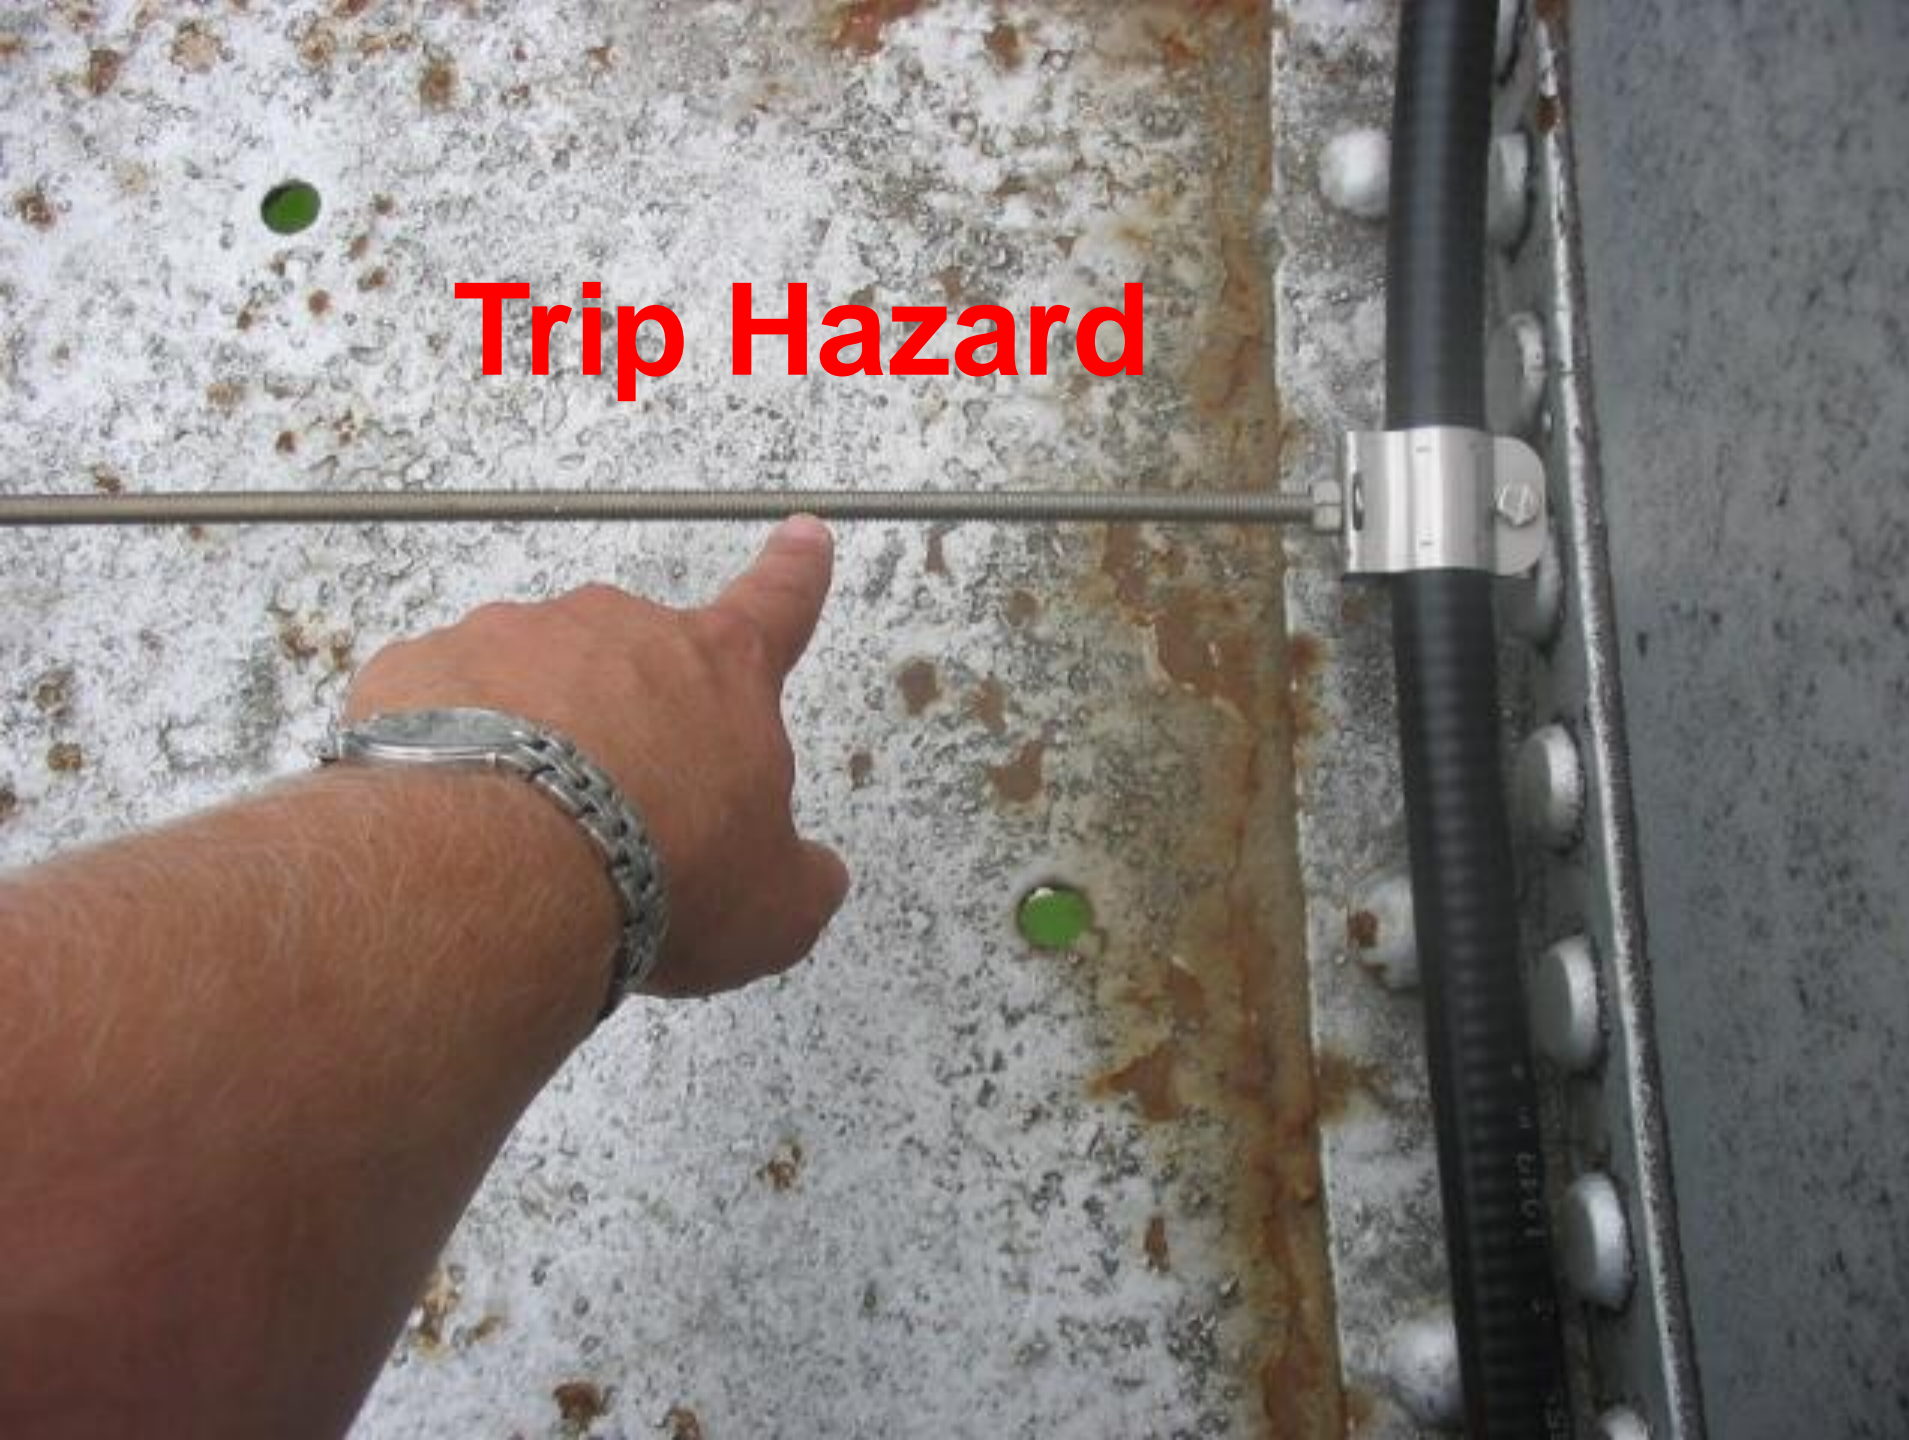
Trip Hazard

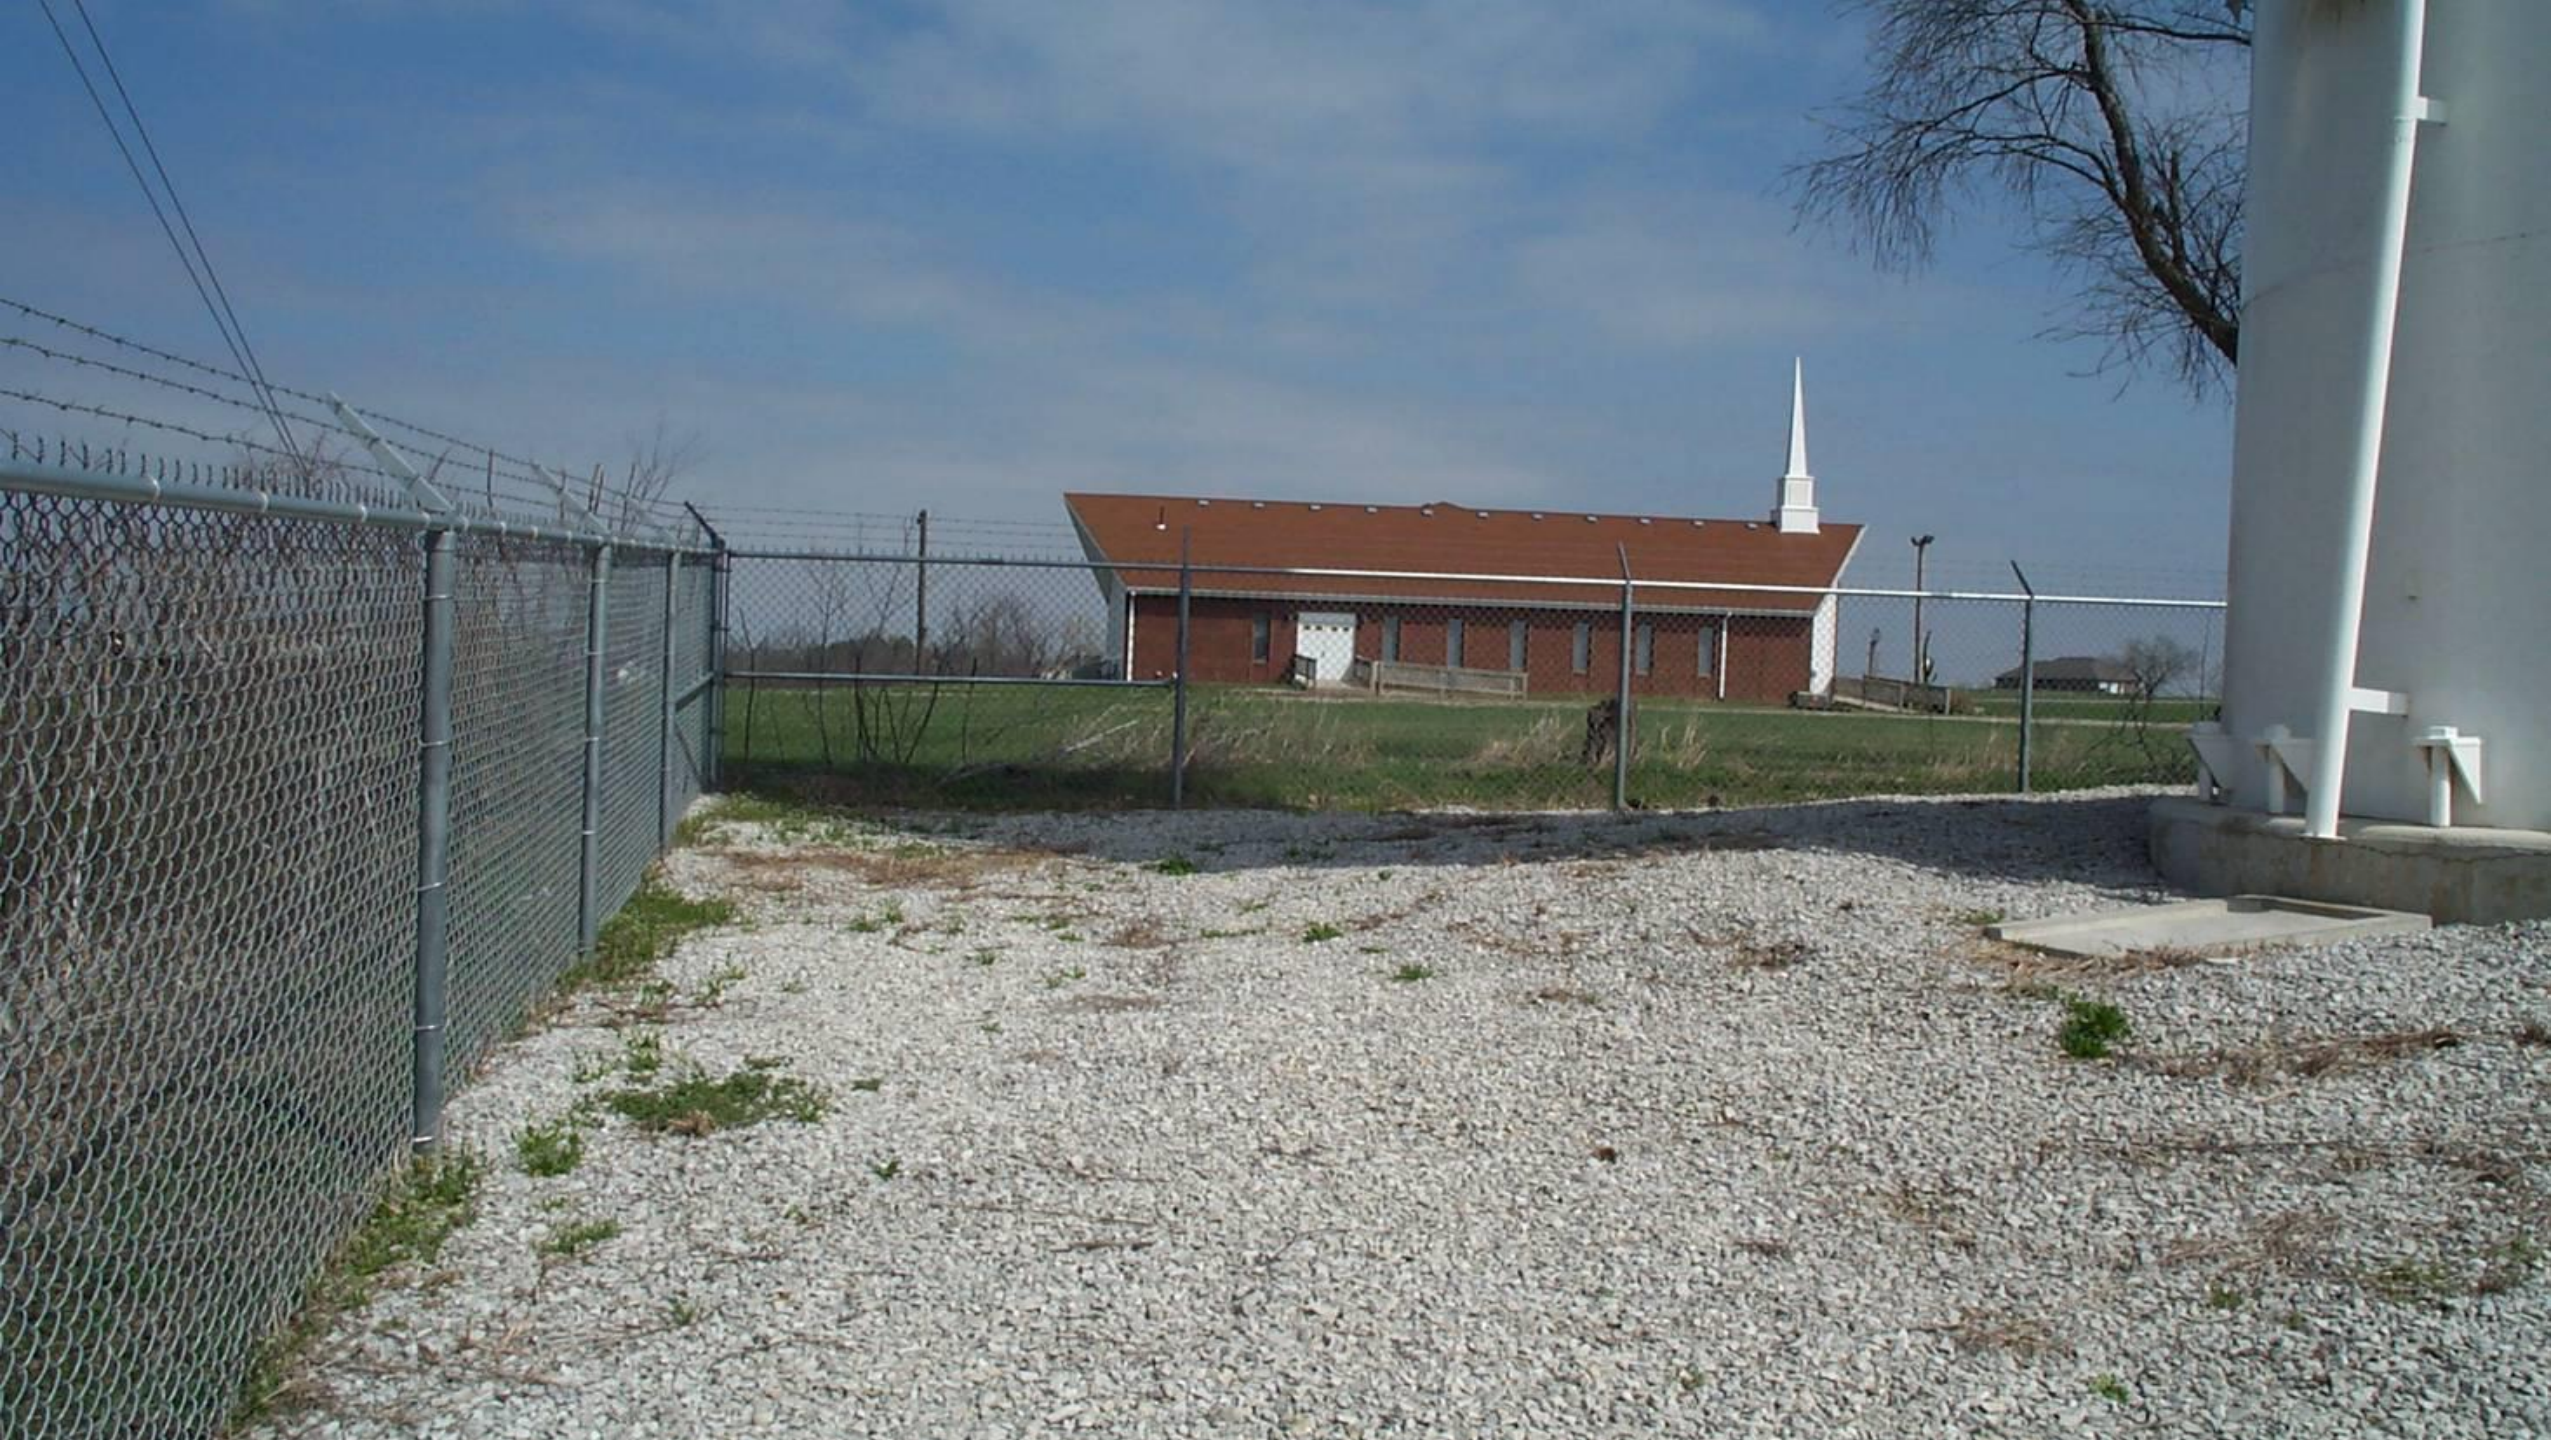
Security Conditions

- Exterior ladders terminate at least 12 ft above grade
- Properly fenced site
- All doors and access hatches are locked.
