# THE LASER WELD REPAIR OF FATIGUE CRACKS IN SHIP STEELS

P.M. Brown\*, G. Shannon\*\*, W. Deans\*\*\* and J. Bird\*\*\*\*.

The laser weld repair of fatigue cracks in 10mm thick S275J2G3 grade C-Mn ship steel has been investigated. Results indicate that helical laser weld repair is a viable alternative to conventional arc weld repair. One such repair exhibited a restoration in initial fatigue life of more than 500% and was associated with a repair time of approximately 20 minutes. This should be compared with an equivalent arc weld repair time of about 5 hours. It is envisaged that this technique has the potential to reduce the costs associated with the fatigue crack repair of maritime vessels. Partial and full repair of fatigue cracks was found to be ineffective in restoration of initial fatigue life because either repair techniques were unable to capture fatigue cracks in their entirety.

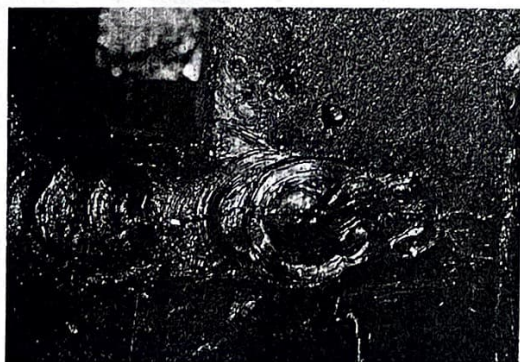
Fig. 9. View of weld metal "blemish" in the run-off area of helical repair LFA14 caused by accidental laser re-ignition. ( $\times 2.5$ )

cycle in the repair run-off area. This momentary re-ignition of the laser produced a weld metal blemish, Fig. 9, which was found to contain a large defect, Fig. 10. That post-repair fatigue crack initiation also occurred at this point is an important observation and will be discussed later.
