Lakes at Deer Creek
Deerfield Beach, FL

Report #: 36235-1
Beginning: January 1, 2025
Expires: December 31, 2025

RESERVE STUDY
Update "With-Site-Visit"

August 21, 2024

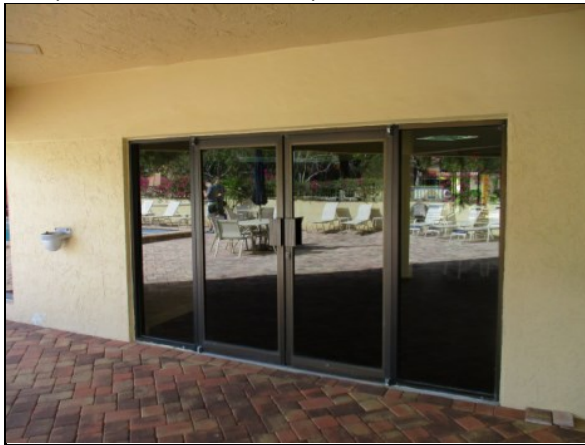
Useful Life:
40 years

Remaining Life:
5 years

Best Case: \$ 38,400

Worst Case: \$ 57,600

# Component	Useful Life (yrs)	Rem. Useful Life (yrs)	Current Average Cost
Clubhouse Renovations			
2367 Windows & Doors (Clubhouse) - Replace	40	5	\$48,000
2741 Clubhouse - Remodel Allowance	20	10	\$40,000
2743 Furniture/Fixtures/Eqpmt - Partia Repl.	10	5	\$12,500
2746 Kitchen - Remodel	20	19	\$11,000
2749 Bathrooms - Remodel	20	10	\$22,500
Roof			
2377 Clubhouse Roof (Mod. Bitumen) - Replace	20	18	\$47,000
2377 Residential Bldgs. (Mod. Bitumen) - Repl	20	1	\$180,000
2383 Residential Bldgs. Roof (Tile) - Replace	25	5	\$2,080,000
Painting			
2343 Building Exterior - Seal/Paint/Restor.	10	5	\$125,500
Pool Renovation			
2763 Pool Deck Furniture - Replace	8	4	\$20,000
2769 Pool Deck (Pavers) - Resurface	30	18	\$62,750
2771 Pool Fence - Replace	30	6	\$12,000
2773 Swimming Pool - Resurface	12	6	\$55,000
2775 Spa/Jacuzzi - Resurface	12	6	\$4,500
2781 Pool/Spa Heaters - Replace	8	0	\$22,500
2787 Pool Equipment - Maintain/Replace	5	2	\$6,000

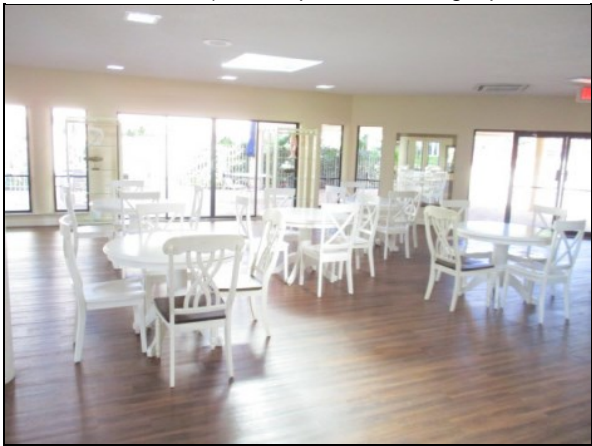
Useful Life:
20 years

Remaining Life:
10 years

Best Case: \$ 35,000

Worst Case: \$ 45,000
