## **APPENDIX A**

13 April 2022 (These notes were amended 6 June 2022 to reflect changes made by the applicant subsequent to the 19 April meeting. See Notes on pages 2, 3, 9, 10, 12, 15, 17, 22, 25, 29 & 30.)

Following OGNED's meetings before the Historic Preservation Commission (HPC) on 6 & 27 April 2021, three members—Deborah Osepchuk, Lucinda Heinlein, and Jeffery Rudell—were asked by Bernie Haney, to meet and offer feedback to the development team on ways their application (the Plan) could be brought into conformity with the Architectural Design Guidelines (Guidelines). These meetings were similar to the informal weekly Tech Review meetings available to all applicants to the HPC.

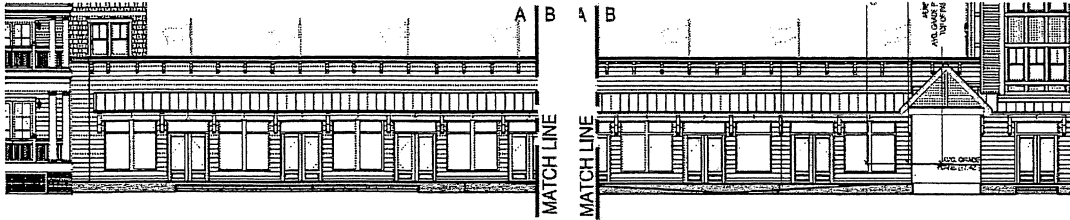
B.10. — **Retail:** Are railings specified at the “elevated sidewalk” that runs in front of the Retail? Specifically, will there be railings at each stair to assist people with mobility needs? If so, please submit a cat/cut for review.

**THE HEIGHT OF ELEVATED PORTION OF HE BOARDWALK IS LESS THAN 30" SAO NO RAILINGS ARE REQUIRED BY CODE.**

Illustrations B.10.a and B.10.b — East elevations of proposed retail (Sheet A-5) showing elevated “sidewalk/platform” without guard or stair rails (Sheet A-5).

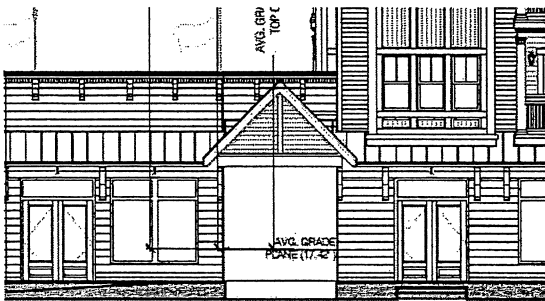
**B.11. — Courtyard Corridor:** At Tech’s request, OGNED agreed to reconsider the access corridor that leads from the boardwalk to the interior courtyard, to better highlight the access point and make it look more like a feature of the Retail frontage and less like an alley. At present, the pedimented entry has little relationship to the rest of the Retail area or the boardwalk itself. Tech asked OGNED to consider ways to extend that entrance forward (as a pergola or other structure extending toward the boardwalk) to better invite pedestrians into the space. The Plan presented did not activate courtyard access in any way, provided no shade, and seemed “uninviting.” No change to this area is reflected in the current Plan. **NOTE: 3 June 2022**  
Summary of Changes: Windows provided in the retail spaces on both sides of the corridor passageway.

**CHANGE MADE AS NOTED. ADDITIONAL MULTIPLE CHANGES WERE MADE AT THE REQUEST OF THE HPCE INCLUDING CHANGES TO THE GABLE END ROOF PROJECTIONS AND THE ADDITION OF WINDOWS ALONG THE CORRIDOR TO ENLIVEN THE LOCATION AS RETAIL SPACE.**

Illustration B.11. — East elevation of proposed pediment-topped entry to courtyard corridor (Sheet A-5).

**B.12. — Courtyard Corridor:** Is the entrance to the courtyard at grade (at boardwalk level) or raised to the level of the sidewalk that runs in front of the Retail? If at grade, what accommodations are made to access the courtyard entrance from the raised sidewalk? Also, will the handicap accessible ramp necessitate closing off the sidewalk with a railing where it meets the corridor entrance? (See Illustration B.11., above.)

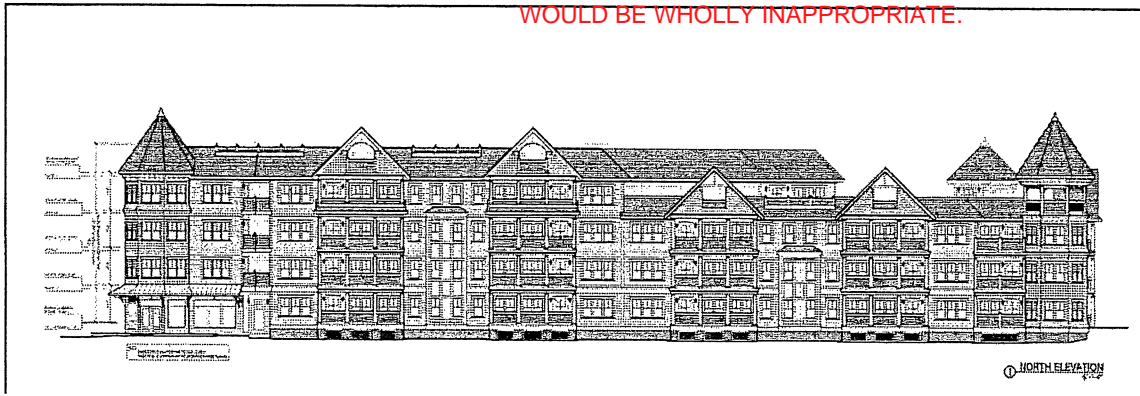
B.14. — **Condominiums:** Tech noted the proposed changes in plane on each of the Condominium buildings was minimal and provided insufficient visual rhythm, presenting instead, as a continuous wall along the north elevations facing Wesley Lake. Given the prominent lakeside location, Tech asked if the elevation of these buildings could better mimic, in scale and massing, individual townhouses. NO CHANGES MADE. APPLICANT RELIES ON ITS EXPERT TESTIMONY PROVIDED AS TO WHY MIMICKING TOWNHOUSES WOULD BE WHOLLY INAPPROPRIATE.

Illustration B.14.a. — North elevation, Condominium Building One (Sheet A-6).

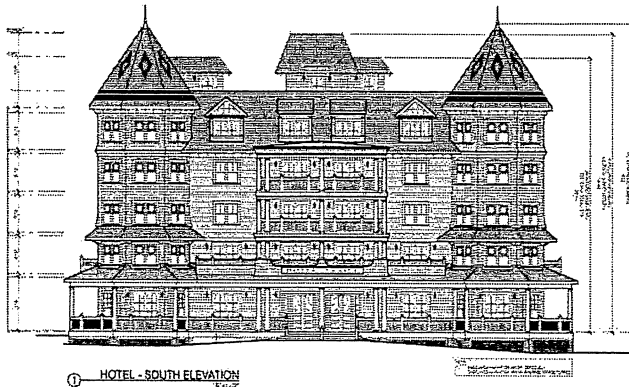
C.3. — **Hotel: Tower Roofs.** The two towers are decorated with over-scaled diamond shapes and wide banding (both created using contrasting roof shingles). Tech found these decorative elements “Disney-esque” in scale and out of character with more nuanced rooftop articulation typical of historic buildings.

THE SCALE OF THE DIAMOND PATTERNS WERE REDUCED ON THE SETTLEMENT PLANS.

Illustration C.3. — South elevation of the Hotel showing proposed diamonds and banding on tower roofs (Sheet A-11).

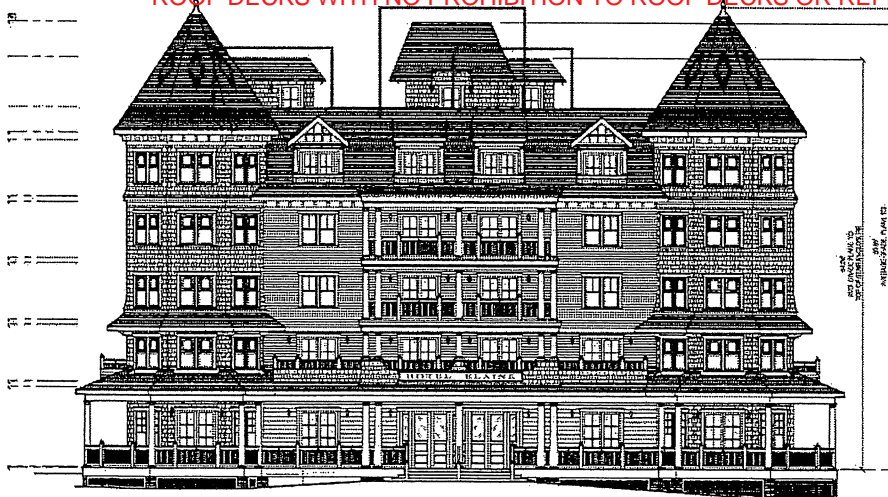
**C.4. — Hotel: Roof Projections.** A central elevator meant to serve a non-conforming roof deck results in a mechanical projection that rises above the level of the parapet roof. While this projection is not expected to be visible from streets immediately surrounding the Hotel, it will be visible from Ocean Avenue as it approaches the Hotel from the south. Likewise, it will be visible from most of the Ocean Grove beach to the south and east of the building. This projection would not be unnecessary were it not for OGNED's intention to provide access to a non-conforming roof deck.

THE ELEVATOR TOWER WAS REDESIGNED PER THE HPC SUGGESTION ON THE REVISED PLANS. APPLICANT CONTINUES TO CONTEND THAT THE DESIGN GUIDELINES DO NOT PROHIBIT ROOF DECKS. SEE SECTION N OF THE RESIDENTIAL GUIDELINES PROHIBITING CERTAIN TYPES OF CONSTRUCTION ON ROOF DECKS WITH NO PROHIBITION TO ROOF DECKS OR REFERENCE TO USE. THE COMMERCIAL

Illustration C.4.a. — South roof elevation of the Hotel (Sheet A-11).

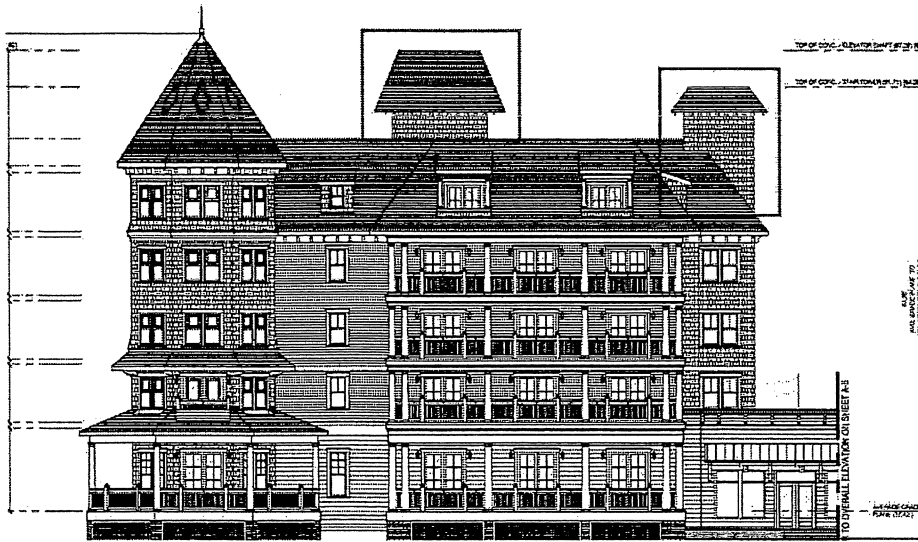
Illustration C.4.b. — East roof elevation of the Hotel (Sheet A-11).

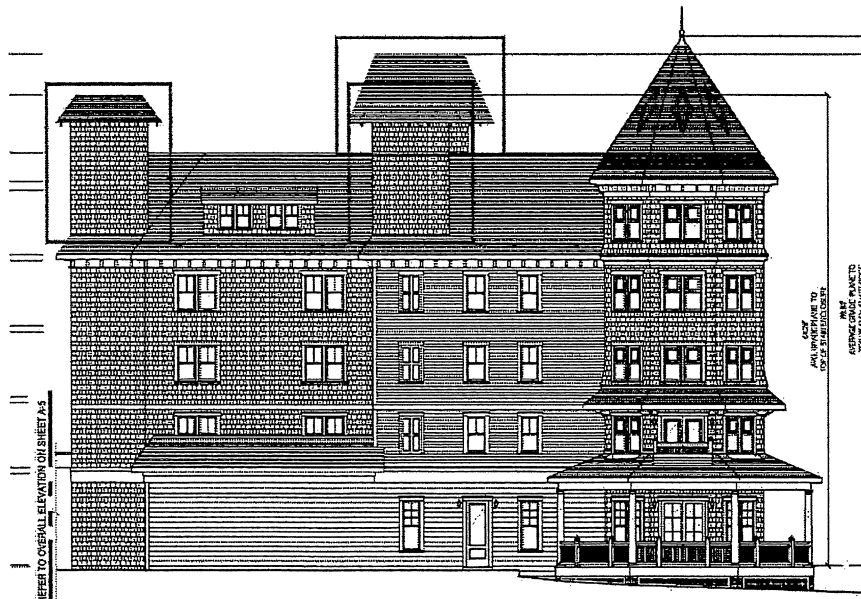
C.5. — **Hotel: Roof Projections.** Two staircase towers also serve the non-conforming roof decks and present similar design non-conformities as a result. **INFORMATIONAL. NO CHANGE REQUIRED.**

Illustration C.5.a. — West roof elevation of the Hotel (Sheet A-12).

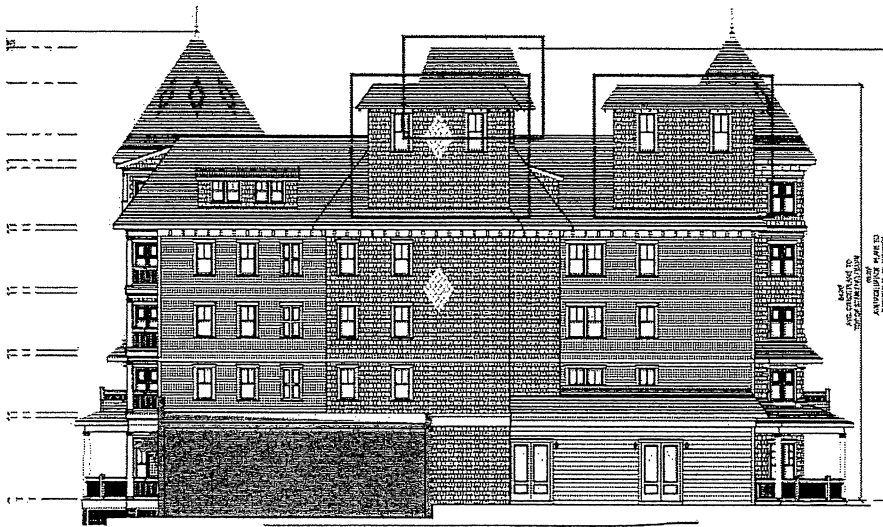
Illustration C.5.b. — North roof elevation of the Hotel (Sheet A-12).

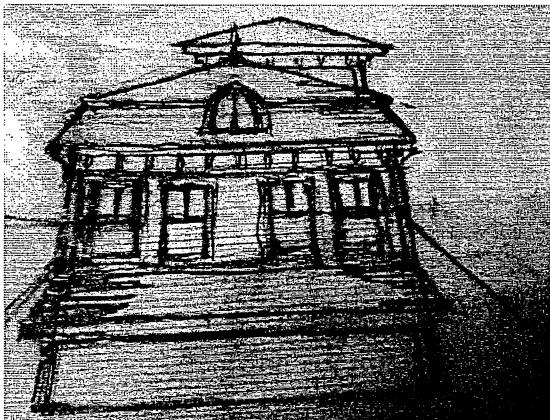
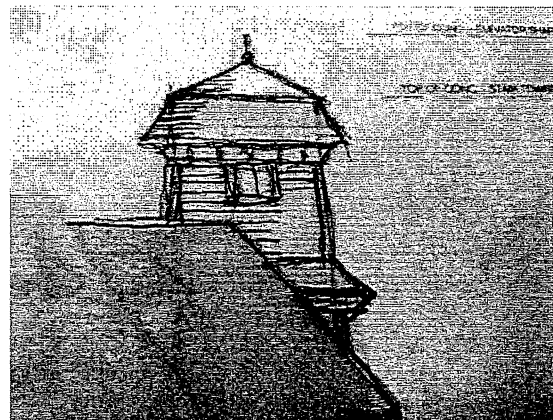
**C.7. — Hotel: Roof Projections.** Tech shared with OGNED a sketch that showed a possible architectural treatment for disguising the elevator tower using “forced perspective.” In the sketch, a cupola structure hangs over the elevator shaft like an acorn cap, rather than sitting atop it, as with a standard roof. A related sketch showed a similar treatment of staircase towers.

Illustrations C.7.a. and C.7.b. — Sketch of “forced perspective” roof treatments for elevator mechanicals and rooftop stair access.

**THE ELEVATOR TOWERS WERE REDESIGNED ON THE REVISED PLANS PER THE HPC SUGGESTION.**

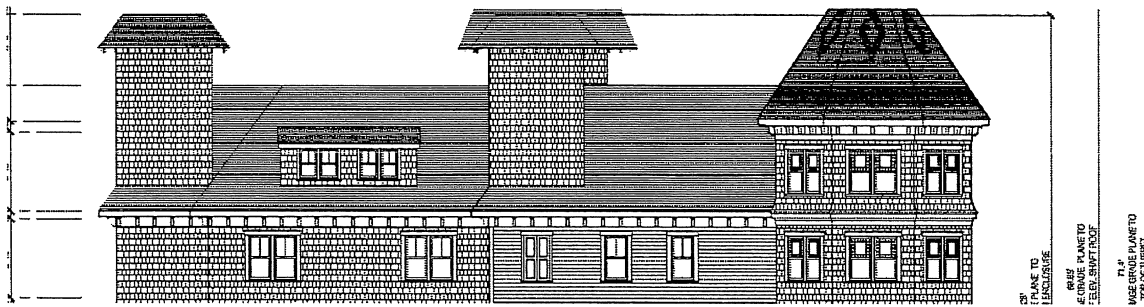
Illustration C.8.d. — Hotel dormers, west elevation, showing two sets of double windows beneath a shed roof (Sheet A-12).

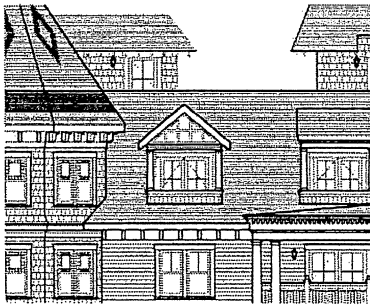
C.9. — **Hotel: Dormers.** The inclusion of paneling in the dormer gables at the south and east is historically inappropriate. Examples exist of doweled screens and orthogonal lattice in gables, but paneling of this sort is not appropriate. **THE PANELING WAS REMOVED AND BOARD AND BATTEN DETAILING ADDED ON THE REVISED PLANS.**

Illustration C.9. — Hotel dormers, south elevation, showing proposed paneled gable ornamentation (Sheet A-11).

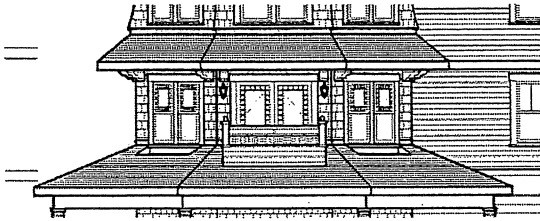
C.10. — **Hotel: Dormers.** Use of Tuscan columns on roof dormers on the south and east elevations are inappropriate. Properly scaled corbels, similar to those used at the tower balconies below the pent, are more appropriate and would help unify the design through repetition. **NOTE:** 3 June 2022 Summary of Changes: *Revised detailing at roof-top dormers. Half-size columns removed and replaced with large brackets. Dormer roof changed from shed to gable to accommodate the revised detailing. Dormer width enlarged to accommodate (1) wall lantern on each side of the doors.* **CHANGE MADE AS NOTED.**

Illustration C.10.c. — East elevation of Hotel tower, second floor, showing corbels suggested for use in dormers (Sheet A-11).

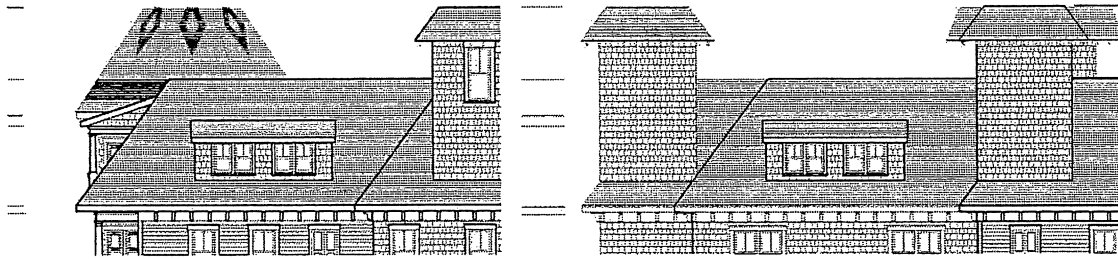
**C.11. — Hotel: Dormers.** The double dormers on the north and west should be changed to conforming individual dormers. Also, these dormers appear smaller than those at the south and east, perhaps due to them containing only windows and not doors. Please clarify.

Illustrations C.11.a. and C.11.b. — The north and west elevations of the Hotel showing proposed, non-conforming, double dormers (i.e., pop-ups) (Sheet A-12).

THESE DORMERS COULD NOT BE CHANGED DUE TO HEADROOM REQUIREMENTS IN INTERIOR.

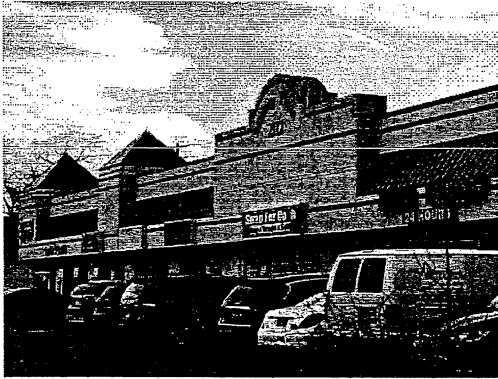
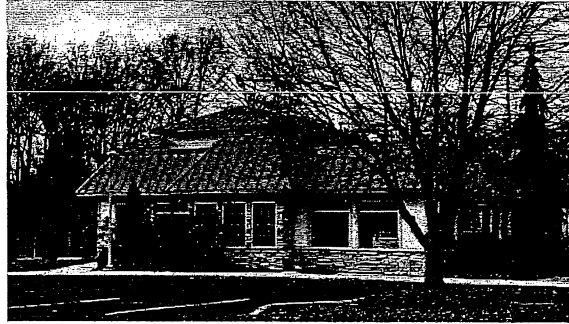
Illustration C.12.b., C.12.c. — Reference photographs showing modern, standing-seam roofs on area commercial buildings.

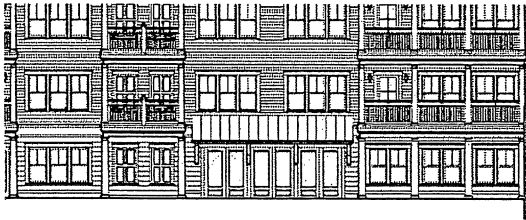
C.13. — **Condominium:** The main entrance to Building One (south elevation) has a non-conforming standing seam roof. (See Guidelines, page 14, 4: “Avoid use of modern standing seam factory painted metal roofing, and shingles of inappropriate historic period color, such as white or green.”)

THE METAL ROOFING PROPOSED IS NOT FACTORY PAINTED. SIMILAR TO THE MATERIAL USED FOR THE GREAT AUDITORIUM (AND APPROVED BY THE STATE HISTORIC PRESERVATION OFFICE) THE MATERIAL WILL BE NATURAL ZINC, WHICH IS A HISTORICALLY APPROPRIATE SUBSTITUTE FOR LEAD-COATED STEEL, WHICH WAS USED DURING THE PERIOD OF SIGNIFICANCE BUT CAN NO LONGER BE USED FOR ENVIRONMENTAL REASONS. THE METAL ROOFING WILL MATCH IN COLOR AND APPEARANCE WITH THE ROOF ON THE GREAT AUDITORIUM AS NON-PAINTED, STANDING FOLDED SEAM.

Illustration C.13. — South elevation of Condominium Building One showing proposed standing seam roof over main building entrance (Sheet A-6).

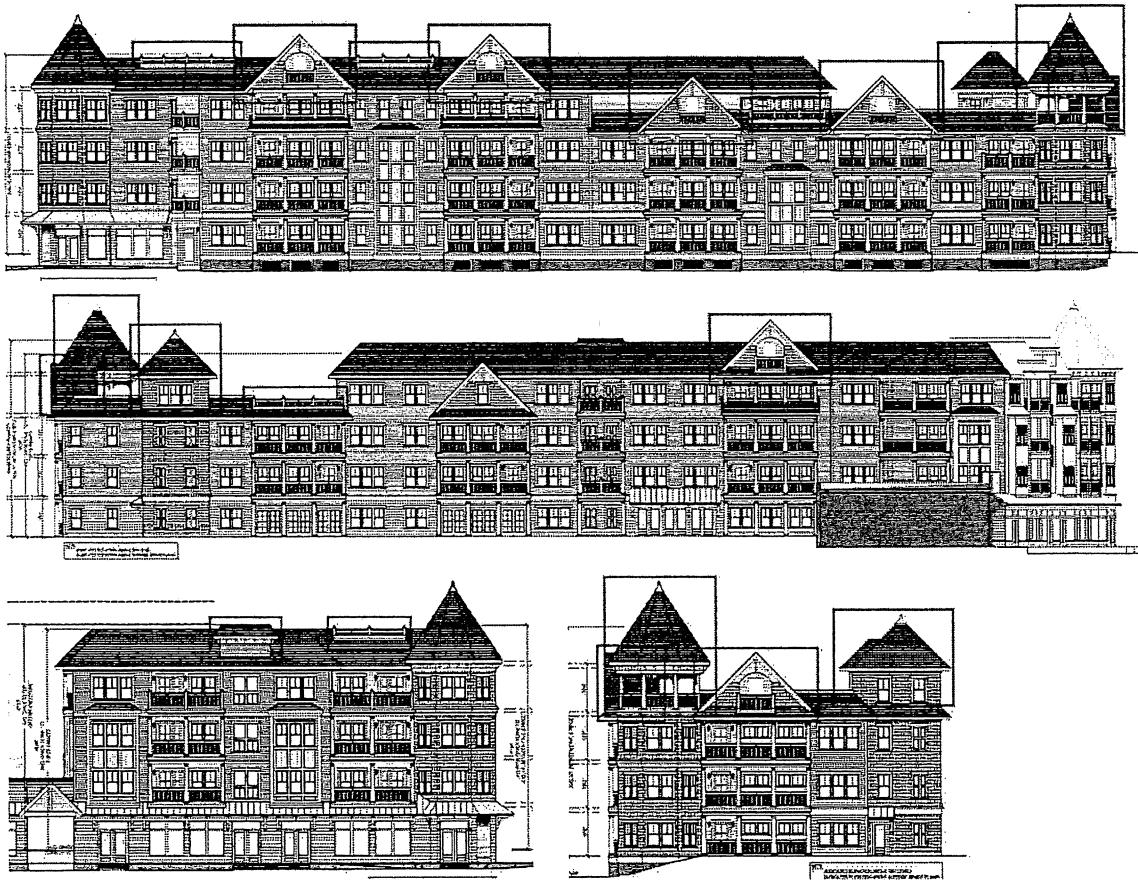
C.14. — **Condominiums:** Rather than strong, historically appropriate, roof forms, the Condominium buildings display disparate architectural elements that fail to unify or strengthen the design. These include a parapet roof meant to suggest a faux-Mansard roof, railing breaks in the parapet with short runs of newel posts and balusters, (that work against the faux-Mansard illusion), stair towers at the east and west elevations that penetrate the parapet, and unusual, non-historic faux-gables with cut-out openings, that further emphasize the non-historic roof treatment. NOTE: 3 June 2022 Summary of Changes: *Sidelights removed on porches/balconies. Removed all visible roof railings on North and East Elevations. Removed visible roof railings on Building Two. Finials added to the towers. Roof top dormers (on 3-story portion of the building) increased in depth. Roof top dormers on Building Two increased in depth.* ALL CHANGES MADE AS NOTED.

Illustrations C.14.a., C.14.b., C.14.c., and C.14.d. — The north, south, east, and west elevations of Condominium Building One showing non-conforming faux-gables, balusters and rails, cupola, and stair towers (Sheets

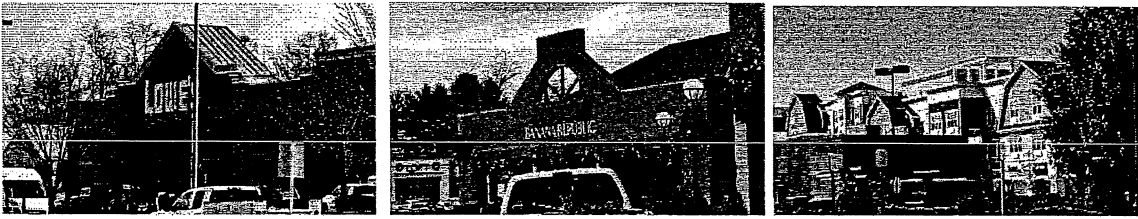
C.15. — **Condominiums:** Tech found the proposed faux-gables that dot the Condominium roofs especially counter-historical. Each faux-gable has an opening cut into its façade (some square, some arched) in a manner that Tech felt looked less architectural than theatrical. The artificiality of these forms is evident from vantage points to the west, north, and east. Faux-gables at the fourth story rise, but do not connect, to other roof forms behind them in a manner that is visually awkward and non-historic. The roofline of both Condominiums is a collection of odd-shaped intrusions that look distinctly modern. Tech shared the following images with OGNED to help illustrate their view that the proposed faux-gables are distinctly modern and historically inappropriate. **NO ADDITIONAL CHANGES MADE.**

Illustrations C.15.e., C.15.f., and C.15.e. — Reference photographs showing faux-gable roof projections on area commercial buildings.

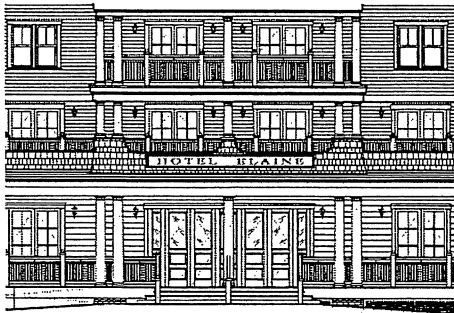
D.2. — **Hotel:** In elevation, the Hotel's main entrance doors are flanked by single sidelight windows on the far left and far right of the two sets of doors (with possibly a third window occupying the area between sets of doors). However, the plan view shows only doors, and no sidelight windows. Sidelight windows should flank each set of double doors or be eliminated completely. Please clarify.

SIDELIGHT WINDOWS FLANKING EACH SET OF DOUBLE DOORS ON THE HOTEL WERE ADDED AS DETAILED ON THE REVISED PLAN AS SUGGESTED BY THE HPC.

Illustration D.2. — The south elevation (Sheet A-11) showing proposed double set of double ½ doors, with non-conforming single side-light windows to the left and right.

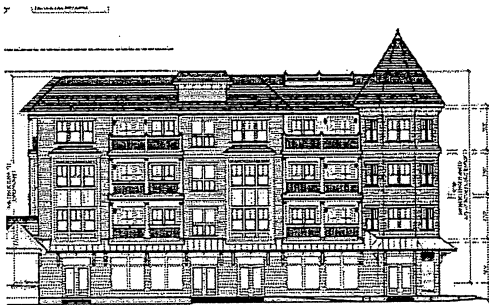
**D.4. — Condominiums:** The east elevation of Building One show single balcony doors flanked by single sidelight windows. Single sidelight windows are inappropriate. These doors should match the single doors found elsewhere on Building One and Building Two. **NOTE: 3 June 2022 Summary of Changes: *Sidelights removed on porches/balconies. Single french door centered in each bay with a single light fixture located on the latch side of the door.***

Illustration D.4. — East elevation of Condominium Building One (Sheet A-5) showing single balcony doors with non-conforming single side-light windows on each of the six balconies. These balcony doors should match single balcony doors on other elevations and should not include side-light windows.

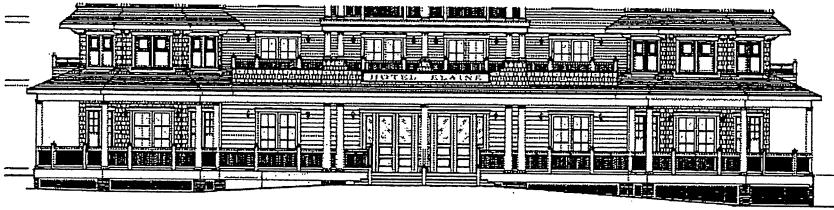
E.3. — **Hotel:** Proposed first-floor windows are 6/1, Colonial Revival style. Such windows have no correlation to a Queen Anne design and fall outside the period of significance. Windows with a 2/1 pane configuration are more appropriate. (See Guidelines, page 18, 5: "Retain or replicate the glazing configuration(s) as per the original or otherwise determined to be historically appropriate...") **REVISED PLANS SHOW 6/1 DOUBLE-HUNG WINDOWS ON FIRST FLOOR REPLACED WITH 2/1 DOUBLE-HUNG WINDOWS.**

Illustration E.3.a. — First-floor, south elevation of the Hotel showing inappropriate Colonial Revival windows (Sheet A-11).

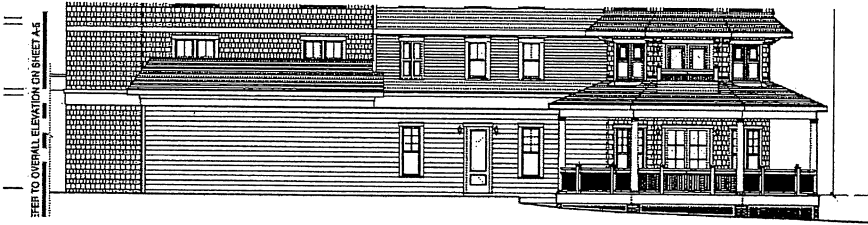
Illustration E.3.b. — First floor, west elevation of the Hotel showing inappropriate Colonial Revival windows (Sheet A-12).

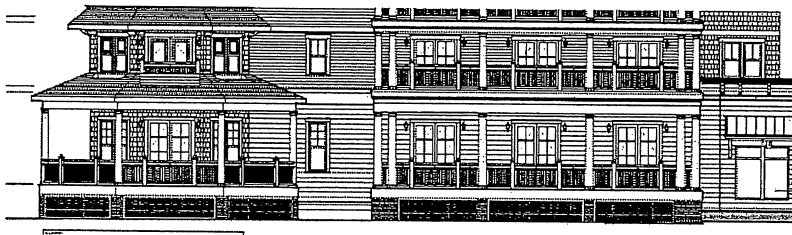
Illustration E.3.c. — First floor, east elevation of the Hotel showing inappropriate Colonial Revival windows (Sheet A-12).

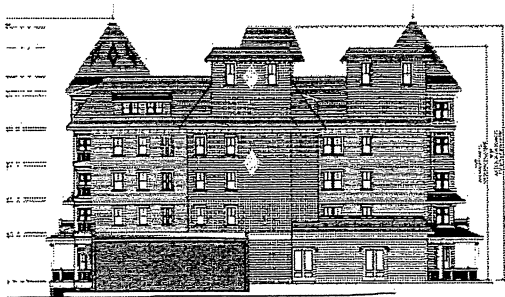
E.5. — **Hotel:** The fifth-floor stair tower, north elevation, should have a third window (or shuttered window) in order to maintain the rhythm of the fenestration.

THIRD WINDOW ADDED ON REVISED PLAN PER RECOMMENDATION OF HPC.

Illustration E.5. — North elevation of Hotel (Sheet A-12), showing upper staircase towers with two windows each.

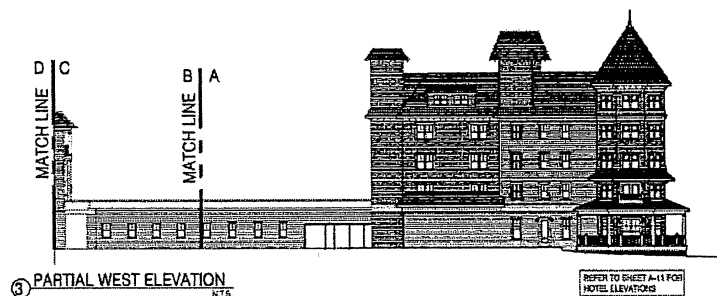
E.6. — **Retail:** Sheet A-5 show single 2/1 windows along the west elevation of the Retail spaces. Are these windows placeholders? Are rear access doors proposed for Retail shops?

REVISED PLANS SHOW DETAILS OF WINDOWS AND DOORS ON RETAIL SPACES. REAR ACCESS DOORS ADDED.

Illustration E.6. — West elevation showing proposed rear fenestration of Retail shops (Sheet A-5).

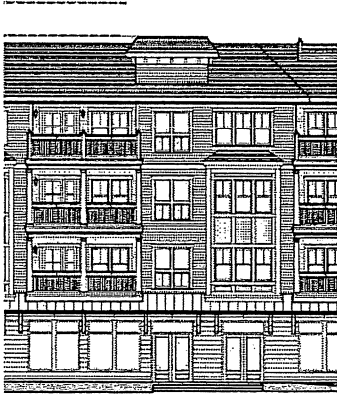
E.7. — **Condominiums:** On the east elevation of Building One, a stack of double windows in the stairwell are configured in such a way as to appear to be 1/2. This oddity gives the impression that 2/1 windows, evident elsewhere on the elevation, have been installed upside down. If these are proposed awning windows, awning windows are not appropriate to a Queen Anne design. Tech suggests a conforming solution be developed to replace this fenestration.  
NOTE: 3 June 2022 Summary of Changes: *East Elevation: Smaller proportioned windows in the stair tower were removed and replaced with double hung windows to match adjacent windows.*

CHANGE MADE AS NOTED.

Illustration E.7. — Detail of staircase windows (center) configured in such a way as to suggest 2/1 windows have been installed upside down (Sheet A-5).

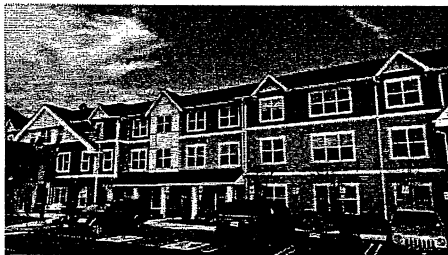
E.8. — **Condominiums:** Building One and Building Two include stacks of double and triple windows characteristic of modern fenestration patterns (see reference photo, below). Such modern window patterns are non-historic and lead to a “wall of windows” designs. Historic windows employ wider mullions and are only occasionally doubled. The south elevation of Building One employs double sets of stacked triple window above the main entrance (and elsewhere). Triple windows are historically inappropriate to the period of significance.

Illustration E.8.a. — Reference photograph showing modern double and triple window fenestration as found in a non-historic area residential structure. Note the use of a standing-seam roof in this contemporary example.

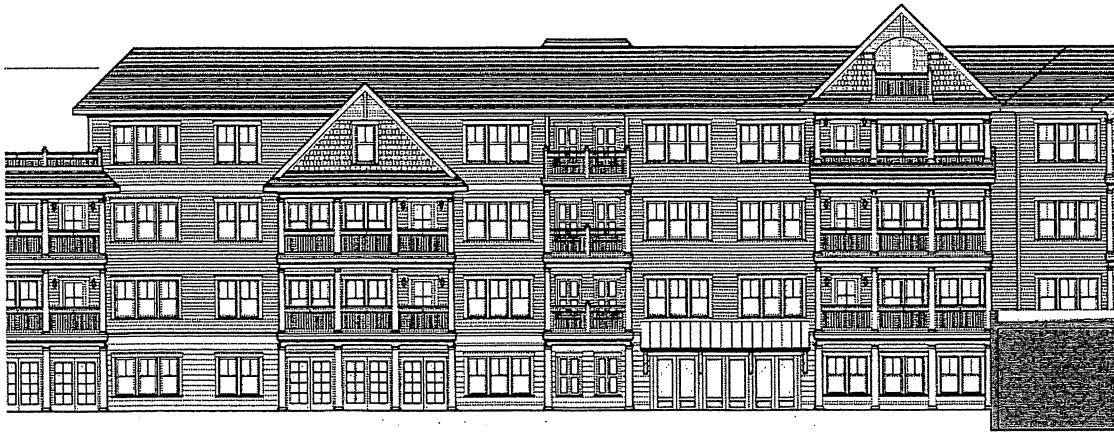
ON THE REVISED PLANS FOR SETTLEMENT, ALL OF THE NORTH AND SOUTH ELEVATION TRIPLE WINDOWS WERE SEPARATED INTO THREE INDEPENDENT WINDOWS. EACH WINDOW WAS MADE NARROWER AND LONGER WITH SIDING AND TRIM INSTALLED BETWEEN EACH WINDOW.

Illustration E.8.b. — Detail of south elevation of Condominium Building Two showing stacked courses of double and triple windows in non-historic fenestration patterns.

E.11. — **Condominiums:** Overall, Tech found the Condominiums to be overly, and inappropriately fenestrated, creating “walls of windows” that prioritize views from the interiors of the buildings over historically appropriate design of the exterior of the buildings. This disregard for historically appropriate window placement conflicts with the requirements of the Guidelines. Efforts should be made to amend the fenestration to bring it into conformity with historic precedence. **SEE CHANGES IN E-8, E-9, E-10 AND E-11.**

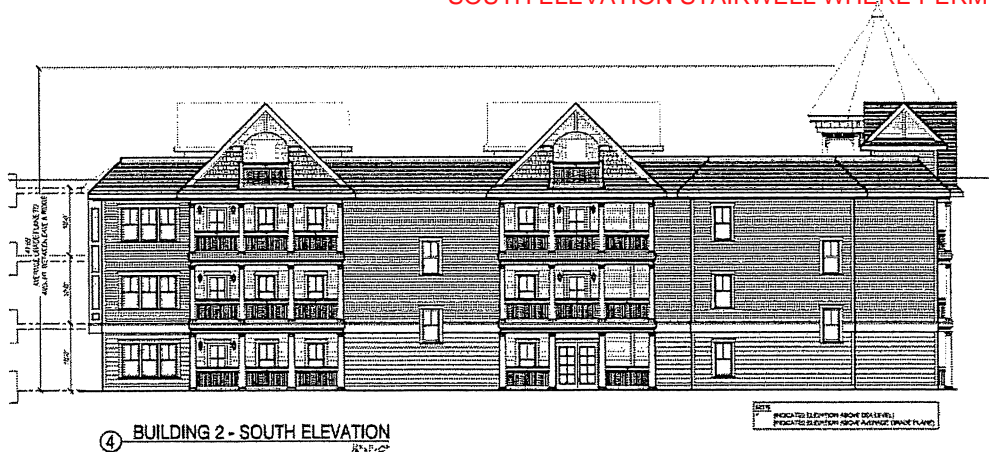
④ BUILDING 2 - SOUTH ELEVATION  
8'-0" x 10'-0"

E.9. — **Condominiums:** Likewise, Building Two includes stacks of double the triple windows on the east, north, and part of the south elevations. However, elsewhere the fenestration appears oddly minimal. This is especially obvious on the south elevation walls: one is blank, save for two off-center stairway windows, the other is mostly blank with two stairway and three regular windows, set with peculiar spacing.

ON THE REVISED PLANS FOR SETTLEMENT, WINDOWS WERE ADDED ON THE SOUTH ELEVATION STAIRWELL WHERE PERMISSIBLE BY FIRE CODE.

Illustration E.9. — South elevation of Condominium Building Two showing oddly spare single-window fenestration (Sheet A-8).

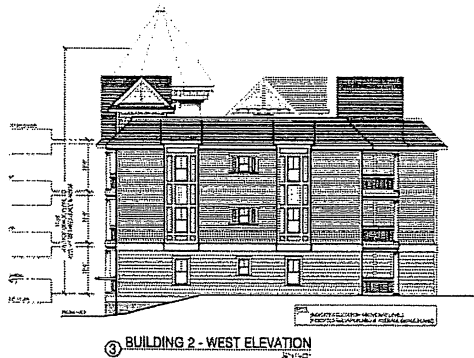
E.10. — **Condominiums:** Tech found the west elevation of Building Two particularly unsuccessful with two floating projections hanging down from shed roofs. These projections end abruptly above single windows at the first story. The projections include single windows on each floor (with the rest of the projection covered in vertical-paneled frames). Single windows on projections of this type are non-historic. In the center of the west elevation are three under-sized windows: one with traditional trim, the other two flanked by more panels and extended crowns. The west elevation will be prominent not only to residents in properties to the west of the development and pedestrians walking along Wesley Lake, but also to traffic traveling east down

ON THE PLANS FOR SETTLEMENT, "FLOATING" PROJECTIONS ON THE WEST ELEVATION WERE REMOVED BY FILLING IN THE FLOOR PLAN WITH ANOTHER LEVEL OF BAY WINDOWS DOWN TO GRADE LEVEL.

Lake Avenue on the Asbury side of Wesley Lake. Tech considers this elevation under-designed, un-historic, and in need of redesign.

Illustration E.10. — West elevation of Condominium Building Two (Sheet A-8).

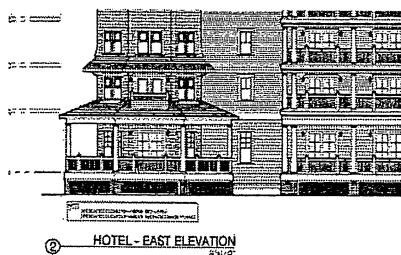
F.1. — **Hotel & Condominium Siding.** The Plan proposes cladding the Hotel with Hardie Plank with two different clapboard reveal dimensions: wide on the first story and narrower on the upper stories. Mixing clapboard reveal sizes is sometimes found on historical examples, but only rarely, and only to highlight important architectural features. No such highlighting of architectural features is present in the proposed Plan. Uniform dimensions of clapboard reveals should be used, instead.

**PLANS FOR SETTLEMENT SHOW CLAPBOARD REVEAL CONSISTENT ON ALL ELEVATIONS.**

Illustration F.1.a. — East elevation of the Hotel showing proposed clapboard reveal at first floor (wide) and upper floors (narrow) (Sheet A-11).

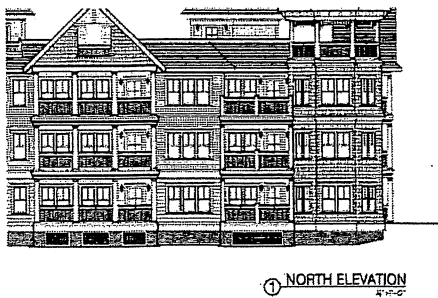
Illustration F.1.b. — North elevation of Condominium Building One showing proposed clapboard reveal at first floor (wide) and upper floors (narrow) (Sheet A-6).

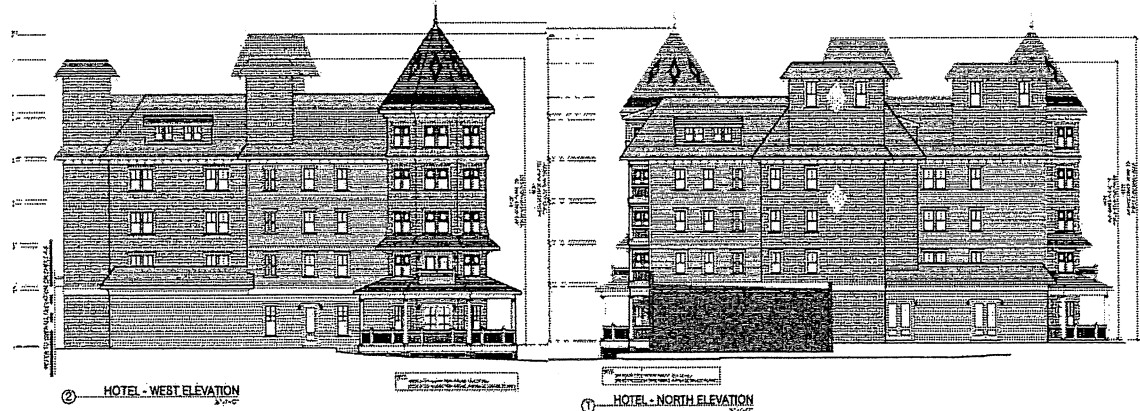
F.2. — **Hotel: Siding.** Cladding the two hotel towers in shakes seems appropriate. However, elsewhere on the Hotel shakes are applied in unusual and confusing locations, including on the rear of the building (as seen on the north and west elevations), and on the two staircase towers. Cladding prominent and important projections, such as inset-balcony stacks and towers, might make sense. However, the over-use of shakes on secondary elements is inappropriate, detracts from more important projections, and is not in keeping with the Queen Anne design.

ON THE SETTLEMENT PLANS, THE SHAKES WERE REMOVED FROM ALL EXTERIORS EXCEPT FOR THE HOTEL TOWERS AND PROMINENT AND IMPORTANT PROJECTS SUCH AS INSET BALCONY STACKS AND STAIR TOWERS.

Illustrations F.2.a. and F.2.b. — The west and north elevation of the Hotel showing secondary planes covered in shingles (Sheet A-12).

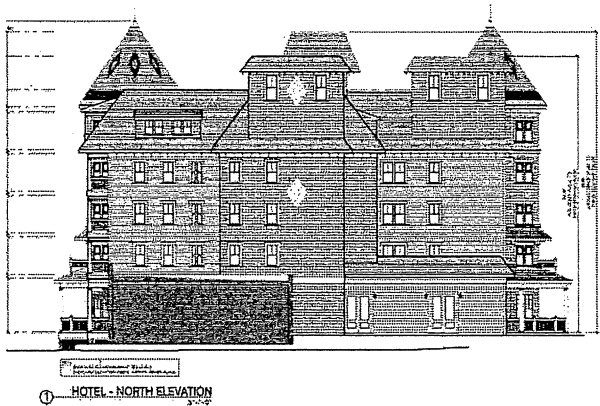
F.4. — **Hotel: Siding.** At the north elevation two “diamond” details are indicated in the proposed shakes. The size of the diamonds is excessive and the location awkward: in the fifth story staircase tower the diamond appears crowded and crammed near the roofline; on the blank wall further down the tower, the diamond is oddly aligned and oversized. Both diamonds should be eliminated or reconsidered in more historic scale and placement. **NOTE: 3 June 2022 Summary of Changes: North Elevation. Reduced the size of the diamond shingle pattern by 20%.**

**CHANGE MADE AS NOTED.**

Illustration F.4. — North elevation of the Hotel showing over-sized diamond patterns in shingled cladding. (Sheet A-12).

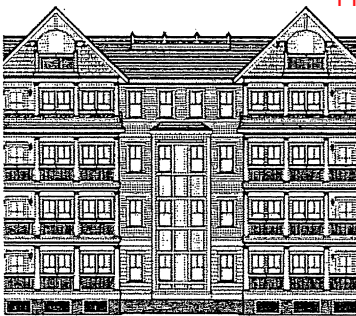
F.5. — **Condominiums:** Projections on the Condominiums rely heavily on framed panels situated beneath and beside windows. These panels are filled with vertical boards. While projections on Queen Anne structures may include panels, they are typically used sparingly and do not contain vertical paneling. Vertical paneling of this sort is a modern decorative technique and should be removed. **ON THE PLANS FOR SETTLEMENT, THE VERTICAL BOARD PANELING WAS REMOVED FROM WINDOWS.**

Illustration F.5.a. — Detail of north elevation, Condominium Building One showing paneled areas between windows on projection between balconies (Sheet A-6).

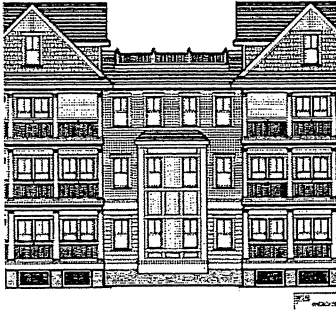
Illustration F.5.b. — Detail of north elevation, Condominium Building Two, showing paneled areas between windows on projection between balconies (Sheet A-8).

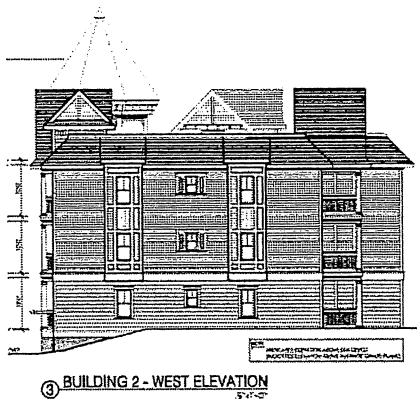
Illustration F.5.c. — Detail of west elevation, Condominium Building Two, showing paneled areas between windows on projections (Sheet A-8).

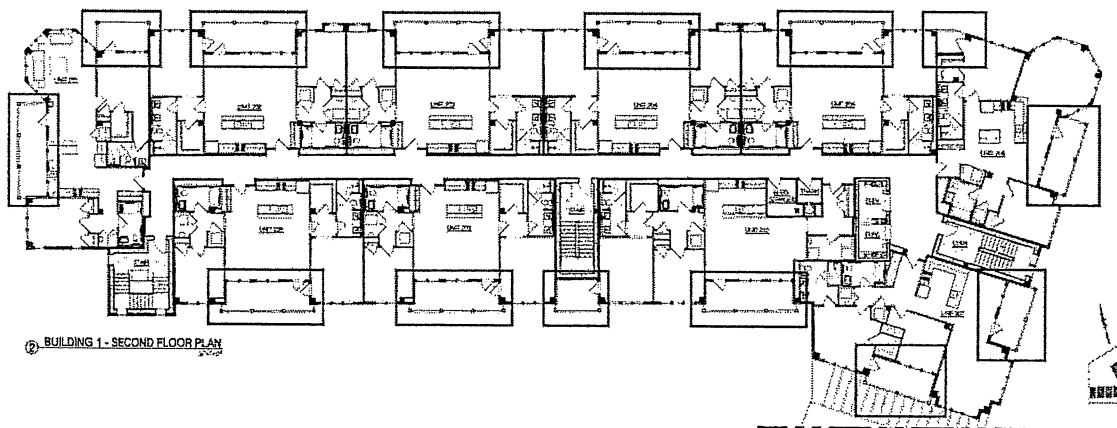
Illustration G.4.a. — Second floor plan of Condominium Building One showing hybrid inset balconies at all four elevations (Sheet A-2).

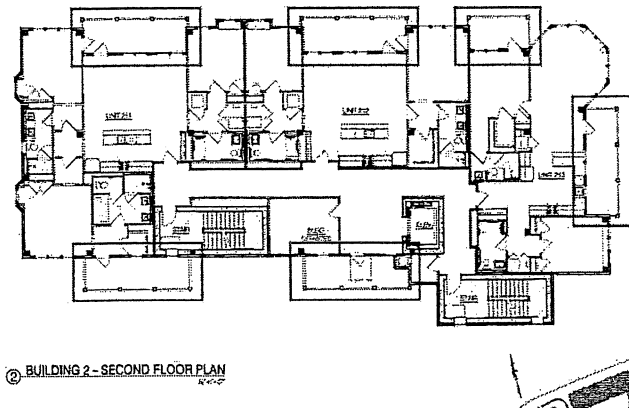
Illustration G.4.b. — Second floor plan of Condominium Building Two showing hybrid inset balconies along the north, south, and east elevations (Sheet A-7).

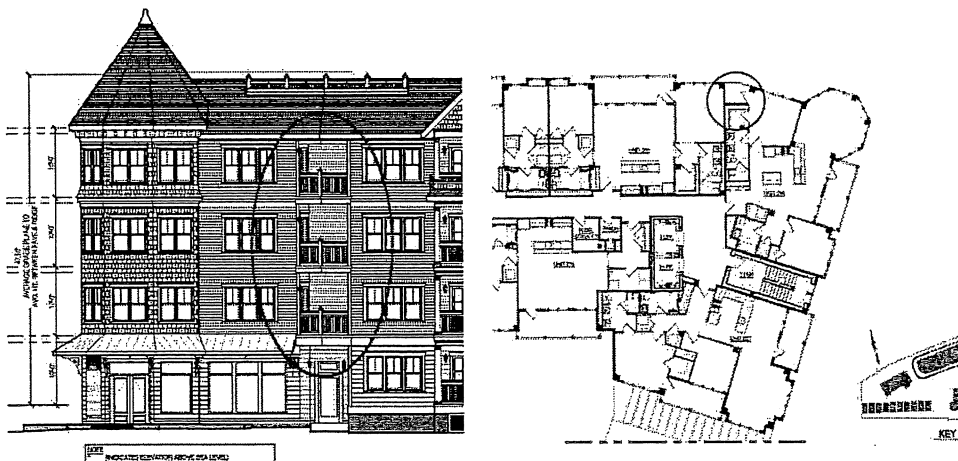
G.5. — **Condominiums:** At the north elevation, just west of the Building One tower, above the north access door, are a row of inset-balconies. These balconies occur at the point where the building jogs southwest along Wesley Lake. These balconies are five-sided, due to a bend in their railings, have no windows, single doors, and no lighting. They are non-historic in character, awkward in size and placement, and differ in every way from any other balcony in the project. Tech recommends they be reconsidered or eliminated. NOTE: 3 June 2022 Summary of Changes: *Shutters added at inset balcony on the North East corner.*

CHANGE MADE AS NOTED.

Illustrations G.5.a. and G.5.b. — Detail of northeast corner of Condominium Building One showing windowless mini-balconies above the north building access door (Sheet A-6). These balconies are circle in the second-floor plan, at right (Sheet A-2).

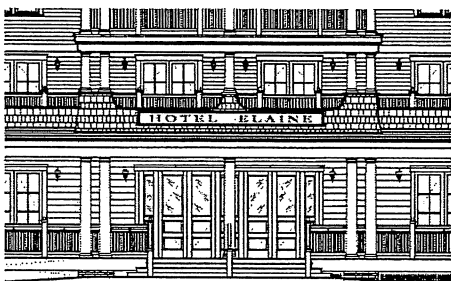
H.1. — **Hotel:** The main entrance stair of the Hotel is bisected by a singled porch column yet flanked by double porch columns. Elimination of the single column is recommended to better frame the entrance. **SINGLE COLUMN REQUIRED FOR STRUCTURAL SUPPORT. NO CHANGE MADE.**

Illustration H.1. — Hotel entrance flanked by double columns with single column bisecting the entry area (Sheet A-11).

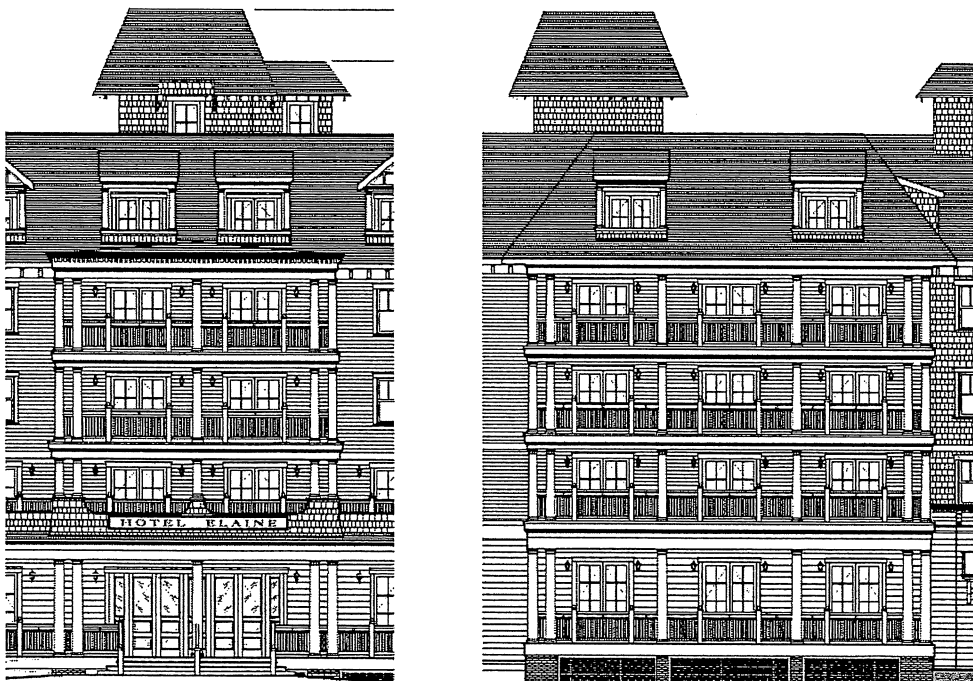
H.2. — **Hotel:** Across the south and east elevation of the Hotel there is an unusual reliance on double-columns. These are paired with single columns and interstitial newel posts in ways that create non-rhythmic spacing of vertical elements. This spacing disrupts in a way that is atypical of historical hotels and boarding houses in Ocean Grove. “Mini” columns at the fifth story (south and east elevations) add to the inharmonious effect. **DOUBLE COLUMNS TO REMAIN ON THE HOTEL, BUT ON THE PLANS FOR SETTLEMENT, THE COLUMNS ON THE 5TH FLOOR WERE REPLACED WITH BRACKETS.**

Illustration H.2.a. and H.2.b. — Details of the balcony stacks at the south and east elevation of the Hotel showing double and single columns and newels (Sheet A-11).

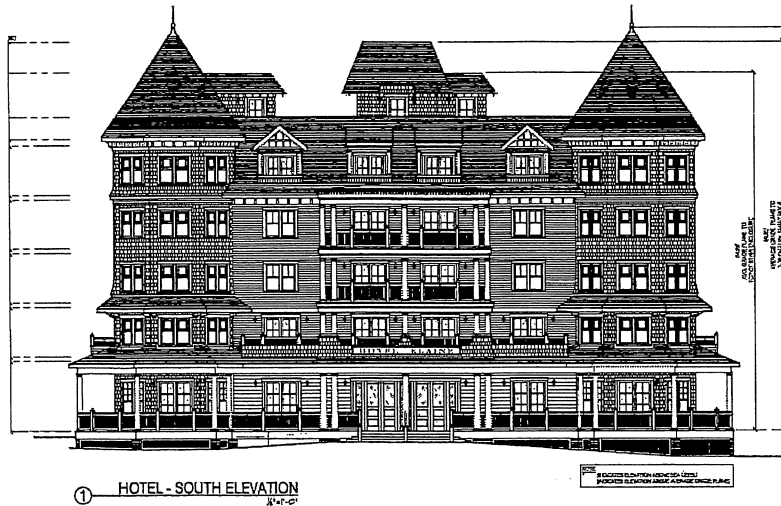
H.3. — **Hotel:** Diamonds and banding on tower roofs is over-scaled. **AS STATED ABOVE, DIAMOND SHINGLE PATTERN REDUCED BY 20%.**

Illustration H.3. — Roof tile patterns showing oversized diamonds and banding (Sheet A-11).

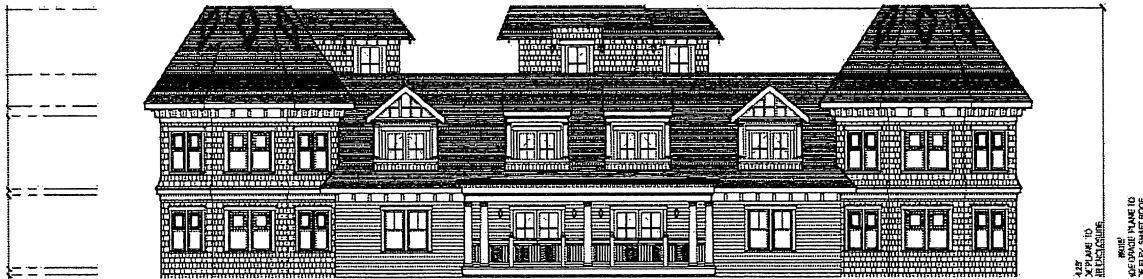
H.5. — **Hotel & Condominiums.** Turned and chamfered columns are more typical of Queen Anne designs than Tuscan columns. Turned columns were suggested to OGNED during Tech.

NO CHANGE MADE. TURNED COLUMNS DO NOT PROVIDE THE STRUCTURAL SUPPORT REQUIRED FOR THIS TYPE OF STRUCTURE.

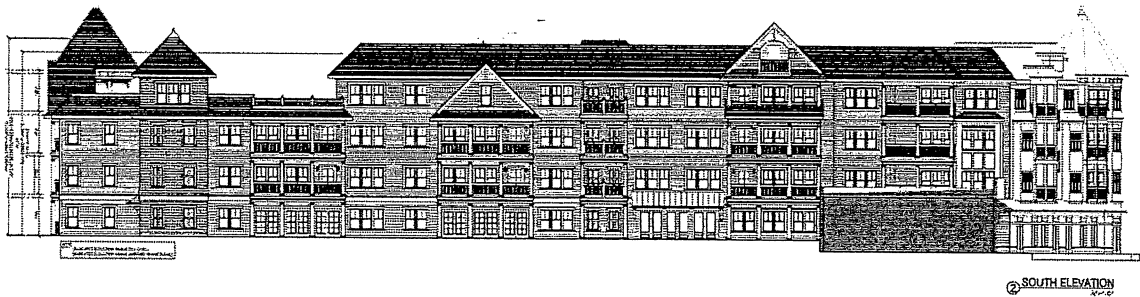
H.7. — **Condominiums:** The south elevation of Building One shows twelve (12) Tuscan columns sitting on tori without plinths. This irregularity also occurs on the west elevation of Building One. It may also exist at the east and south elevations of Building Two. Please clarify.

ON THE PLANS FOR SETTLEMENT, COLUMN PLINTHS ADDED TO ALL COLUMNS.

Illustration H.7. — South elevation of Condominium Building One showing Tuscan columns without plinths at the first floor (Sheet A-6).

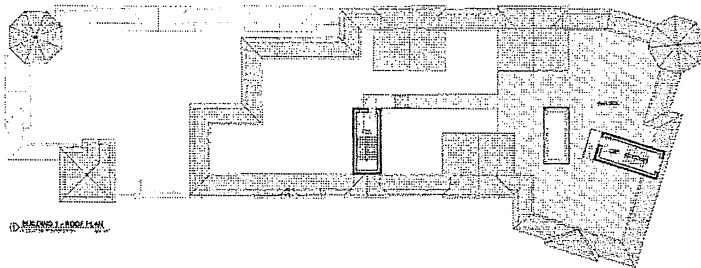
H.8. — **Condominiums:** Are railings proposed for the rooftop pathway and roof deck of Condominium Building One? Please provide cat/cut for review. **RAILING DETAIL FOR ROOFTOP PATHWAY AND ROOF DECK ADDED TO PLANS FOR SETTLEMENT.**

Illustration H.6. — Plan showing proposed Condominium Building One roof path and roof deck (Sheet A-4).

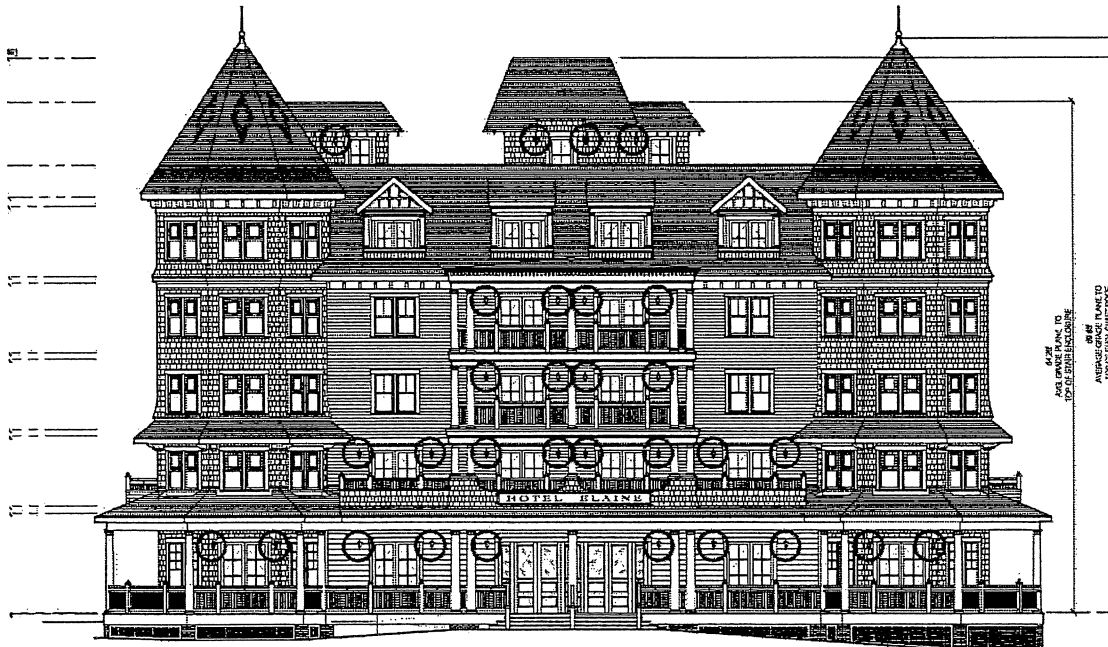
I.4. — **Hotel:** The south elevation of the Hotel indicates thirty (30) lanterns, including four on the roof projections, with an additional twenty-eight (28) lanterns on the east elevation, facing the boardwalk. In contrast, the west elevation shows only six (6) lanterns. Tech considers the number of proposed lights excessive to a degree that is typically modern and recommends that lighting at the south and east elevations be reconsidered. NOTE: 3 June 2022 Summary of Changes: *Revised detailing at roof-top dormers. Half-size columns removed and replaced with large brackets. Dormer roof changed from shed to gable to accommodate the revised detailing. Dormer width enlarged to accommodate (1) wall lantern on each side of the doors.*

CHANGE MADE AS NOTED.

Illustration I.4.a. — South elevation of the Hotel showing thirty (30) proposed lantern fixtures (Sheet A-11).

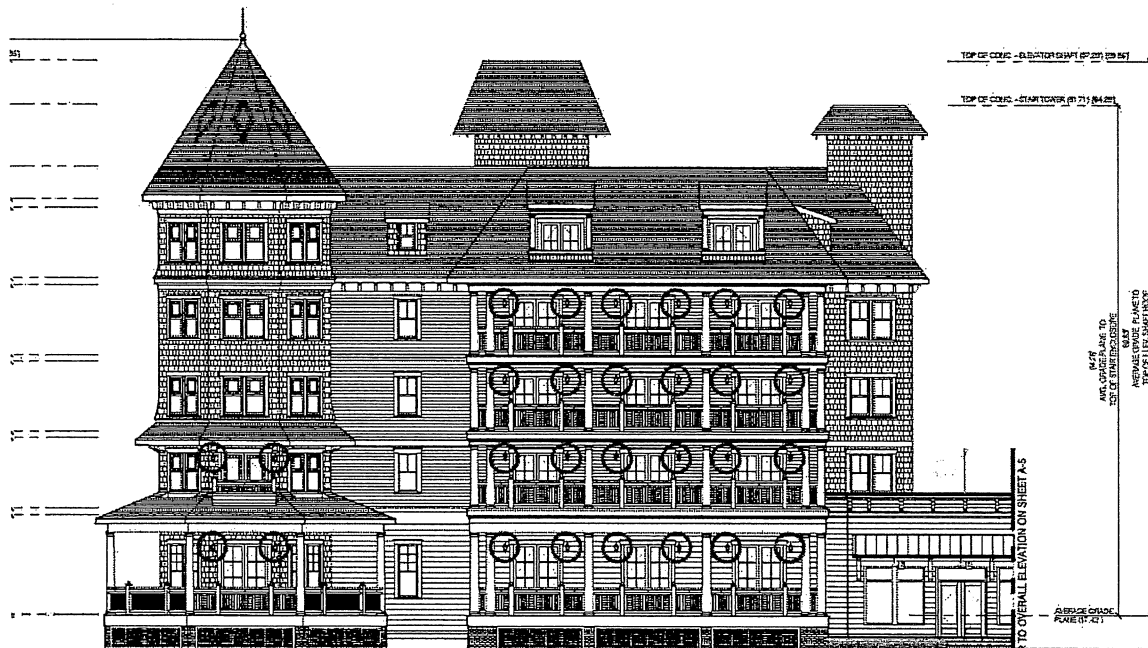
Illustration I.4.b. — East elevation of the Hotel showing twenty-eight (28) proposed lantern fixtures (Sheet A-11).

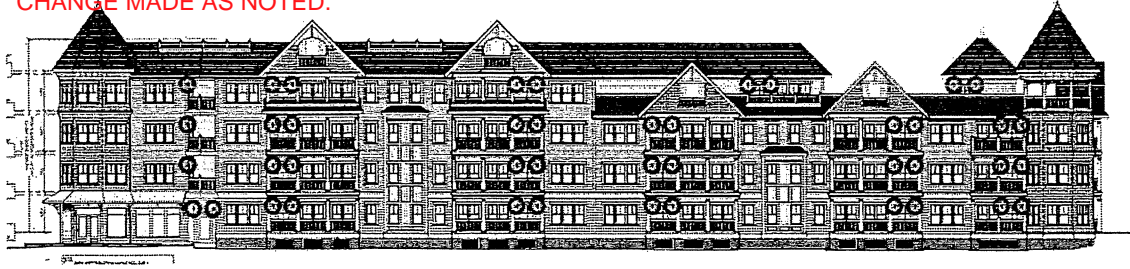
Illustration I.8.a. — North elevation of Condominium Building One showing lighting (most of which entails two light fixtures flanking single doors onto balconies) (Sheet A-6).
