## **APPENDIX A**

13 April 2022 (These notes were amended 6 June 2022 to reflect changes made by the applicant subsequent to the 19 April meeting. See Notes on pages 2, 3, 9, 10, 12, 15, 17, 22, 25, 29 & 30.)

Following OGNED's meetings before the Historic Preservation Commission (HPC) on 6 & 27 April 2021, three members—Deborah Osepchuk, Lucinda Heinlein, and Jeffery Rudell—were asked by Bernie Haney, to meet and offer feedback to the development team on ways their application (the Plan) could be brought into conformity with the Architectural Design Guidelines (Guidelines). These meetings were similar to the informal weekly Tech Review meetings available to all applicants to the HPC.

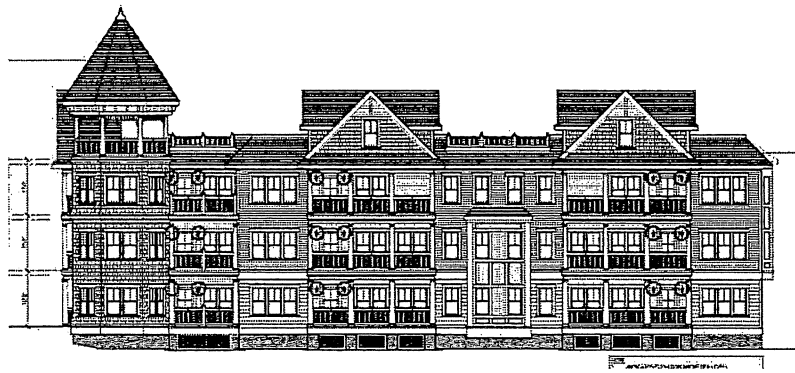
Illustration I.8.b. — North elevation of Condominium Building Two showing lighting (all of which entails two light fixtures flanking single doors onto balconies) (Sheet A-8).

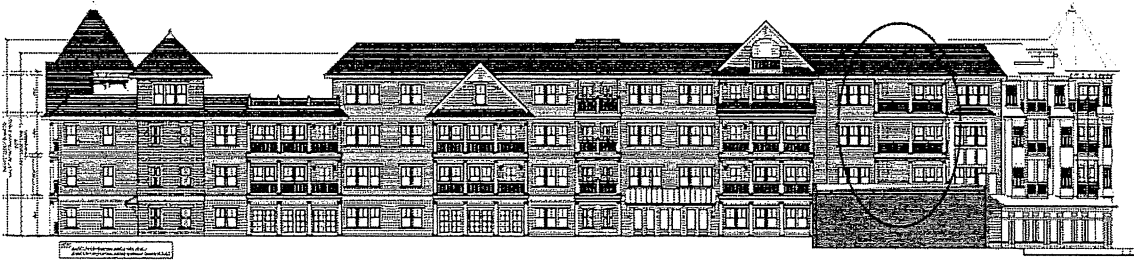
Illustration I.10. — South elevation of Condominium Building One showing balconies with no lighting indicated.

I.10. — **Condominiums:** The lighting, while excessive, also appears inconsistent (e.g., no lighting is indicated on Condominium Building One, south elevation, in the stack of balconies directly above the Retail space).

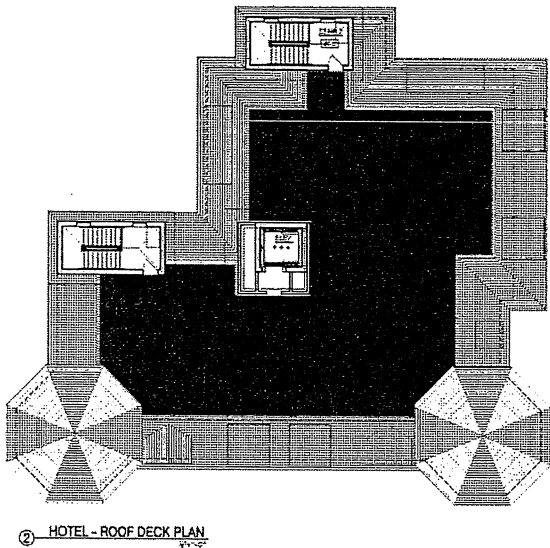
Illustration N.1.a. — Proposed coverage of Hotel Roof deck (emphasis added) (Sheet A-10).

N.1. — **Roof Decks.** The Hotel & Condominium Building One each have large-scale, public roof decks. Condominium Building Two has three private roof decks. Roof decks are non-conforming with the Guidelines. The roof decks proposed are visible in so far as railings and balusters along the parapet provide “viewing platforms” (some beneath the proposed faux-gables). These breaks in the parapet reveal the presence of the roof decks. There is a reasonable expectation that appurtenances related to roof decks (umbrellas, tents, pergolas, rooftop plantings, lighting, etc.) will further reveal the presence of these roof decks atop these buildings. (See, Guidelines, page 27, Section N, “Roof top construction featuring sun decks, swimming pools, and hot tubs are not in keeping with the designs of the Victorian Era nor other historic styles of architecture within the Ocean Grove Historic District. Therefore, such features will be viewed contrary to the “Spirit” of the architectural setting. Introduction of any such feature must fully demonstrate that such a feature would be designed so as not to be visible to public view...”)

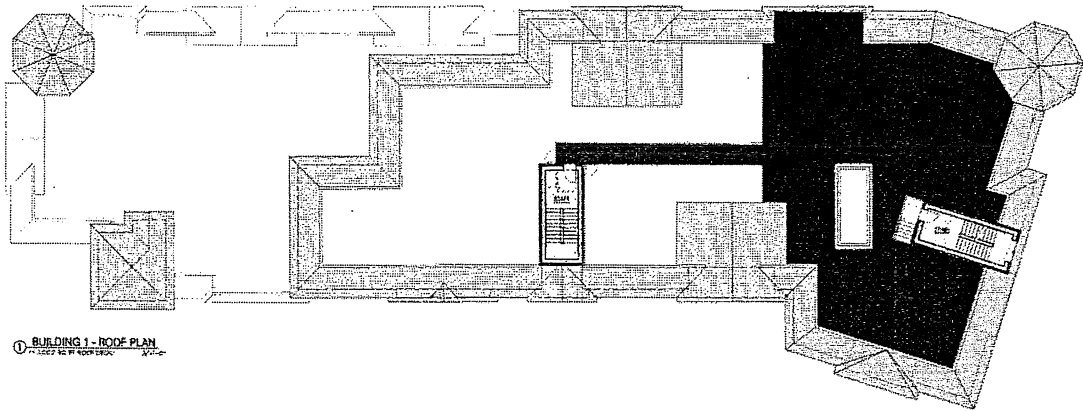
Illustration N.1.b. — Proposed coverage of Condominium Building One east roof deck (color added) (Sheet A-4).

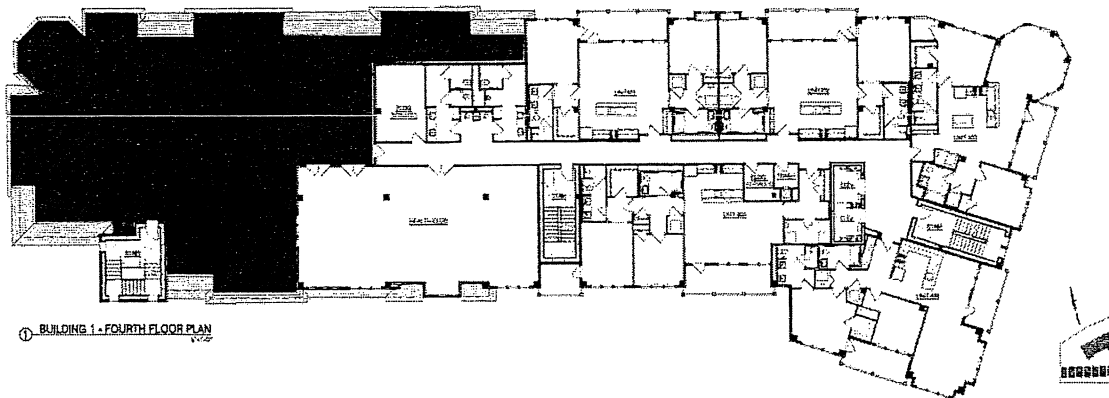
Illustration N.1.c. — Proposed coverage of Condominium Building One west roof deck (color added) (Sheet A-3).

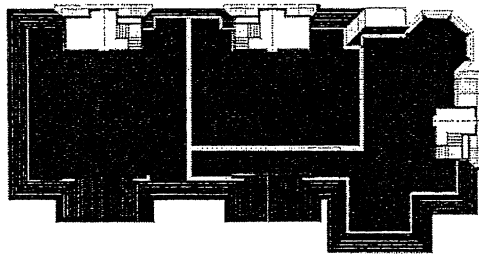
Illustration N.1.d. — Proposed coverage of Condominium Building Two, three private roof decks (color added) (Sheet A-7).

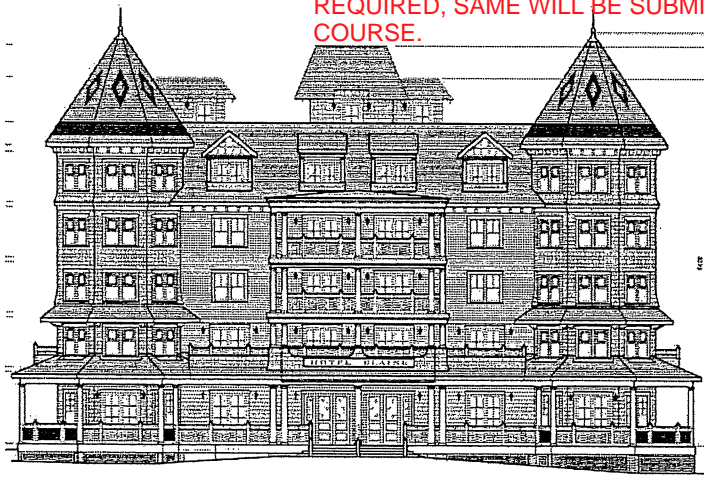
Illustration P.1. — South elevation of the Hotel showing proposed signage (Sheet A-11).

P.1. — No signage schedule was submitted for review by Tech. Excluding the name of the Hotel, which appears on the south elevation (see illustration, below) the current Plan is missing any indicators of type, style, or location of signage on, or around, any of the proposed structures. (See, Commercial Guidelines, Section Q, pages 20-23, "Signs are one of the most prominent visual elements on the street and define the purpose of a building. If designed, signs add interest and variety to the streetscape and building facade while enlivening the street scene. Poorly conceived signs may also detract from the architecture and negatively impact even the best designed storefront...).
