Skystream 3.7

Maintenance, Troubleshooting and Service Guidelines

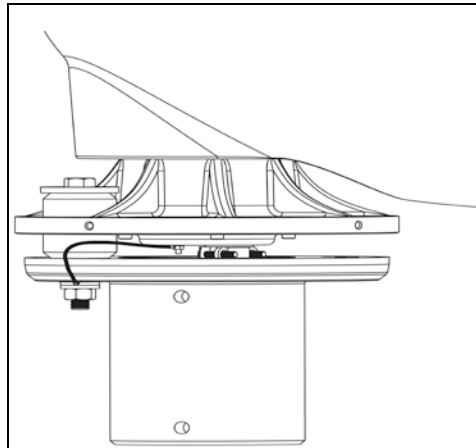
Figure 1

- Check ground lead coming from the yaw terminals of the turbine (the turbine must be grounded to the tower as depicted in Figure 1).

- Verify Skystream is grounded to the tower by measuring resistance between the nacelle (use an unpainted bolt head in the case of marine units) and the tower flange. The resistance must be < 1 ohm.
- Reinstall the yaw shield and secure the fasteners.
- Check that the hatch cover bolts are tight. Bolts should be tightened to 60 in lb (7 N-M). NOTE: Bolts shall not be loosened; only checked that they are at least the specified torque.

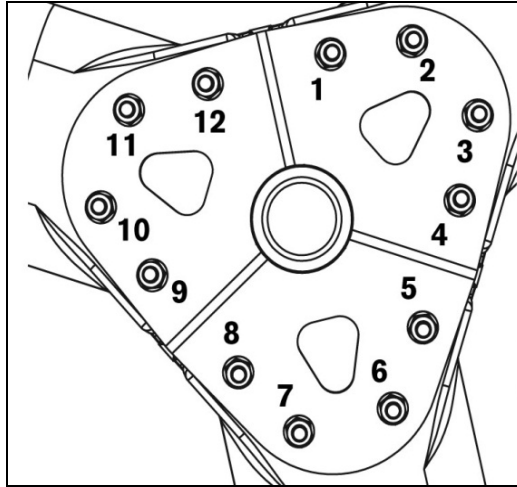
Figure 2

- Check the RF antenna for tightness on nacelle fitting. Fingertight is sufficient.
- Remove the nose cone. Inspect the rotor blades for possible cracking, chipping, flaking or other signs of abnormal stress particularly along the edges of the blades. Very small cosmetic damage is not of concern, but any damage that changes the shape of the blade in any way is cause for shutting turbine down until blade set can be replaced.
- Check "tip to tip" distance (chord length) of each blade set to confirm it is within 1/2 inch (1.3cm) tolerance.
- Blade bolts should be torqued to 50 lb-ft (68 N-m). Follow sequence indicated in Figure 2. NOTE: Bolts shall not be loosened; only checked that they are at least the specified torque.

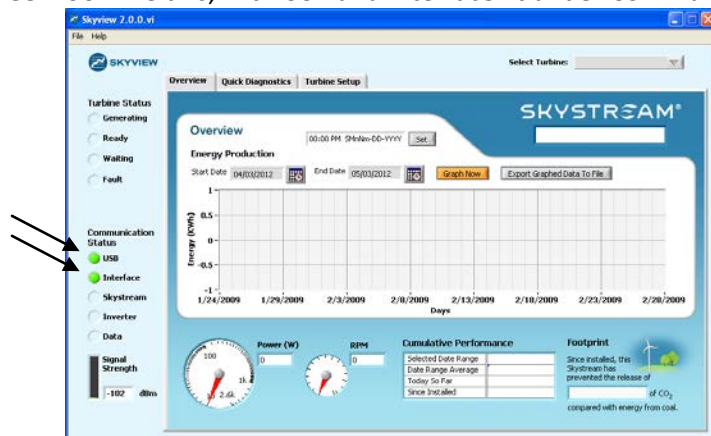
- Does your Skyview screen look like this, with USB and Interface lit under Communication Status?

If so, see Appendix B for Communication Tips and Tricks:

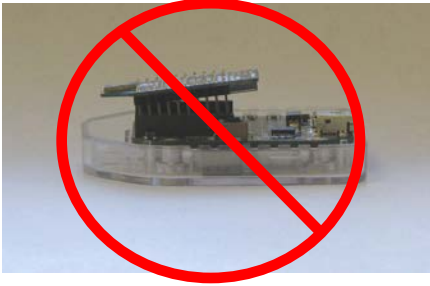
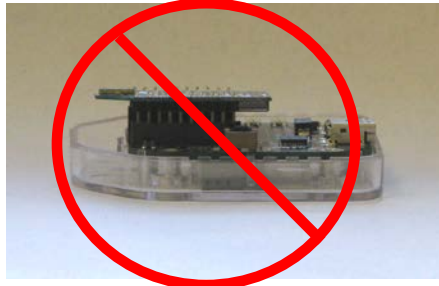
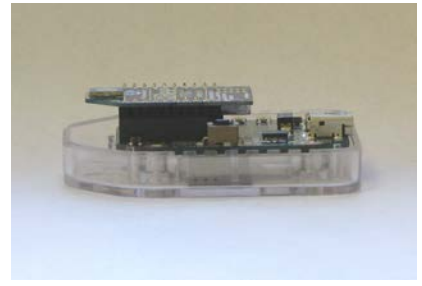
Appendix B - Down Tower xBee boards separated

1. Prior to approximately 2010, the two xBee boards in the down tower receiver could become separated.

If this has occurred, gently re-seat the boards by pushing them back together while observing anti-static protection.
