**To:** Cedar Lake Improvement Lake Board                      **Date:** March 13, 2015  
**From:** Brian Boyer, K&A    **cc:** File  
Mark Kieser, K&A  
**RE: 2014 Cedar Lake Groundwater/Surface Water Database Updates**

### *Program Background*

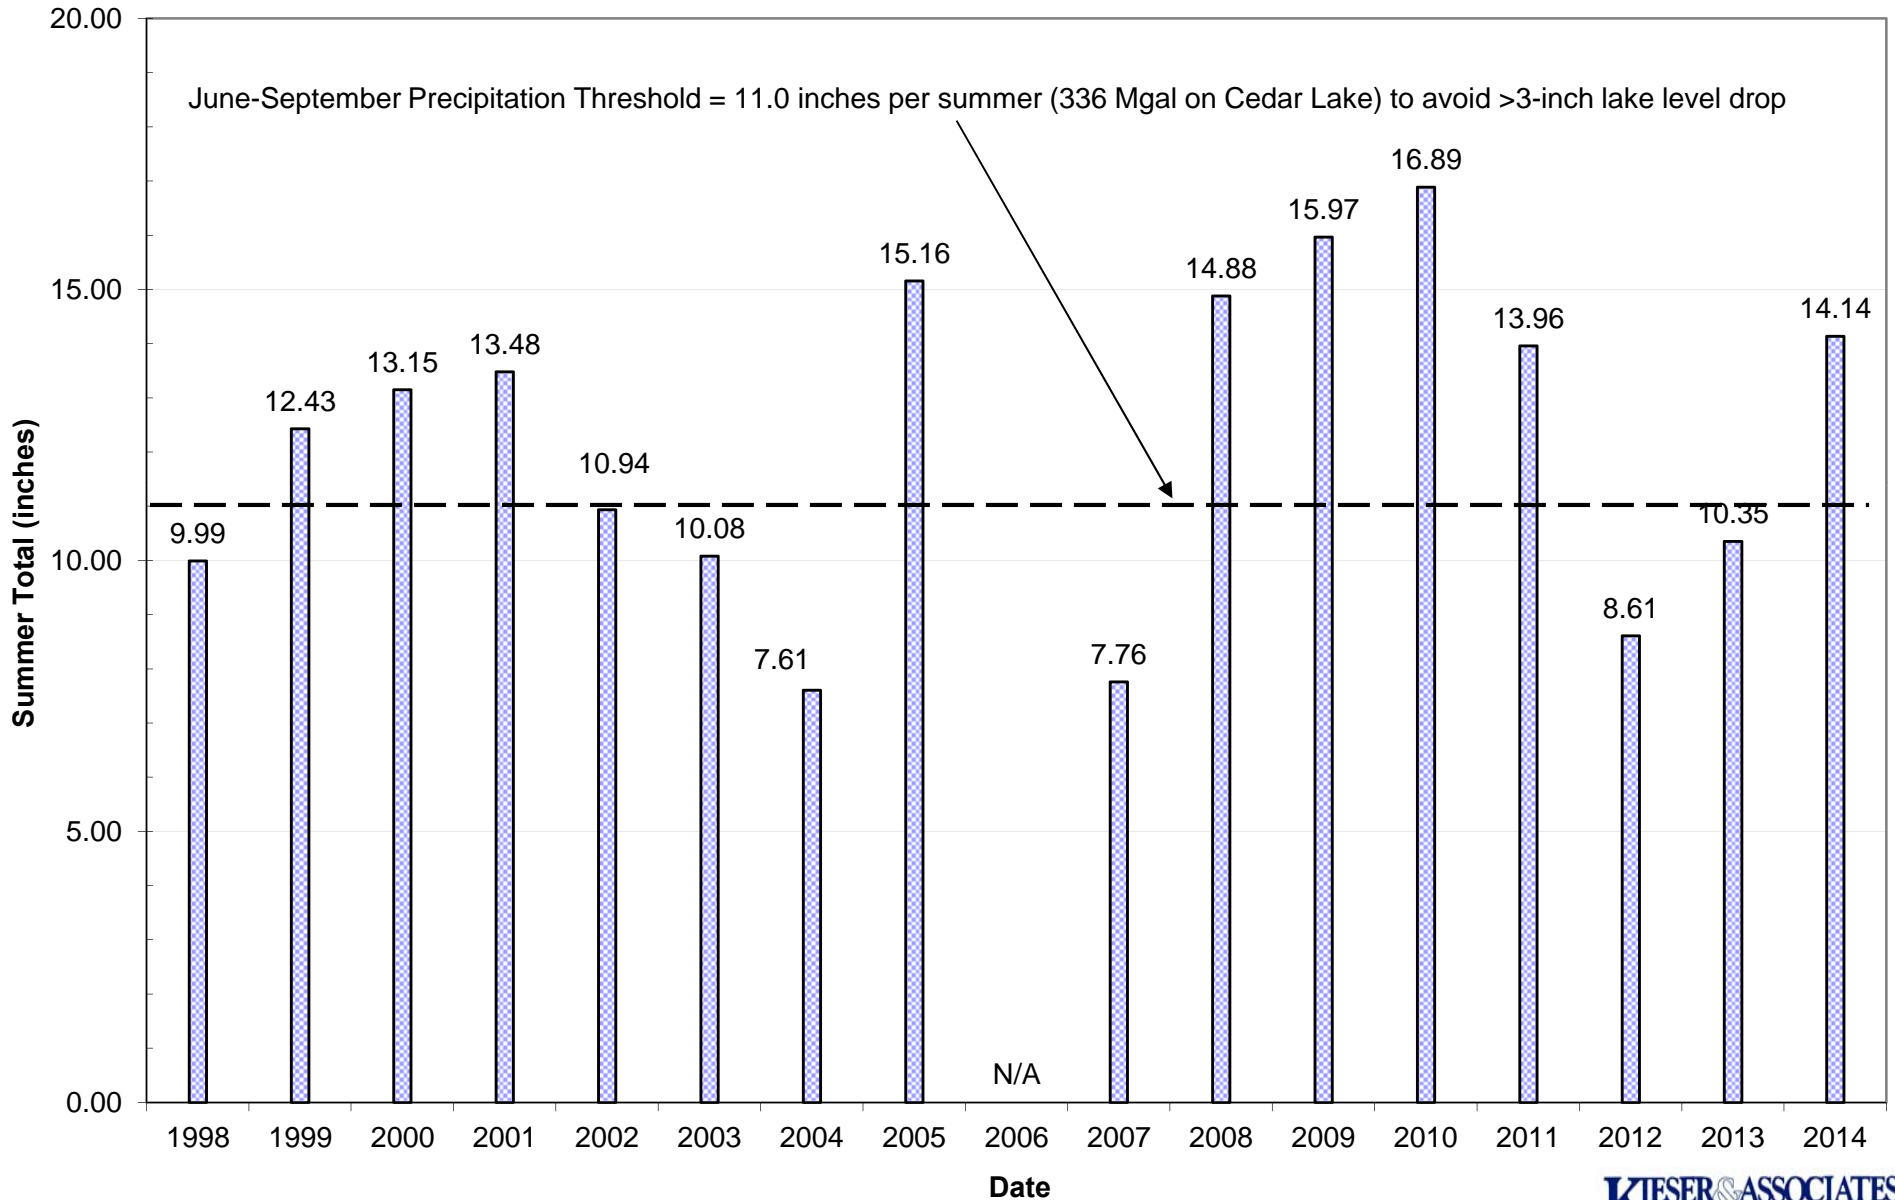
### Figure 13. Summer (Jun - Sept) Precipitation Totals for Cedar Lake

(Precipitation Source: Harrisville, MI, CO-OP Station #203628,  
Alcona County Cedar Lake Rain Gauge,  
Oscoda, MI Oscoda Wurtsmith Airport Station #14808, Iosco County)

Historic summer precipitation totals for the Cedar Lake area are presented in Figure 13. These data represent precipitation data available from the Harrisville, MI CO-OP Station (#203628), the Oscoda, MI Wurtsmith Airport Station (#14808), and a rain gauge installed at Cedar Lake and monitored by volunteers. Available rainfall data from 1998-2014 (no data for 2006) reflect a 16-year summer average (June-September) of 11.93 inches of rainfall. The observed 2014 rainfall data reflect an above-average year for rainfall, measuring over 14 inches during these summer months. The two previous summers (2012 and 2013) exhibited below-average summer precipitation amounting to 8.61 and 10.35 inches, respectively. The years 2008-2011 each had summer precipitation recorded above this recent average.

More importantly, with respect to rainfall, the Cedar Lake Augmentation Feasibility Study completed by K&A in 2011 revealed that in order to avoid water level decreases greater than 3-inches during the critical summer months (June-September), an average monthly rainfall of 2.75 inches would be necessary. In other words, if natural rainfall patterns result in less than 2.75 inches in a given summer month, a lake level drop of approximately 3 inches is to be expected. Likewise, the June-September target goal of 11 inches of rainfall (i.e., 2.75 inches multiplied by 4 months) can be used to assess each summer season as a whole. This target threshold is also plotted on Figure 13 for sake of comparison.

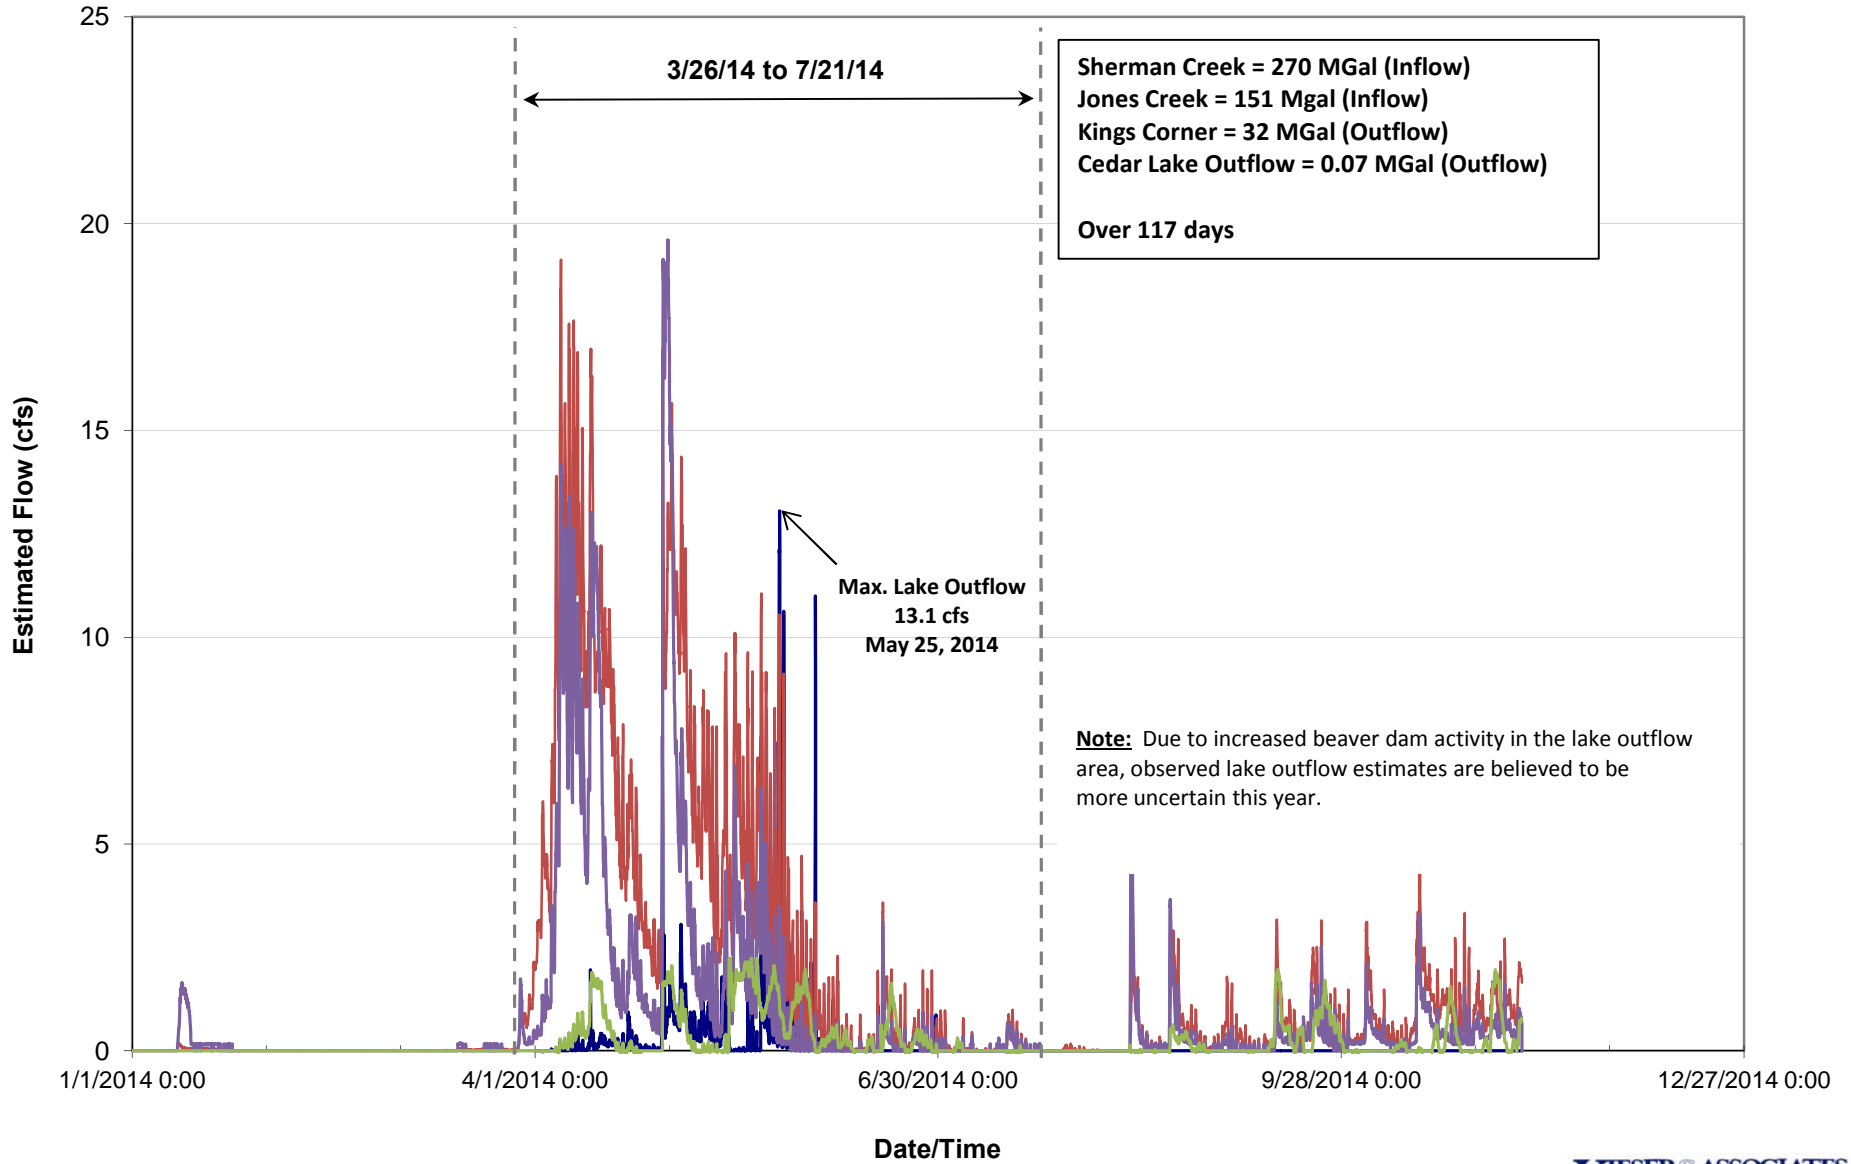
**Figure 19. 2014 Estimated Cedar Lake Inflows/Outflows**

— Lake outflow    — Sherman Creek    — Jones Creek    — Kings Corner

significant sources of incoming surface water flows to the lake from the wetland complex northwest of Cedar Lake. On the other hand, the King's Corner road culvert diverts water from the immediate watershed to the south toward Phelan Creek and Van Etten Lake, resulting in water loss from the Cedar Lake watershed. The two Cedar Lake outflow structures at the north end of the lake discharge to Lake Huron once water levels exceed the legal lake level. Figures 15-18 illustrate estimated surface inflows and outflows associated with Cedar Lake for spring and summer 2014 at these four monitoring locations. All flow monitoring data are derived from long-term water level stage-discharge relationships specific to each location. Flow data from all four of these critical locations were combined and plotted together as illustrated on Figure 19.

The Jones Creek and Sherman Creek monitoring data exhibit inflows of 151 and 270 million gallons (Mgal), respectively, into Cedar Lake from March 26-July 21, 2014 (refer to Figure 19). During the same time period, 32 Mgal flowed out of the Cedar Lake watershed via the King's Corner road culvert. Measured outflow volume leaving Cedar Lake totaled 0.07 Mgal during this time period. As noted on Figure 17, the magnitude of the recorded lake outflow (based on water levels) is likely inaccurate due to increased observed beaver dam activity at the outflow area this past year, although the total estimated volume of 0.07 Mgal is a reasonable approximation since most discernible lake outflows ceased in mid-June.
