To: Cedar Lake Improvement Board
From: Mark Kieser, K&A
Josh Kieser, K&A
Date: March 12, 2019
cc: Doug Pullman, Aquest
RE: Findings for 2018 Cedar Lake Groundwater/Surface Water Level Monitoring

This memorandum presents 2018 results compiled by Kieser & Associates, LLC (K&A) related to the ongoing water level monitoring program at Cedar Lake, Alcona and Iosco Counties, MI. K&A staff were authorized to continue management and oversight of ongoing data collection efforts in 2018 on behalf of the Lake Board. The purpose of the long-term monitoring program is to best understand critical needs and relevant influences on water levels in Cedar Lake. These are becoming particularly important as lake level management activities are now under way.

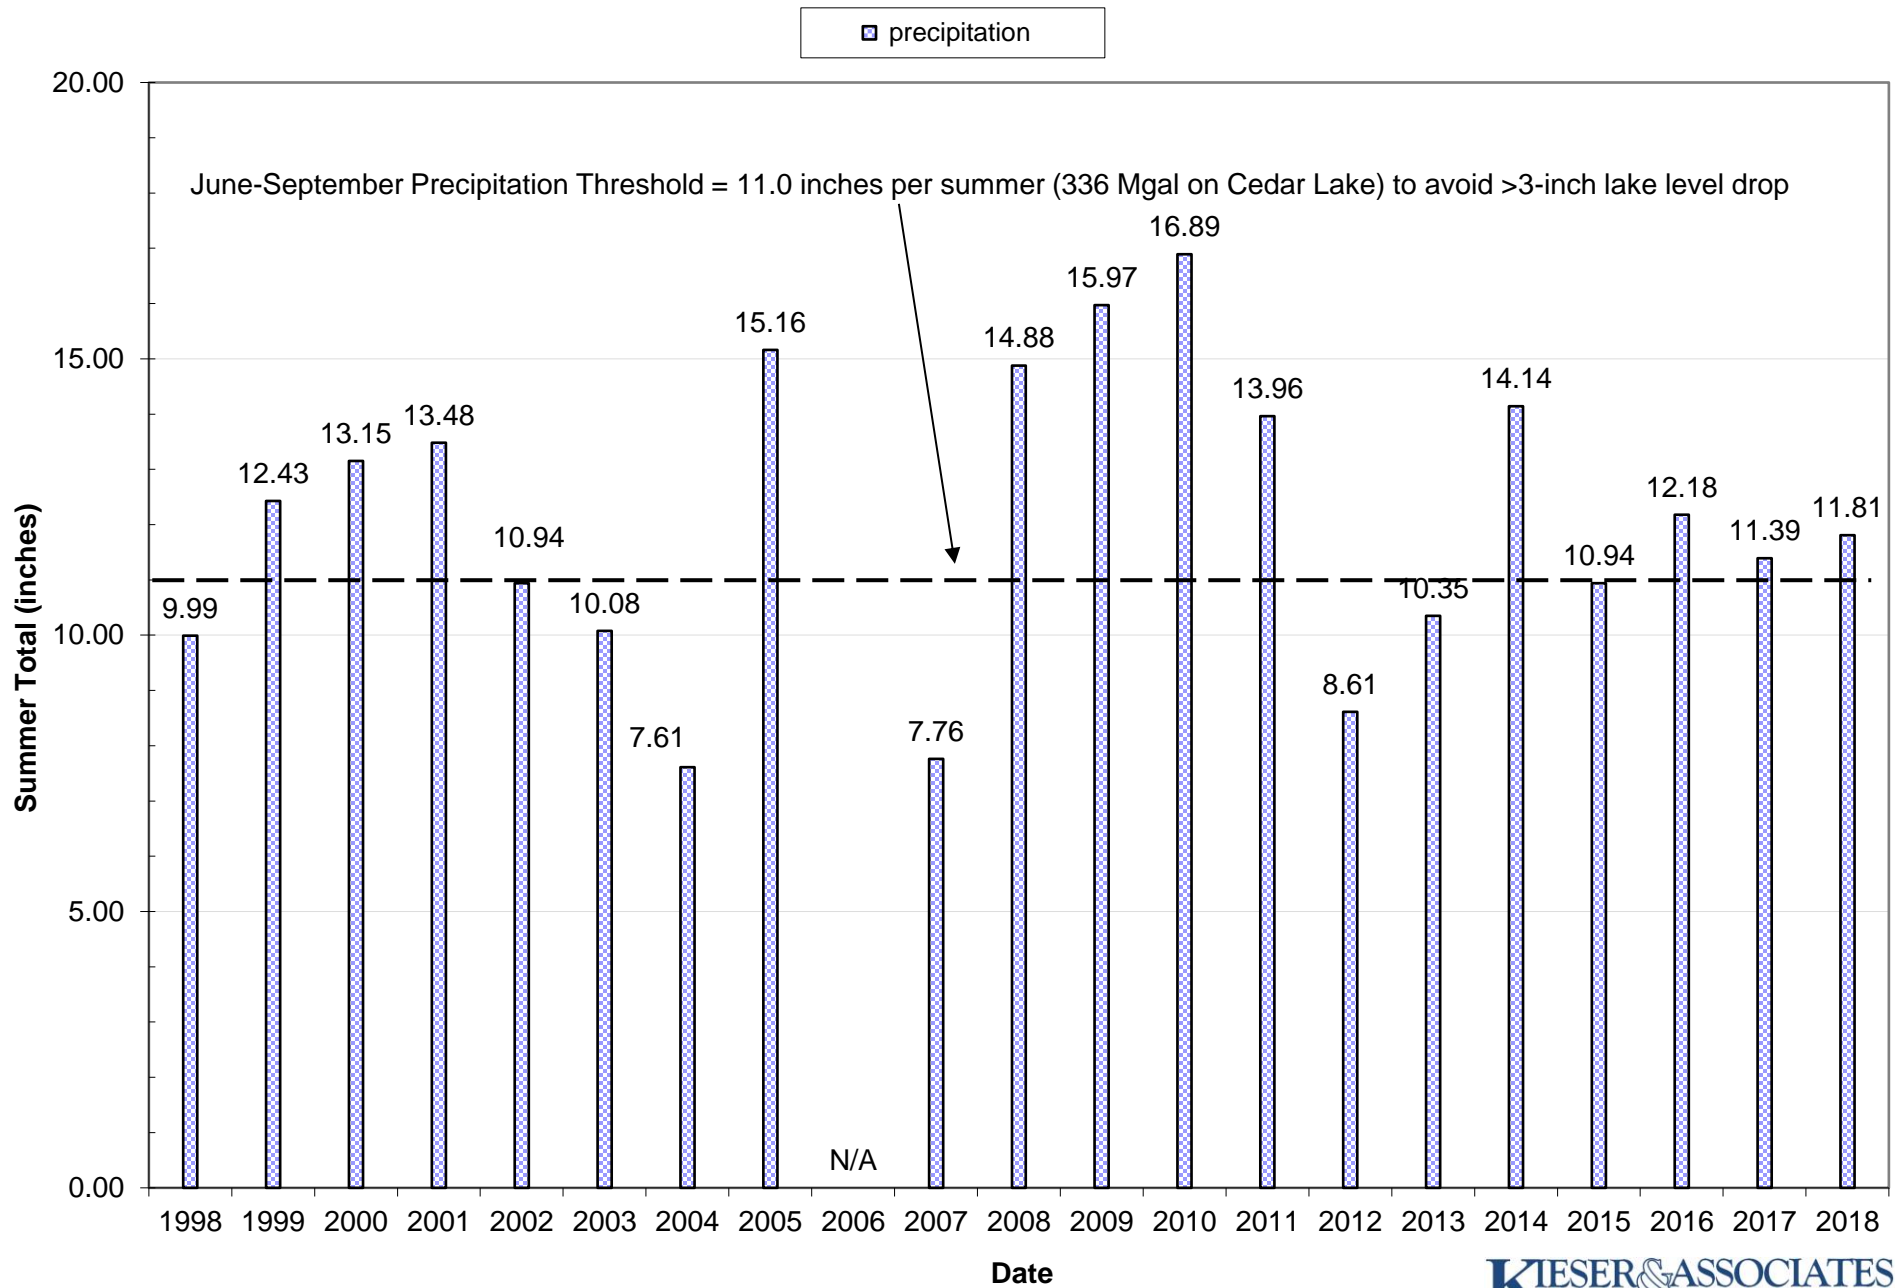
Figure 2. Summer (Jun - Sept) Precipitation Totals for Cedar Lake

(Precipitation Source: Harrisville, MI, CO-OP Station #203628,
Alcona County Cedar Lake Rain Gauge,
Oscoda, MI Oscoda Wurtsmith Airport Station #14808, Iosco County)

Cedar Lake remained above the legal lake level with outflow conditions occurring from the beginning of the monitoring season to early July. Consistent with the target rainfall threshold data plotted on Figure 2 (i.e., 11 inches per summer season), Figure 3 shows that in 2018 Cedar Lake water levels steadily declined from April to July, after heavy spring rains and snowmelt. Lake levels dropped to within 0.3 feet below the legal lake level from July to mid-September. This drop corresponded with low precipitation levels of 1.1 inches in June. While Cedar Lake levels rose and fell in response to several significant rainfall events during the summer months of 2018, lake levels remained just-below the legal lake level from mid-July to mid-October. The most notable drop, within 0.5 feet below the legal lake level, occurred from mid-September to mid-October. Lake levels returned to the legal lake level in response to heavy rainfall in October and remained above the legal lake level through the end of the monitoring period.

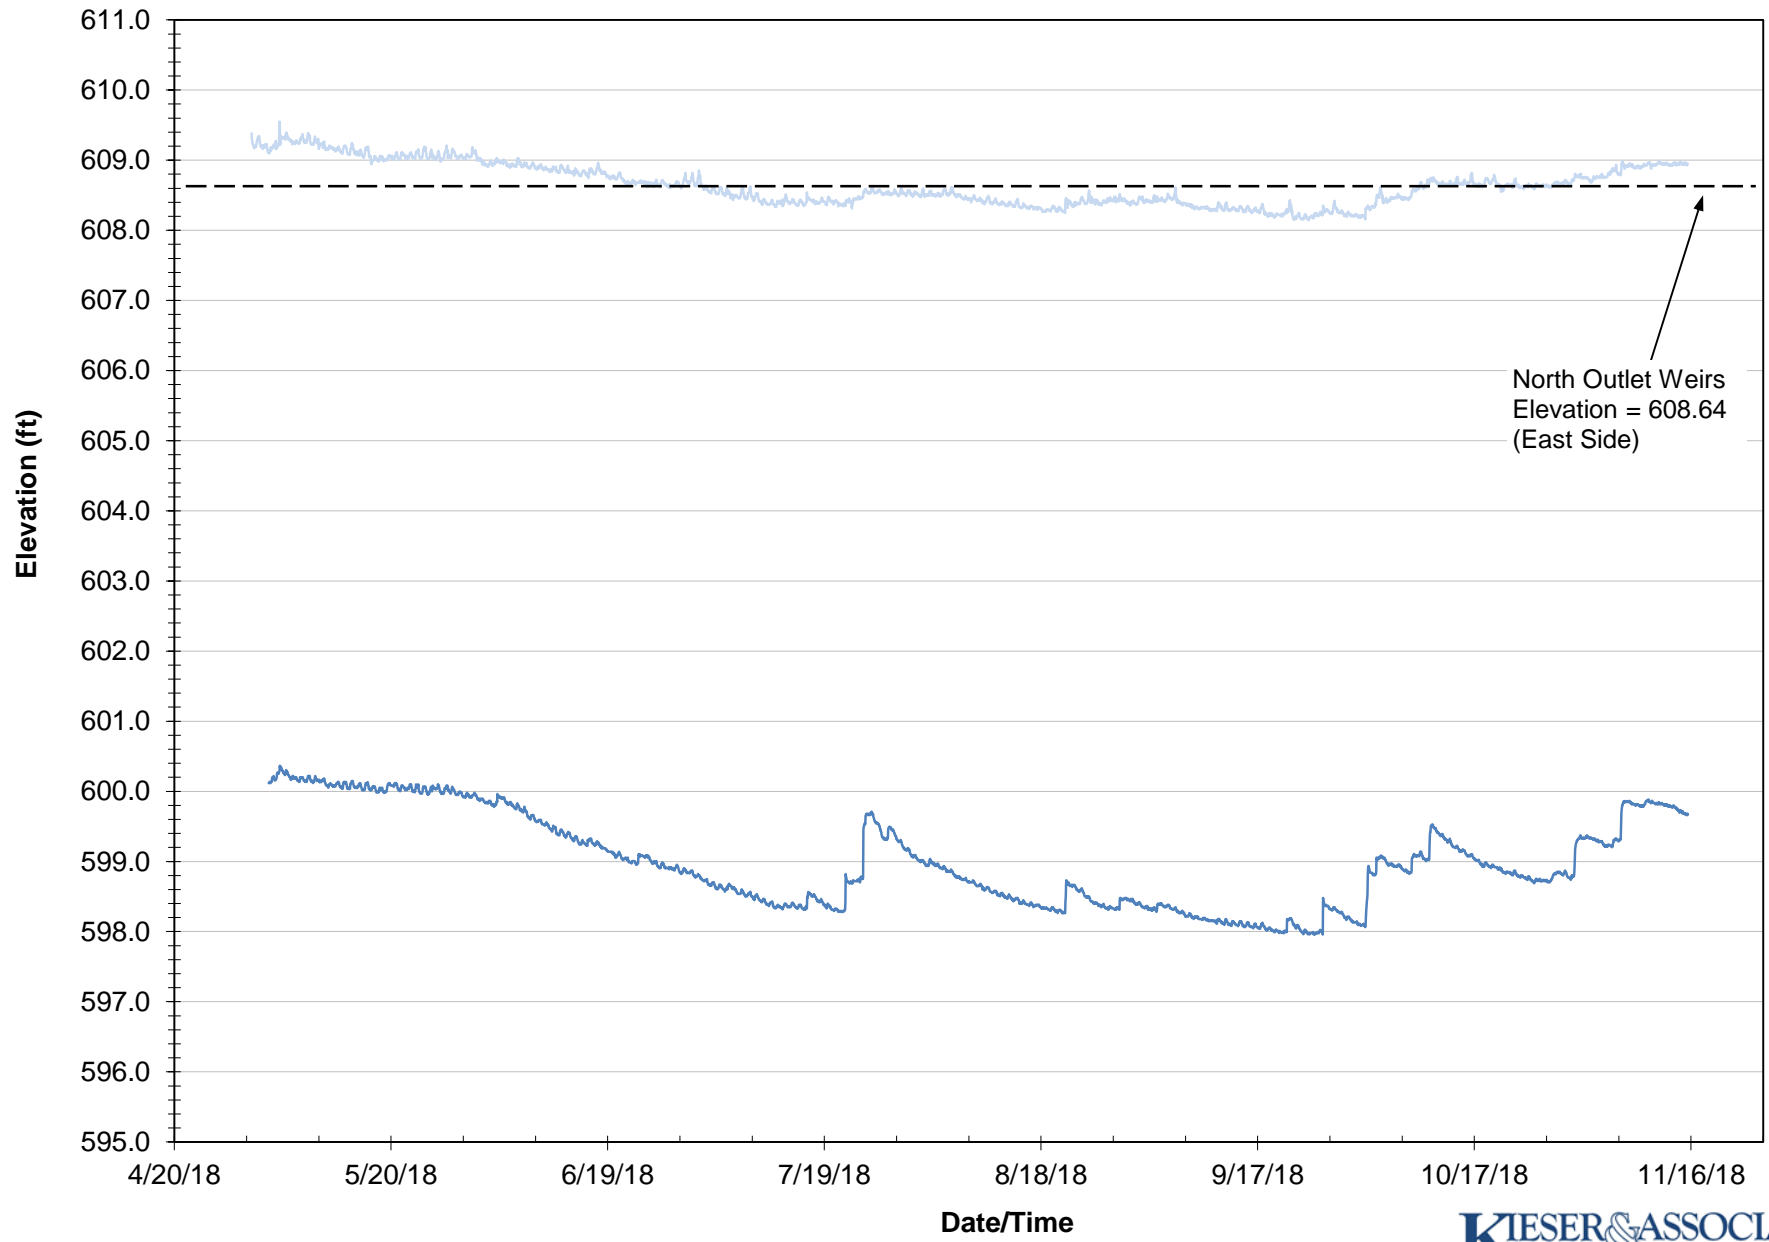
Figure 12. 2018 Cedar Lake Groundwater / Surface Water Elevations (Site 9)

PZ-9s (shallow) Lake Level

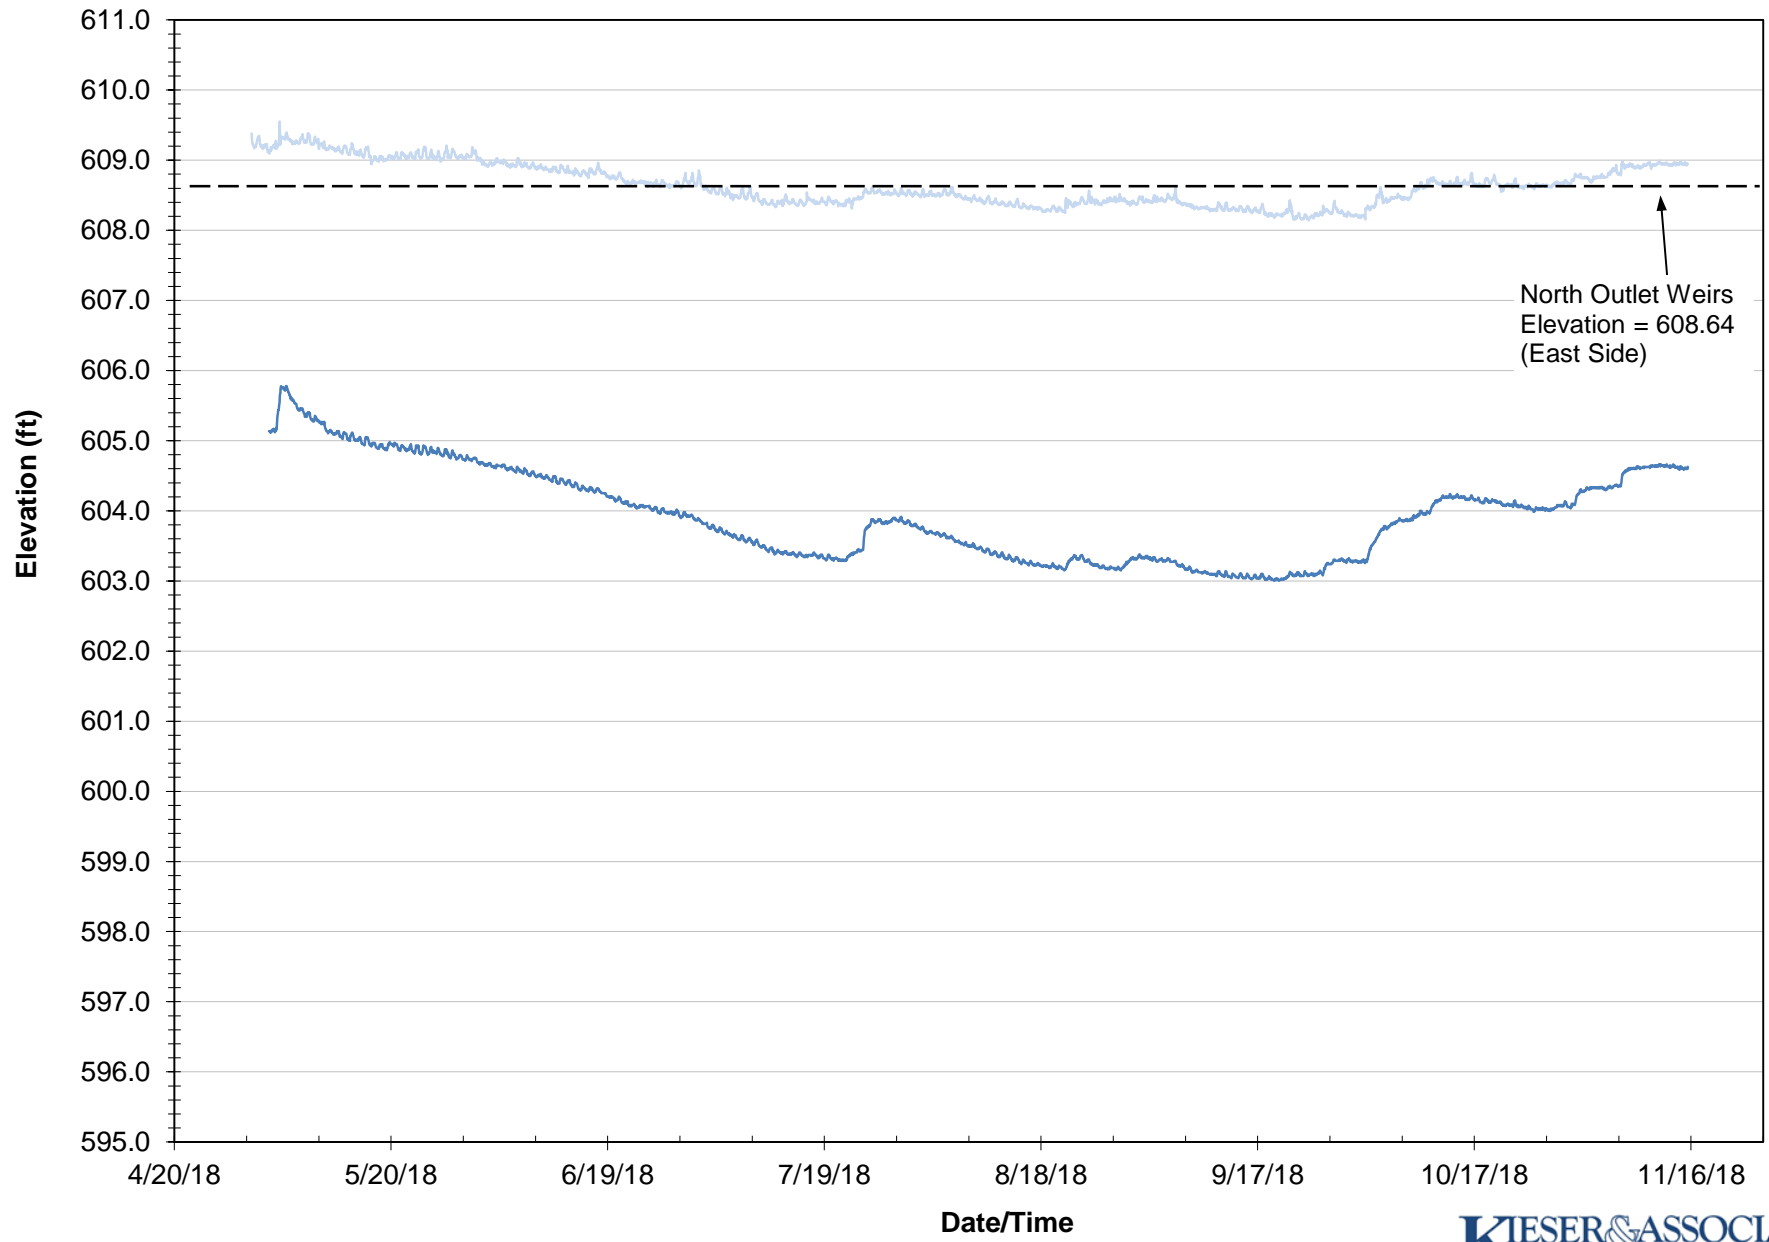
Figure 13. 2018 Cedar Lake Groundwater / Surface Water Elevations (Site 11)

PZ-11s (shallow) Lake Level

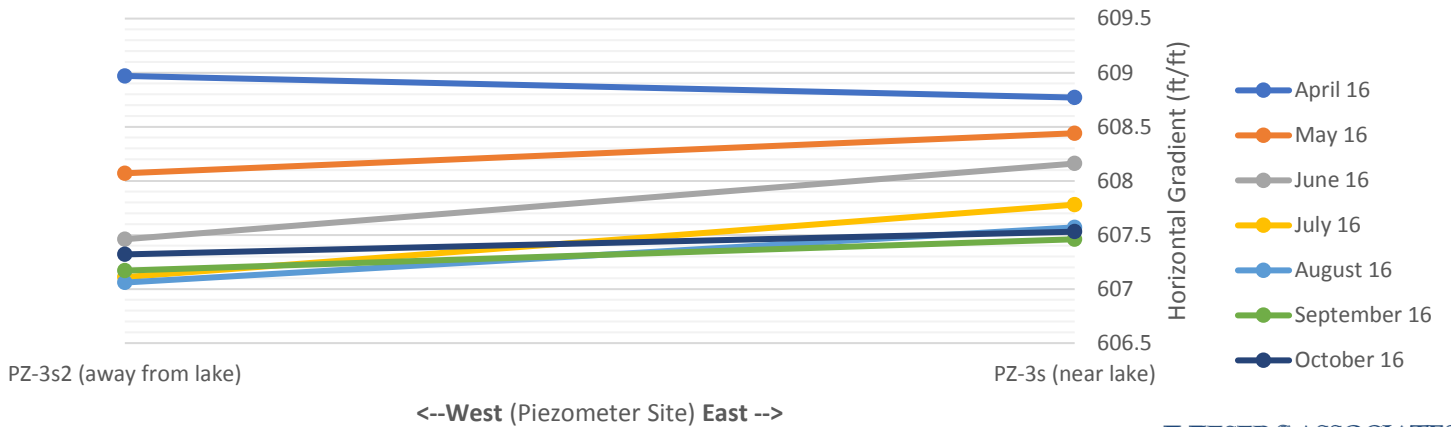
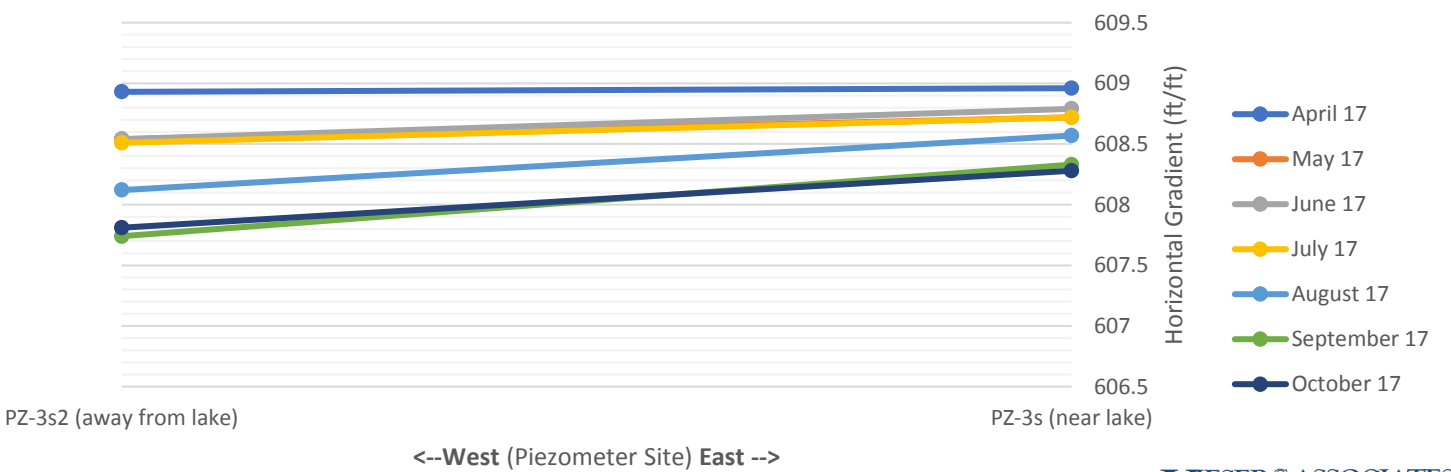
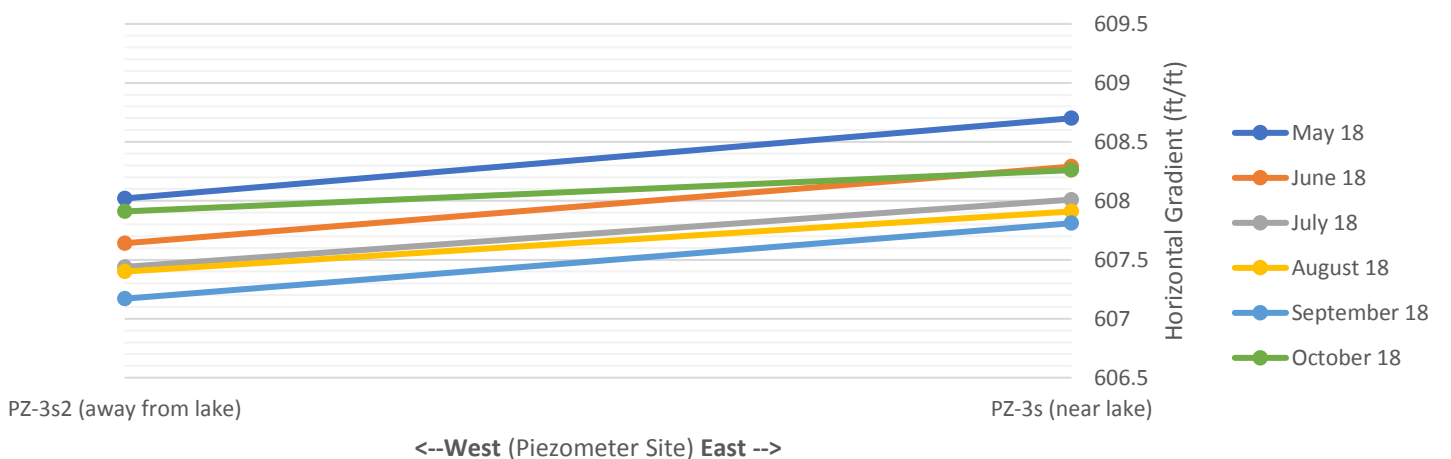
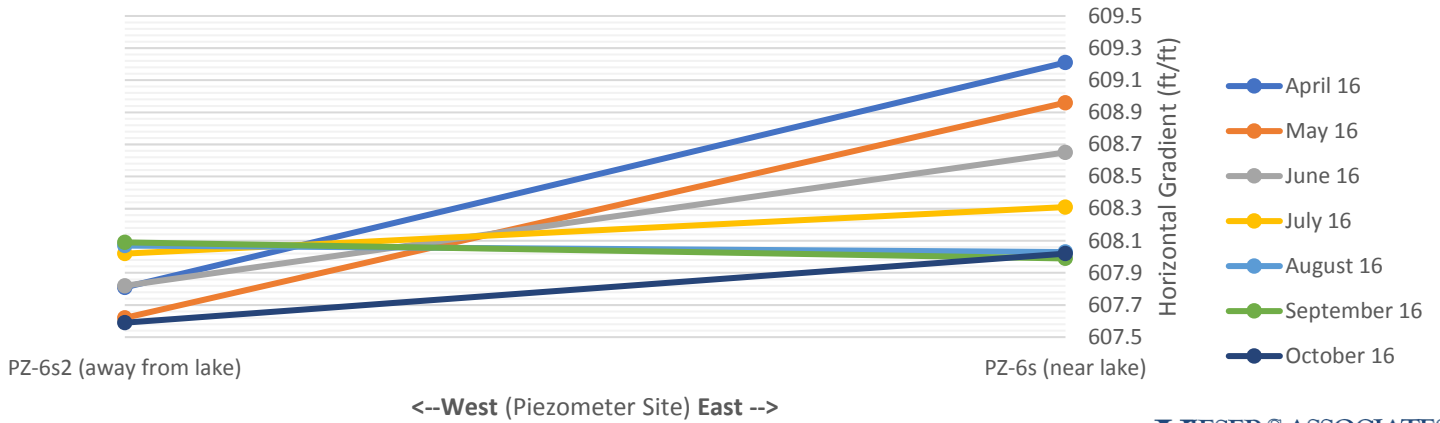
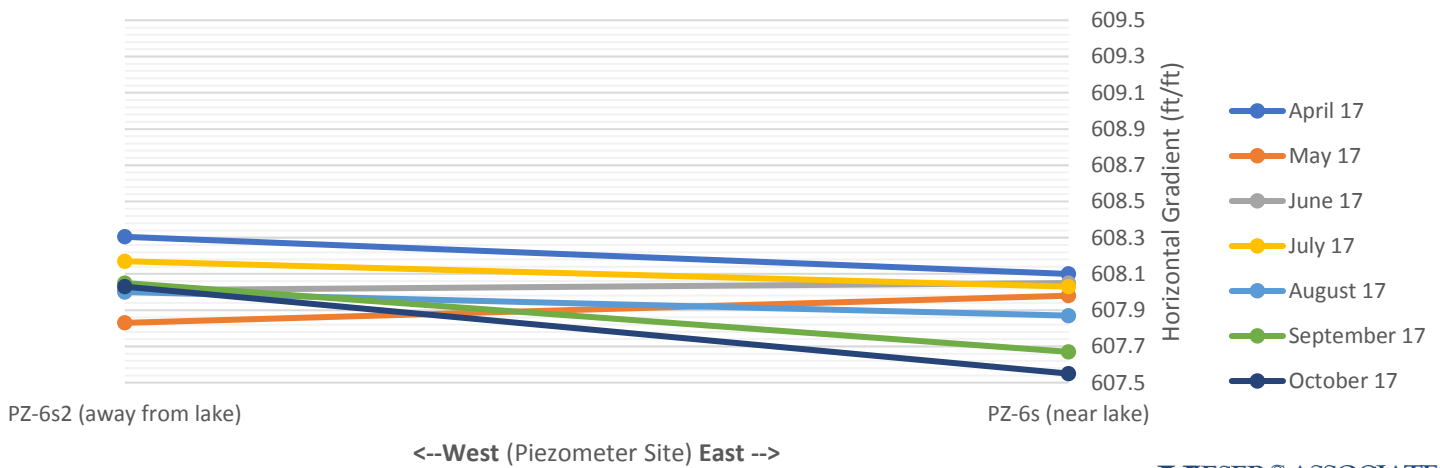
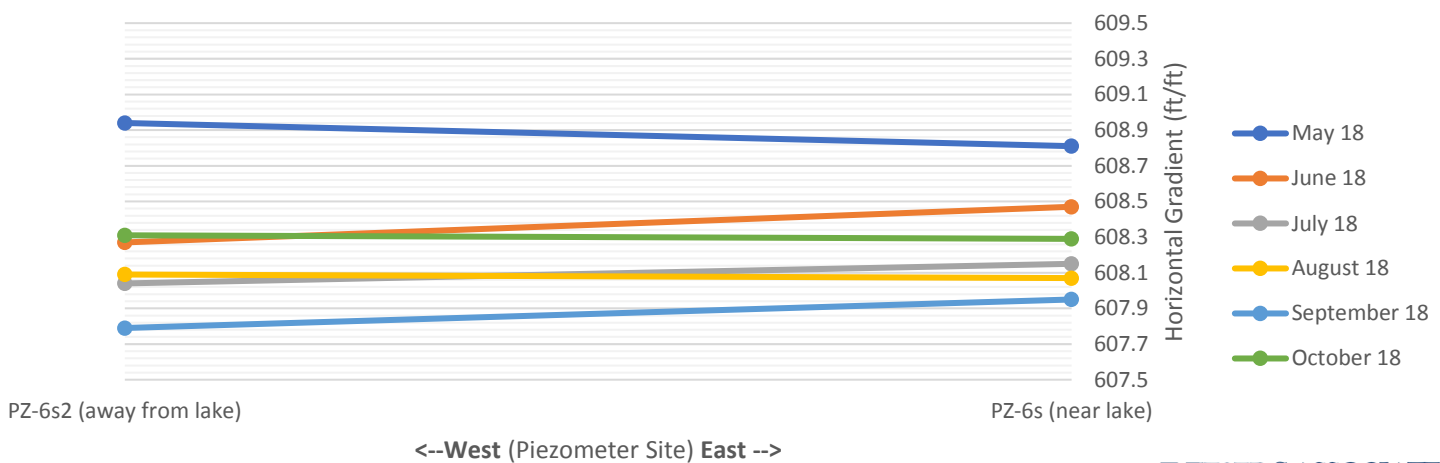
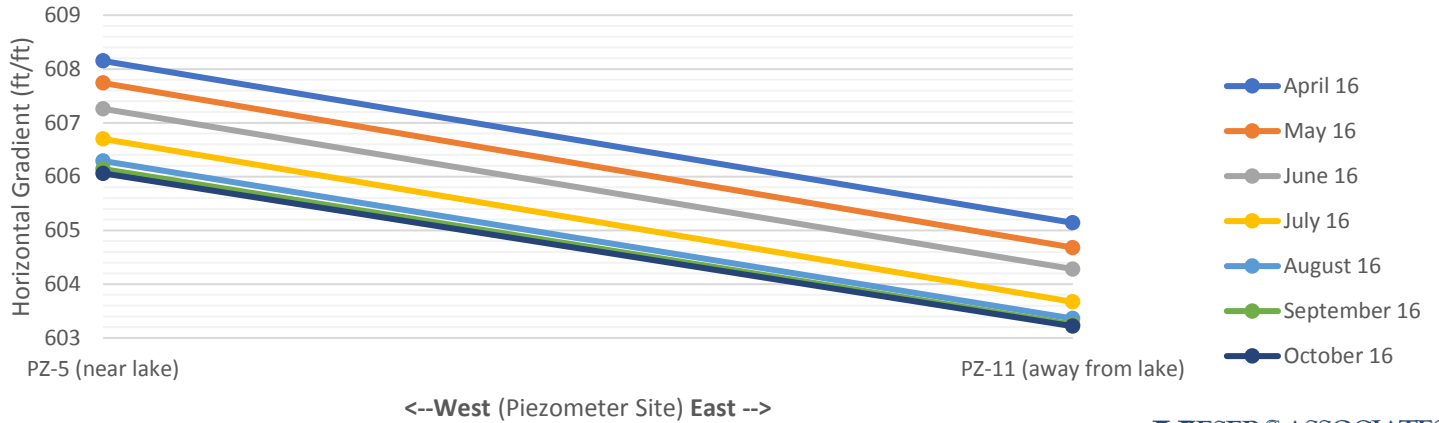
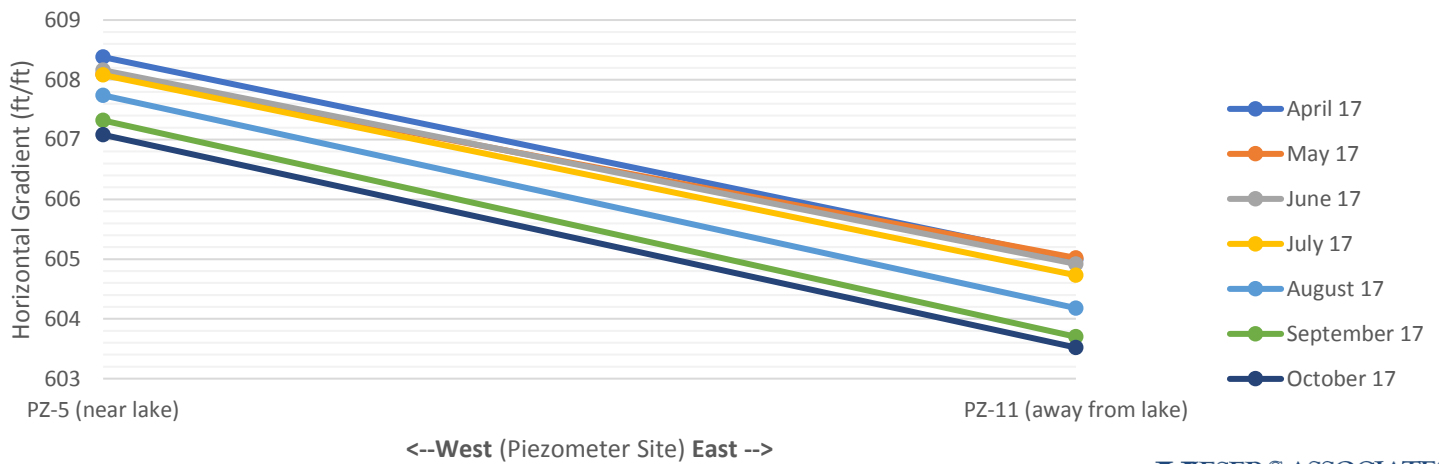
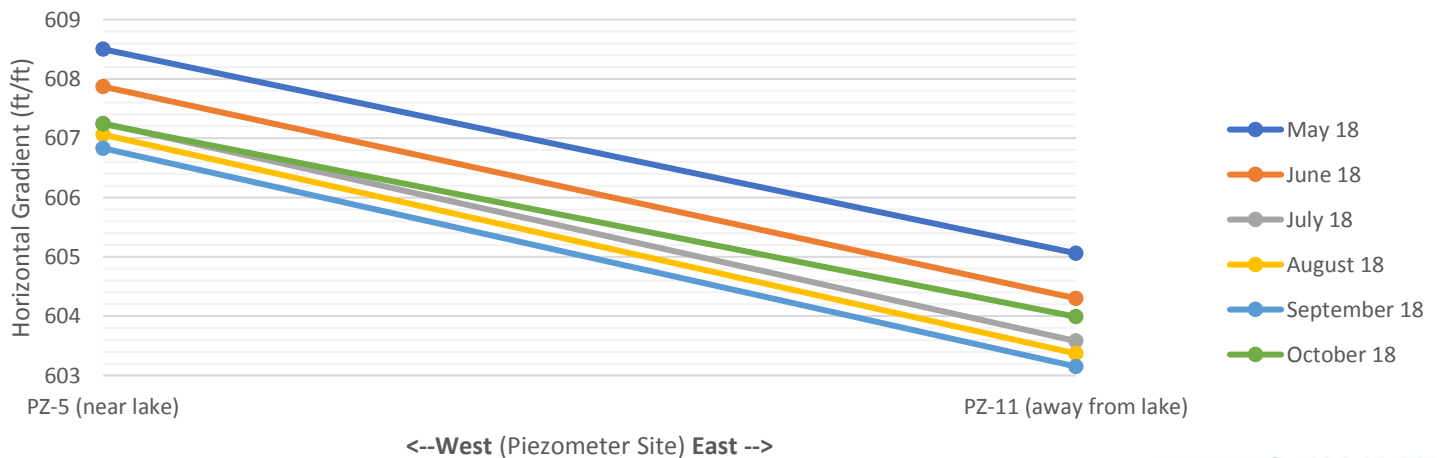
**Figure 14.1: 2016 Monthly Average Groundwater Gradients
Site #3 (Southwest Side of Cedar Lake)**

**Figure 14.2: 2017 Monthly Average Groundwater Gradients
Site #3 (Southwest Side of Cedar Lake)**

**Figure 14.3: 2018 Monthly Average Groundwater Gradients
Site #3 (Southwest Side of Cedar Lake)**

**Figure 14.4: 2016 Monthly Average Groundwater Gradients
Site #6 (West Side of Cedar Lake)**

**Figure 14.5: 2017 Monthly Average Groundwater Gradients
Site #6 (West Side of Cedar Lake)**

**Figure 14.6: 2018 Monthly Average Groundwater Gradients
Site #6 (West Side of Cedar Lake)**

**Figure 14.7: 2016 Monthly Average Groundwater Gradients
Sites #5 & #11 (Southeast Side of Cedar Lake)**

**Figure 14.8: 2017 Monthly Average Groundwater Gradients
Sites #5 & #11 (Southeast Side of Cedar Lake)**

**Figure 14.9: 2018 Monthly Average Groundwater Gradients
Sites #5 & #11 (Southeast Side of Cedar Lake)**

Figures 14.1-14.9 utilize historic data from Sites 3 and 6. These data sets were cross-checked for accuracy and noted in 2018 to have been plotted incorrectly in previous reports. Appendix A therefore contains updated, notated groundwater elevations graphs for Sites 3 and 6.

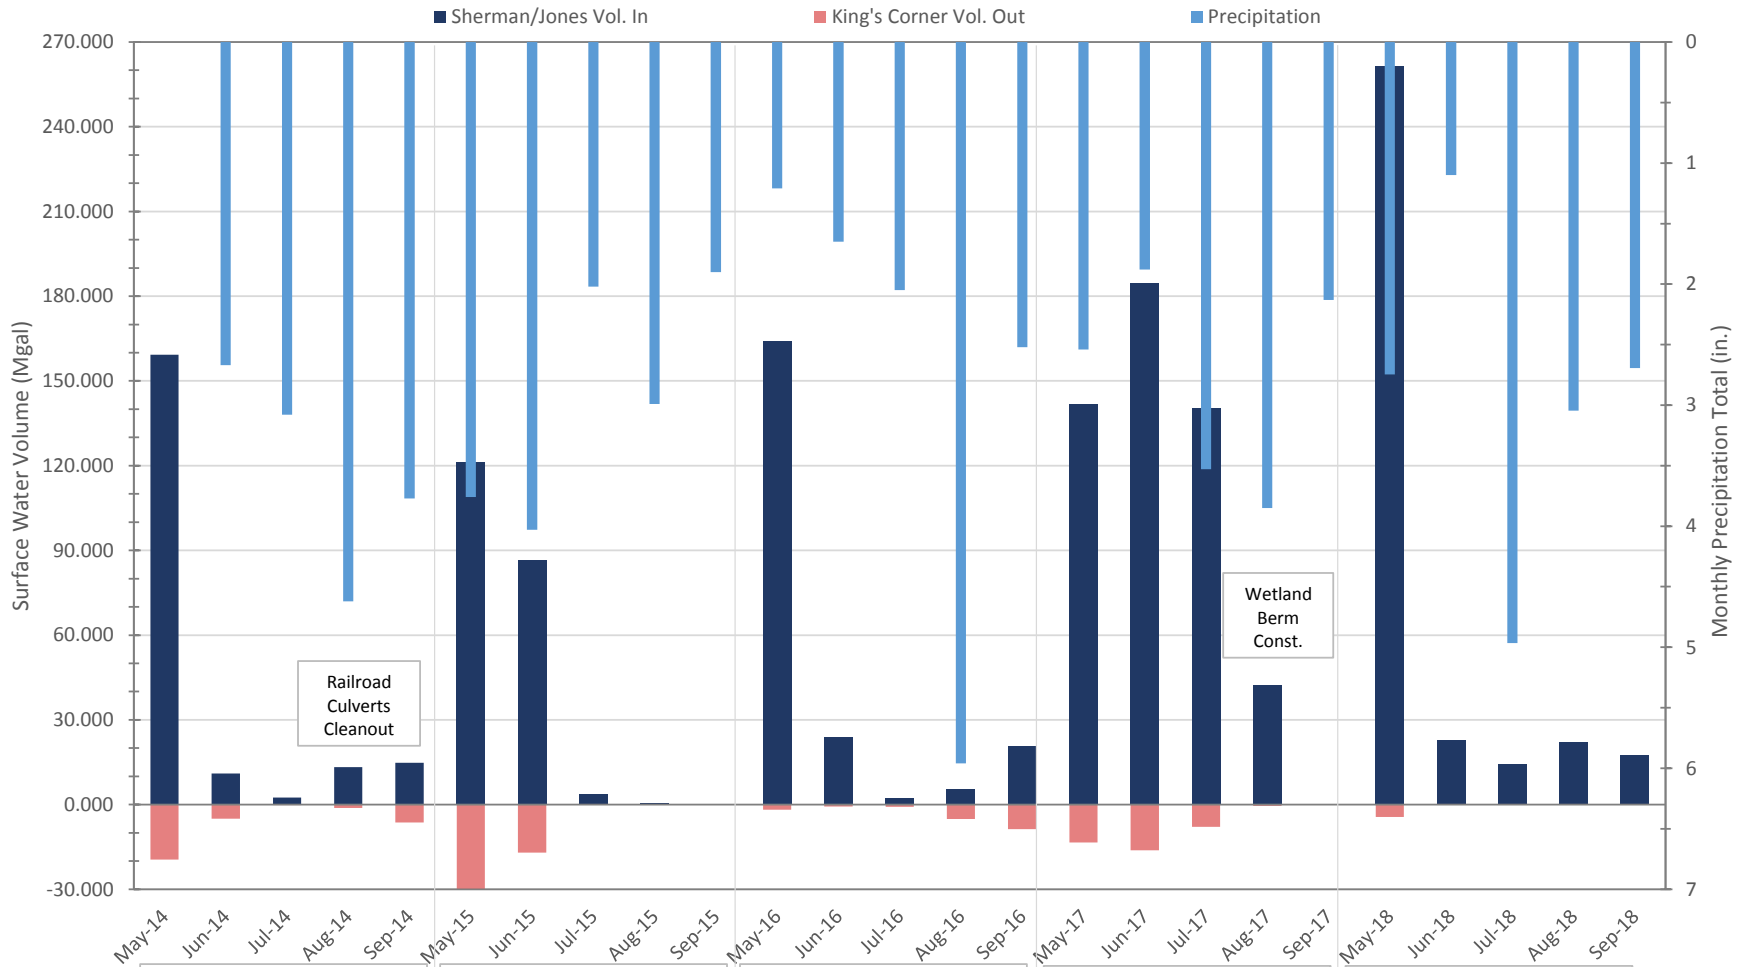
Figure 23. May-Sep, 2014-18 : Precipitation, Sherman/Jones Creeks Combined Surface Water Volume into Cedar Lake, and King's Corner Surface Water Volume Away from Cedar Lake

2014 May-September:
 Precipitation: 14.14 in.
 Inflow Volume: 200.9 Mgal
 King's Vol. Out: 32.2 Mgal

2015 May-September:
 Precipitation: 14.70 in.
 Inflow Volume: 212.5 Mgal
 King's Vol. Out: 46.9 Mgal

Figure 23 demonstrates the overall increase in surface water volume entering Cedar Lake through Sherman and Jones Creeks during summer months since 2014. These watershed improvements may prove to mitigate any immediate need to pursue deep groundwater withdrawal augmentation wells as outlined in the WMP and feasibility study. Moreover, the proposed instream grade structures for Sherman Creek may ultimately provide the naturalized solution to mitigate long-term concerns of future lake level drops during dry summers. This would also benefit the ecology of the lake by protecting important springtime fish-spawning habitat. As noted earlier, issues of PFAS groundwater contamination also raise a cautionary concern with deeper groundwater pumping for lake level augmentation.

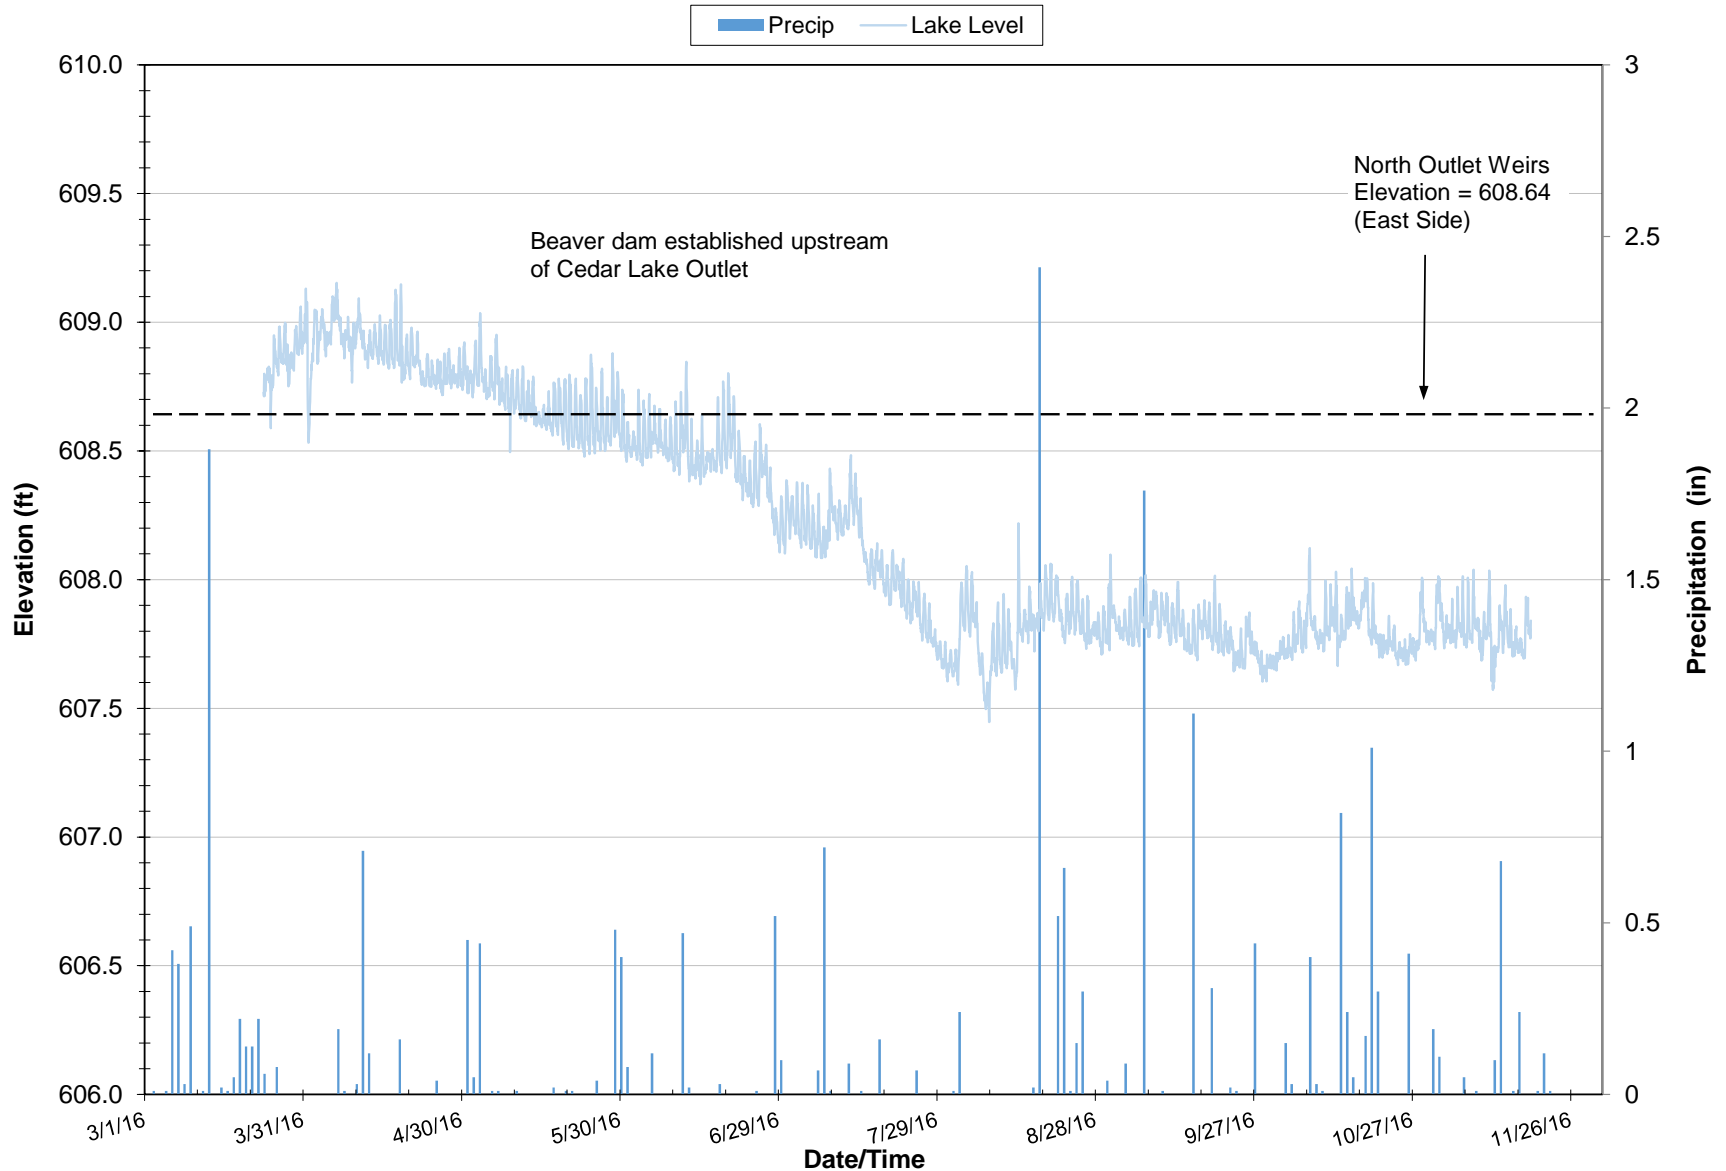
Appendix A.1. Updated 2016 Cedar Lake Water Elevation and Measured Rainfall

Note: This updated graph represents water elevation conditions for 2016 at the Cedar Lake Outlet. Elevations plotted in 2016 attempted to represent in-lake conditions above the beaver dam, which was established immediately upstream of the Lake Out level logger. Lake level readings here are used to update calculated outflows for 2016. The beaver dam caused a significant elevation drop at the Outlet, as observed here.

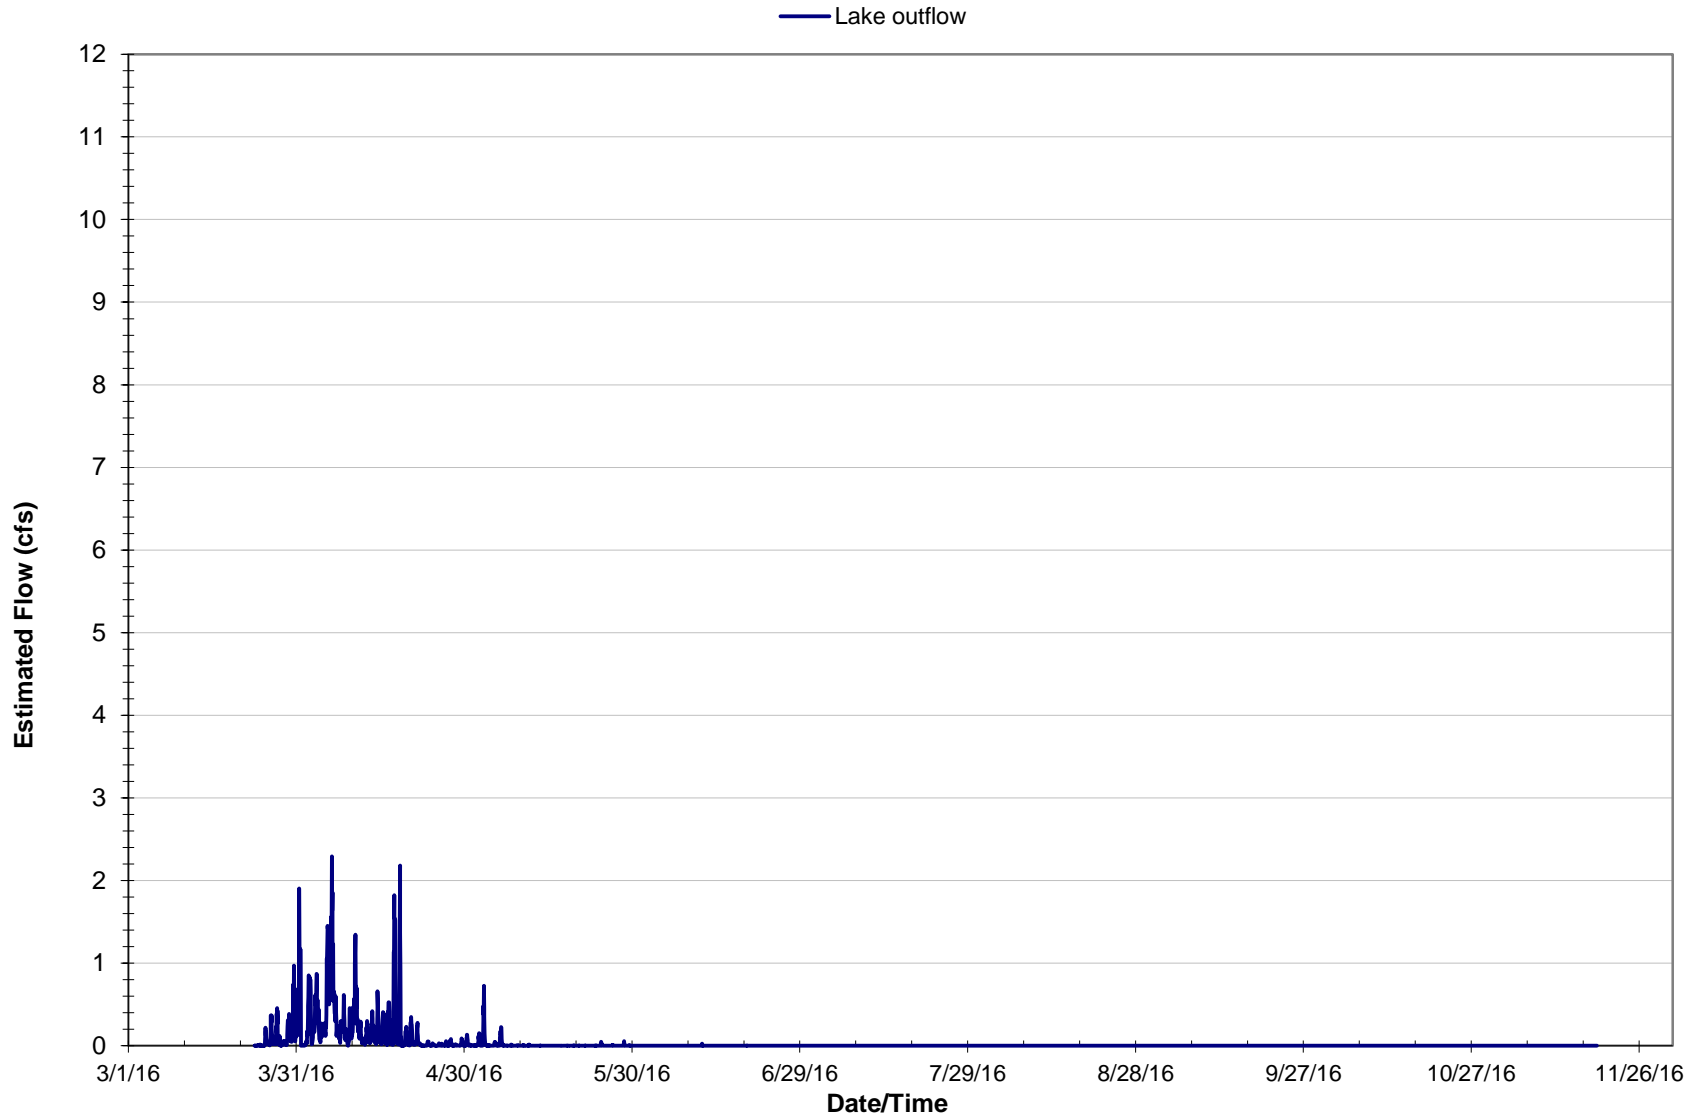
Appendix A.2. Updated 2016 Estimated Cedar Lake Outflows

Note: This updated graph represents estimated surface water outflows for 2016 at the Cedar Lake Outlet, per Appendix Figure A.1.

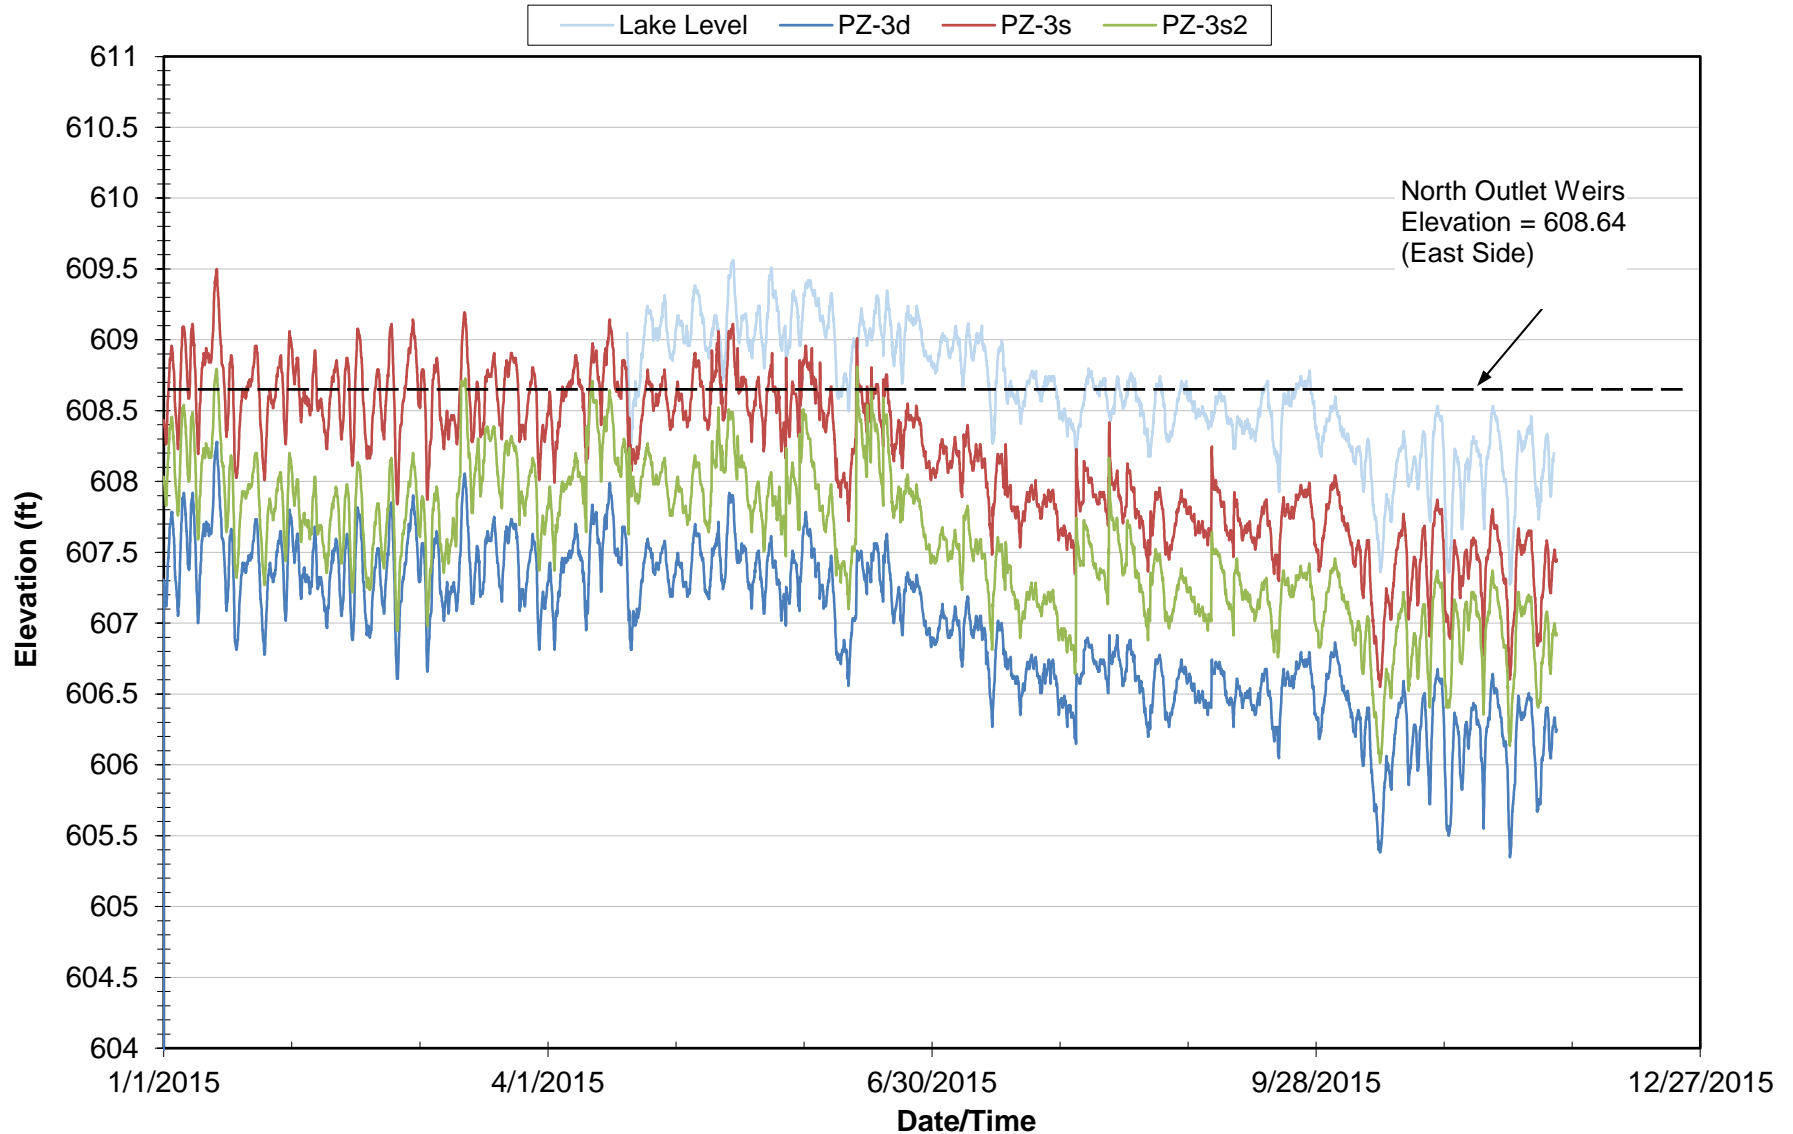
Appendix A.3. Updated 2015 Cedar Lake Groundwater /Surface Water Elevations (Site 3)

Note: This graph presents updated 2015 Site 3 water elevations, which were previously reported using the incorrect top of casing elevations.
