To: Cedar Lake Improvement Board
From: Mark Kieser, K&A
Josh Kieser, K&A
Date: March 12, 2019
cc: Doug Pullman, Aquest
RE: Findings for 2018 Cedar Lake Groundwater/Surface Water Level Monitoring

This memorandum presents 2018 results compiled by Kieser & Associates, LLC (K&A) related to the ongoing water level monitoring program at Cedar Lake, Alcona and Iosco Counties, MI. K&A staff were authorized to continue management and oversight of ongoing data collection efforts in 2018 on behalf of the Lake Board. The purpose of the long-term monitoring program is to best understand critical needs and relevant influences on water levels in Cedar Lake. These are becoming particularly important as lake level management activities are now under way.

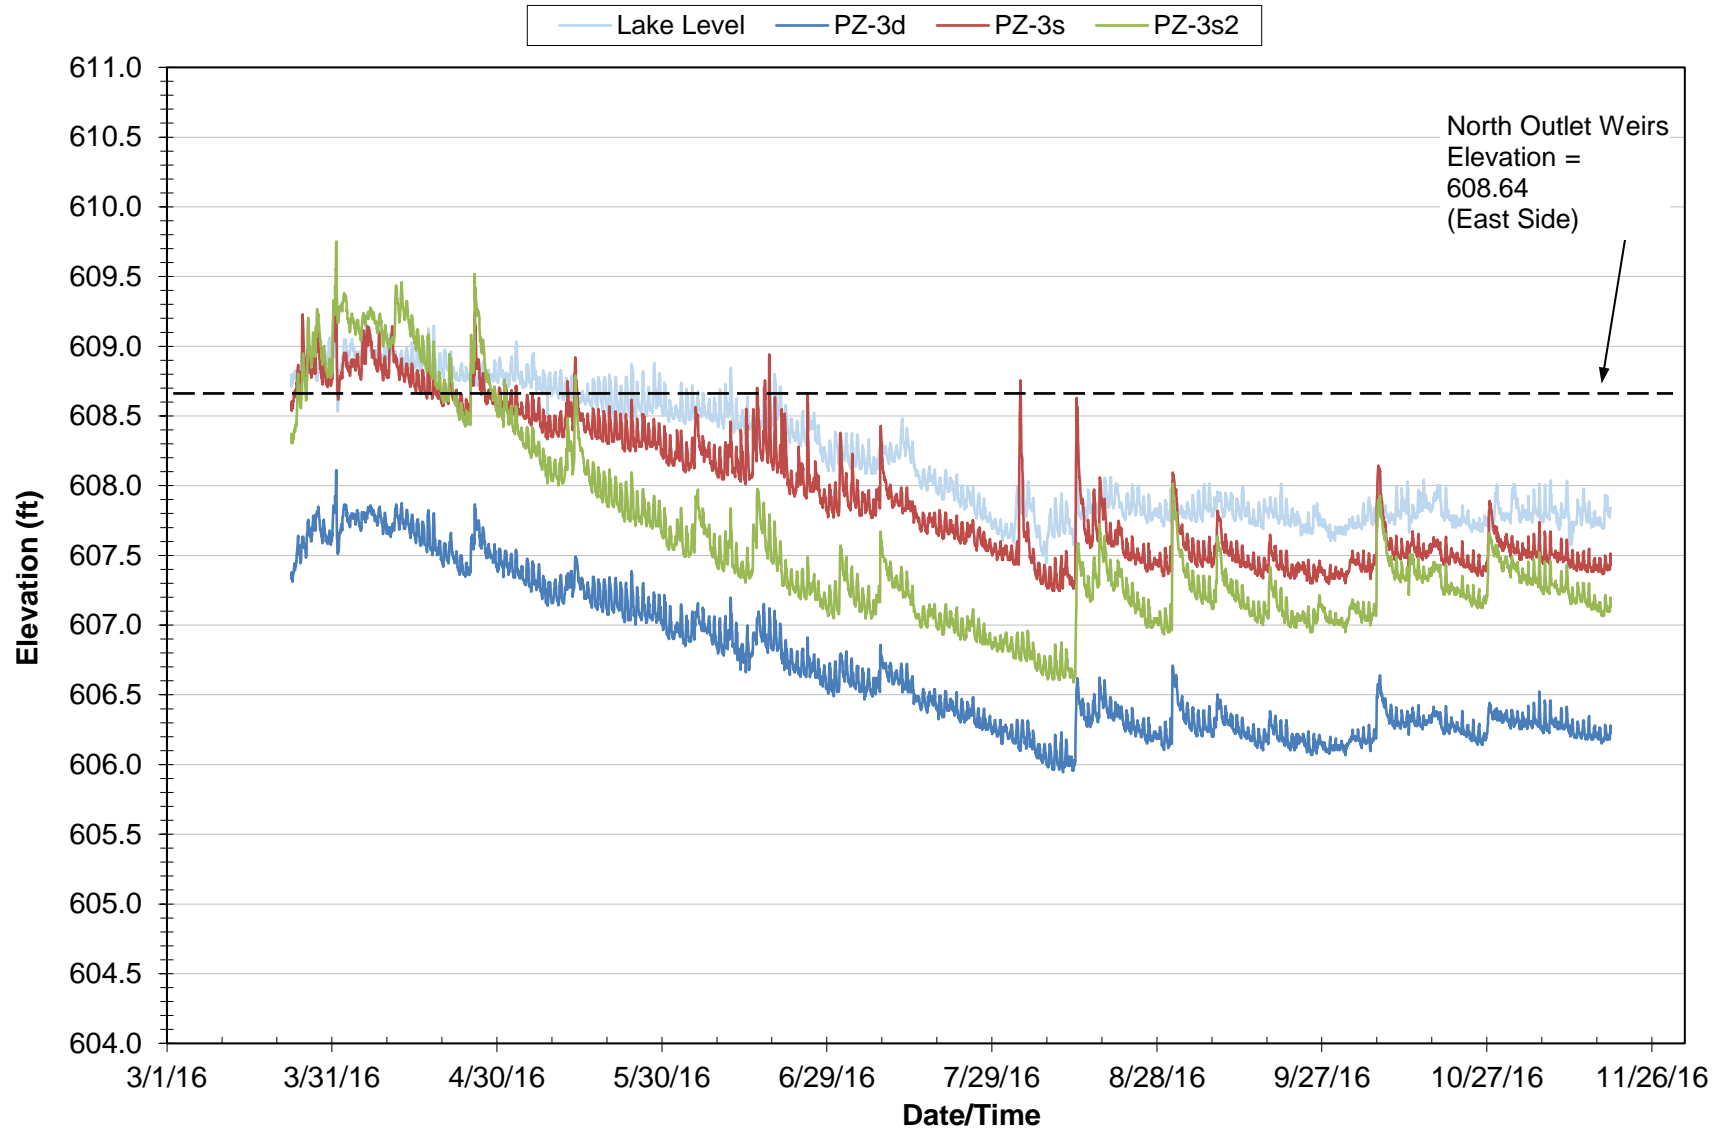
Appendix A.4. Updated 2016 Cedar Lake Groundwater /Surface Water Elevations (Site 3)

Note: This graph presents updated 2016 Site 3 water elevations, which were previously reported using the incorrect top of casing elevations.

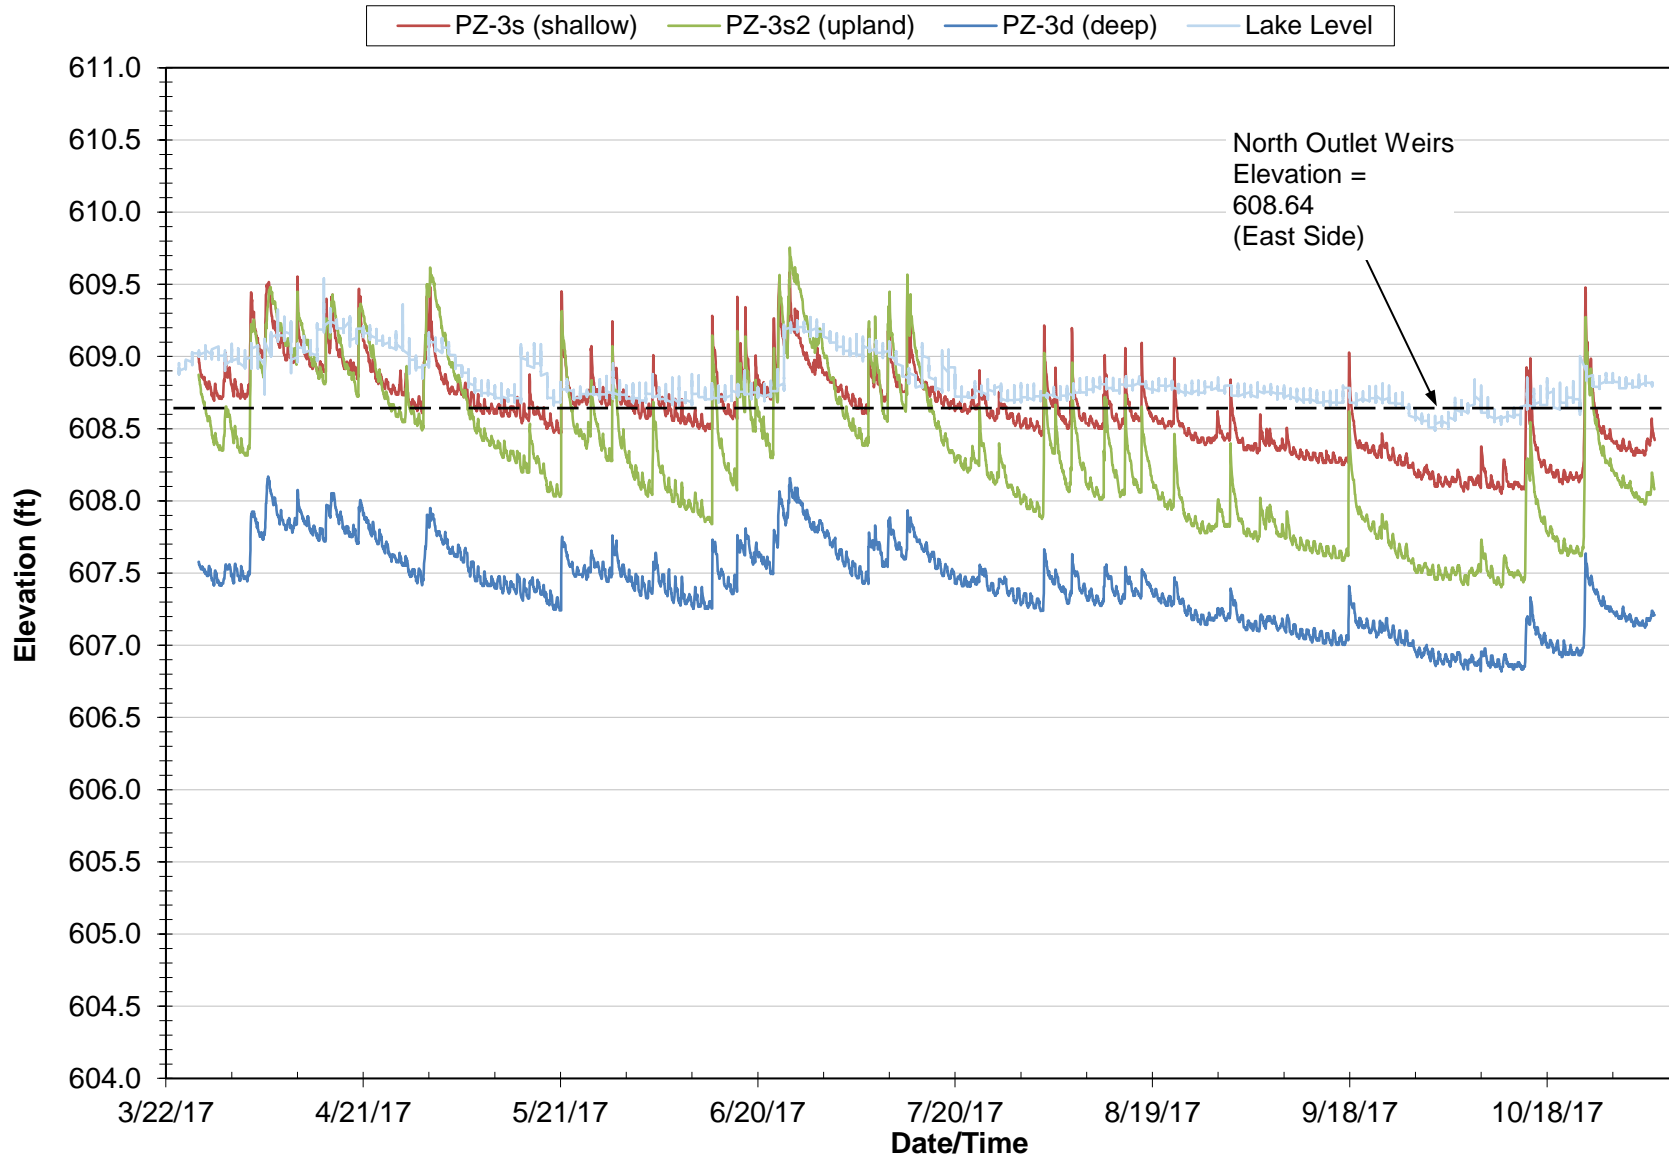
Appendix A.5. Updated 2017 Cedar Lake Groundwater /Surface Water Elevations (Site 3)

Note: This graph presents updated 2017 Site 3 water elevations, which were previously reported using the incorrect top of casing elevations.

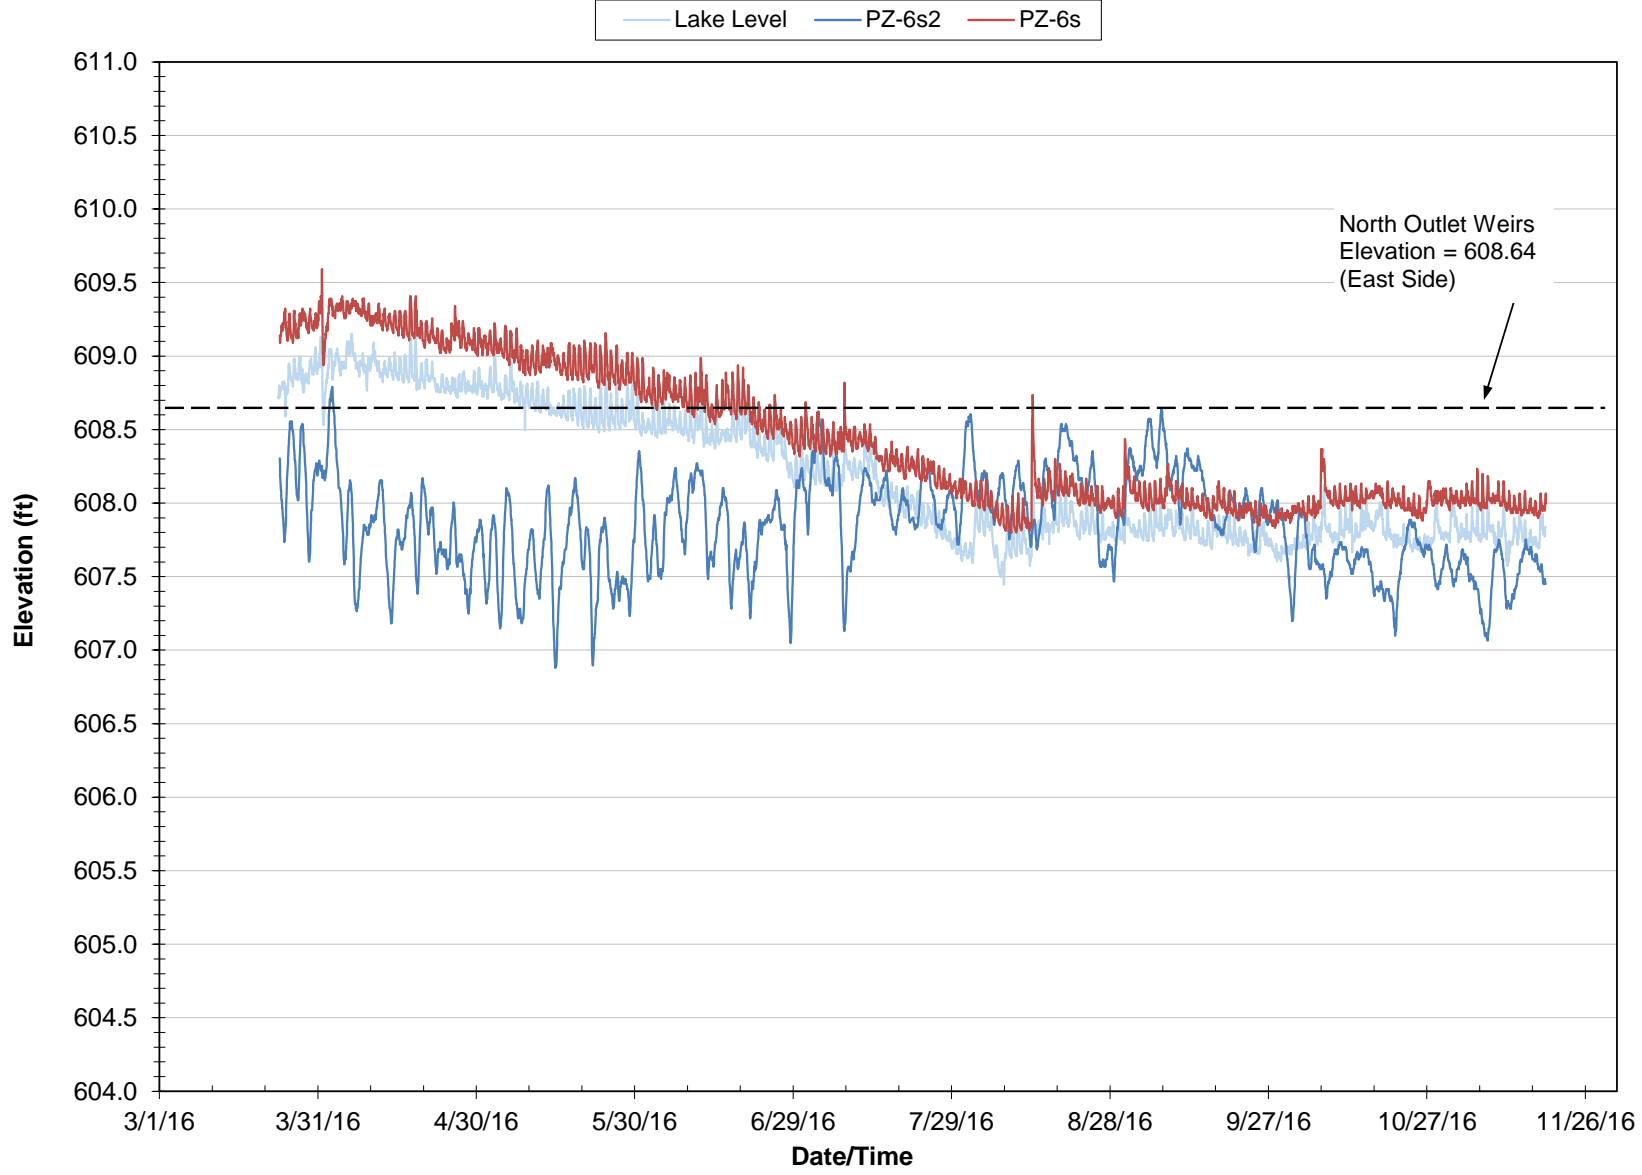
Appendix A.6. Updated 2016 Cedar Lake Groundwater /Surface Water Elevations (Site 6)

Note: This graph presents updated 2016 Site 6 water elevations, which were previously plotted and reported incorrectly.

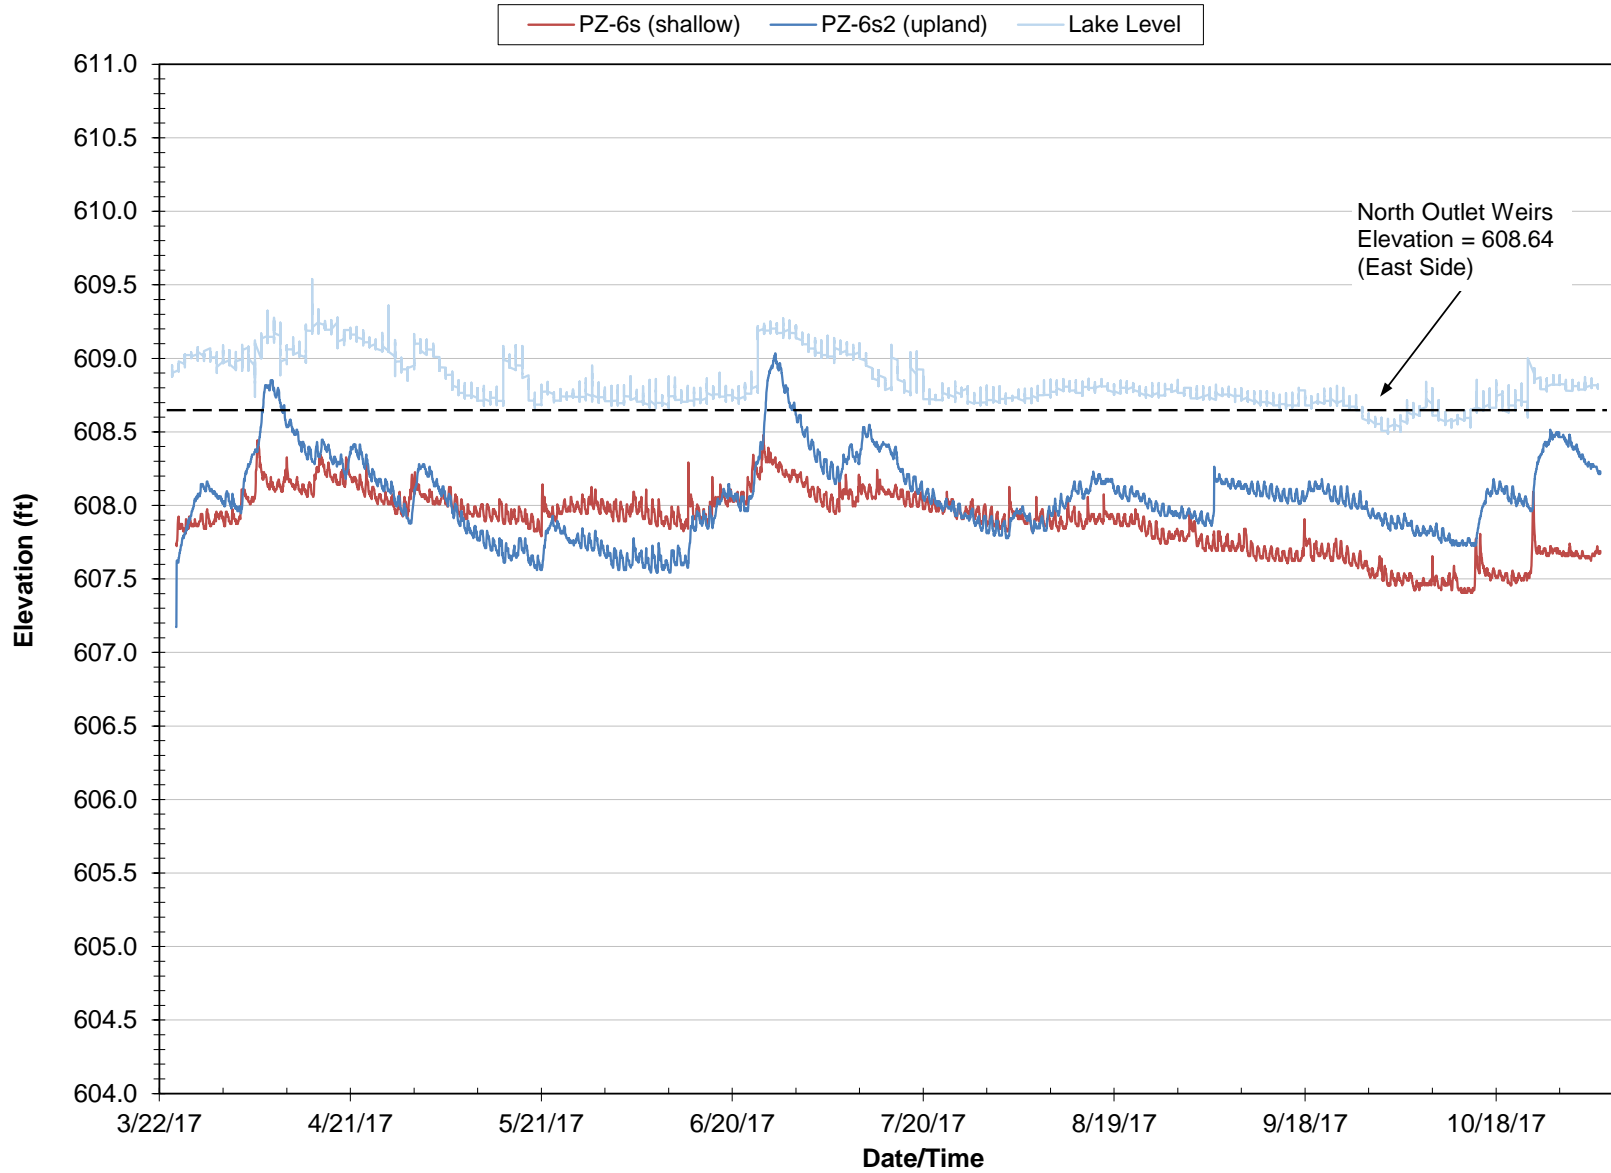
Appendix A.7. Updated 2017 Cedar Lake Groundwater /Surface Water Elevations (Site 6)

Note: This graph presents updated 2017 Site 6 water elevations, which were previously plotted and reported incorrectly.
