Client: Telling Architectural Ltd
7 The Dell
Enterprise Drive
Four Ashes
Wolverhampton, England WV10 7DF

Job Number: 11-0045A

- AAMA 501.1** Standard Test Method for Water Penetration of Windows, Curtain Walls, and Doors Using Dynamic Pressure
- AAMA 501.5** Standard Test Method for Thermal Cycling
- AAMA 508-07** Voluntary Test Method and Specification for Pressure Equalized Rain Screen Wall Cladding Systems
- ASTM E283-04** Standard Test Method for Determining Rate of Air Leakage Through Exterior Windows, Curtain Walls, and Doors Under Specified Pressure Differences Across the Specimen
- ASTM E331-00(2009)** Standard Test Method for Water Penetration of Exterior Windows, Skylights, Doors, and Curtain Walls by Uniform Static Air Pressure Difference
- ASTM E330-02(2010)** Standard Test Method for Structural Performance of Exterior Windows, Doors, Skylights and Curtain Walls by Uniform Static Air Pressure Difference

Rain Screen System: ArGeTon with Horizontal Rails and Vertical Top Hats

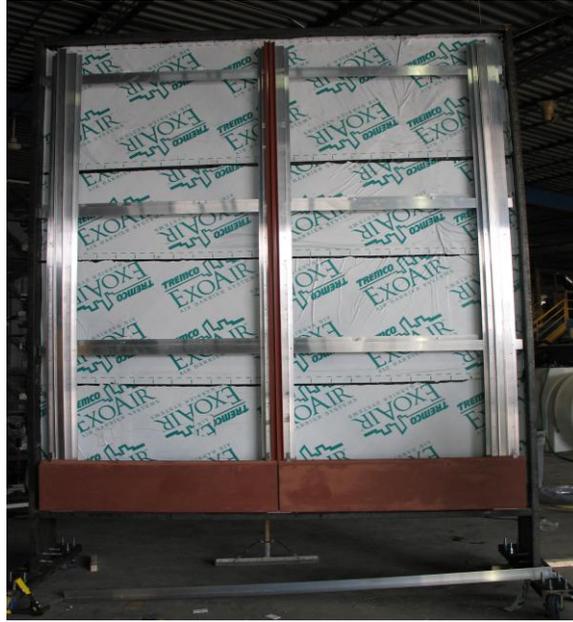
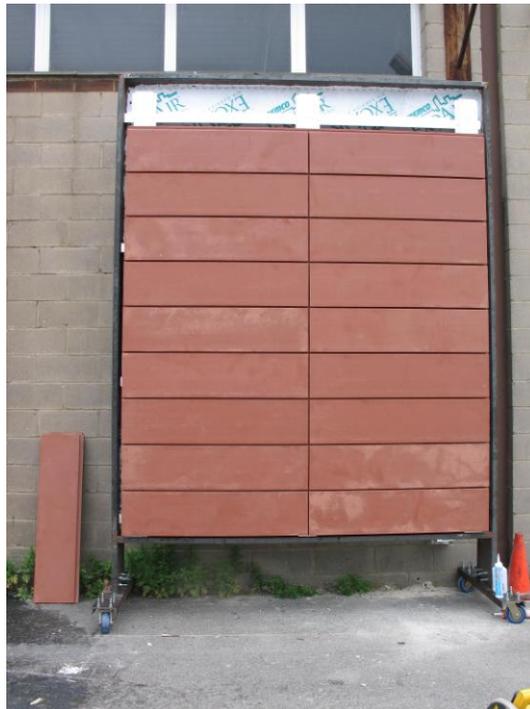
Aluminum Horizontal 'Z' was fastened to the helping hand brackets using 1/4" x 2" screws starting six inches from the bottom of the buck and 3' centers.

Aluminum Top Hat was fastened to the aluminum 'Z' with 1/4" x 2" screws. The top hat employed 3/16" holes pre-punched through the face @ 6" centers. The tiles bottom edges were placed into base clips. The drainage profile is located on the central tile joint and the spring profiles on the outer edge of the tiles were inserted behind the tiles. The top of the tiles were held in place with intermediate clips. These clips were pop riveted in place. The system included (18) terracotta tiles.

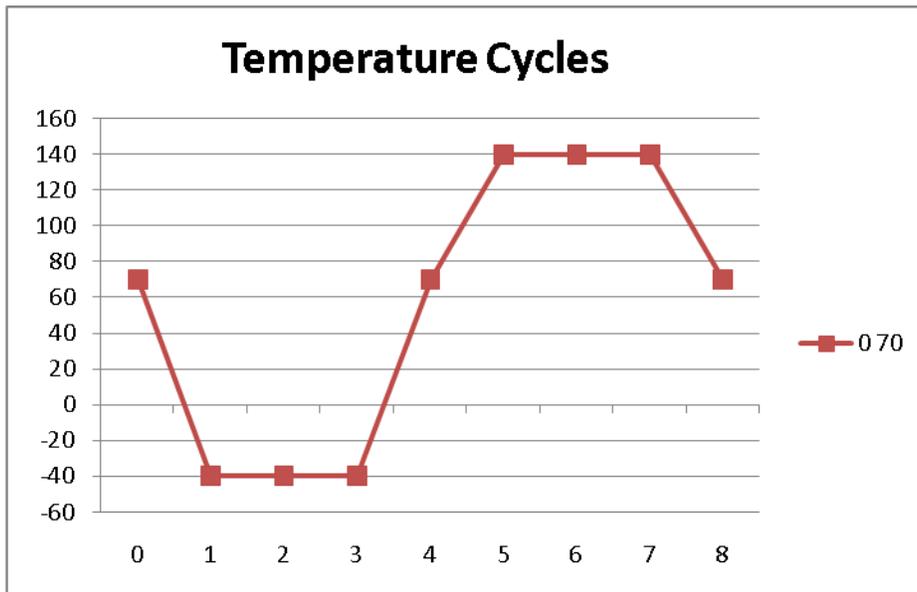
Thermal Cycling

AAMA 501.5 (Three(3) cycles -40°F – +140°F)

Cycle 1 No damage, deformation, cracking
 Cycle 2 No damage, deformation, cracking
 Cycle 3 No damage, deformation, cracking
