Client:	Telling Architectural Ltd 10 Worthington Road Suite K Cranston RI 02920 p. 401/632-4577 c. 401/787-8551
Job Number:	11-0045D
Test Date(s):	6/30-7/1/11
Report Date:	7/22/11

Rainscreen System: Corium Brick System

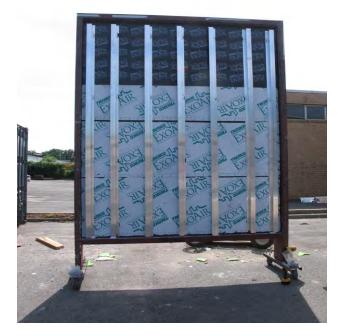
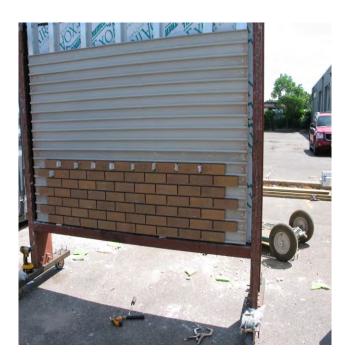
(7) 9 gauge vertical aluminum 2" deep 'Z' sections were fixed 6" from edge and at 16" through the sheathing to the stud behind using 1/4" x 2" stainless steel hexagon head course thread. (39) proprietary HPS200 Colorcoat steel brick trays were fastened in to the vertical 'Z's using 3/16" x 1" stainless steel hexagon head coarse thread screws. The trays interlock. The brick slips are inserted into trays using spacers to maintain 3/8" vertical joints between the brick slips. The slips are built stagger bond or stacked. The mortar joints were pointed manually with an Eastpointe Historic natural hydraulic lime mortar.

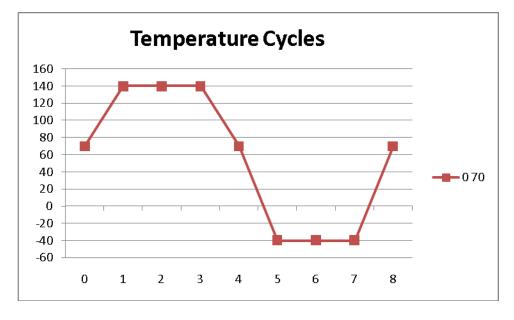
AAMA 501.5 (Three (3) cycles -40°F - +140°F)

- Phase 1: During the first hour, the temperature was increased on the weather side condition to the specified high temperature conditions of 140°F. These conditions were maintained for two hours.
- Phase 2: Weather side temperature decreased to 75°F in one hour.
- Phase: 3 Weather side conditions were lowered to specified low temperature conditions -40°F over the next hour. These conditions were maintained for two hours.
- Phase: 4 Weather side temperature increased to 75°F in one hour.

(*The temperatures were average readings based on thermocouples placed six* (6) *inches from the top, center and six* (6) *inches from the bottom.*)
