Rosebud Power Plant Annual Engineer's Inspection Report

Prepared for Rosebud Operating Services, Inc.
by Allied Engineering Services, Inc.
2017 Report
Posted: January 19, 2018

**ROSEBUD POST-CLOSURE DESIGN
 EXISTING CONDITIONS (AS-BUILT)
 ROSEBUD COUNTY, MT**

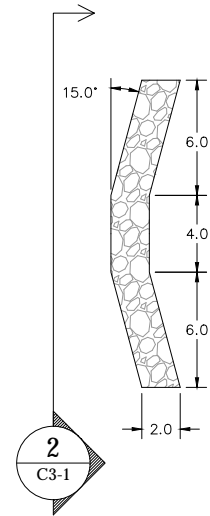
1 DETAIL
C3-1 DRAINAGE WAY 4 GRADE CONTROL - PLAN VIEW
1" = 5'

NOTES:
1. ROCK RIPRAP IS TO BE ANGULAR ROCK WITH A D50 OF 8 INCHES.

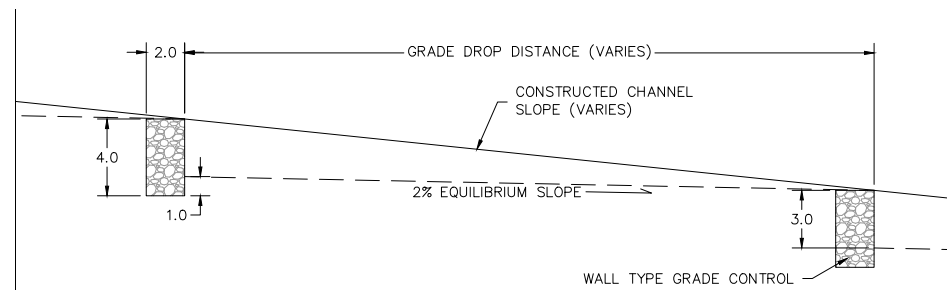
2 DETAIL
C3-1 TYPICAL WALL GRADE CONTROL PROFILE
1" = 5'

NOTES:
1. WALL GRADE BREAKS WILL CONSIST OF COHESIVE MATERIAL OR STRUCTURE SUCH AS REINFORCED CONCRETE, GROUTED ROCK, OR GABION WALL.
2. DISTANCE BETWEEN GRADE DROPS IS SHOWN ON PLANS. IT VARIES WITH CHANNEL SLOPE.
3. EQUILIBRIUM SLOPE WAS DETERMINED BY COMPARISON OF EXISTING SLOPES.

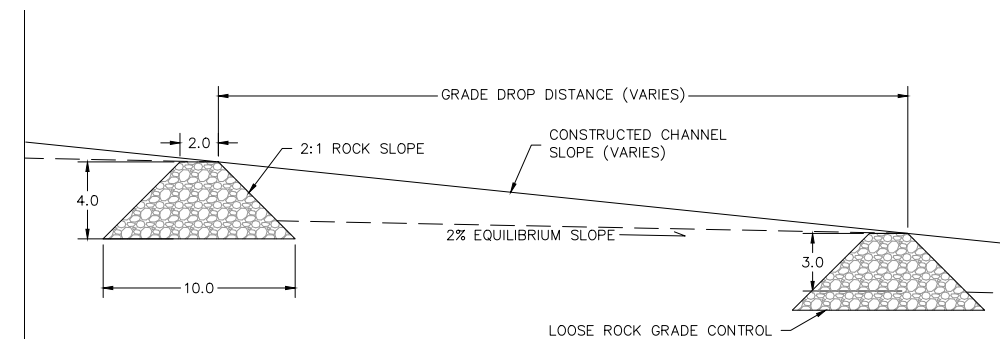
3 DETAIL
C3-1 TYPICAL LOOSE ROCK GRADE CONTROL PROFILE
1" = 5'

NOTES:
1. ROCK RIPRAP IS TO BE ANGULAR ROCK WITH A D50 OF 8 INCHES.
2. DISTANCE BETWEEN GRADE DROPS IS SHOWN ON PLANS. IT VARIES WITH CHANNEL SLOPE.
3. EQUILIBRIUM SLOPE WAS DETERMINED BY COMPARISON OF EXISTING SLOPES.

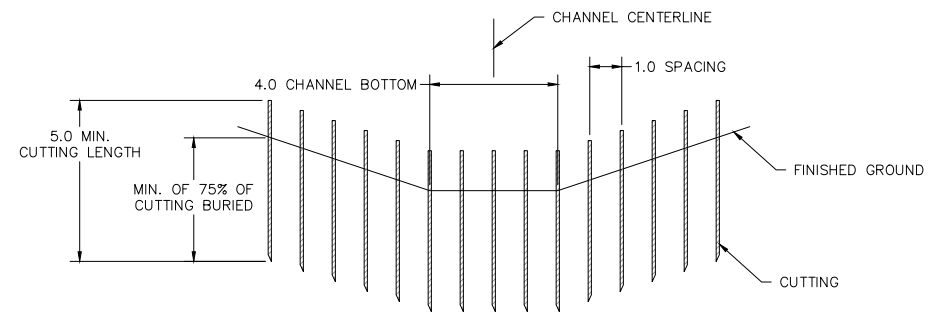
SECTION VIEW - TYPICAL FULL CHANNEL LIVE STAKING

- LIVE STAKING SPECIFICATIONS:
- CUTTINGS USED IN STAKING MUST BE A MINIMUM LENGTH OF 5 FT WITH A MINIMUM DIAMETER OF 1".
 - LARGER DIAMETER AND LENGTH CUTTINGS SHOULD BE USED WHEN PLACED IN ROCK (3-5" DIAMETER, 5-10' LENGTH).
 - CUTTINGS ARE TO BE BURIED A MINIMUM OF $\frac{3}{4}$ IN THE GROUND.
 - PREFERRED SPECIES OF CUTTINGS ARE: PLAINS COTTONWOOD (*Populus deltoids*), AND BLACK COTTONWOOD (*Populus trichocarpa*).
 - CUTTINGS ARE BEST HARVESTED FROM LIVE DORMANT TREES, 2-7 YEARS OLD.
 - PREFERRED TIMING OF PLANTING IS LATE SPRING AFTER PEAK RUN-OFF.
 - IT IS RECOMMENDED TO SOAK CUTTINGS FOR A MINIMUM OF 24 HOURS BEFORE PLANTING.
 - ADDITIONAL PLANTING INFORMATION CAN BE FOUND IN THE USDA, NRCS TECHNICAL NOTE PLANT MATERIALS NO. 23 - HOW TO PLANT WILLOWS AND COTTONWOODS FOR RIPARIAN RESTORATION.

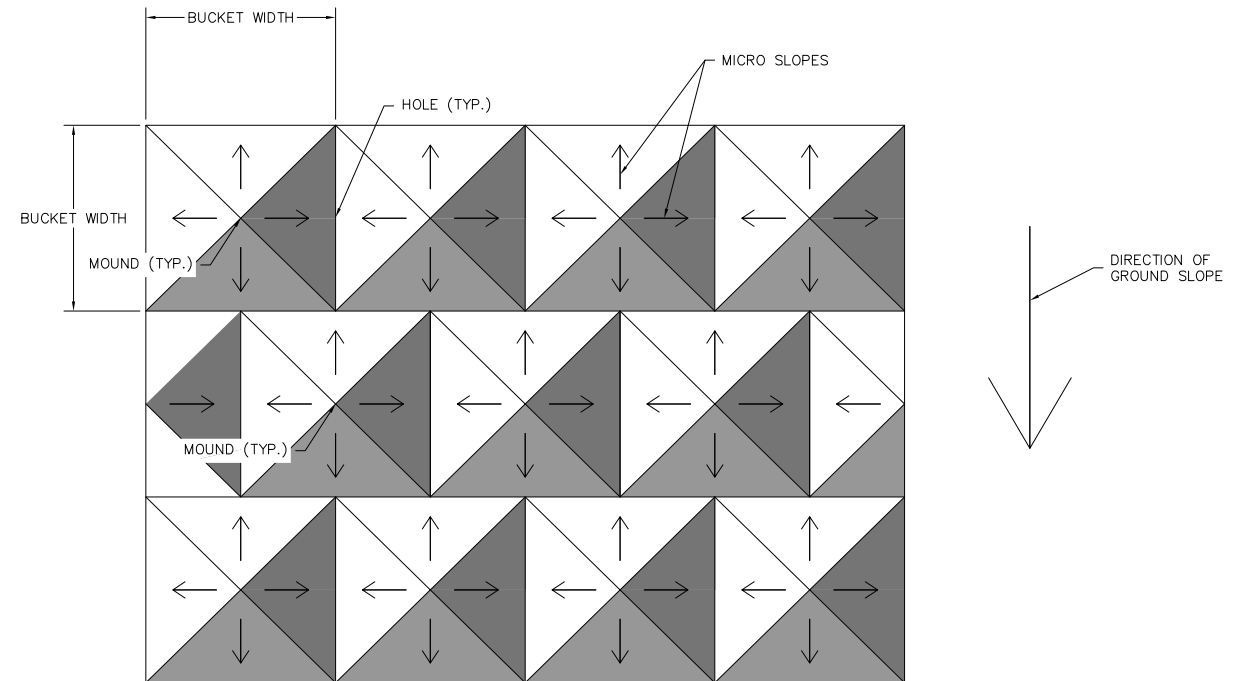
1 **DETAIL**
C3-2 **ROUGH AND LOOSE TREATMENT**
NTS

CONSTRUCTION OF A ROUGH AND LOOSE SURFACE INVOLVES AN EXCAVATOR AND A SIMPLE PATTERN TO CREATE A ROUGH SURFACE OF MOUNDS AND HOLES. THE EXCAVATOR DIGS A BUCKET OF SOIL THEN PLACES THE SOIL TO THE LEFT OF THE HOLE JUST OPENED, HALF A BUCKET WIDTH FROM THE HOLE SO IT IS HALF IN AND HALF OUT OF THE HOLE. A SECOND HOLE IS THEN EXCAVATED HALF A BUCKET WIDTH TO THE RIGHT OF THE FIRST HOLE. MATERIAL FROM THIS HOLE IS THEN PLACED BETWEEN THE FIRST AND SECOND HOLES. A THIRD HOLE IS NOW OPENED HALF A BUCKET WIDTH TO THE RIGHT OF THE SECOND HOLE, WITH THE EXCAVATED SOIL BEING PLACED BETWEEN THE SECOND AND THIRD HOLES. CARE SHOULD BE TAKEN WHEN EXCAVATING THE HOLES TO SHATTER THE MATERIAL BETWEEN THE HOLES AS DIGGING PROGRESSES. THE PROCESS OF MAKING HOLES AND DUMPING SOIL IS CONTINUED UNTIL THE REASONABLE OPERATING SWING OF THE EXCAVATOR IS REACHED. THE EXCAVATOR THEN BACKS UP THE WIDTH OF THE HOLE AND REPEATS THE PROCESS, BEING SURE TO LINE UP THE HOLES IN THE NEW ROW WITH THE SPACE BETWEEN THE HOLES (MOUNDS) ON THE PREVIOUS ROW.

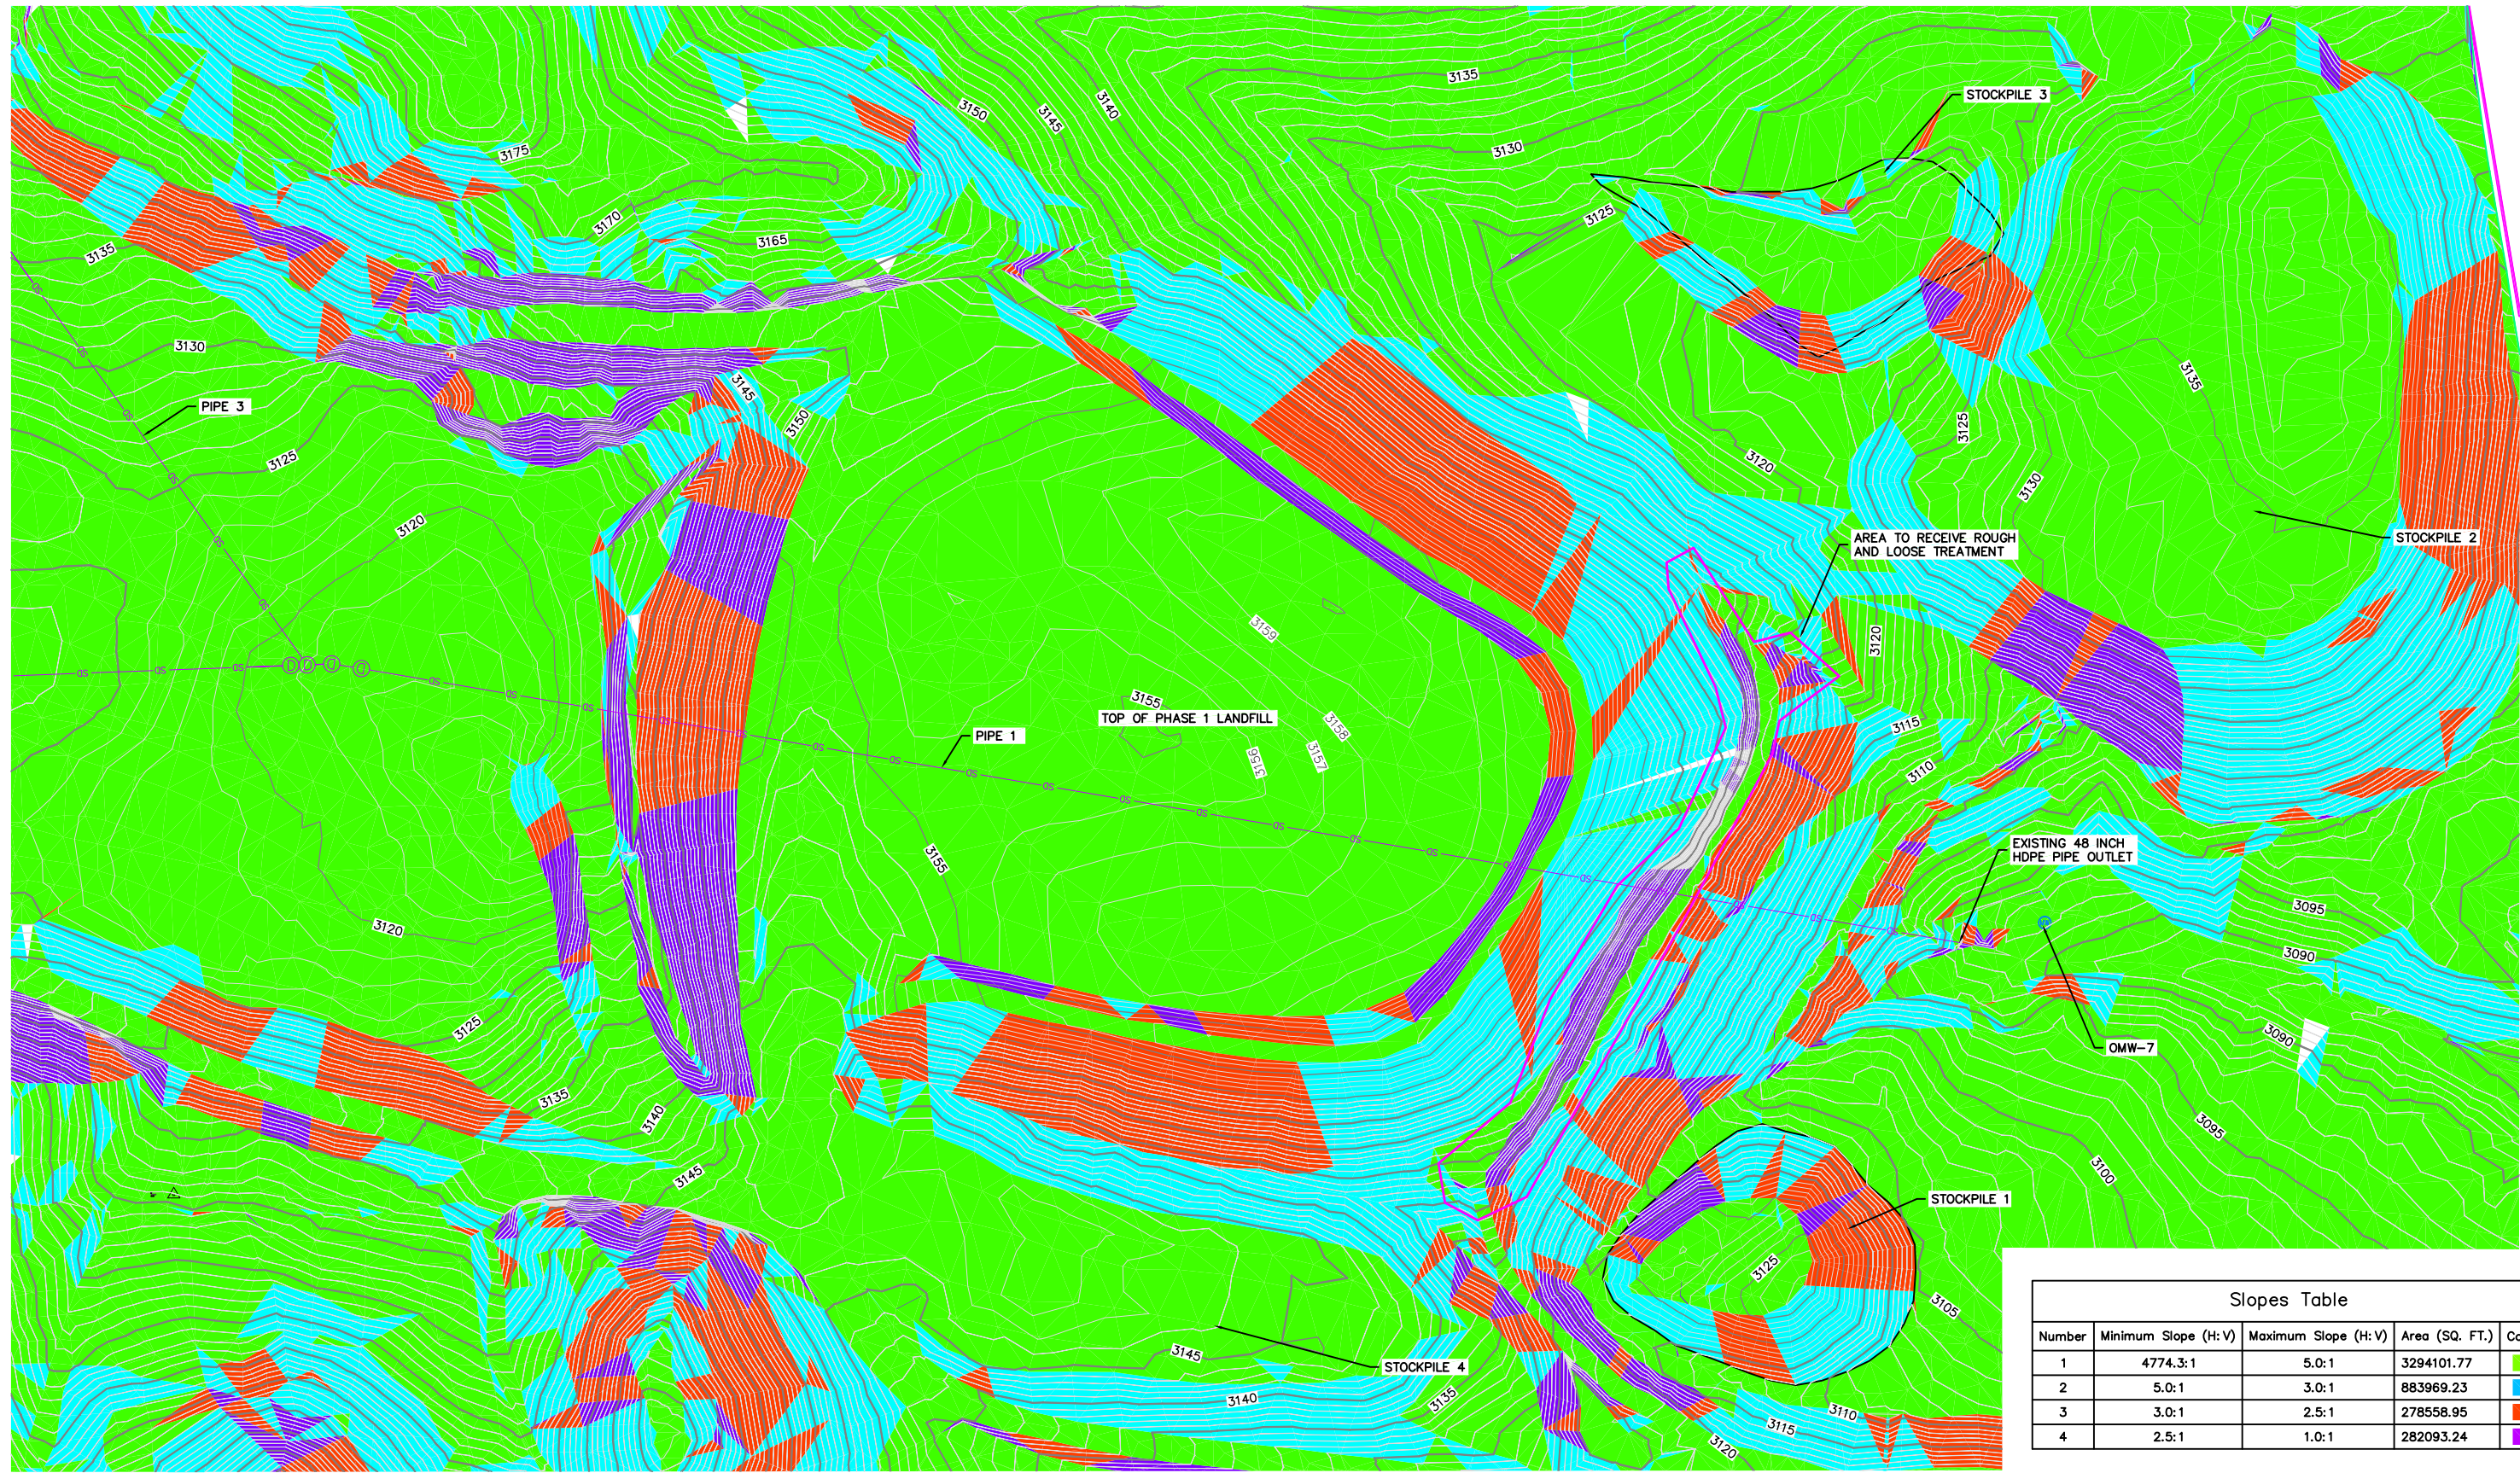
SHEET
S-1

Slopes Table				
Number	Minimum Slope (H:V)	Maximum Slope (H:V)	Area (SQ. FT.)	Color
1	4774.3:1	5.0:1	3294101.77	Green
2	5.0:1	3.0:1	883969.23	Blue
3	3.0:1	2.5:1	278558.95	Orange
4	2.5:1	1.0:1	282093.24	Purple

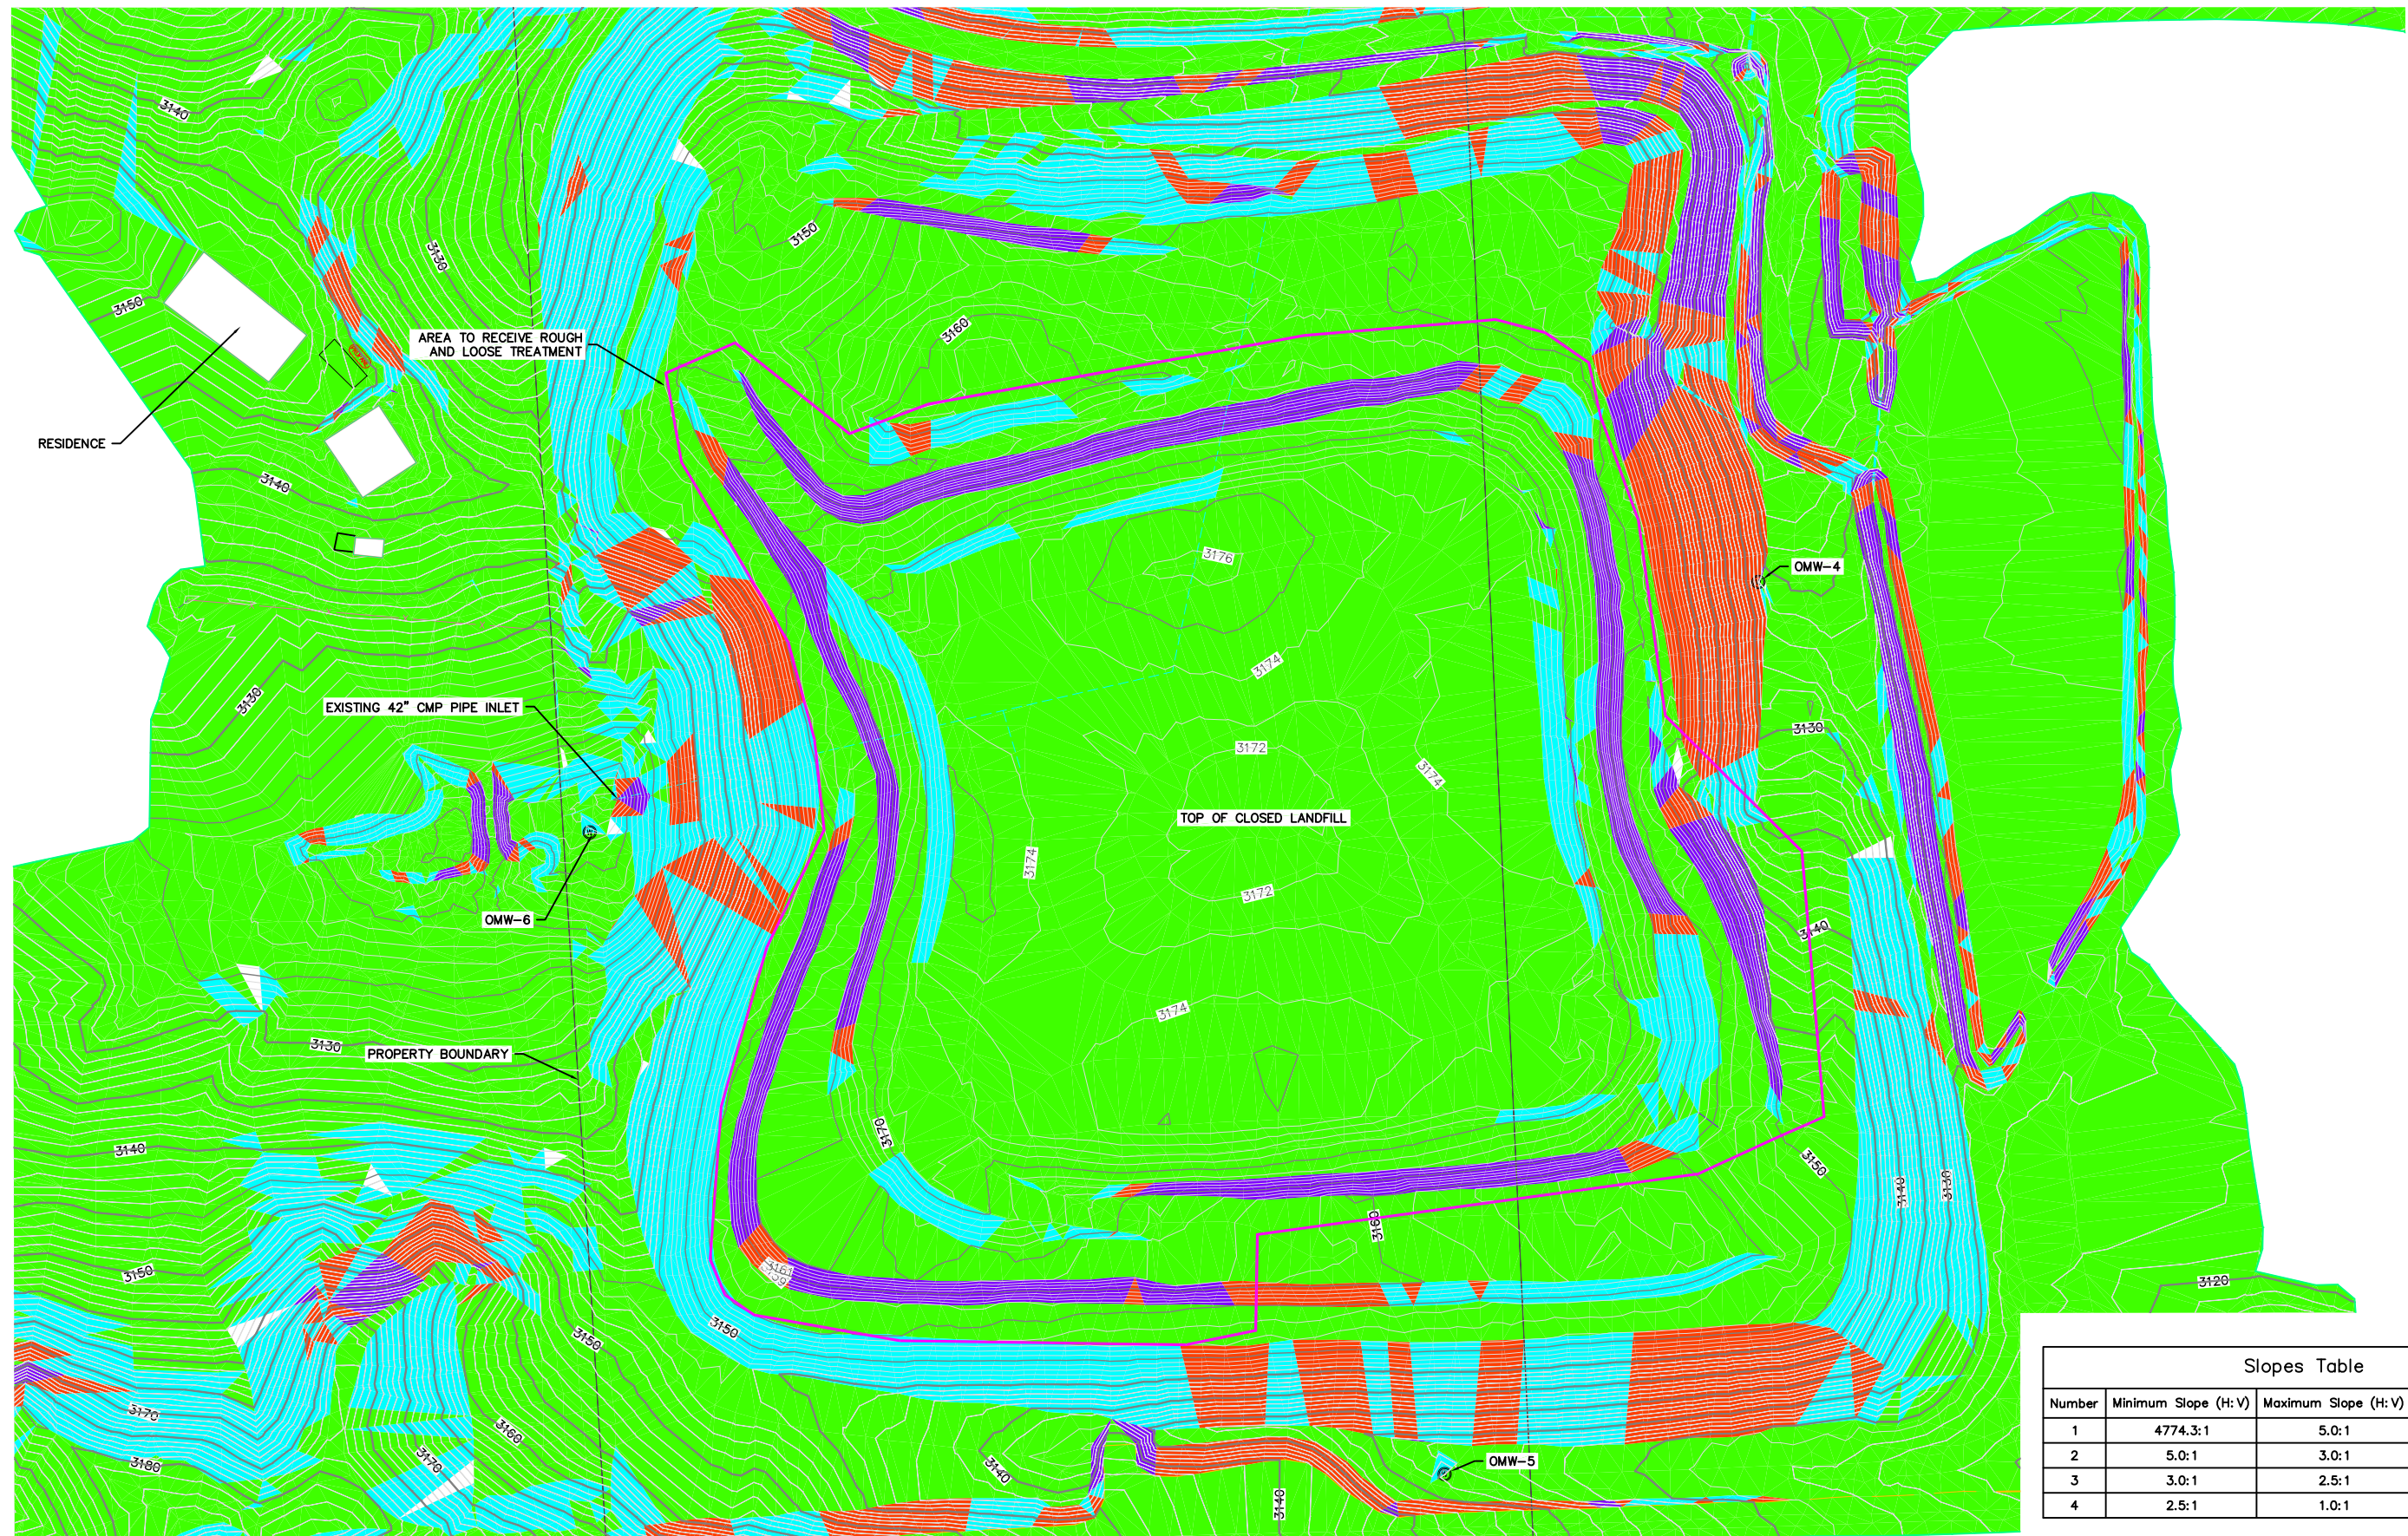
Slopes Table				
Number	Minimum Slope (H:V)	Maximum Slope (H:V)	Area (SQ. FT.)	Color
1	4774.3:1	5.0:1	3294101.77	Green
2	5.0:1	3.0:1	883969.23	Blue
3	3.0:1	2.5:1	278558.95	Orange
4	2.5:1	1.0:1	282093.24	Purple

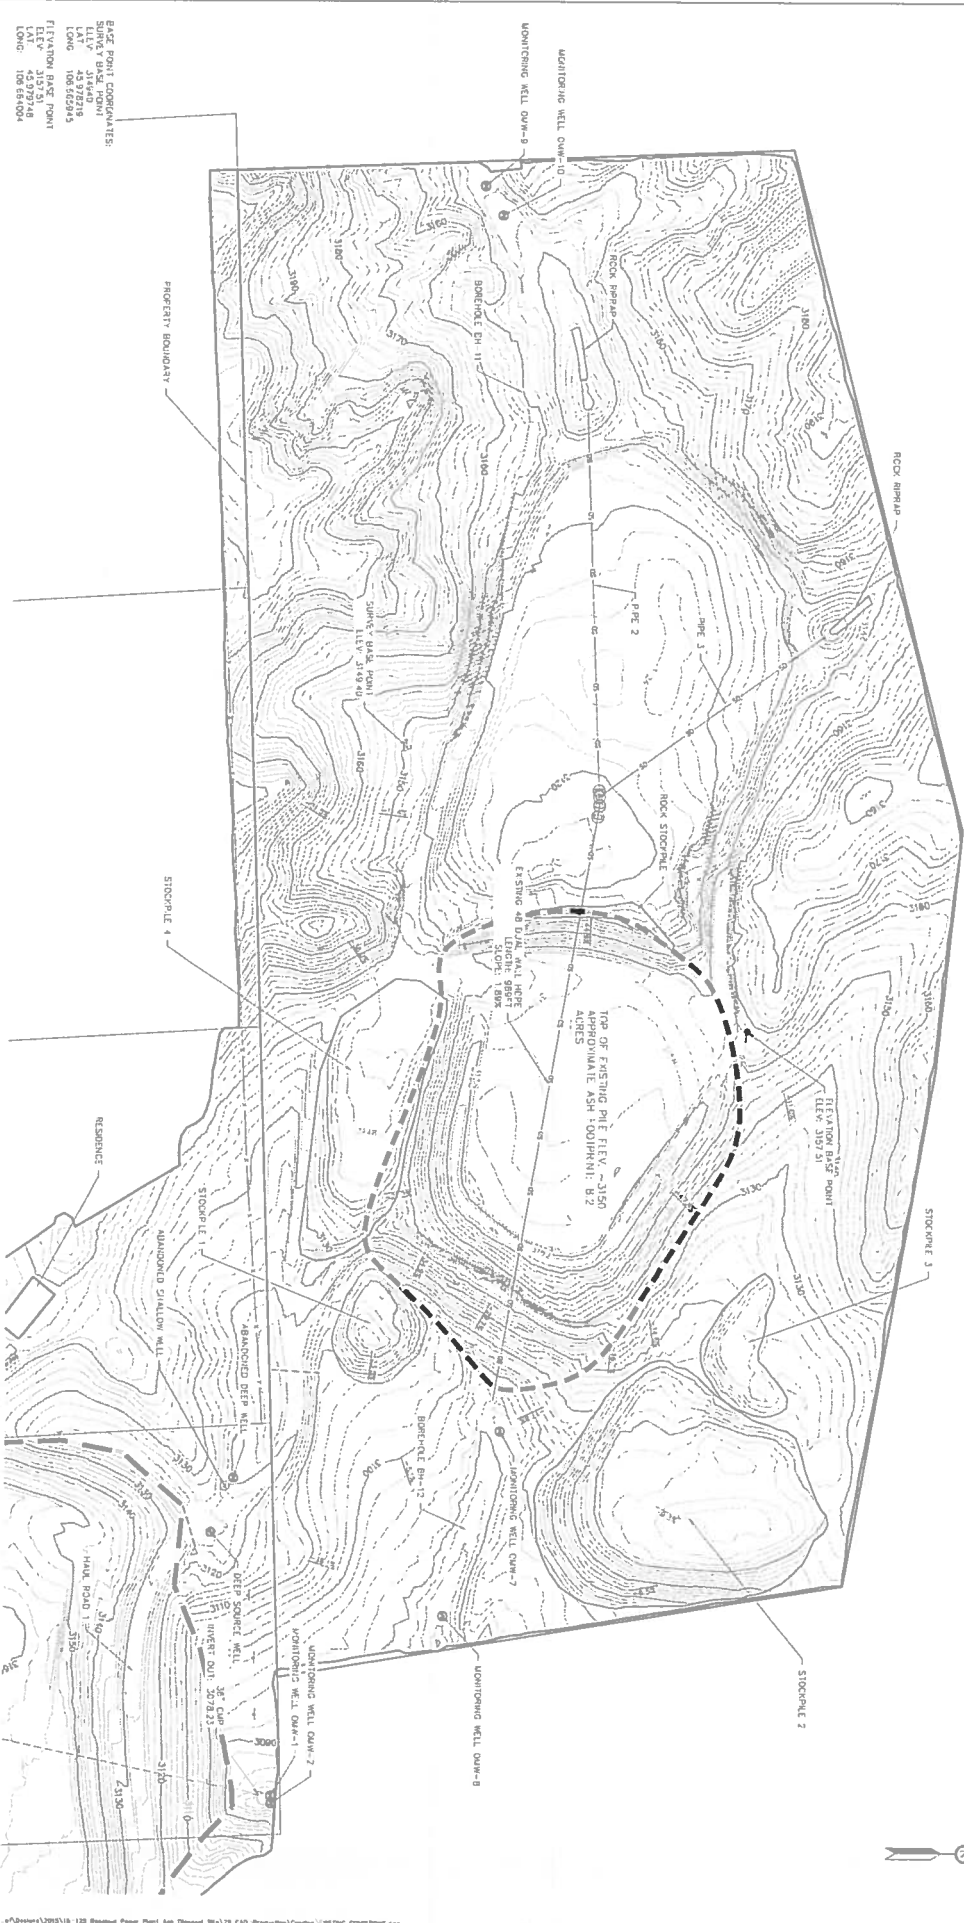
PROJECT # 15-125	SHEET
DATE: 9/15/2015	
EXISTING CONDITIONS	C0-3

SURVEY OF PLATE 1, LOCAL AND SURROUNDING AREA
 9/14/15 BY CHRIS FINCH OF AEG
 1/27/16 BY CHRIS FINCH AND KYLE THOMPSON OF AEG

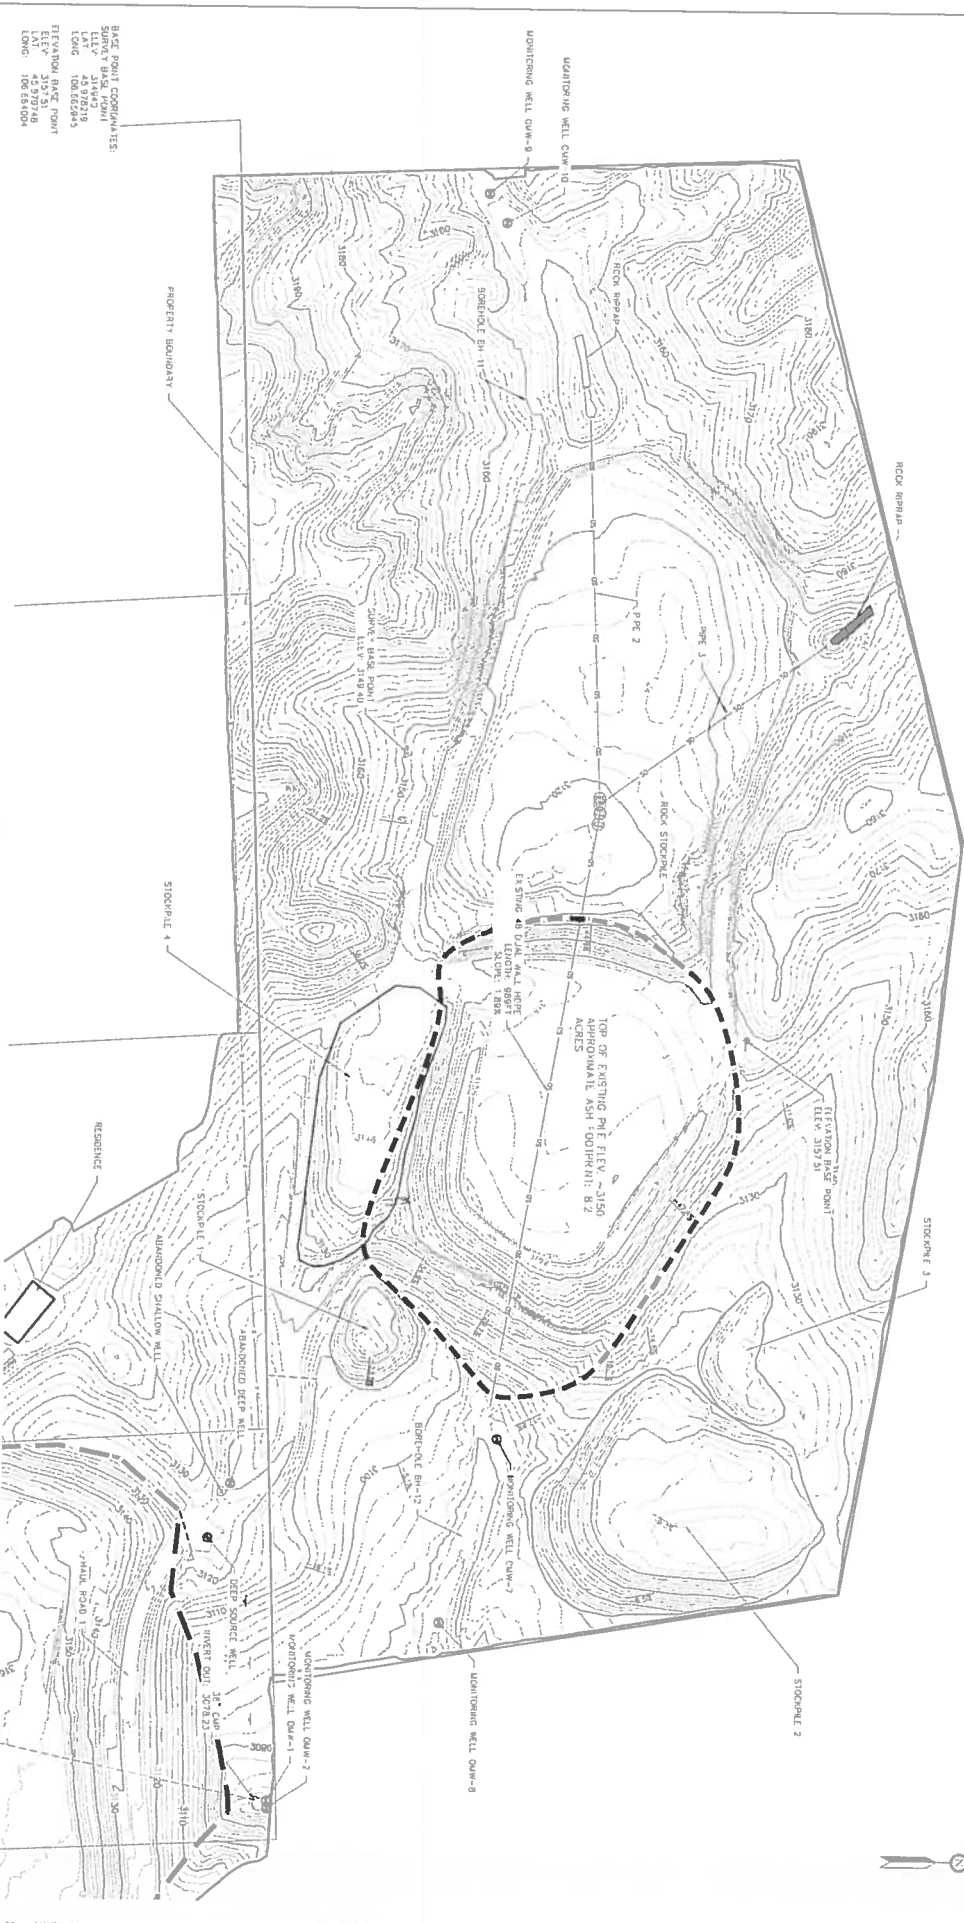
PROJECT # 13-135	SHEET
DATE 9/12/2015	C0-3
EXISTING CONDITIONS

PORTION OF MAP AND SURROUNDING AREA
BASED ON TOPOGRAPHIC SURVEY COMPLETED ON
9/11/15 BY GREG PENCE OF AEGS
1/27/16 BY GREG PENCE AND KYLE THOMPSON OF AEGS

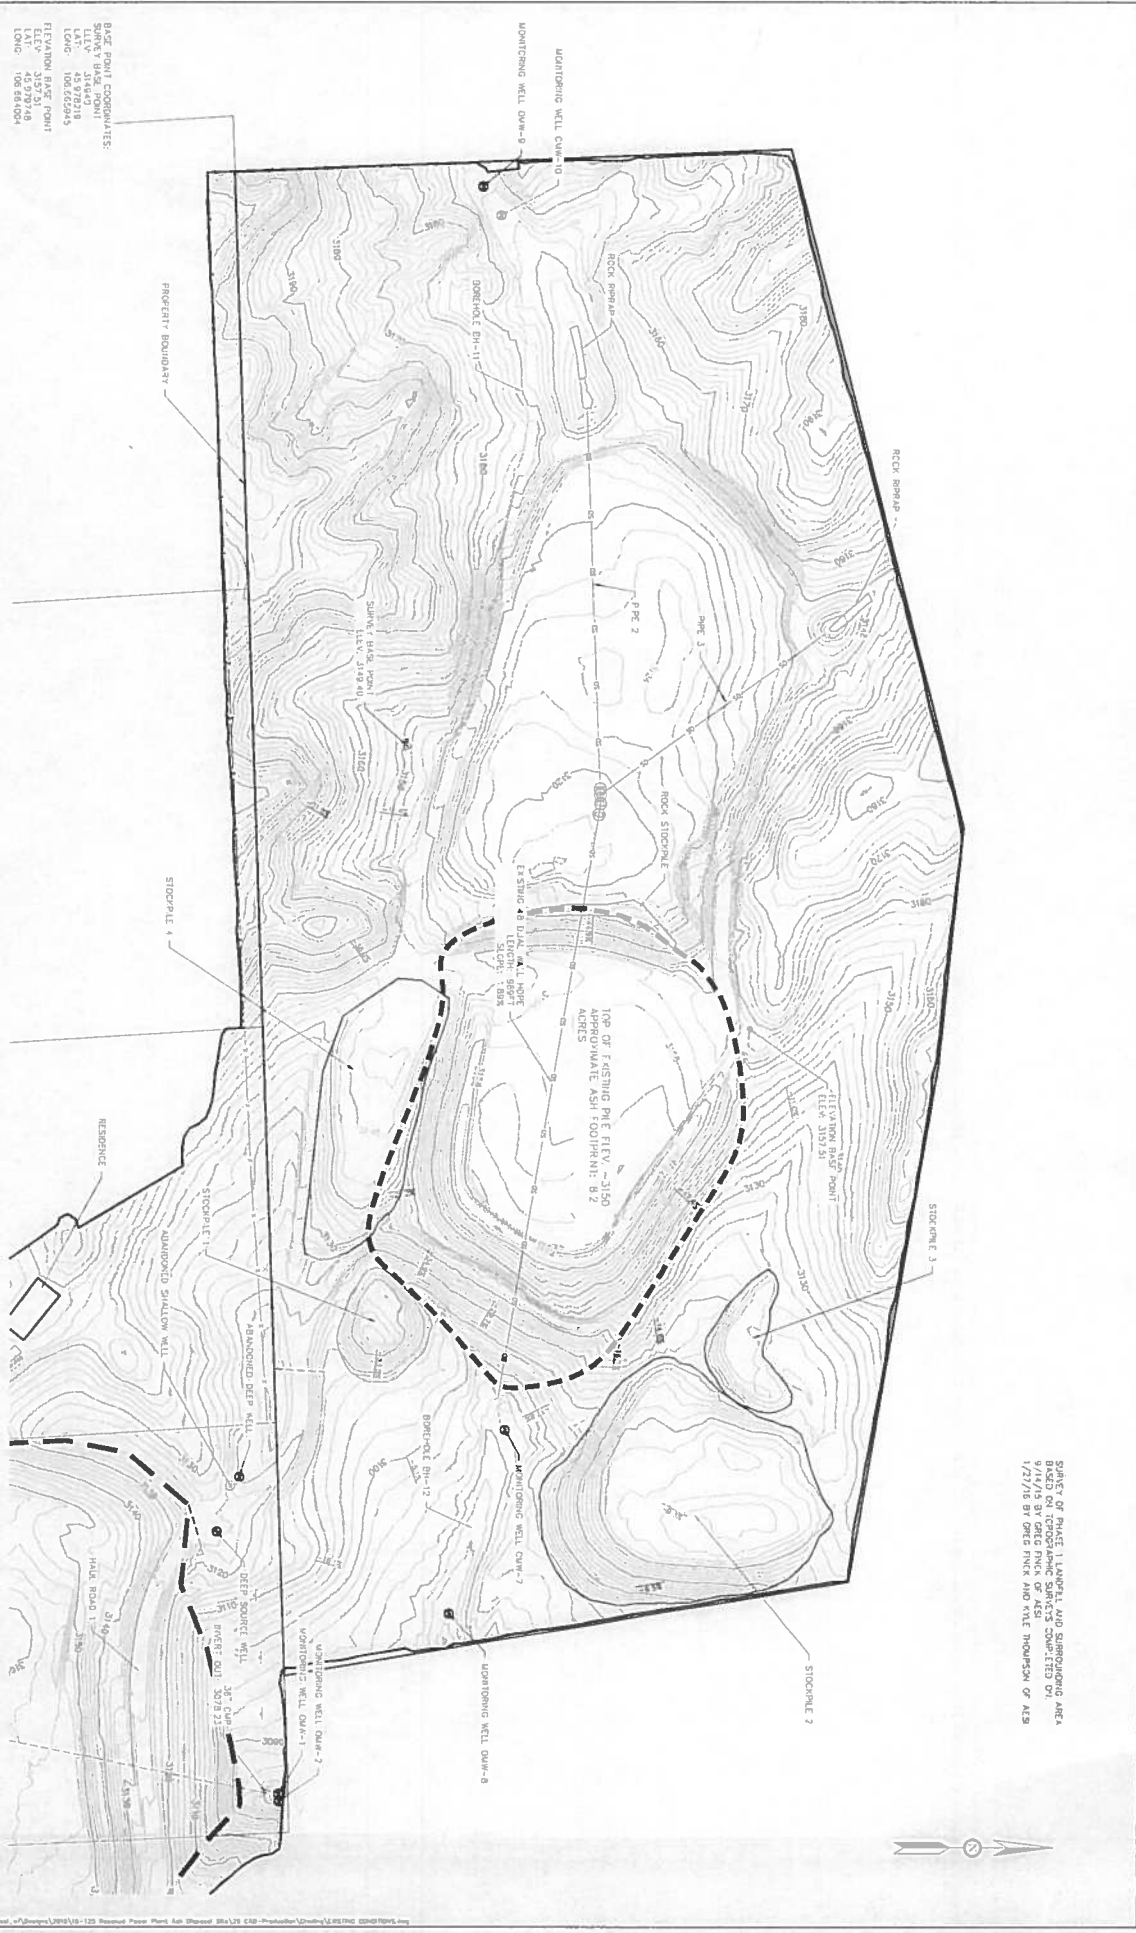
PROJECT # 15-123
 DATE 5/15/2016
 SHEET
 CO-3
 EXISTING CONDITIONS

SURVEY OF PLATE 11 LABEL AND SURROUNDING AREA
 W/AS 5' GRID PINK SURVEY COMPLETED BY
 1/27/15 BY DREG FINCH AND KYLE THOMPSON OF AEG
