SOHS Science Classroom Modernization

ADDENDUM # 1

ASBESTOS & LEAD-BASED PAINT INSPECTION REPORT

LIMITED GEOTECHNICAL INVESTIGATION

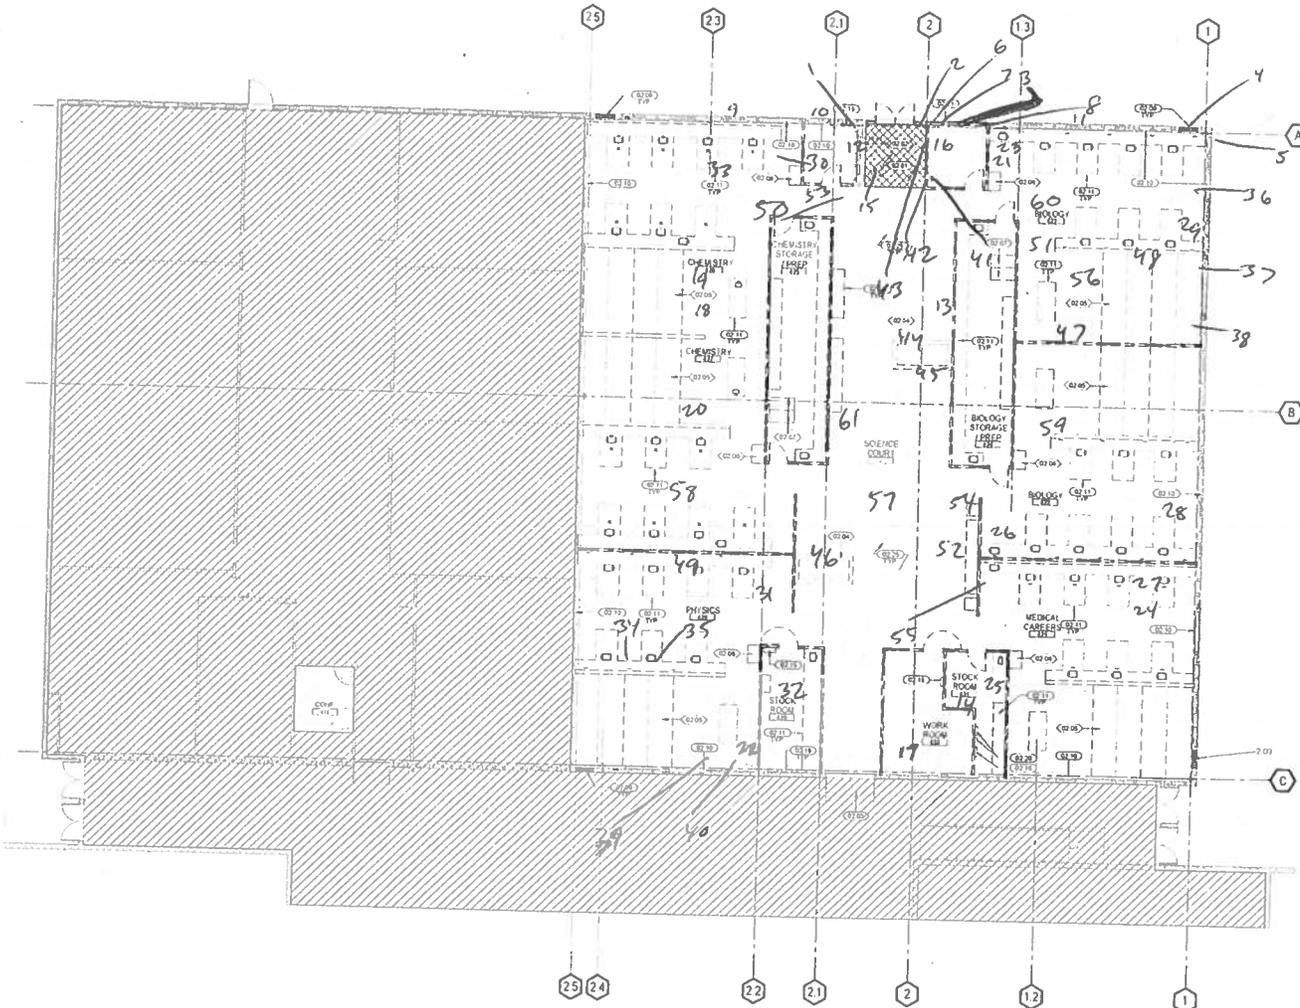
01 - FLOOR DEMOLITION PLAN 11/15/05

Material Description	Locations	Individual Sq Ft	Total Sq Ft	Condition	Qty of Samples	Sample #'s
Partition Curtain	Science 421-428 Int - Classrooms		10004	G	3	47-49
2'x4' Fiberglass Ceiling Panel	- Int throughout		100006			50-52
Gypsum/ Joint Compound	- Throughout Above Drop Ceiling		30006			53-55
Ceiling Space Insulation			12006			56-58
HVAC Insulation			7004			59-61

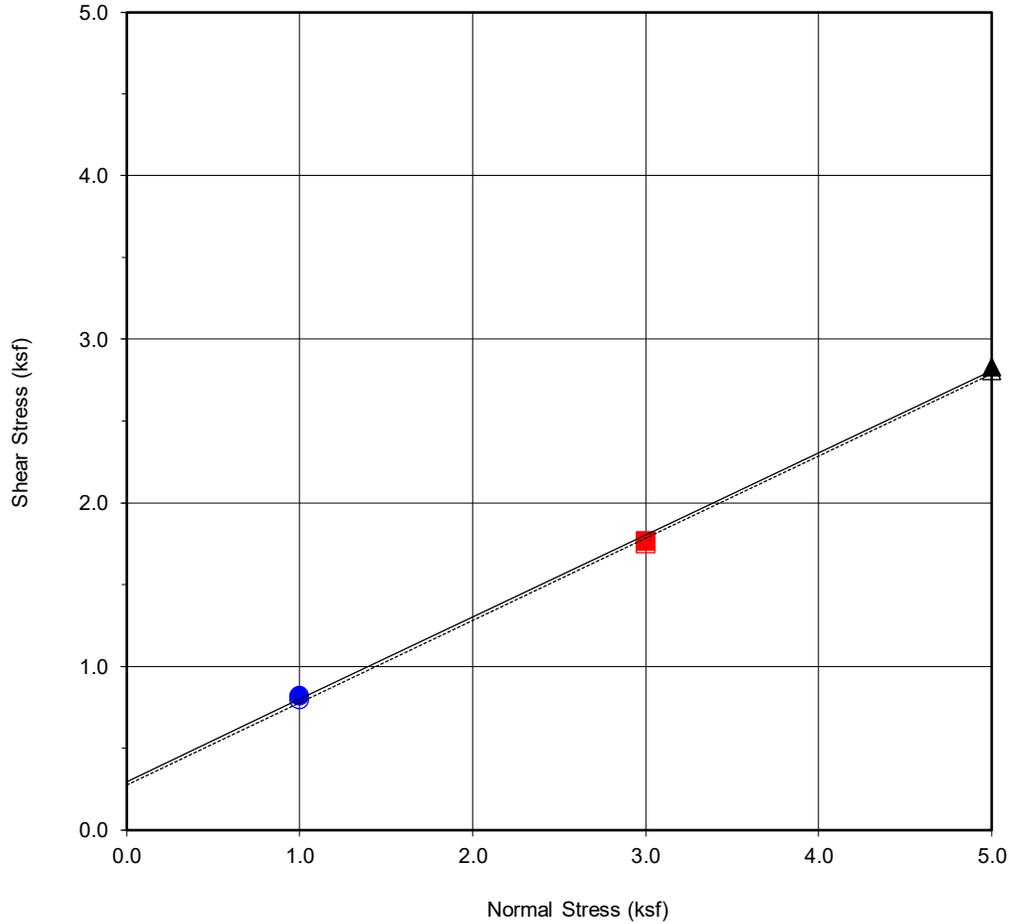
Project No.: W2068-88-02
SONORA HIGH SCHOOL
401 SOUTH PALM STREET
LA HABRA, CALIFORNIA
NOV. 2025 Figure B1

Boring No.	B1
Sample No.	B1@0-5'
Depth (ft)	0-5'
<u>Sample Type:</u>	Bulk

<u>Soil Identification:</u>		
Sand w/ Silt (SP-SM)		
Strength Parameters		
	C (psf)	ϕ ($^{\circ}$)
Peak	296	27
Ultimate	276	27

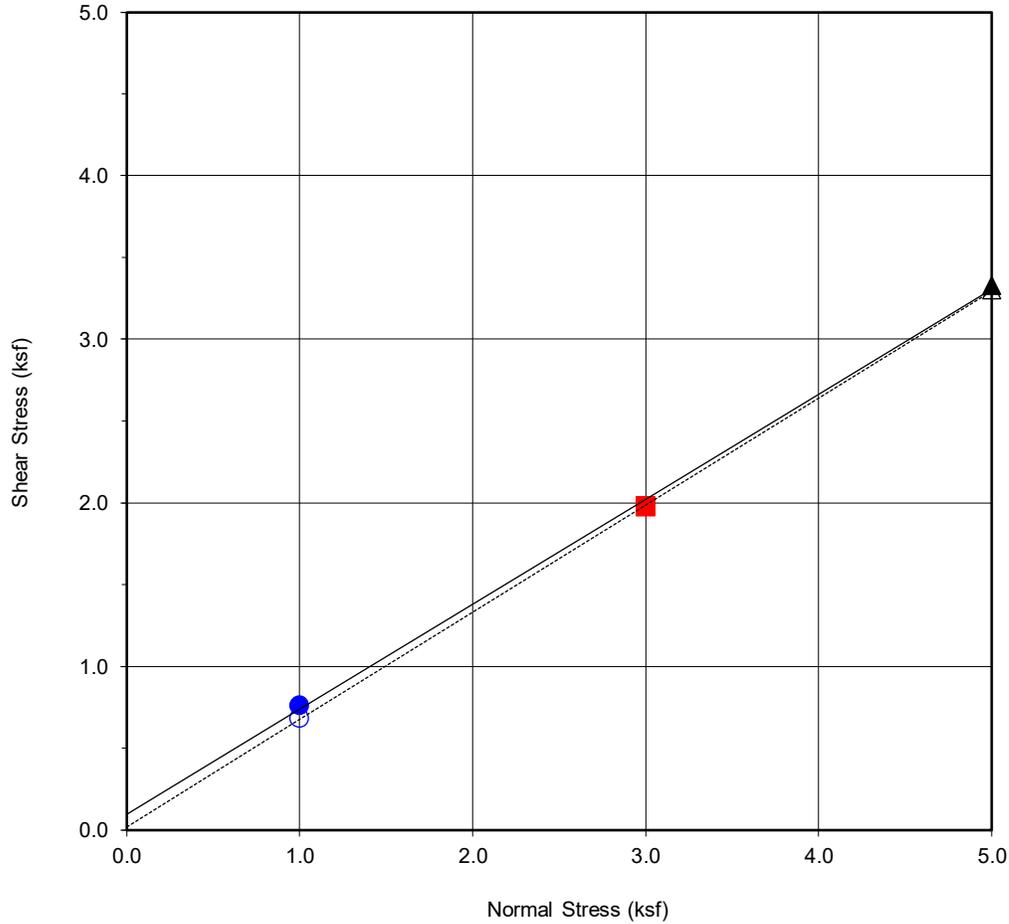
Project No.: W2068-88-02
SONORA HIGH SCHOOL
401 SOUTH PALM STREET
LA HABRA, CALIFORNIA
NOV. 2025 Figure B2

Boring No.	B1
Sample No.	B1@3'
Depth (ft)	3'
<u>Sample Type:</u>	Ring

<u>Soil Identification:</u>		
Sand w/ Silt (SP-SM)		
Strength Parameters		
	C (psf)	ϕ ($^{\circ}$)
Peak	96	33
Ultimate	22	33

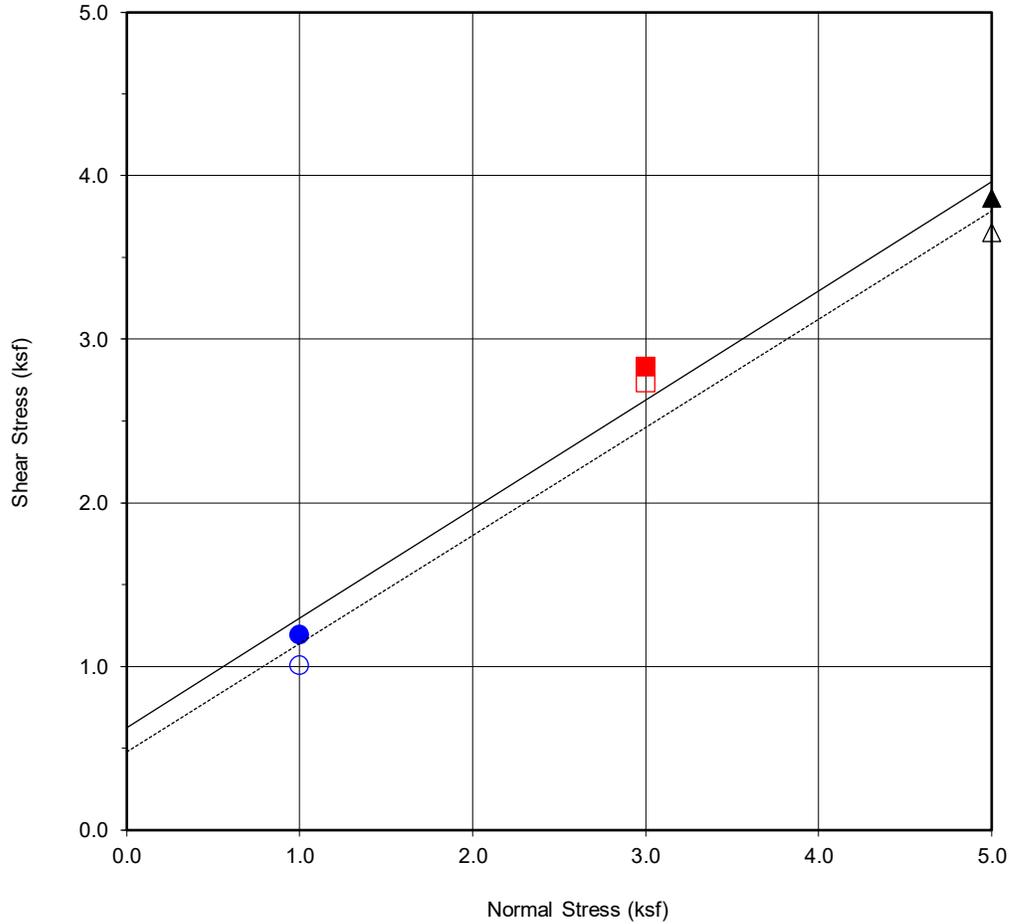
Project No.: W2068-88-02
SONORA HIGH SCHOOL
401 SOUTH PALM STREET
LA HABRA, CALIFORNIA
NOV. 2025 Figure B3

Boring No.	B1
Sample No.	B1@9'
Depth (ft)	9'
<u>Sample Type:</u>	Ring

<u>Soil Identification:</u>		
Sandy Clay (CL)		
Strength Parameters		
	C (psf)	ϕ ($^{\circ}$)
Peak	626	34
Ultimate	478	33

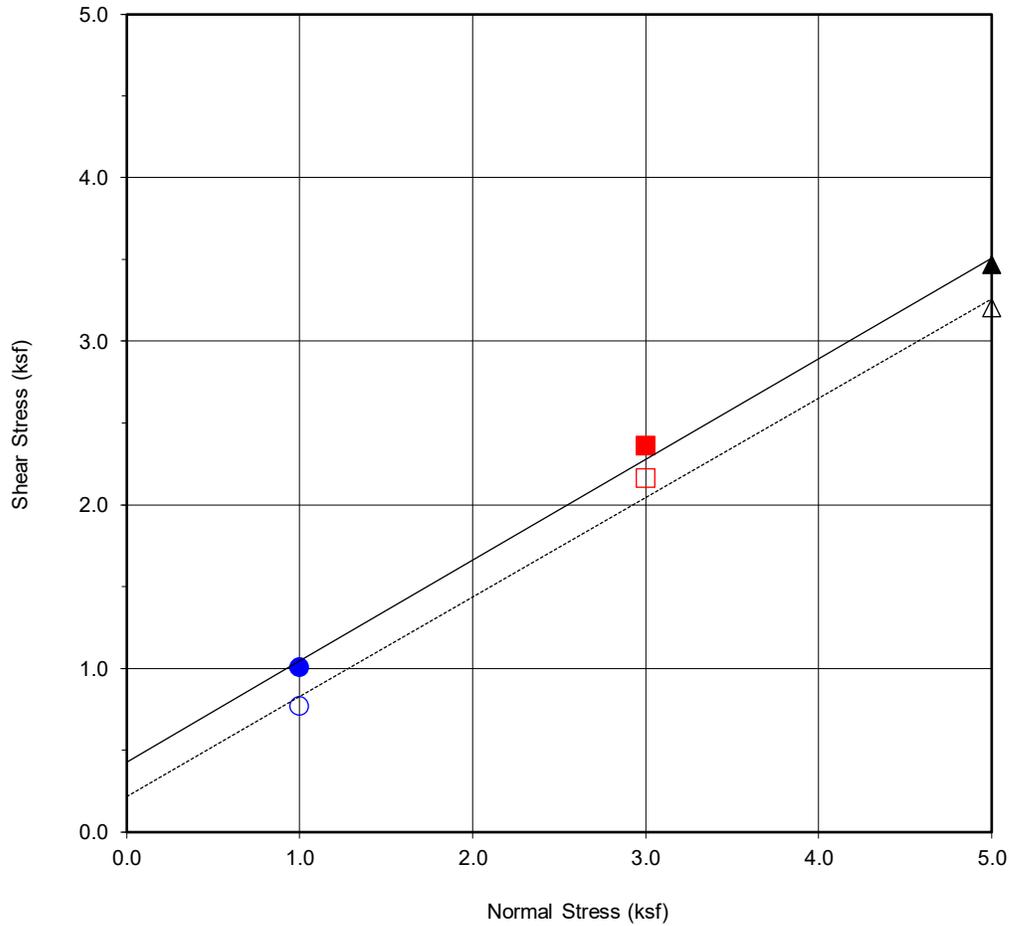
Project No.: W2068-88-02
SONORA HIGH SCHOOL
401 SOUTH PALM STREET
LA HABRA, CALIFORNIA
NOV. 2025 Figure B4

Boring No.	B1
Sample No.	B1@25'
Depth (ft)	25'
<u>Sample Type:</u>	Ring

<u>Soil Identification:</u>		
Clayey Sand (SC)		
Strength Parameters		
	C (psf)	ϕ ($^{\circ}$)
Peak	430	32
Ultimate	219	31

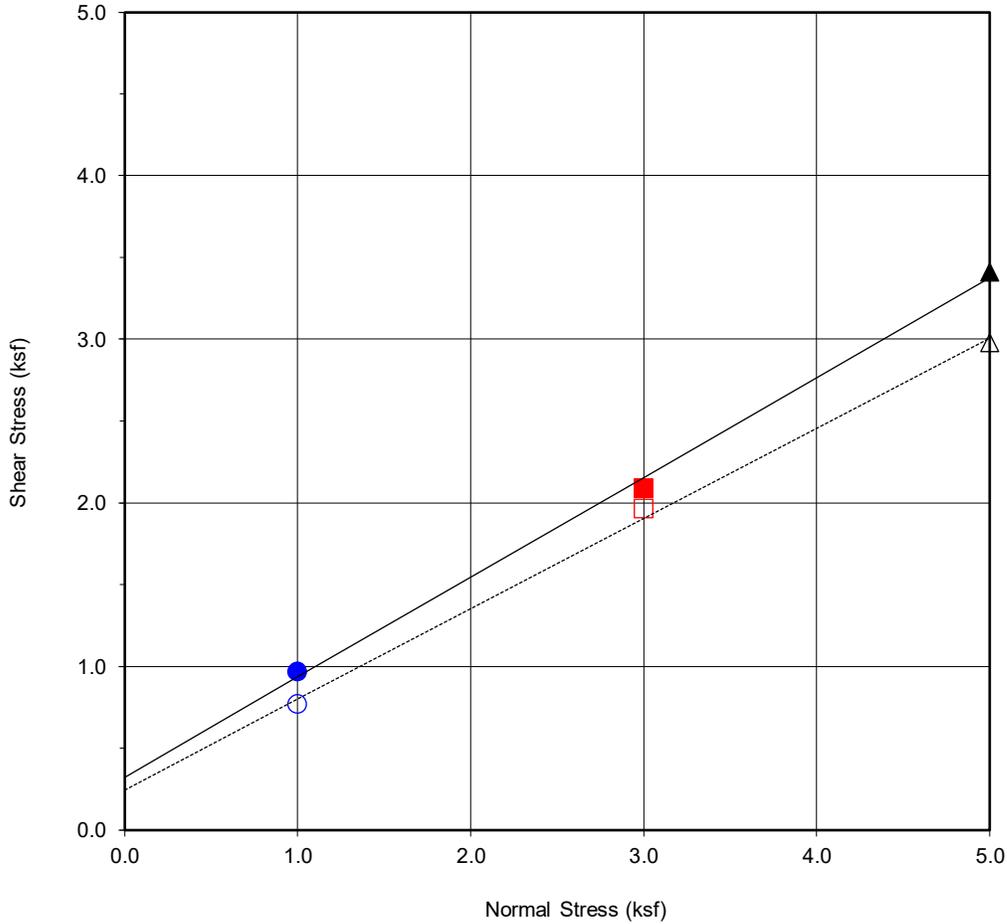
NOV. 2025 Figure B5

Boring No.	B2
Sample No.	B2@10'
Depth (ft)	10'
<u>Sample Type:</u>	Ring

<u>Soil Identification:</u>		
Clayey Sand (SC)		
Strength Parameters		
	C (psf)	ϕ ($^{\circ}$)
Peak	324	31
Ultimate	246	29

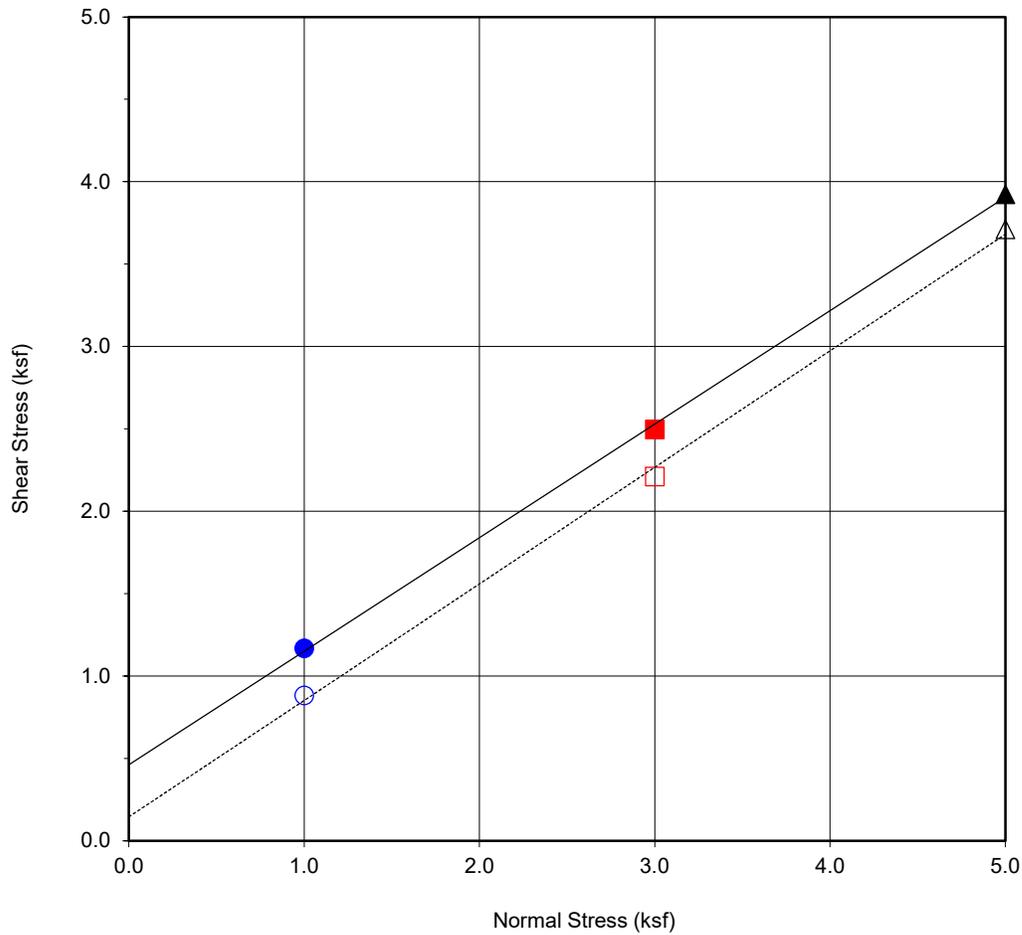
Figure B6

Boring No.	B2
Sample No.	B2@15'
Depth (ft)	15'
<u>Sample Type:</u>	Ring

<u>Soil Identification:</u>		
Clayey Sand (SC)		
Strength Parameters		
	C (psf)	ϕ ($^{\circ}$)
Peak	461	35
Ultimate	146	35

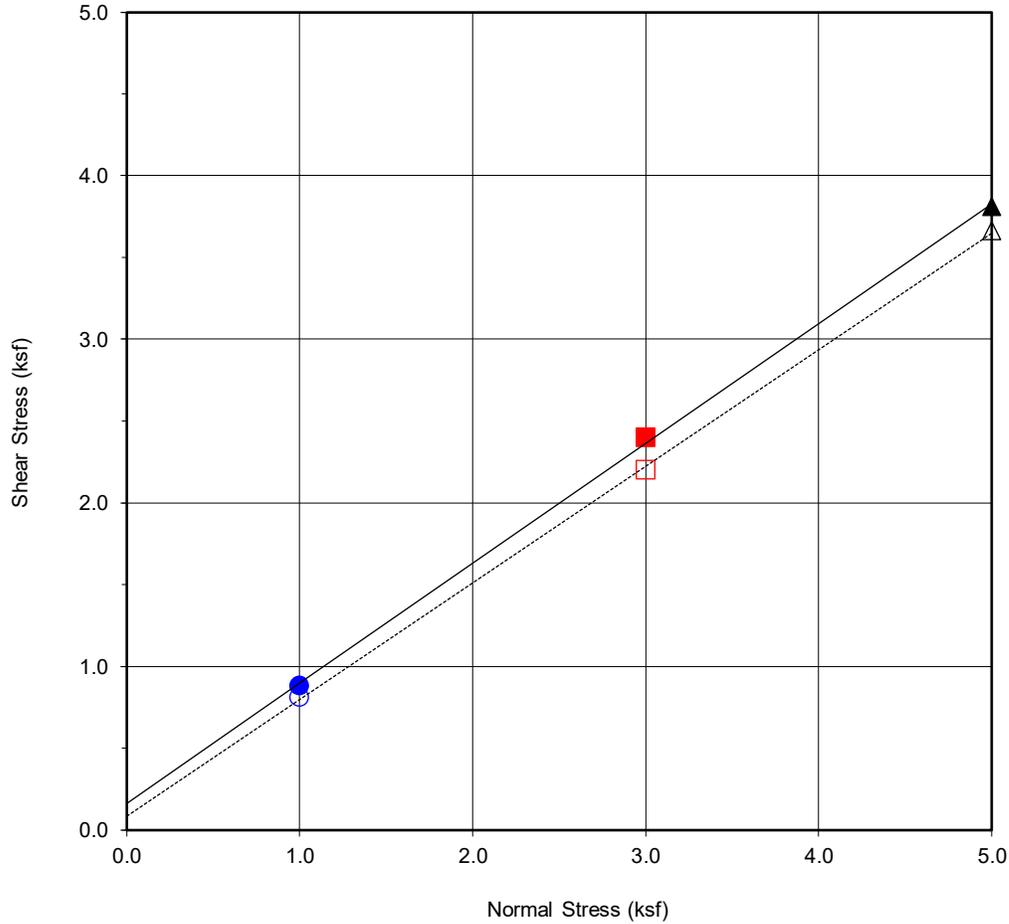
Figure B7

Boring No.	B2
Sample No.	B2@20'
Depth (ft)	20'
<u>Sample Type:</u>	Ring

<u>Soil Identification:</u>		
Sand w/ Clay (SP-SC)		
Strength Parameters		
	C (psf)	ϕ ($^{\circ}$)
Peak	164	36
Ultimate	85	35

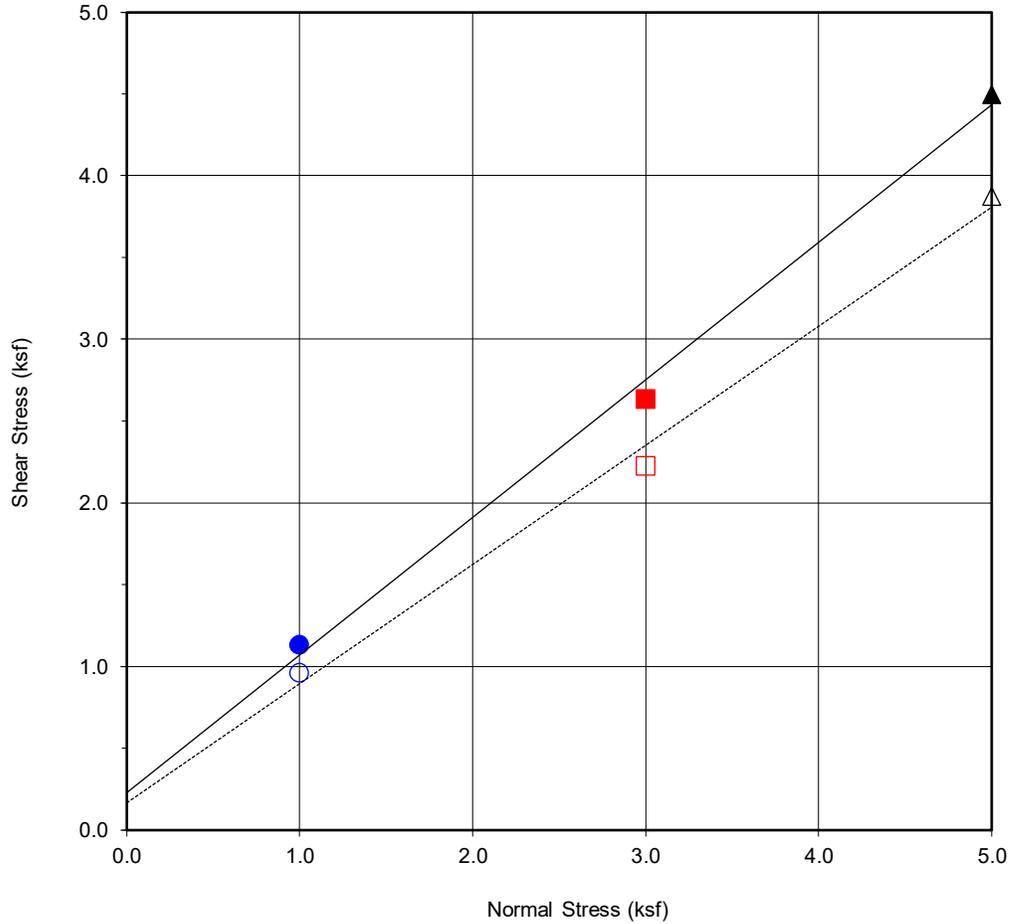
Figure B8

Boring No.	B3
Sample No.	B3@20'
Depth (ft)	20'
<u>Sample Type:</u>	Ring

<u>Soil Identification:</u>		
Sand w/ Clay (SP-SC)		
Strength Parameters		
	C (psf)	ϕ ($^{\circ}$)
Peak	229	40
Ultimate	167	36

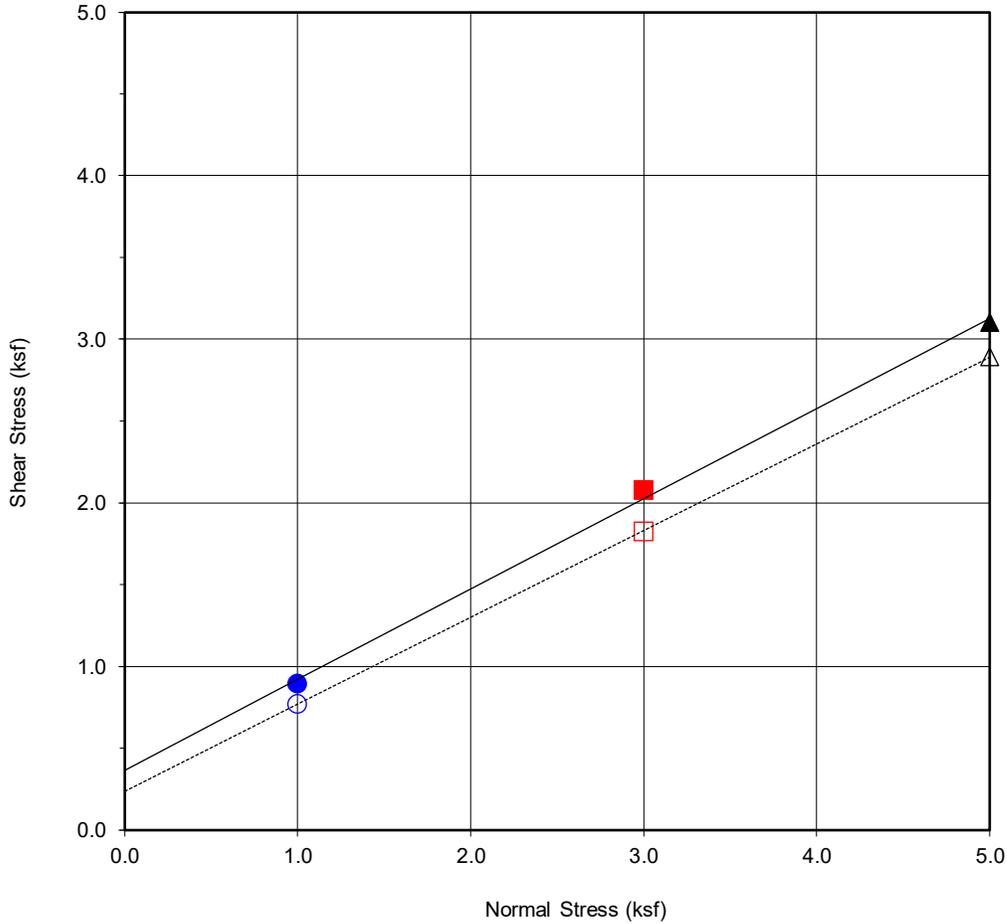
Project No.: W2068-88-02
SONORA HIGH SCHOOL
401 SOUTH PALM STREET
LA HABRA, CALIFORNIA
NOV. 2025 Figure B9

Boring No.	B4
Sample No.	B4@20'
Depth (ft)	20'
<u>Sample Type:</u>	Ring

<u>Soil Identification:</u>		
Clayey Sand (SC)		
Strength Parameters		
	C (psf)	ϕ ($^{\circ}$)
Peak	367	29
Ultimate	237	28

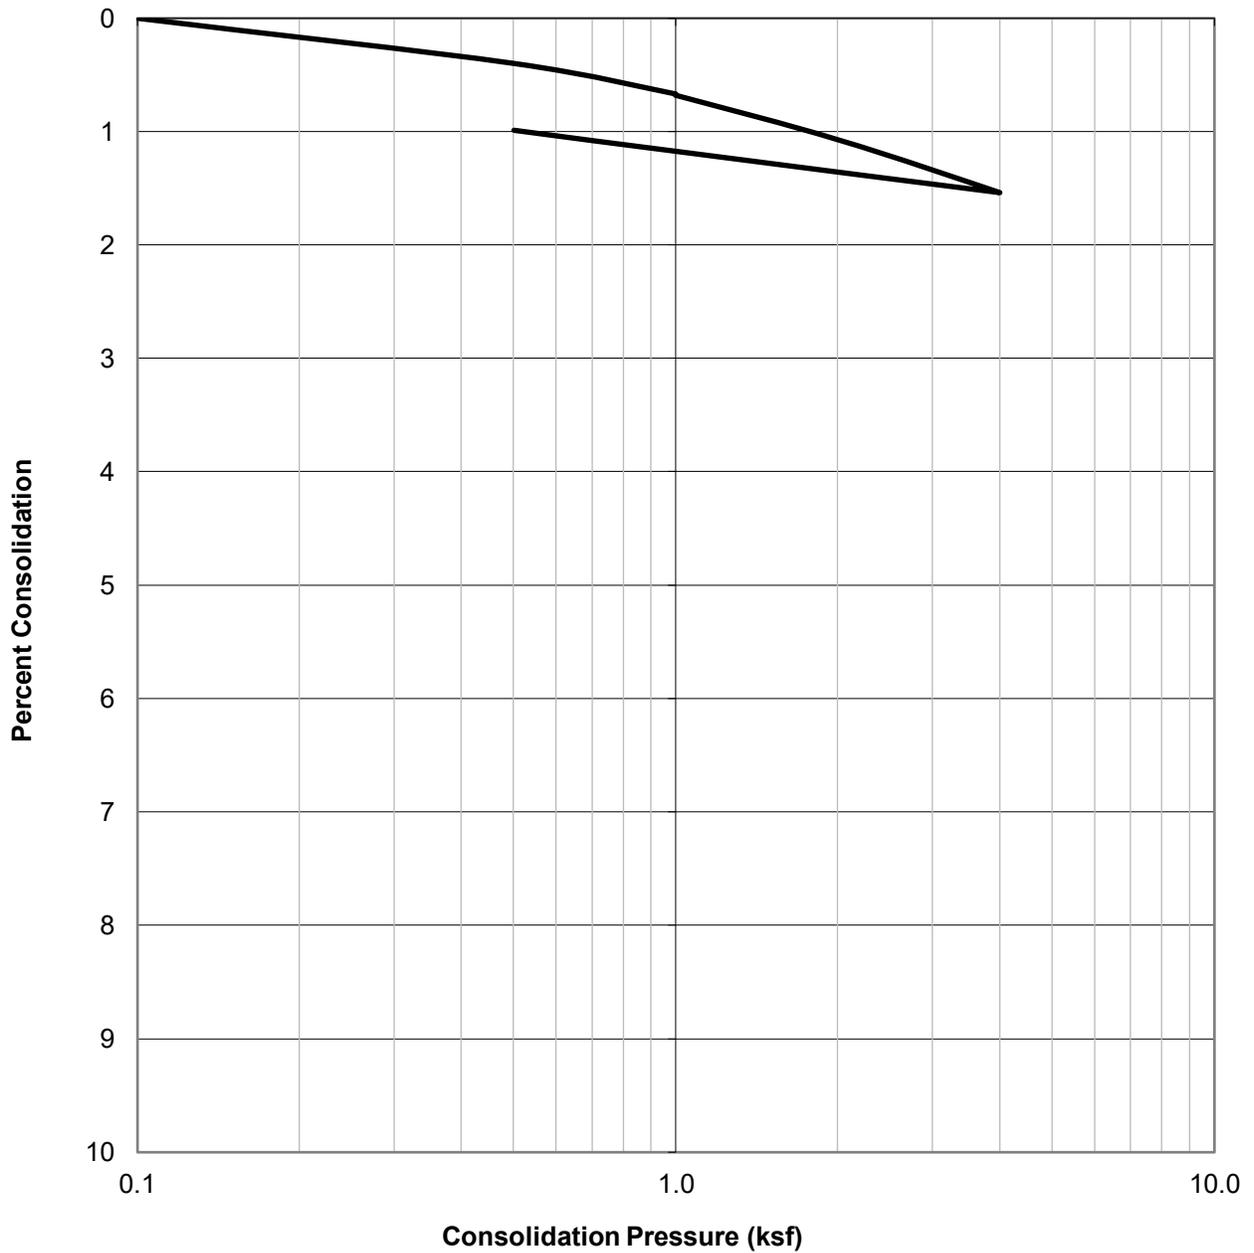
Figure B10

WATER ADDED AT 1.0 KSF

SAMPLE ID.	SOIL TYPE	DRY DENSITY (PCF)	INITIAL MOISTURE (%)	FINAL MOISTURE (%)
B1@25'	Clayey Sand (SC)	115.4	13.9	15.7

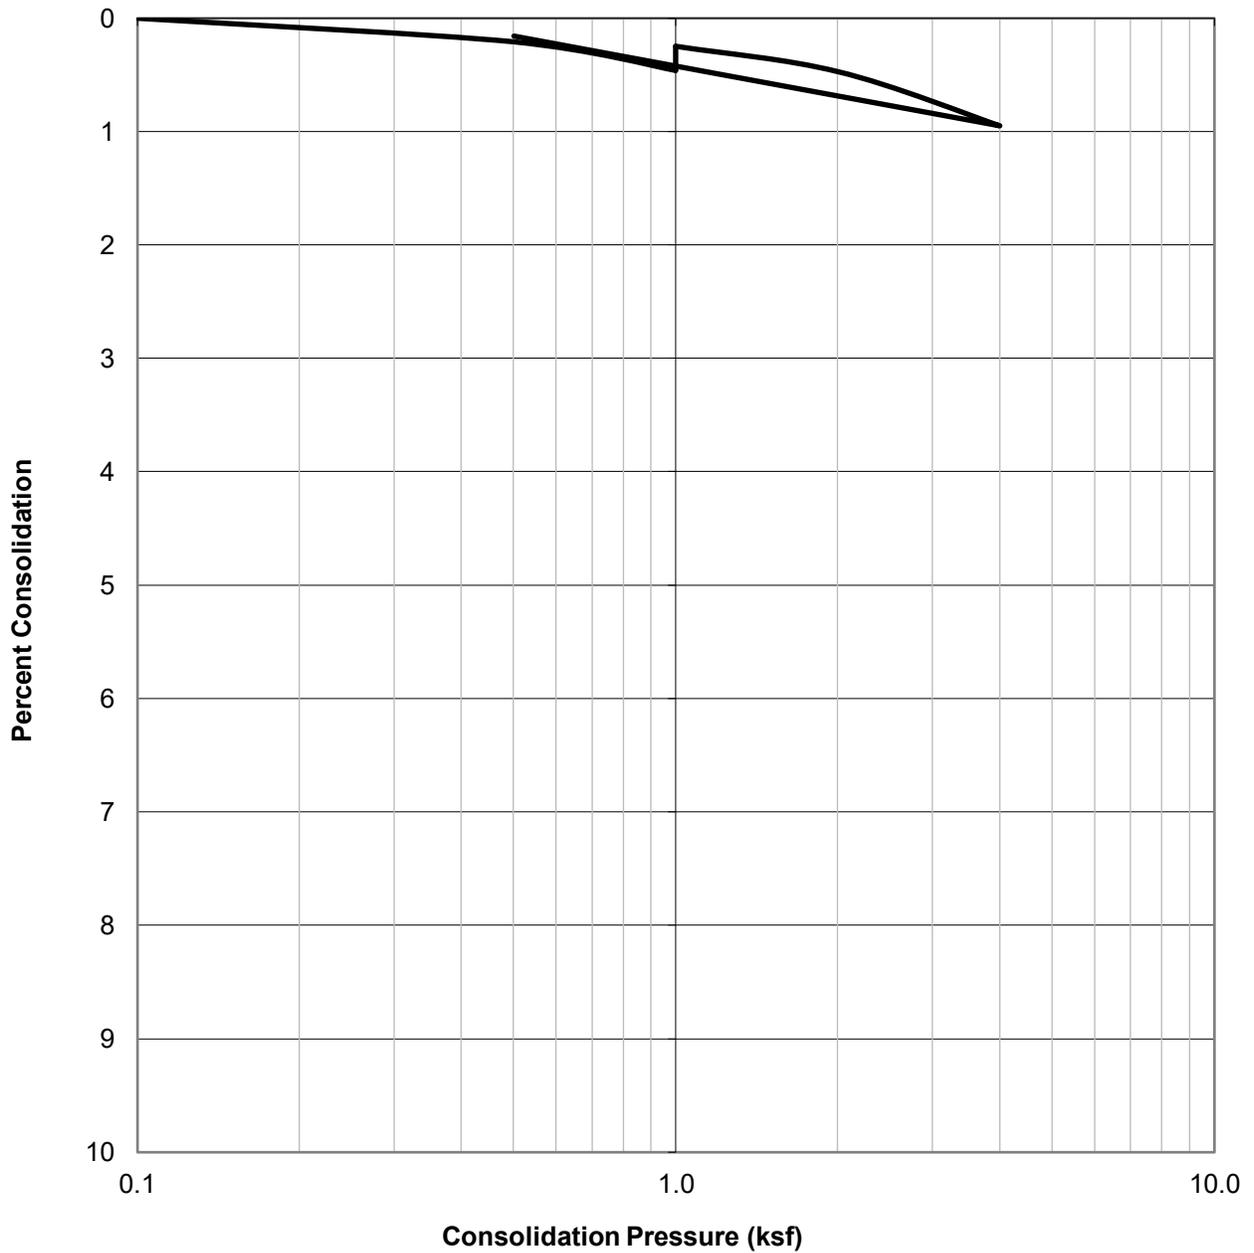
WATER ADDED AT 1.0 KSF

SAMPLE ID.	SOIL TYPE	DRY DENSITY (PCF)	INITIAL MOISTURE (%)	FINAL MOISTURE (%)
B3@3'	Clayey Sand (SC)	102.8	19.3	23.3

CONSOLIDATION TEST RESULTS ASTM D-2435	Project No.: W2068-88-02
	Checked by: RP	SONORA HIGH SCHOOL 401 SOUTH PALM STREET LA HABRA, CALIFORNIA
		NOV. 2025 Figure B11

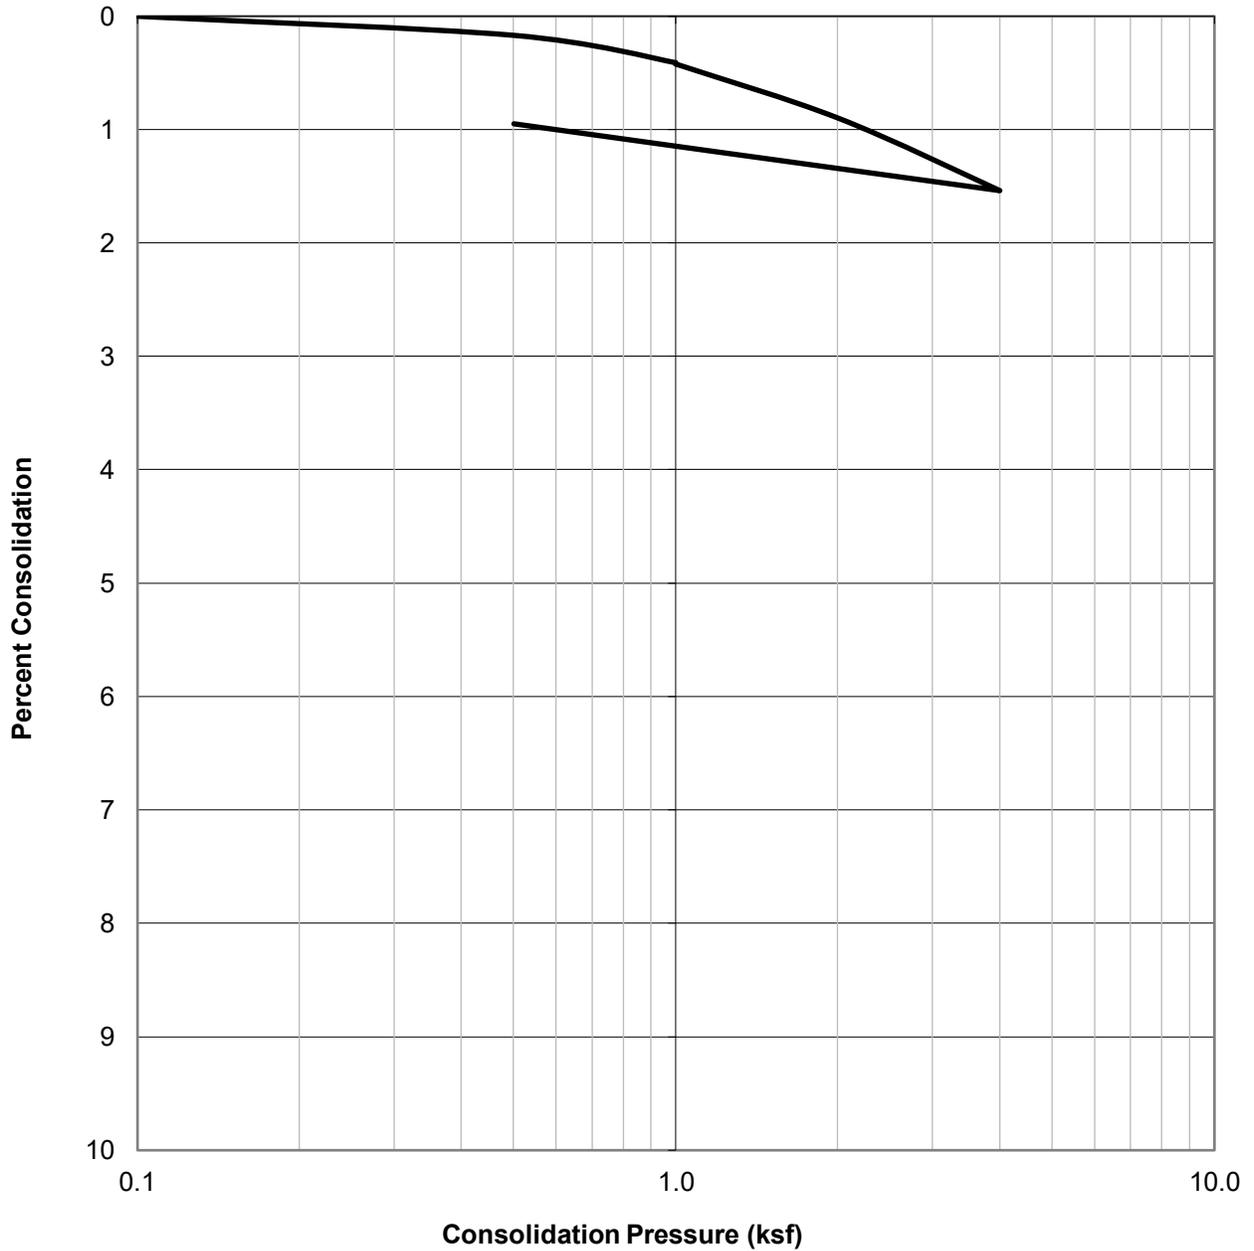
Figure B12

WATER ADDED AT 1.0 KSF

SAMPLE ID.	SOIL TYPE	DRY DENSITY (PCF)	INITIAL MOISTURE (%)	FINAL MOISTURE (%)
B3@20'	Sand w/ Clay (SP-SC)	112.0	16.4	17.4

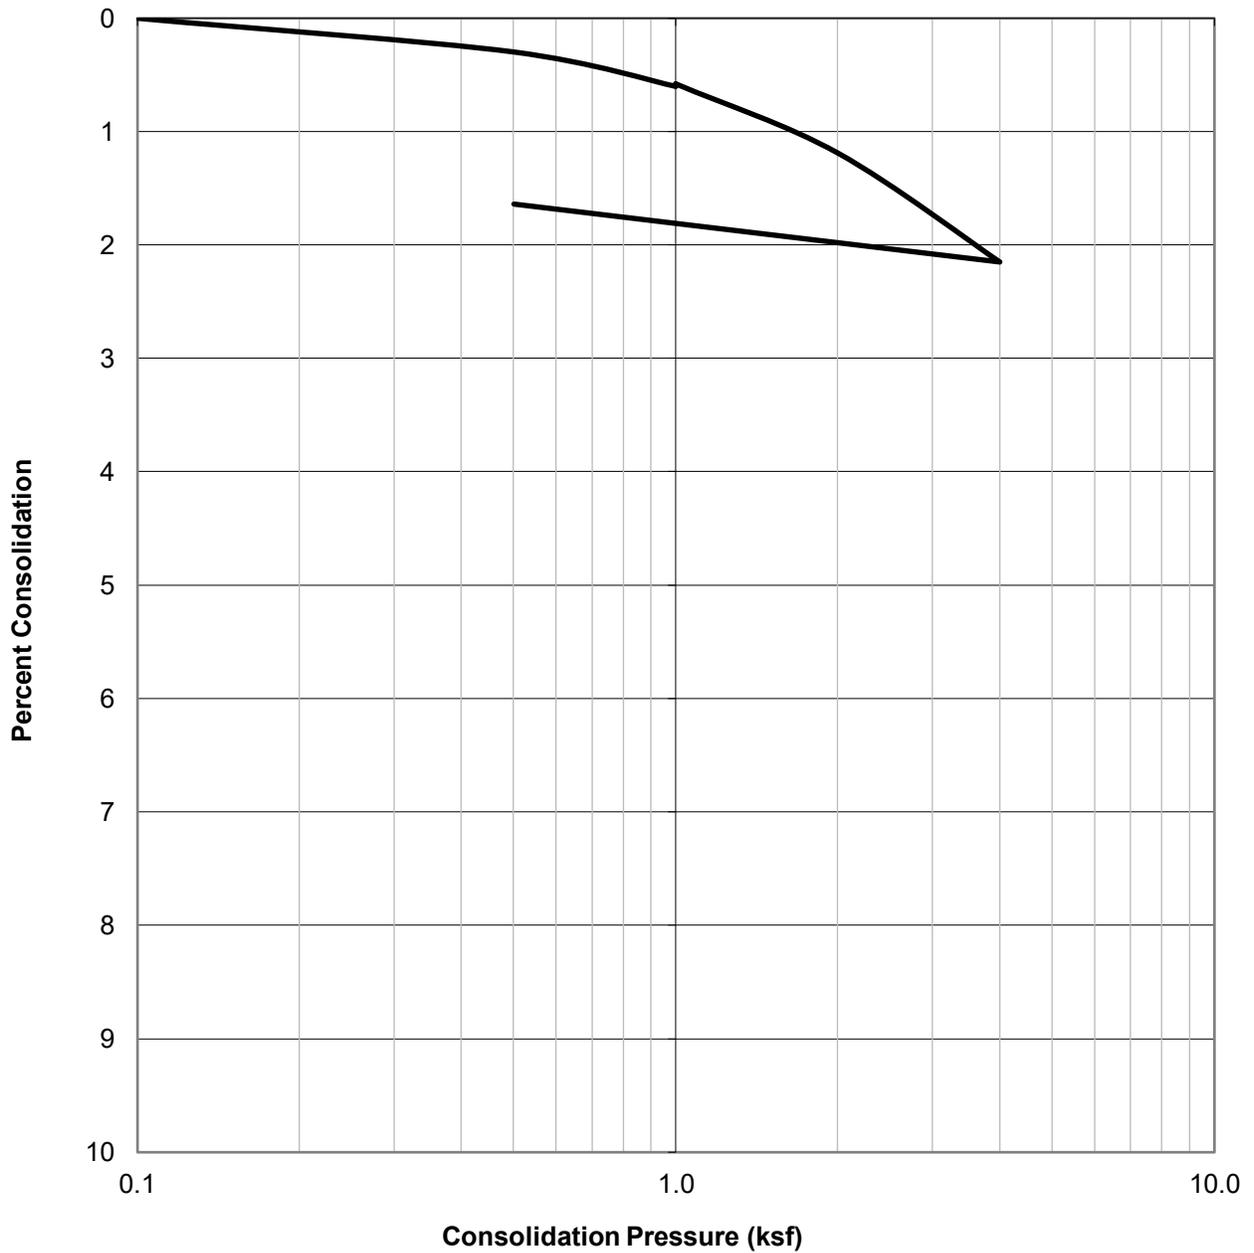
WATER ADDED AT 1.0 KSF

SAMPLE ID.	SOIL TYPE	DRY DENSITY (PCF)	INITIAL MOISTURE (%)	FINAL MOISTURE (%)
B4@20'	Clayey Sand (SC)	106.0	19.7	20.2

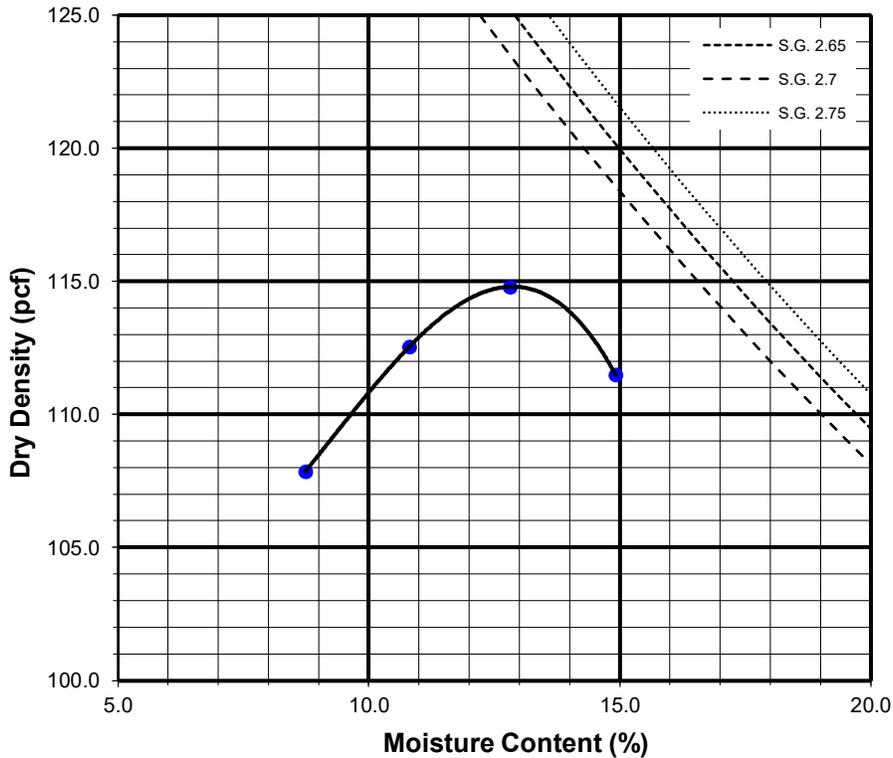
Maximum Dry Density (pcf) 115.0

Optimum Moisture Content (%) 13.0

Preparation Method: A

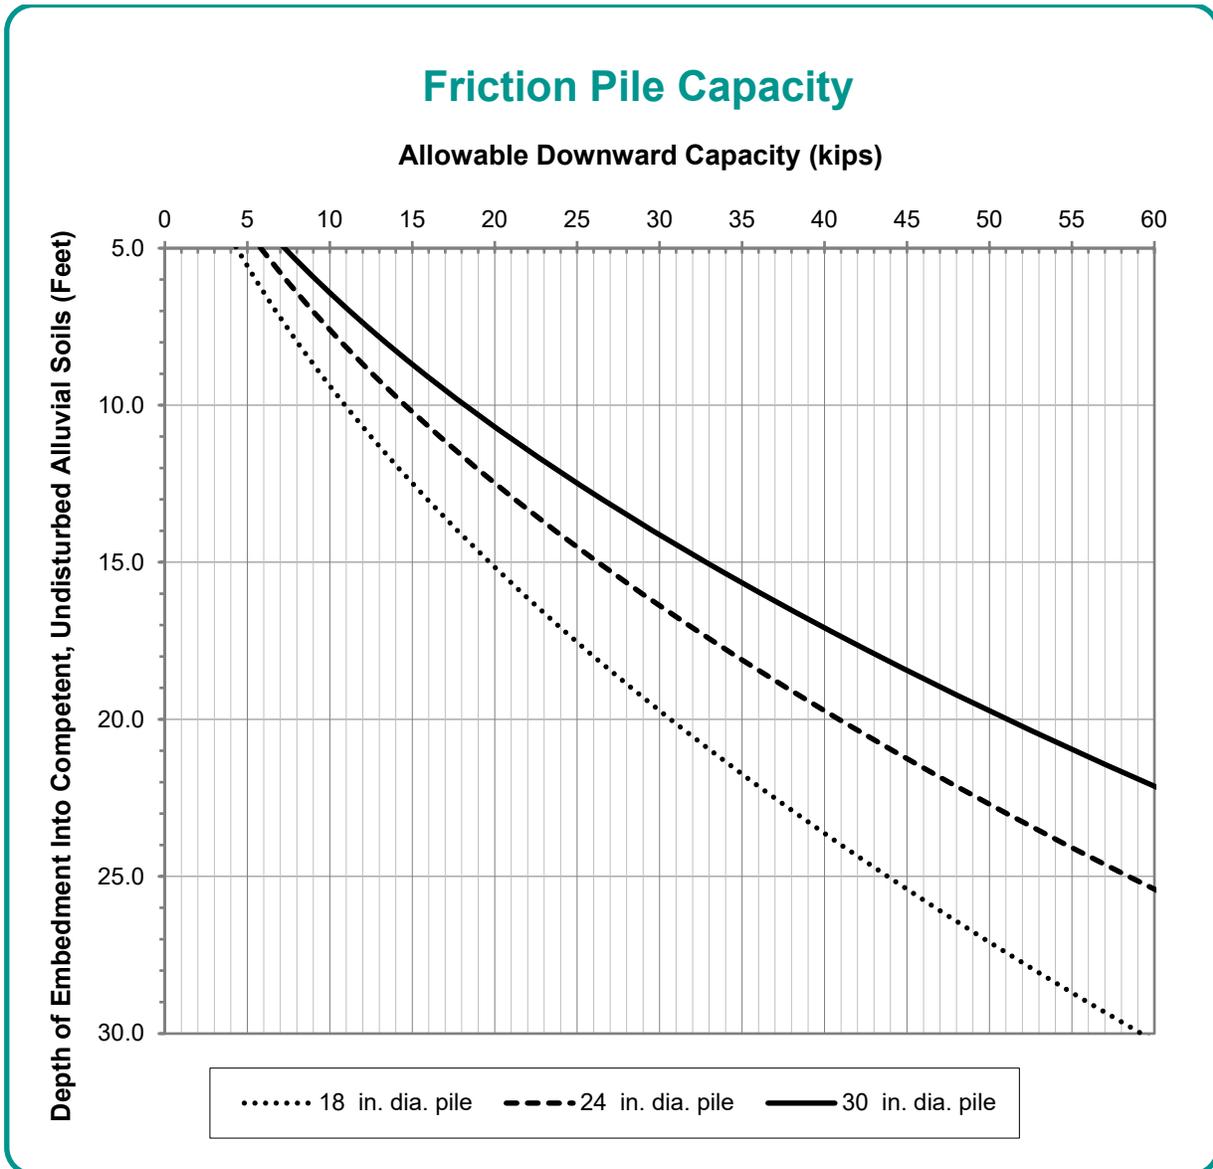
- 7.10.1 Cast-in-place friction piles may be utilized for support of the proposed light poles provided foundations derive support in competent alluvium.
- 7.10.2 Friction piles should be a minimum of 18 inches in diameter and should be embedded at least 10 feet below the existing ground surface. Where not protected by pavement, the upper two feet of soil should be ignored when calculating lateral capacity. Piles may be assumed fixed at an embedment depth of 10 feet. The allowable axial capacities for embedment below the ground surface for 18-, 24-, and 30-inch diameter piles is provided in the following chart.

7.10.3 All drilled pile excavations should be continuously observed by personnel of this firm to verify adequate penetration into the recommended bearing materials. The capacity presented is based on the strength of the soils. The compressive and tensile strength of the pile sections should be checked to verify the structural capacity of the piles.

7.10.4 Uplift capacity may be assumed to be $\frac{2}{3}$ the allowable downward capacity. The allowable axial compression and uplift capacities may be increased by one-third when considering transient wind or seismic loads.

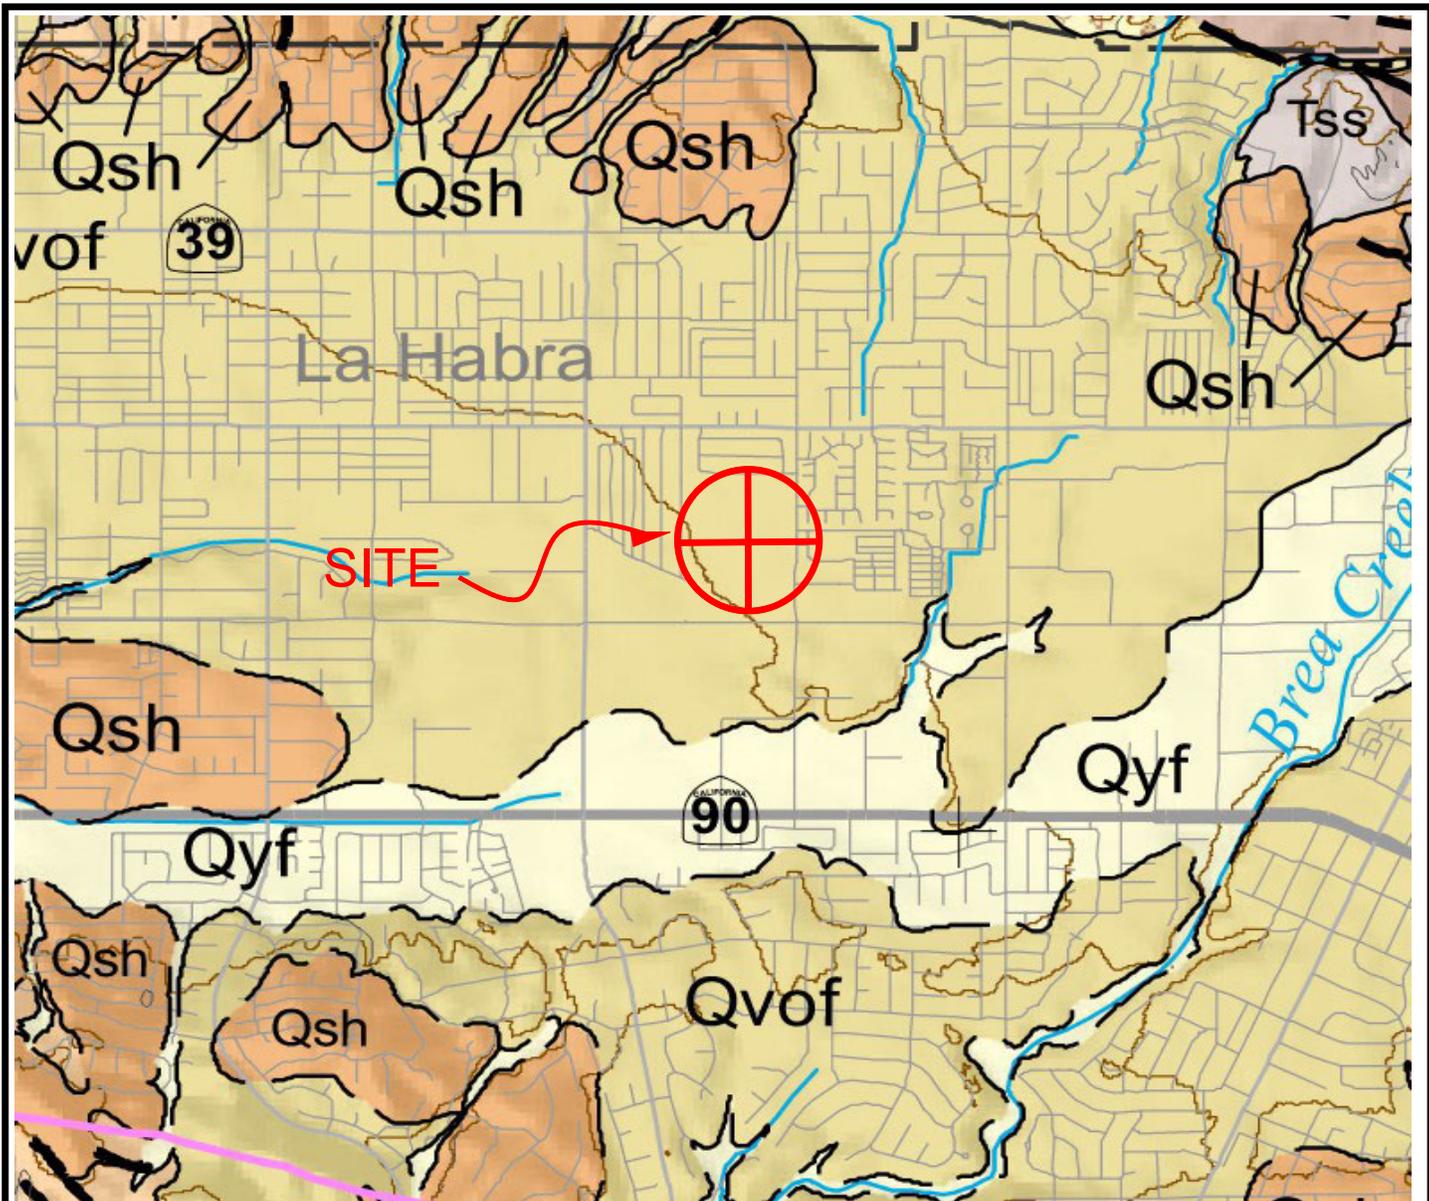
MAY 2025	PROJECT NO. W2068-88-01	FIG. 3
----------	-------------------------	--------

- Qyf - Holocene to Late Pleistocene Age Alluvial Fan Deposits
- Qvof - Pleistocene Age Very Old Alluvial Fan Deposits
- Qsh - Pleistocene Age Fine-grained Bedrock
- Tss - Tertiary Age Coarse-grained Bedrock

REFERENCE: CALIFORNIA GEOLOGICAL SURVEY 2010, GEOLOGIC COMPILATION OF QUATERNARY SURFICIAL DEPOSITS IN SOUTHERN CALIFORNIA SANTA ANA 30'x60' QUADRANGLE, CGS SPECIAL REPORT 217, PLATE 16.

Based on our field investigation and published geologic maps of the area, the site is underlain by artificial fill and Pleistocene-age very old alluvial fan deposits consisting of interbedded silt, sand, and gravel (California Geological Survey [CGS], 2010). The local geologic conditions are shown on Figure 3, Local Geologic Map. Detailed stratigraphic profiles of the materials encountered at the site are provided on the boring and CPT logs in Appendix A.
