SOHS Science Classroom Modernization

ADDENDUM # 1

ASBESTOS & LEAD-BASED PAINT INSPECTION REPORT

LIMITED GEOTECHNICAL INVESTIGATION

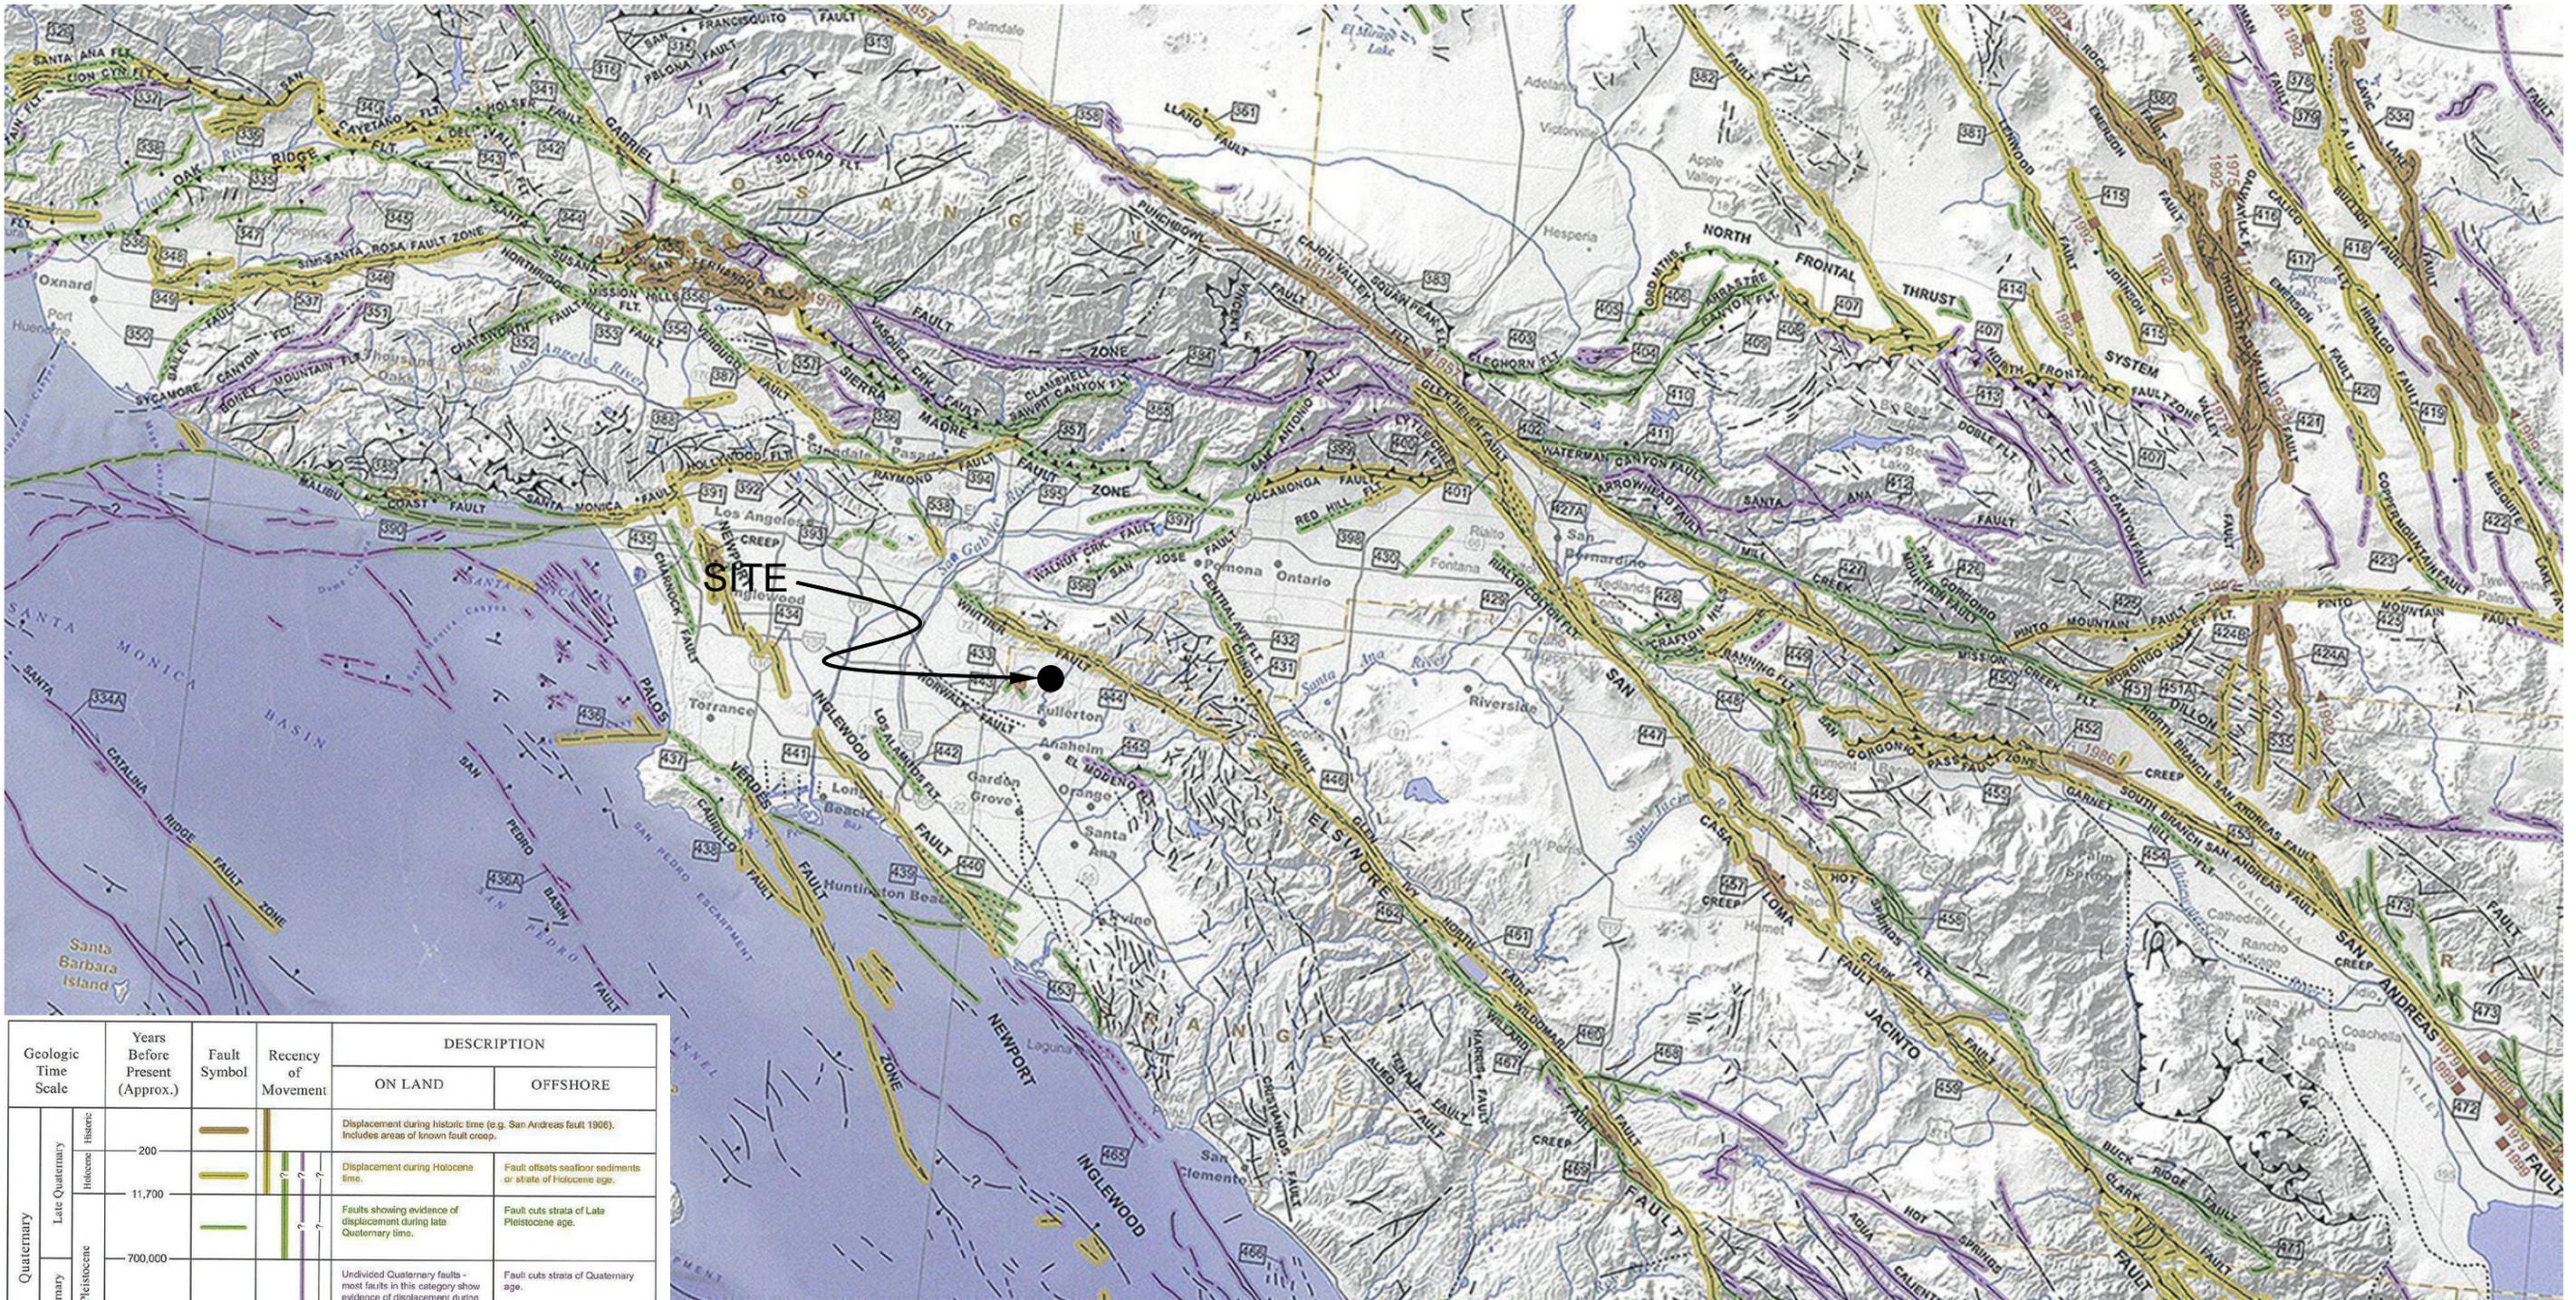
MAY 2025 PROJECT NO. W2068-88-01 FIG. 4

Reference: Jennings, C.W. and Bryant, W. A., 2010, Fault Activity Map of California, California Geological Survey Geologic Data Map No. 6.

Geologic Time Scale	Years Before Present (Approx.)	Fault Symbol	Recency of Movement	DESCRIPTION	
				ON LAND	OFFSHORE
Quaternary	Holocene / Historic			Displacement during historic time (e.g. San Andreas fault 1906). Includes areas of known fault creep.	
	Late Quaternary			Displacement during Holocene time.	Fault offsets seafloor sediments or strata of Holocene age.
Quaternary	Pleistocene			Faults showing evidence of displacement during late Quaternary time.	Fault cuts strata of Late Pleistocene age.
	Early Quaternary			Undivided Quaternary faults—most faults in this category show evidence of displacement during the last 1,600,000 years; possible exceptions are faults which displace rocks of undifferentiated Plio-Pleistocene age.	Fault cuts strata of Quaternary age.
Pre-Quaternary	1,600,000+ 4.5 billion (Age of Earth)			Faults without recognized Quaternary displacement or showing evidence of no displacement during Quaternary time. Not necessarily inactive.	Fault cuts strata of Pliocene or older age.

The site is not within a state-designated Alquist-Priolo Earthquake Fault Zone (CGS, 2025b; CDMG, 1986) for surface fault rupture hazards. No Holocene-active or pre-Holocene faults with the potential for surface fault rupture are known to pass directly beneath the site. Therefore, the potential for surface rupture due to faulting occurring beneath the site during the design life of the proposed development is considered low. However, the site is located in the seismically active Southern California region and could be subjected to moderate to strong ground shaking in the event of an earthquake on one of the many active Southern California faults. The faults in the vicinity of the site are shown in Figure 4, Regional Fault Map.

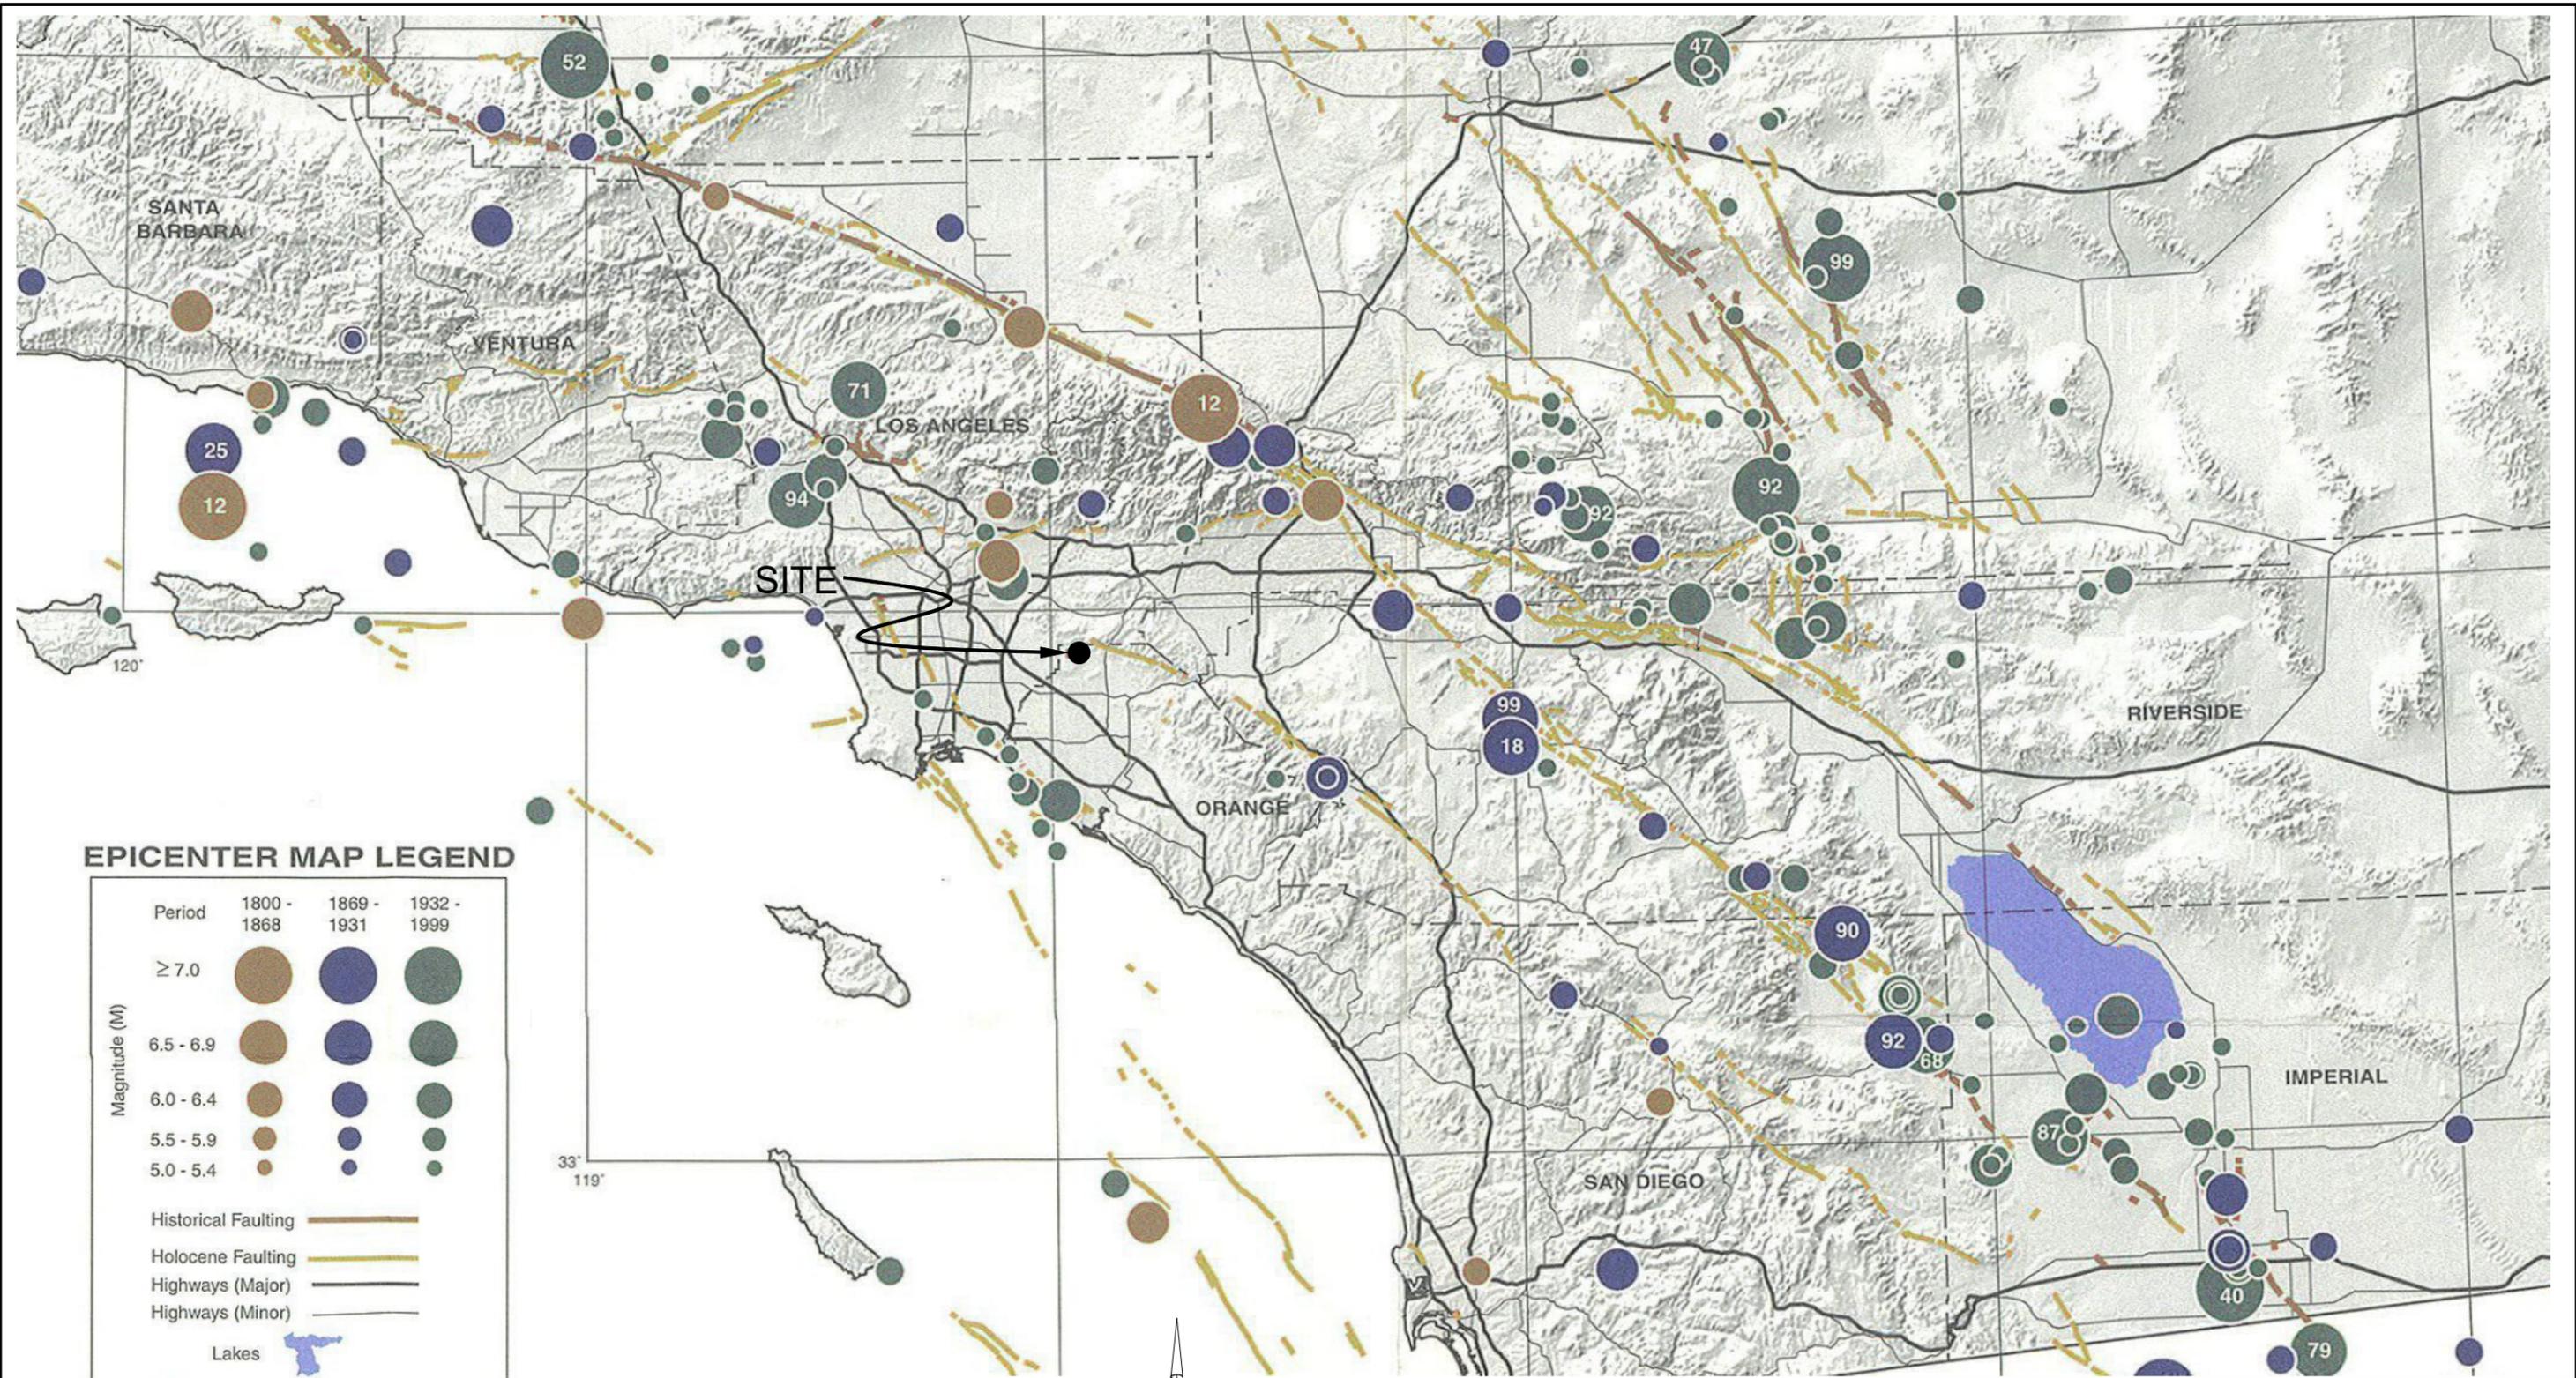
EPICENTER MAP LEGEND

Period	1800 - 1868	1869 - 1931	1932 - 1999
Magnitude (M)			
≥ 7.0			
6.5 - 6.9			
6.0 - 6.4			
5.5 - 5.9			
5.0 - 5.4			
Historical Faulting			
Holocene Faulting			
Highways (Major)			
Highways (Minor)			
Lakes			
	Last two digits of M ≥ 6.5 earthquake year

Reference: Topozada, T., Branum, D., Petersen, M., Hallstrom, C., Cramer, C., and Reichle, M., 2000, Epicenters and Areas Damaged by M≥5 California Earthquakes, 1800 - 1999, California Geological Survey, Map Sheet 49.

As with all of Southern California, the site has experienced historic earthquakes from various regional faults. The seismicity of the region surrounding the site was formulated based on research of the USGS earthquake catalog. The epicenters of recorded events with earthquake magnitudes (M_w – moment magnitude) equal to or greater than 5.0 in the site vicinity are depicted in Figure 4, Regional Seismicity Map. For informational purposes, a partial list of moderate to major magnitude earthquakes that have occurred in the Southern California area within the last 100 years is included in the table on the following page.

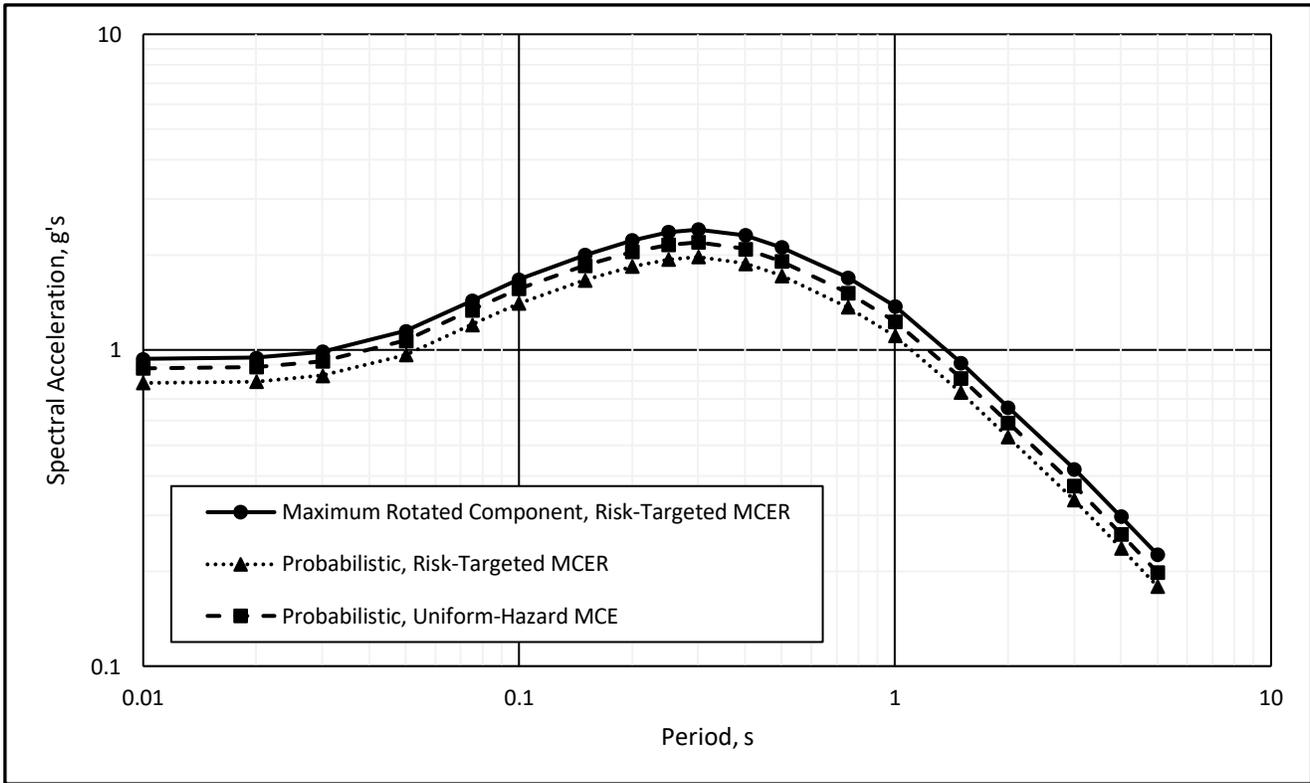
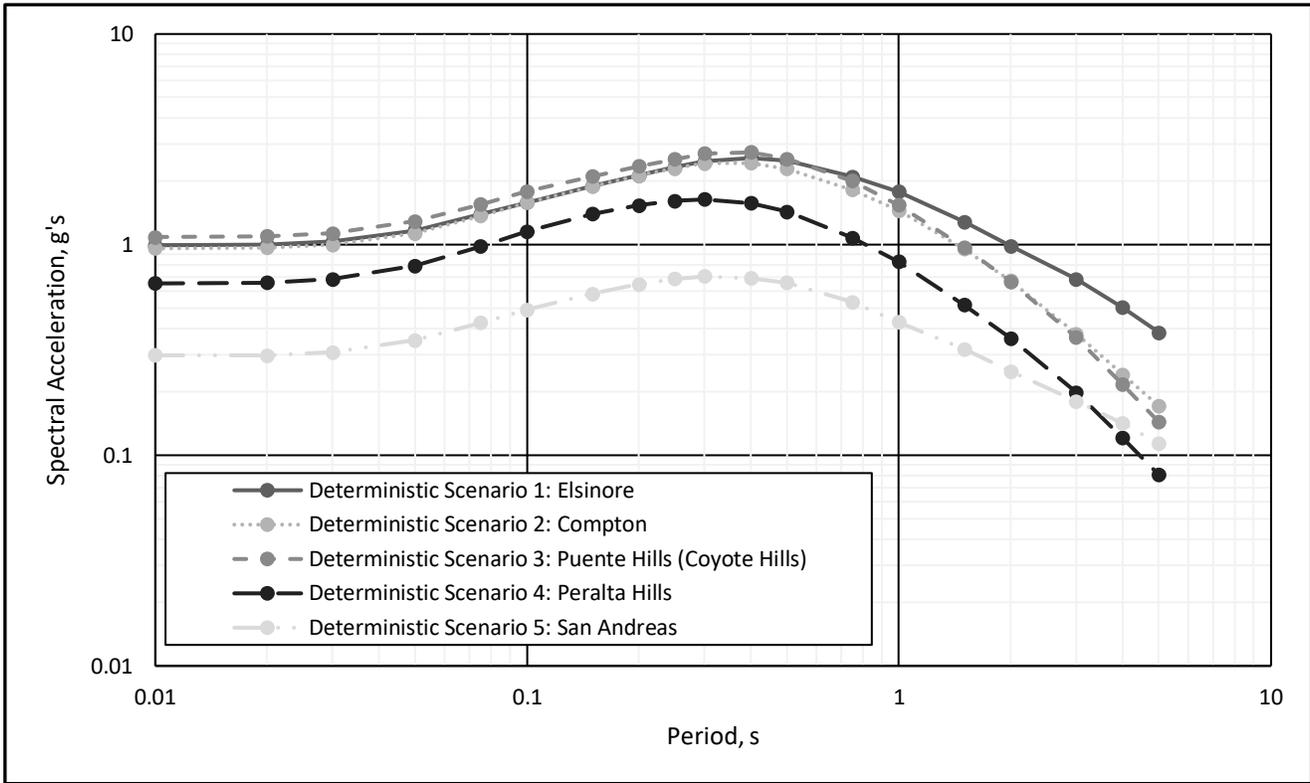
MAY 2025 PROJECT NO. W2068-88-01 FIG.5

RESPONSE SPECTRUM

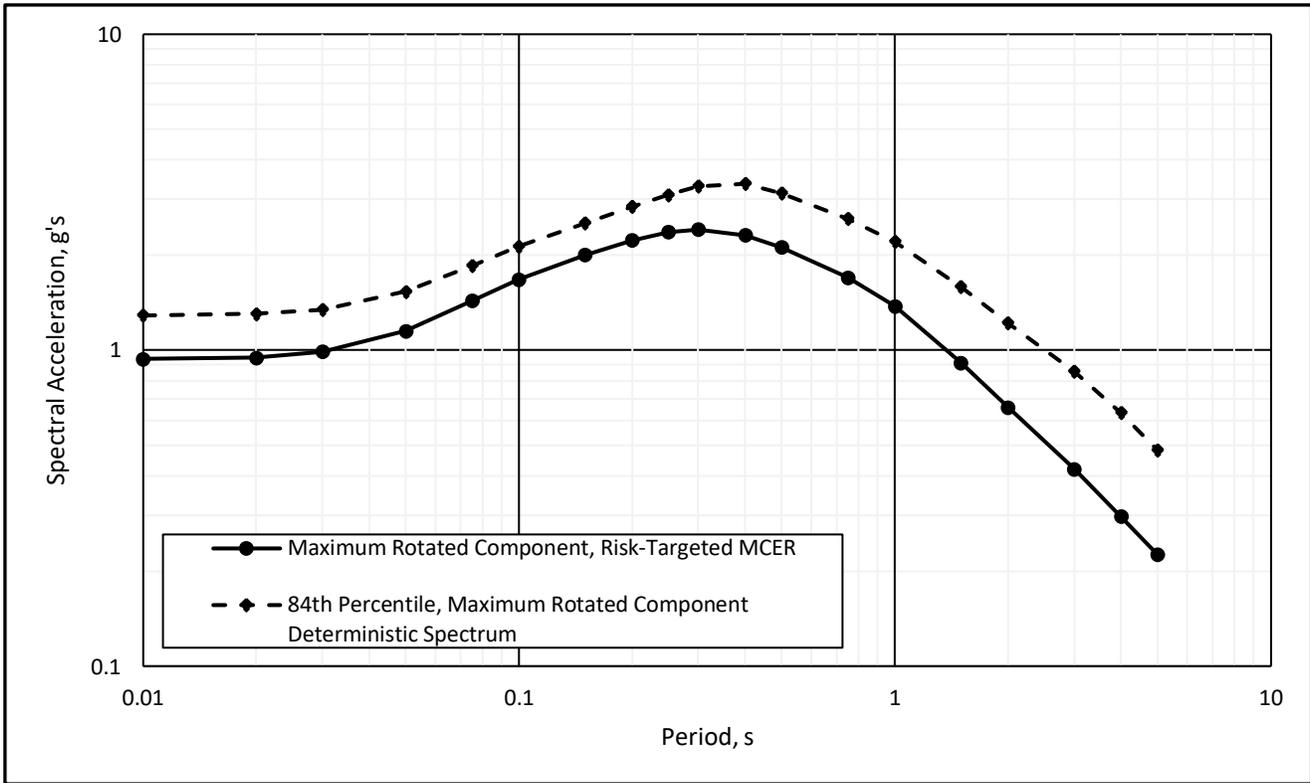
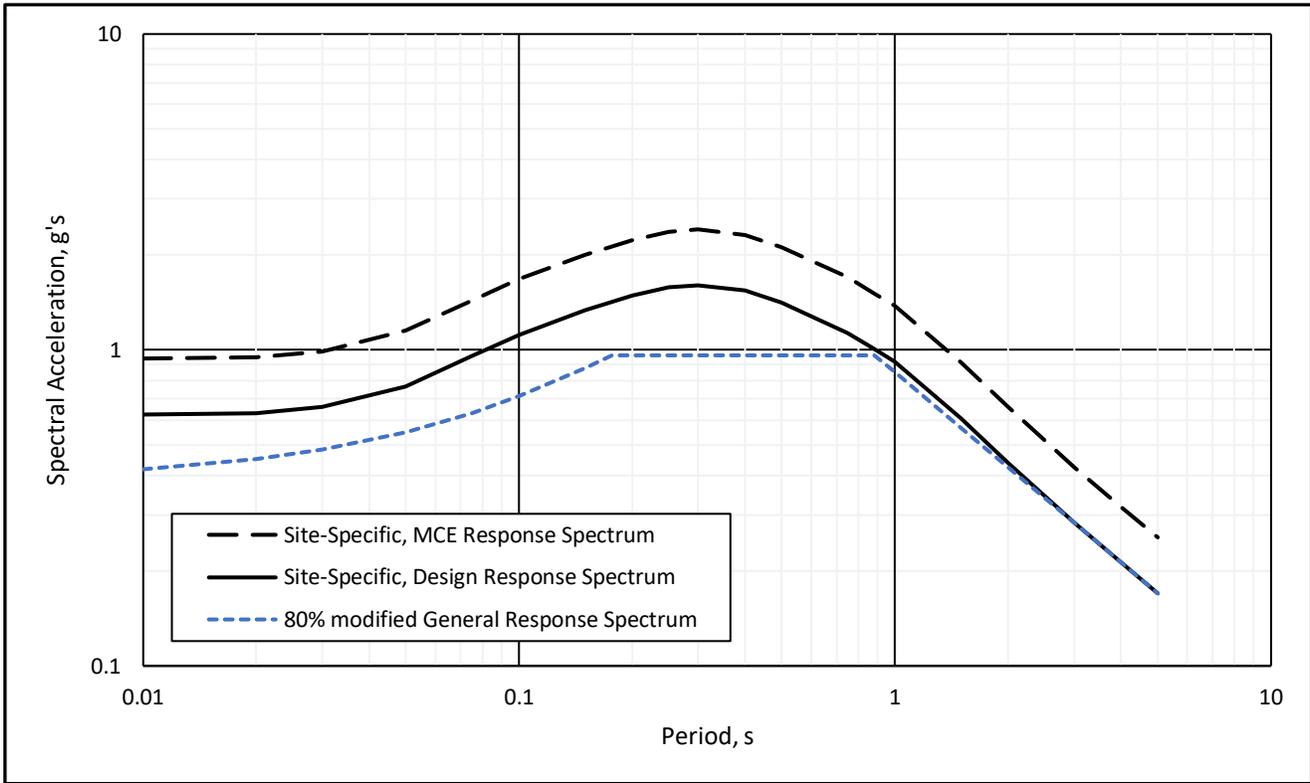
MAY 2025 Figure 6

RESPONSE SPECTRUM

The risk-targeted Maximum Considered Earthquake (MCE_R) probabilistic response spectrum is provided on Figure 6.

Graphical representations of the analyses are presented on Figures 6 and 7. The Site-Specific Design Earthquake response spectrum at 5 percent damping is presented on Figure 7 and in tabular form on Figure 8.

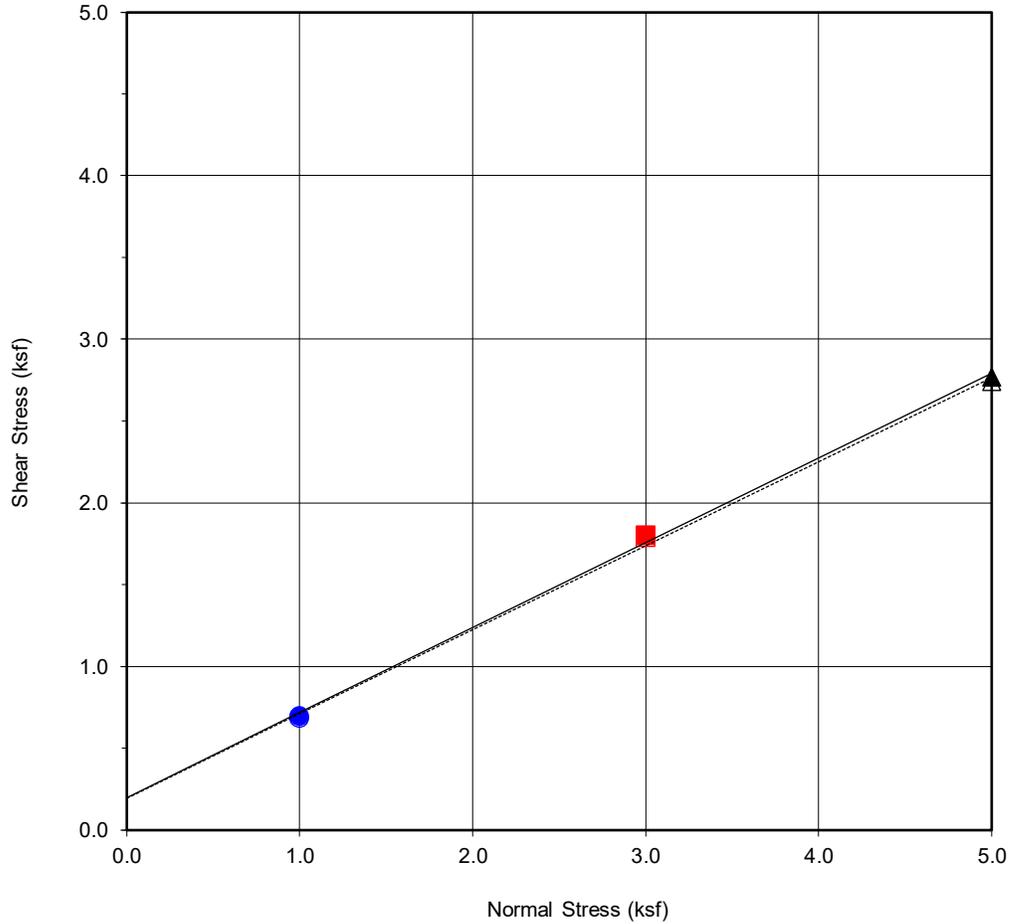
Figure B1

Boring No.	B5
Sample No.	B5@0-5'
Depth (ft)	0-5'
<u>Sample Type:</u>	Ring

<u>Soil Identification:</u>		
Sandy Silt (ML)		
Strength Parameters		
	C (psf)	ϕ ($^{\circ}$)
Peak	200	27
Ultimate	196	27

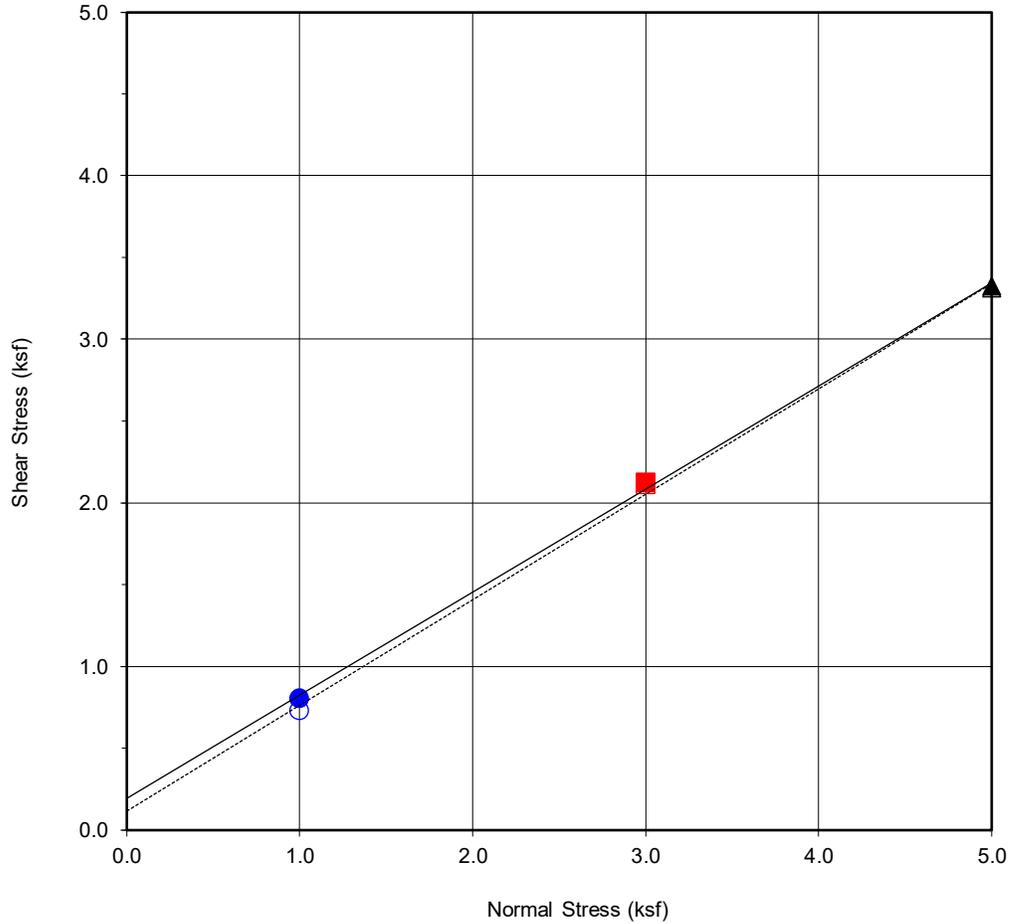
MAY 2025 Figure B2

Boring No.	B7
Sample No.	B7 @ 0-5'
Depth (ft)	0-5'
<u>Sample Type:</u>	Ring

<u>Soil Identification:</u>		
Silty Sand (SM)		
Strength Parameters		
	C (psf)	ϕ ($^{\circ}$)
Peak	194	32
Ultimate	117	33

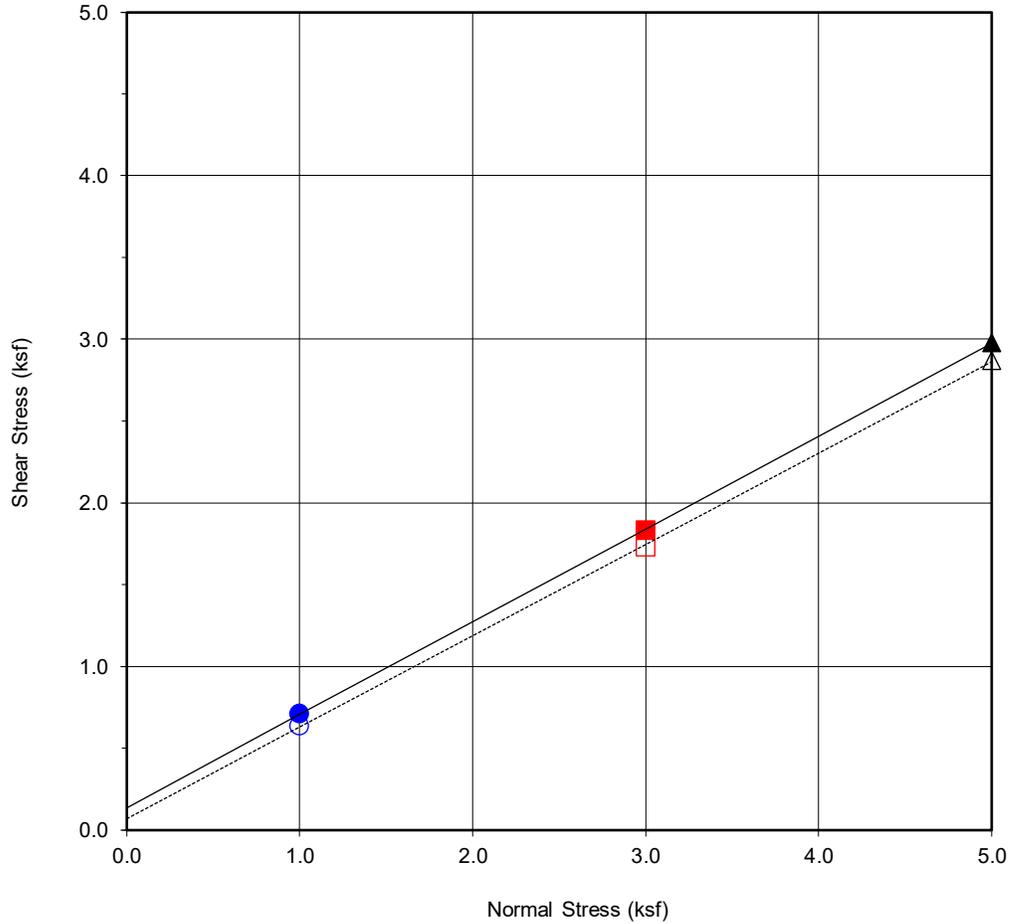
Figure B3

Boring No.	B10
Sample No.	B10@0-5'
Depth (ft)	0-5'
<u>Sample Type:</u>	Ring

<u>Soil Identification:</u>		
Silty Sand (SM)		
Strength Parameters		
	C (psf)	ϕ ($^{\circ}$)
Peak	138	30
Ultimate	69	29

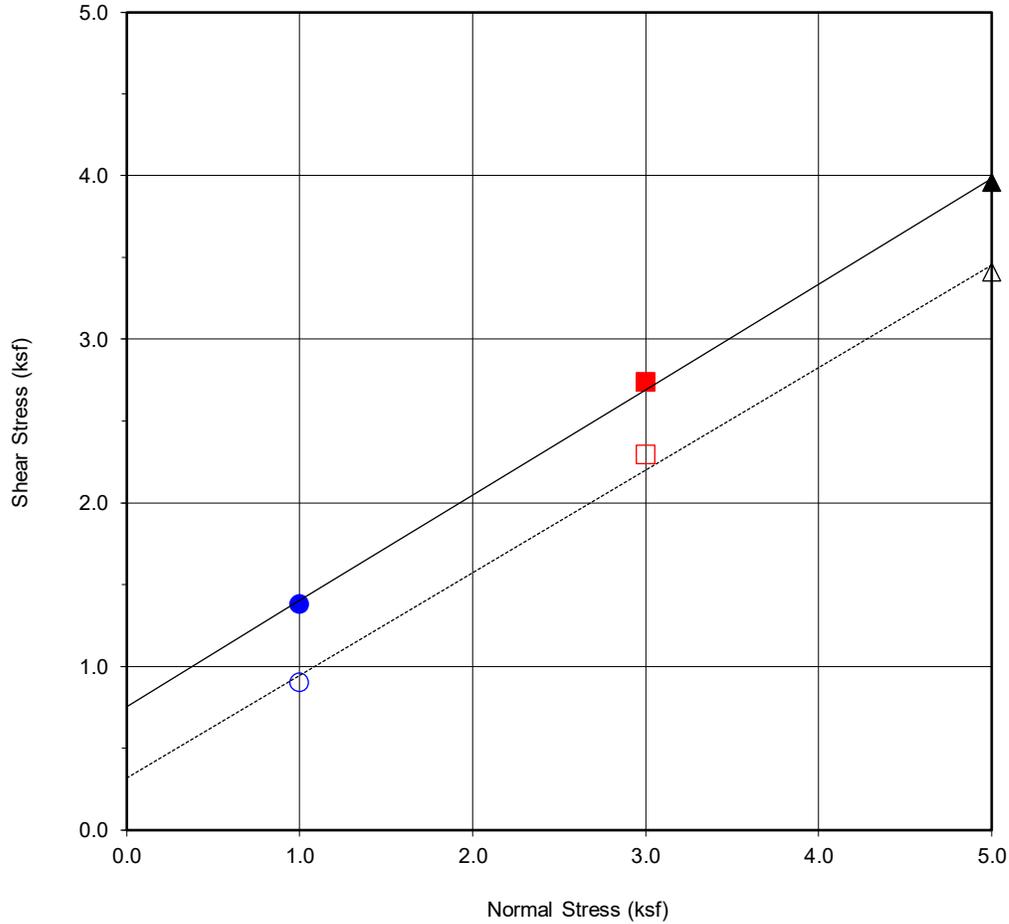
Figure B4

Boring No.	B1
Sample No.	B1@6'
Depth (ft)	6'
<u>Sample Type:</u>	Ring

<u>Soil Identification:</u>		
Sandy Clay (CL)		
Strength Parameters		
	C (psf)	ϕ ($^{\circ}$)
Peak	757	33
Ultimate	318	32

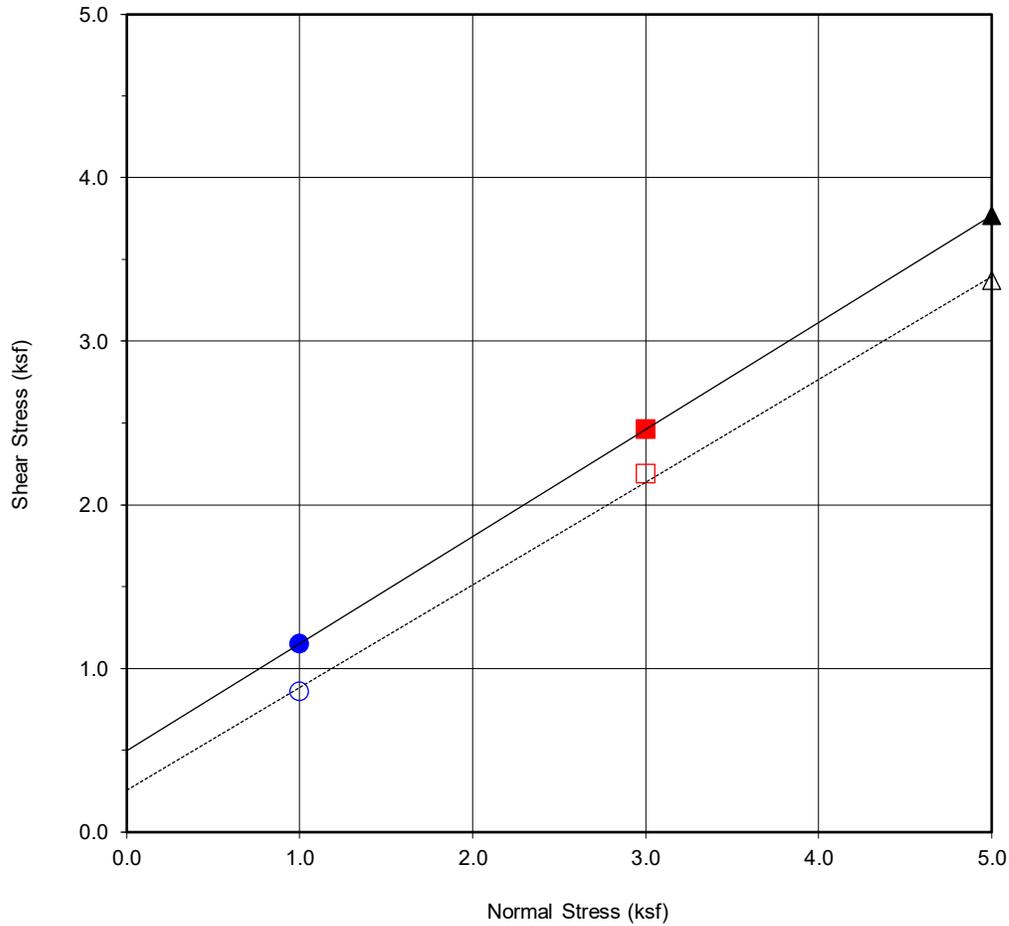
Figure B5

Boring No.	B1
Sample No.	B1@15'
Depth (ft)	15'
<u>Sample Type:</u>	Ring

<u>Soil Identification:</u>		
Sandy Silty Clay (CL-ML)		
Strength Parameters		
	C (psf)	ϕ ($^{\circ}$)
Peak	498	33
Ultimate	256	32

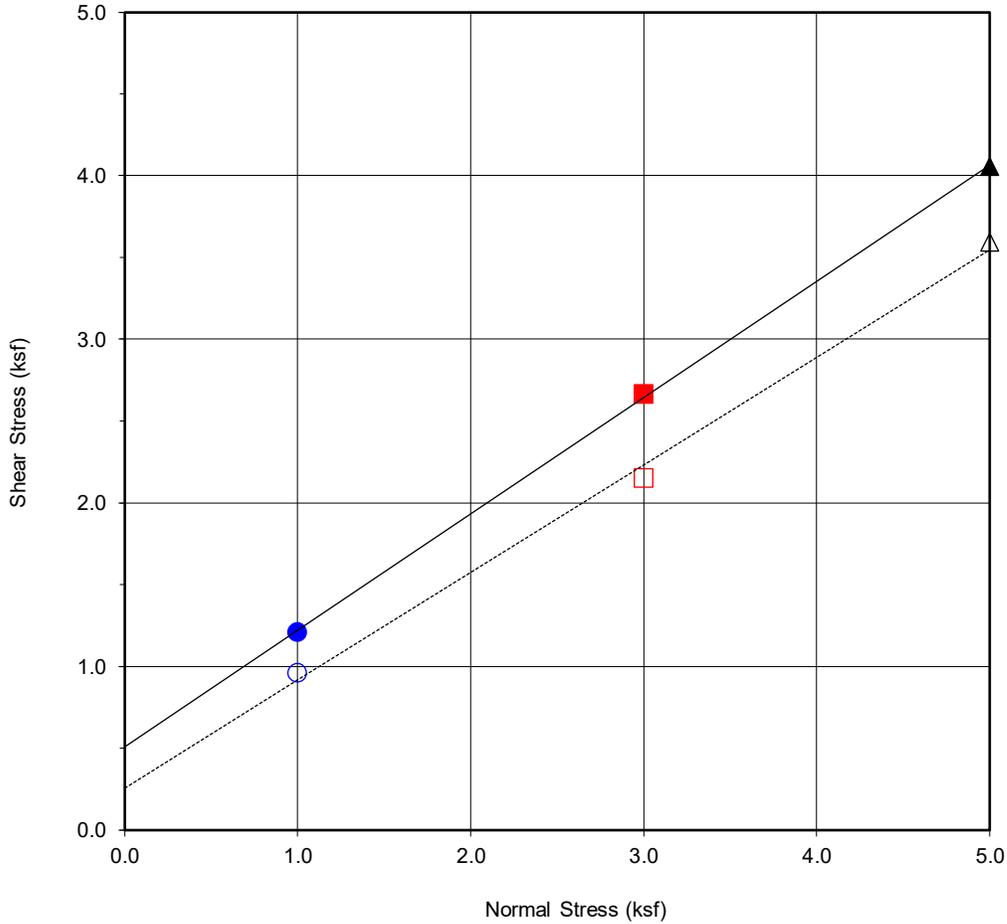
Figure B6

Boring No.	B3
Sample No.	B3@3'
Depth (ft)	3'
<u>Sample Type:</u>	Ring

<u>Soil Identification:</u>		
Sandy Silty Clay (CL)		
Strength Parameters		
	C (psf)	ϕ ($^{\circ}$)
Peak	509	35
Ultimate	259	33

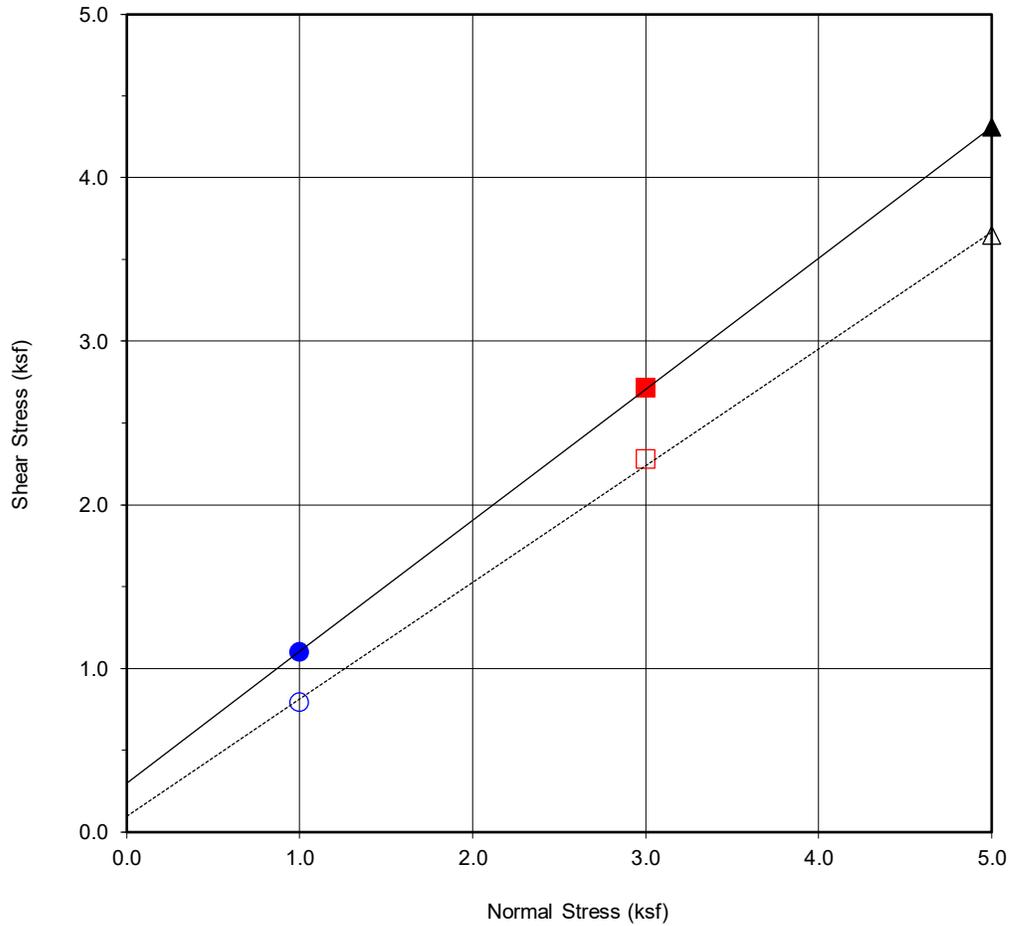
Figure B7

Boring No.	B3
Sample No.	B3@9'
Depth (ft)	6'
Sample Type:	Ring

Soil Identification:		
Silty Sand (SM)		
Strength Parameters		
	C (psf)	ϕ ($^{\circ}$)
Peak	301	39
Ultimate	98	36

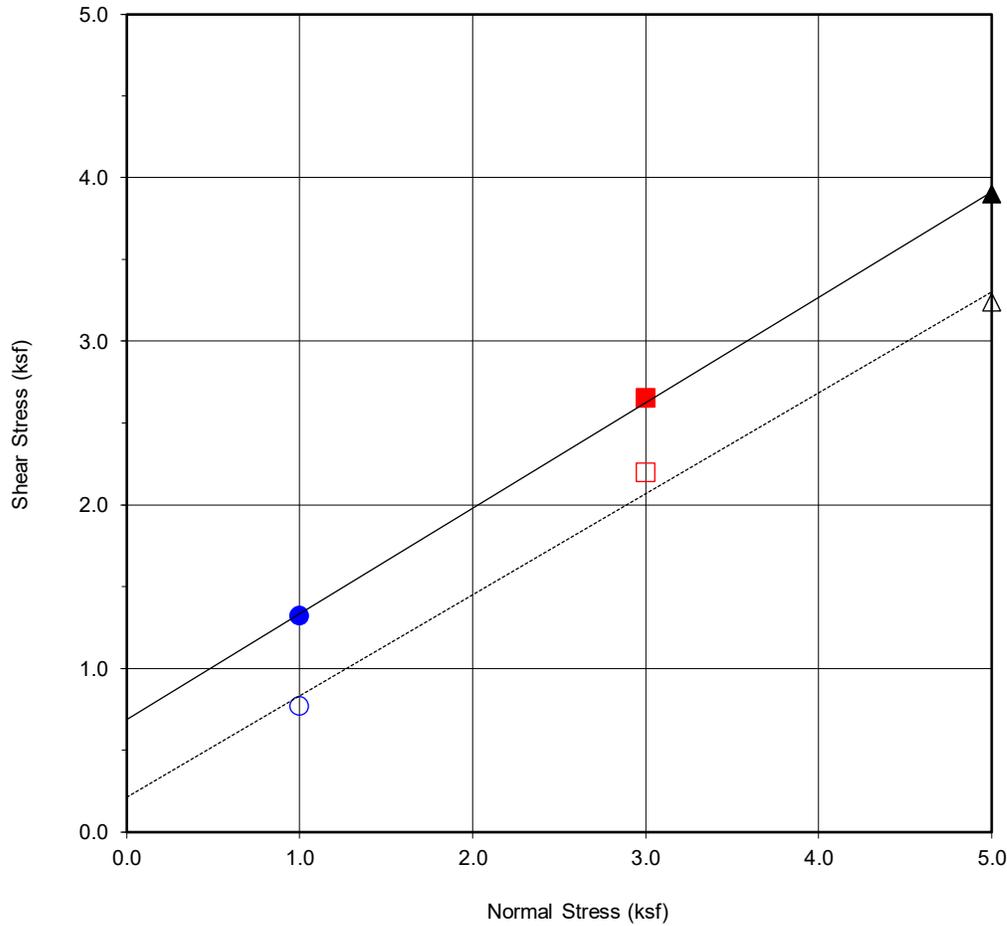
Figure B8

Boring No.	B3
Sample No.	B3@15'
Depth (ft)	15'
<u>Sample Type:</u>	Ring

<u>Soil Identification:</u>		
Silty Clay (CL-ML)		
Strength Parameters		
	C (psf)	ϕ ($^{\circ}$)
Peak	689	33
Ultimate	214	32

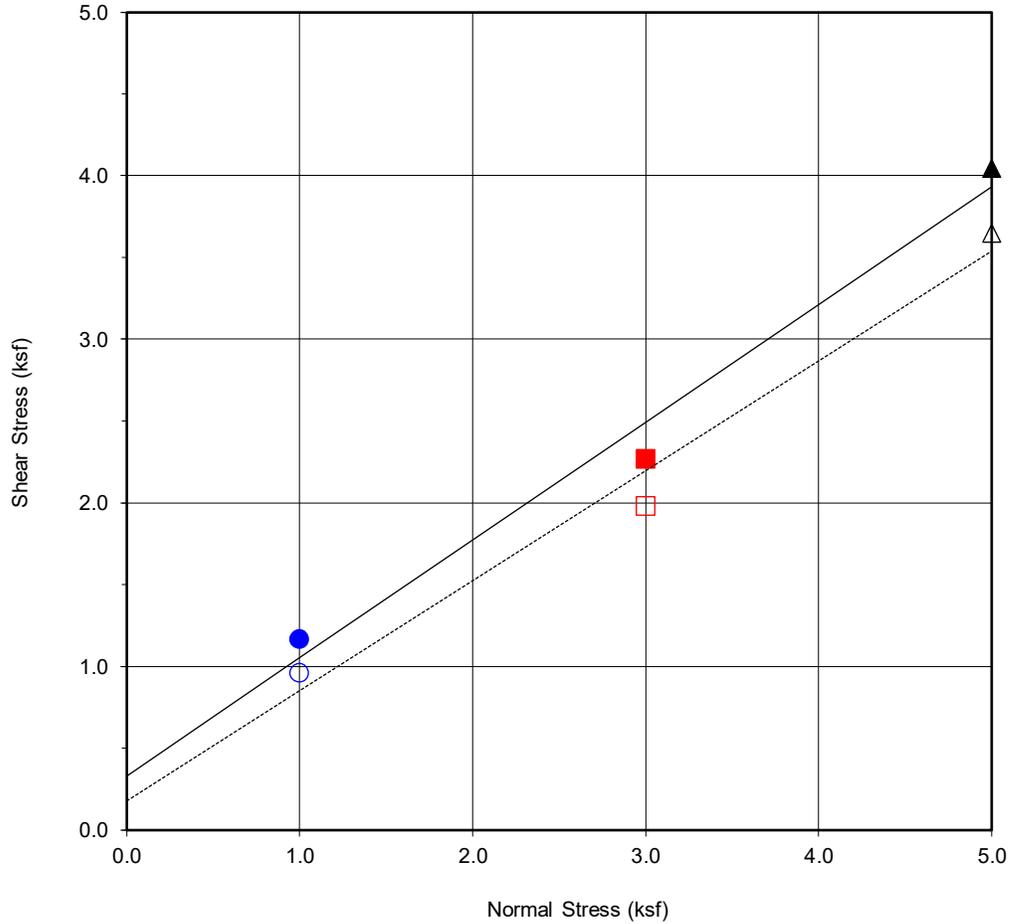
MAY 2025 Figure B9

Boring No.	B7
Sample No.	B7@6'
Depth (ft)	6'
<u>Sample Type:</u>	Ring

<u>Soil Identification:</u>		
Sandy Clay (CL)		
Strength Parameters		
	C (psf)	ϕ ($^{\circ}$)
Peak	332	36
Ultimate	180	34

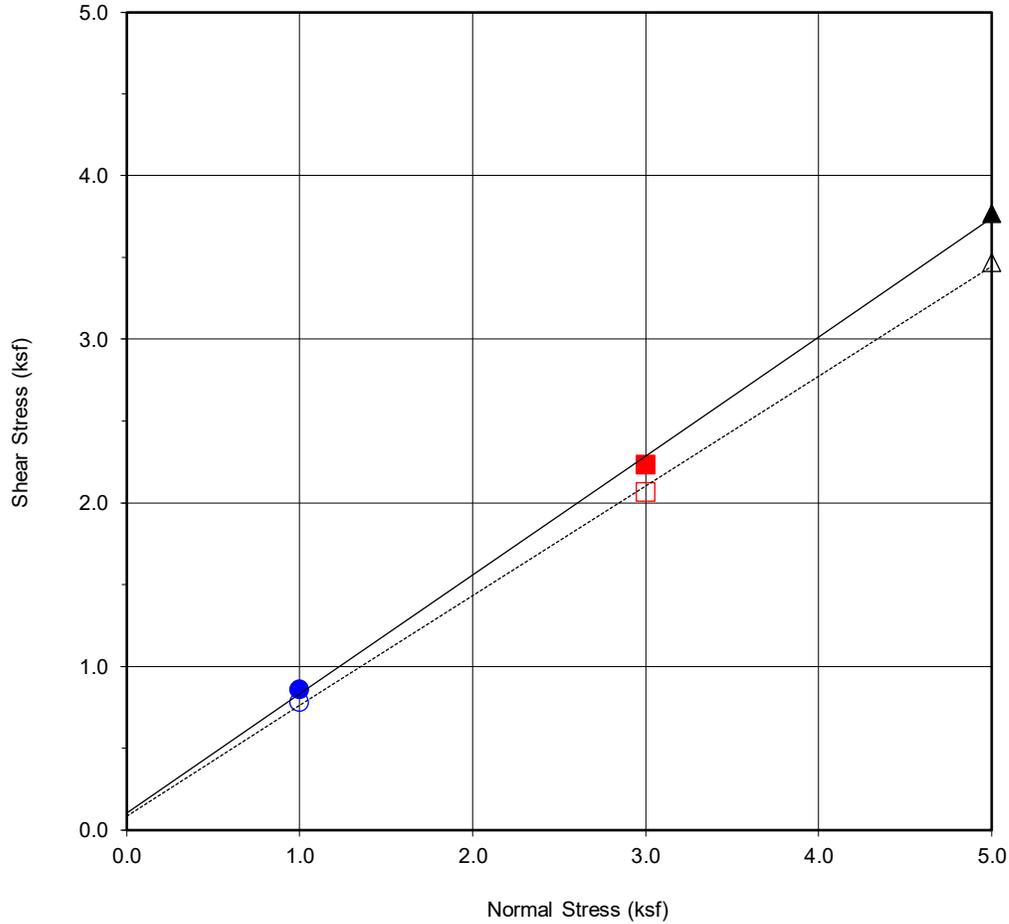
Figure B10

Boring No.	B10
Sample No.	B10@6'
Depth (ft)	6'
<u>Sample Type:</u>	Ring

<u>Soil Identification:</u>		
Silty Sand (SM)		
Strength Parameters		
	C (psf)	ϕ ($^{\circ}$)
Peak	106	36
Ultimate	88	34
