SOHS Science Classroom Modernization

ADDENDUM # 1

ASBESTOS & LEAD-BASED PAINT INSPECTION REPORT

LIMITED GEOTECHNICAL INVESTIGATION

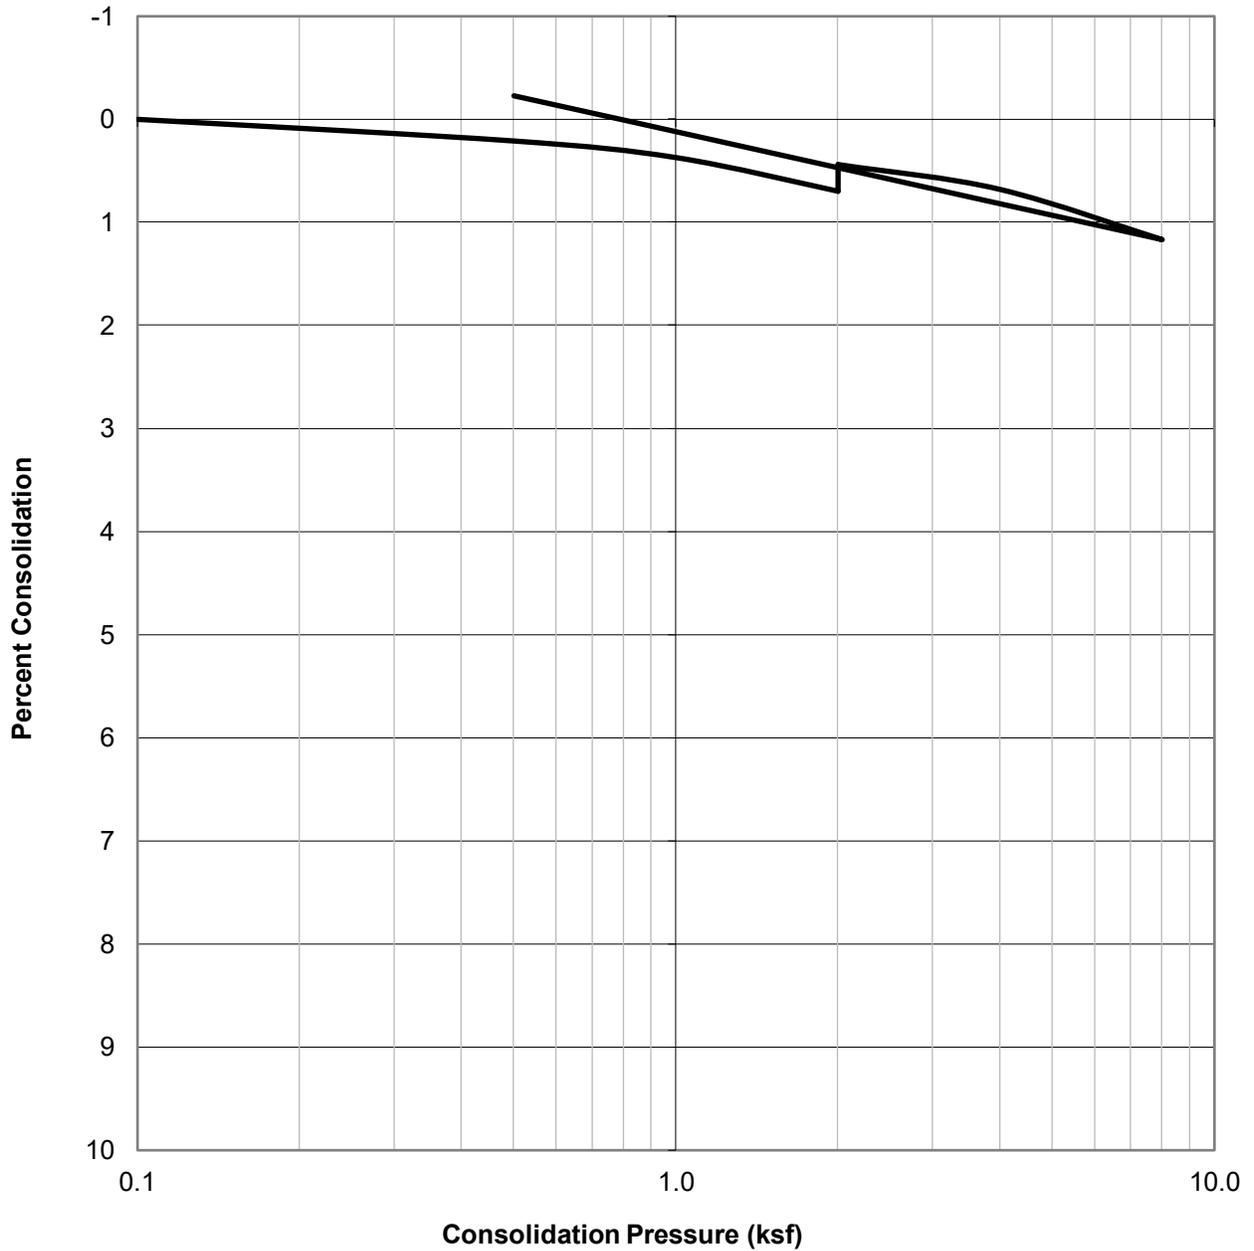
Figure B11

WATER ADDED AT 2.0 KSF

SAMPLE ID.	SOIL TYPE	DRY DENSITY (PCF)	INITIAL MOISTURE (%)	FINAL MOISTURE (%)
B7 @ 6'	Sandy Clay (CL)	115.6	14.7	16.6

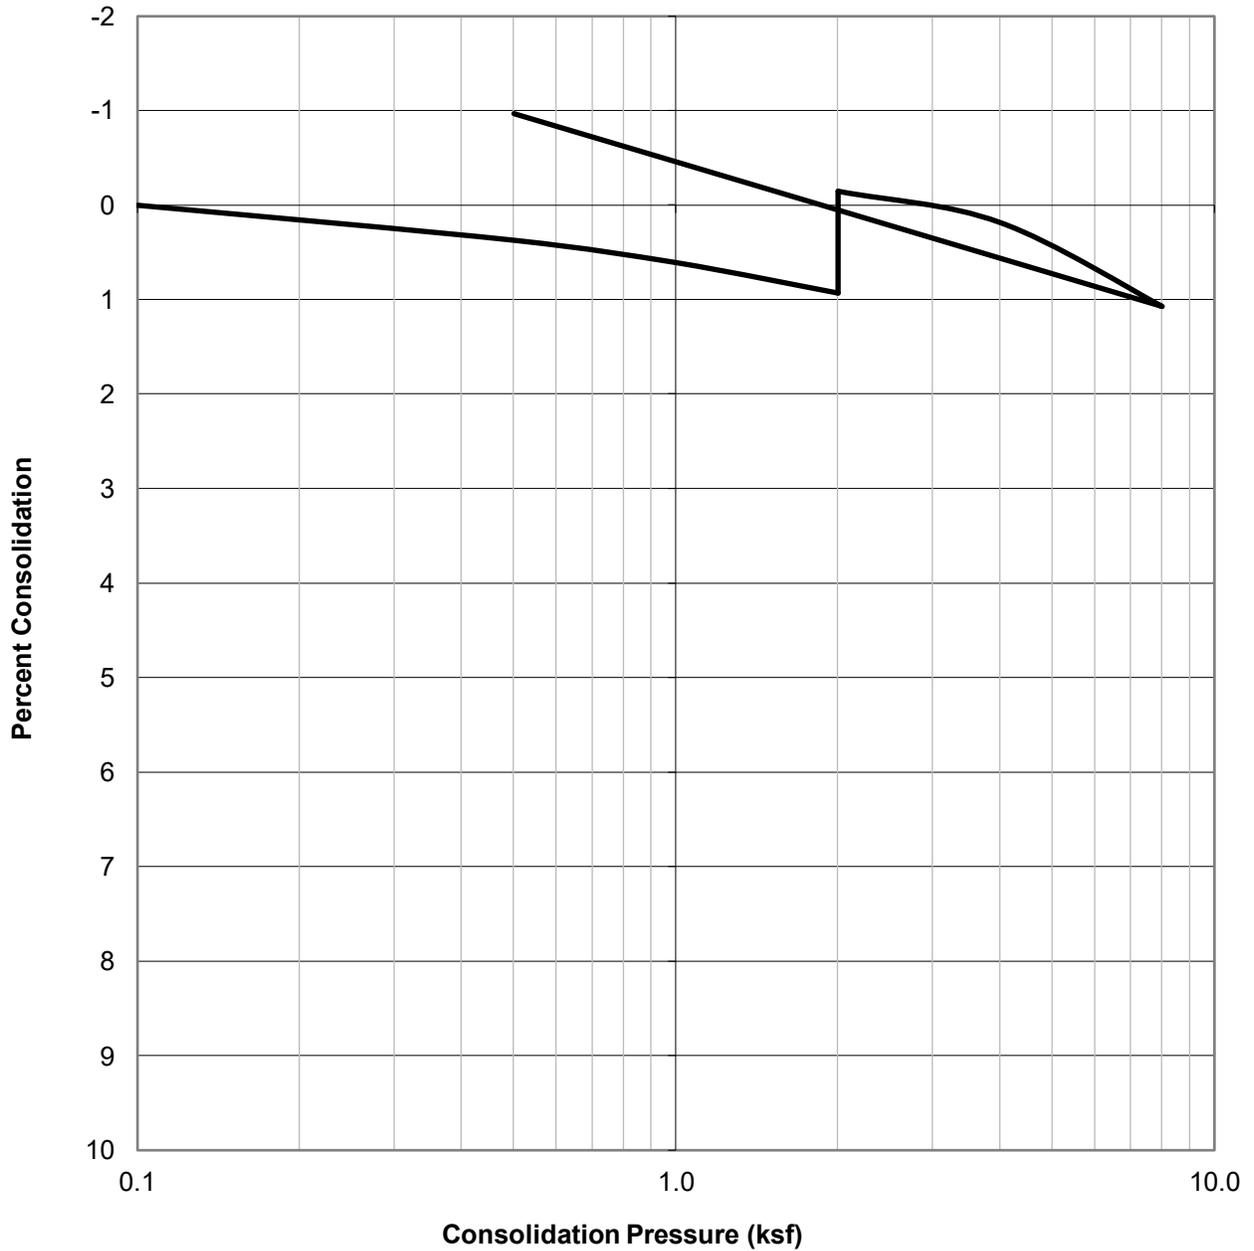
Figure B12

WATER ADDED AT 2.0 KSF

SAMPLE ID.	SOIL TYPE	DRY DENSITY (PCF)	INITIAL MOISTURE (%)	FINAL MOISTURE (%)
B7 @ 9'	Sandy Clay (CL)	118.4	14.2	16.6

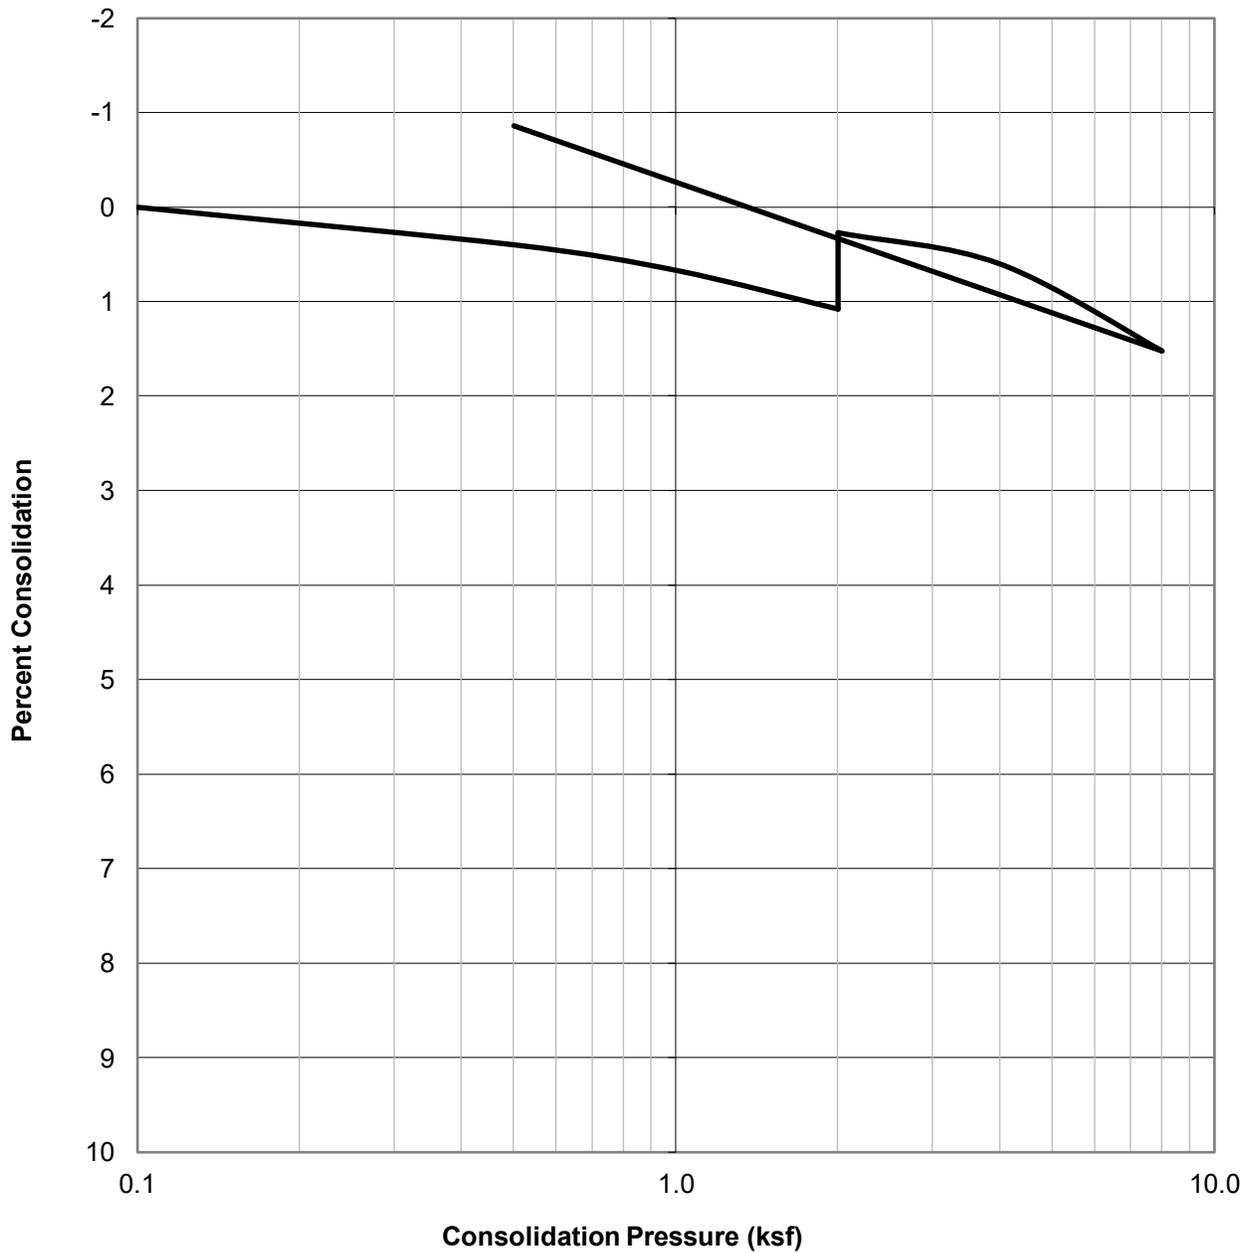
Figure B13

WATER ADDED AT 2.0 KSF

SAMPLE ID.	SOIL TYPE	DRY DENSITY (PCF)	INITIAL MOISTURE (%)	FINAL MOISTURE (%)
B7 @ 12'	Sandy Clay (CL)	112.6	18.1	19.8

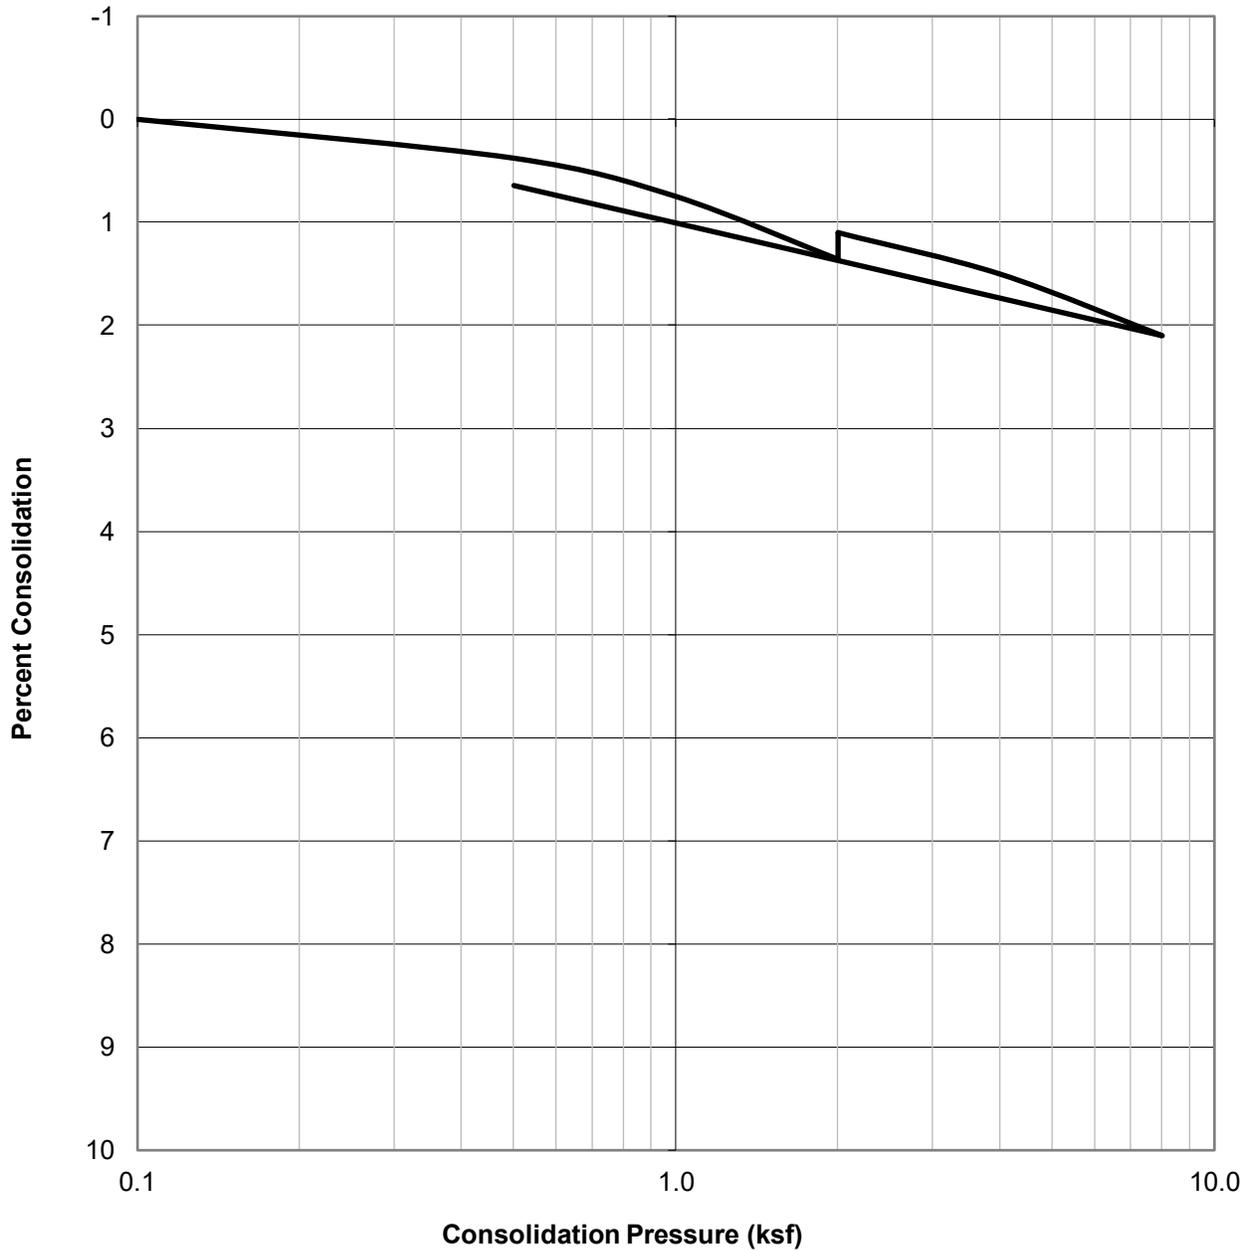
Figure B14

WATER ADDED AT 2.0 KSF

SAMPLE ID.	SOIL TYPE	DRY DENSITY (PCF)	INITIAL MOISTURE (%)	FINAL MOISTURE (%)
B7 @ 15'	Sandy Clay (CL)	109.2	18.8	20.2

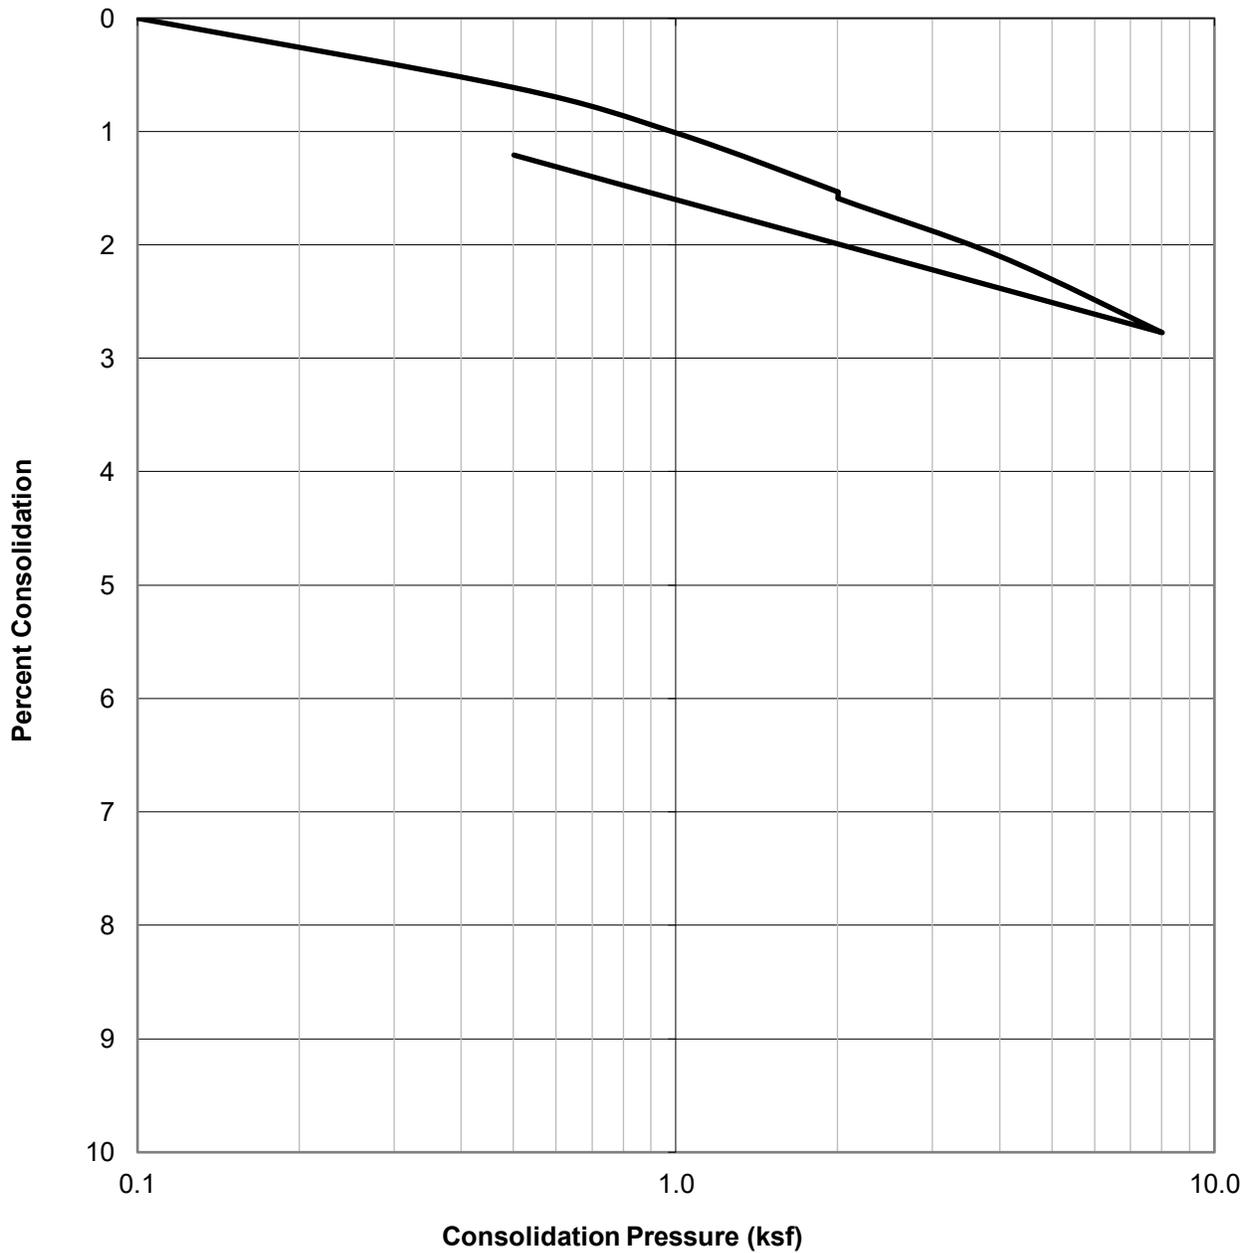
Figure B15

WATER ADDED AT 2.0 KSF

SAMPLE ID.	SOIL TYPE	DRY DENSITY (PCF)	INITIAL MOISTURE (%)	FINAL MOISTURE (%)
B7 @ 20'	Sandy Clay (CL)	112.0	17.4	18.5

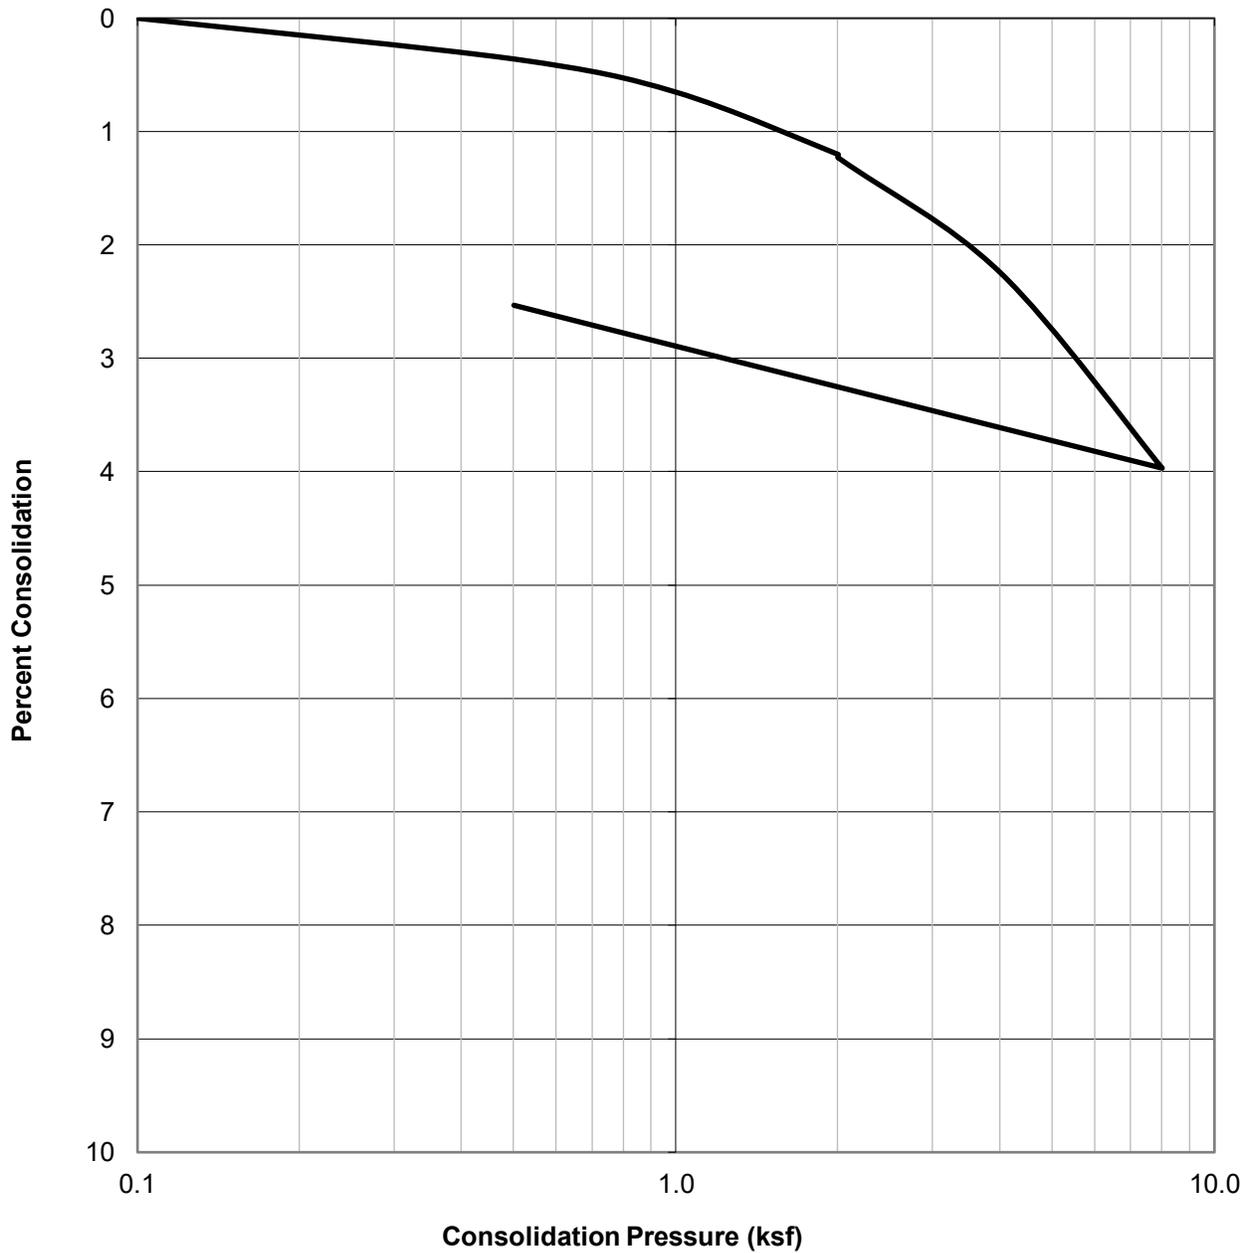
Figure B16

WATER ADDED AT 2.0 KSF

SAMPLE ID.	SOIL TYPE	DRY DENSITY (PCF)	INITIAL MOISTURE (%)	FINAL MOISTURE (%)
B8 @ 6'	Sandy Silty Clay (CL-ML)	91.2	39.0	22.8

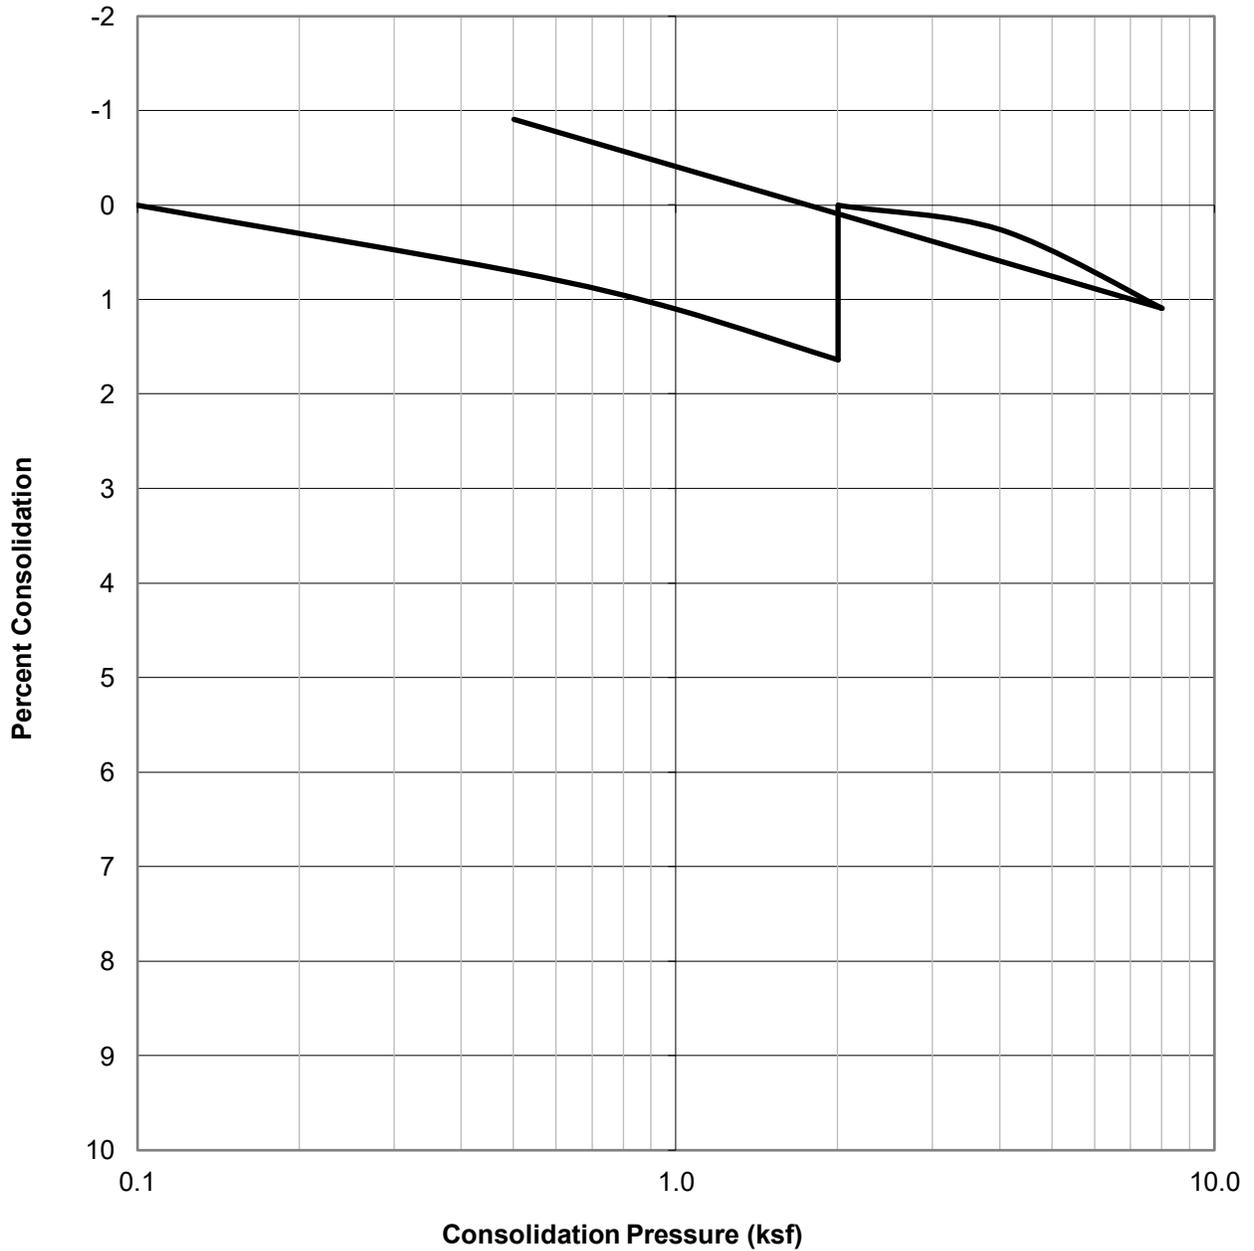
Figure B17

WATER ADDED AT 2.0 KSF

SAMPLE ID.	SOIL TYPE	DRY DENSITY (PCF)	INITIAL MOISTURE (%)	FINAL MOISTURE (%)
B8 @ 9'	Sandy Clay (CL)	114.6	16.9	19.1

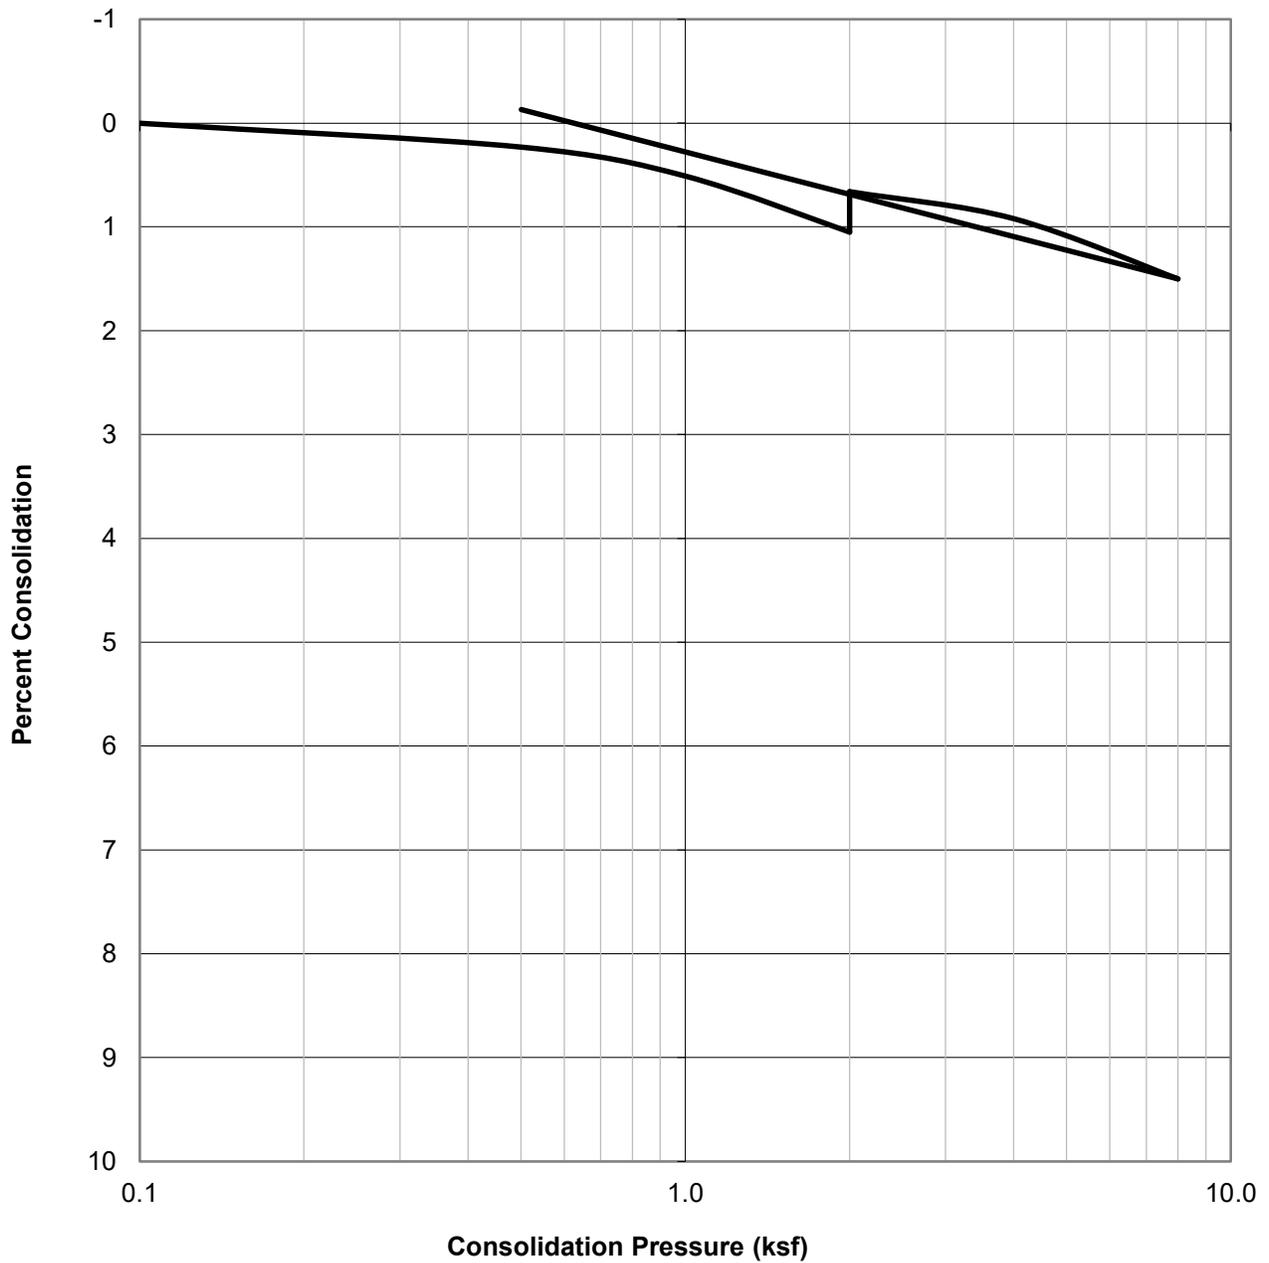
Figure B18

WATER ADDED AT 2.0 KSF

SAMPLE ID.	SOIL TYPE	DRY DENSITY (PCF)	INITIAL MOISTURE (%)	FINAL MOISTURE (%)
B8 @ 12'	Sandy Clay (CL)	116.0	15.7	17.1

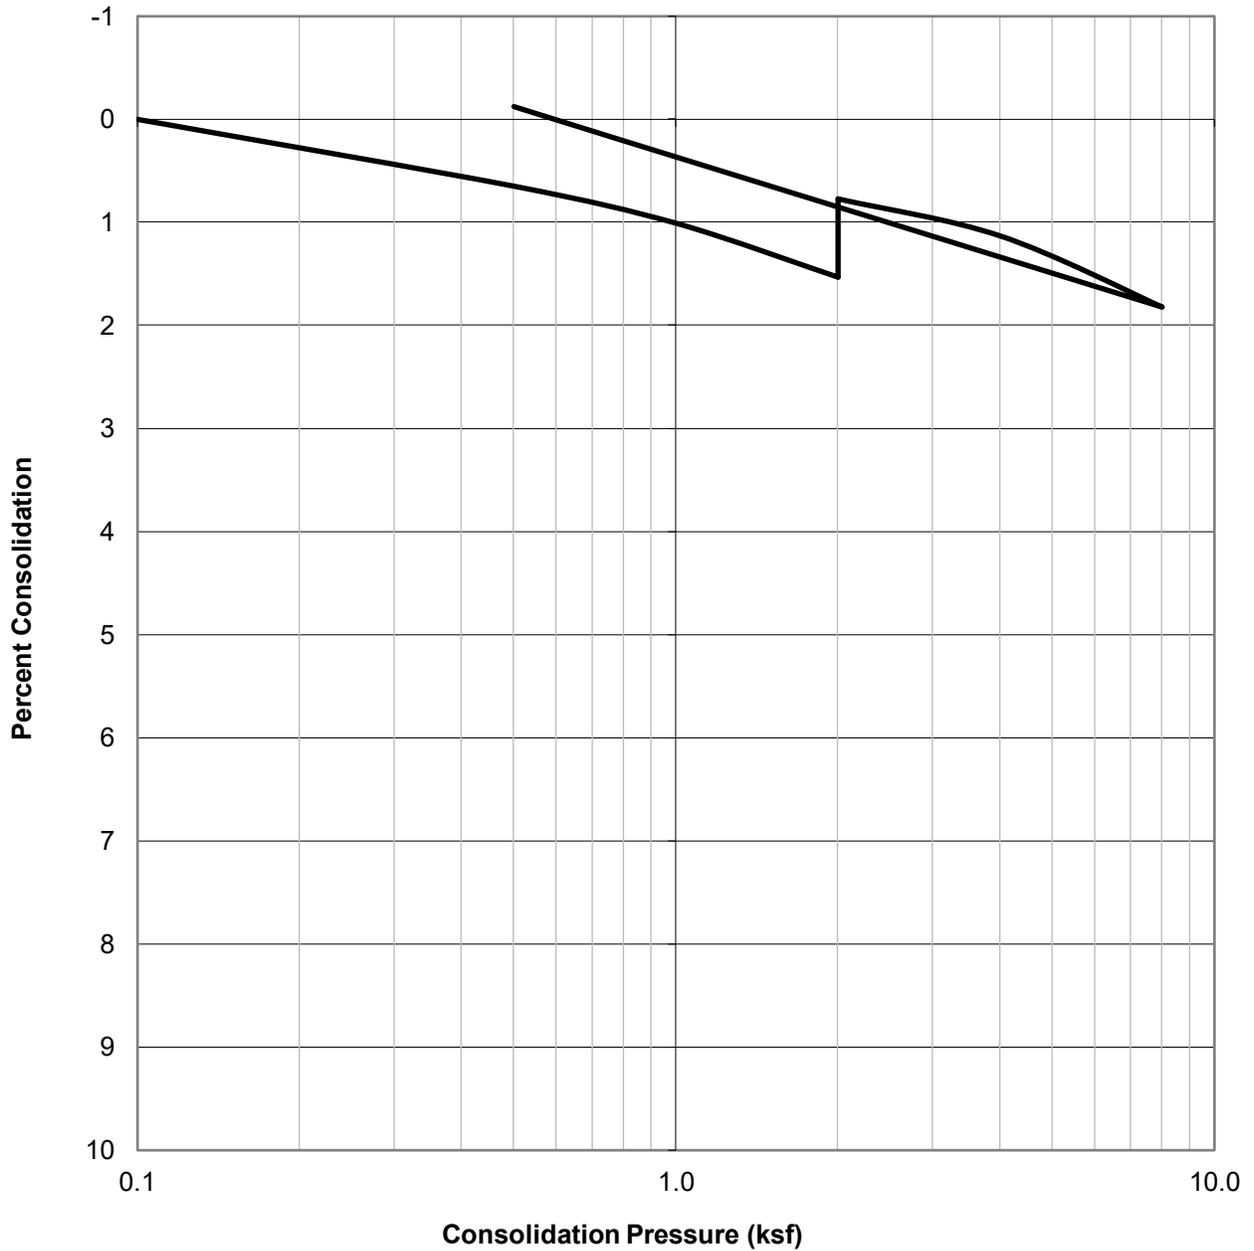
Project No.: W2068-88-01
 SONORA HIGH SCHOOL
 401 SOUTH PALM STREET
 LA HABRA, CALIFORNIA
 MAY 2025 Figure B19

WATER ADDED AT 2.0 KSF

SAMPLE ID.	SOIL TYPE	DRY DENSITY (PCF)	INITIAL MOISTURE (%)	FINAL MOISTURE (%)
B8 @ 15'	Sandy Clay (CL)	114.6	15.4	17.9

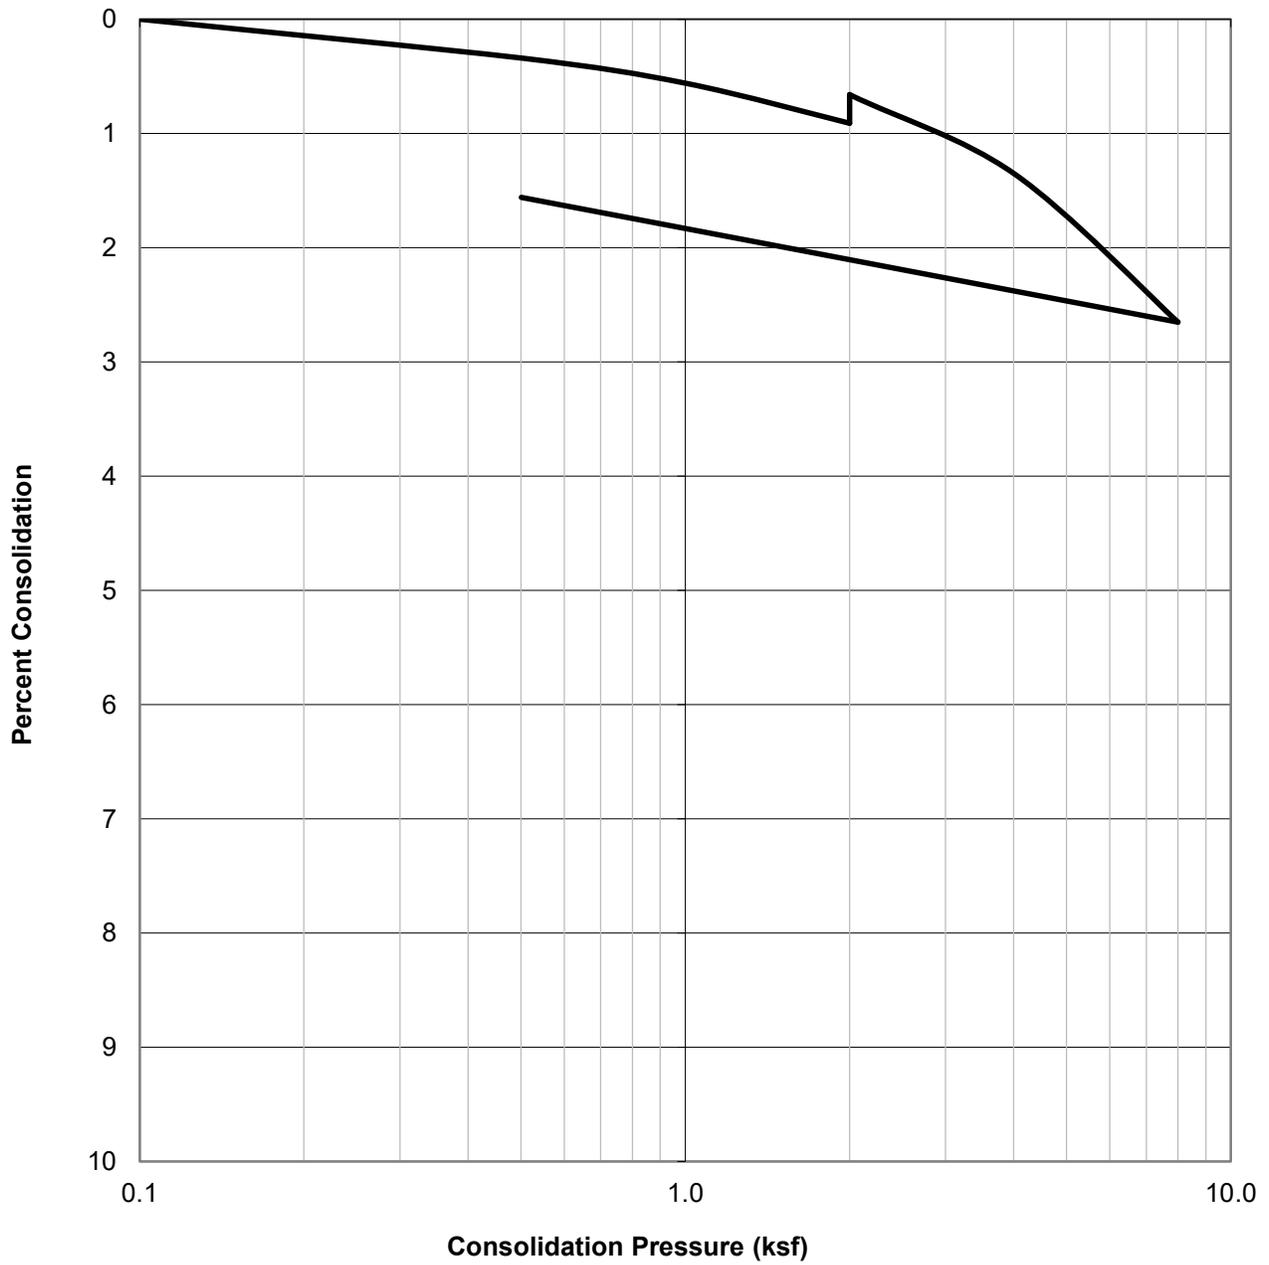
Figure B20

WATER ADDED AT 2.0 KSF

SAMPLE ID.	SOIL TYPE	DRY DENSITY (PCF)	INITIAL MOISTURE (%)	FINAL MOISTURE (%)
B10 @6'	Sandy Clay (CL)	104.3	14.4	19.4

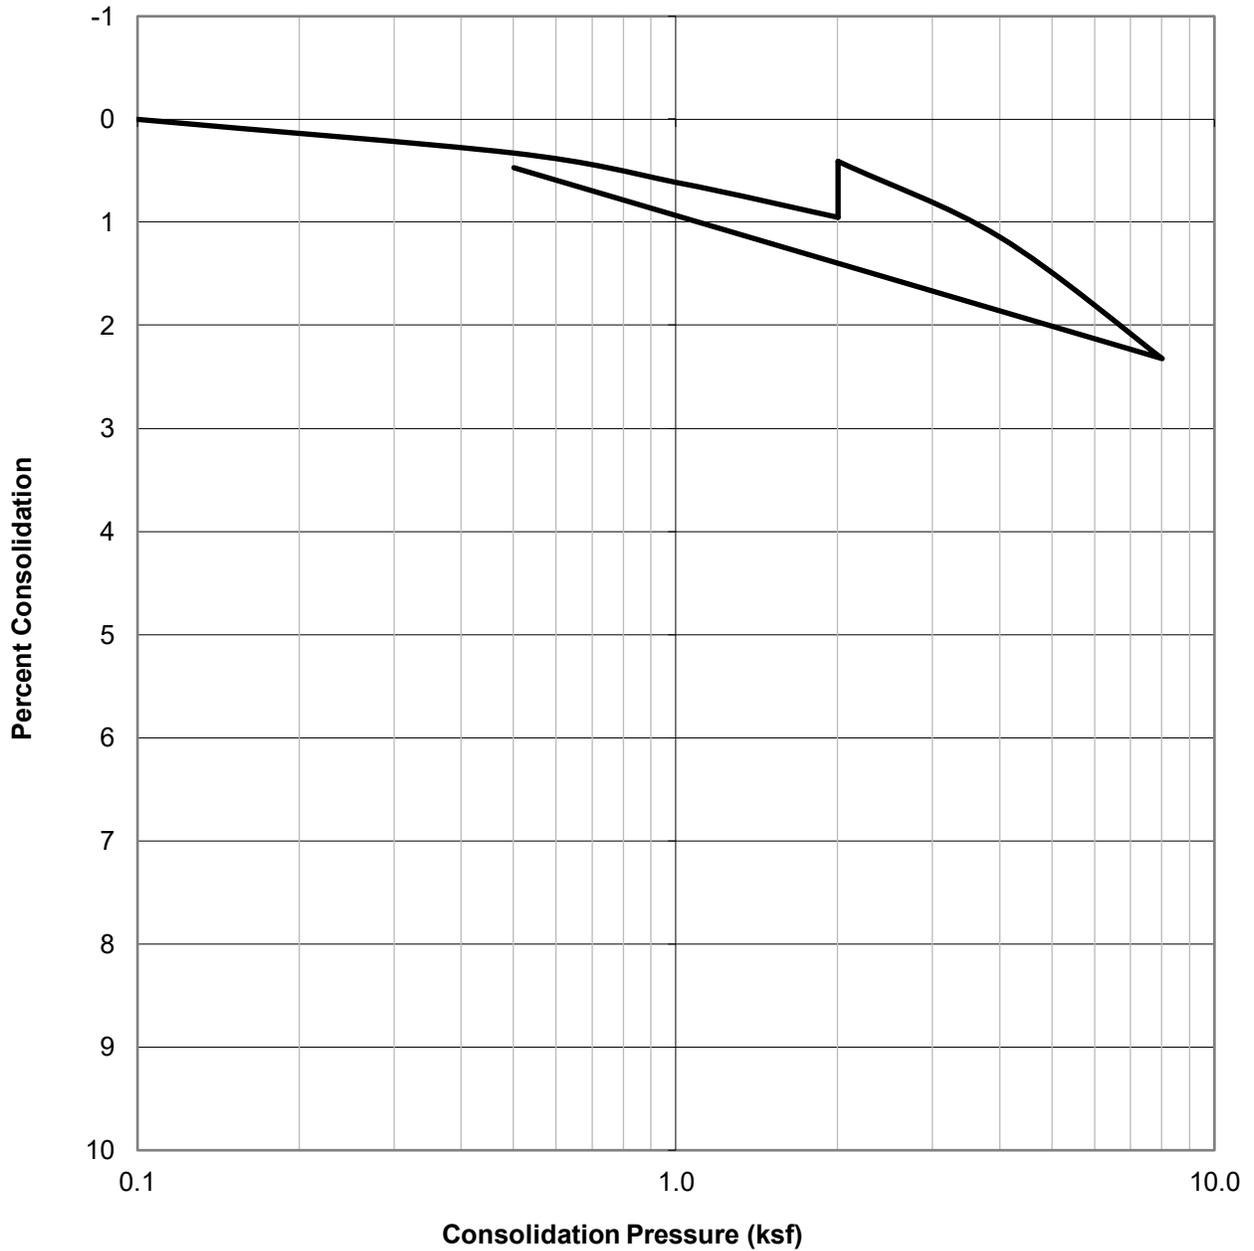
Figure B21

WATER ADDED AT 2.0 KSF

SAMPLE ID.	SOIL TYPE	DRY DENSITY (PCF)	INITIAL MOISTURE (%)	FINAL MOISTURE (%)
B10 @ 9'	Sandy Clay (CL)	113.6	12.1	17.1

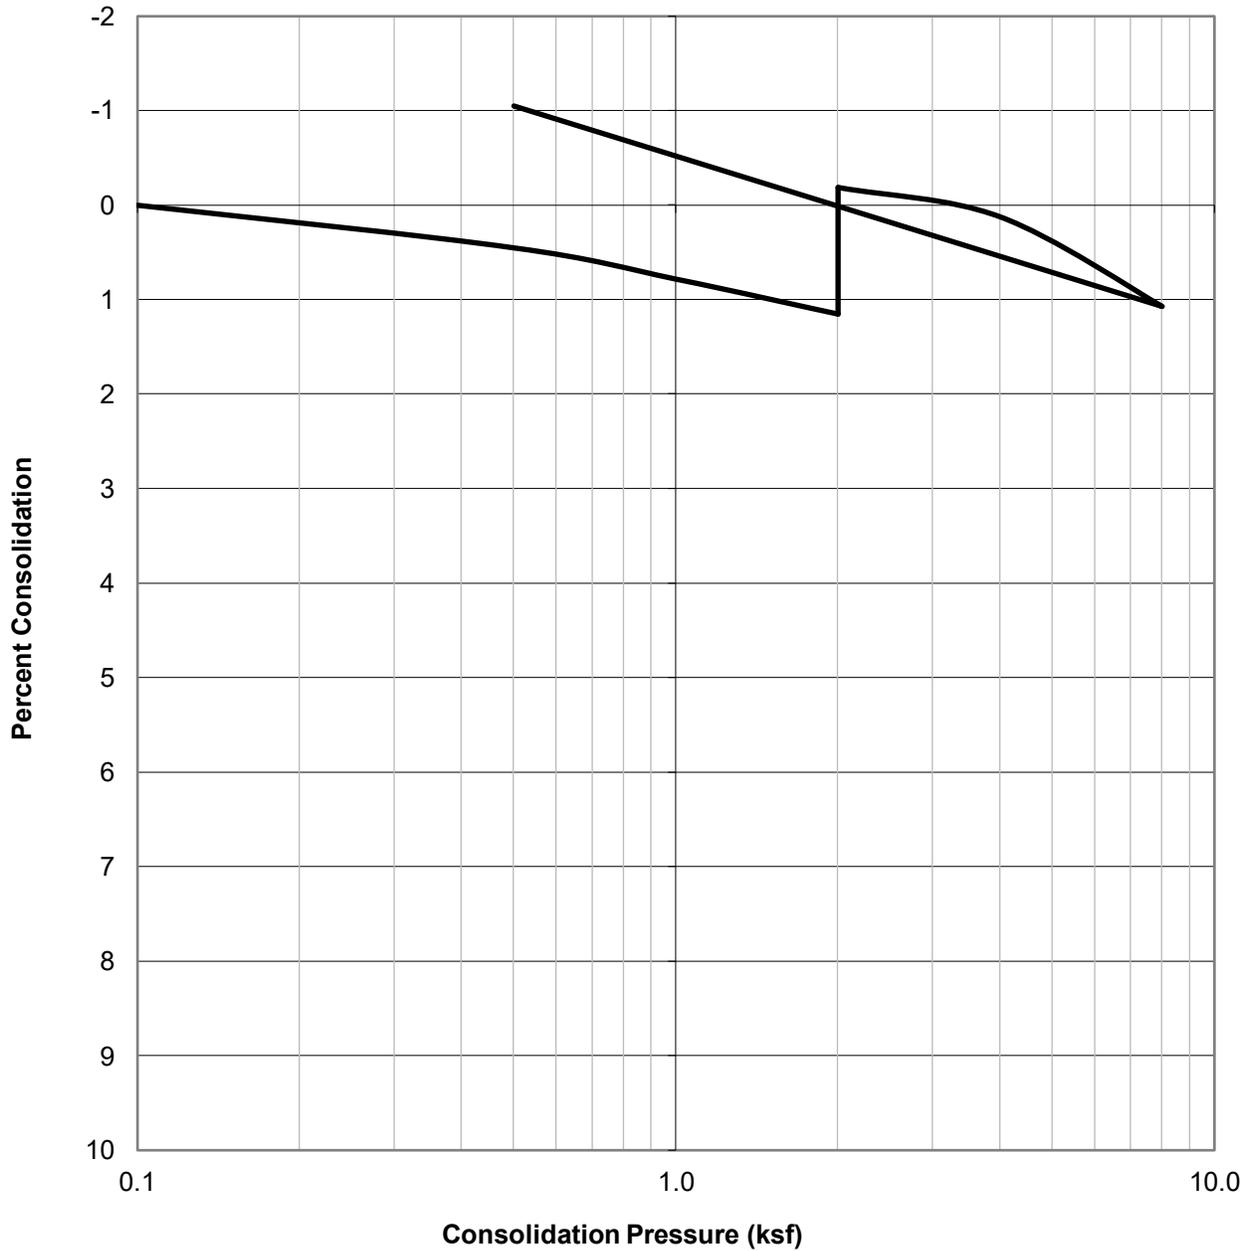
Figure B22

WATER ADDED AT 2.0 KSF

SAMPLE ID.	SOIL TYPE	DRY DENSITY (PCF)	INITIAL MOISTURE (%)	FINAL MOISTURE (%)
B10 @ 12'	Sandy Clay (CL)	114.0	15.8	18.7

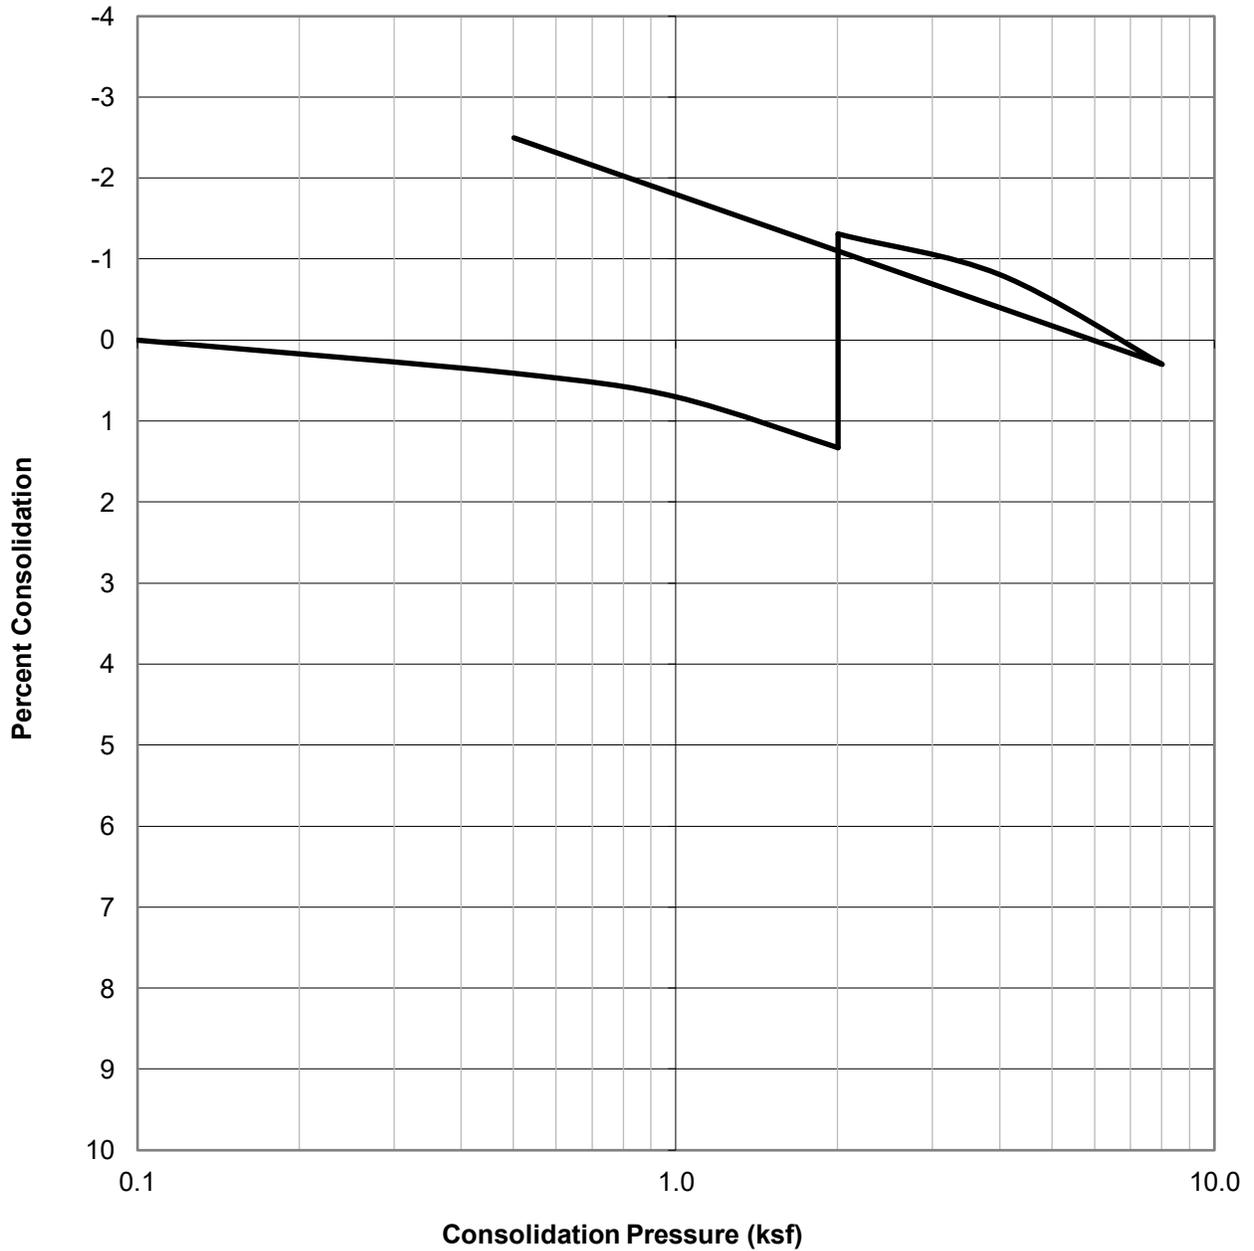
CONSOLIDATION TEST RESULTS ASTM D-2435	Project No.: W2068-88-01
	Checked by: RP	SONORA HIGH SCHOOL 401 SOUTH PALM STREET LA HABRA, CALIFORNIA
	MAY 2025	Figure B23

WATER ADDED AT 2.0 KSF

SAMPLE ID.	SOIL TYPE	DRY DENSITY (PCF)	INITIAL MOISTURE (%)	FINAL MOISTURE (%)
B4@3	Sandy Clay (CL)	107.4	14.6	21.8

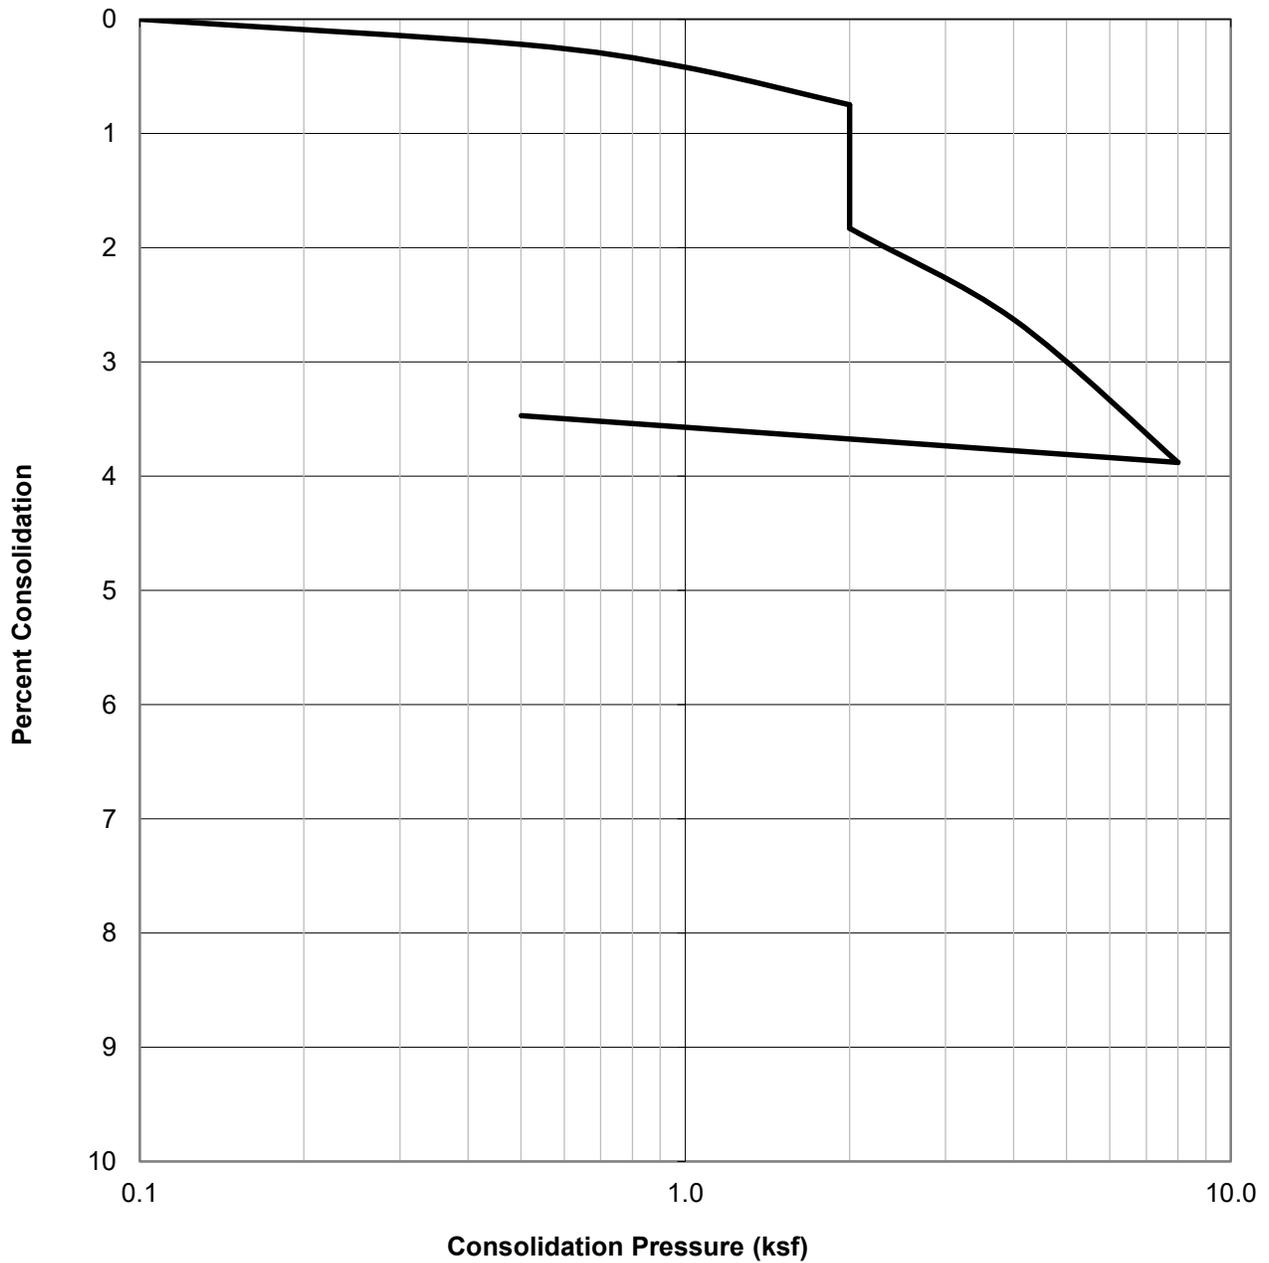
Figure B24

WATER ADDED AT 2.0 KSF

SAMPLE ID.	SOIL TYPE	DRY DENSITY (PCF)	INITIAL MOISTURE (%)	FINAL MOISTURE (%)
B4@9	Clayey Sand (SC)	86.0	12.7	23.4
