SOHS Science Classroom Modernization

ADDENDUM # 1

ASBESTOS & LEAD-BASED PAINT INSPECTION REPORT

LIMITED GEOTECHNICAL INVESTIGATION

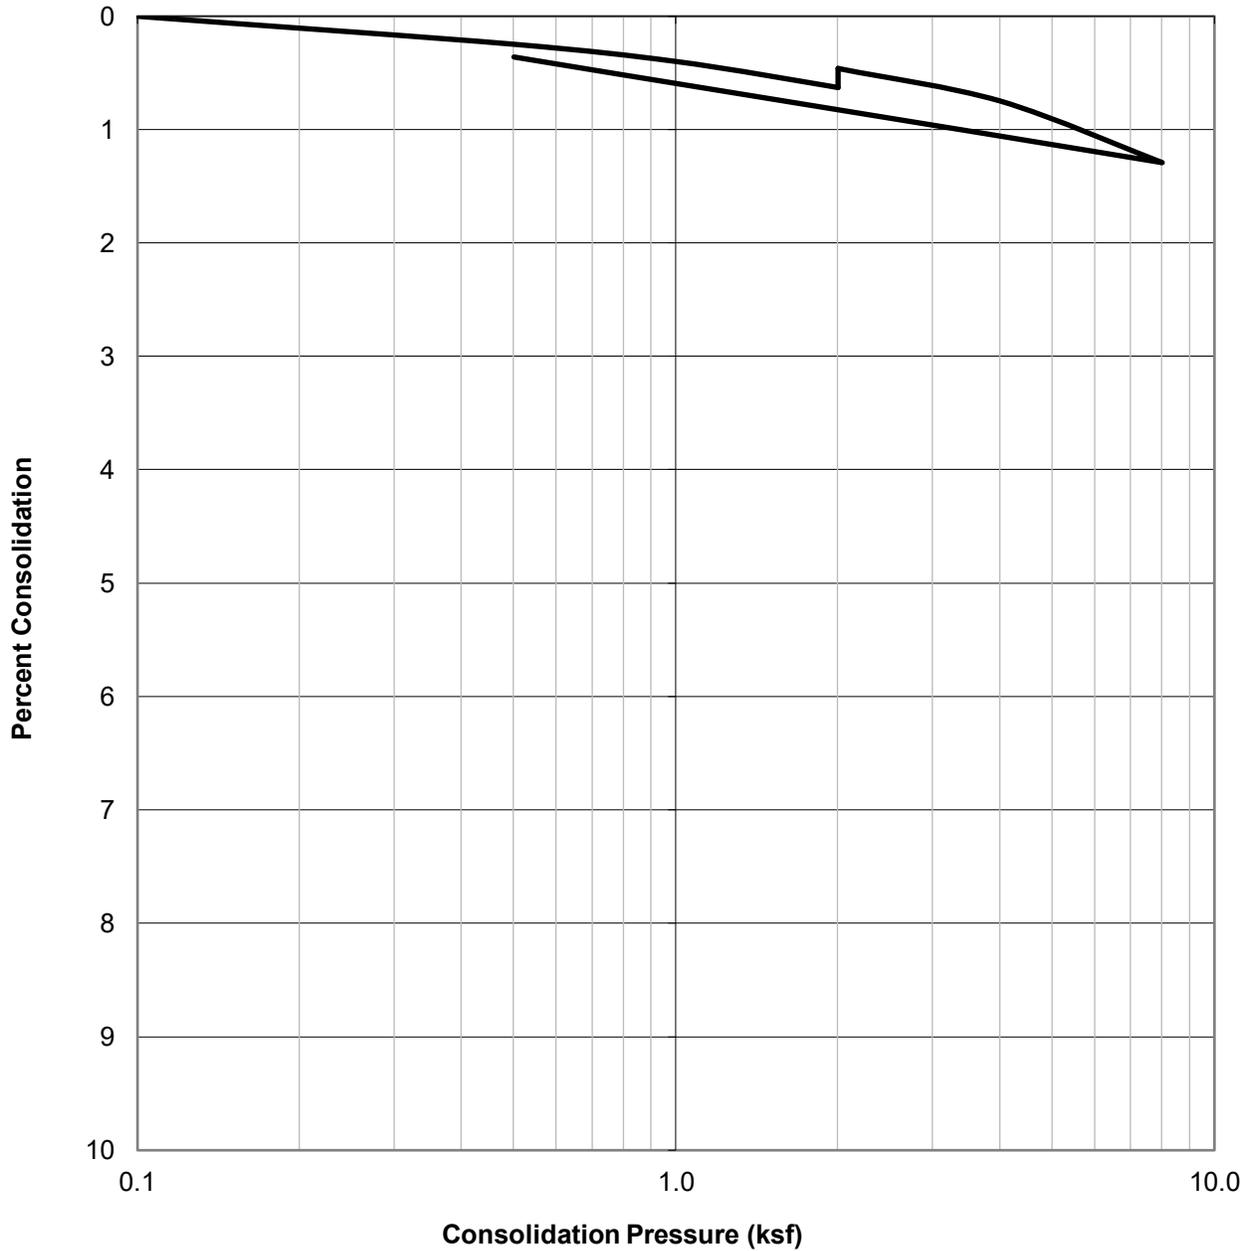
Figure B25

WATER ADDED AT 2.0 KSF

SAMPLE ID.	SOIL TYPE	DRY DENSITY (PCF)	INITIAL MOISTURE (%)	FINAL MOISTURE (%)
B4@15	Clayey Sand (SC)	86.0	12.7	23.4

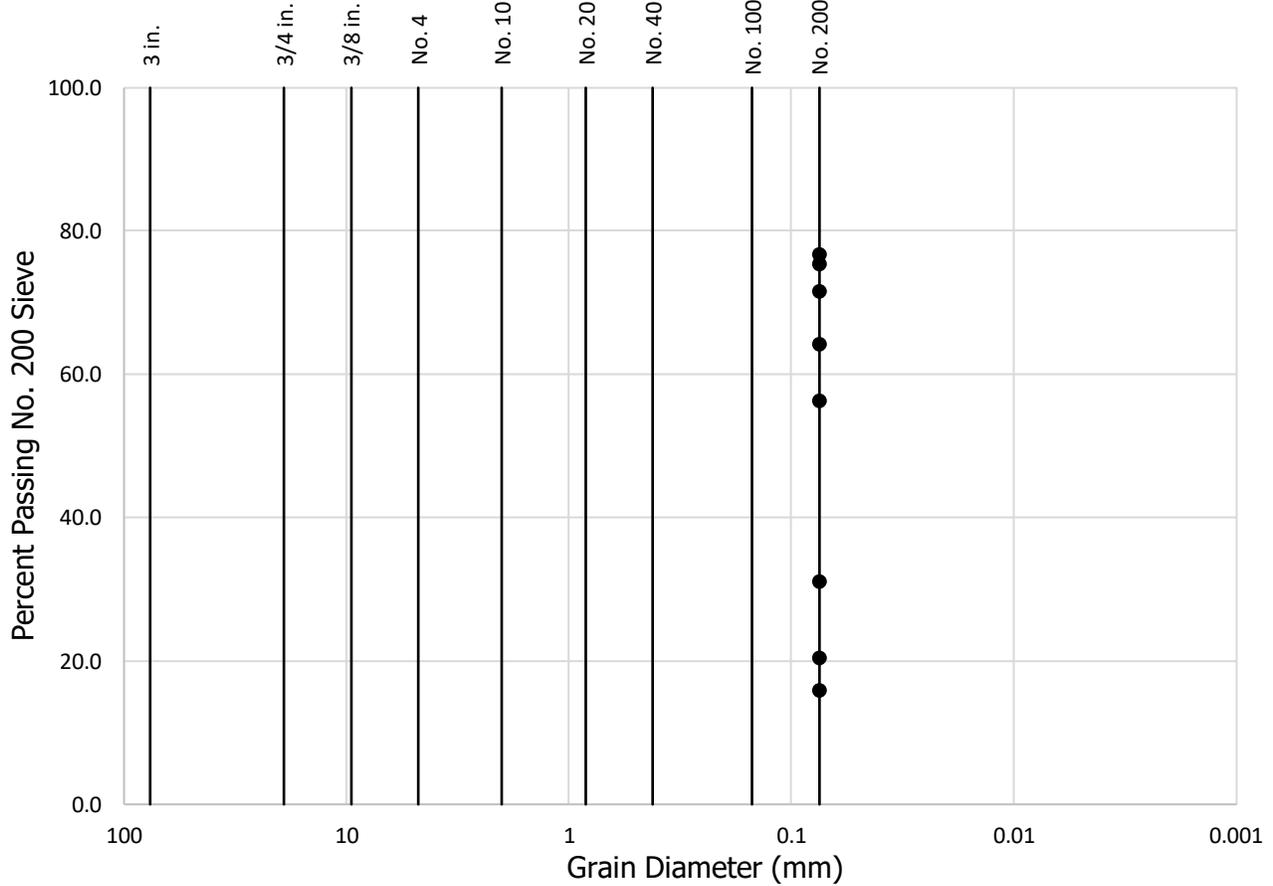
GRAVEL		SAND			SILT AND CLAY
COARSE	FINE	COARSE	MEDIUM	FINE

Sample No.	Percent Passing No. 200 Sieve
B8 @ 6'	64.2
B8 @ 9'	75.4
B8 @ 12'	76.7
B8 @ 15'	56.3
B8 @ 20'	31.1
B8 @ 24.5'	20.4
B8 @ 30'	71.5
B8 @ 35'	15.9

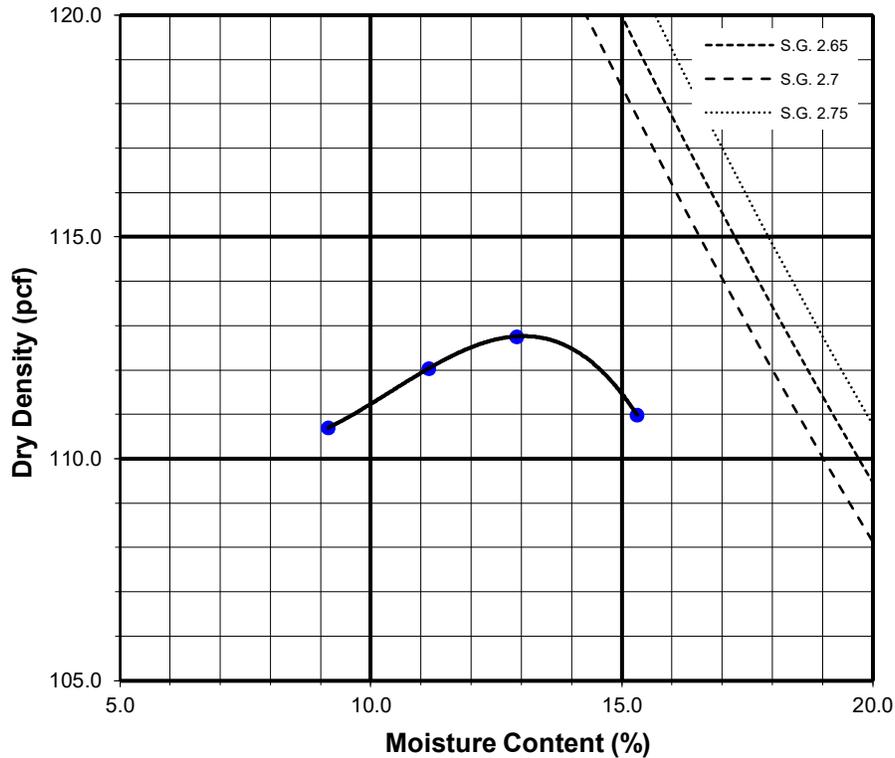
Maximum Dry Density (pcf) 113.0

Optimum Moisture Content (%) 12.5

Preparation Method: A

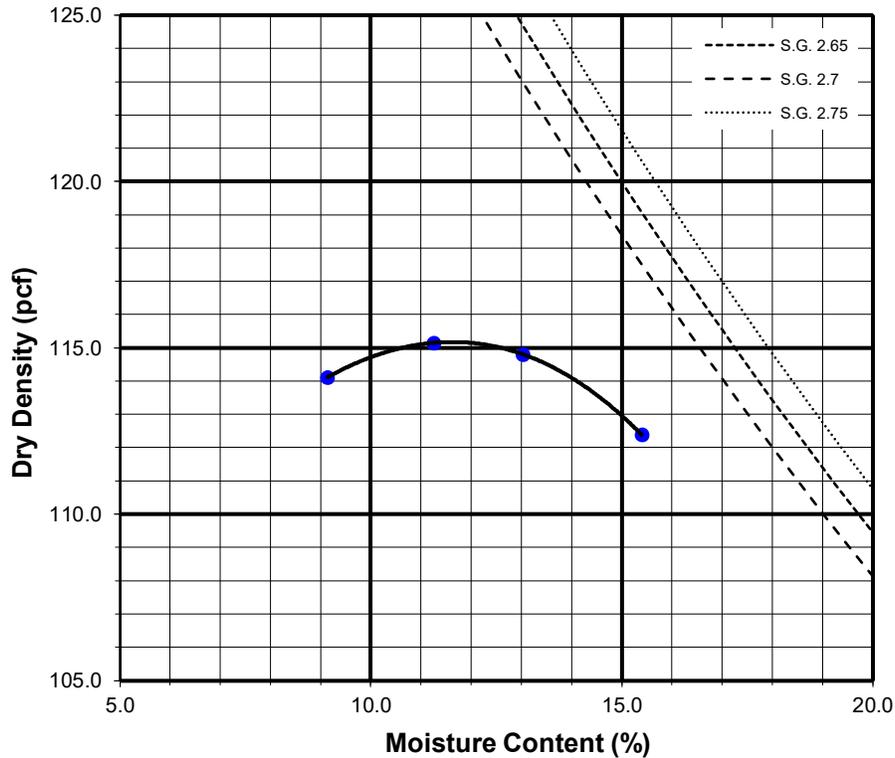
Maximum Dry Density (pcf) 113.0

Optimum Moisture Content (%) 12.5

Preparation Method: A

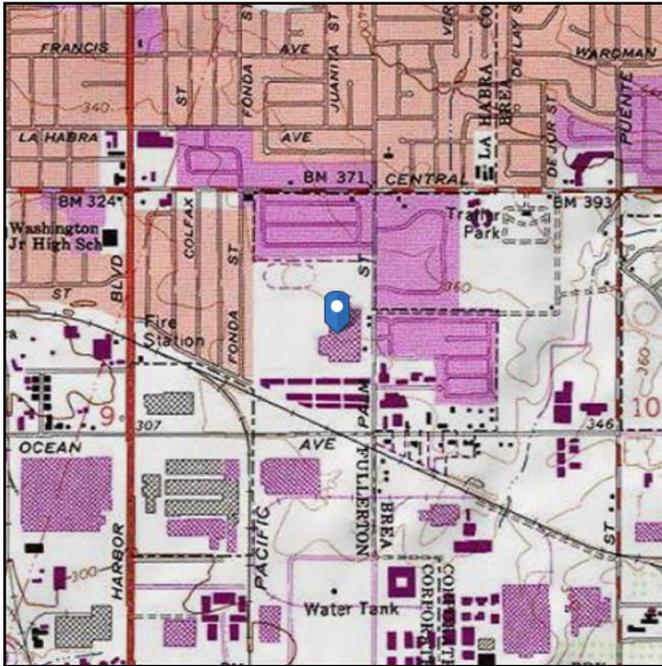
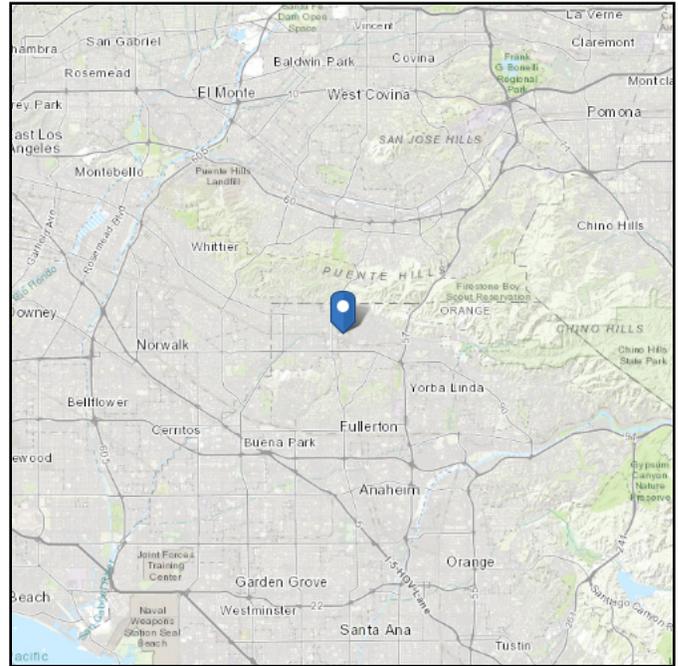
Standard: ASCE/SEI 7-22
Risk Category: I
Soil Class: CD

Site Soil Class: CD

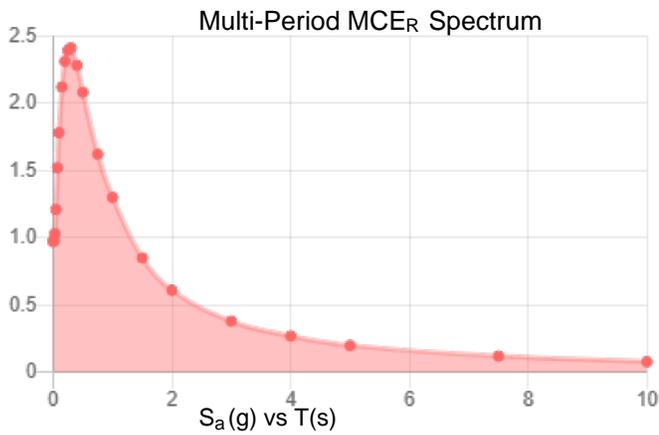
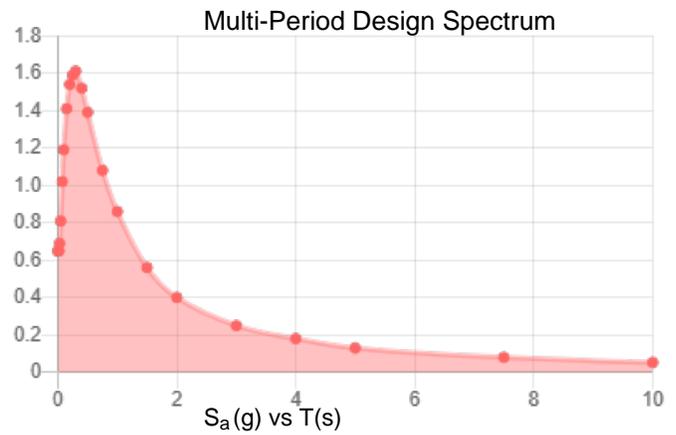
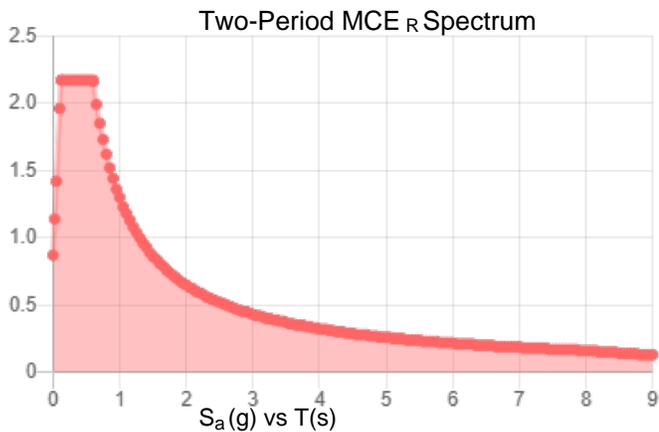
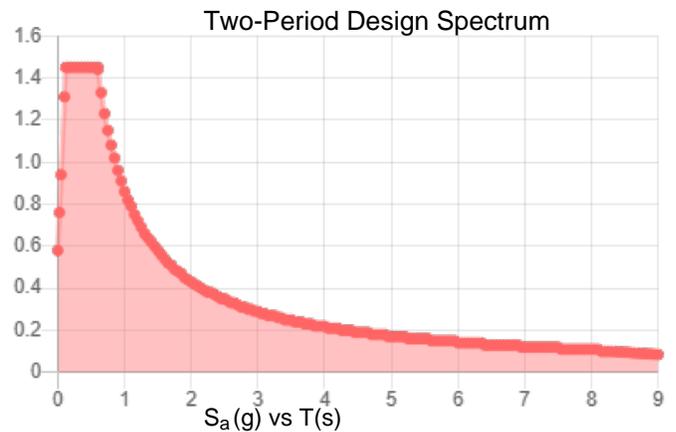
PGA _M :	0.87	T _L :	8
S _{MS} :	2.17	S _s :	2.04
S _{M1} :	1.3	S ₁ :	0.72
S _{DS} :	1.45	V _{S30} :	365
S _{D1} :	0.86

Seismic Design Category: D
