# GUIDE TO RETROFIT ASSESSMENT

How to complete an excellent assessment focused  
on specific improvement measures

The success of the entire PAS2035 process is reliant on a high quality and comprehensive Retrofit Assessment. C6 Funding look to go above and beyond the current minimum requirements and provide our clients with a detailed assessment which covers all potential measures and enables the Retrofit Coordinator to confidently recommend a package of improvement measures which are suitable and achievable.

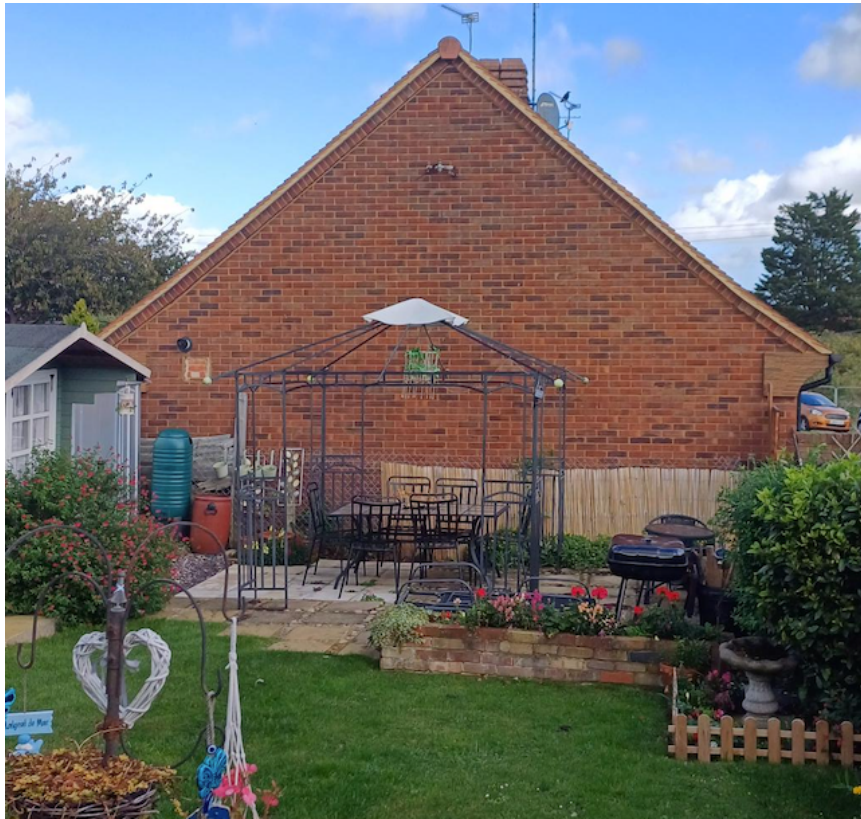
- Lofts are very full of resident belongings – please speak with the resident, is it actually achievable for the loft to be cleared?
- Lofts are boarded – please speak with the resident, would they be opposed to boards being lifted?
- Elevations which are only accessible from neighbouring properties – while it might not be possible to speak with neighbours, is it actually possible for contractors and machinery to access the required areas? This can be particularly tricky with rear gardens that do not have their own access, such as below where the side elevation is impossible to access without working from the neighbour's property:

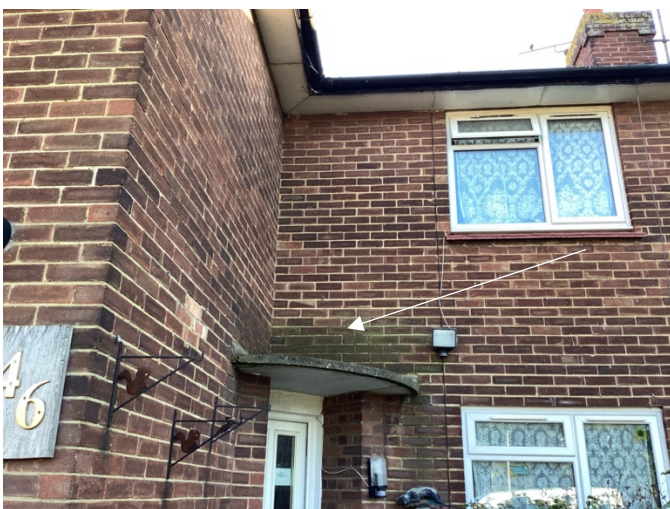
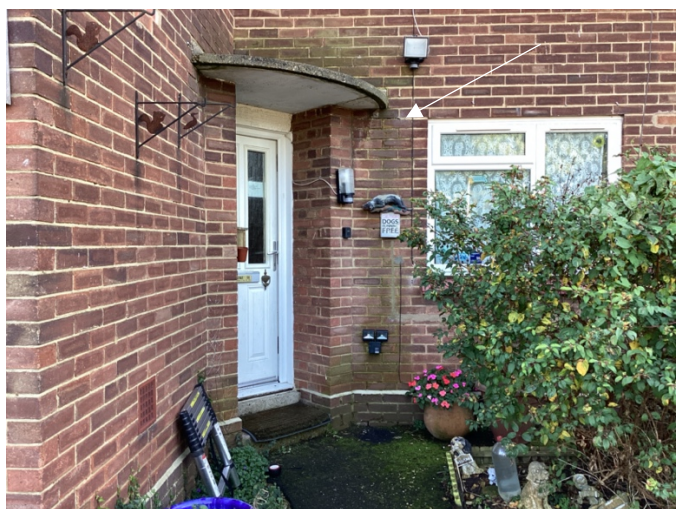
Please keep an eye out for basic issues such as blocked and leaking gutters, while these may not be visible from the ground there are often tell-tale signs of issues such as staining to the walls as shown below.

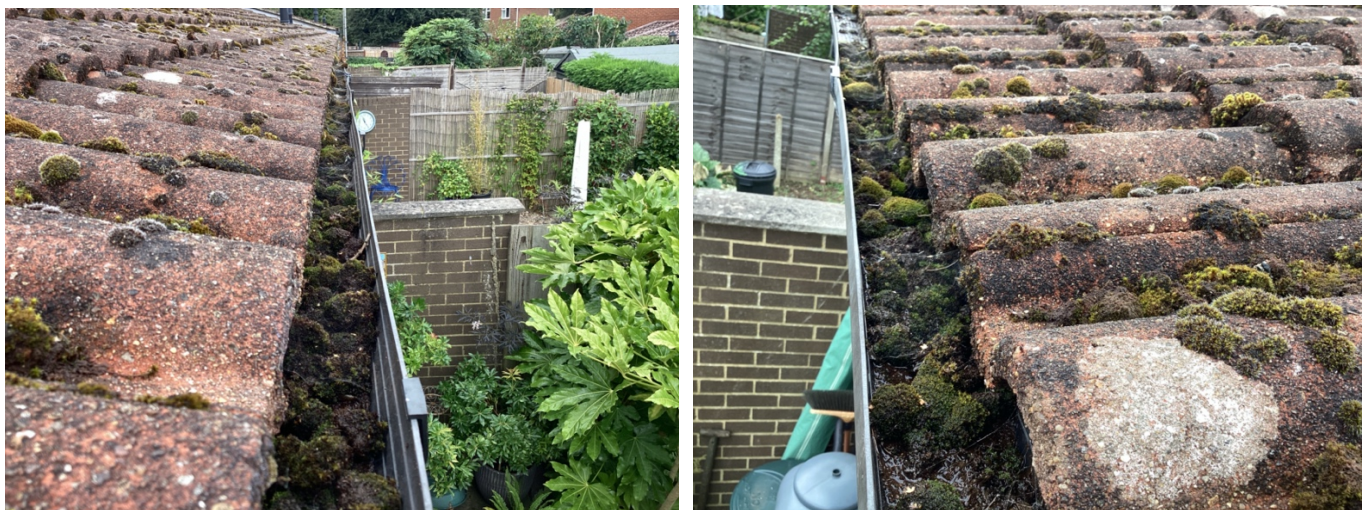
When inspecting bungalows, an inspection of the gutters is usually possible.

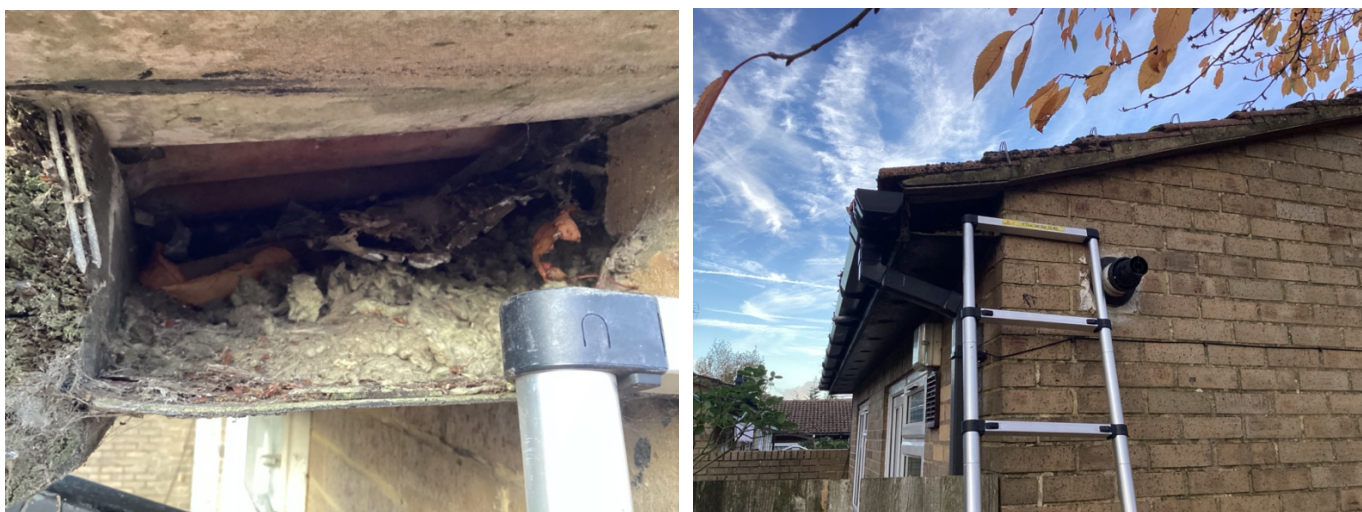
Where issues are found, close up and context photos are useful when reporting back concerns to the client, as with the damage to the fascia board below.

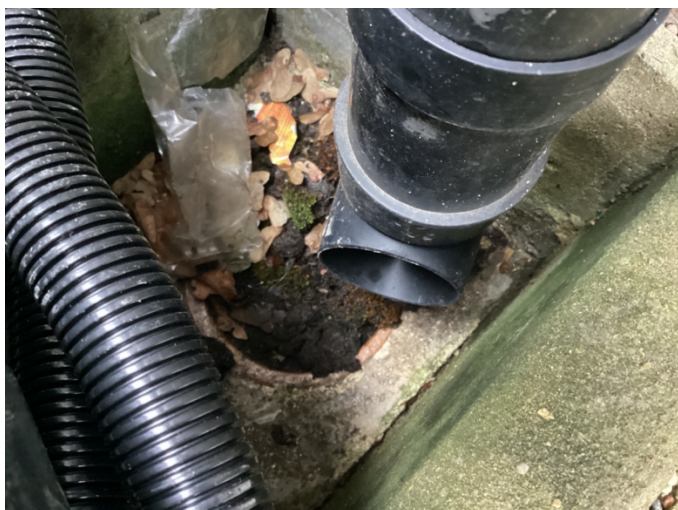
A basic investigation of external drains is important as it may give clues to water damaged brickwork

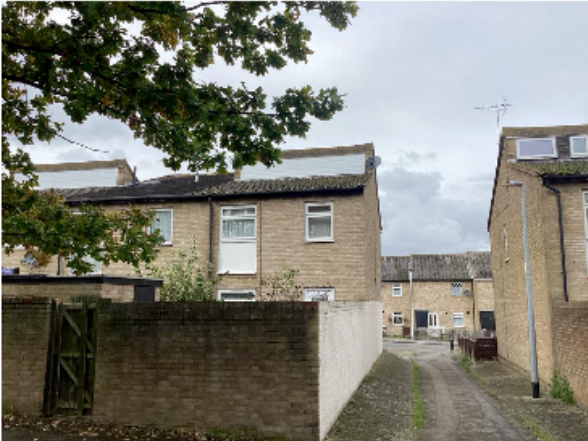
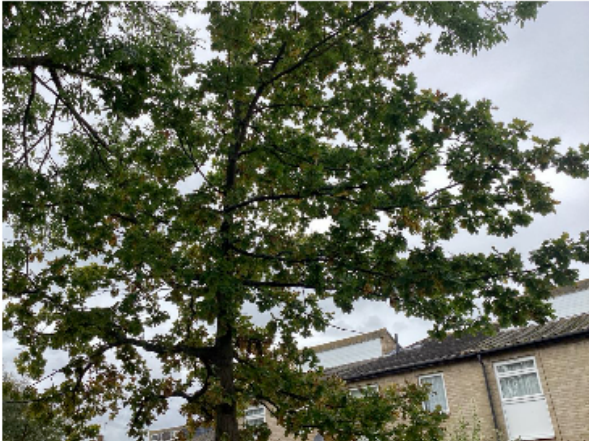
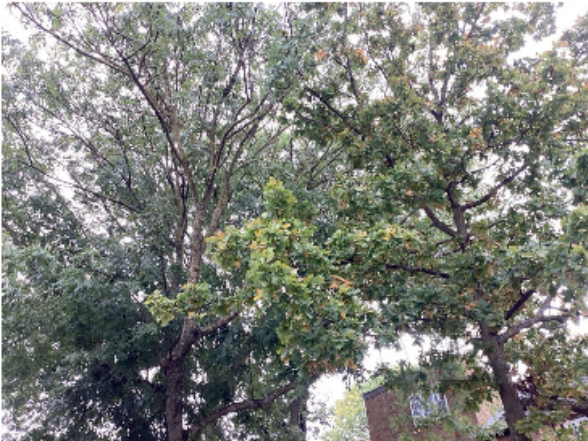
| Solar Suitability | |
|---|---|
| <b>Description</b> The most suitable roof for Solar faces South East | |
| <b>Condition</b> The amount of Solar shading is significant | |

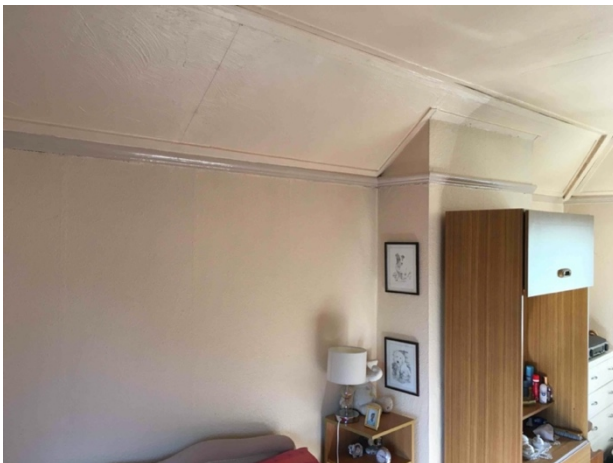
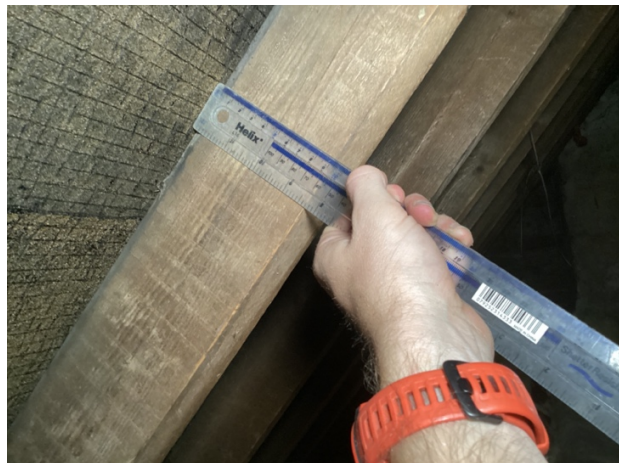
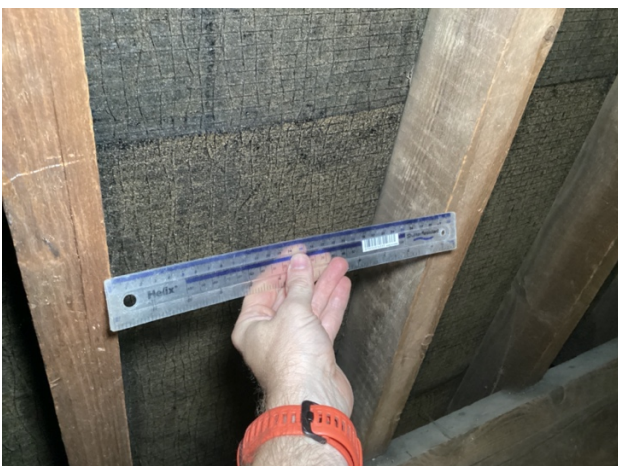
Example of skeling:

- Should skelings (section of sloping ceiling) be present in the floor below the loft, then please measure the rafter depth and distance between rafters as this will help the designer to determine a suitable solution.

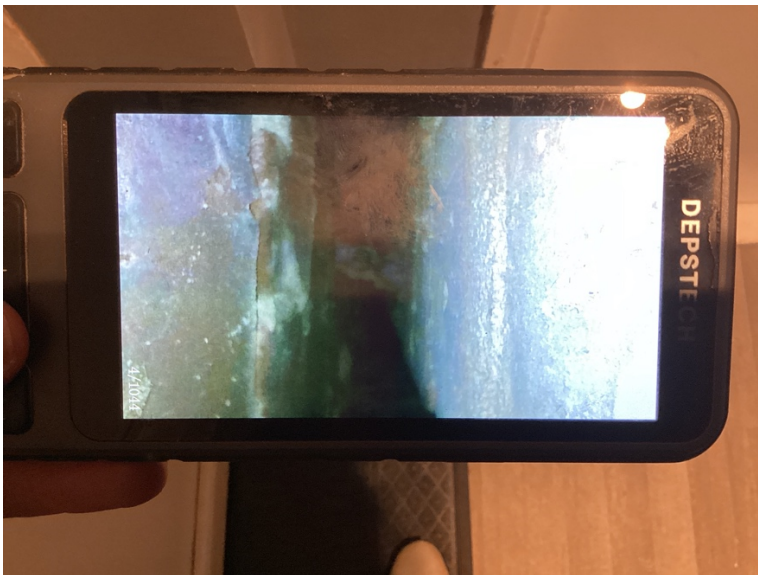
Empty cavity with wall tie visible:

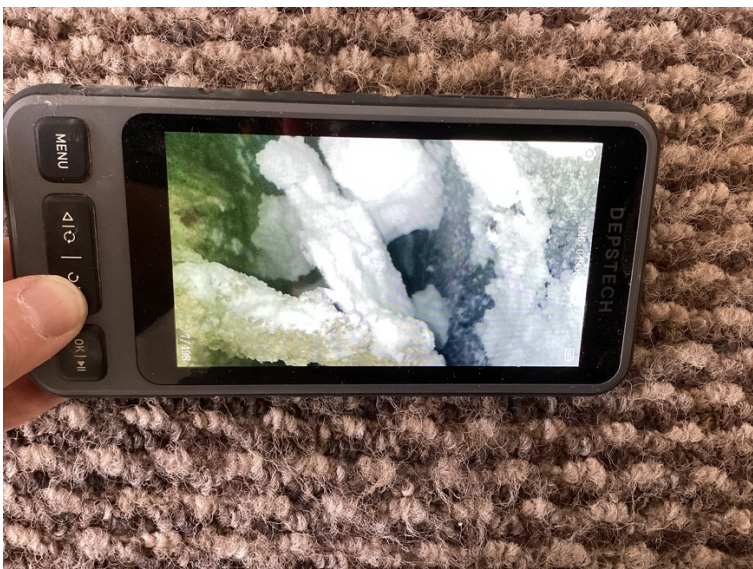
Foam insulation with evidence of failure:

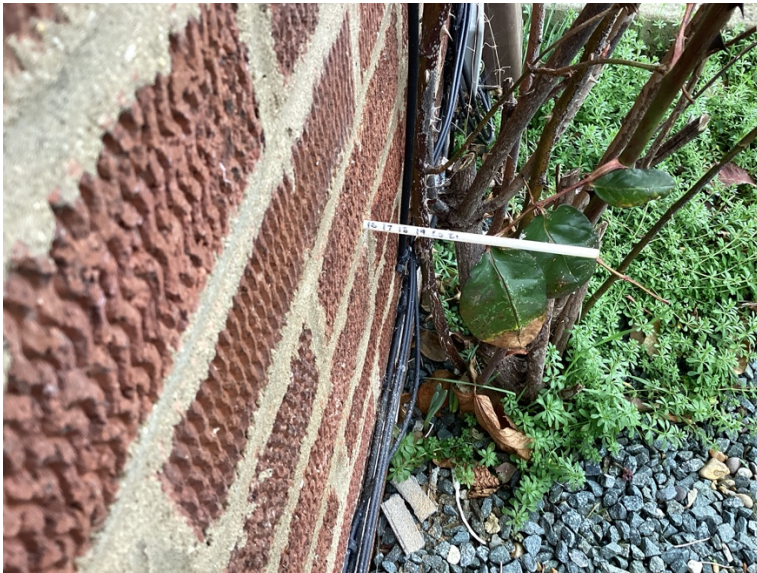
A depth measurement of the cavity is also a useful thing to include in the assessment:

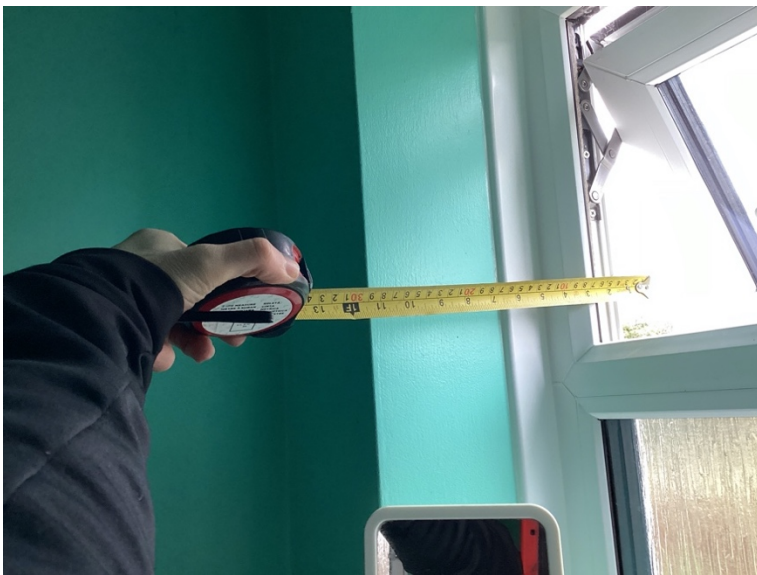
Please include a photo of the wall width, along with the cavity depth measurement this will supply the evidence required to calculate a u-value for a post retrofit cavity wall:

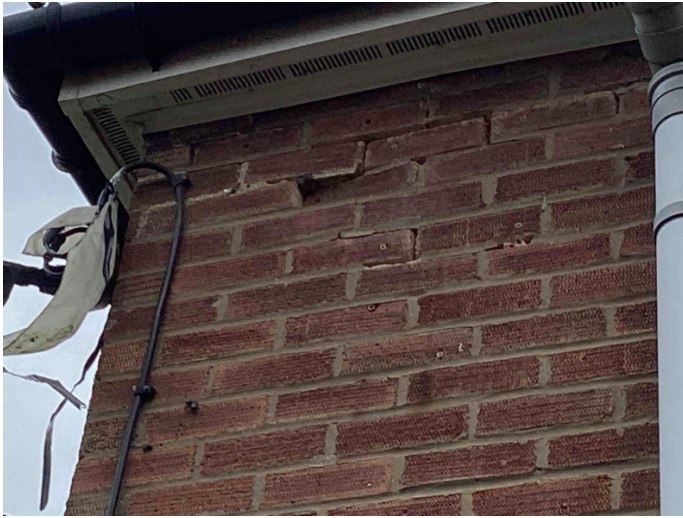
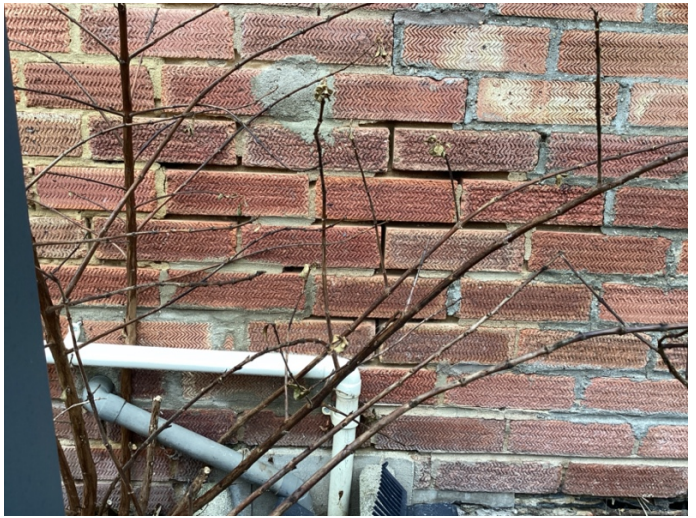
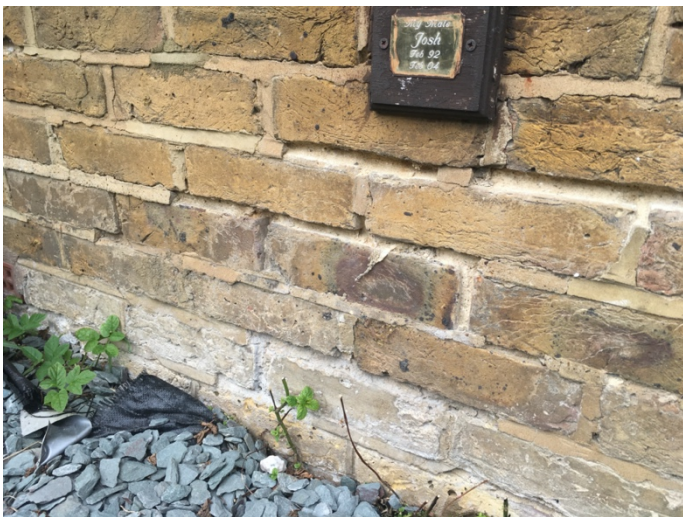
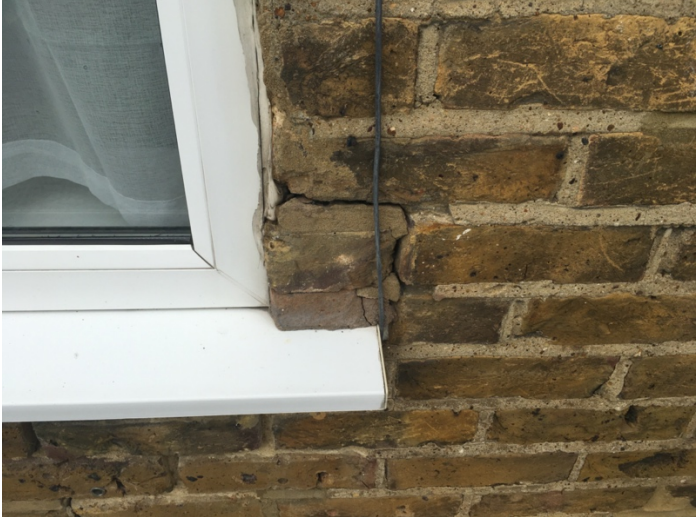
Some investigation into the condition of both the brickwork and pointing is required, if either are in particularly poor condition then they will need to be repaired before CWI or EWI could be installed.

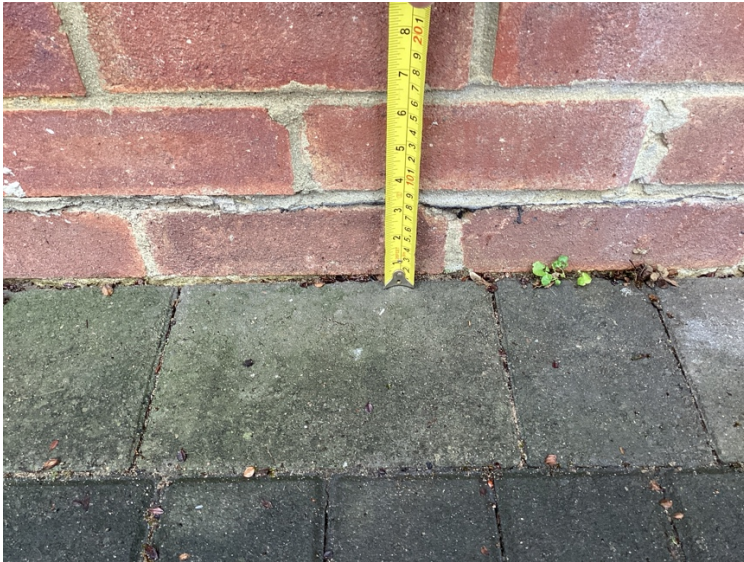
The damp proof course (DPC) should be 150mm above ground level to stop rain splash back rising up through brick work through capillary action, if incorrectly placed or bridged by the external ground level then damp issues can permeate. Please measure on all elevations and evidence as many times as required. Below is a picture where a paved drive has been installed leaving the DPC at just 80mm.

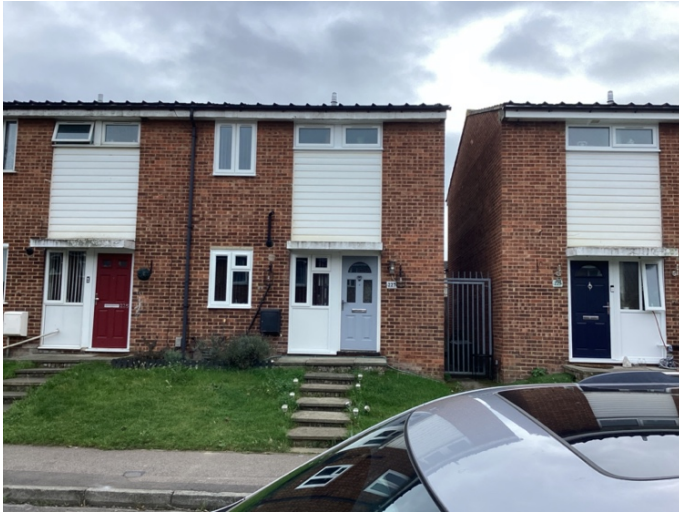
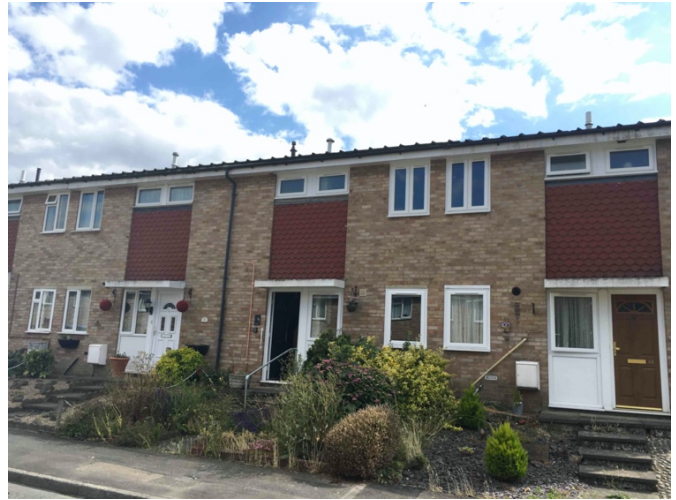
A good example of this would be a typical 1970's cavity wall property which may have a small section of either Tile Hang or PVC board as below:

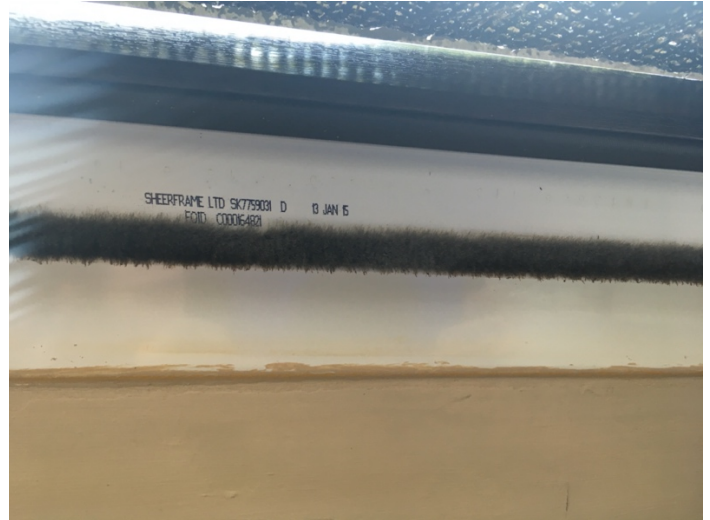
Please take clear photos of all external doors when they are closed and a close up of their draught proofing and seals. The installation dates and number of windows and doors can be searched prior to the assessment using the [FENSA website](https://forms.fensa.org.uk). Be aware that not all window installs are registered with FENSA particularly older installs. Please still investigate the date stamping on the windows to make sure they corroborate each other as below:

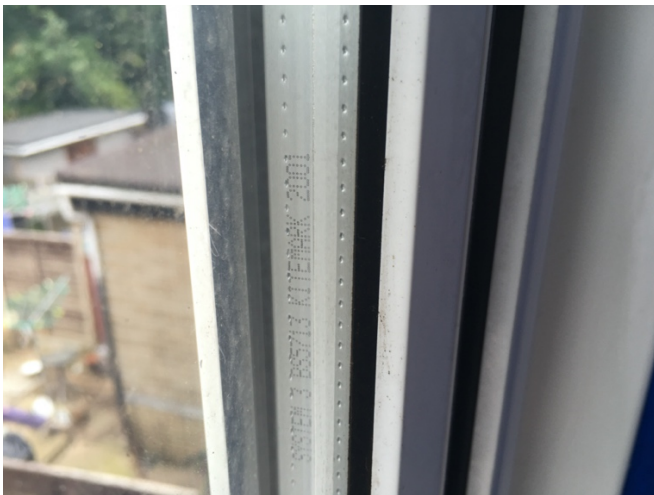
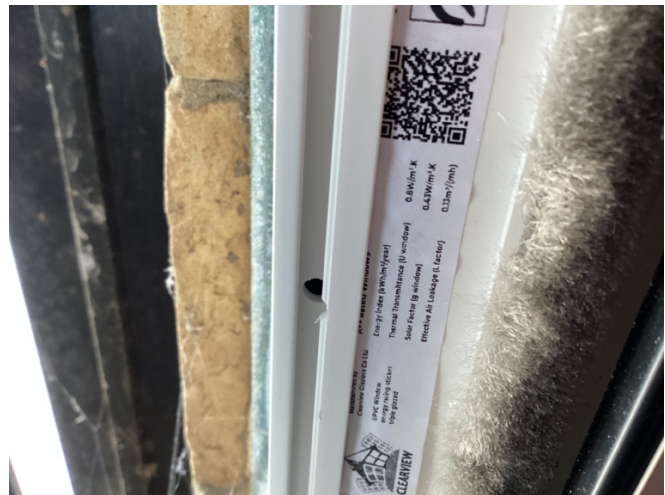
Accurate aging of windows is very important, if you can evidence the KiteMark then that is ideal. In some cases you may find the u-values of windows and doors on the frames themselves, if you have evidence of this then please use in your assessment.

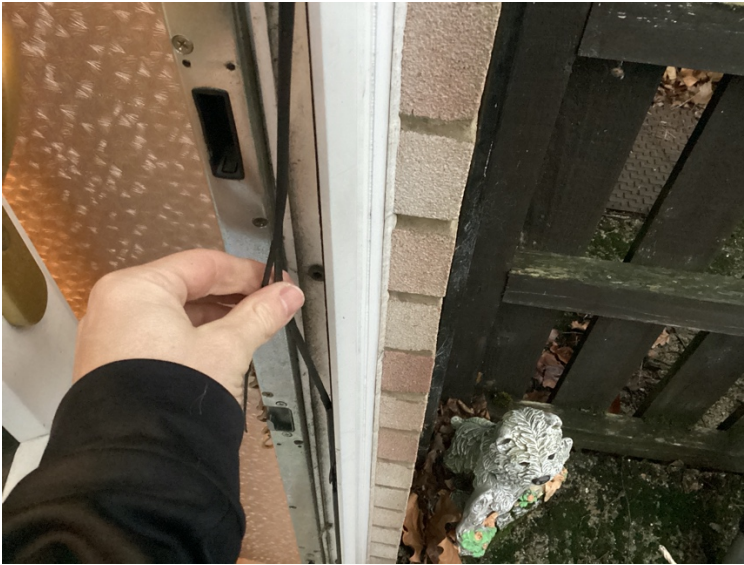
Seal damage around doors

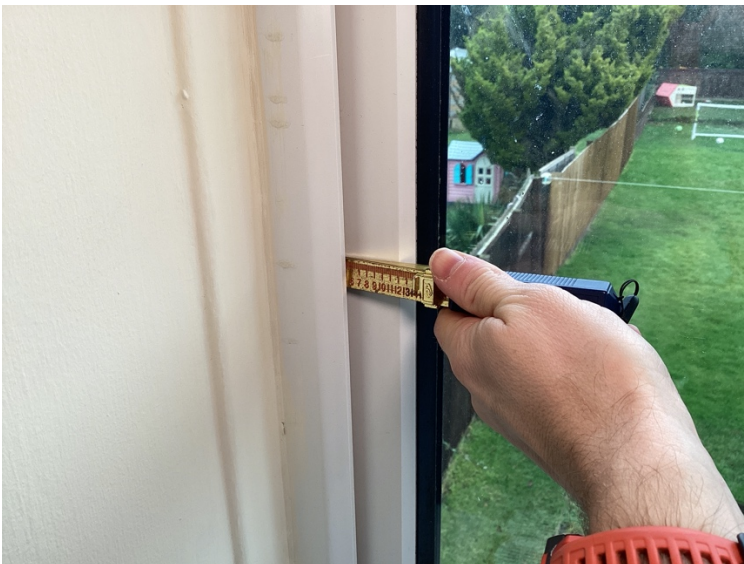
Damaged frames and mechanisms not sealing properly

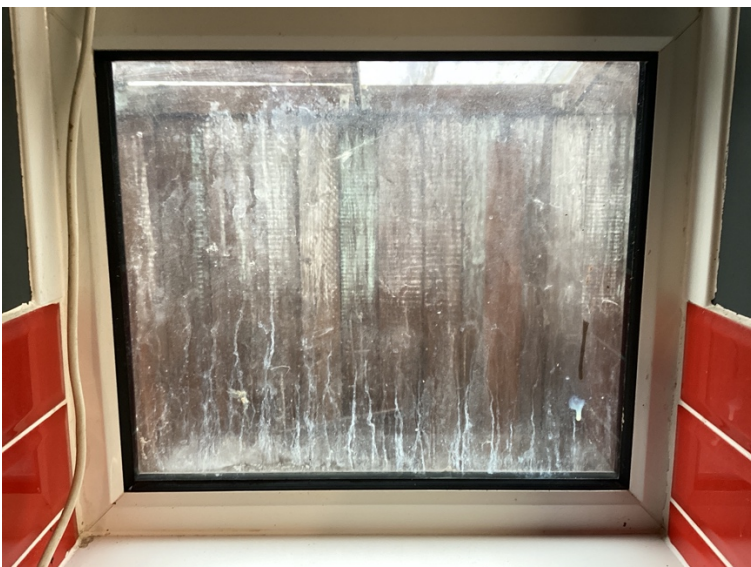
Glazing blown

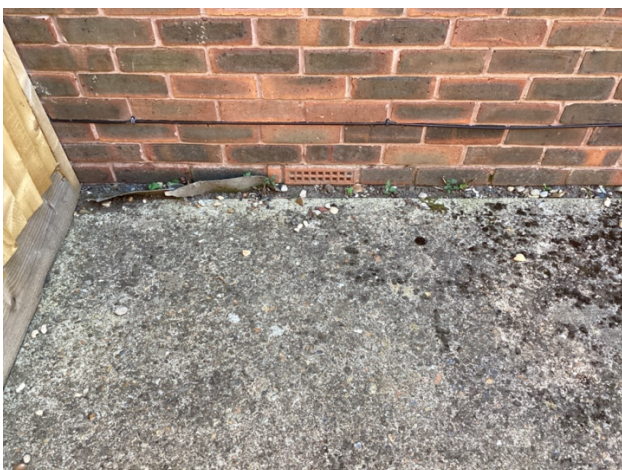
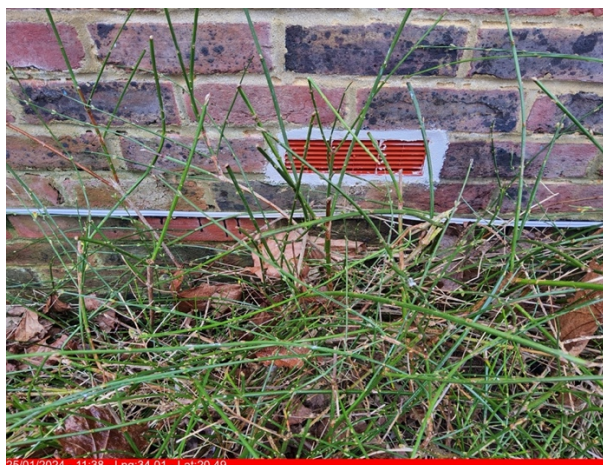
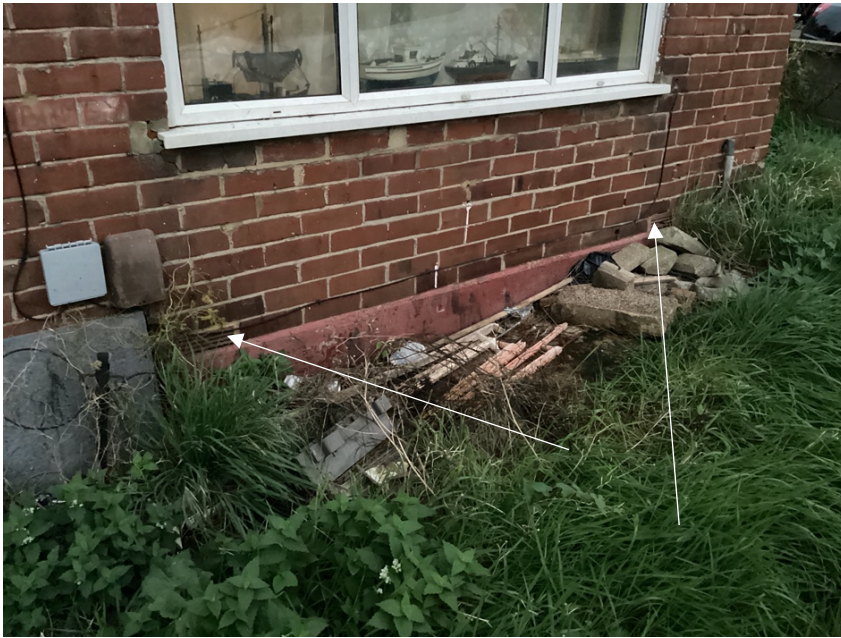
Suspended timber floors must be ventilated to ensure that the joists do not rot as a result of a buildup of humidity. Typically, timber floors are ventilated by a series of air bricks just below DPC level which are installed on opposite elevations to allow cross flow ventilation. Air bricks should be 75mm above ground level, keep a look out for air bricks which have been blocked either partially or fully. Photographs of all sub-floor airbricks should be included in the condition report and their locations should be noted on the floorplan. Sub-floor vents will often be hidden by furniture or plants, please make an effort to capture a photo of them. There should be close ups so that their type can be determined, and photos from further away to show locations.

In some cases, the Retrofit Designer will need to undertake an assessment using the methodology in 'BS493:1995 +A1:2010 Specification for airbricks and gratings for wall ventilation' to ensure that adequate ventilation is present.

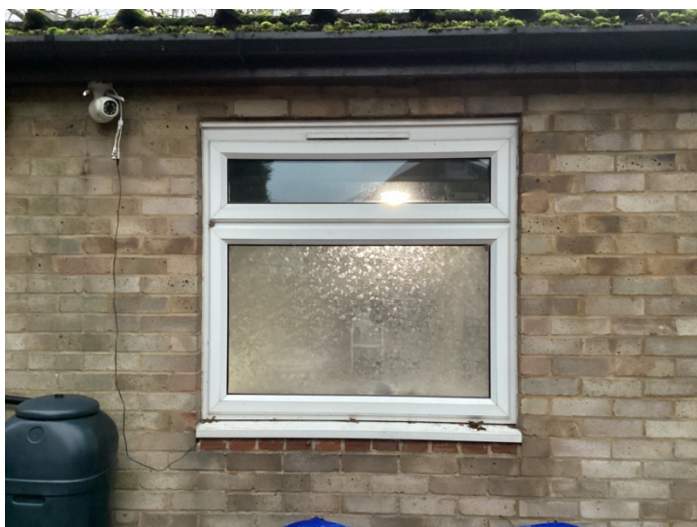
External photos of all windows should be taken to show whether trickle vents are present within each room. Trickle vents should also be marked up on the floorplan.

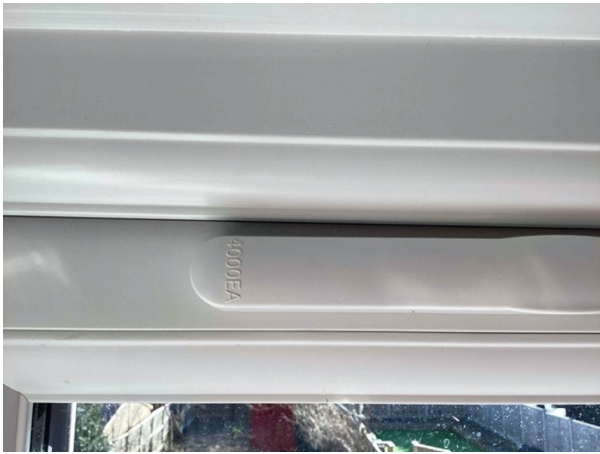
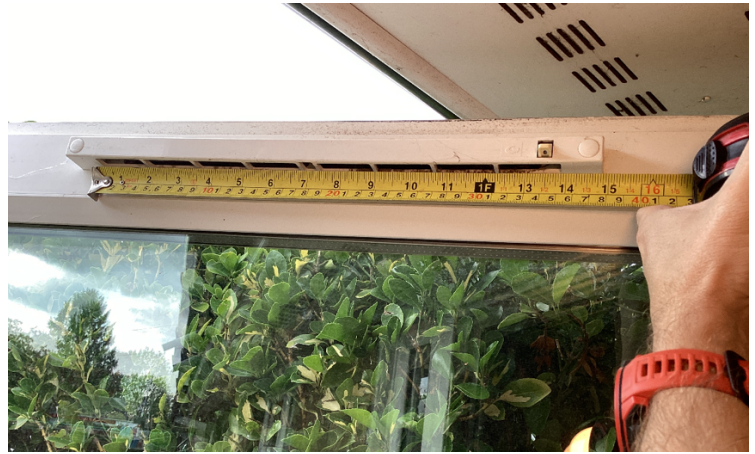
On newer windows there may be evidence of the equivalent area supplied by each trickle vent, if it is present then please evidence this. If this is not present, then a dimensional measurement should be taken and recorded on the condition report, measurement evidence of each size is required ie: if all trickle vents are the same size then only one photo is required.

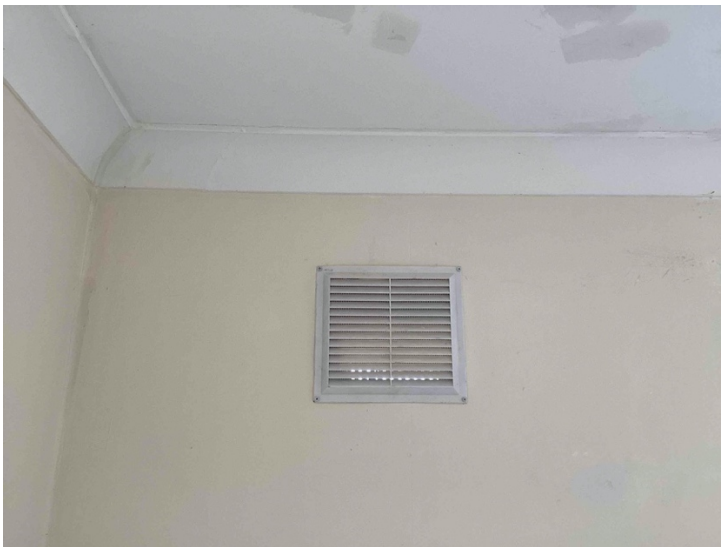
Please include all background ventilation that is present, not just trickle vents. Core vents may need to be closed as part of any airtightness improvements planned by the designer or coordinator.

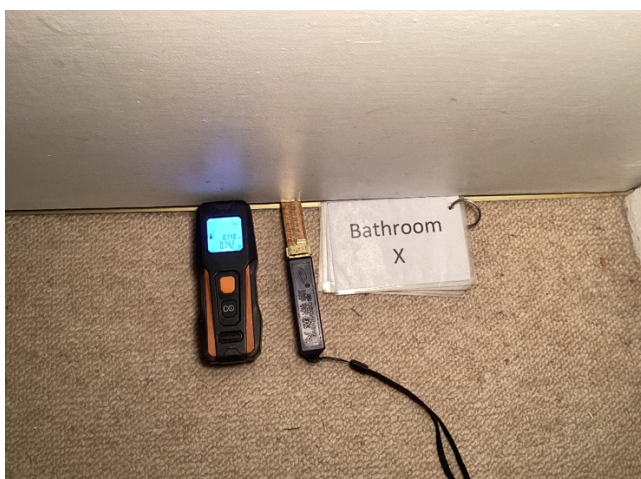
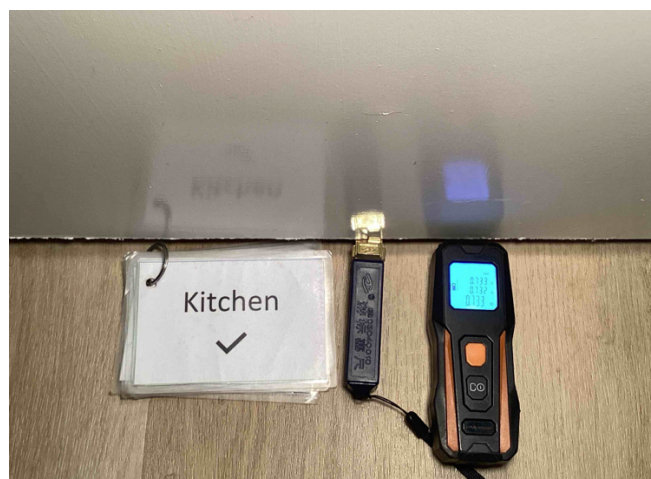
## Undercuts

Please ensure all undercuts are evidenced clearly using a measurement tool and a labelling system as below. Doors must be closed when measuring the undercut. The door width must also be evidenced within the condition report, this can be written in the notes or displayed as below:

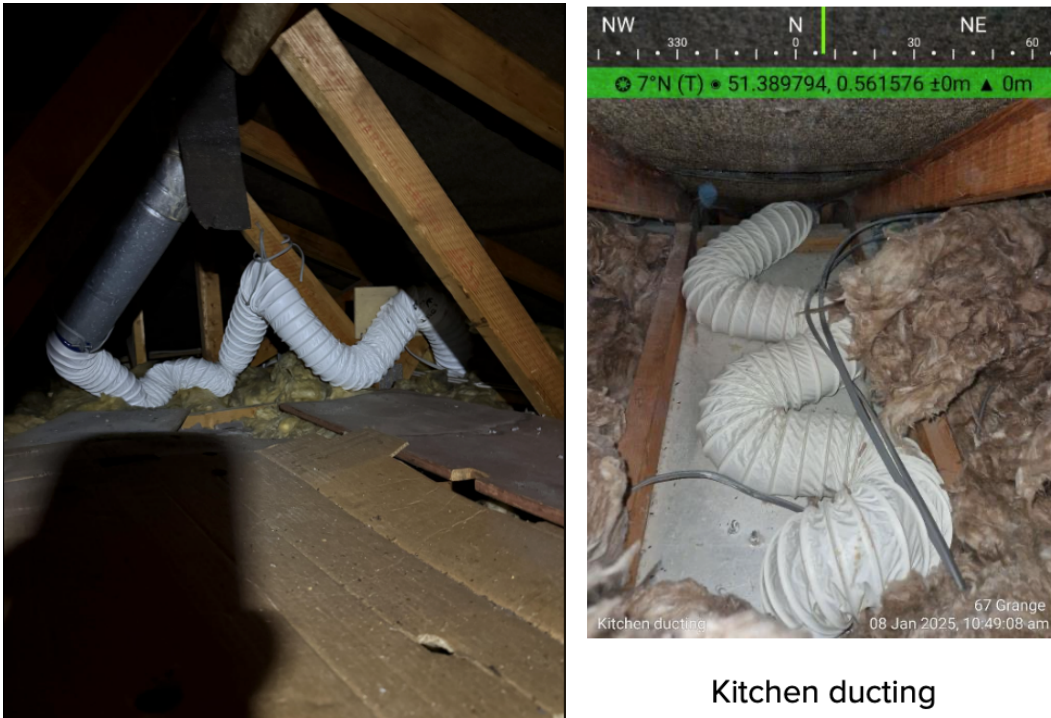
Ducting should be installed to the requirements of Part F. Where fans are installed through walls then the ducting will not be visible however in loft spaces it is important to try and see the ducting and makes sure it is the correct type and installed well. In loft spaces the ducting should be semi rigid and insulated, pulled taught and connected to an external grille or vent. Flexi ducting should only be used for final connections and if it is used, it should be pulled to 90% of its length, supported and protected.

Poor standards of ducting type and installation:

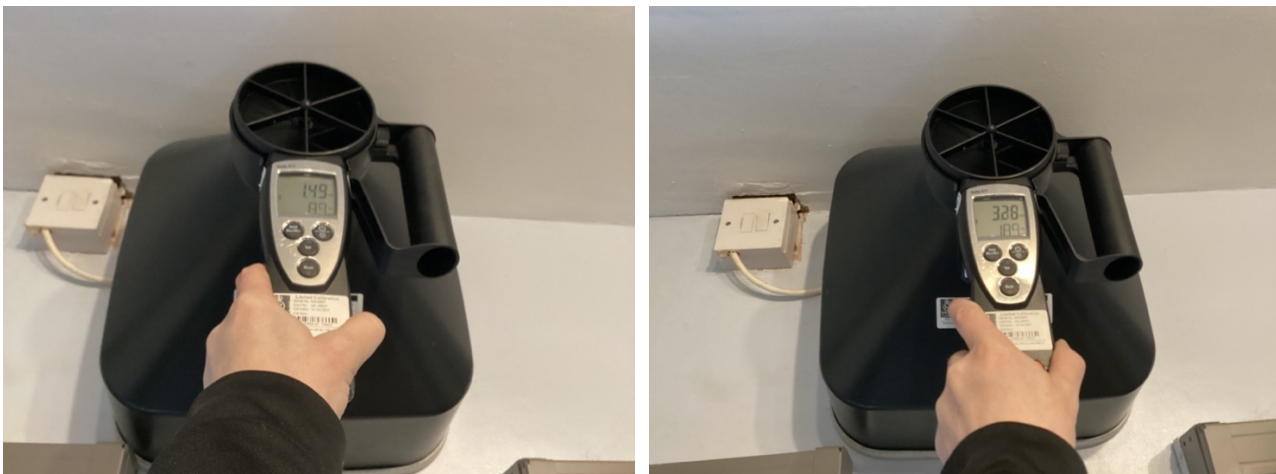
Kitchen ducting

Ventilation is a key part of the PAS2035 compliance process so having fans installed is not enough to show that the ventilation rates required by Part F have been achieved. To do this Retrofit Assessments should include a physical measurement of the flow rates from each fan using a calibrated vane anemometer as picture below. Both the trickle and boost rates should be measured and recorded.

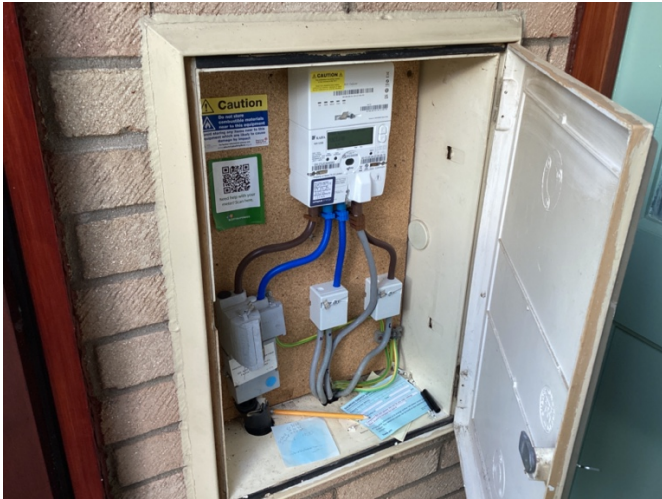
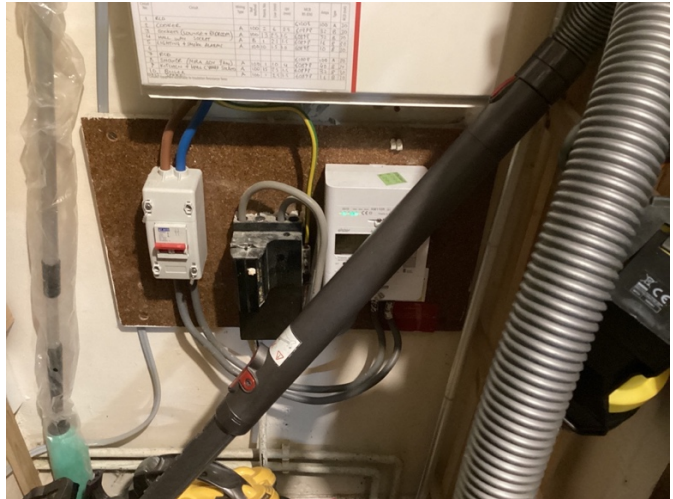
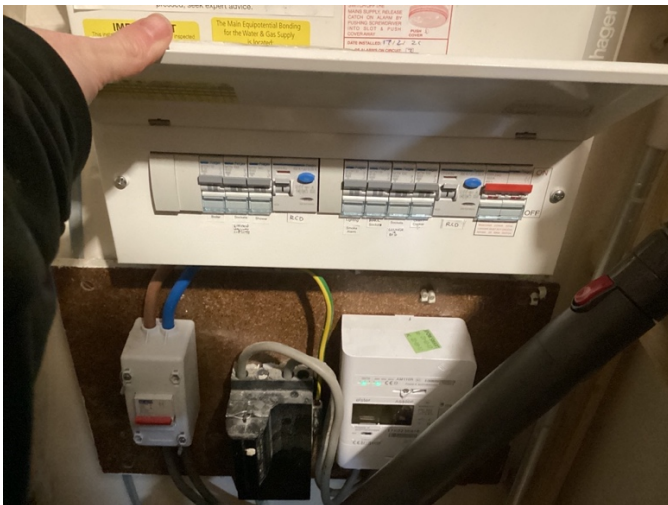
The installation of some measures, particularly Solar PV and electric forms of heating, will require work to be completed to the properties electrical circuits. Capturing clear photos of the distribution board (with lid open) and fuses to show whether the property has a single or 3-way supply is important but not always easy due to resident belongings, please try your best to capture this information. When the meters are located in an external box, this is usually straight forward.

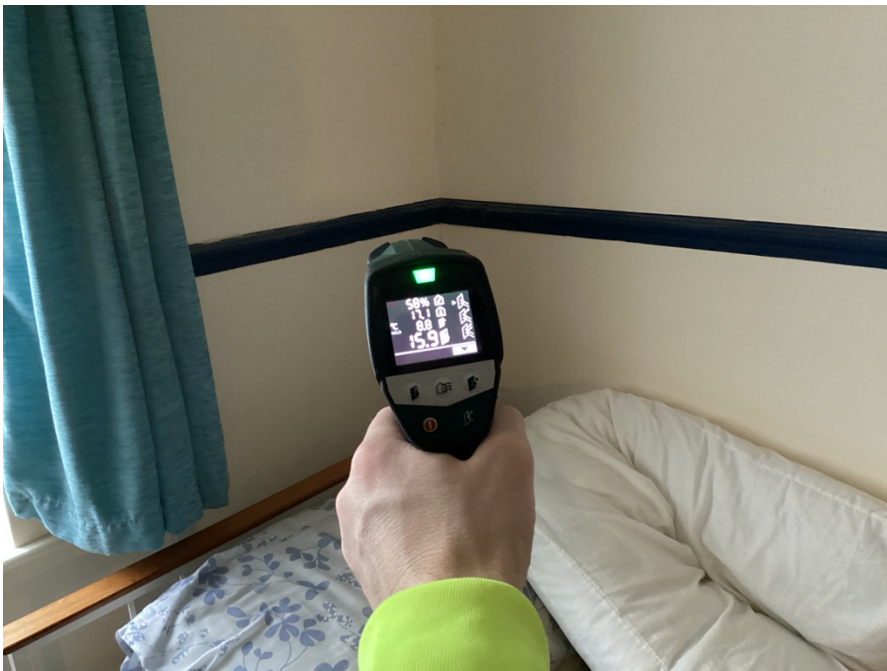
The Bosch model below collects and displays this information with just a button press and displays a basic warning light, there are some nuances to understand but this should be explained in the product user manual:

BS40104 is likely to be adopted into the PAS3035 framework and is likely to include the measurement of some basic IAQ information: internal temperature, relative humidity, dew point, surface temperature (in problem areas) and external information.

Where possible, we would ask assessors to start gathering this information. Most hygrometers are relatively inexpensive and extremely easy to use in order to gather this information.
