# 10 COMMON ISSUES AND MISTAKES TO AVOID

## Retrofit Assessment

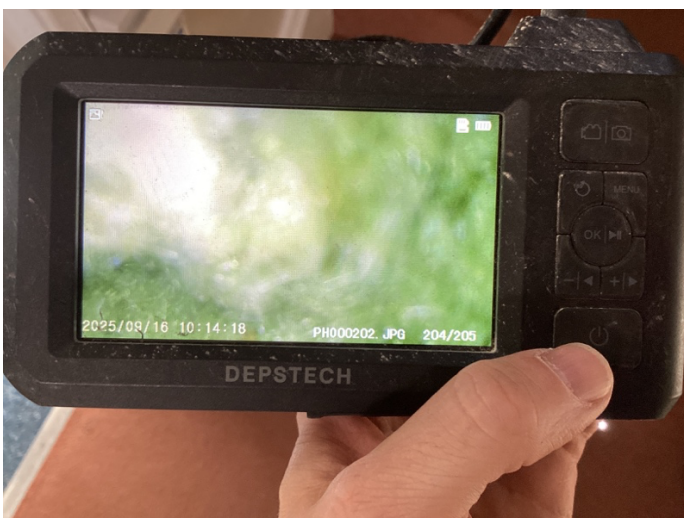
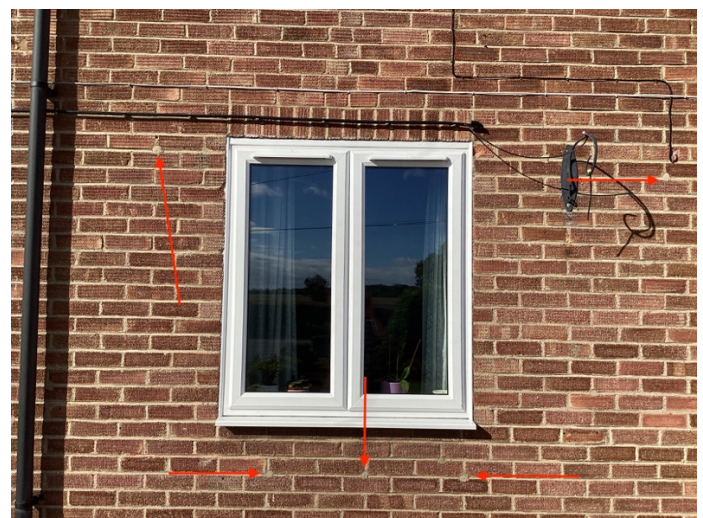
Where borescope inspections are completed in conjunction with simply looking for CWI drill holes, as we would for an EPC, we have seen a number of assessments confusing 'Filled' cavities, with cavities which were insulated on construction ie: 'As Built'. The presence of a CWI material needs to be seen in conjunction with a clear drill hole pattern for the wall to be entered as a 'Filled Cavity'. Sometimes drill holes can be difficult to see, if struggling to find them then beneath the windows is often one of the easiest places to identify them. Make sure to check every elevation, it has been known for installers to install CWI to the easy to access areas and just leave entire walls uninsulated.

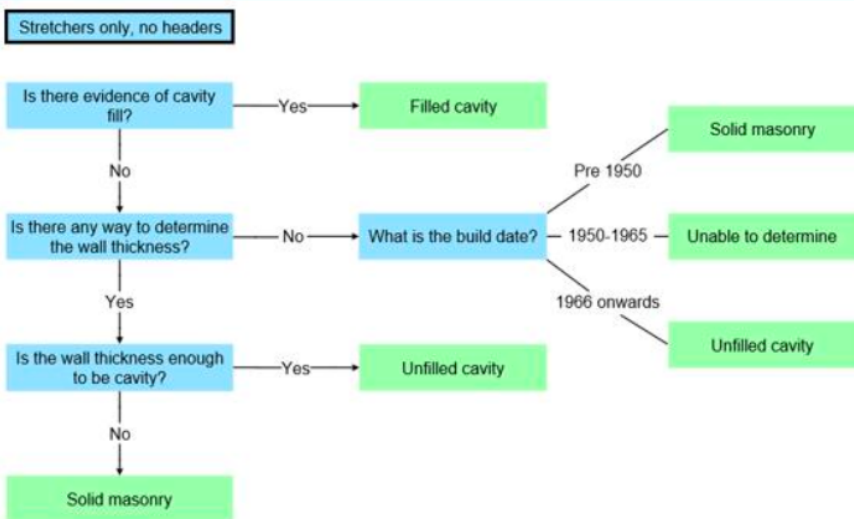
The party wall construction for conventional properties should be very simple to determine. If there are headers or flat laid blocks in the party wall then it should be recorded as 'Solid'. If there are only stretchers or blocks laid upright then the following flow chart must be followed:

| 2.24a | Party wall identification | <p>Basis for determining party wall type to be entered when stretcher bond brickwork / blocks face on only and laid upright are encountered and there is no other specific construction evidence.</p> <pre> graph TD Start[Stretchers only, no headers] --&gt; Q1{Is there evidence of cavity fill?} Q1 -- Yes --&gt; Filled[Filled cavity] Q1 -- No --&gt; Q2{Is there any way to determine the wall thickness?} Q2 -- No --&gt; Q3{What is the build date?} Q2 -- Yes --&gt; Q4{Is the wall thickness enough to be cavity?} Q4 -- Yes --&gt; Unfilled[Unfilled cavity] Q4 -- No --&gt; Solid1[Solid masonry] Q3 -- Pre 1950 --&gt; Solid2[Solid masonry] Q3 -- 1950-1965 --&gt; Indet[Unable to determine] Q3 -- 1966 onwards --&gt; Unfilled2[Unfilled cavity] </pre> |

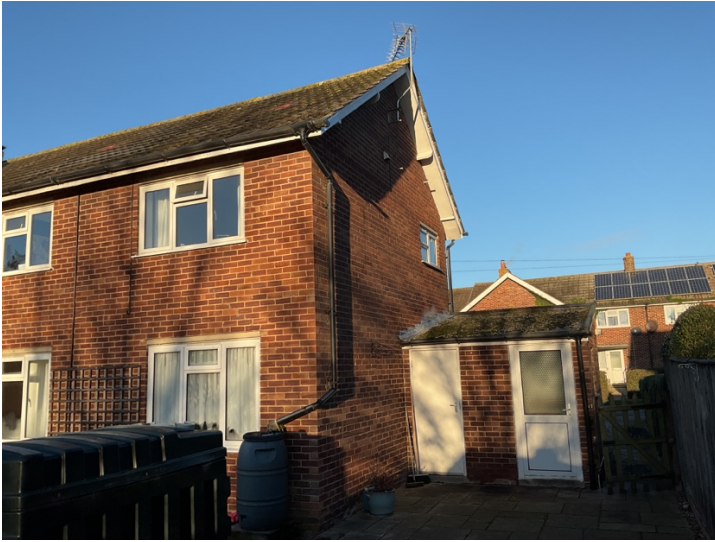
We often come across properties which are of cavity construction but have extensions to the side or rear.

Sometimes these are part of the heat loss perimeter, sometimes they are not. Sometimes they are heated, sometimes they are not. Sometimes they are cavity construction, but most often they are solid brick conversions of old sheds / storage areas. It is important that all of these variations, as well as the use (wet room, habitable room, storage, not used) are made clear as part of the assessment.

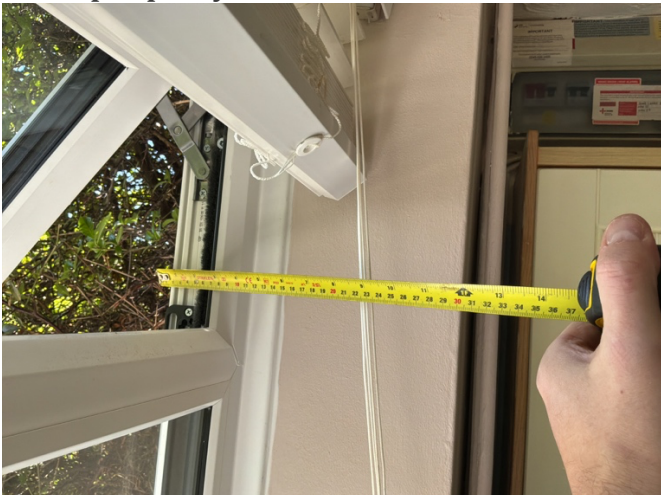
Main property:

A common mistake we see is for these extensions to be assumed to be same construction of the main dwelling but when we look at the condition report, the window reveals are clearly not deep enough for the construction to be a cavity wall. It is essential from an audit, compliance and planned works perspective that the wall constructions on all extensions and alternative walls are identified properly and wall thicknesses evidenced:

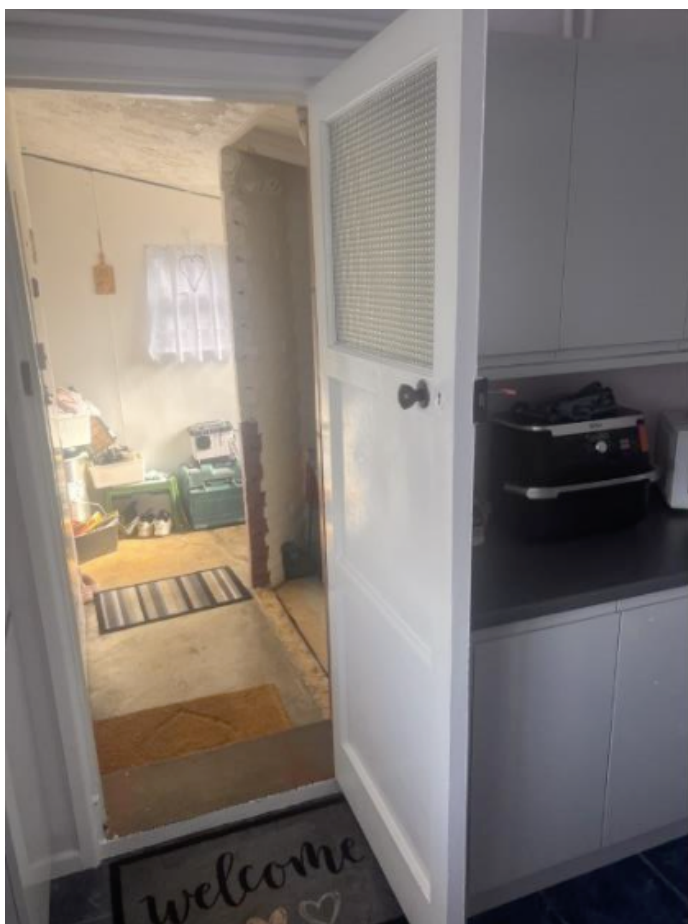
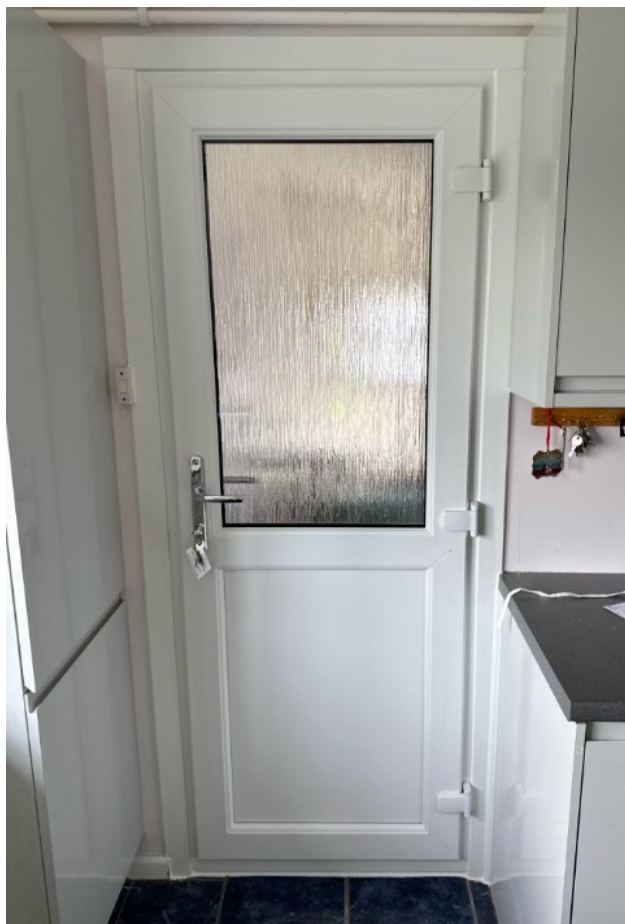
This is a particular issue where a door separates the main property from an extension or sheltered area, it is not uncommon for the door to be of internal quality. If the extension is insulated and heated then this is fine however if an extension is uninsulated and unheated then this can cause a huge amount of heat loss which can easily be mitigated by installing an external quality door on the heat loss perimeter. Therefore, a very clear picture of the quality and condition of the door is an essential part of the Retrofit Assessment.

Poor quality door with no draught proofing replaced for external quality door:

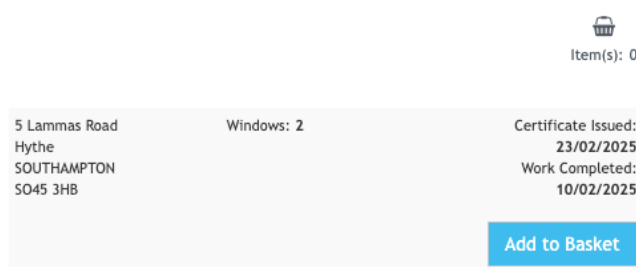
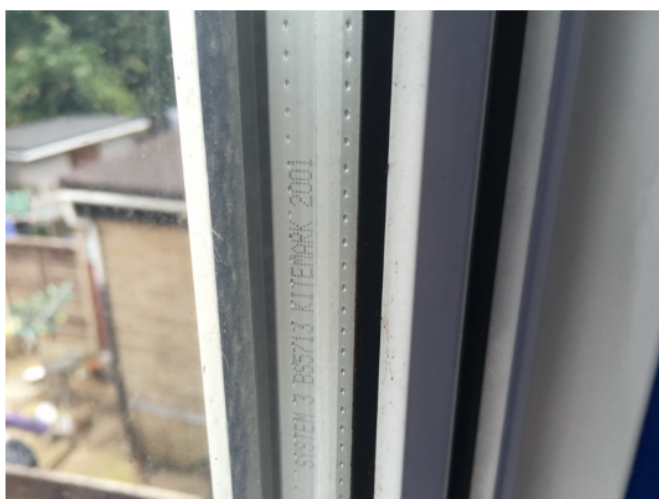
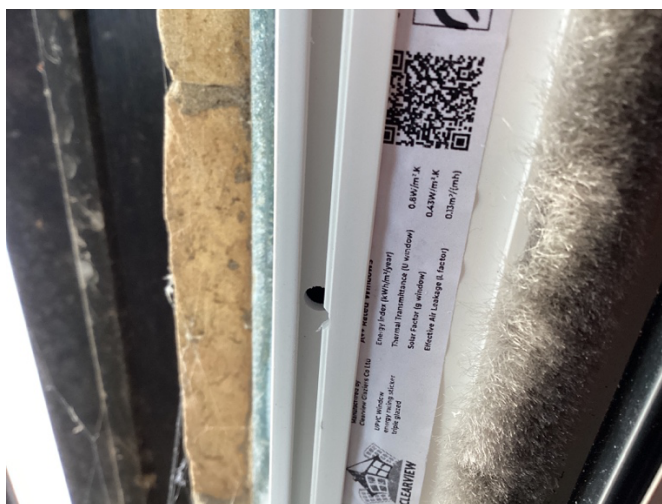
While age may not always be able to be determined, a thorough inspection of the glazing gaps and frames should be completed to see if a manufactured date can be found. In rare cases you may even find the u and g-values. A check of the FENSA website should also be completed and this is often a very useful resource:

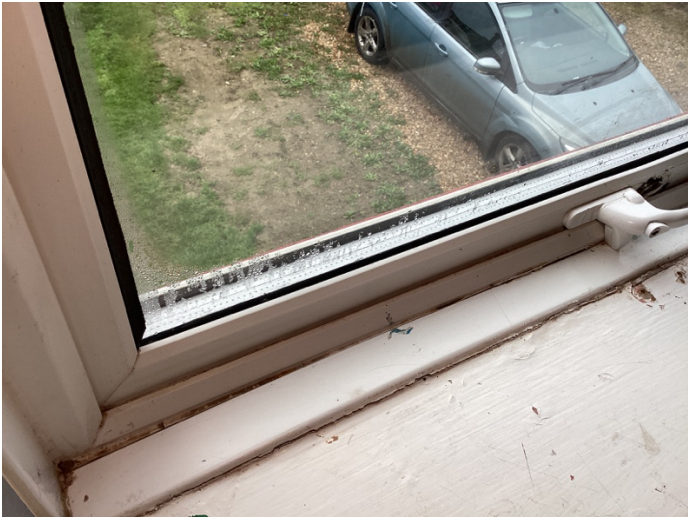
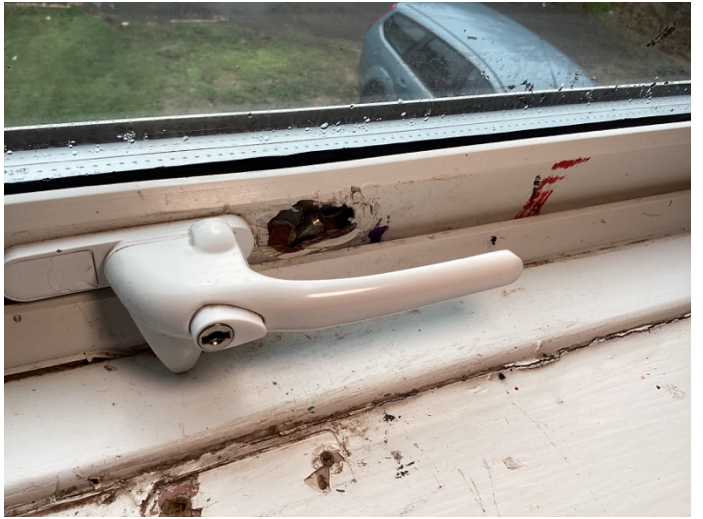
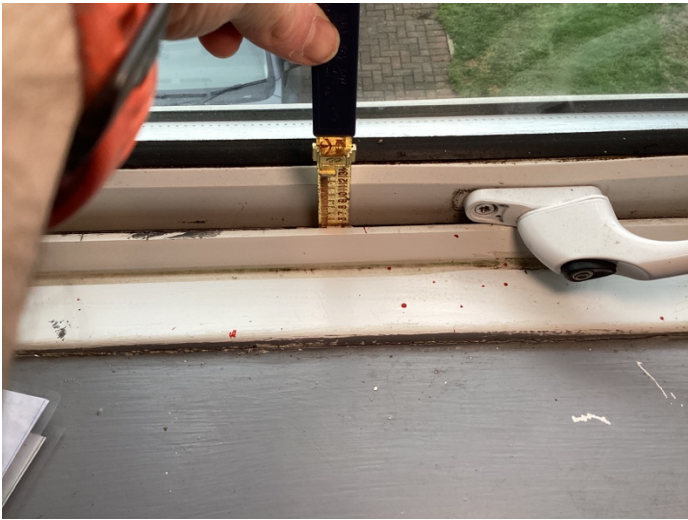
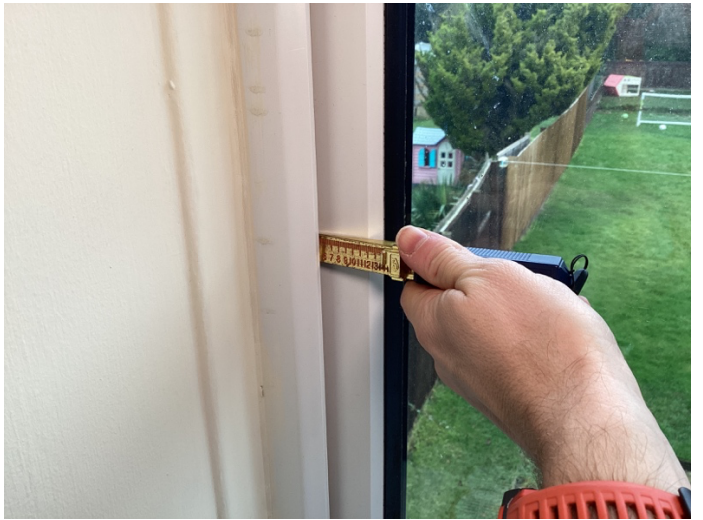
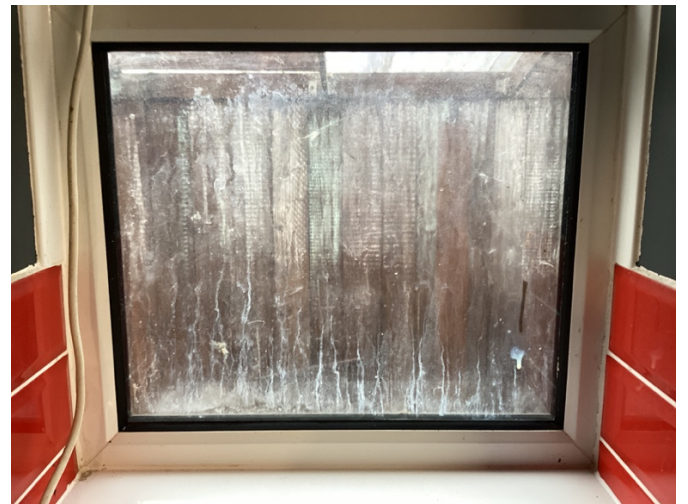
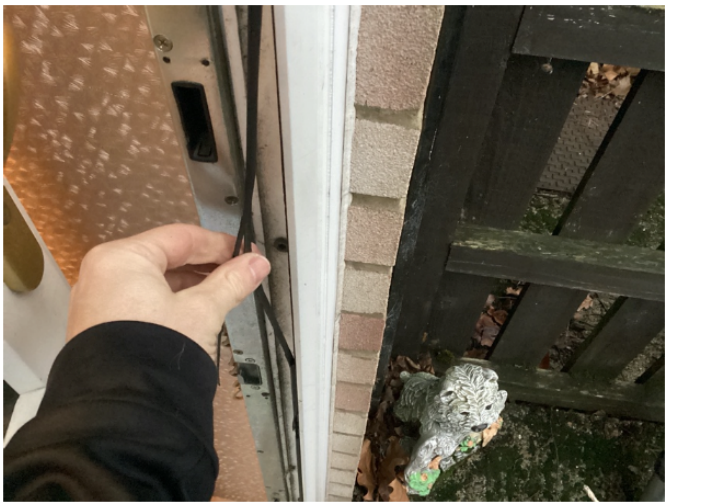
Once age is determined, the condition should be evidenced as not all older windows or doors will be in poor condition, and not all new windows or doors will be in good condition. Sometimes a repair may be more financially viable or appropriate so the more detail the better. Typical pictures of windows should include the glazing gaps, external sealant, evidence that they open fully and evidence that seals are in good condition plus evidence of any defects found, blown glazing or excessive condensation such as below:

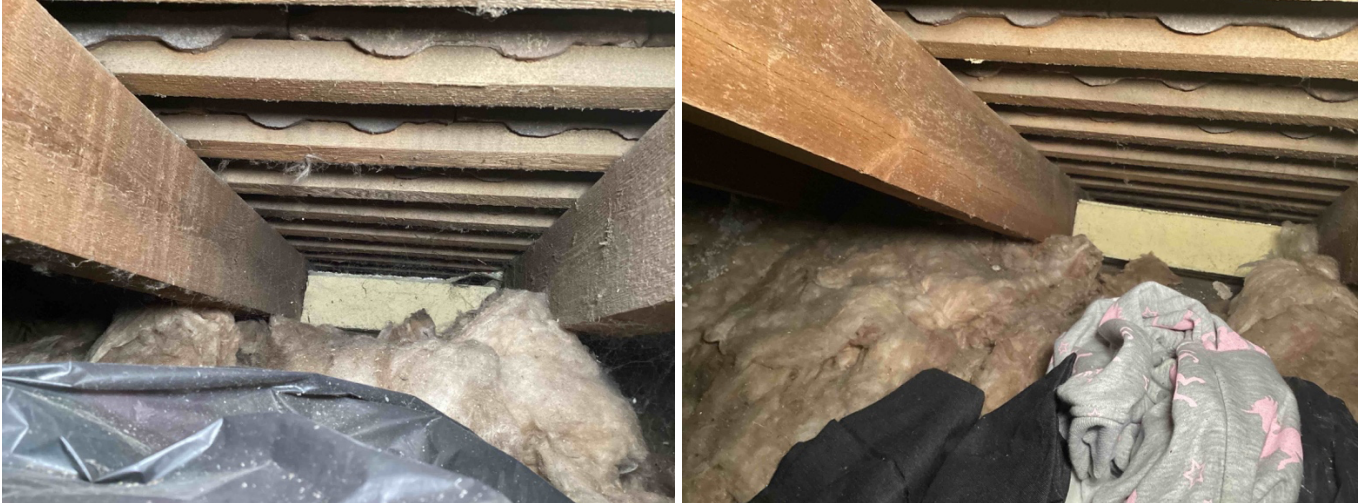
Sceilings (sloping ceiling sections) can be awkward to insulate at the best of times and can often require roof tiles to be removed externally to install insulation which mitigates the thermal bridge effectively. If these sections can be evidenced as being insulated already then this can save additional investigations and potentially remove the needs for further works, we would be looking for evidence that these sections are in good condition internally with no damp or mould and that insulation is present between the rafters:

Well installed insulation board evidenced in multiple locations:

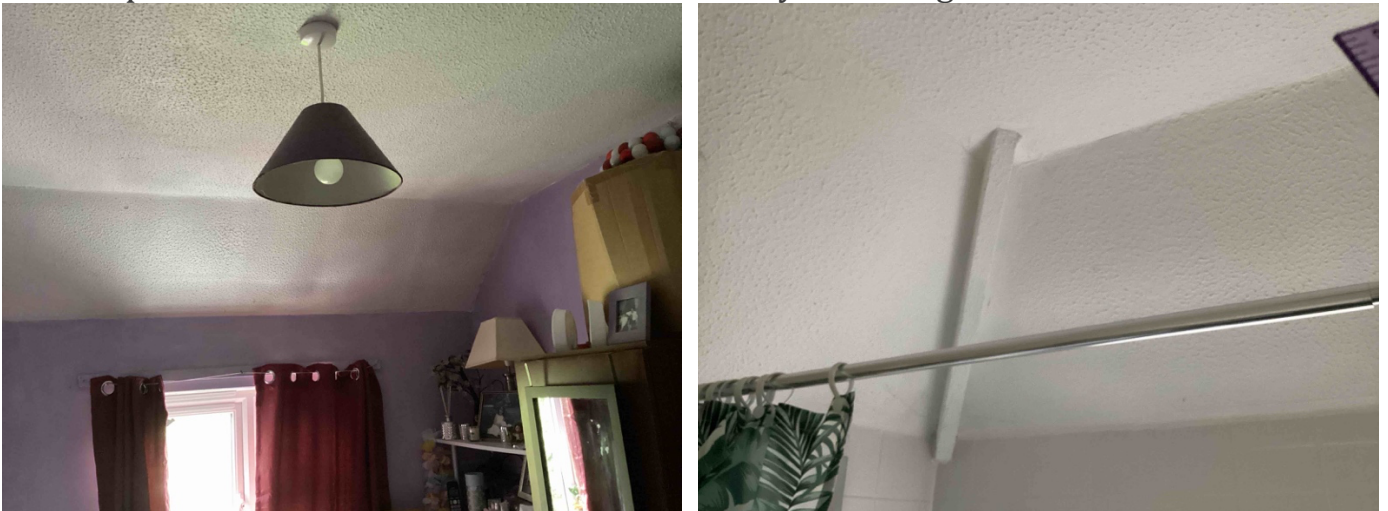
No damp and mould related issues seen internally including in a wet room:

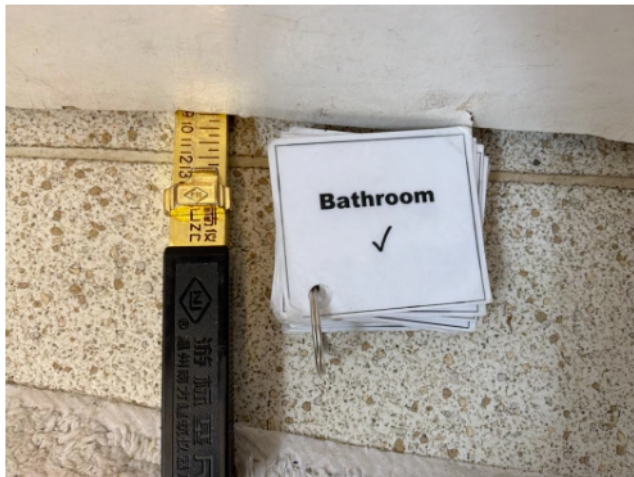
Undercut compliance is a very common issue with both assessments and installations. The undercut must be 7600mm<sup>2</sup> where there are floor coverings and twice this where there are no floor coverings. A common issues on Condition Reports to see undercuts which have clearly been measured as non-compliant but are marked as compliant on the report:

**Are the undercuts on all the internal doors (7,600 mm<sup>2</sup> gap)? Yes**

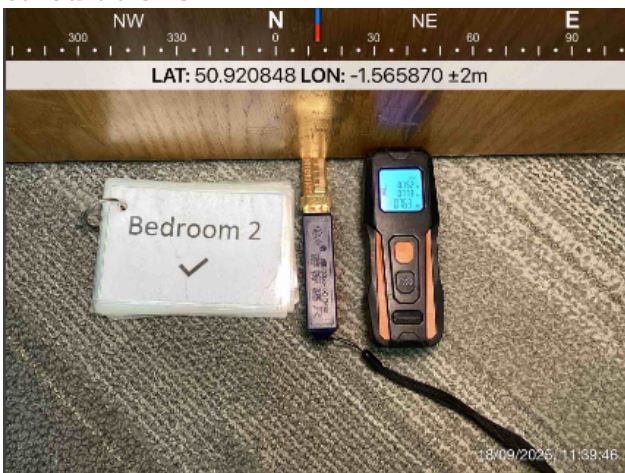
Below are examples of how undercuts would ideally be evidenced and their associated calculations:

Undercut: 10mm  
Door width 763mm  
Equivalent area: 7630mm  
**Compliant**

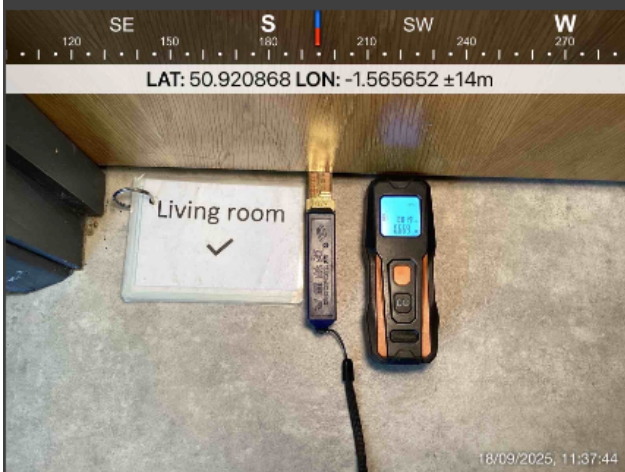
Undercut: 12mm  
Door width 669mm  
Equivalent area: 8028mm  
**Compliant**

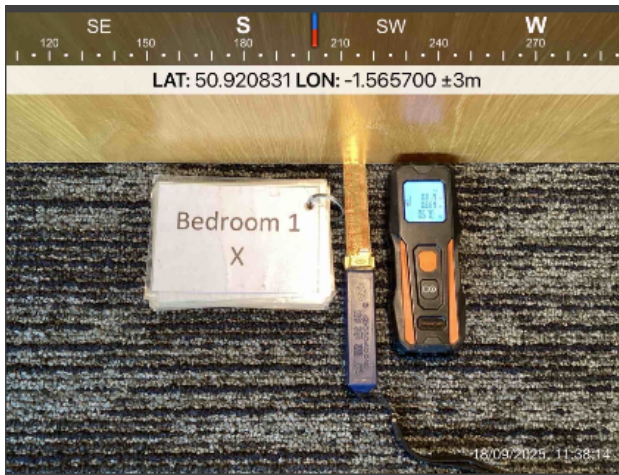
Undercut: 2.5mm  
Door width 670mm  
Equivalent area: 1675mm  
**Non-Compliant**

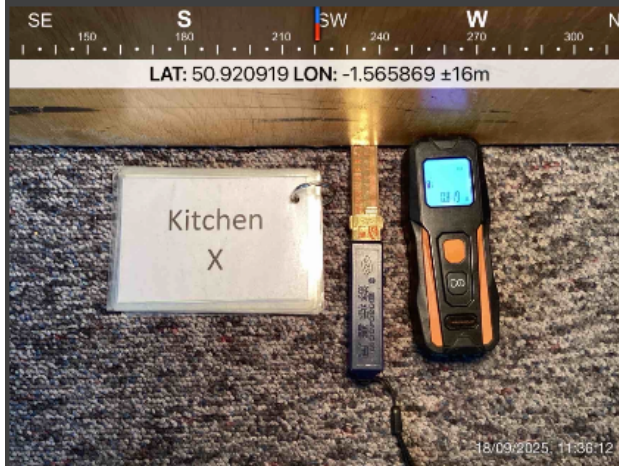
Undercut: 6mm  
Door width 819mm  
Equivalent area: 4914mm  
**Non-Compliant**

The slider on a typical door wedge should be moved out of the way so the measurement can be clearly seen.

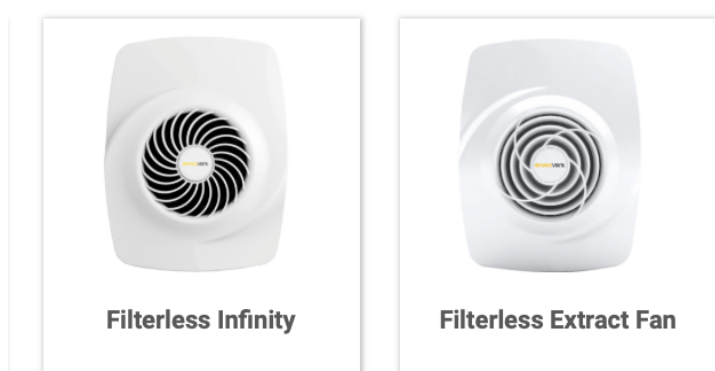
### Envirovent Filterless Infinity and Filterless

Identifying a dMEV is fairly easy – they will have a trickle rate so will be running continuously. Below are some common types found across social housing in particular:

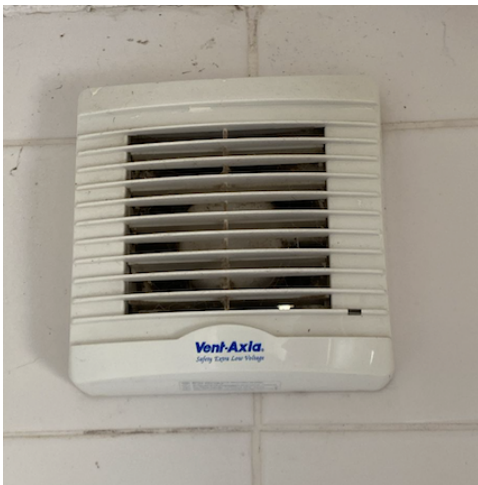
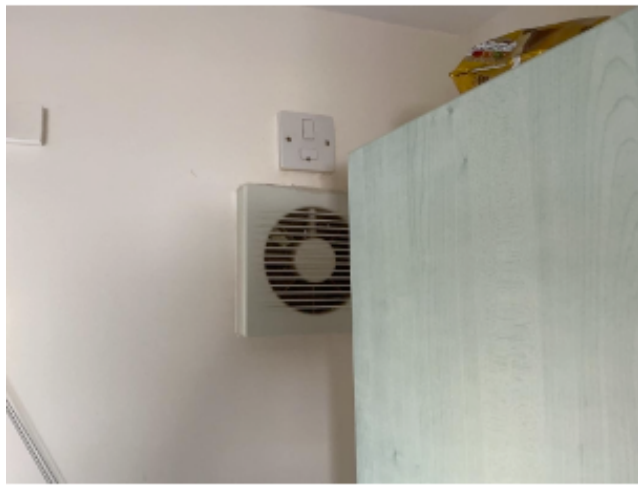
Intermittent fans will often be older, thinner and only turned on via a pull cord or operated via a light switch, such as these models:

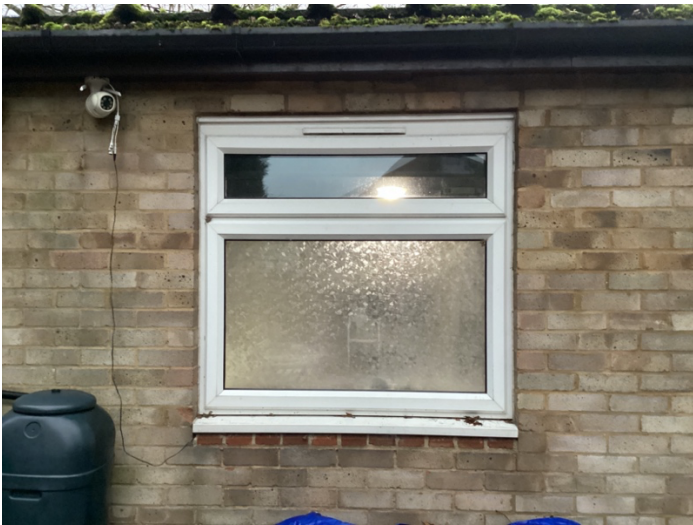
External photos of all windows should be taken to show whether / the number of trickle vents present within each room. Trickle vents should also be marked up on the floorplan. There should be no trickle vents in wet rooms where dMEV are installed.

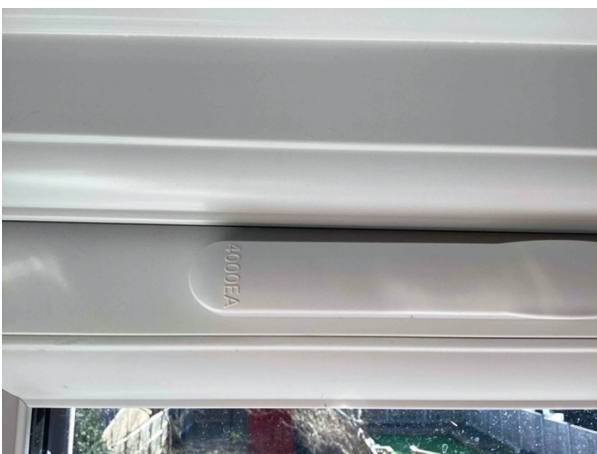
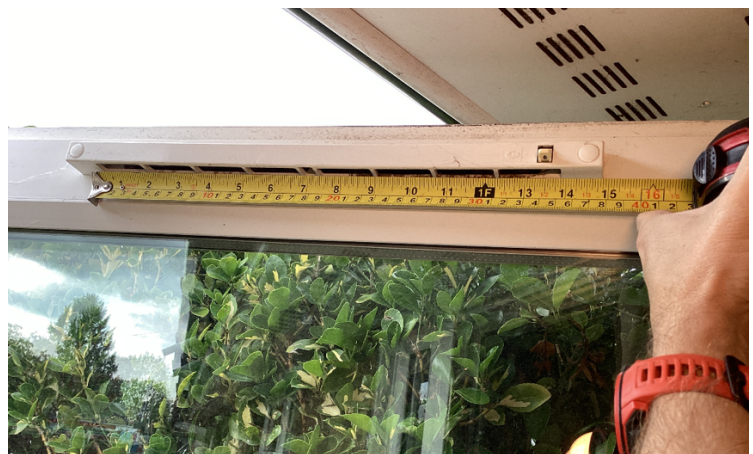
On newer windows there may be evidence of the equivalent area supplied by each trickle vent, if it is present then please evidence this. If this is not present, then a dimensional measurement should be taken and recorded on the condition report, measurement evidence of each size is required ie: if all trickle vents are the same size then only one photo is required. Typically a trickle vent can be presumed to be 10mm wide.

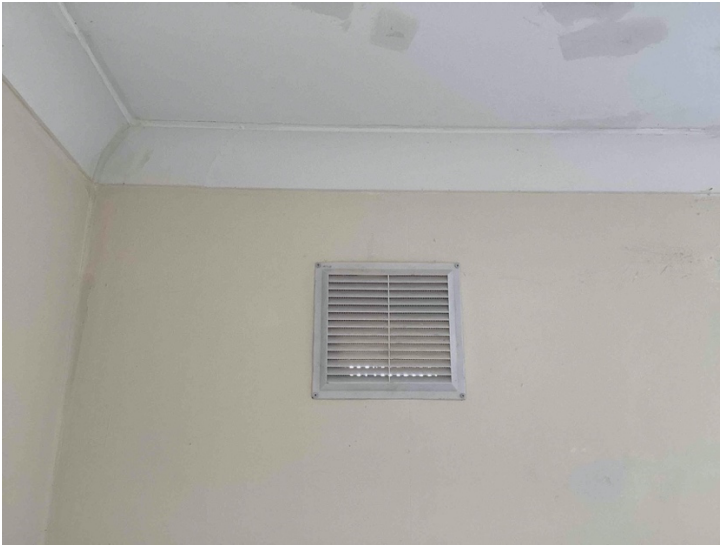
Please include all background ventilation that is present, not just trickle vents. Core vents may need to be closed as part of any airtightness improvements planned by the designer or coordinator or may be used as an alternative to trickle vents to gain compliance with Part F:
