Case Study: Medium Voltage Motor Testing Results

In this case study, the results of a periodic, planned, predictive maintenance test sequence on a relatively large electric motor are analyzed. The steps and concepts of the data analysis are discussed. Electrical insulation construction characteristics of a large electric motor are also briefly covered. How they may affect test results is also touched upon.

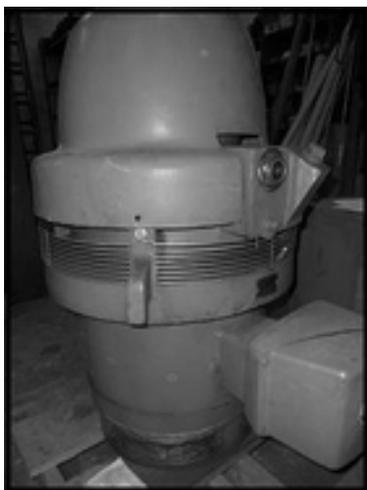
Figure 1

An important large electric induction motor driving a sump pump was part of a periodic, predictive maintenance testing program. This was at an industrial facility. The electric motor characteristics were as follows: Westinghouse, 2300 Volts, 100 HP, 25 Amps, 3 Phase, 705 RPM, Enclosure: ODP. Vertical Motor. (Enclosure type similar to Fig 1)

Think about this a bit. The motor is driving a sump pump, and is in an open drip proof NEMA enclosure. Note the outdoor temperature was 10°C. These two items raise the possibility of water or moisture contamination. If water has penetrated the motor enclosure, it may be present in the windings, or on the surface of the electric insulation system. Possibly it is a layer of droplets, forming a layer of dew. Each of the electric coils could be coated. A large electric motor has many coils. There could be 60 or more slots in the stator. This would result in many parallel path's for leakage current. Remember your calculation from Electric circuits 101, for resistive circuits in parallel...
