Site Investigations in Limestone Formation for Pile Foundation Design

Name of Speaker : Ir. Mak Wai Kin

Date : 25th February 2025

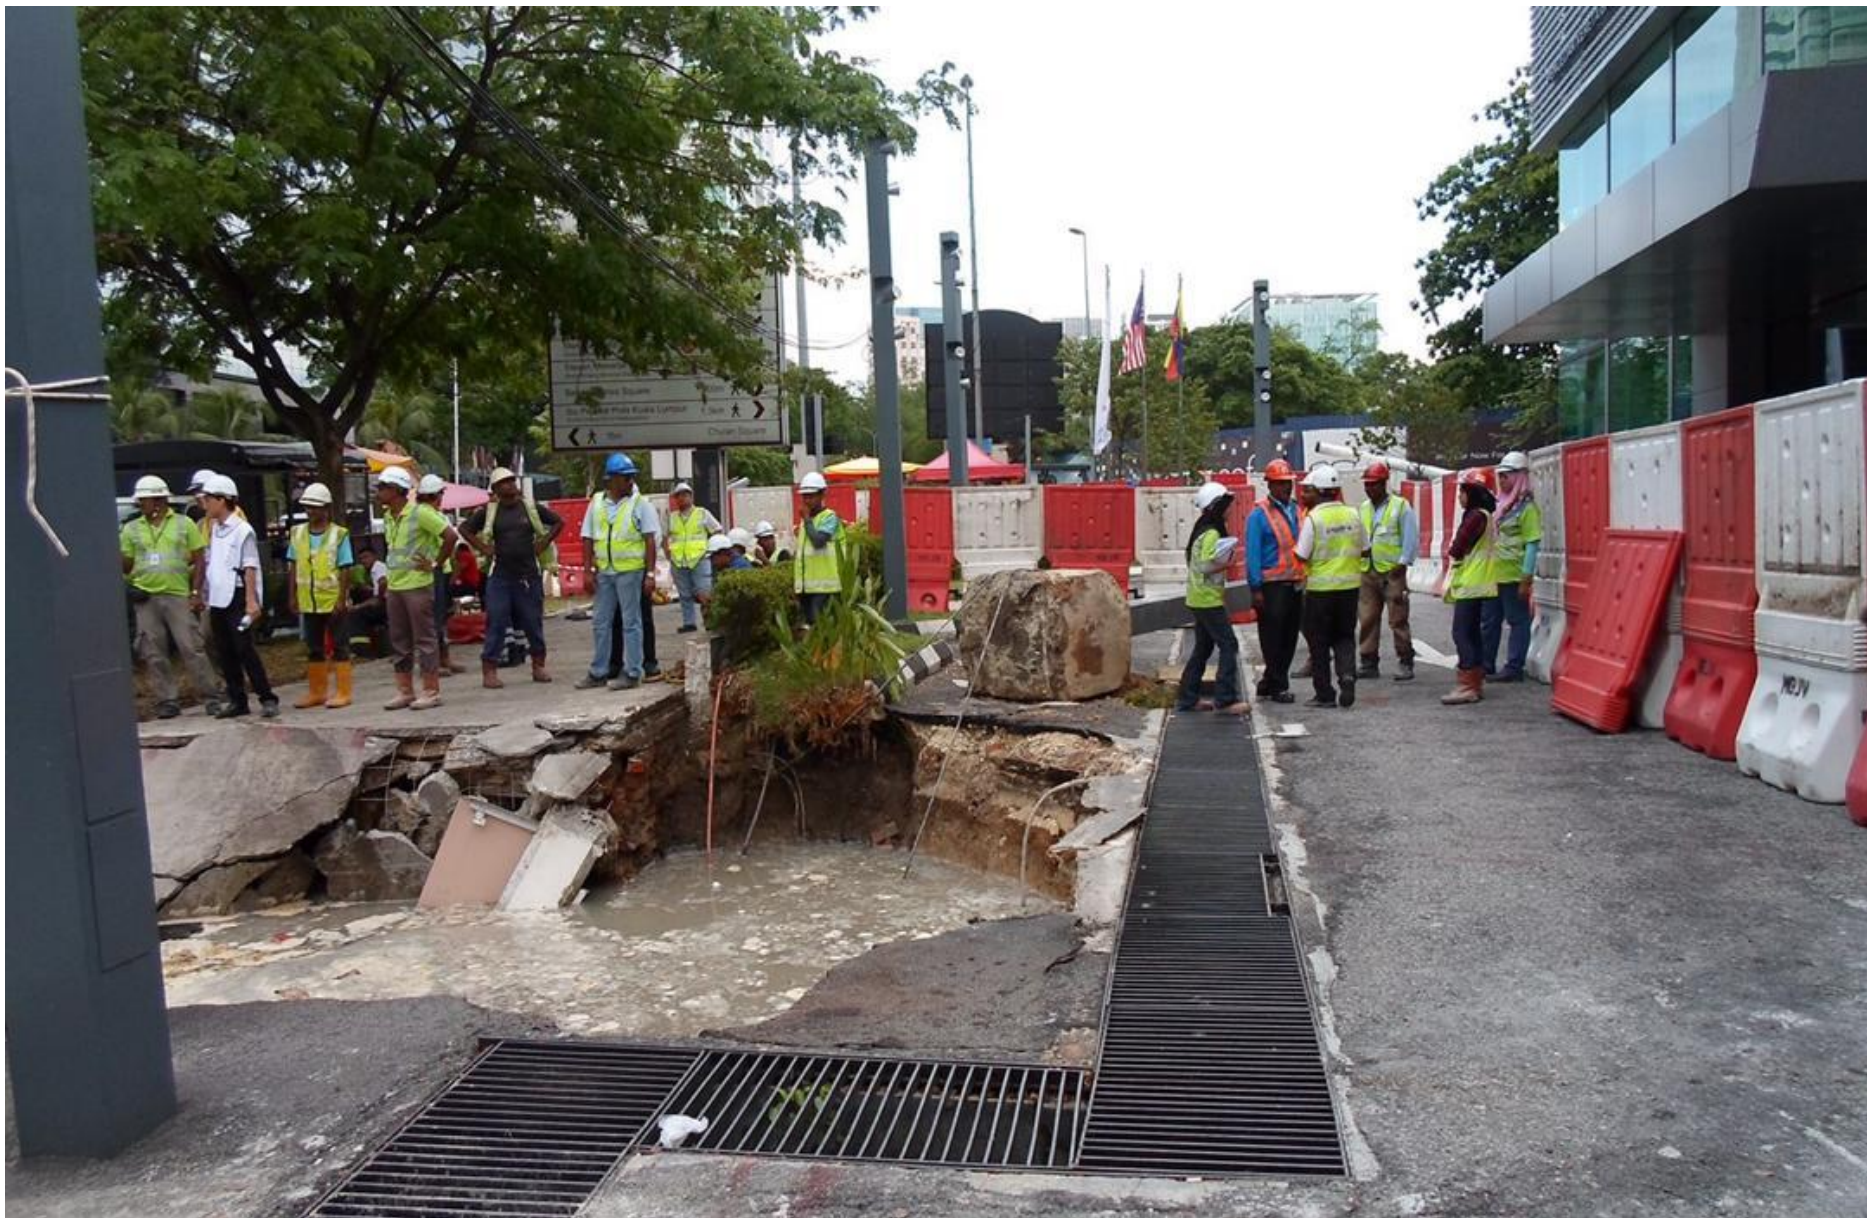
Sinkhole in limestone formation.

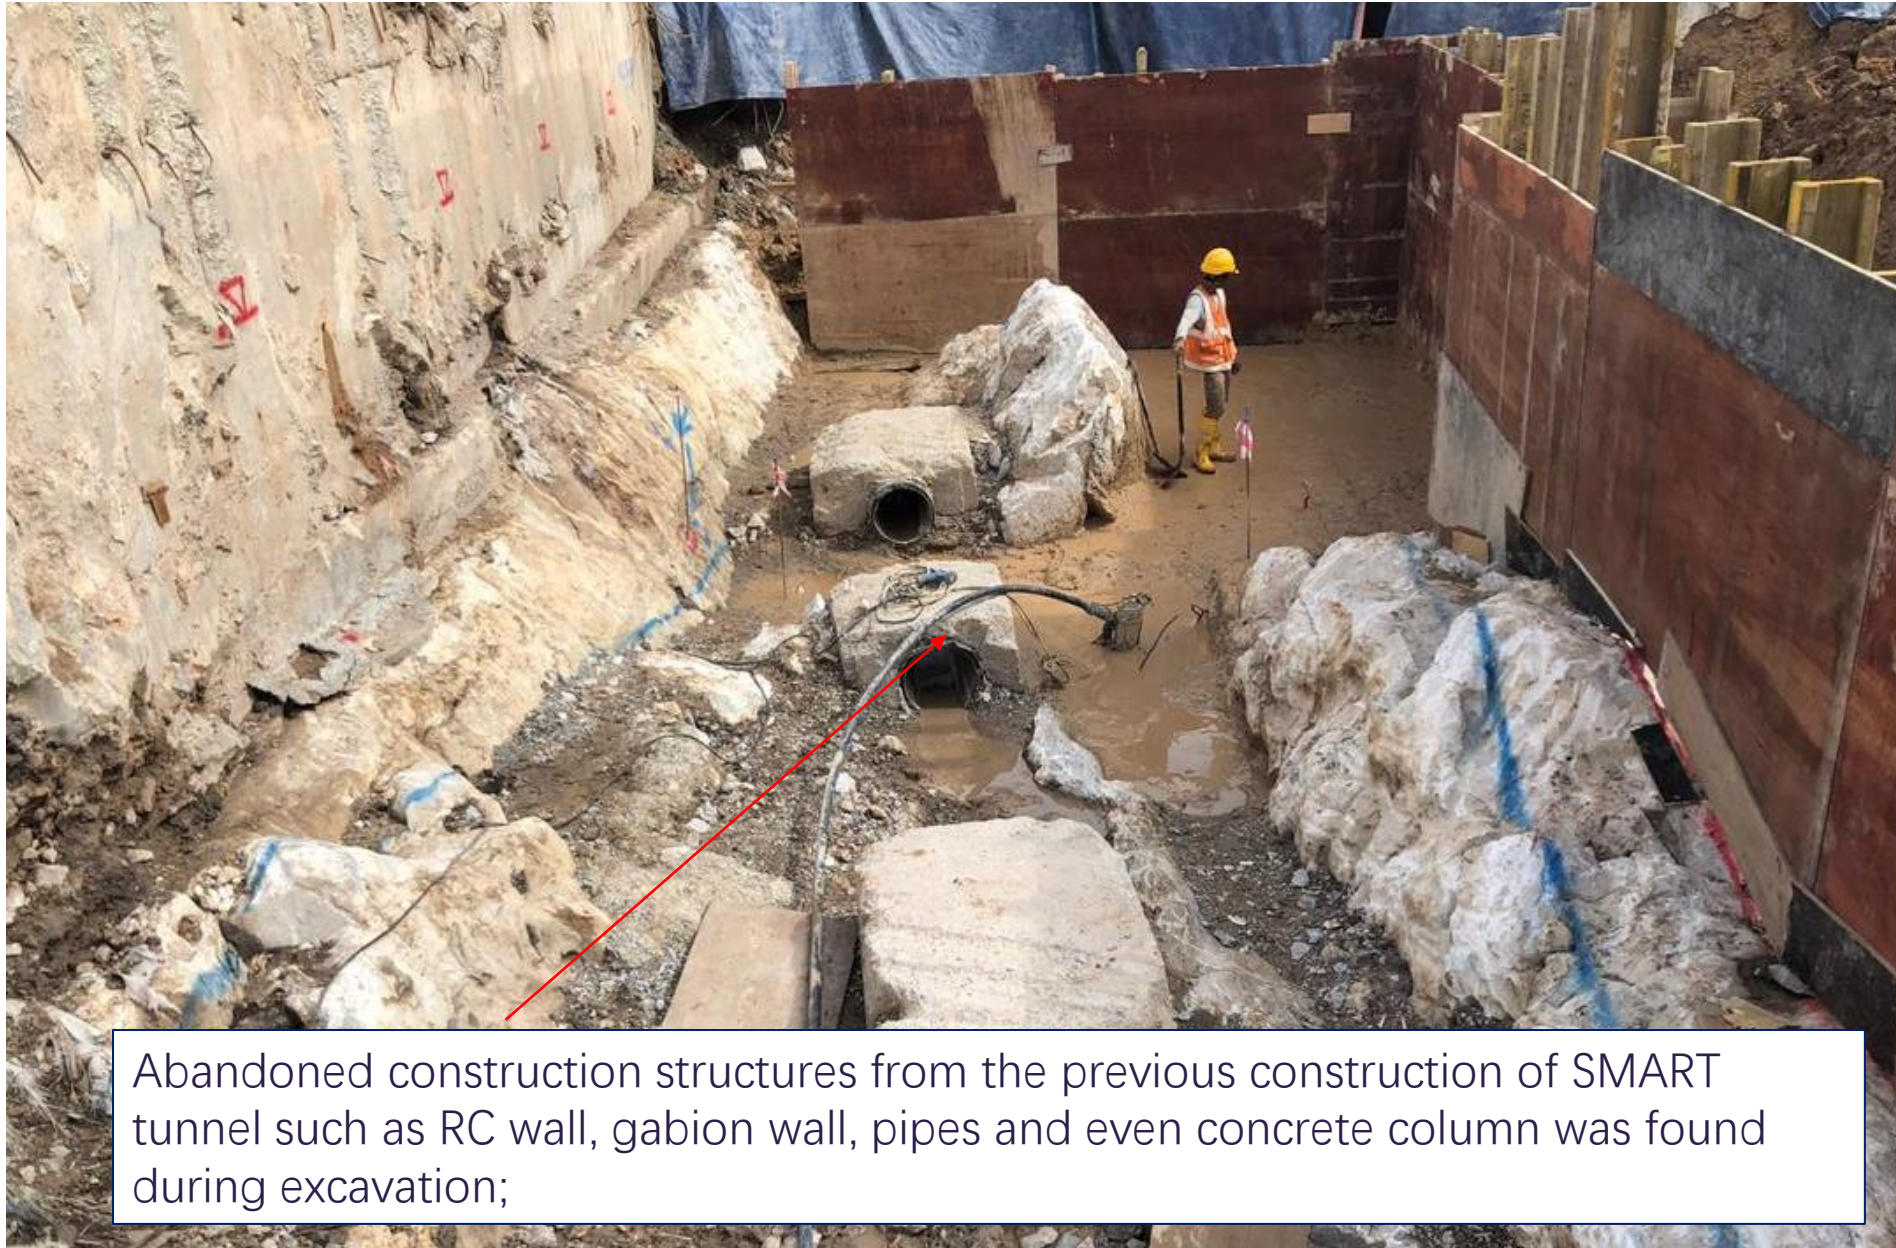
Actual Condition of Site After Excavation

Abandoned construction structures from the previous construction of SMART tunnel such as RC wall, gabion wall, pipes and even concrete column was found during excavation;

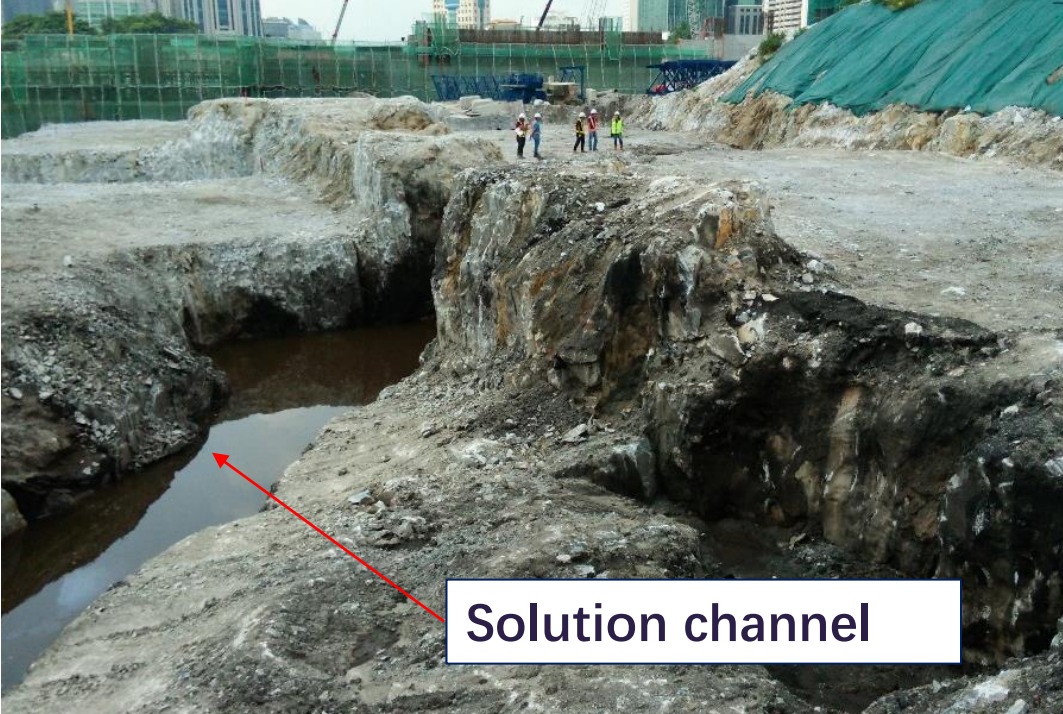
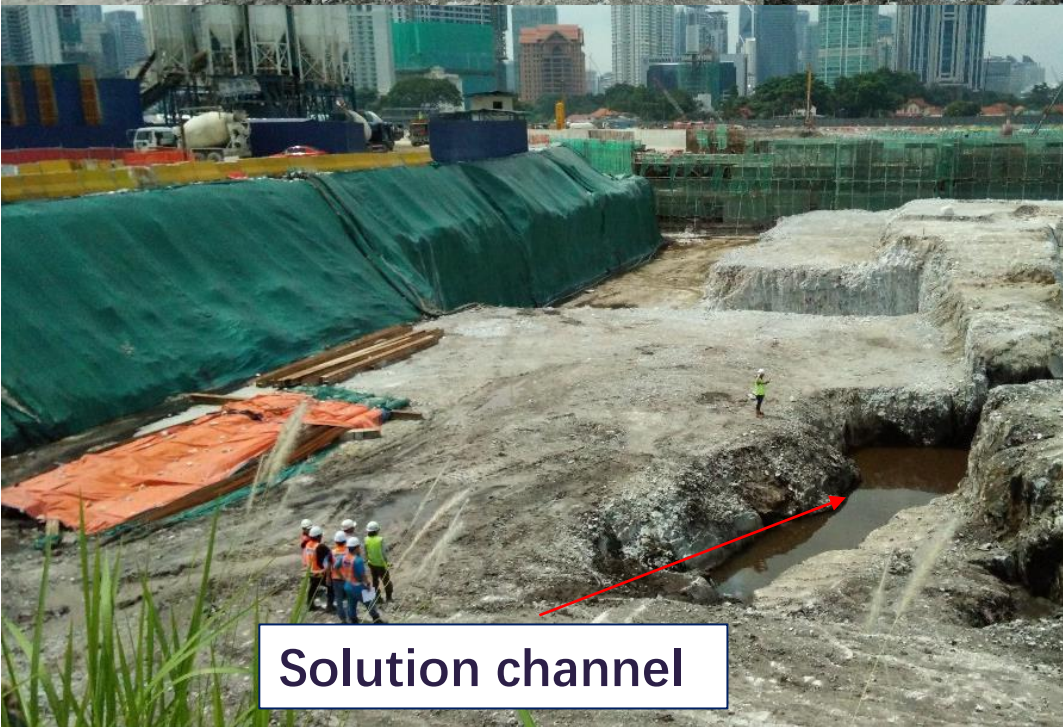
- A long and wide solution channel resembling a "stream" was discovered.
- It was detected by only one MP test which was initially considered to be a localised depression in limestone rock.

- Probably additional MP test points around the suspected "depressed" area would be able to detect extent of solution channel.
- Important to allocate some budget for additional investigation point during SI work
- Geophysical survey might be useful for site with shallow limestone bedrock.

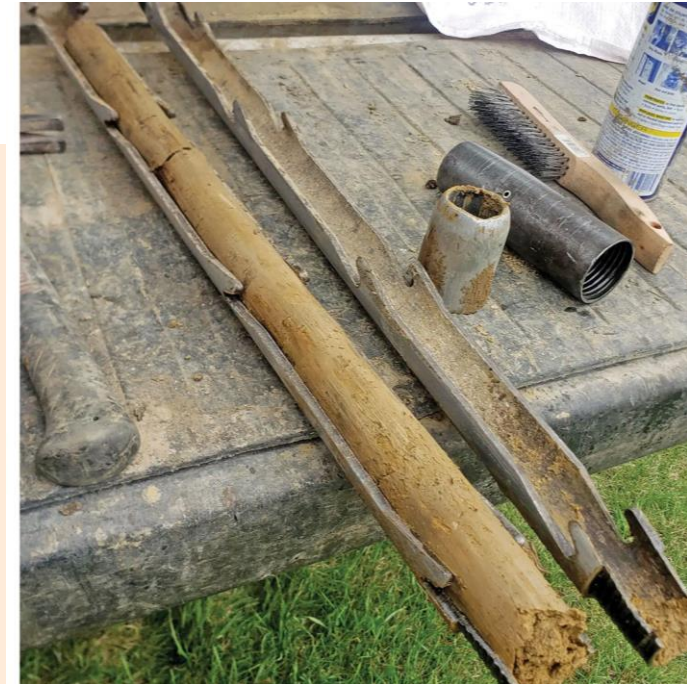
- Split Spoon Sampler

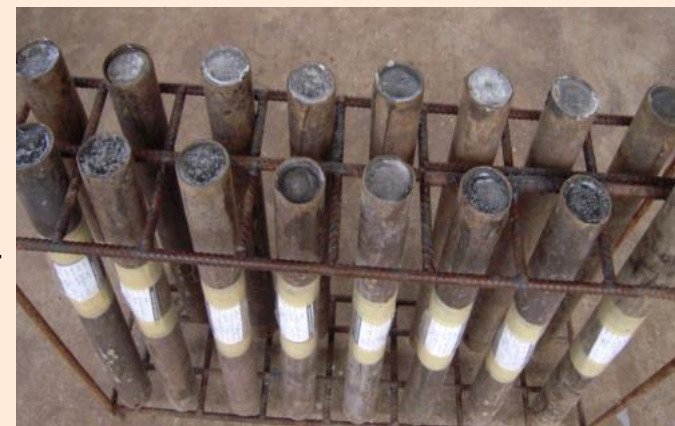
- Thin Wall Sampler
- Mazier Sampler

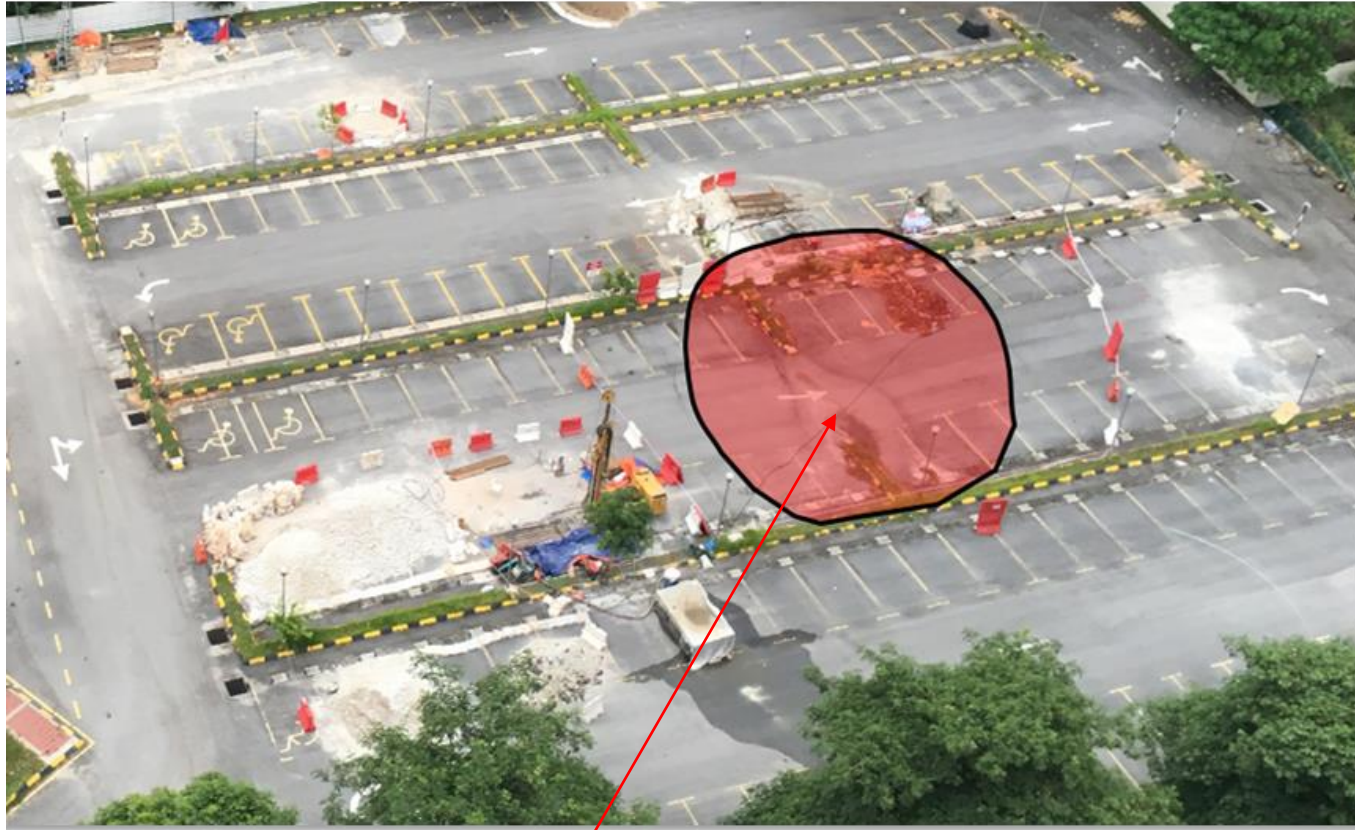
Ground Depression

The collapse of cavities or voids in limestone bedrock during borehole drilling leads to ground depression or subsidence at the surface.

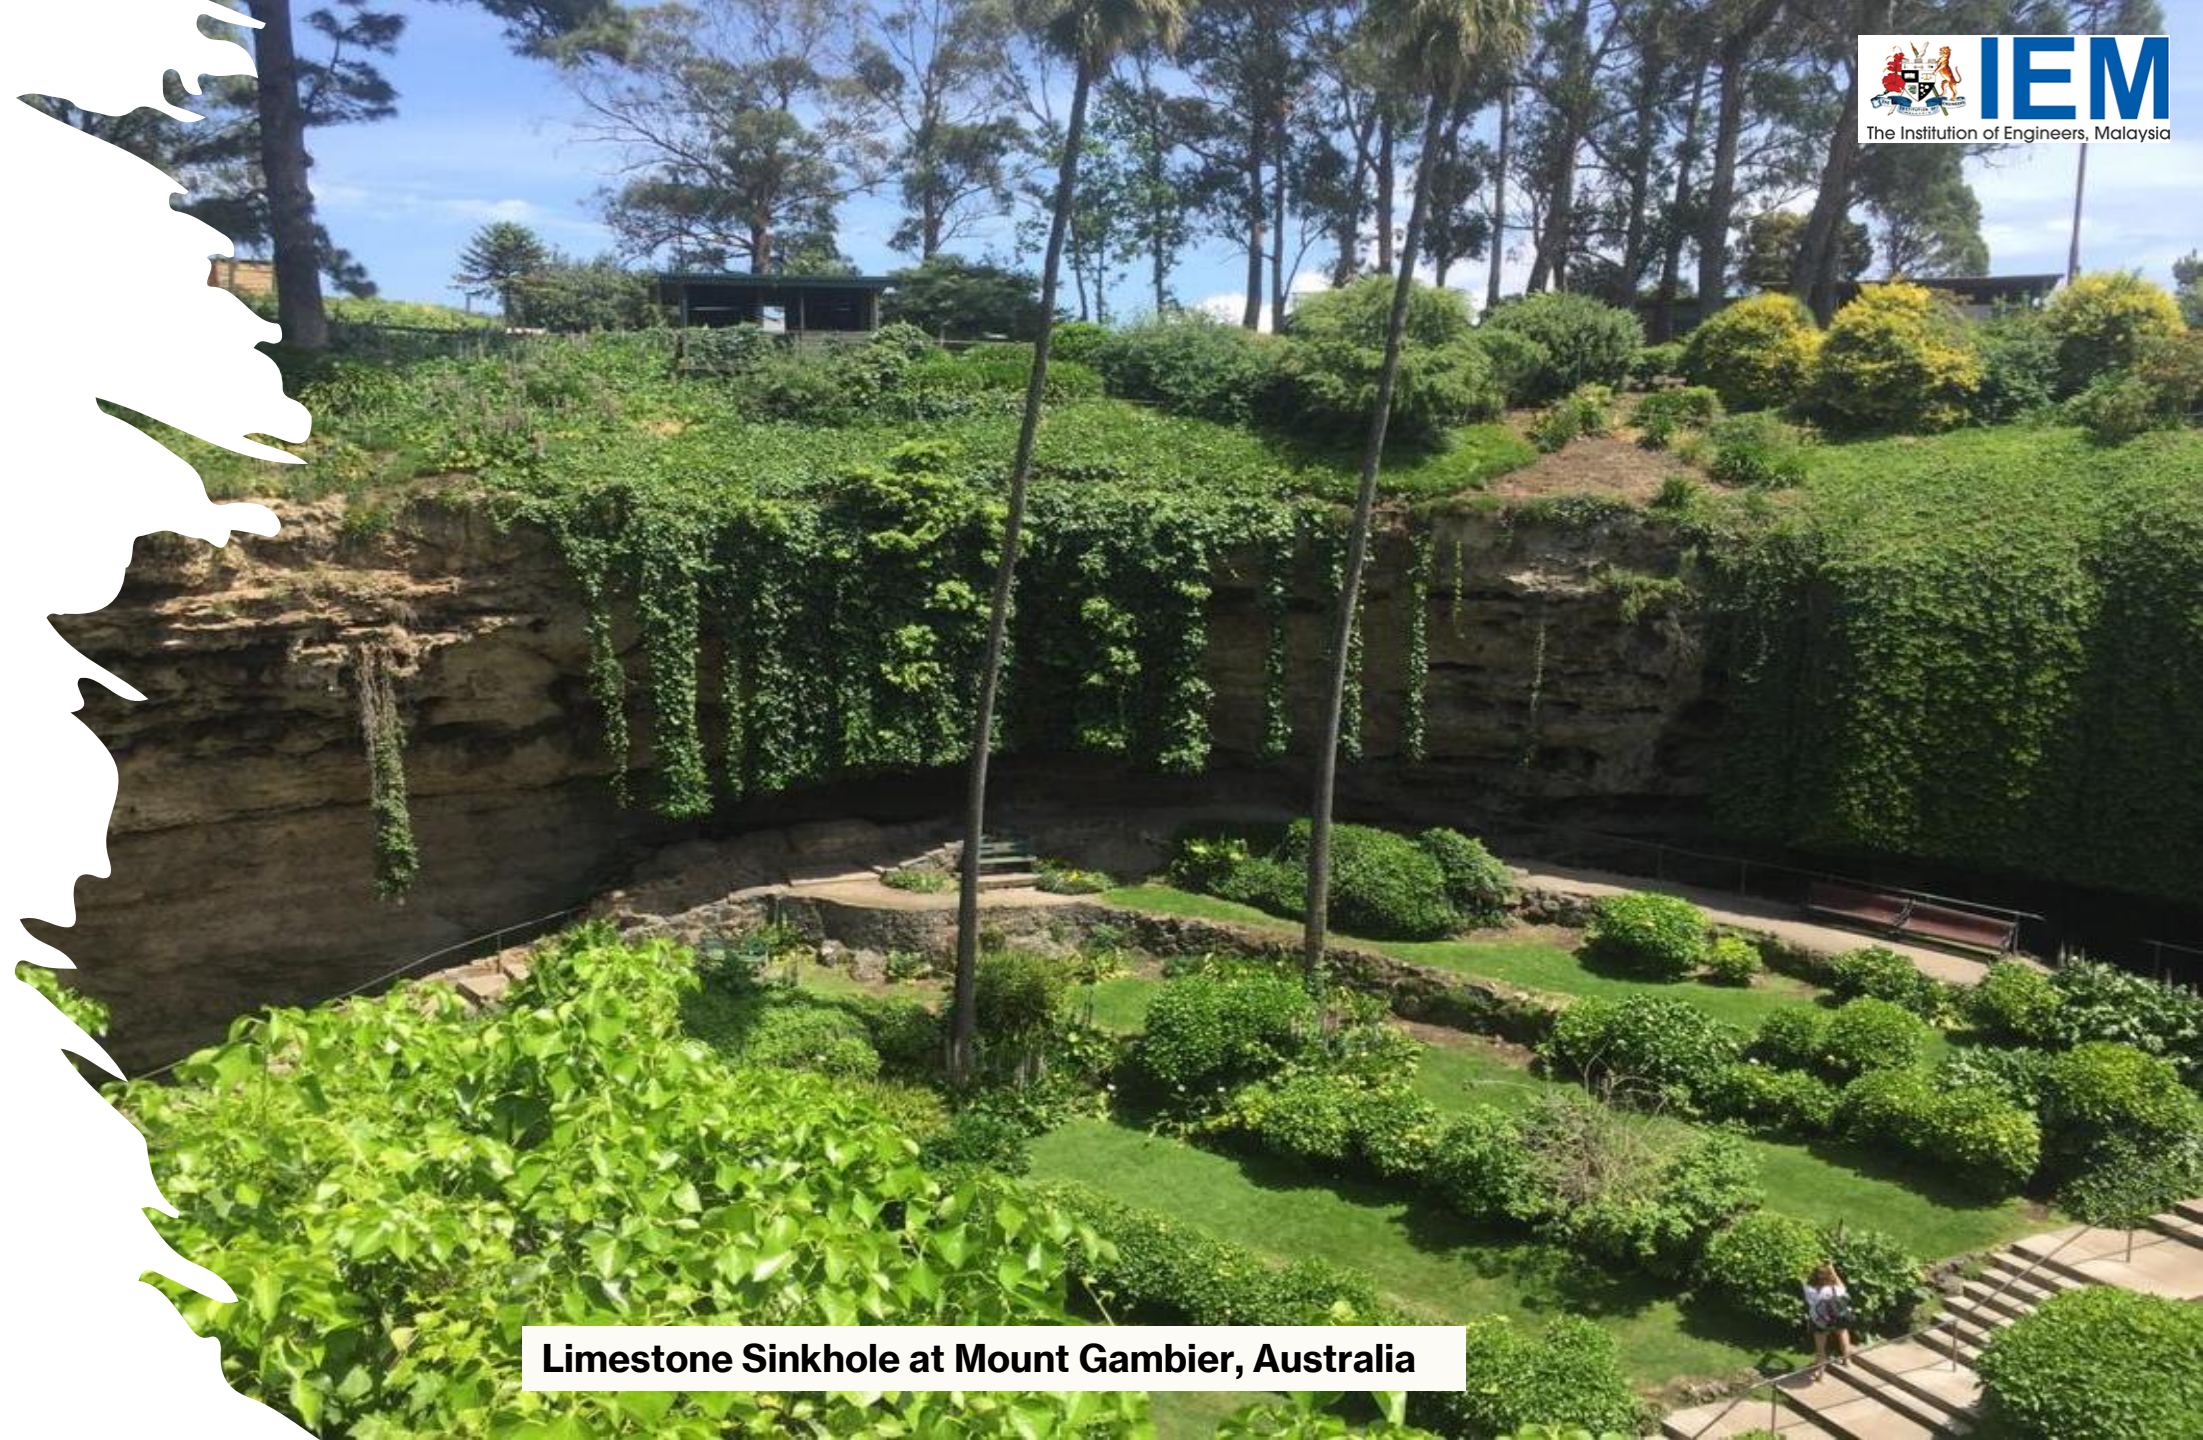
Limestone Sinkhole at Mount Gambier, Australia
