# Saguache Creek Stream Management Plan

Rio Grande Basin Roundtable and the  
Stream Management Plan Technical Advisory Team

Rio Grande Headwaters Restoration Project  
623 E Fourth St  
Alamosa, CO 81101

**2020**

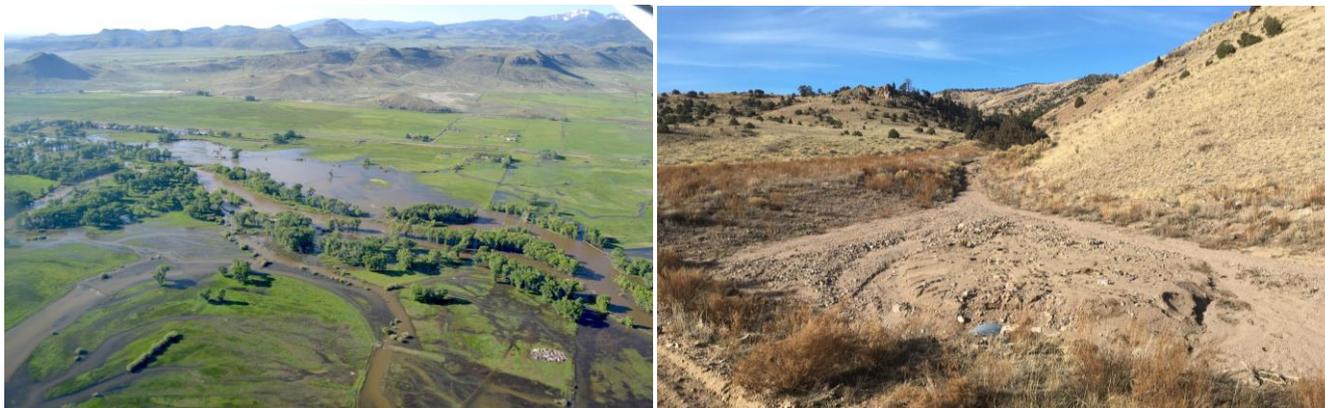
**Figure 1.7: Left: Snowmelt runoff doing geomorphic work on the Rio Grande floodplain, June 2019. Right: Sediment washed down from a small watershed that feeds a tributary to Saguache Creek (Photo: Round River Design, LLC).**

Monsoon season typically results in sufficient precipitation to increase flows again in mid- to late-summer. Flooding from both snowmelt runoff and small-scale convective rainfall events during the monsoon are common mechanisms for high water events in the SMP study streams (Figure 1.7). Though rare in the period of record, extreme events have been observed to occur on streams draining into the SLV from the San Juan Mountains. Localized flash floods are likely to occur on tributary streams, which may cause the mainstems to swell, but more likely influence the streams by bringing fresh sediment down to the valley bottom and supplying the channels with material (Figure 1.7).

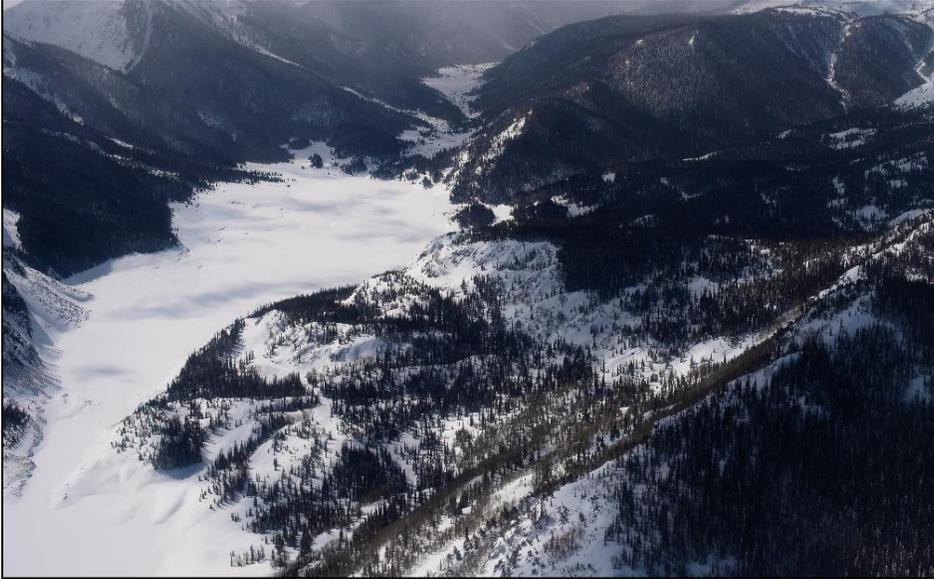
**Upper portion of Platoro Reservoir during winter (Photo: Christi Bode).**

Platoro Reservoir and Trujillo Meadows Reservoir, both of which are post-Compact reservoirs, provide the only significant storage in the Conejos River watershed. The Platoro dam was completed in 1951 by the Bureau of Reclamation (BOR), making it a post-Compact reservoir. The dam is an earthfill structure consisting of a main embankment and a dike section, separated by a rock knoll in which the spillway is excavated. The reservoir formed by the dam has a capacity of 59,570 AF, 6,060 AF of which are for flood control and 53,510 AF for joint use. While BOR retains ownership of the dam, operations are managed by the Conejos Water Conservancy District (CWCD). The dam is situated at 10,000 ft, relatively high in the watershed.

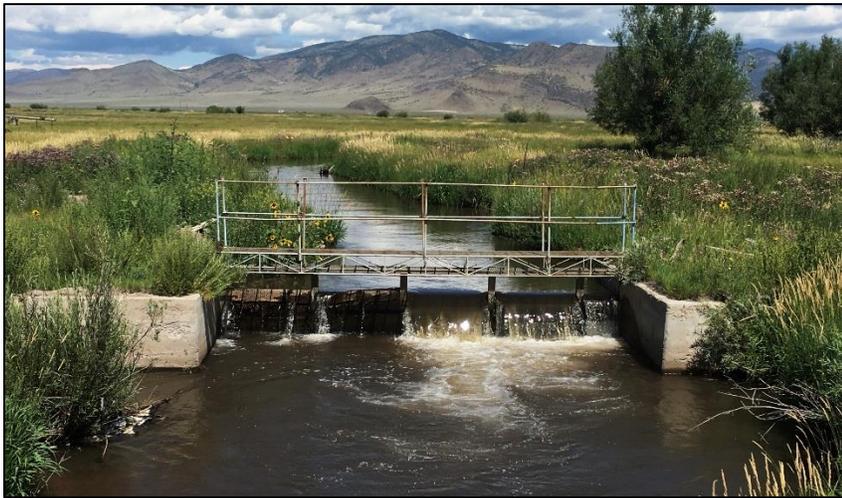
**Figure 2.1: Braun Brothers Ditch No. 1 diversion on Saguache Creek.**

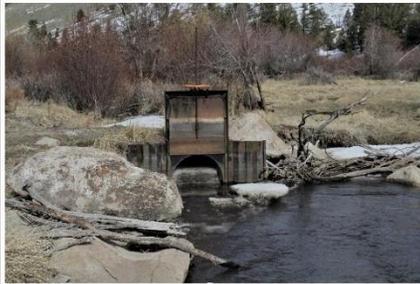
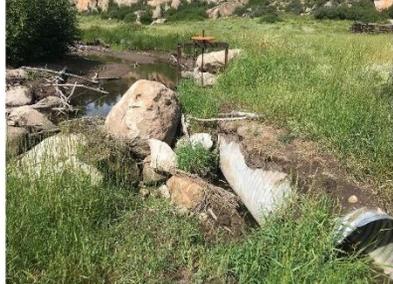
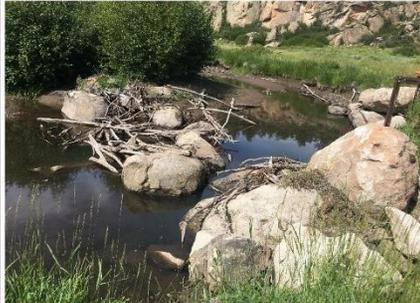
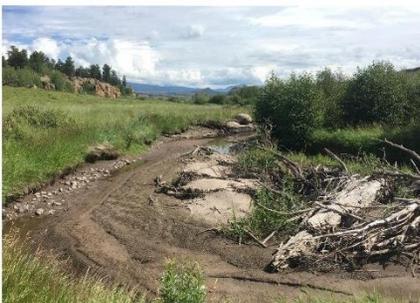
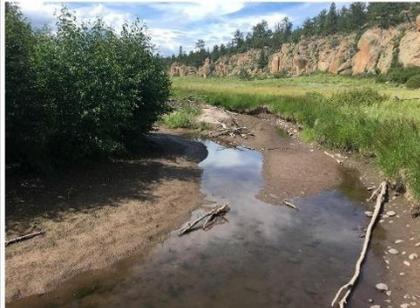
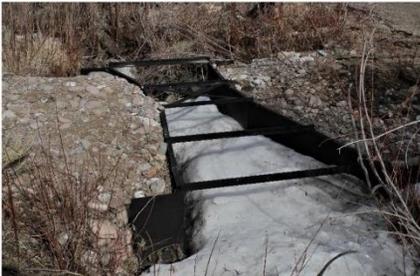
**Figure 2.3: Example report card developed for diversion infrastructure inventory (pages 1-2).**

**Structure Description:** This is the first diversion on Saguache Creek. A stacked rock diversion dam directs water to the headgate, located on the north bank of the stream. A new diversion dam and bank stabilization structures were installed in 2019 in partnership with NRCS. The headgate and flume were not affected as part of those repairs. Bank erosion and meander cutoffs are relatively common on upper Saguache Creek. During spring runoff in 2019, the meander feeding this ditch was cut off, resulting in the stream bypassing the structure (see map below).

Headgate (pre-2019 runoff)	Headgate outlet (post-2019 runoff)

Headgate and diversion dam	Dry channel looking downstream

Dry channel looking upstream	Flume looking downstream

SAGUACHE CREEK DIVERSION INFRASTRUCTURE INVENTORY	
CHASE PEYTON DITCH	
PHOTO LOG	
Saguache Creek Stream Management Plan

Using the information described above, a “report card” containing descriptive statistics, photographs, location, and channel migration maps, and recommended improvements was created for each structure. An example report card for the Chase Peyton Ditch is shown in Figures 2.3 and 2.4.

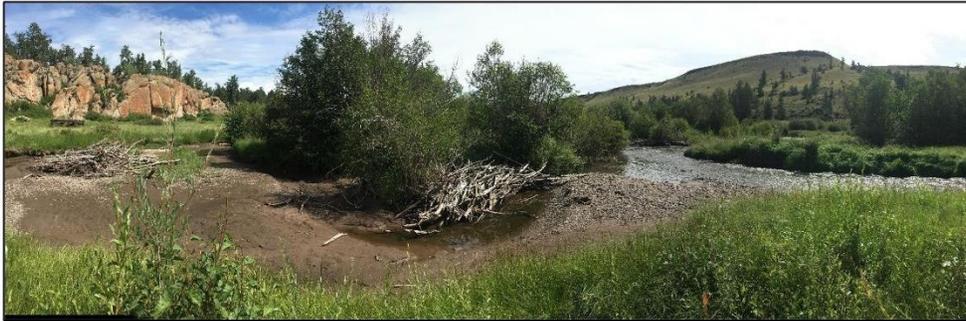
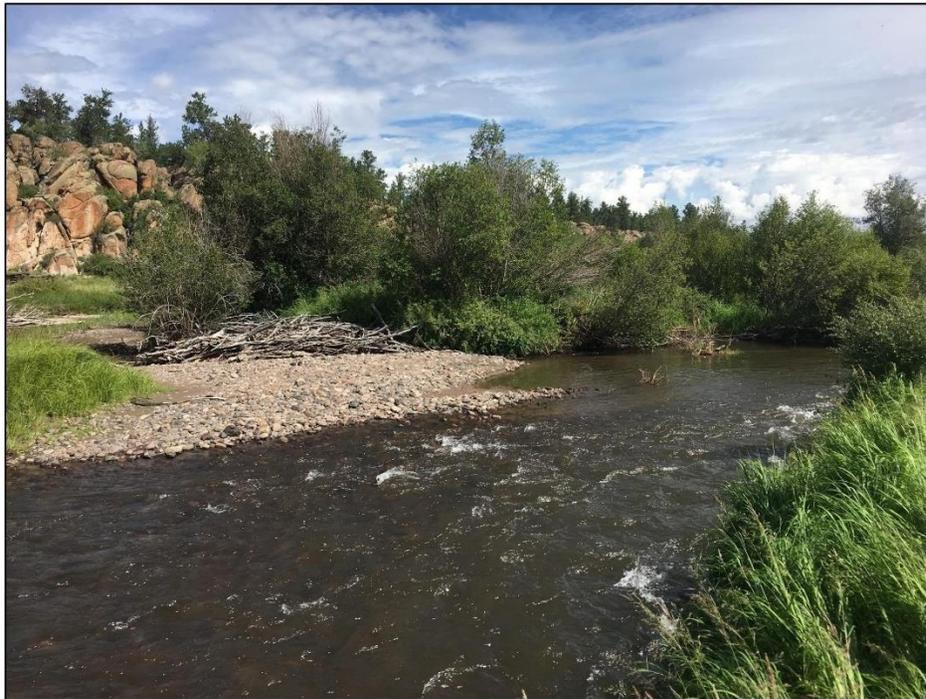
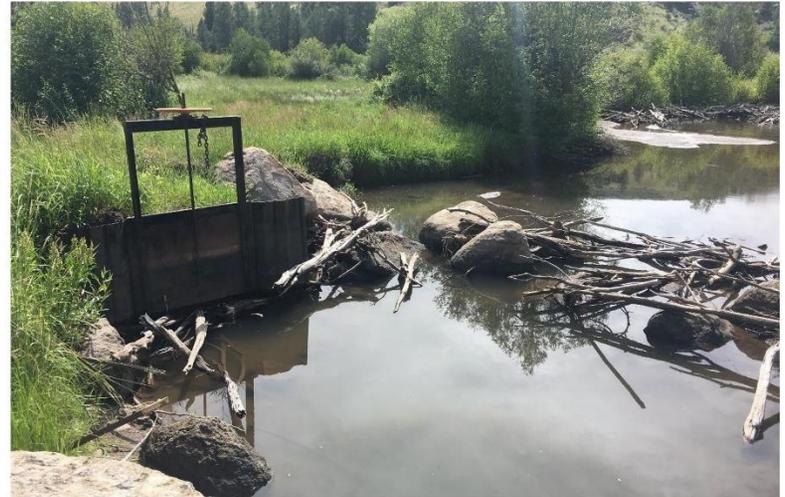
**Figure 2.4: Example report card developed for diversion infrastructure inventory (pages 3-4).**

Dry meander, which was cut off during 2019 spring runoff.

This photo, looking downstream, shows the meander (left) that was cut off during 2019 spring runoff.

Headgate and diversion looking downstream

Point of diversion and meander that was cut off during 2019 spring runoff.

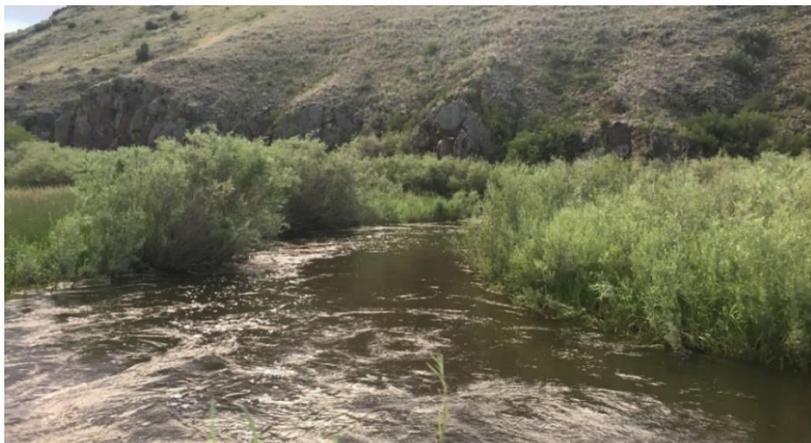
**Figure 2.7: Floodplain activation on Saguache Creek, June 2019.**

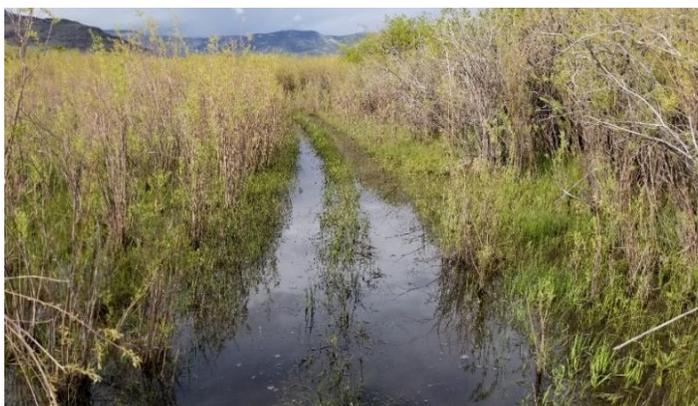
**Figure 2.8: Activated floodplain in Saguache Creek riparian area, August 2019 (Photo: Tyrell Mares).**

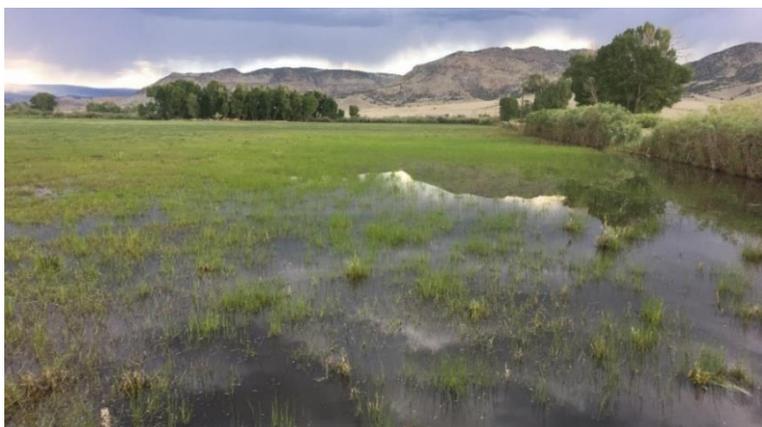
**Figure 2.9: Wet meadow adjacent to Saguache Creek near County Road 46, July 2019.**

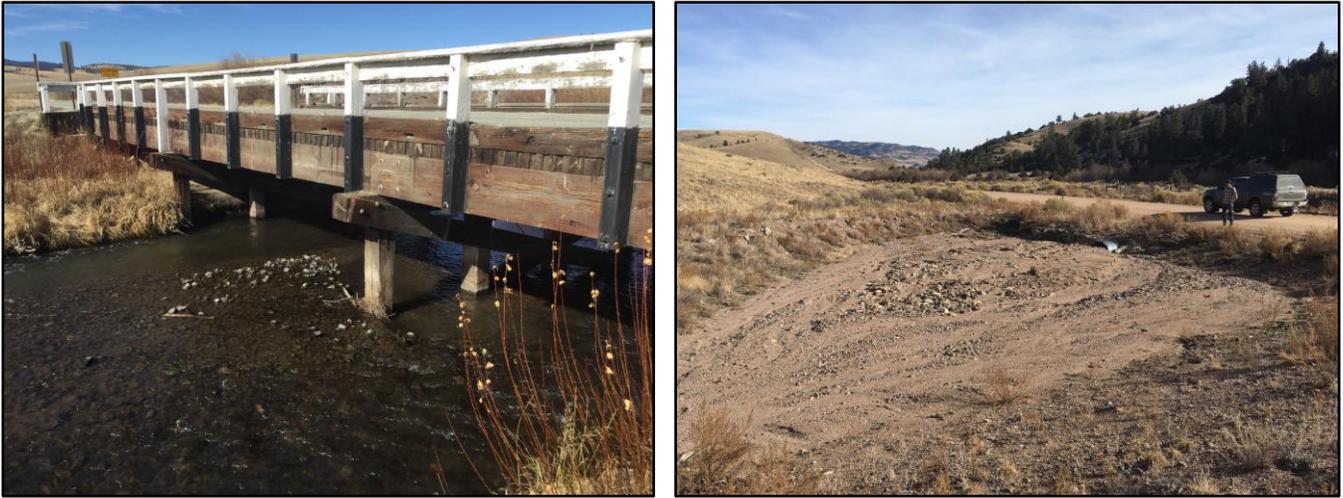
**Figure 2.12: (Left) Bridge over Saguache Creek with a pier in the middle of the bridge that may collect debris during a flood. (Right) Undersized culverts failing to transport sediment in a dry wash in Saguache County.**

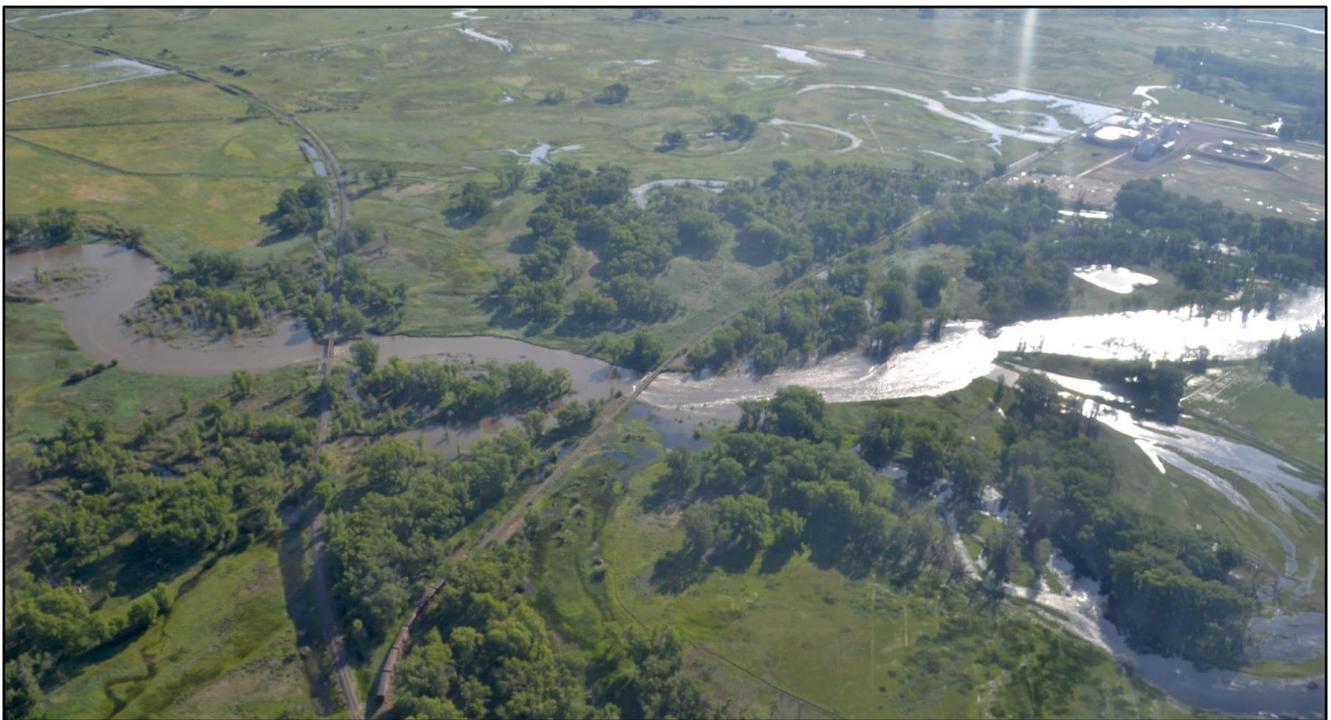
**Figure 2.13: Railroad lines and bridges crossing the Rio Grande near flood stage, June 2019.**

Roads oriented so they constrict the active river corridor can increase flow depths, shear stresses, and sediment transport capacities of streams. These constrictions can affect reaches upstream and downstream. Road and railroad bed encroachment does not appear to be significantly affecting the geomorphic stability of any of the streams in the SMP study area (Figure 2.13).

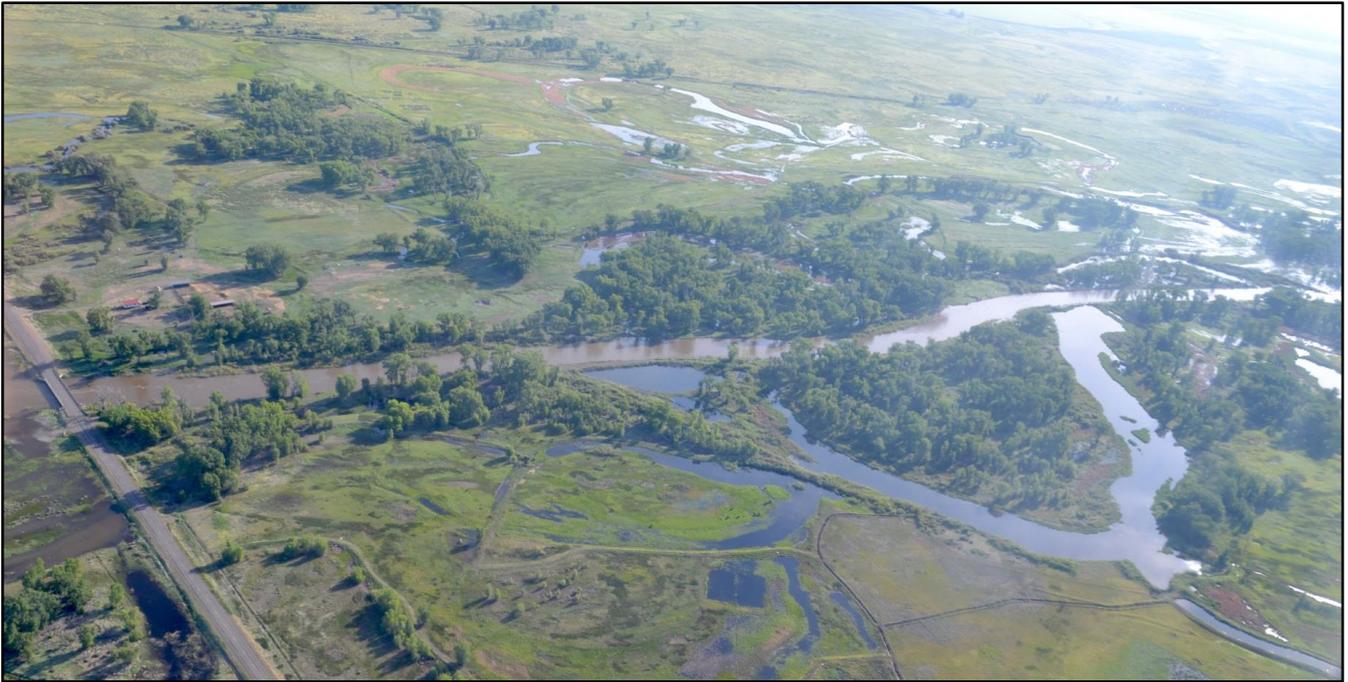
**Figure 2.14: Channelization of the Rio Grande at the Soldiers Home Road (County Road 3E).**

Channelization (i.e., straightening of channel meanders; removal of large wood and/or beavers; filling of side channels to force a stream into a single-thread) and stream bank armoring (i.e., placement of rock riprap, concrete barriers, or other materials to prevent channel migration or widening) has occurred on the SMP study streams and adversely affects natural channel processes and stream health. Figure 2.14 shows a channelized portion of the Rio Grande.

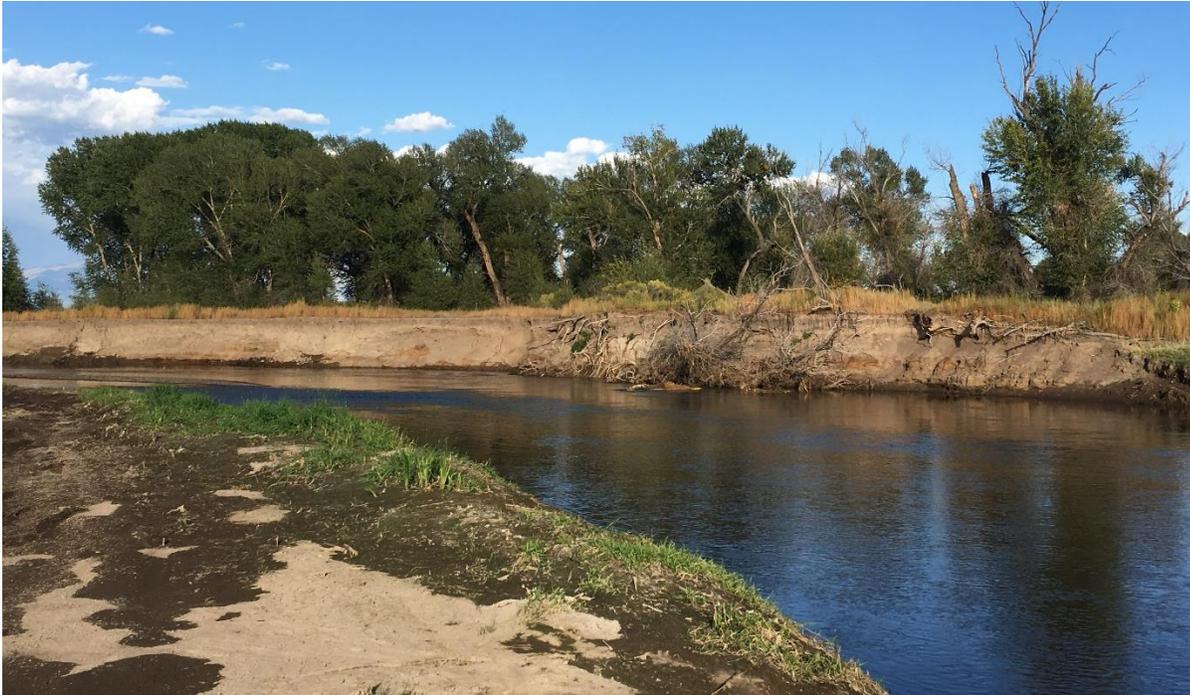
**Figure 2.15: River-floodplain disconnection on the Rio Grande upstream of Alamosa.**

These features can cause river-floodplain disconnection (i.e., the river is unable to access its floodplain at high flows where it otherwise would have). Stream response to floodplain disconnection and/or bank armoring typically results in the transfer of erosive energy to the opposite bank, a downstream reach, or toward the channel bed.

Generally speaking, these changes lead to a fluvial response (i.e., instability seen as increased erosion, sedimentation, and/or channel movement). Disconnecting features such as berms or levees are not uncommon in the SMP study area, typically as a result of land conversion or road and railroad construction that now occupies former river floodplain.

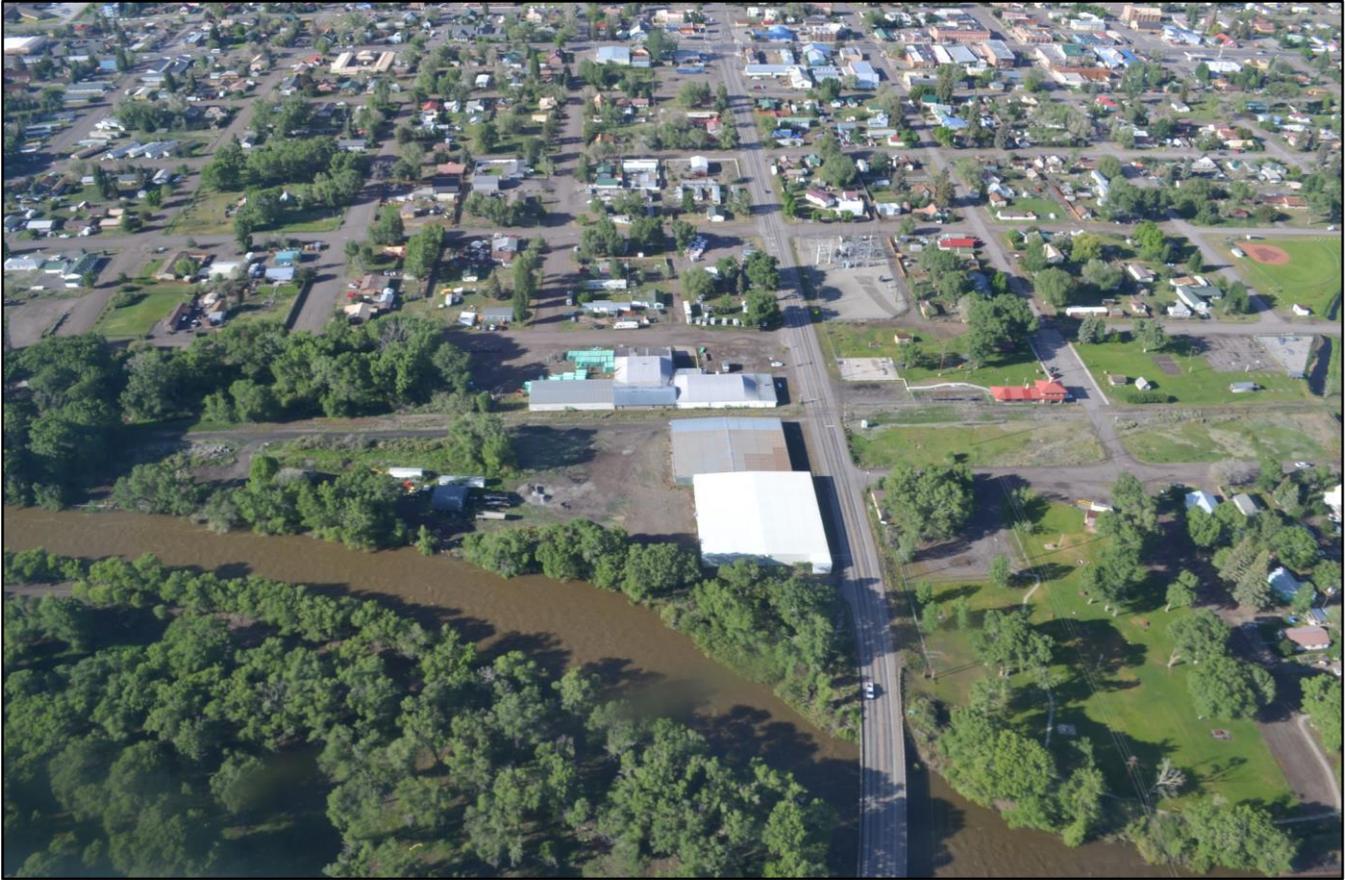
**Figure 2.16: Development in the active river corridor of the Rio Grande in the Town of Del Norte.**

Land conversion can alter or eliminate floodplain complexity, side channels, wetlands, riparian vegetation, overflow relief channels, and other important geomorphic and ecological components of streams. Riparian vegetation and wetlands along some SMP reaches are impacted by fill and/or floodplain/riparian area conversion resulting from development, overgrazing, and nonnative species dominance. Riparian vegetation throughout the floodplain and river corridor, not just along the main channel, is critical to energy dissipation, stream shading, bank stability, wildlife habitat, and many other natural stream processes. Overgrazing and/or development fill brought into the corridor erases the evidence of past channel migration, possibly creating a false sense of protection from fluvial erosion to those that occupy the land. Furthermore, development creates the expectation (e.g., stable banks) that these rivers will remain in their current location indefinitely and therefore current and future generations will be willing and able to invest in the costs (both monetary and ecological) that will be required to resist natural channel processes (e.g., bank erosion and channel migration) (Figure 2.16).

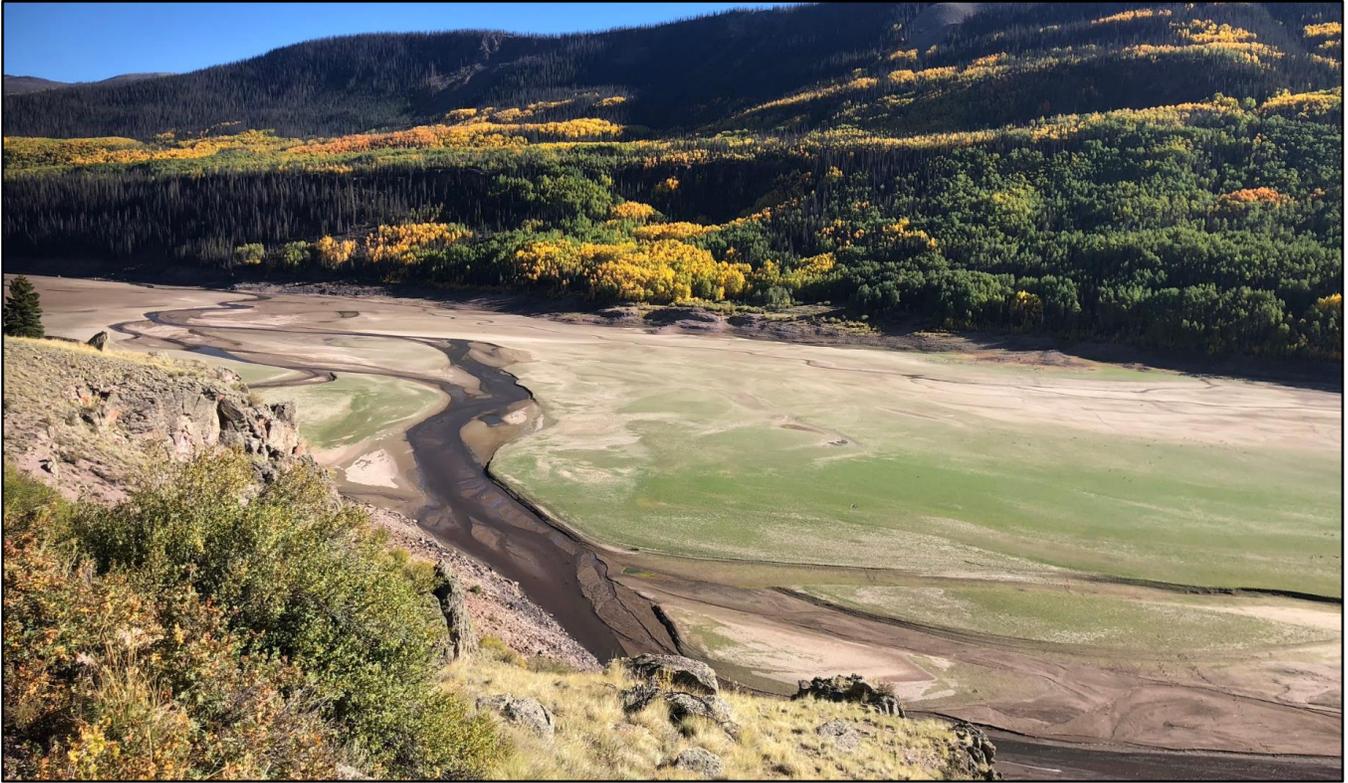
**Figure 2.17: Sediment trapped behind the Rio Grande Reservoir (seen during dam repairs which had the reservoir drained during the fall of 2018).**

While Saguache Creek is a free-flowing stream, large dams affect both the Rio Grande and Conejos River. Dams affect these rivers both by reducing sediment transport, by trapping sediment behind them (Figure 2.17), as well as by reducing the peak flows that might otherwise provide channel-forming flows to flush fines, mobilize sediments, and do other geomorphic work. The Rio Grande is controlled by the earthen dam of the Rio Grande Reservoir which sits approximately 20 miles west of Creede. To a lesser degree, flows are also affected by Continental and Santa Maria reservoirs, which flow into Clear Creek. The Platoro dam on Conejos River is located roughly 1 mile above the town of Platoro, Colorado. Because these reservoirs are required to pass inflows during spring runoff, peak runoff is only altered when reservoir inflows surpass reservoir outlet capacity.

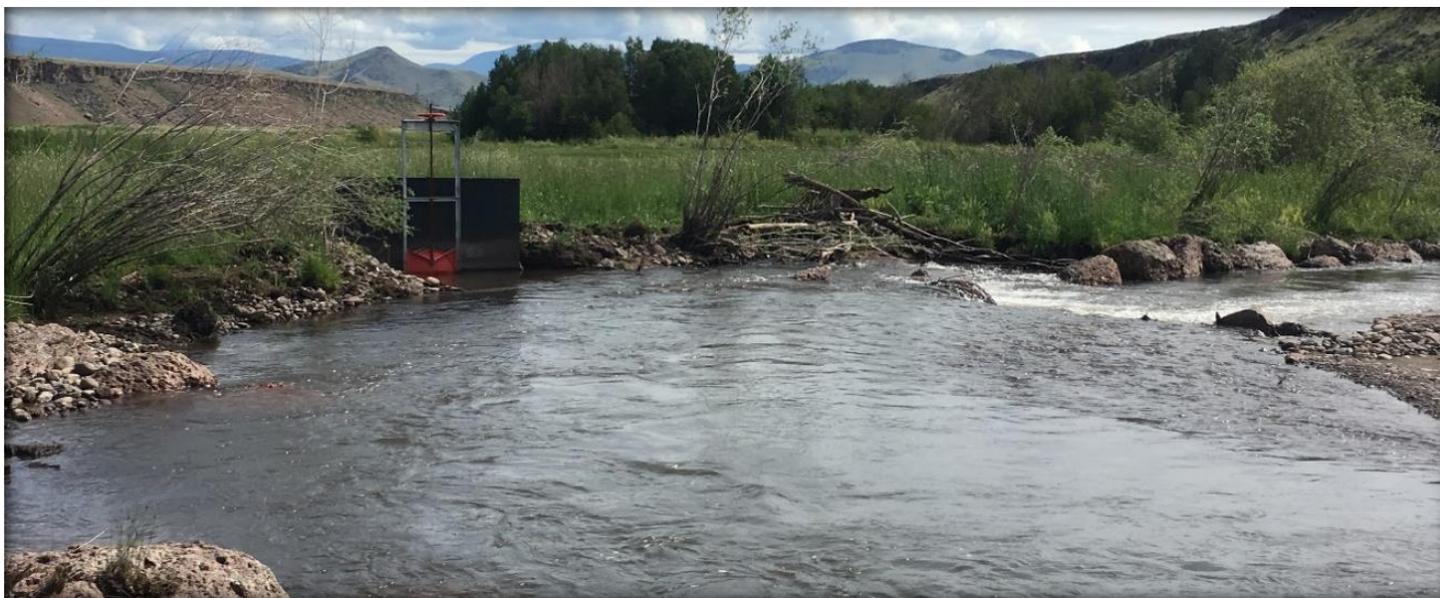
**Figure 4.1: Middle D-Curtis Ditch diversion and headgate on Saguache Creek.**

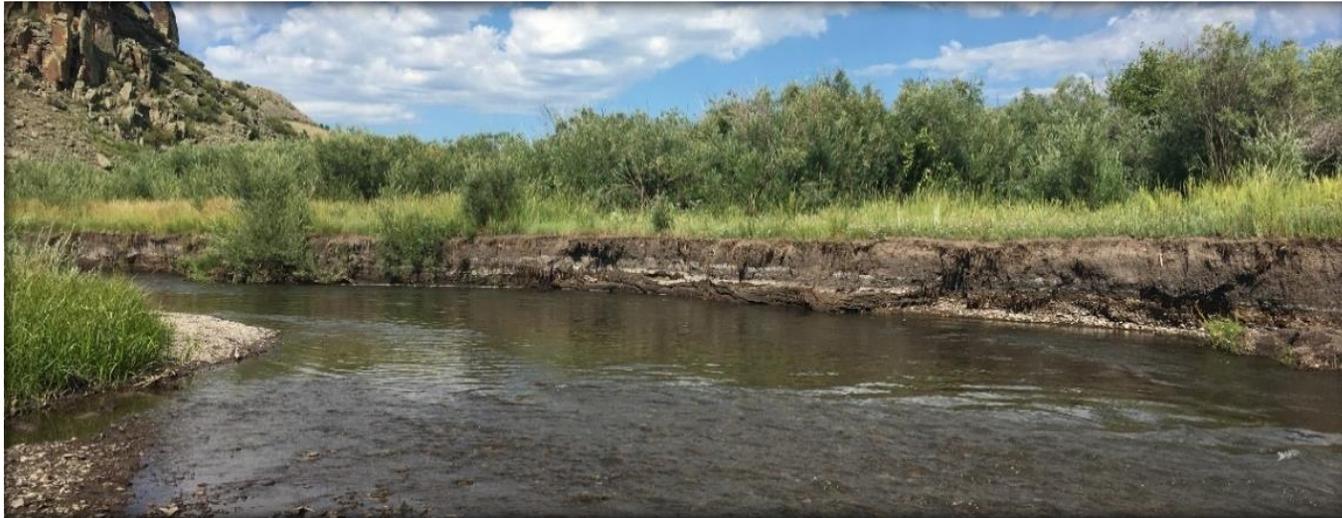
**Figure 4.2: Bank and channel instability downstream of the Middle Creek confluence.**

Bank Stabilization and Infrastructure Resiliency	This project will implement bank stabilization downstream of the Rio Grande National Forest boundary to reduce erosion, protect infrastructure, and promote channel stability.	Reaches 3 through 5	C and D	Improved floodplain connectivity, natural channel processes, riparian vegetation condition, and water quality; enhanced aquatic habitat.	Medium-High
Bank Stabilization and Fish Habitat Enhancement	This project will result in bank stabilization and riparian revegetation including fish habitat enhancements.	Reaches 3 through 5	C, D, F, and G	Improved floodplain connectivity, natural channel processes, riparian vegetation condition, and water quality; enhanced aquatic habitat.	Medium-High

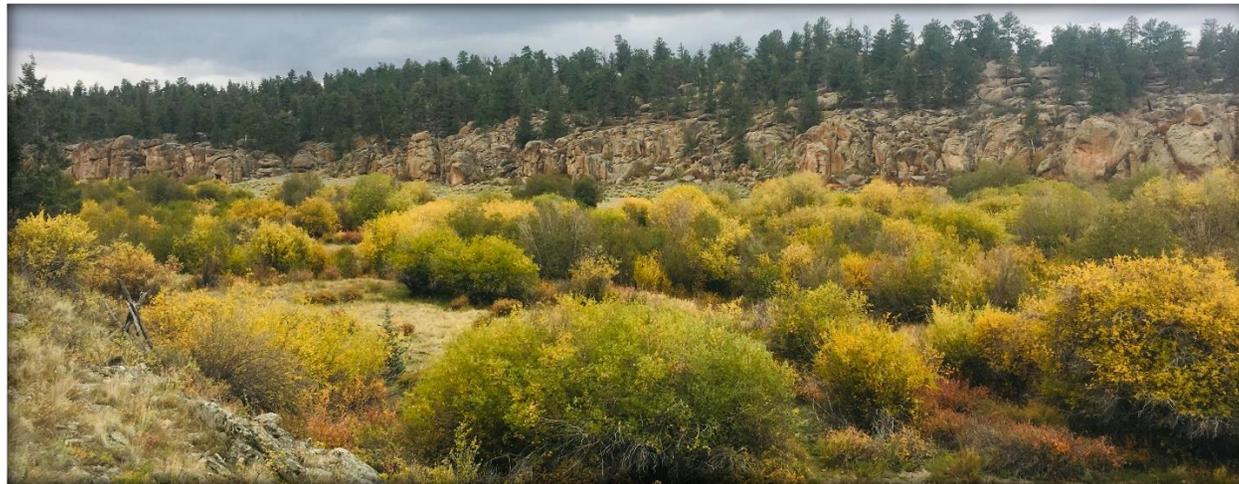
**Figure 4.3: Riparian vegetation near the Fourmile Creek confluence.**
