Report on Geotechnical Investigation

Designation: **Sedona Parking Structure**

Location: **430/460 Forest Road
Sedona, Arizona**

Project Number: **210124SF**

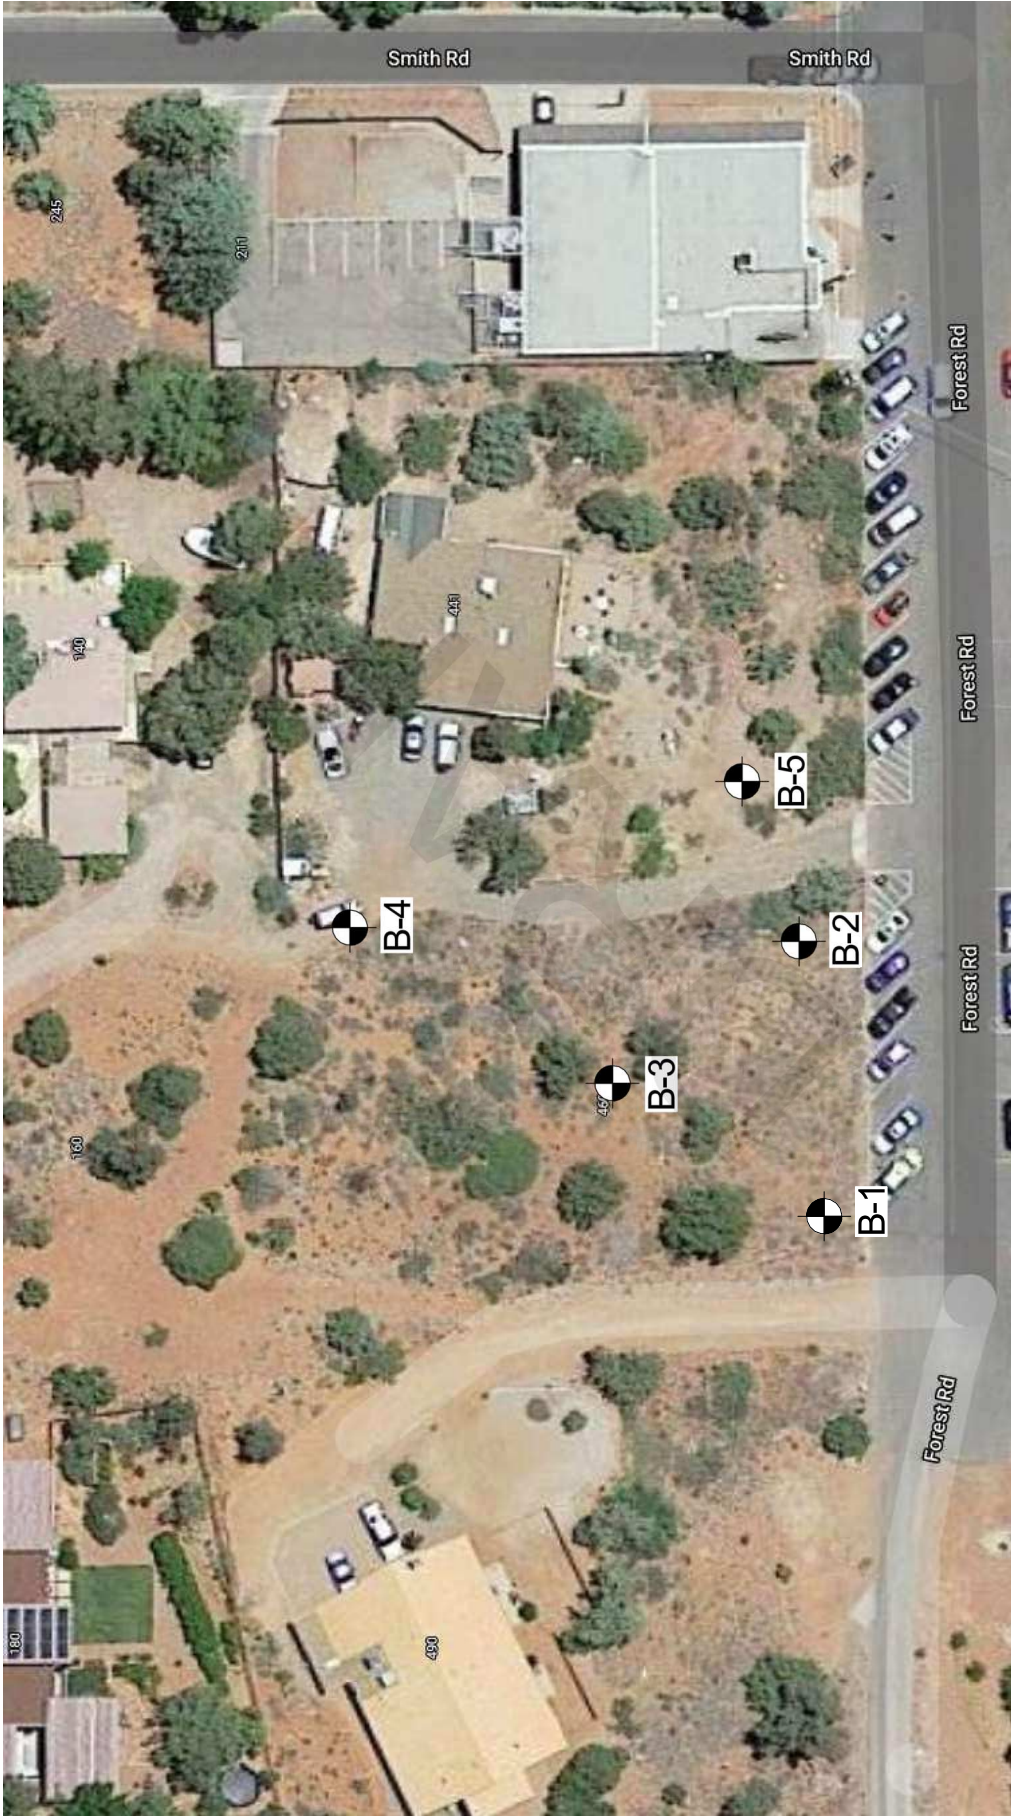
— APPROXIMATE SOIL BORING LOCATIONS

Drawing Courtesy of Google Earth
