Holistic Technical Report

Advanced Technical Investigations

ATARAXI

I begin by introducing the case study and its context, to form an understanding of the structure and landscape. Included are cross-referenced technical drawings, including site plan, various floor plans, and sections. Real images from the site have been included, providing an insight into its performance and aesthetics, in addition to my interpretation.

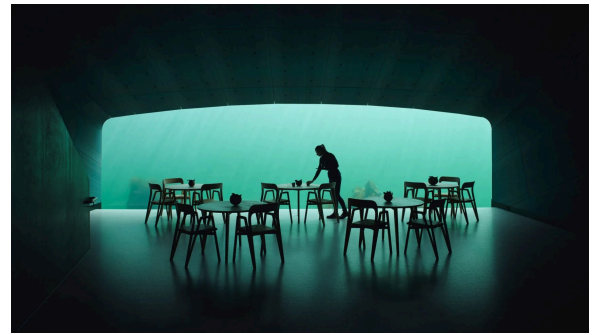
Figure 9: Main Window

The structure features an immense glass window in the dining area, which is used as the main light source.

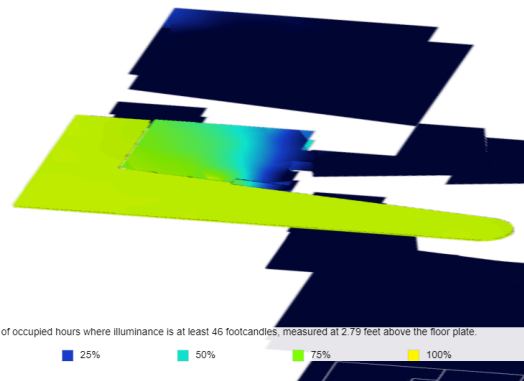
Percentage of occupied hours where illuminance is at least 46 footcandles, measured at 2.79 feet above the floor plate.

- Entrance is south-west facing - catching afternoon and evening sunlight.
- Terrace area is completely daylit, due to being completely exposed.
- Entire lobby is sufficiently daylit due to low depth and appropriate orientation.
- No artificial lighting is necessary for the lobby area during daylight hours - surpasses the required 400 lux requirement for daytime hours.
