19th SYMPOSIUM ON INDUSTRIAL APPLICATIONS OF GAS TURBINES

Training Session 8: Gas Turbine Repair Technology

Scott Hastie / Liburdi Turbine Services

Presented at the 19th Symposium on Industrial Application of Gas Turbines (IAGT)
Banff, Alberta, Canada - October 17-19, 2011

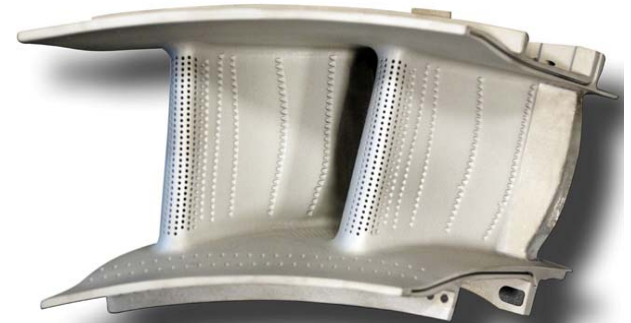
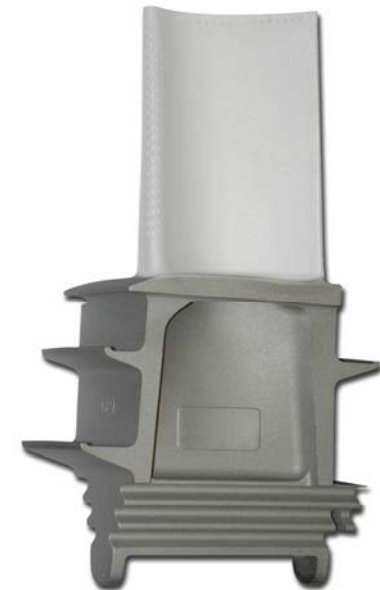
Repair Process

Incoming Inspection

Clean & Strip Coatings

Fluorescent Penetrant Inspection

Geometry Repair

Machine/Finish Geometry

Heat Treatment

Pre-Coating Inspection

Coating

Final Inspection

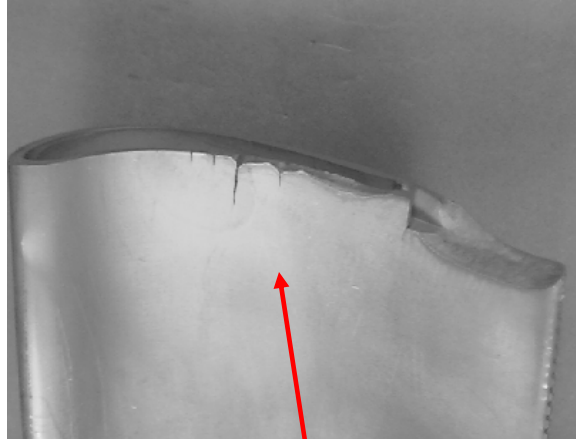
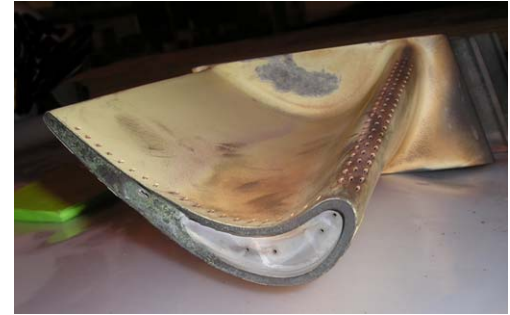
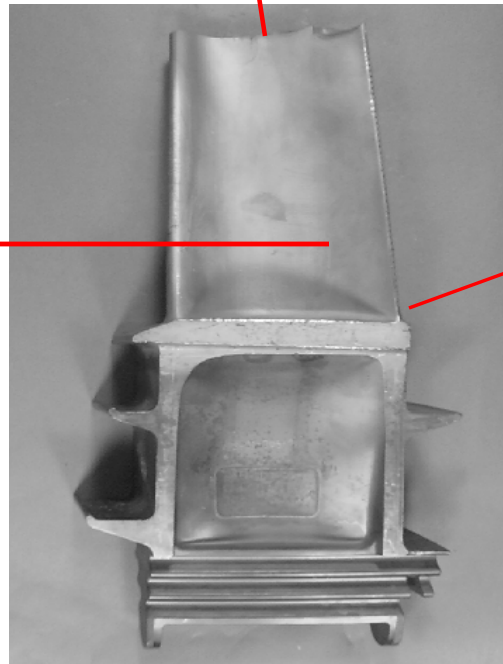
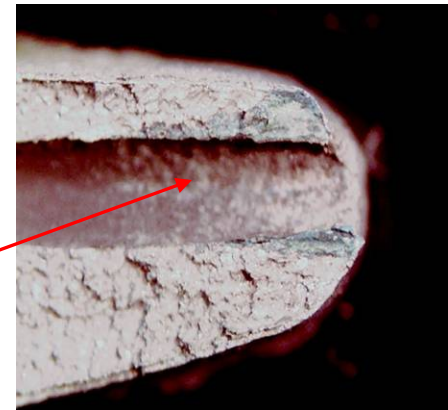
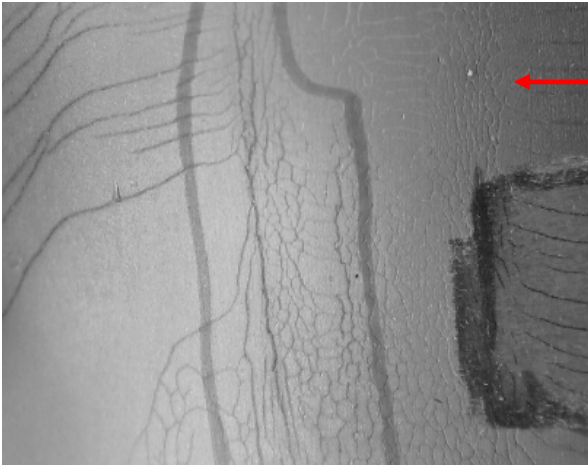
DS Alloy Damage

Life Analysis

Cracking along DS grain boundaries at tip

Oxidation burning at tip

Coating cracks in airfoil

#1 Cooling hole crack

Incomplete internal coating

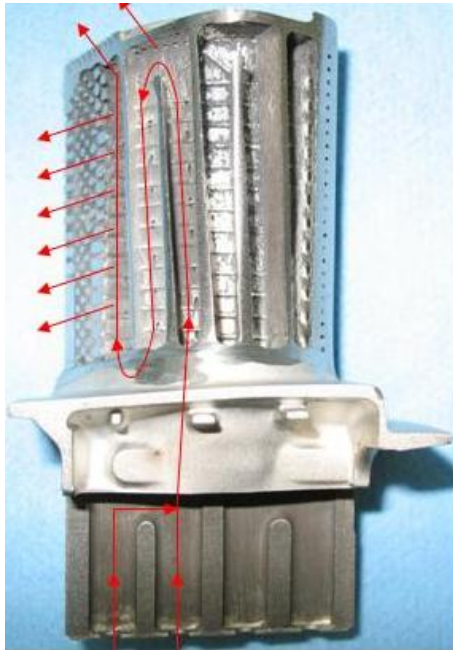
Incoming Inspection

- Cooling Hole Inspection
- Air Flow
- Cooling Flow Analysis

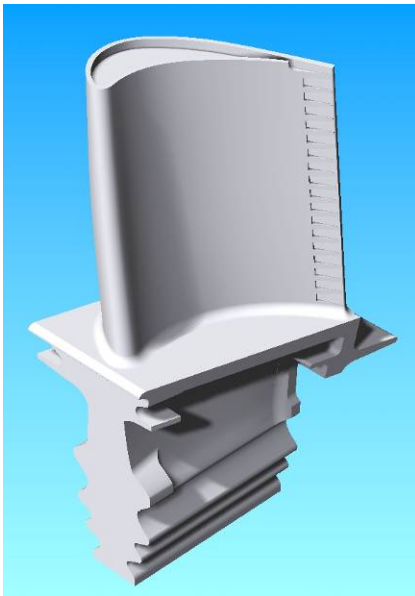
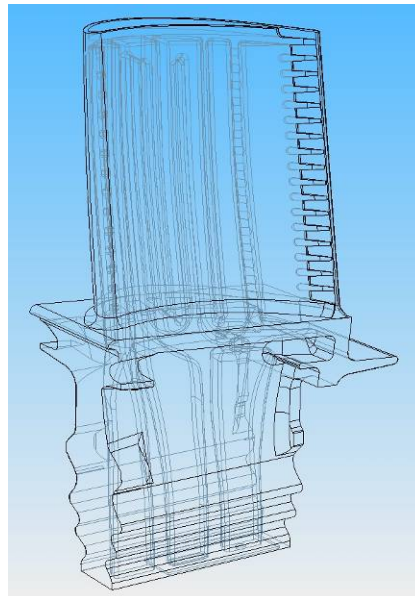
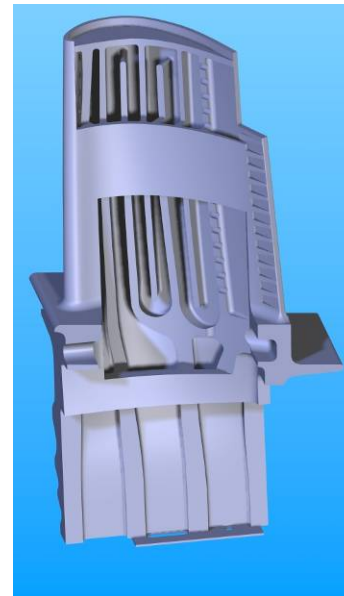
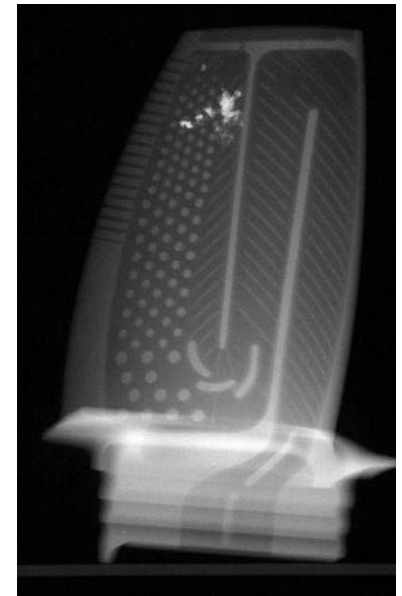
Incoming Inspection

- Internal Geometry

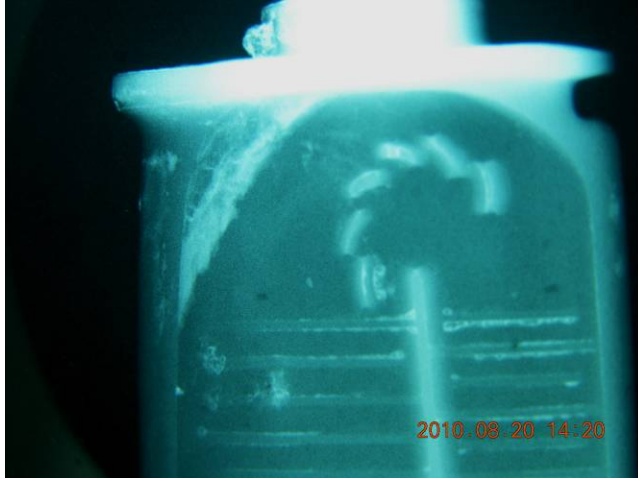
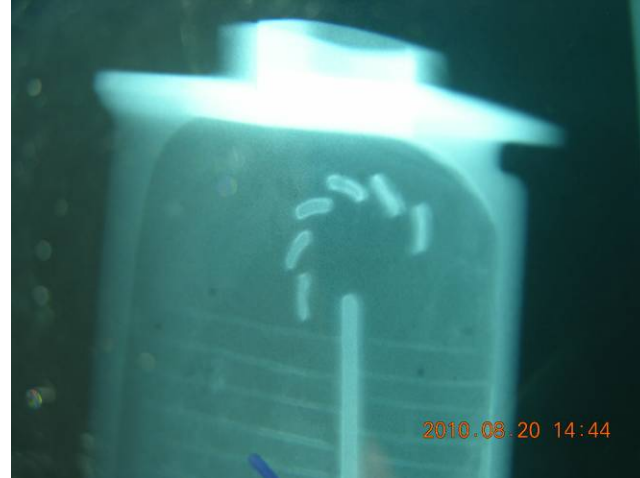
Internal Cleaning

- Internal Cleaning using thermal and chemical process are necessary before stripping
 - Internal deposits and oxides limit effectiveness of stripping process

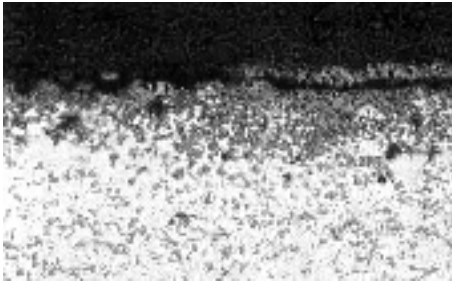
- Oxide removal allows complete stripping

Before cleaning

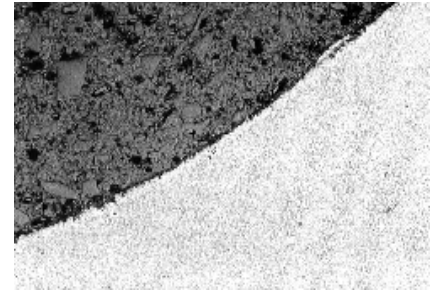
After cleaning

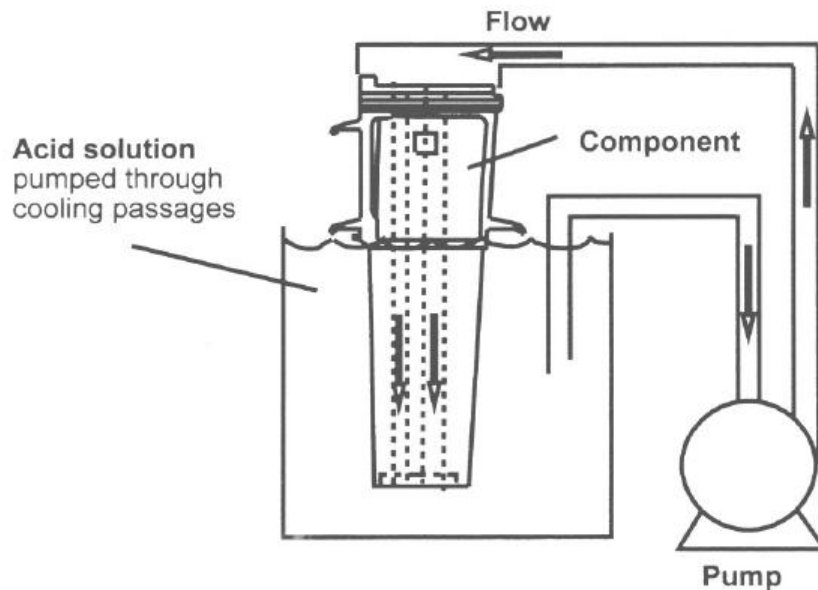
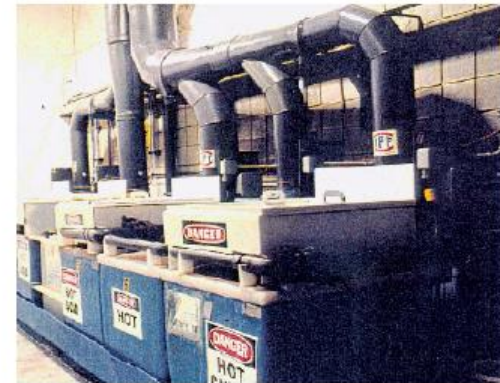
Coating Stripping

- Masking Required for Internal Only Strip
- Internal Stripping

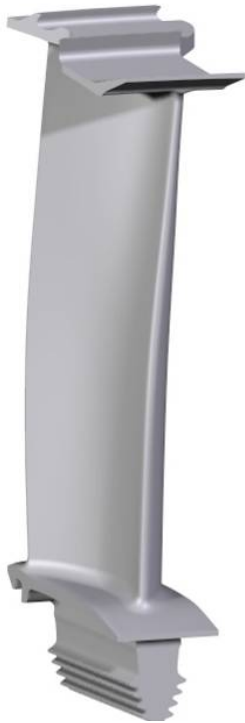
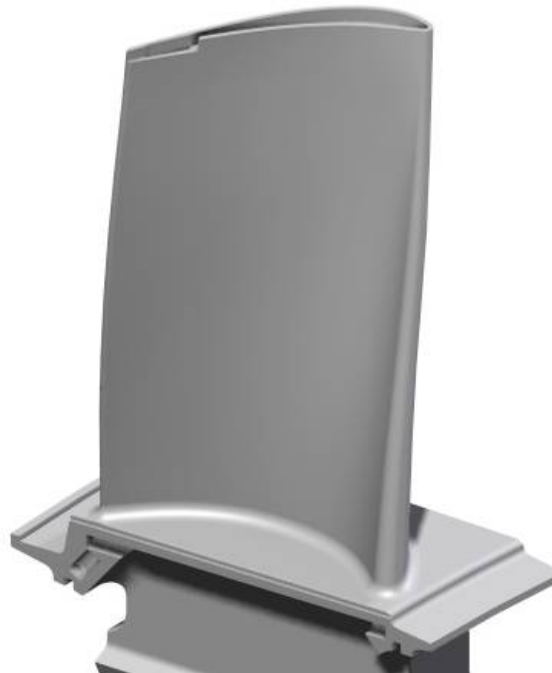
Dimensional Repair

- Tip weld of un-shrouded blades
- Z-notch restoration of shrouded blades
- Seal fin restoration

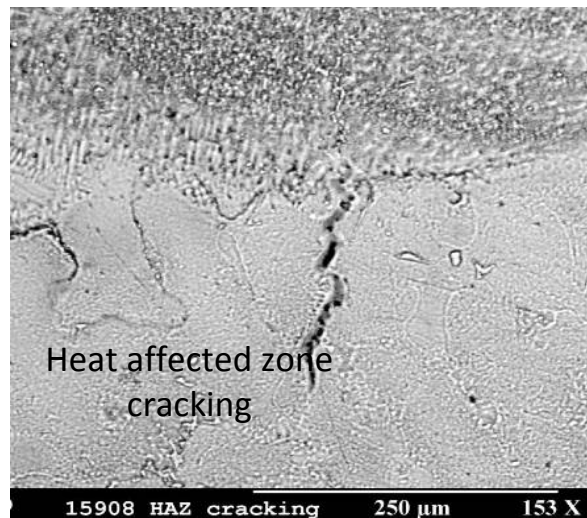
Dimensional Repair

- Welding of gamma prime (γ') strengthened superalloys is not as easy when compared to welding of cobalt base alloys or stainless steel alloys.
- Fusion Zone cracking
- HAZ cracking (microfissuring)
- Post weld heat treat cracking (strain age cracking)

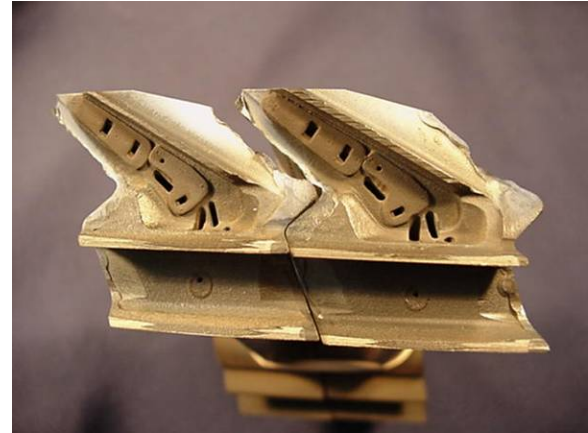
New Blade

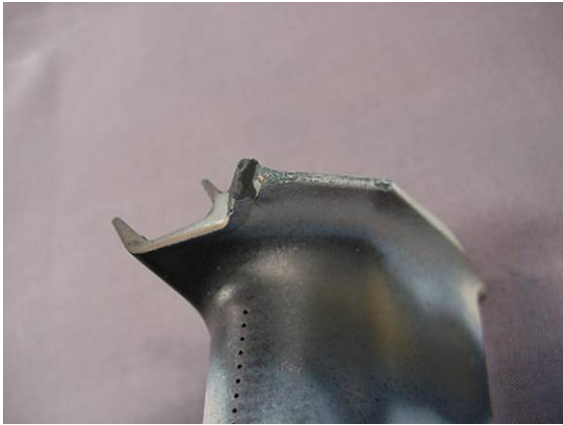
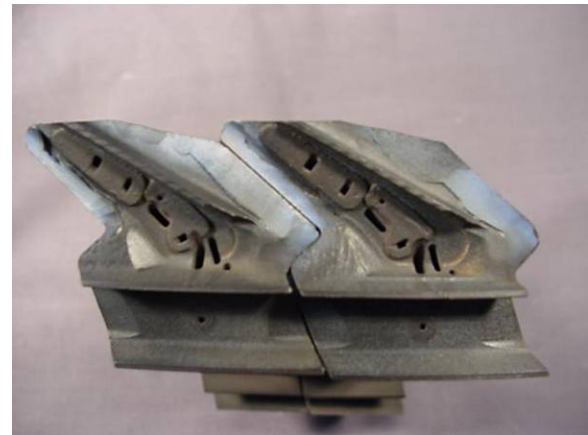
Repaired Blades

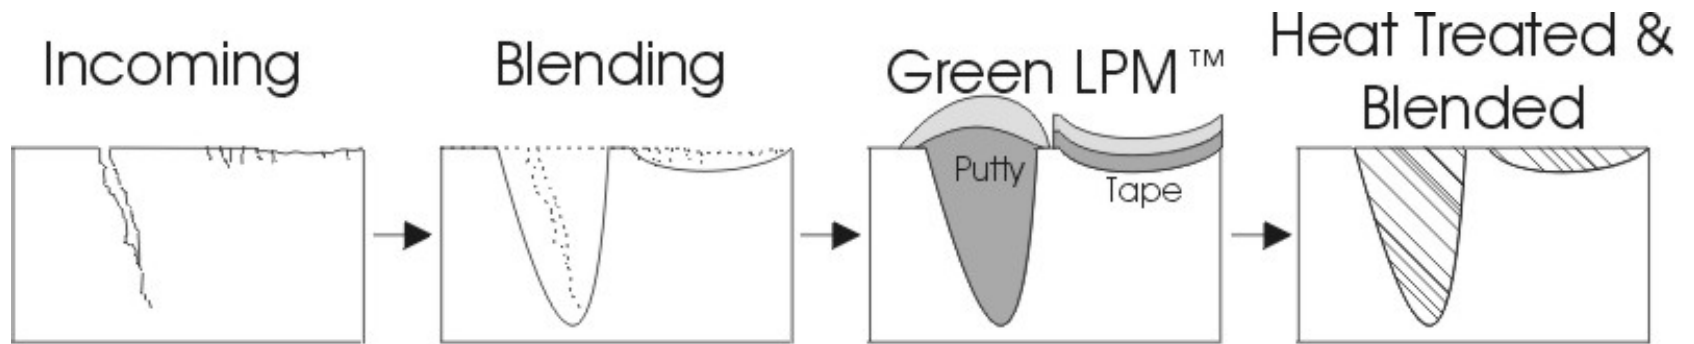
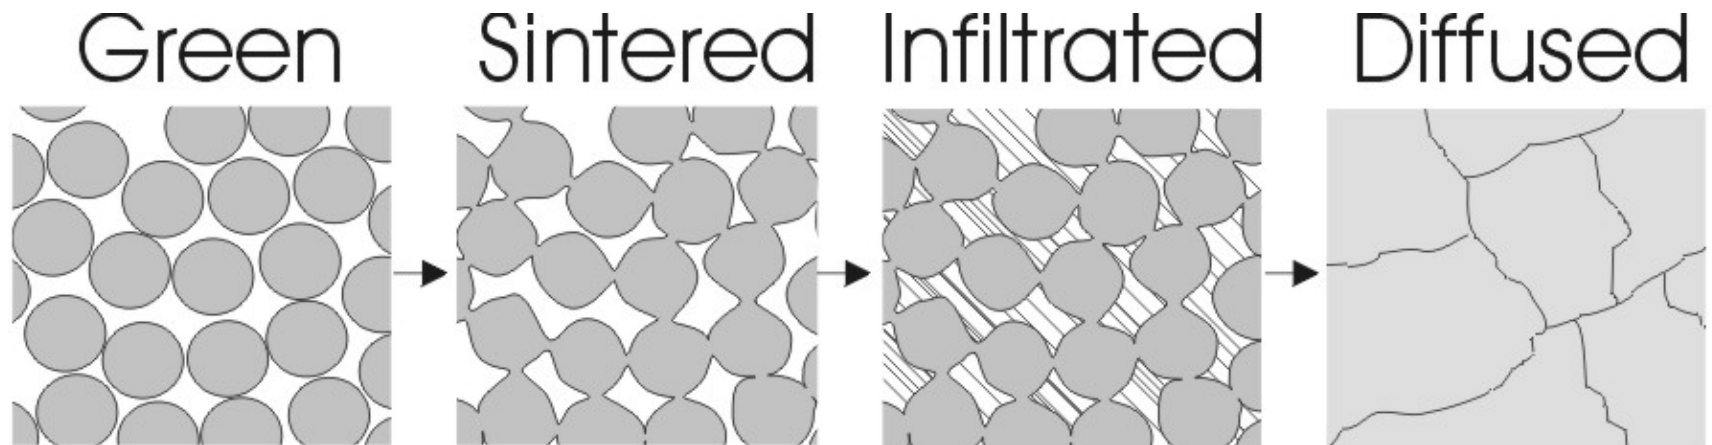
Geometry Repair - Vanes

□ Low Melt ■ High Melt ▨ Consolidated

Liburdi Powder Metallurgy (LPM™) is a modified wide gap brazing process.

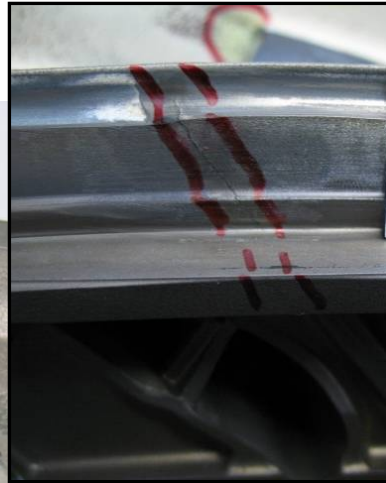
Original braze joint
requires
repair/restoration

- Incoming damage – burned leading and trailing edges, thin airfoils, burned outer shroud surfaces, shroud braze joints deteriorated

- Previously NGVs were considered not repairable and were replaced with new.

Severely burned
trailing edges

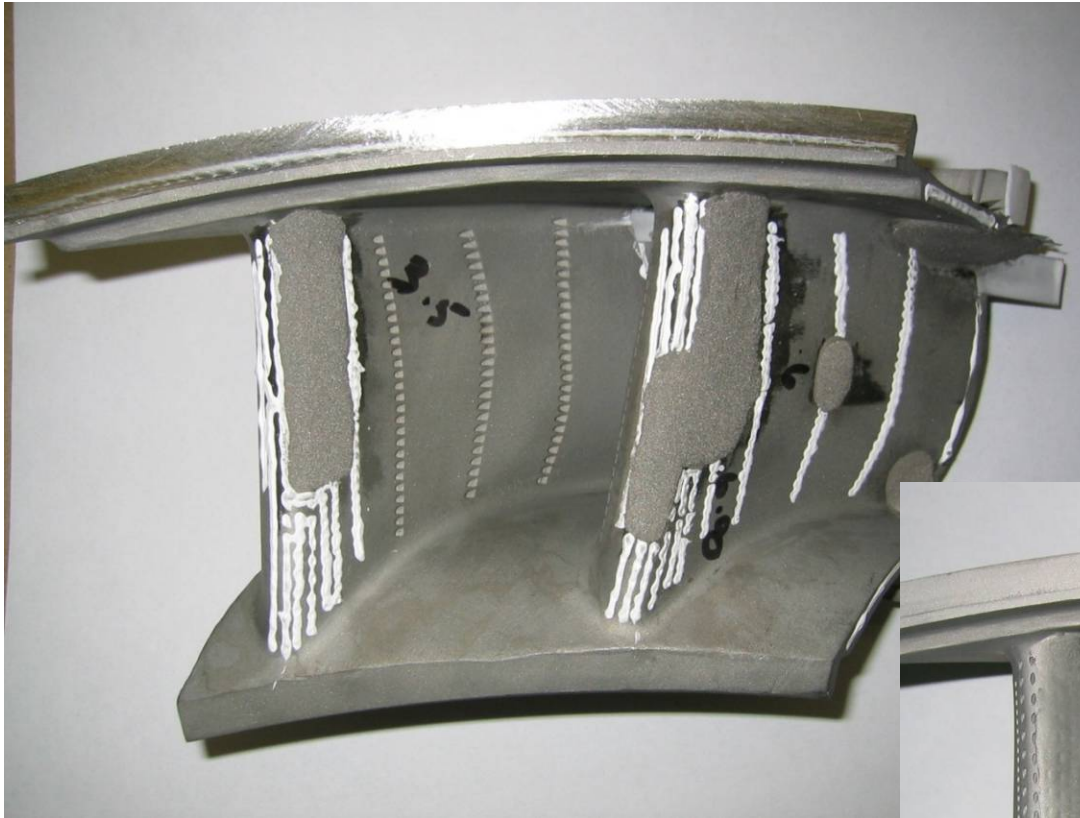
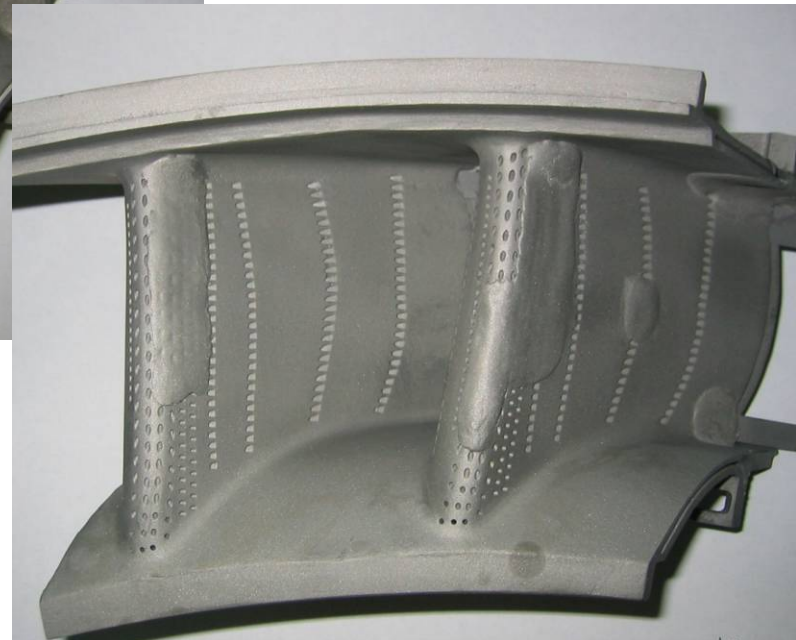
Geometry Repair - Vanes

- LPM high strength alloy as-applied to leading edge, mid airfoil, and trailing edges

- LPM material after high temperature vacuum heat treatment to "cast" material to the airfoils

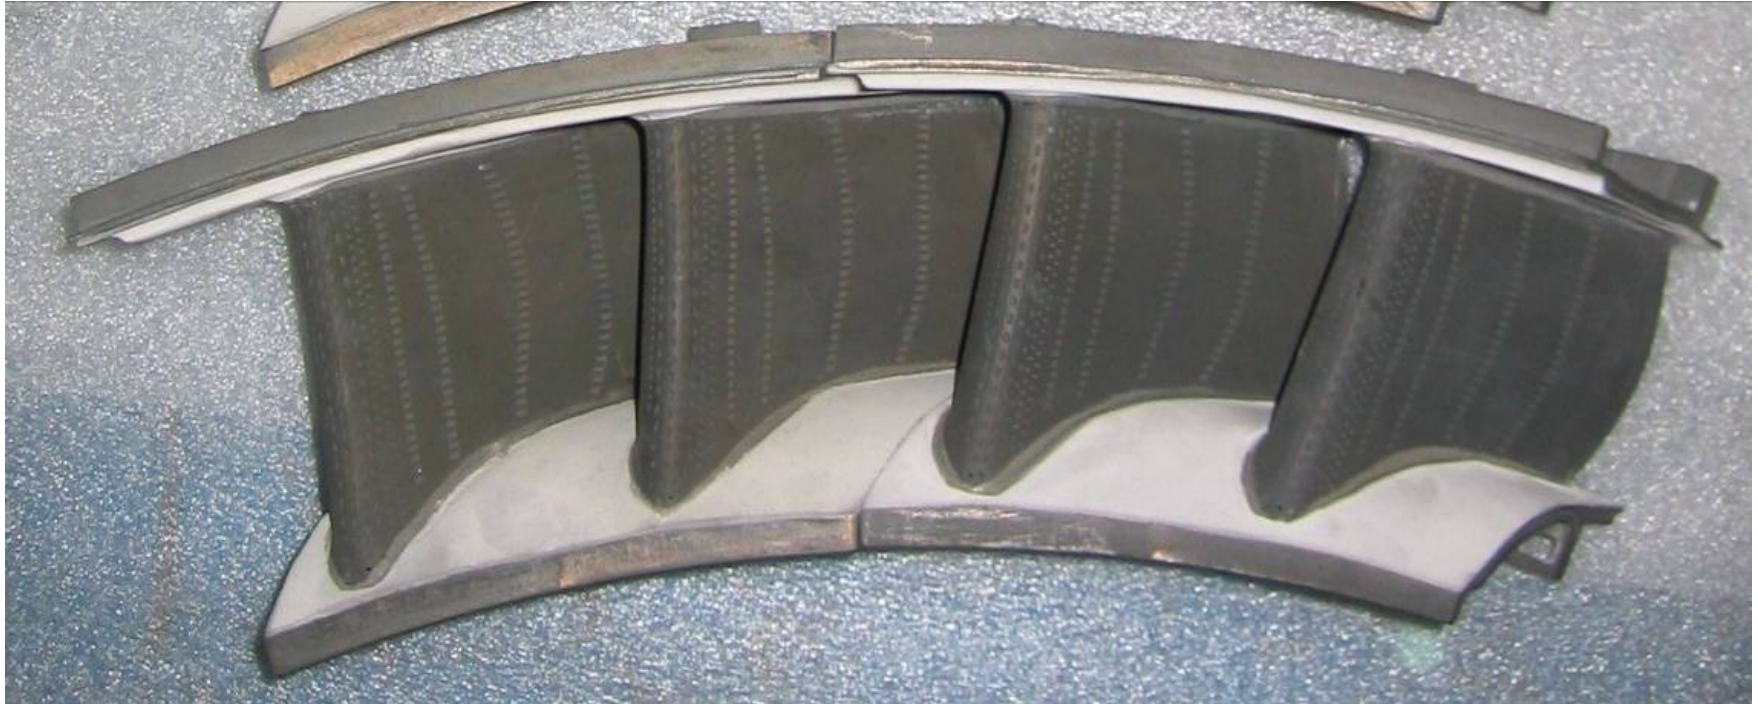
Geometry Repair - Vanes

- Airfoils machined to original contours, all cooling holes re-established by EDM machining, airfoils re-coated, and shrouds coated with TBC coatings. **NVGs fully restored for continued service**

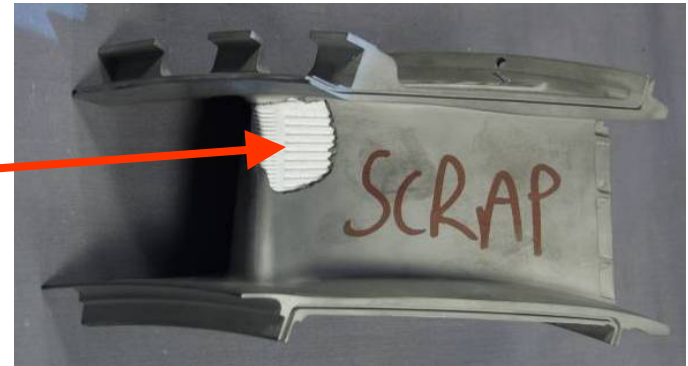
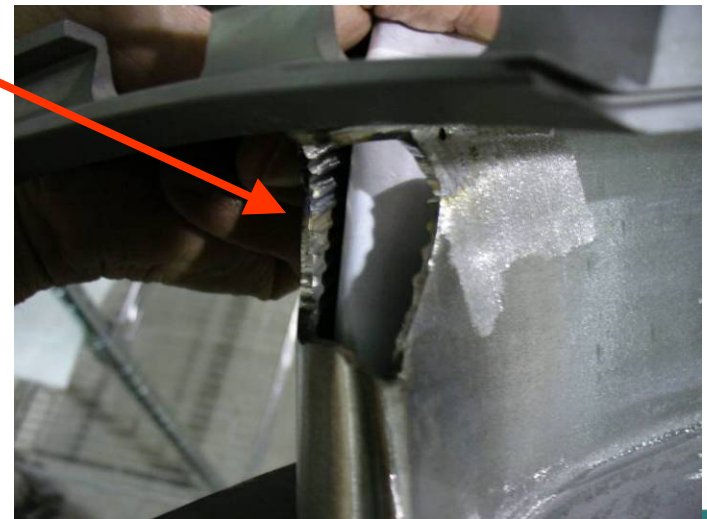
Geometry Repair - Vanes

Significant missing material
on leading edge due to FOD

To maintain cooling design
internal geometry must be
recreated during repair

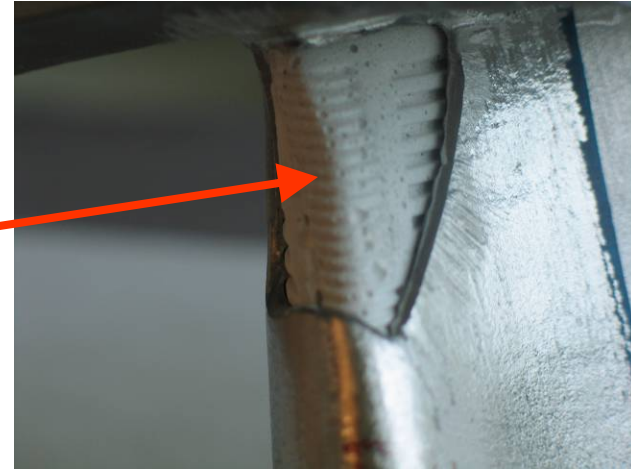
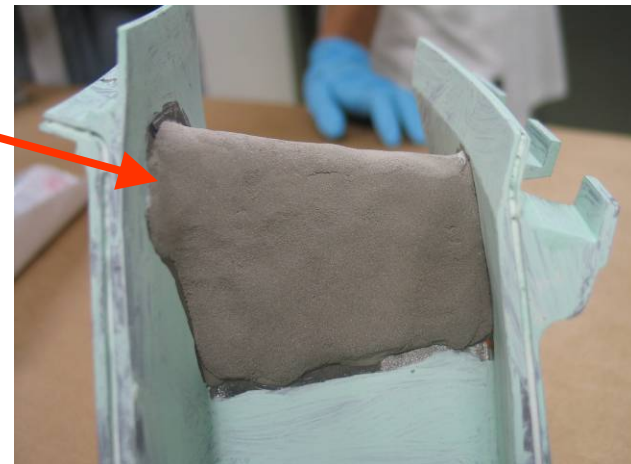
Geometry Repair - Vanes

Form casting process allows
LPM to be formed to match
internal geometry

Reduces post consolidation
machining operations

LPM™ superalloy applied
over form and onto base
alloy

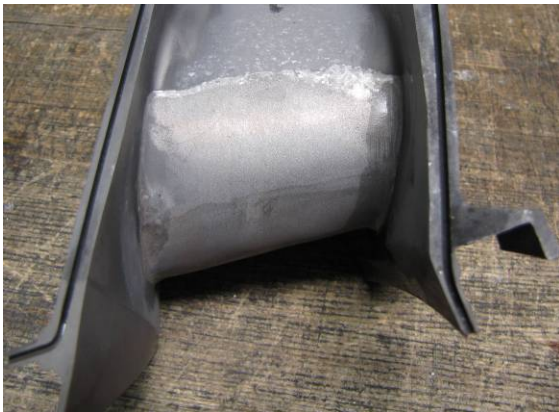
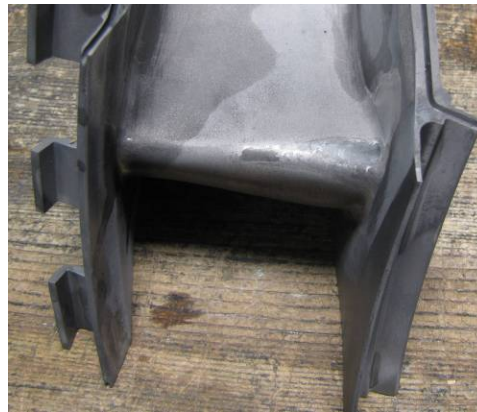
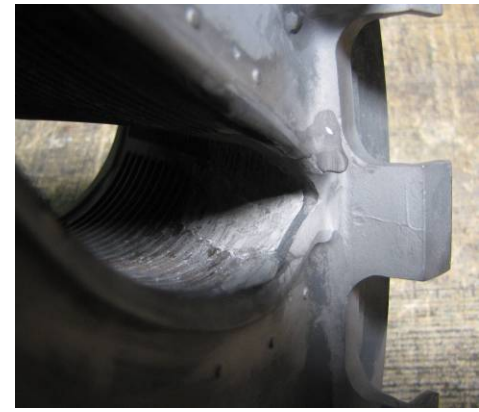
Geometry Repair - Vanes

Part returned for repair after 24,000 hours
Inspection revealed no indications or material loss

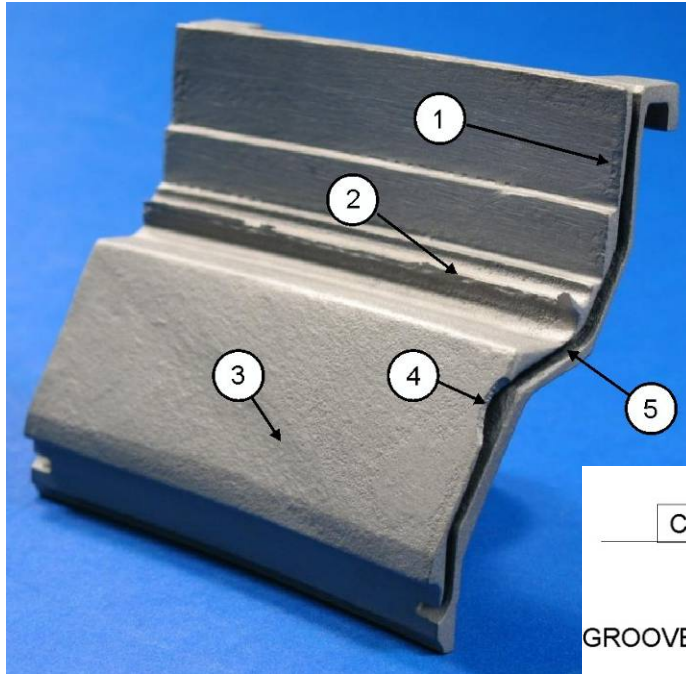
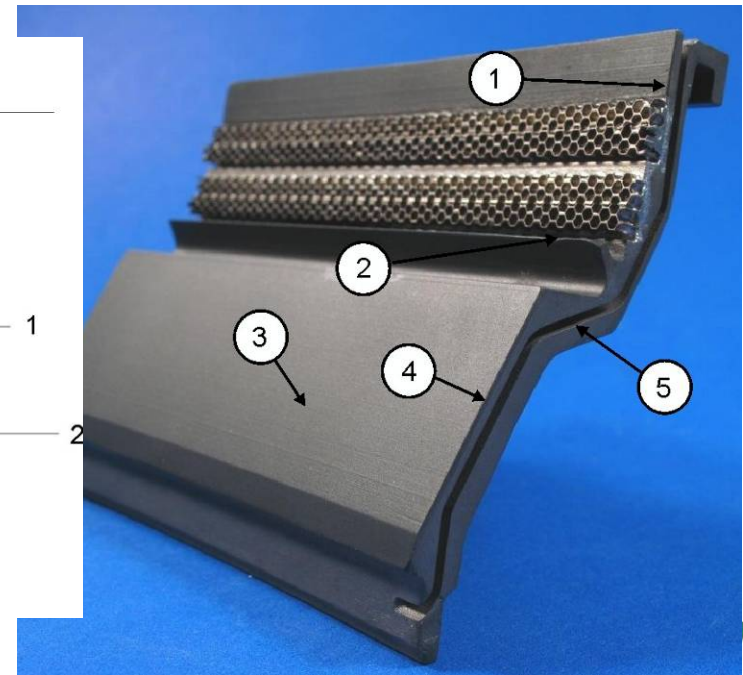
Geometry Repair - Vanes

- Incoming seal segs distorted (out of round), seal slots misaligned, backing plates thin due to oxidation – parts were previously declared scrap and replaced with new

- Backing plate is re-formed, then thickened and machined to original dimensions. Seal slots filled and re-machined to original dimension and location, new honeycomb added – **parts reconstructed to as-new dimensions for continued service**

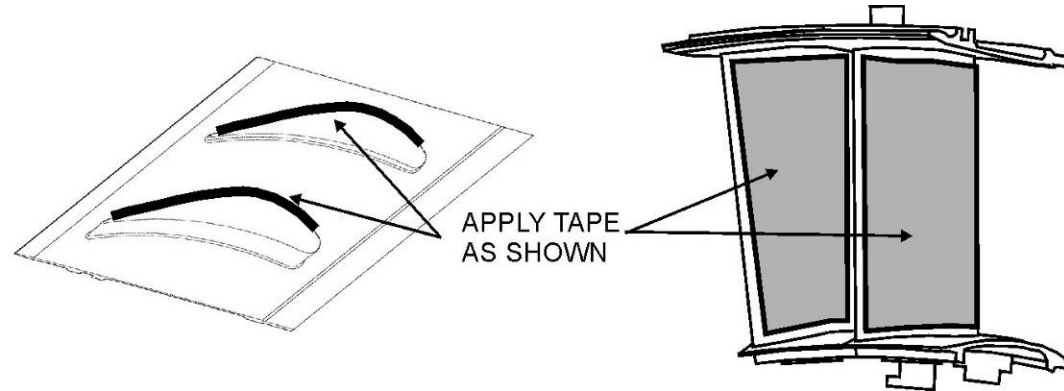
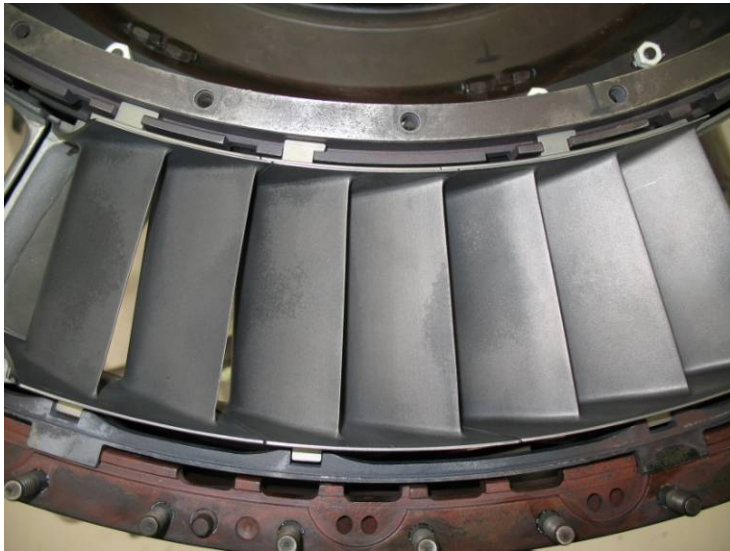
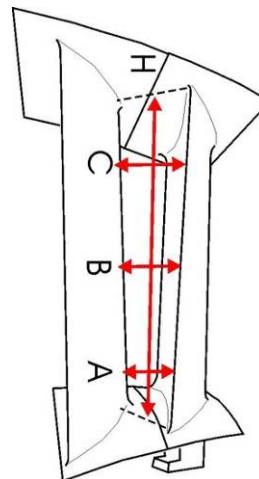
Geometry Repair - Vanes

- LPM superalloy sheets of required thickness are applied to the airfoils
- Parts are heat treated in vacuum furnace to bond and diffuse the LPM into the airfoil castings
- The airfoils are final machined to original throat dimensions
- **Final dimensional checks and re-qualify set**

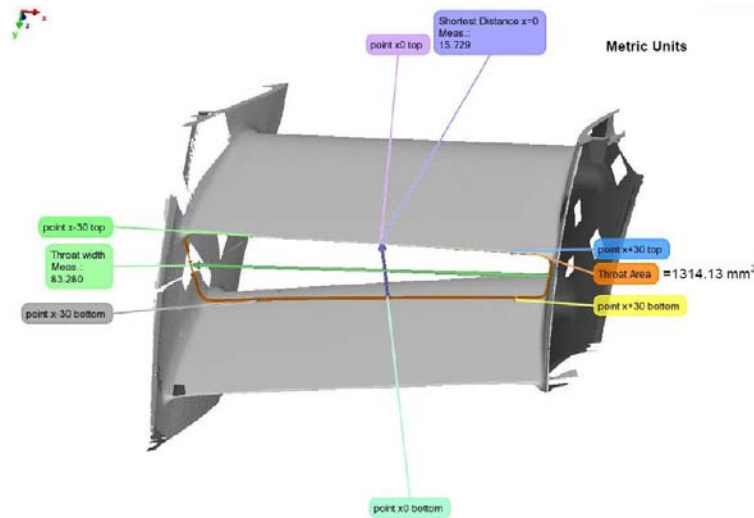
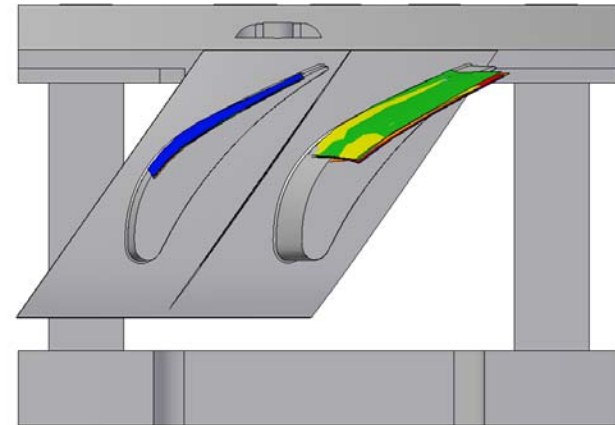
Geometry Repair - Vanes

- White Light Inspection
- CMM Inspection

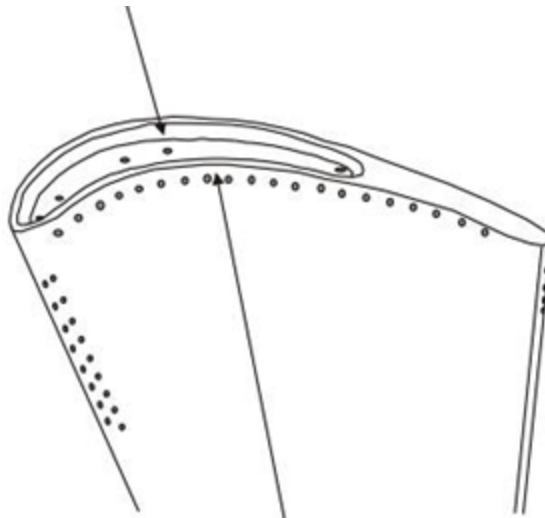
- Tip Cap Machining
- EDM Hole Drilling

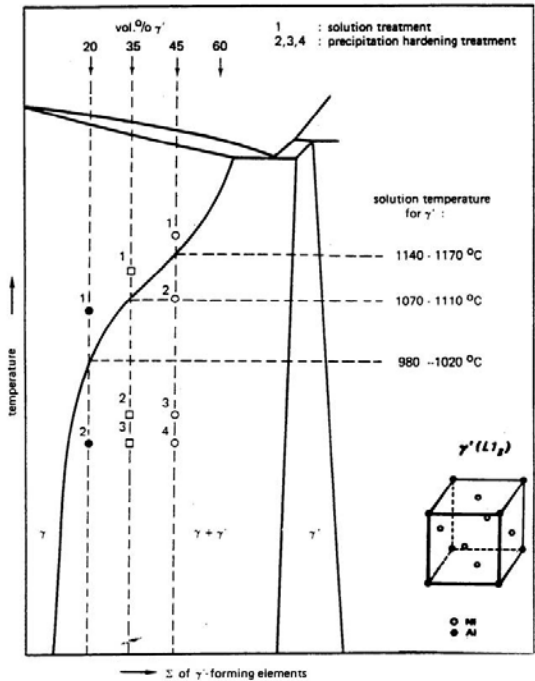
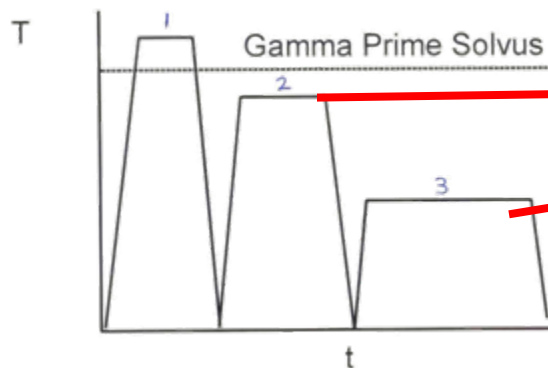
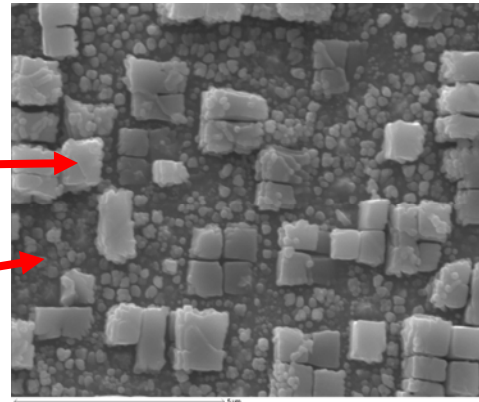
Effect of Heat Treatment

Solutioning

γ' formation

Aging cycles

Multiple aging cycles can be used to form a duplex microstructure

Time and temperature parameters are unique to individual alloys

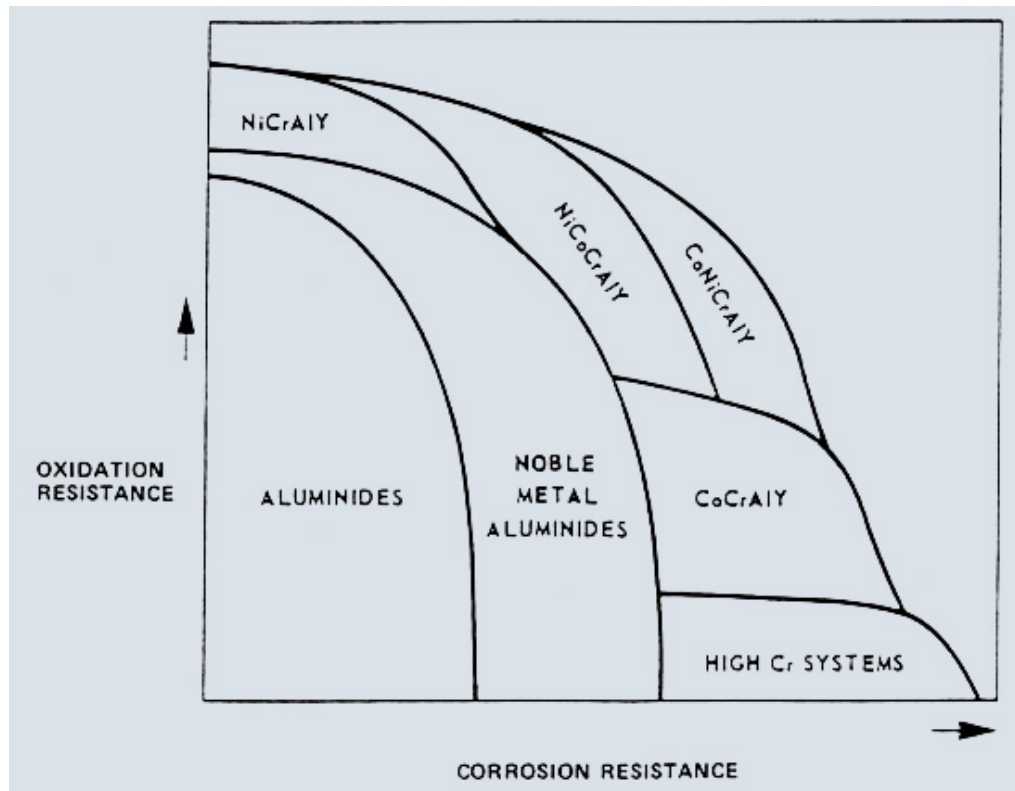
- Selection of Coating System

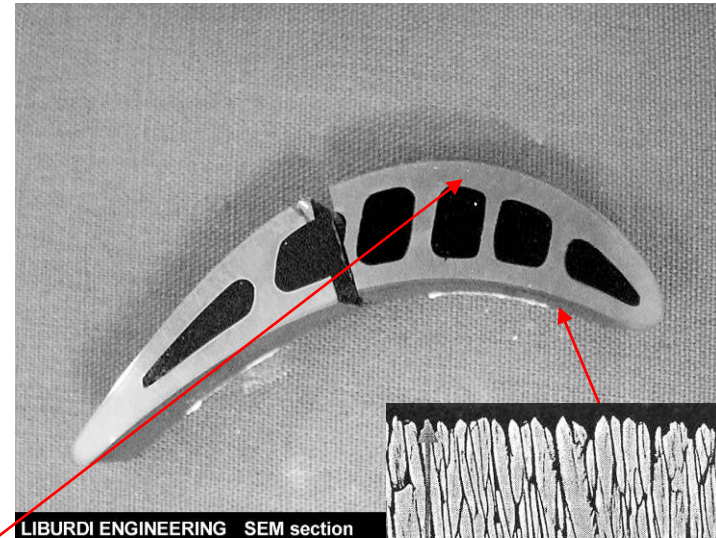
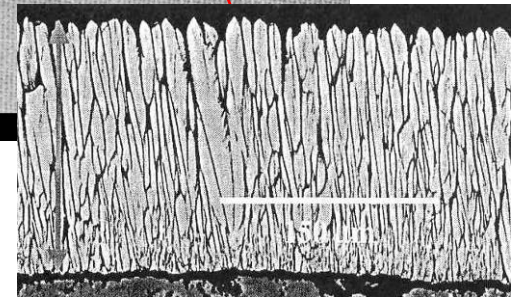
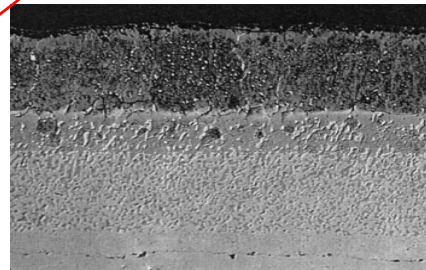
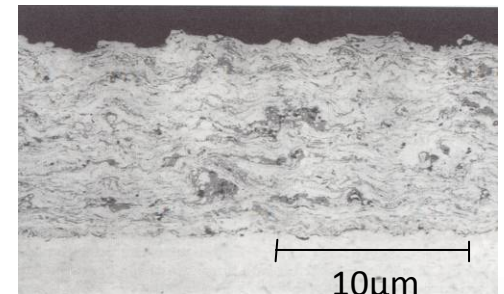
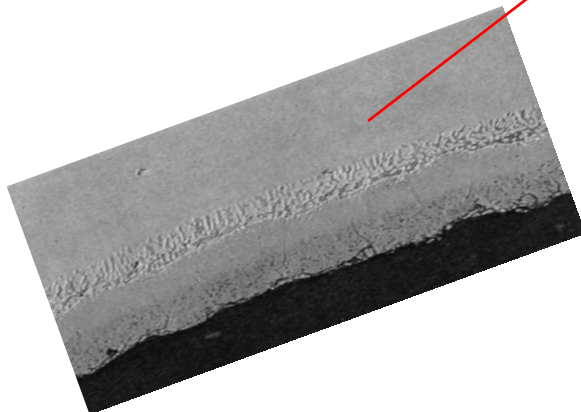
Coating

External airfoil surfaces – MCrAlY with over aluminize or MCrAlY bond coat with DVC or EB-PVD TBC.

Recoating internal airfoil surfaces – diffusion aluminide or silicon aluminide
