HOT-DIP GALVANIZED COATING APPEARANCE

Introduction

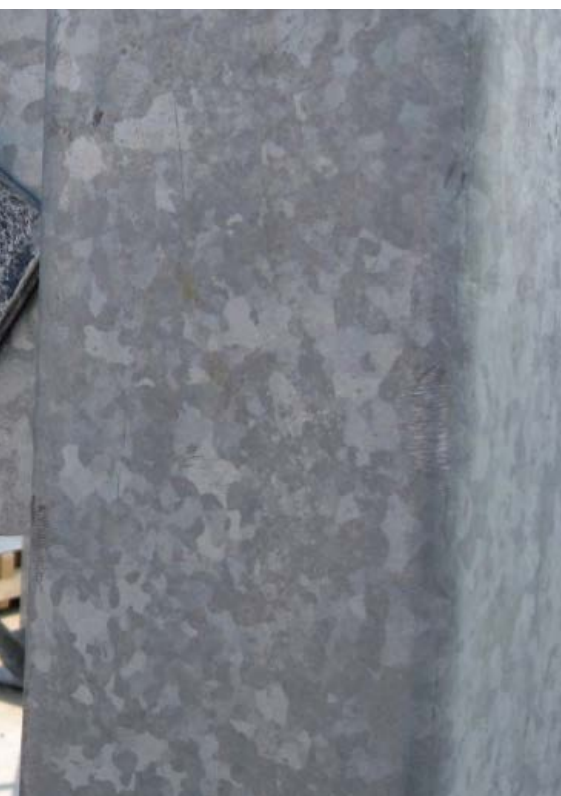
Spangle

When many architects, designers, and other specifiers think of hot-dip galvanized coating appearance, they picture galvanized sheet metal coatings, common in ductwork, that have a spangled, metallic look. It is possible for hot-dip galvanized structural steel coatings to also have a spangled appearance, but it is not nearly as common as in sheet metal coatings. The occurrence of spangle on hot-dip galvanized coatings is the result of minor bath additions enhancing the appearance of zinc crystals on the coating surface. This coating phenomenon is not within full control of the galvanizer, but for steel grades within the recommended ranges for steel chemistry listed within Section 3.2 of ASTM A385/A385M, a spangled appearance can ultimately be controlled by adjusting cooling time, immersion time, and the concentration of optional alloying elements (typically tin, lead, and aluminum) by the galvanizer to the zinc bath. Generally, larger and more defined spangles are produced on smooth surfaces from minimized immersion times, the slowest possible cooling times, and higher amounts of the minor alloying elements in the galvanizing bath. To minimize the potential for a spangled appearance, request immediate quenching of articles after withdrawal from the galvanizing bath to ensure the zinc coating quickly cools to a temperature below which alloy crystals can form. Additionally, a spangled appearance cannot be achieved when choosing to hot-dip galvanize a reactive steel grade unless coating overgrowth is controlled.

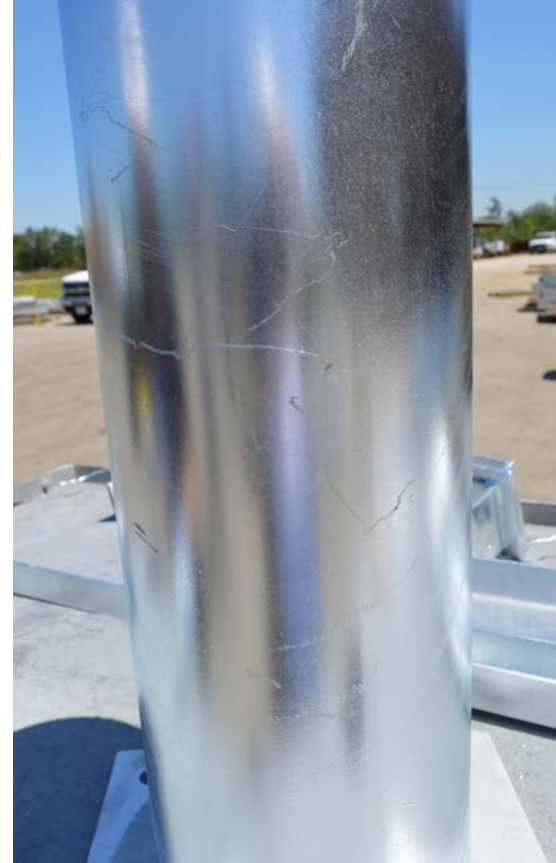
Shiny Coating

A shiny coating appearance is achieved when a free zinc layer (eta layer) is formed atop the hot-dip galvanized coating. A shiny coating appearance is not within full control of the galvanizer. Although the addition of alloying elements such as aluminum and nickel to the zinc bath and performing quenching after galvanizing can influence the development of a shiny coating, steel chemistry has the greatest influence on the development of a free zinc layer and shiny surface appearance. To increase the likelihood of achieving an initial shiny coating appearance, select a steel grade which falls within the recommended limits and ranges for steel chemistry listed within Section 3.2 of ASTM A385/A385M, increase the withdrawal rate from the galvanizing kettle, and quench the newly galvanized articles immediately. For projects where a shiny coating is not preferred or a low reflectivity level is required, some galvanizers have the ability to perform a chemical post-treatment process for dulling of the surface immediately after galvanizing. Otherwise, the article can be left to weather naturally and become dulled over time, typically between six months to two years.

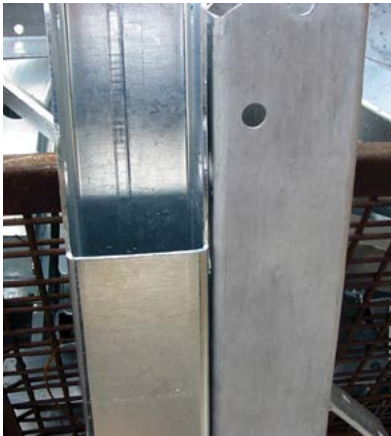
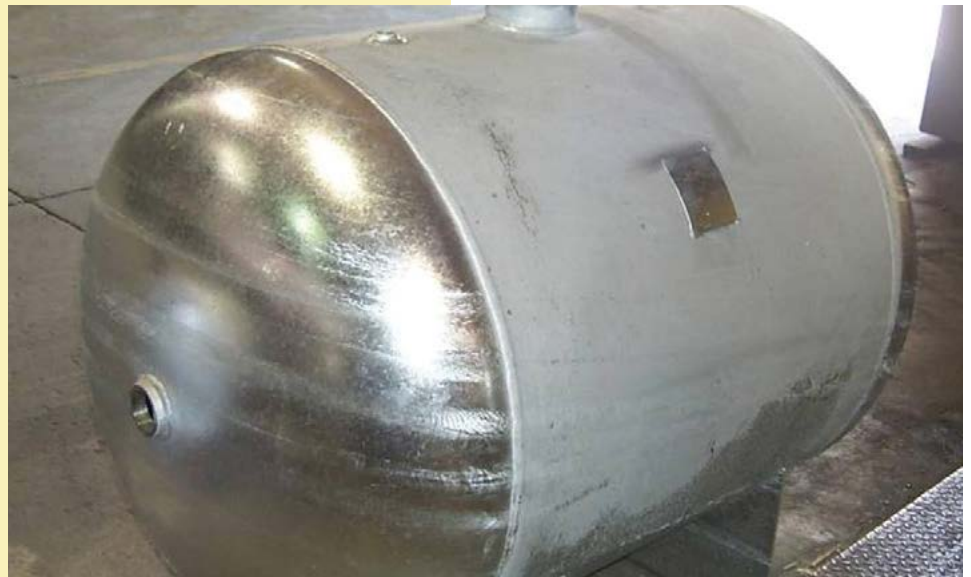
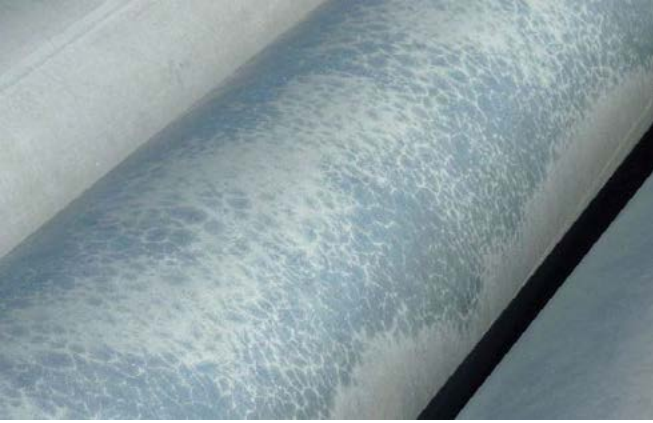
Matte Coating

A matte coating appearance occurs when the coating structure is comprised strictly of overgrown intermetallic layers and contains no free zinc layer (eta layer). The development of a matte coating is likely when hot-dip galvanizing “reactive” steels. Reactive steels contain elemental compositions beyond the recommended limits and ranges for galvanizing listed within Section 3.2 of ASTM A385/A385M and are often more rough in texture. Because steel chemistry has the greatest influence on the hot-dip galvanized coating structure, acquiring an initial matte surface appearance is not within the control of the galvanizer. To increase the likelihood of an initial matte appearance, select a reactive steel grade (Si content $>0.22\%$) and skip quenching after galvanizing. It is important to note that all galvanized articles will eventually take on a matte appearance after natural weathering in environmental exposure.

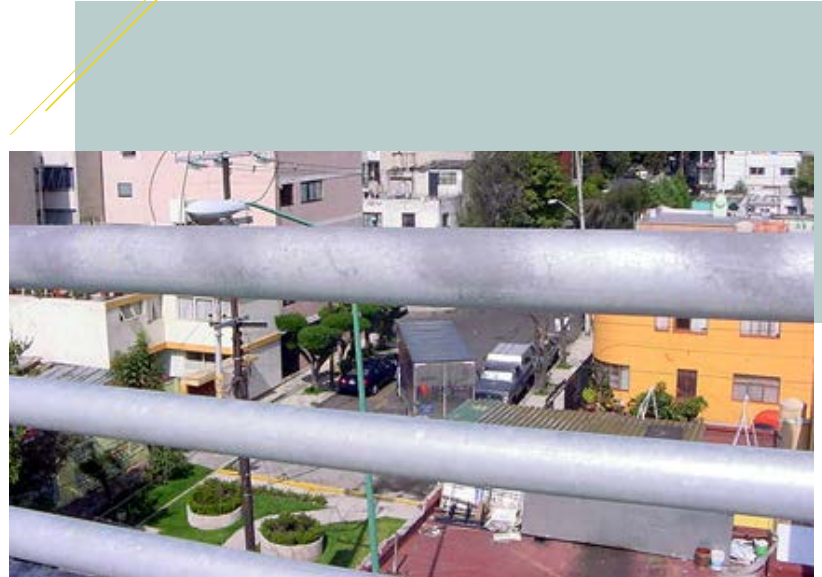
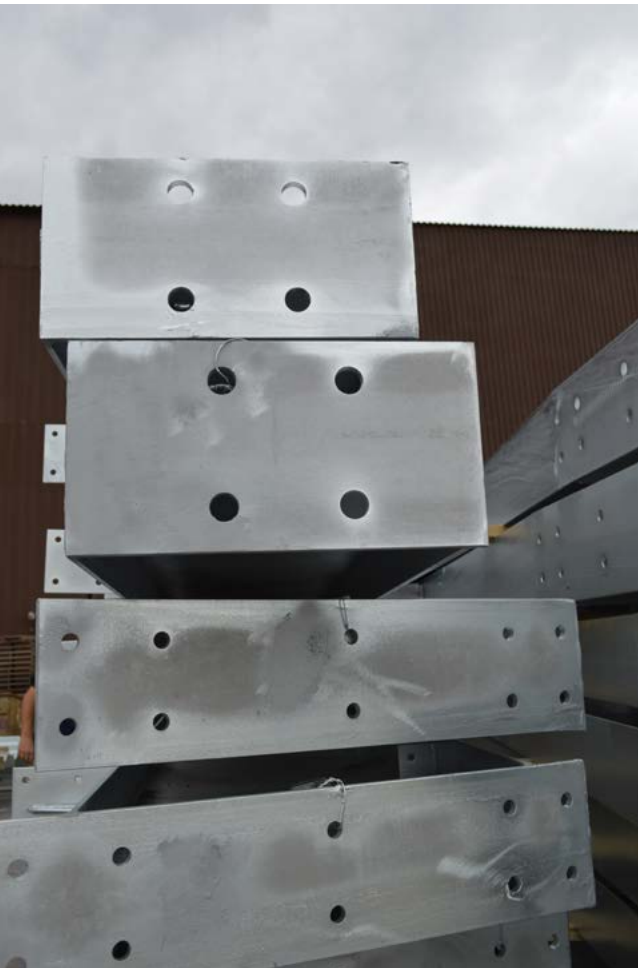
Mottled Appearance

A mottled surface appearance is caused by uneven cooling rates of newly hot-dip galvanized articles after withdrawal from the zinc bath. During air cooling of the articles, the zinc/steel coating formation reaction can continue for a short time as long as the steel stays about 550 F. This continued reaction can consume some of the existing shiny zinc coating layer on top, leaving a matte gray appearance in thicker or internal areas of the article which are slow to cool, and a shiny appearance elsewhere. A mottled appearance can be greatly minimized by performing quench-cooling immediately upon removal from the galvanizing kettle. However, not all galvanizers have the ability to quench and sometimes quenching should be avoided for parts to be painted and powder coated, or those susceptible to warpage and distortion.

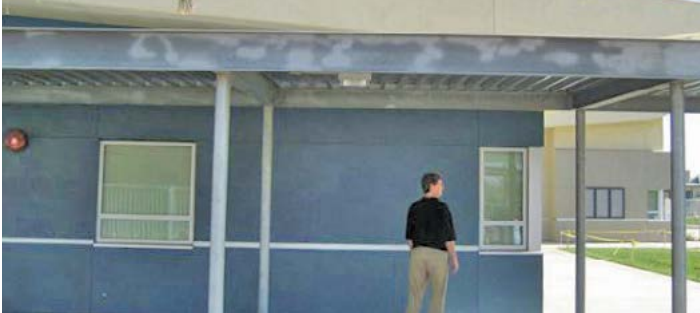
Before: October 2006

A great example of this transformation is the canopied walkway at Mark Twain Elementary in Riverside, CA. The galvanized canopies were installed in October of 2006, and the initial coating appearance varied (see before photos) from bright and shiny to matte gray on the same beam. In June of 2009, the structure was revisited to examine the appearance and performance. The beams are now all uniformly matte gray with little to no visible difference in appearance. Additionally, as hot-dip galvanizing provides 75 years or more of maintenance-free corrosion protection, the beams show no signs of rust staining or corrosion damage.

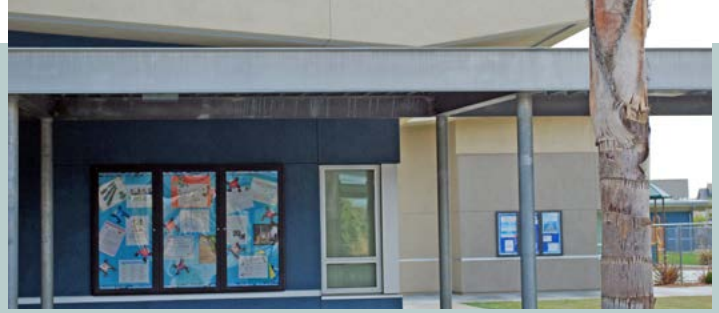
After: June 2009

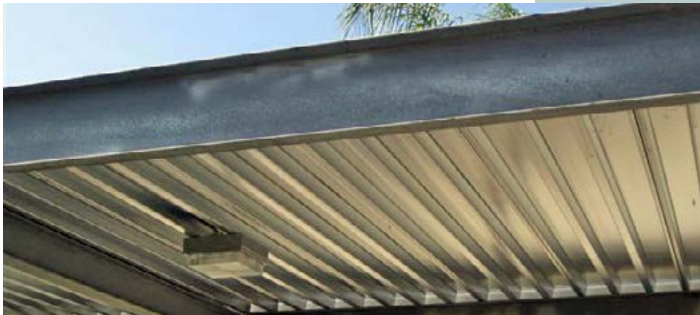
Before: October 2006

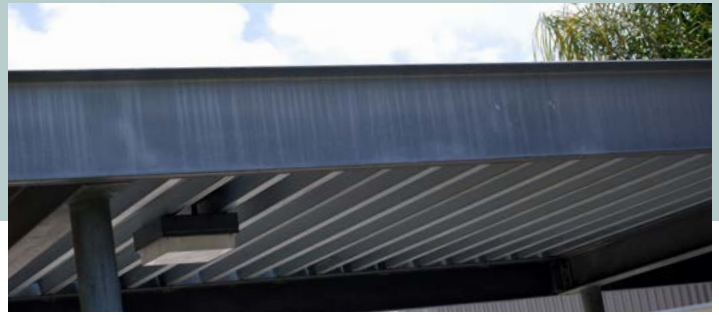
After: June 2009

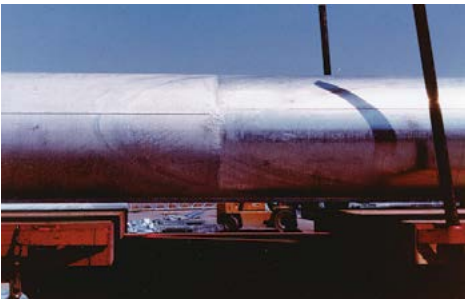
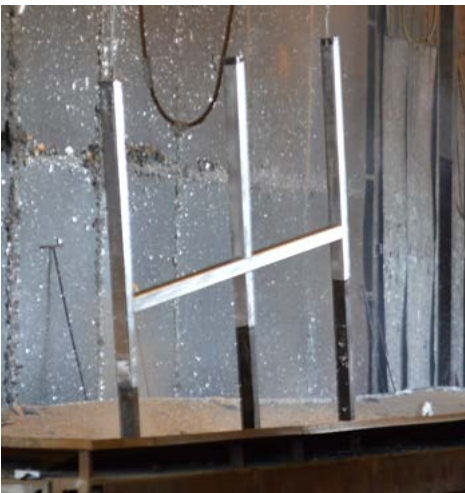
Coating Overlap Line (Progressive Dip)

Progressively dipped pieces often have an overlap area that is visible on the piece. Progressive dipping is accomplished by dipping each end of the article sequentially to coat an entire item which is too large to fit directly into the galvanizing kettle. After bringing the first end through the galvanizing process, the coating is cleaned up and ground down near the center. Afterward, the second end is chemically cleaned and galvanized, where overlapping ensures full coating coverage of the article. The overlap area will most likely appear darker and develop a thicker coating. The color of the overlap area is not within the control of the galvanizer. However, the excess coating thickness can be buffed or ground down even with the surrounding coating for aesthetic purposes or if the area will be an important connection point with other pieces. To avoid the presence of an overlap line, consider a modular design comprised of articles which are able to fully fit within the galvanizing process tanks.

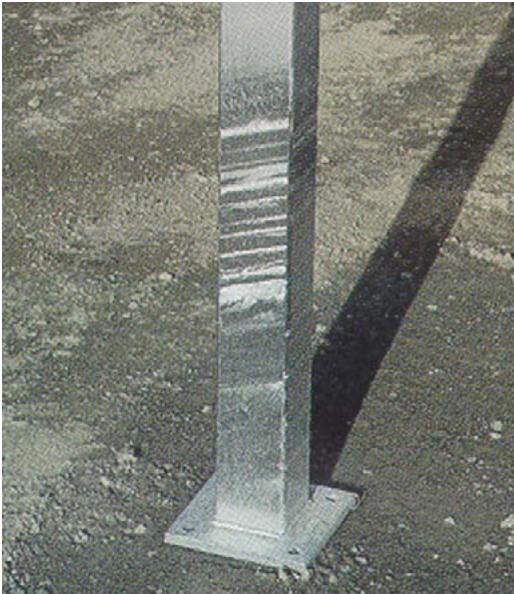
Oxide Lines

Oxide lines are light colored film lines on the galvanized steel surface created when a product is not withdrawn from the galvanizing kettle at a constant rate. Large articles, articles difficult to handle using the galvanizer's lifting equipment, and articles with poor drainage design may require the galvanizer to vary the withdrawal rate of the article and therefore increase the potential for oxide lines. In order to minimize the occurrence of oxide lines, ensure venting and drainage hole sizes for the article are optimized where possible, provide suitable lift points for galvanizing, and discuss lifting operations with the galvanizer prior to fabrication.

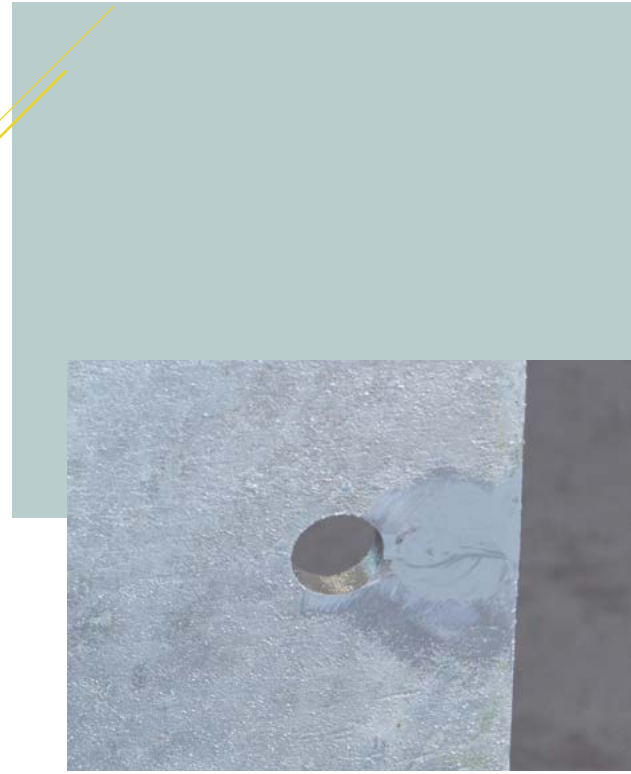
Touch-Up Areas

The use of touch-up materials can alter the appearance of the galvanizing finish as they are not usually an exact color match. Because the galvanized steel surface will weather and become a matte gray color over time (6 months to 2 years in the environment), touch-up performed using metalizing or a weathered-color zinc-rich paint will provide a more consistent final appearance to the product. Touch-up performed using bright/shiny zinc-rich paint will not weather in color similar to the surrounding coating. Differences in appearance from the use of touch-up materials is acceptable and not grounds for rejection. If required for aesthetic purposes, top-coating of the touched-up area with aluminum paint can be used to color-match newly galvanized steel. Areas of hot-dip galvanized steel previously touched-up either after the initial coating or erection should be inspected periodically and tested with a magnetic thickness gauge during the life of the structure.

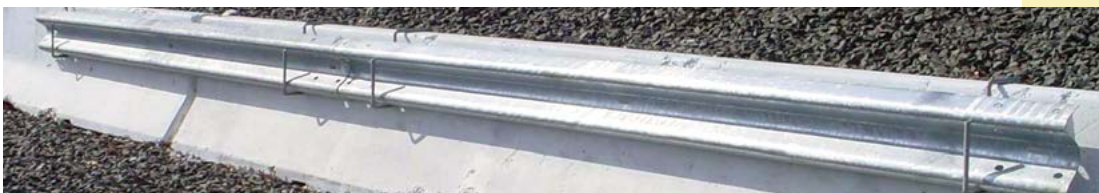
After natural weathering: Consistent appearances

An example of wet storage stain weathering transformation is seen in the guardrail images below. The top image shows two pieces of guardrail, one shiny and one matte. These two pieces were galvanized in the same batch on the same day. The bottom image shows the same two guardrail sections after a little more than three months exposure. Both pieces have naturally weathered to develop the same stable zinc patina which provides hot-dip galvanized steel with its incredible resistance to corrosion. Hot-dip galvanized steel not only provides superior corrosion protection, but once in service will also sustain an aesthetically pleasing, uniform matte gray appearance for decades without maintenance.
