**MOUNTAIN VIEW LAKE DAM
NYS ID NO. 182-0276**

DRAFT FEASIBILITY STUDY

March 2, 2018

**GOMEZ AND SULLIVAN
ENGINEERS**

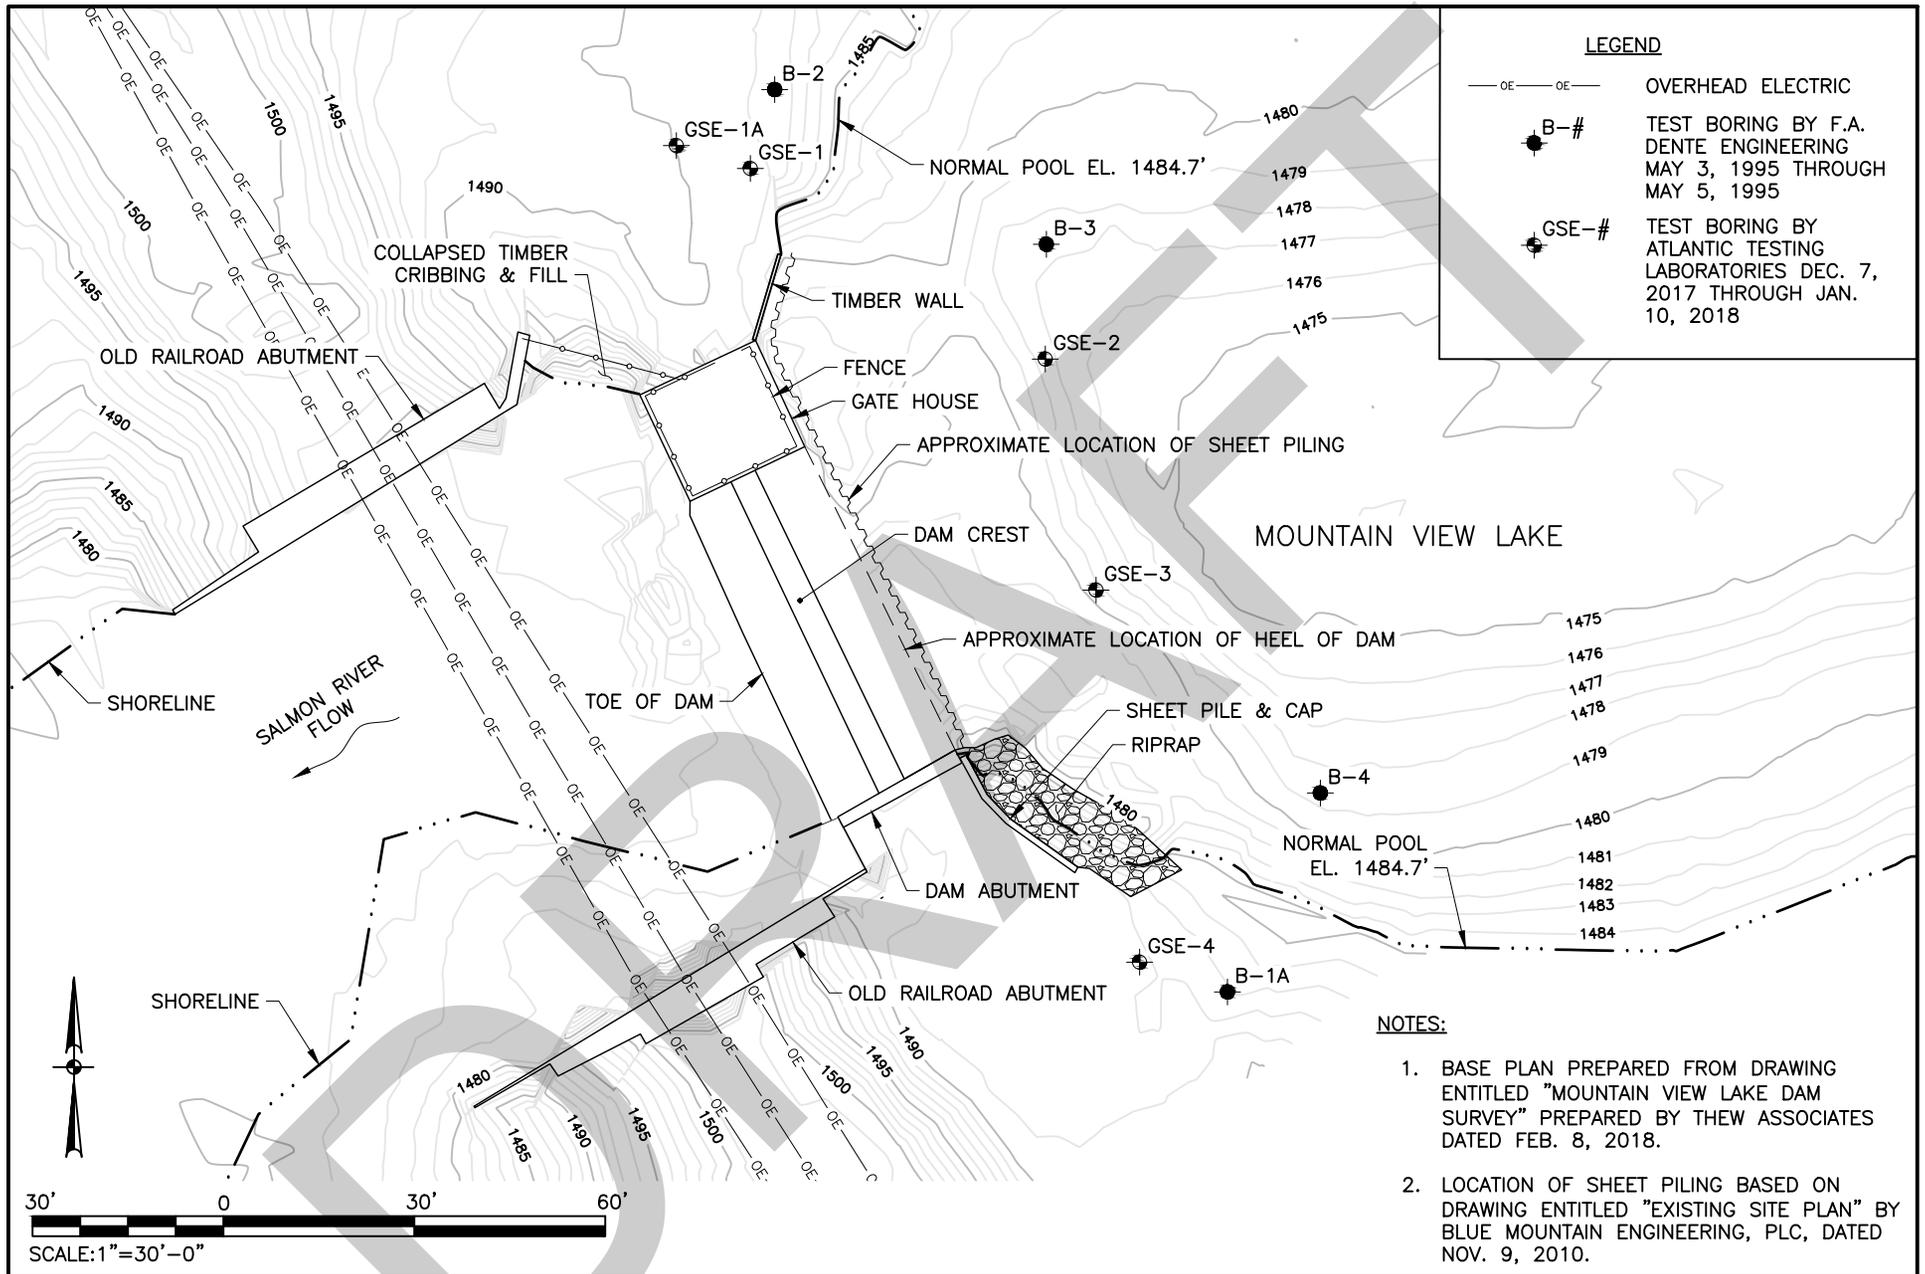
Existing site conditions are shown in **Figure 1**.

The existing dam consists of a timber-crib spillway that is approximately 57 feet wide and a concrete gate structure, that is approximately 18 feet wide. The spillway section is approximately 6.1 feet high, with a crest elevation of approximately El. 1484.7. Discharge through the gate structure is regulated by two 7.5-foot-wide by 6.0-foot-high sluice gates with manual operators. The gate inverts are at El. 1478.0 while the top of the gate structure is at El. 1490.1. The sluice gates are closed and it is unknown if they can be operated under current conditions. Sheet pile is located on the upstream side of the dam, extending from approximately El. 1478.0 to El. 1460.7.

Significant seepage has been reported below the gate structure and timber crib over-flow section. According to reports, the gate structure may be founded on timber foundation. The 1996 construction consisted of placing sheet piles along the upstream side of the dam to help alleviate seepage conditions below the dam and gate structures, however active seepage is still visible below the dam.

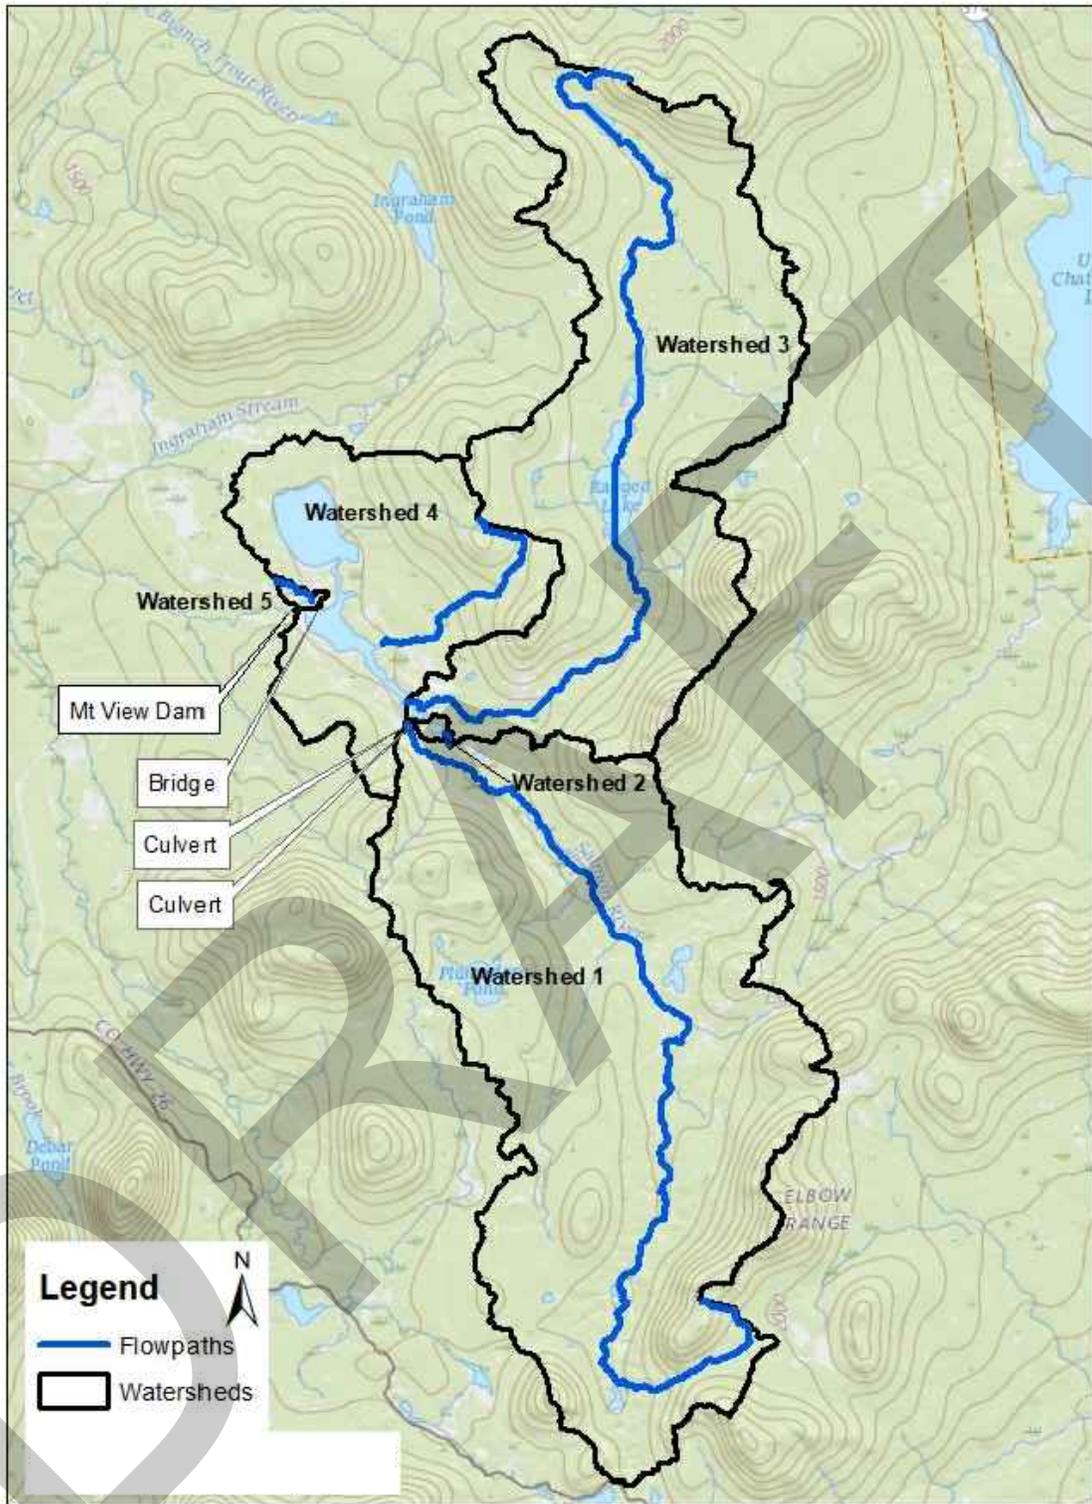
The watershed extents upstream of Mountain View Lake Dam were delineated utilizing a digital elevation model from National Map and GIS based tools and are shown in **Figure 2**. The upstream watersheds were identified based upon key points of interest within the watershed, primarily two culverts upstream of the reservoir, a bridge just upstream of Mountain View Lake Dam, and Mountain View Lake Dam. For each watershed, the time of concentration was computed based on the travel time along the longest flow path using calculations from TR-55 for sheet flow, shallow concentrated flow, and channelized flow, as applicable. Lengths and slopes were measured within each watershed. Roughness parameters and channel dimensions were determined from aerial photographs. Runoff curve numbers were computed for each watershed using soil data from the Natural Resources Conservation Commission (NRCS) and a combination of aerial photography and land use data from the National Land Cover Database (NLCD) to classify the land type. The soil is predominately SCS Group C, which is characteristic of soils with lower infiltration and higher runoff potential (TR-55). The land use is predominately deciduous forest. The total runoff for each subarea was multiplied by an adjustment factor, F, which was determined based upon the percentage of swamp and pond area within each watershed to account for flow attenuation.

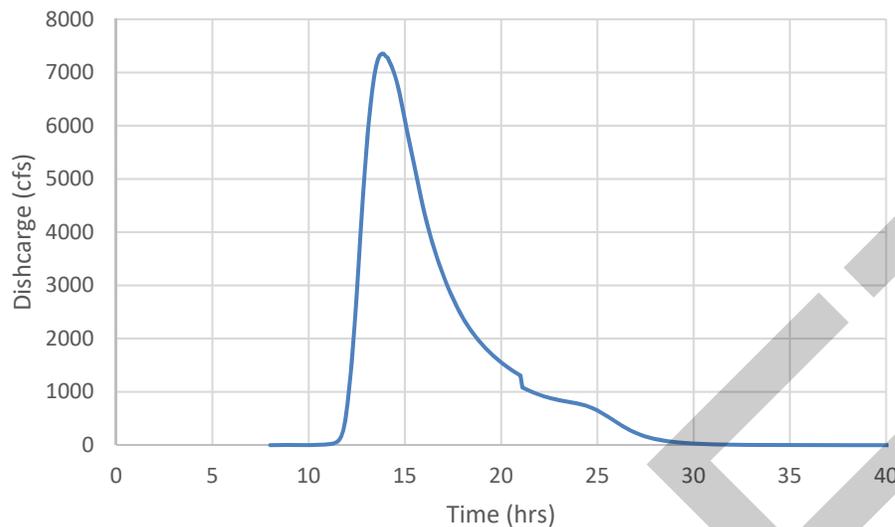
Figure 3 – 100-year hydrograph

Because all five subareas discharge directly into the reservoir, their individual hydrographs were summed to find the total discharge, based upon the assumption that travel time within the reservoir is negligible. due to the time of travel within a reservoir being negligible. The hydrograph was developed for the 2, 5, 10, and 100-year events in this manner. 150% of the 100-year event is typically determined by adjusting the peak 100-year event inflow. In this case, the entire hydrograph was adjusted for 150% of the 100-year event. A summary of the estimated peak inflows with respective return intervals is provided in **Table 5**. The 100-year hydrograph is shown in **Figure 3** below.

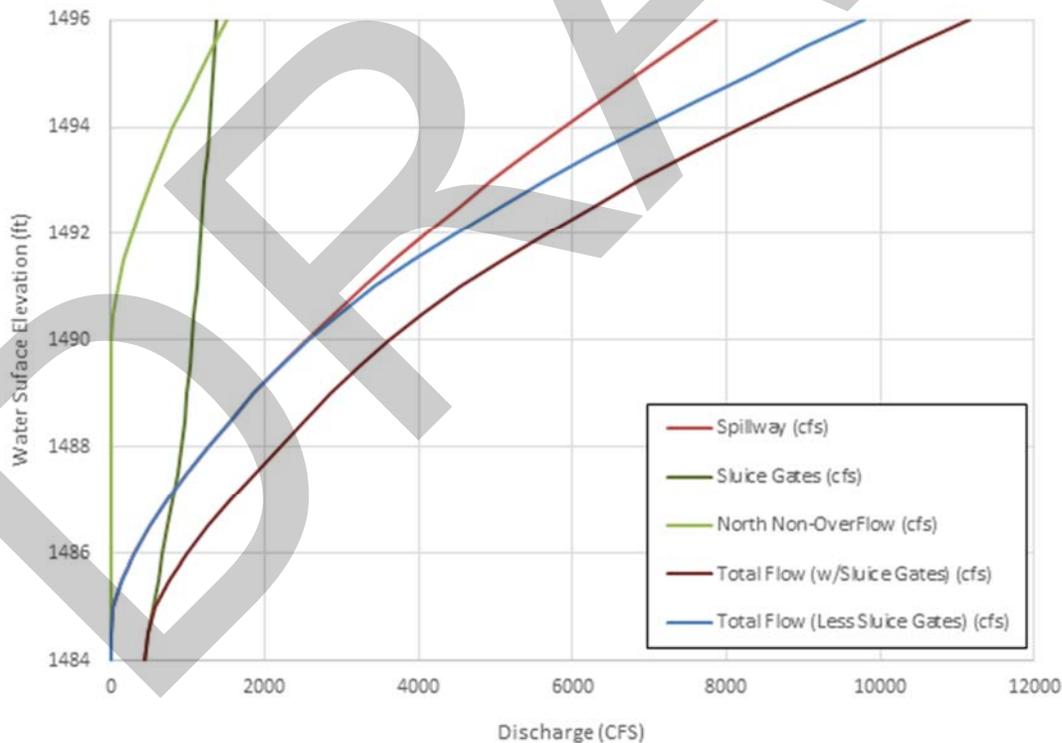
Figure 4 - Stage-Discharge Rating Curve for Mountain View Lake Dam

The top of the 40-foot-long right abutment is at El. 1490.1. The top of the 8-foot-long left abutment is at El. 1489.0. Both non-overflow sections (abutments) were represented as broad crested weirs with a discharge coefficient of 2.65. The stage-discharge rating curve is shown in **Figure 4**.

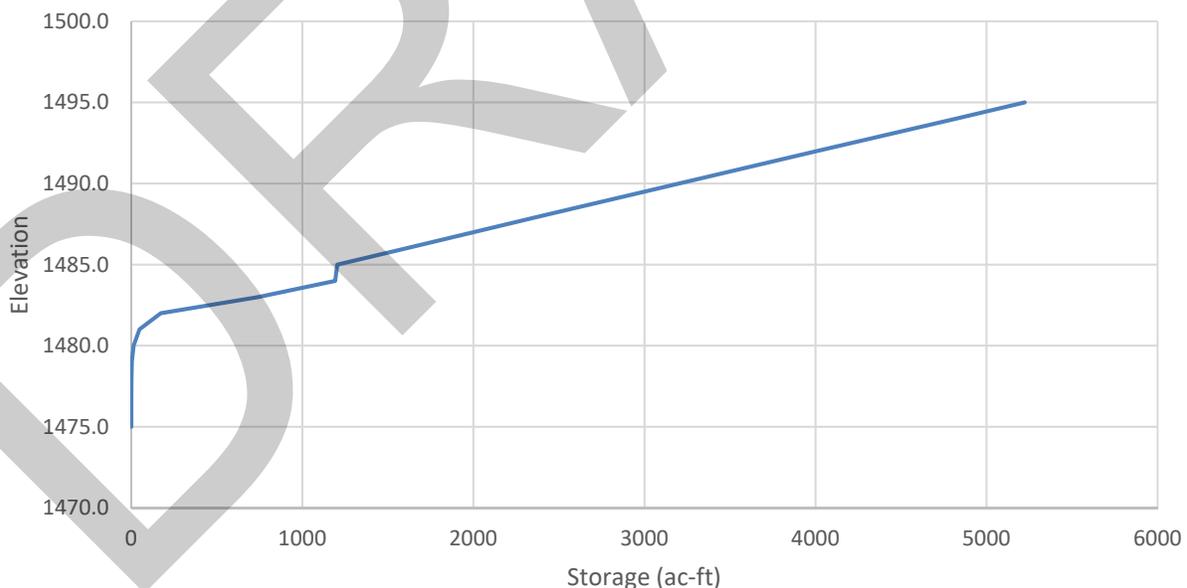
Figure 5 - Stage-storage curve for Mountain View and Indian Lakes

A stage-storage curve relationship was developed to assess the storage capacity of the reservoir, based upon bathymetry data provided by Thew Associates. To calculate the volume of each contour, the average end approach was used.

The stage-storage curve compared the storage capacity in ac-ft to the WSE of the reservoir is shown in **Figure 5**.

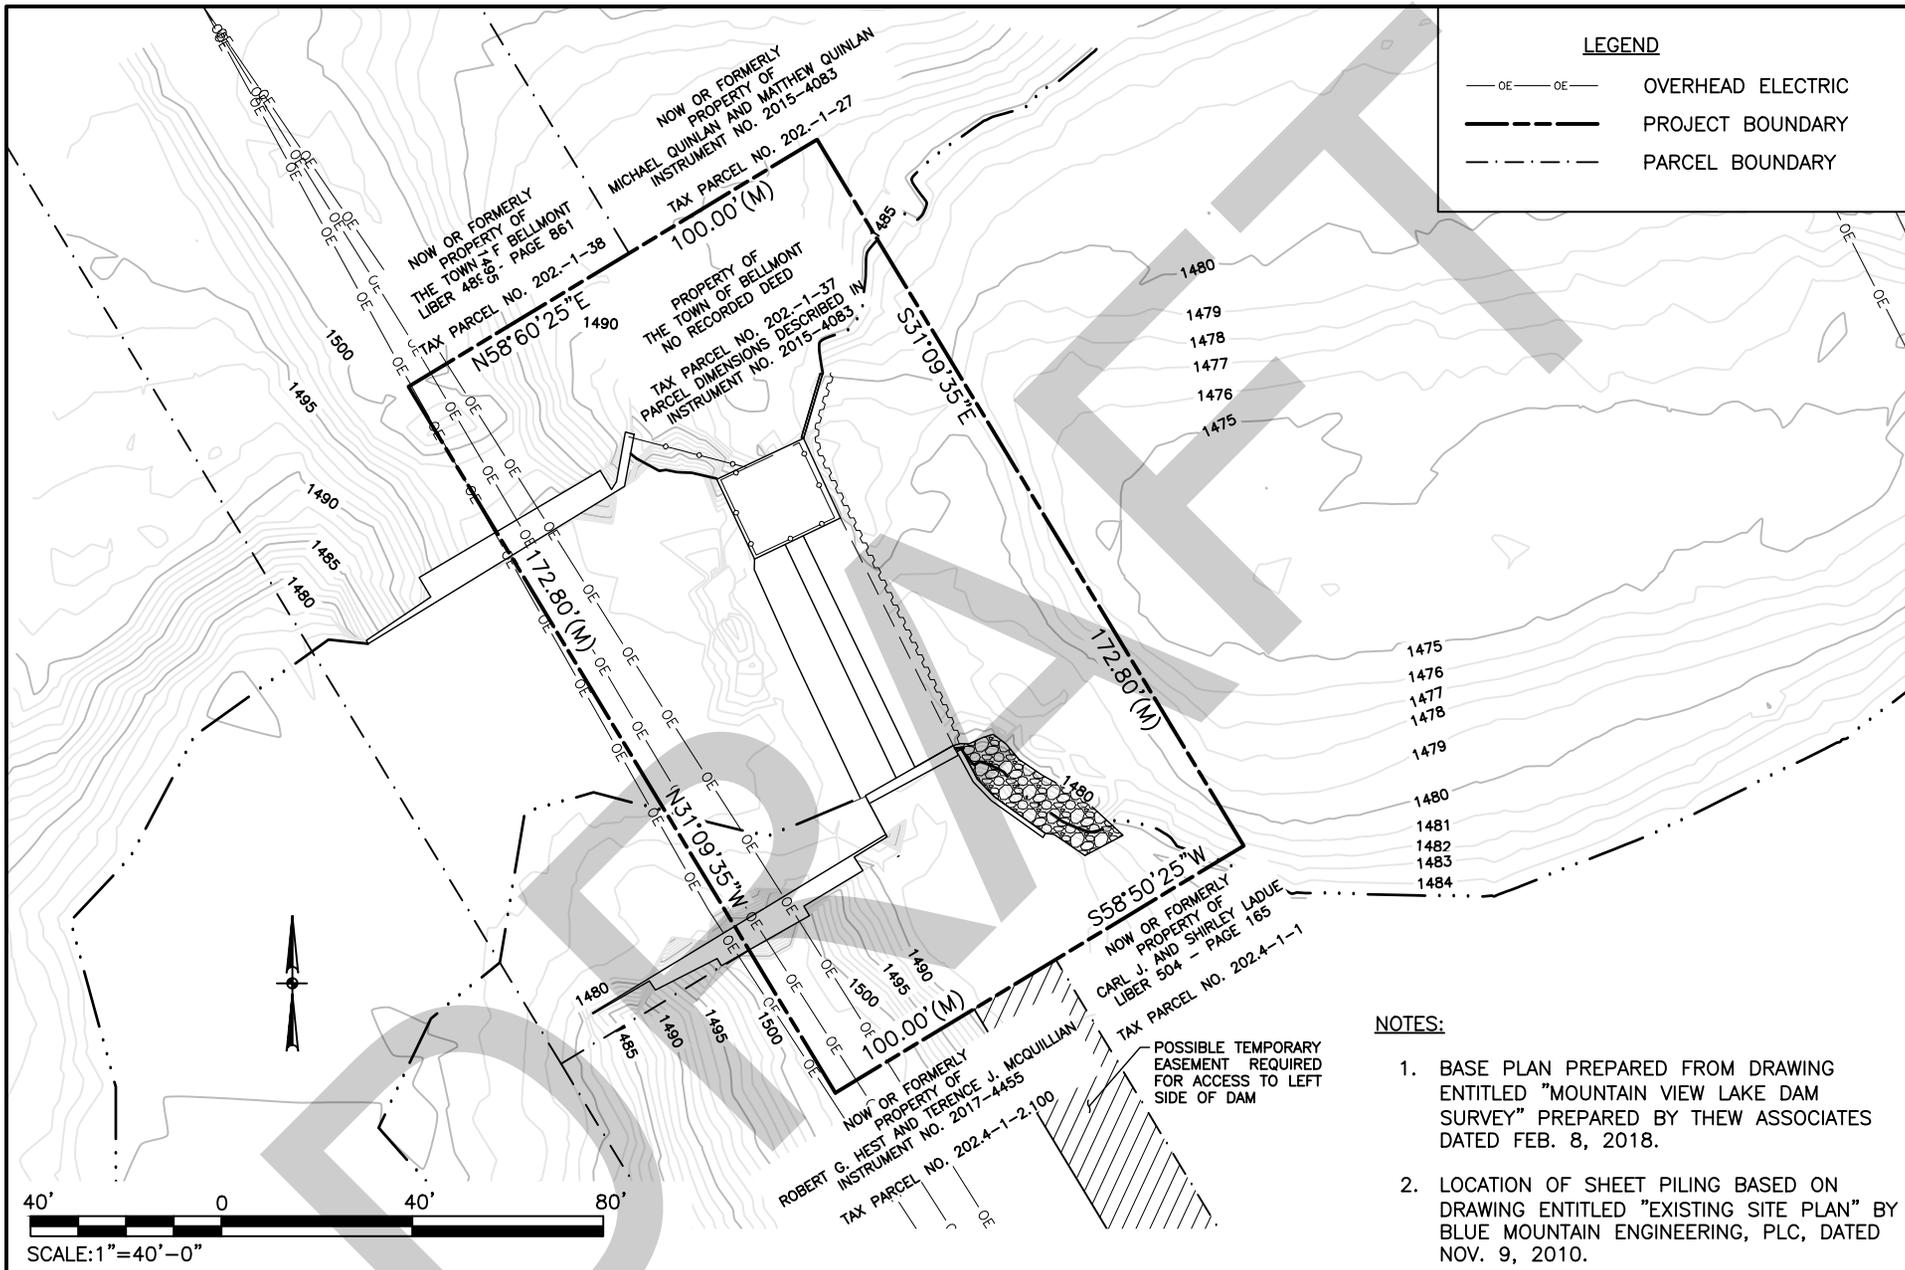
The dam is situated on property owned by the Town of Bellmont. The limits of the project site extend between approximately 40 feet upstream of the existing gate structure, 30 feet downstream of the dam toe, 32 feet north of the right abutment and 50 feet south of the left abutment.

The right dam abutment can be accessed from Beach Road and the National Grid Right of Way. Access to the left side of the dam is limited and restricted by two residential properties. Temporary construction access easements will likely be required with the current property owners at tax parcel 202.4-1-1 and 202.4-1-2. Additional permanent easements may be required from property owners at tax parcel 202.4-1-1 and 202.-1-27 depending upon the selected alternative as described in Section 12.0 Property limits and possible temporary easement requirements are shown on **Figure 6**.

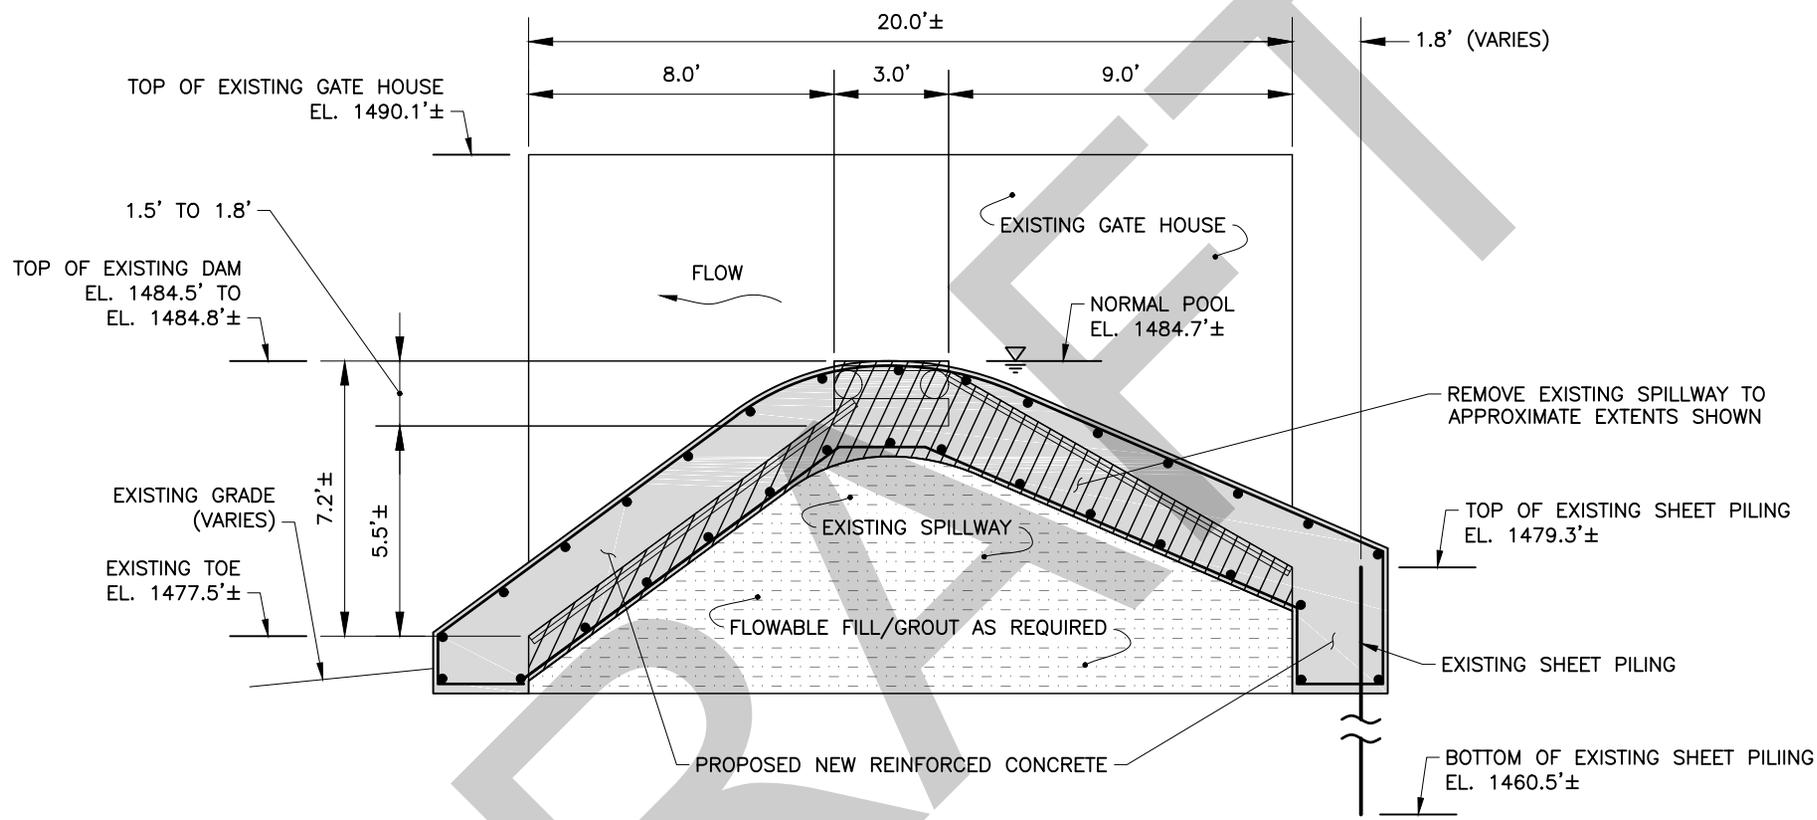
SPILLWAY SECTION
 1" = 5'
 (LOOKING NORTH)

NOTE:
 1. TYPICAL CONCRETE OVERLAY OF 2'-6" MINIMUM

Alternative 1 involves rehabilitating the existing dam structure. This alternative seeks to improve the dam condition while retaining as much of the existing dam structure as possible. Alternative 1 includes encapsulating the existing timber crib overflow section in 2.5 feet-thick reinforced concrete. Portions of the timber crib spillway will be removed prior to placement of the concrete in order to maintain the same spillway crest elevation. The concrete would extend upstream of the dam to the top of the sheet pile to create a positive cutoff wall. A cutoff will be created at the existing gate structure with a concrete apron approximately 2.5 feet-thick, placed on the upstream side of the structure and will tie into the existing sheet pile. Voids below the timber crib and gate structure will be filled with a flowable fill or grout. The existing inoperable sluice gates and controls will be replaced as part of Alternative 1.

visual observations from the shore. The stability of the concrete overlay is dependent upon the condition of the existing timber-crib structure. If a section of the structure is missing or in significant disrepair, that section should be removed and replaced to support the concrete section.

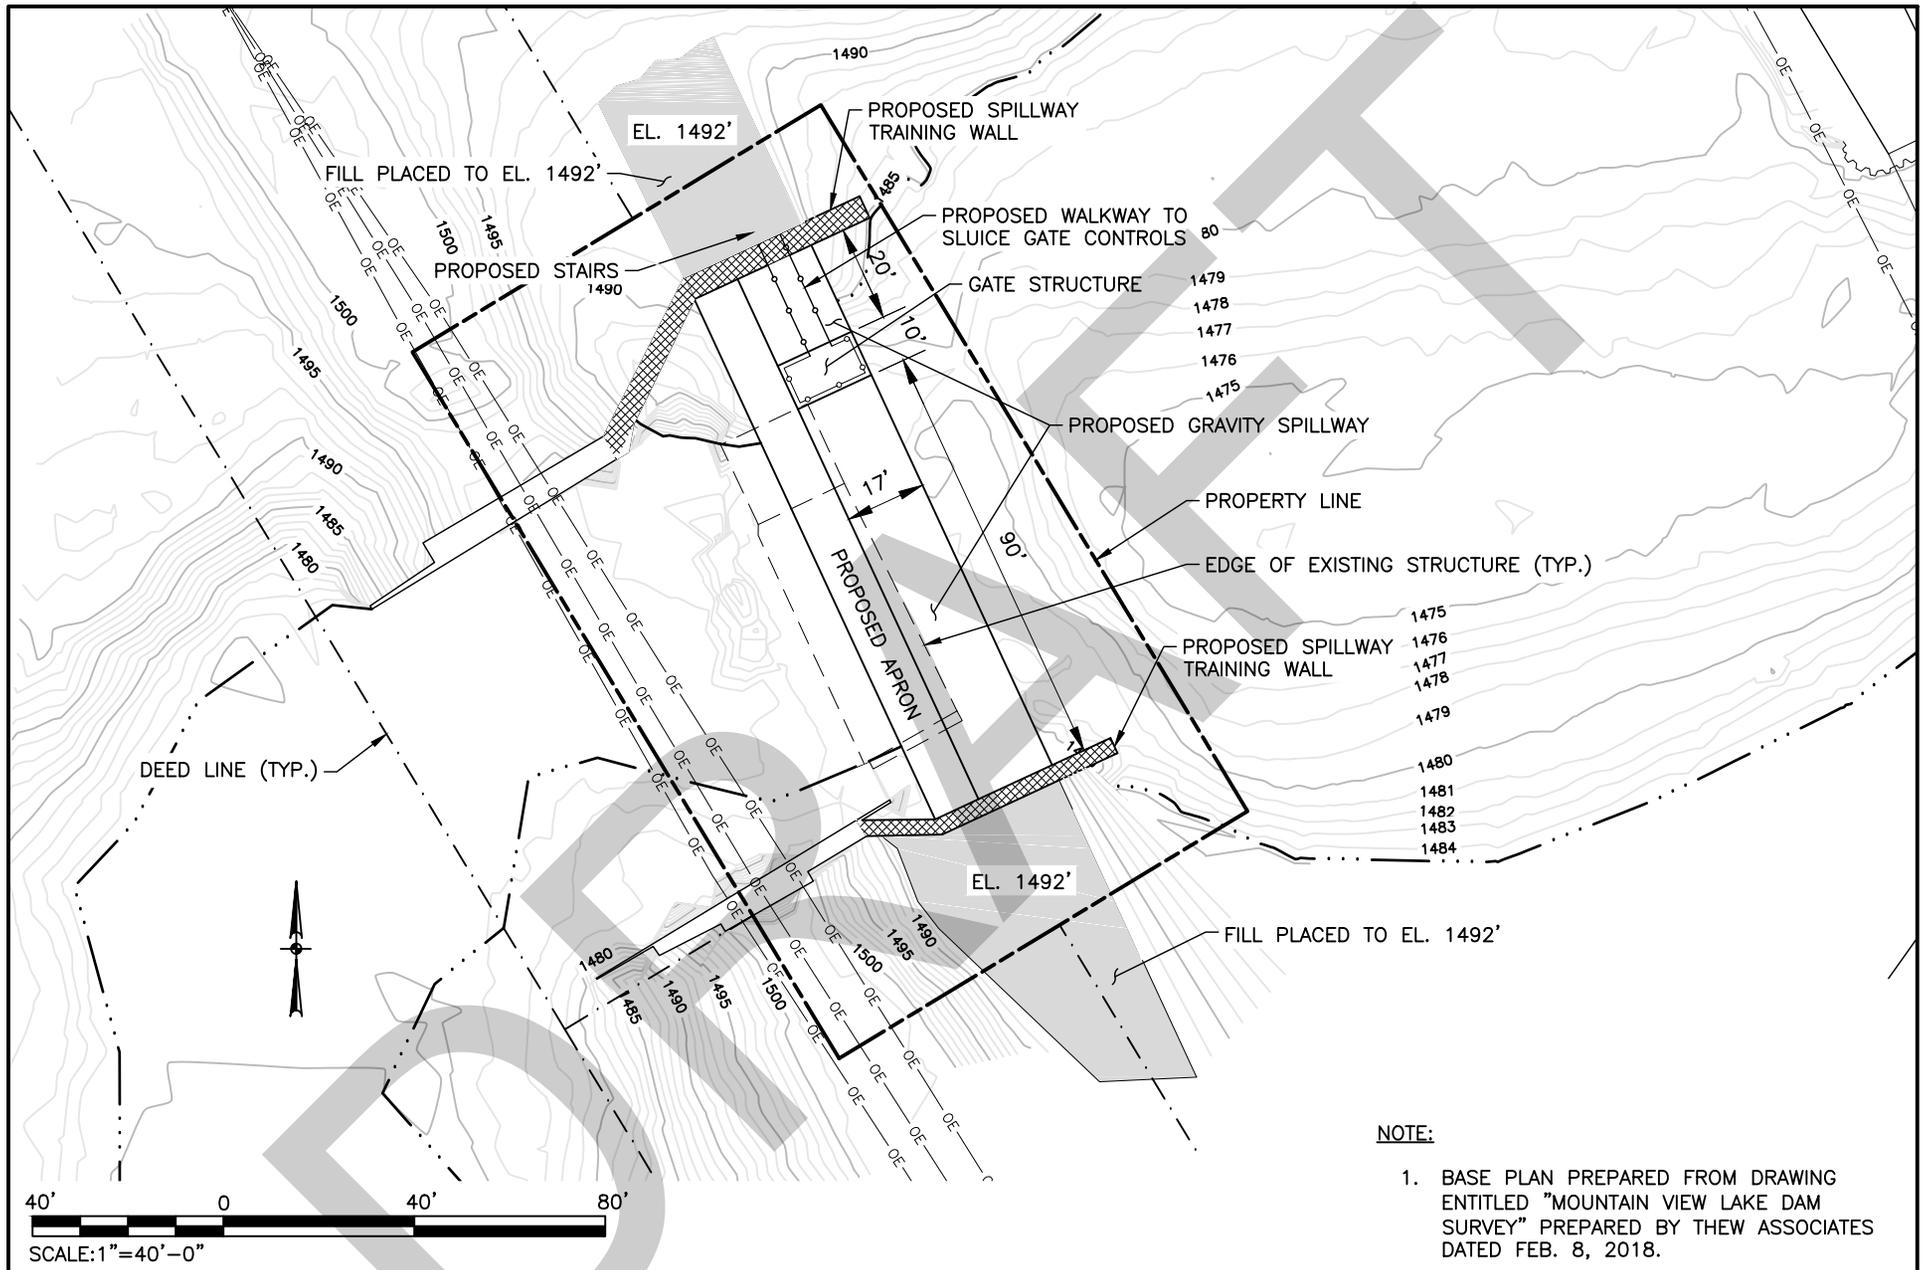
A proposed layout and cross-section of Alternative 2A is shown in **Figures 9 and 10**.

Space at the project site is extremely limited. In order to maintain 2 feet of freeboard during a storm event, as required by NYSDEC regulations, the non-overflow sections and abutments should be at El. 1492.0. In order to reach this elevation at the left abutment a permanent easement is required at Tax Parcel 202.4-1-1.

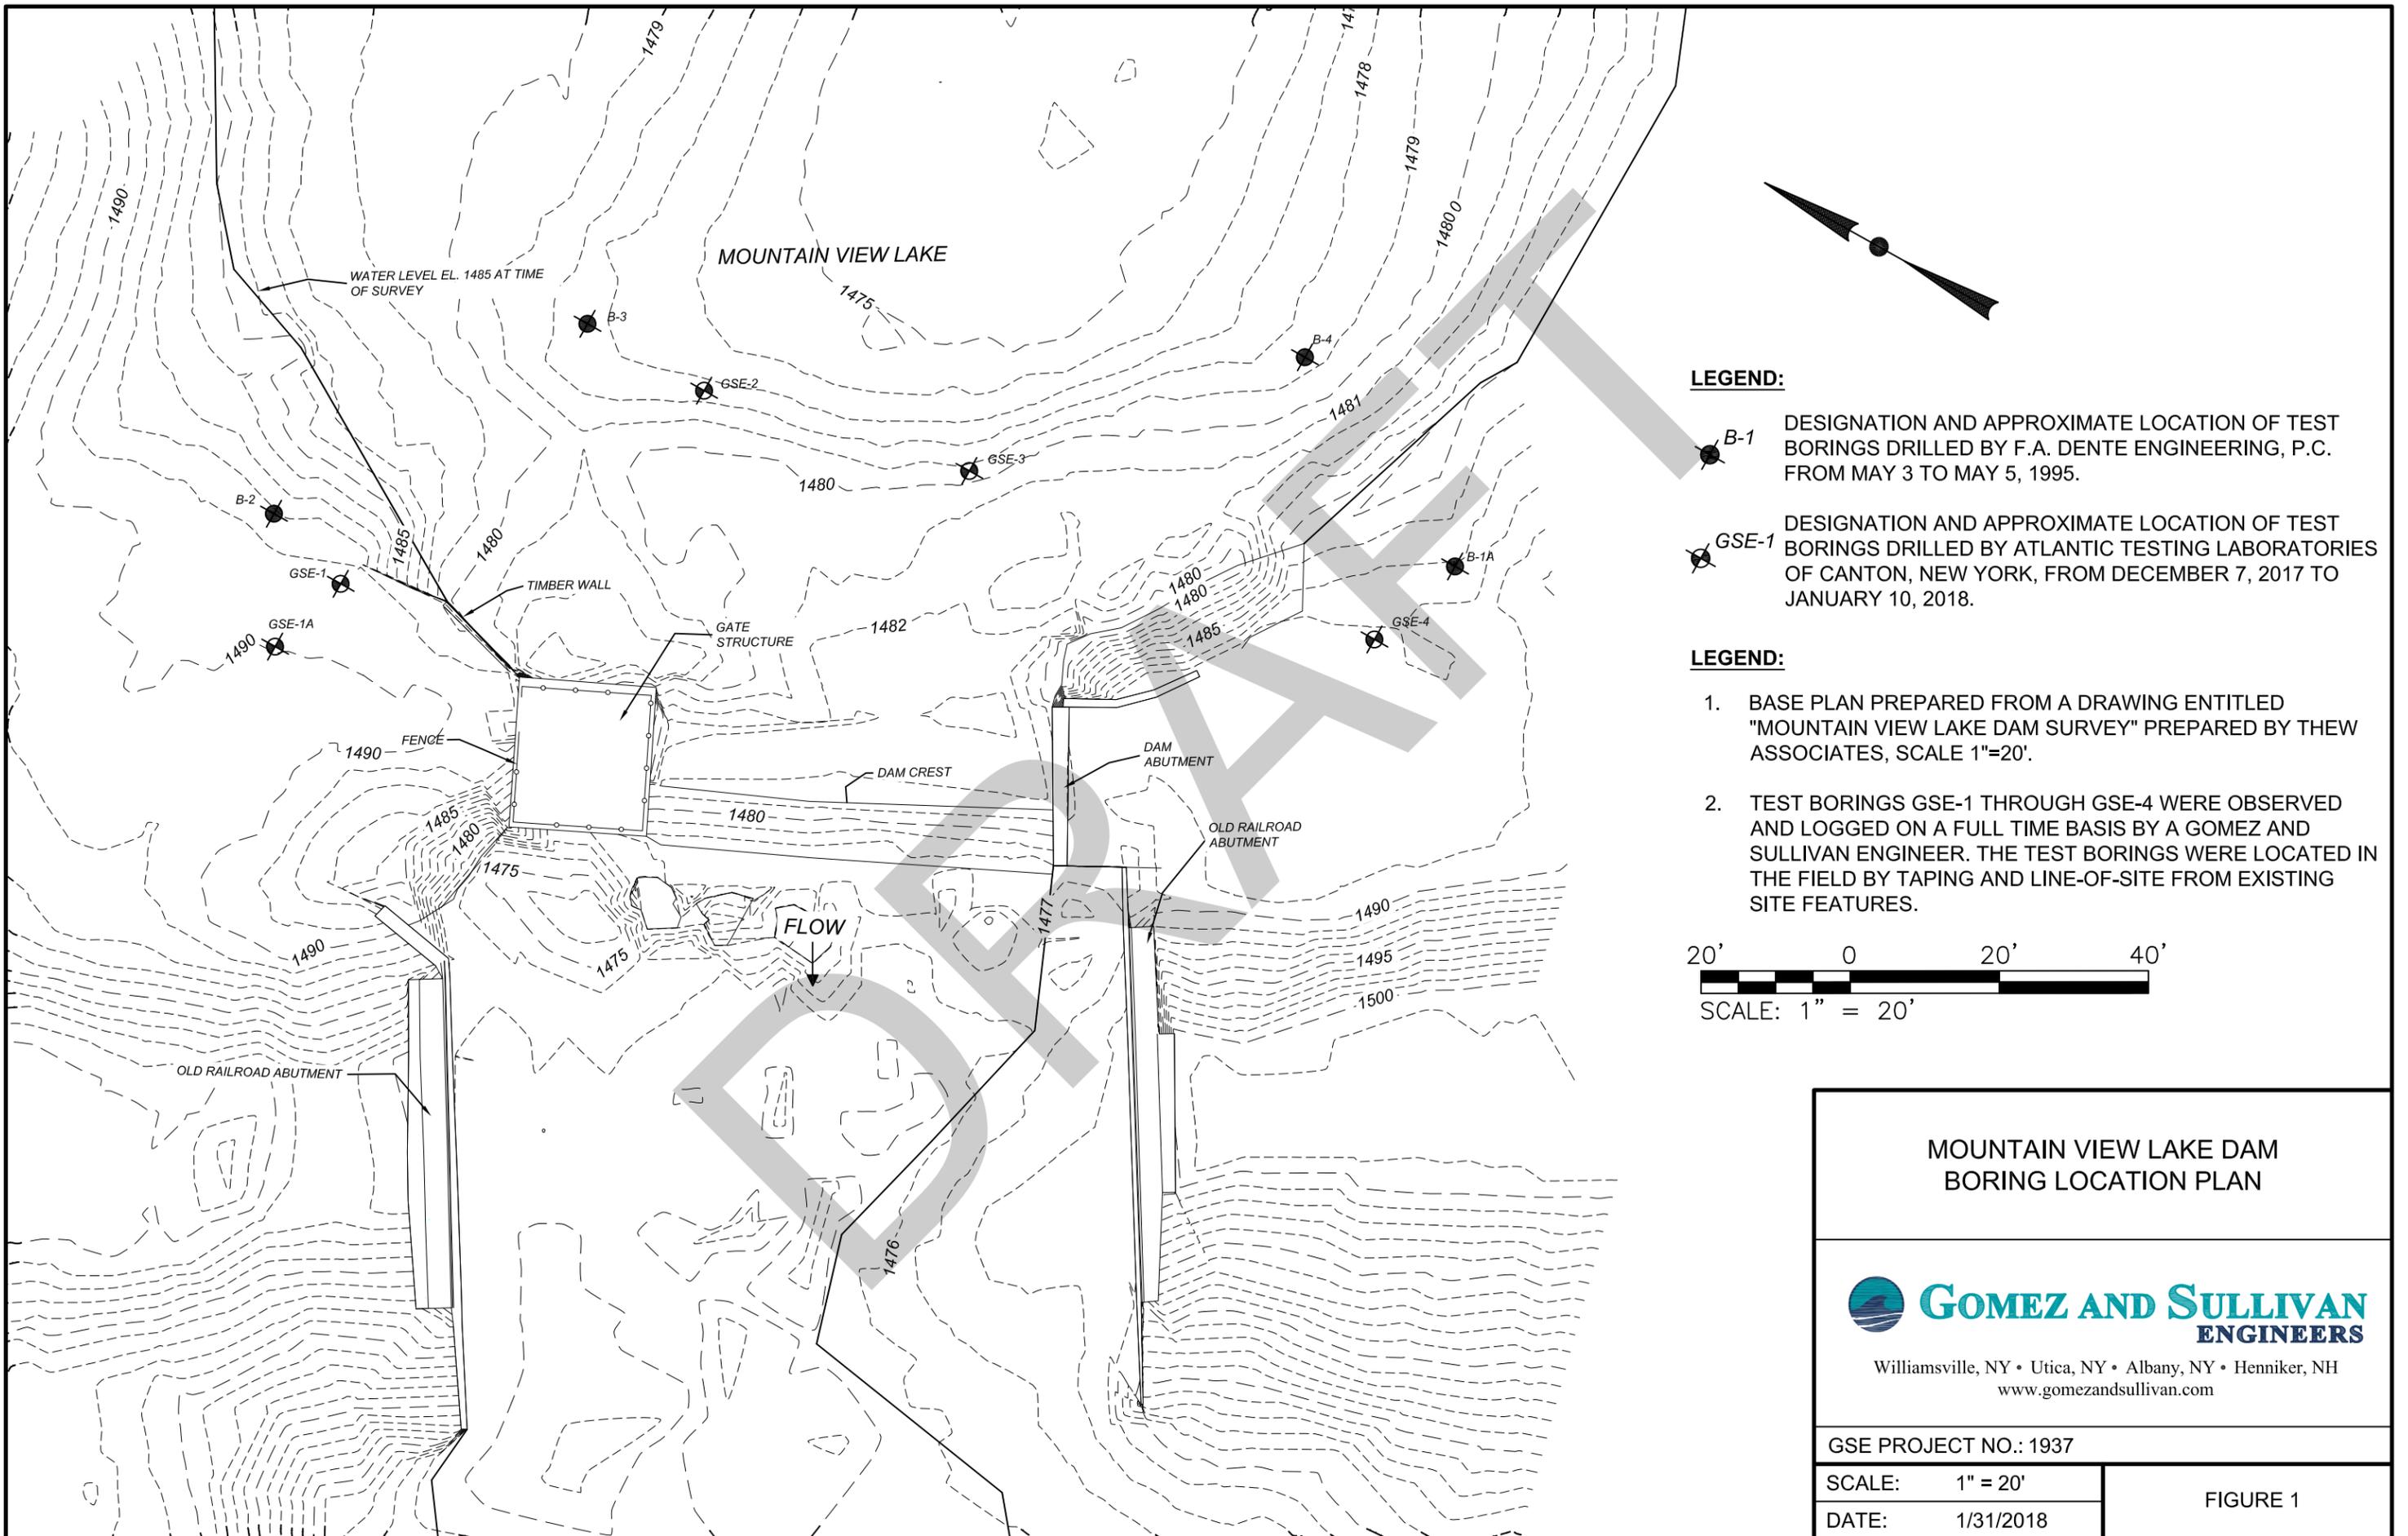
The recent test borings were drilled using drive and wash drilling techniques with 4-inch diameter casing. The recent test borings were drilled to depths between 12 and 50 feet bgs.

Split spoon sampling was conducted in soils continuously from ground surface or mudline (for borings drilled over water) to approximately 50 feet bgs at the recent test borings, excluding test boring GSE-1 which terminated at approximately 12 feet bgs. Sampling was conducted in general accordance with ASTM D-1586. The number of blows required to drive the sampler each 6-inch increment was recorded and the Standard Penetration Test (SPT) resistance (N-Value) was calculated as the sum of the blows over the middle 12 inches of penetration. Split spoon refusal was encountered at all test boring locations. Split spoon refusal was defined as less than 6-inches of penetration resulting from 50 blows from a 140-pound hammer or less than 12-inches of penetration resulting from 100 blows from a 140-pound hammer.

A recent subsurface exploration was performed between December 7, 2017 and January 10, 2018 to investigate the subsurface conditions at the Mountain View Lake Dam. The recent drilling program consisted of 5 test borings GSE-1 through GSE-4 and were drilled by Atlantic Testing Laboratories of Canton, New York. The recent test borings were drilled using drive and wash drilling techniques with 4-inch diameter casing.

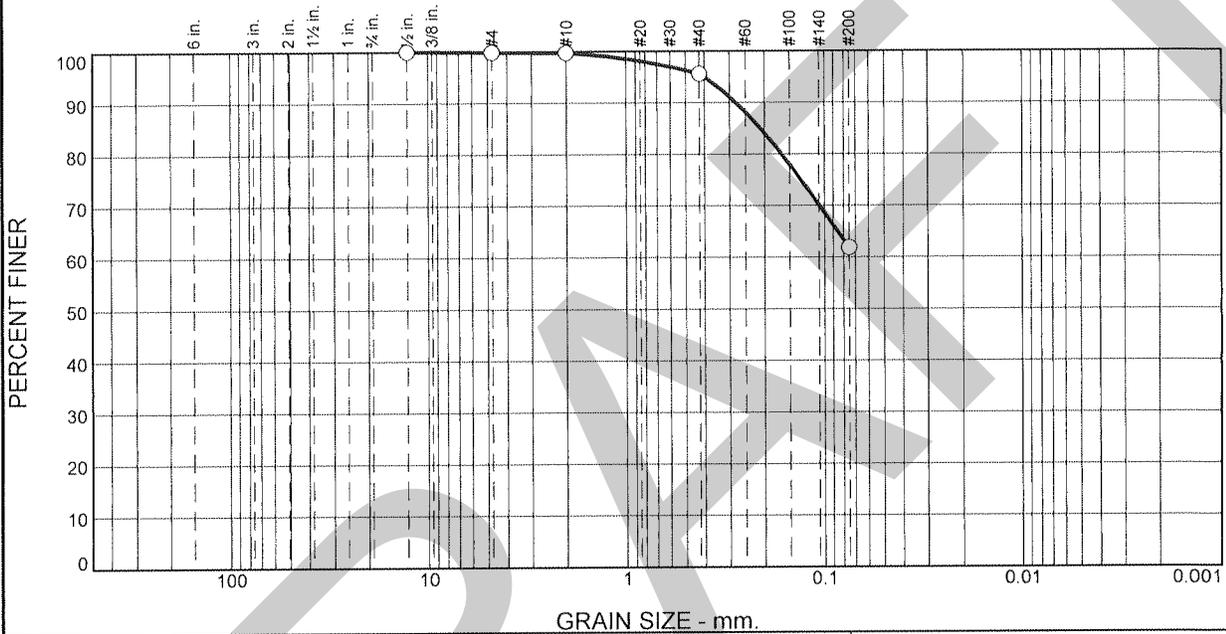
Elev./Depth: 18-20'

% +3"	% Gravel		% Sand			% Fines	
	Coarse	Fine	Coarse	Medium	Fine	Silt	Clay
0	0	0	0	4	34	62

SIEVE SIZE	PERCENT FINER	SPEC.* PERCENT	OUT OF SPEC. (X)
1/2"	100		
#4	100		
#10	100		
#40	96		
#200	62

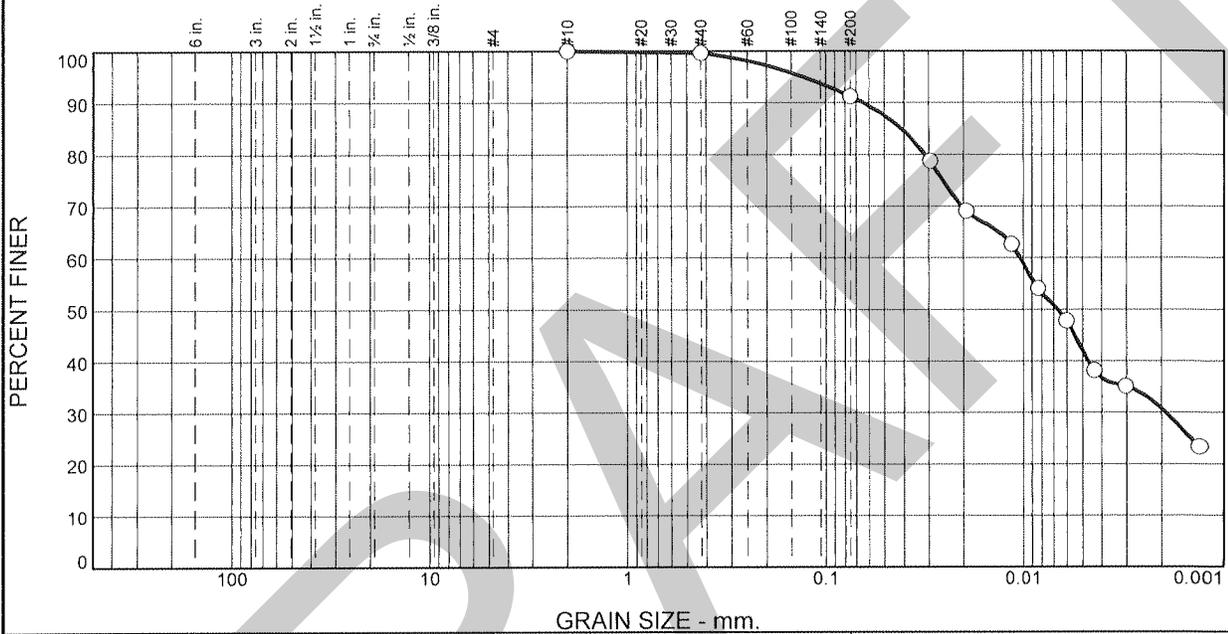
Elev./Depth: 28-30'

% +3"	% Gravel		% Sand			% Fines	
	Coarse	Fine	Coarse	Medium	Fine	Silt	Clay
0	0	0	0	0	9	49	42

SIEVE SIZE	PERCENT FINER	SPEC.* PERCENT	OUT OF SPEC. (X)
#10	100		
#40	100		
#200	91

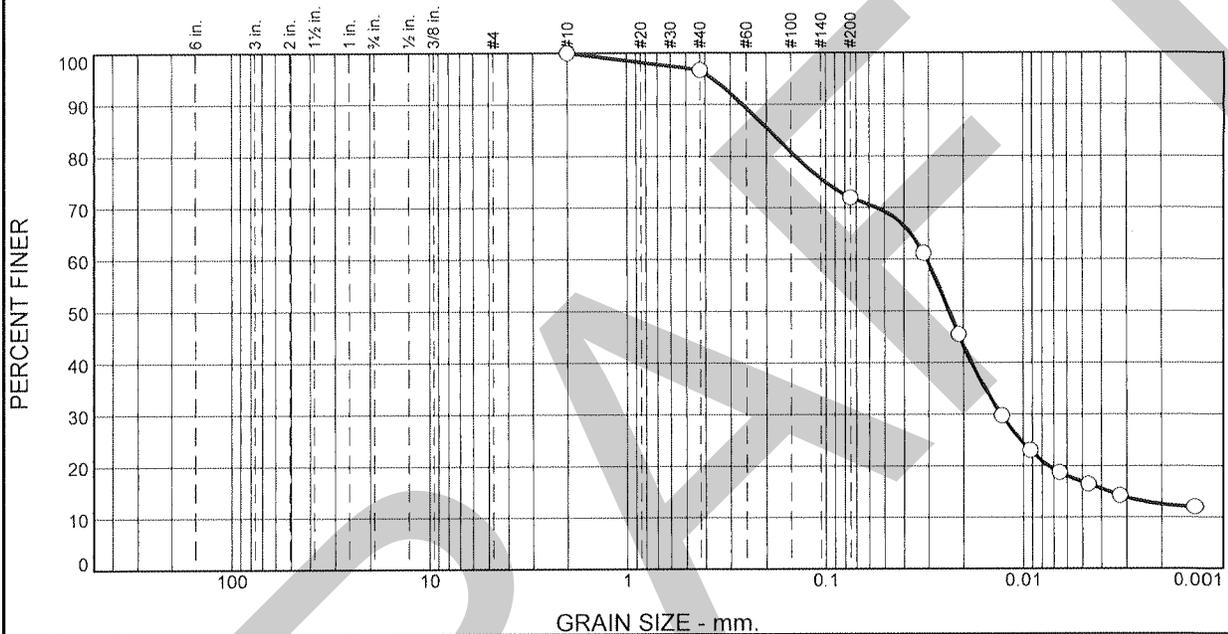
Elev./Depth: 38-40'

% +3"	% Gravel		% Sand			% Fines	
	Coarse	Fine	Coarse	Medium	Fine	Silt	Clay
0	0	0	0	3	25	55	17

SIEVE SIZE	PERCENT FINER	SPEC.* PERCENT	OUT OF SPEC. (X)
#10	100		
#40	97		
#200	72

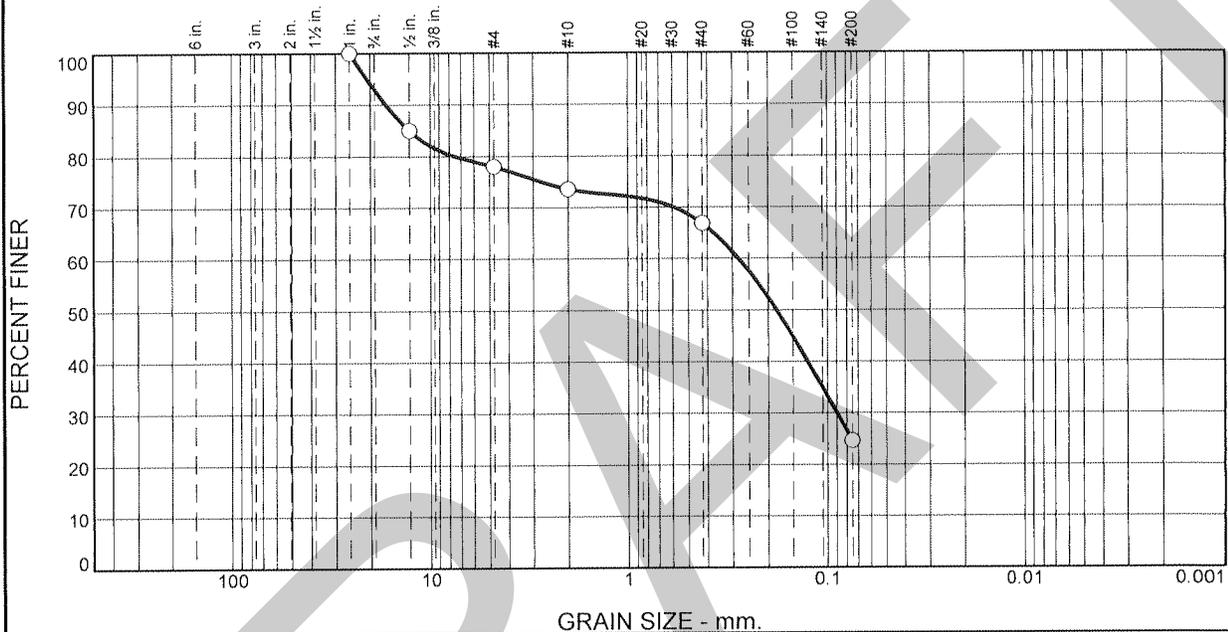
Elev./Depth: 46-48'

% +3"	% Gravel		% Sand			% Fines	
	Coarse	Fine	Coarse	Medium	Fine	Silt	Clay
0	7	15	4	7	42	25

SIEVE SIZE	PERCENT FINER	SPEC.* PERCENT	OUT OF SPEC. (X)
1"	100		
1/2"	85		
#4	78		
#10	74		
#40	67		
#200	25

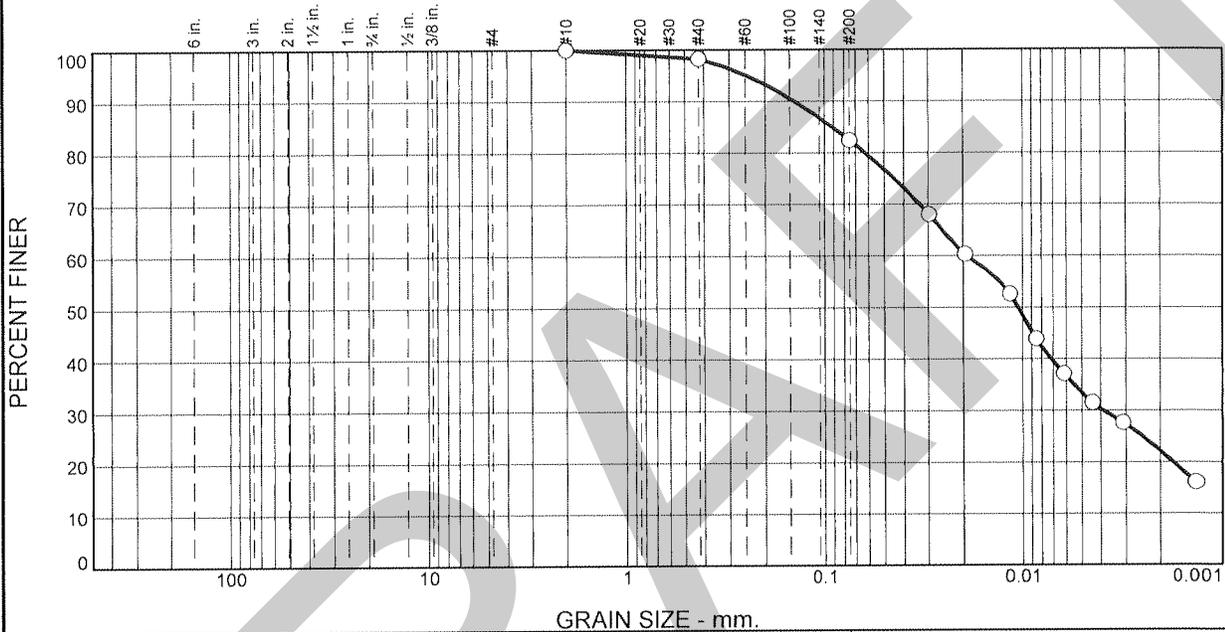
Elev./Depth: 14-16'

% +3"	% Gravel		% Sand			% Fines	
	Coarse	Fine	Coarse	Medium	Fine	Silt	Clay
0	0	0	0	2	16	49	33

SIEVE SIZE	PERCENT FINER	SPEC.* PERCENT	OUT OF SPEC. (X)
#10	100		
#40	98		
#200	82
