**MOUNTAIN VIEW LAKE DAM
NYS ID NO. 182-0276**

DRAFT FEASIBILITY STUDY

March 2, 2018

**GOMEZ AND SULLIVAN
ENGINEERS**

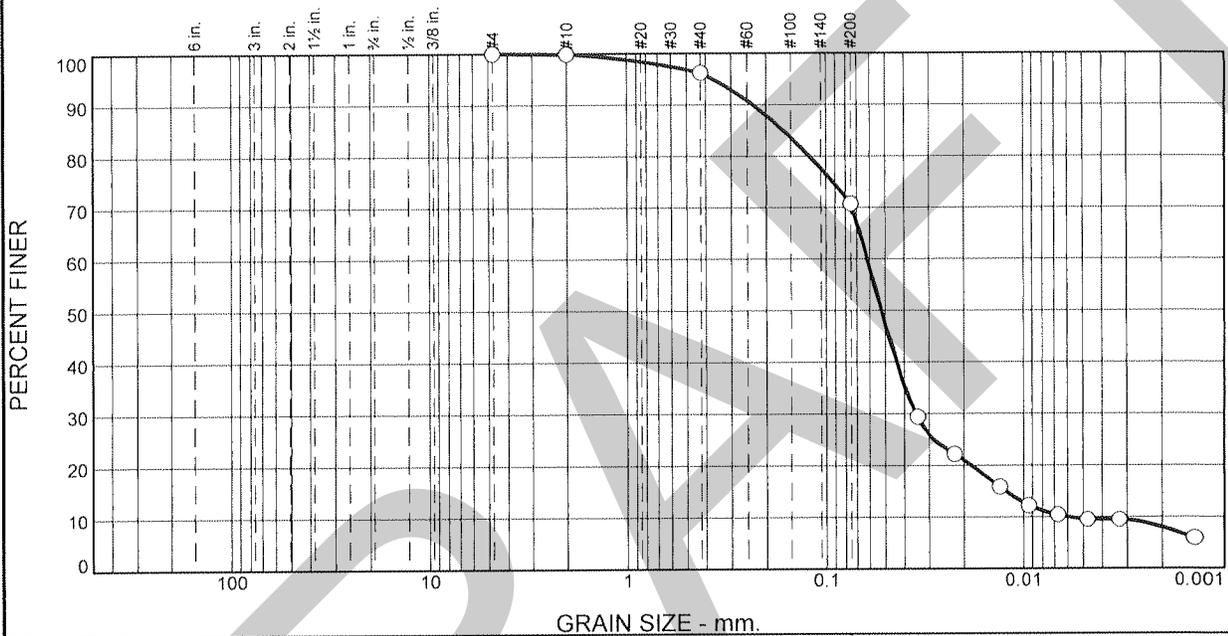
Elev./Depth: 24-26'

% +3"	% Gravel		% Sand			% Fines	
	Coarse	Fine	Coarse	Medium	Fine	Silt	Clay
0	0	0	0	4	25	61	10

SIEVE SIZE	PERCENT FINER	SPEC.* PERCENT	OUT OF SPEC. (X)
#4	100		
#10	100		
#40	96		
#200	71

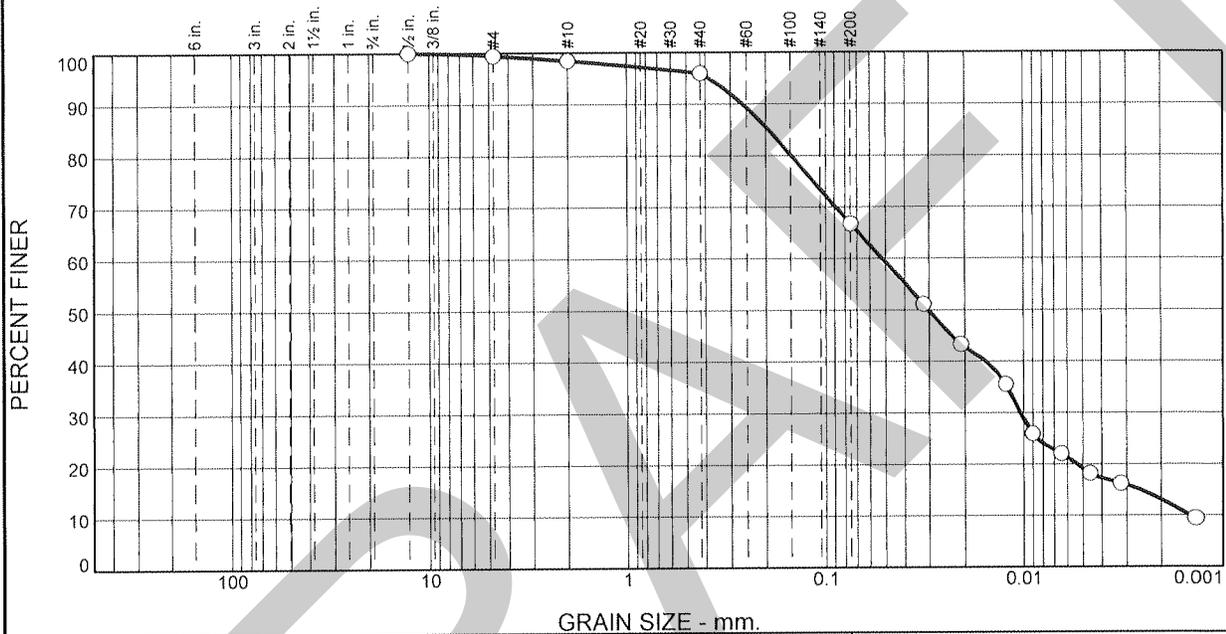
Elev./Depth: 34-36'

% +3"	% Gravel		% Sand			% Fines	
	Coarse	Fine	Coarse	Medium	Fine	Silt	Clay
0	0	1	1	2	29	48	19

SIEVE SIZE	PERCENT FINER	SPEC.* PERCENT	OUT OF SPEC. (X)
1/2"	100		
#4	99		
#10	98		
#40	96		
#200	67

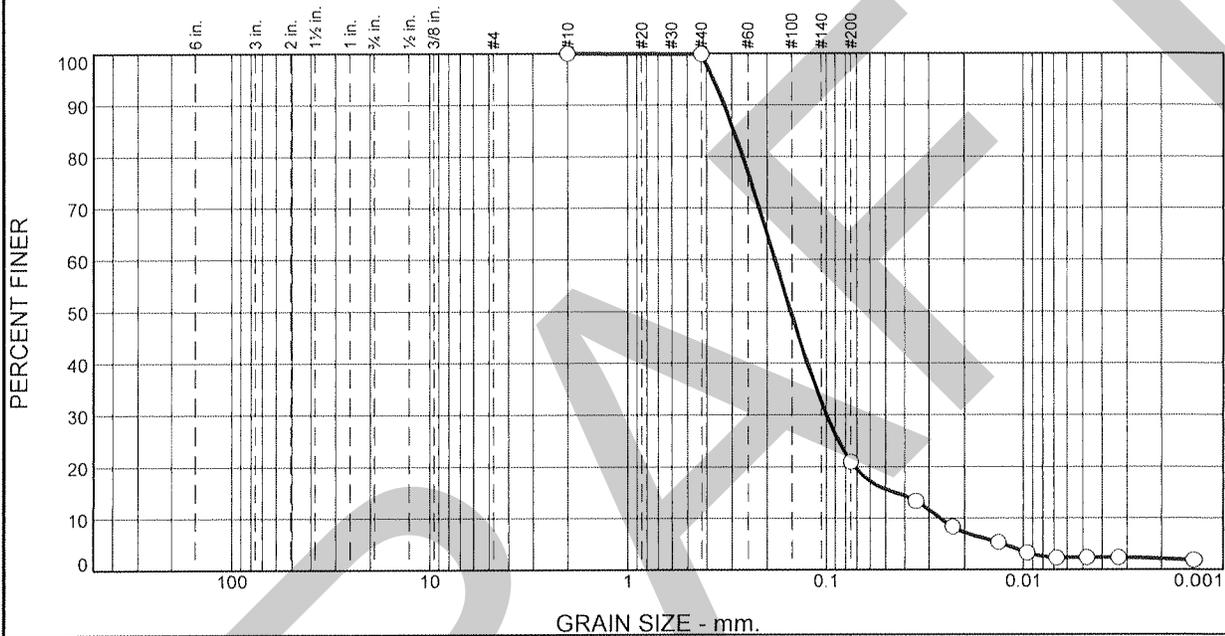
Elev./Depth: 42-44'

% +3"	% Gravel		% Sand			% Fines	
	Coarse	Fine	Coarse	Medium	Fine	Silt	Clay
0	0	0	0	0	79	19	2

SIEVE SIZE	PERCENT FINER	SPEC.* PERCENT	OUT OF SPEC. (X)
#10	100		
#40	100		
#200	21

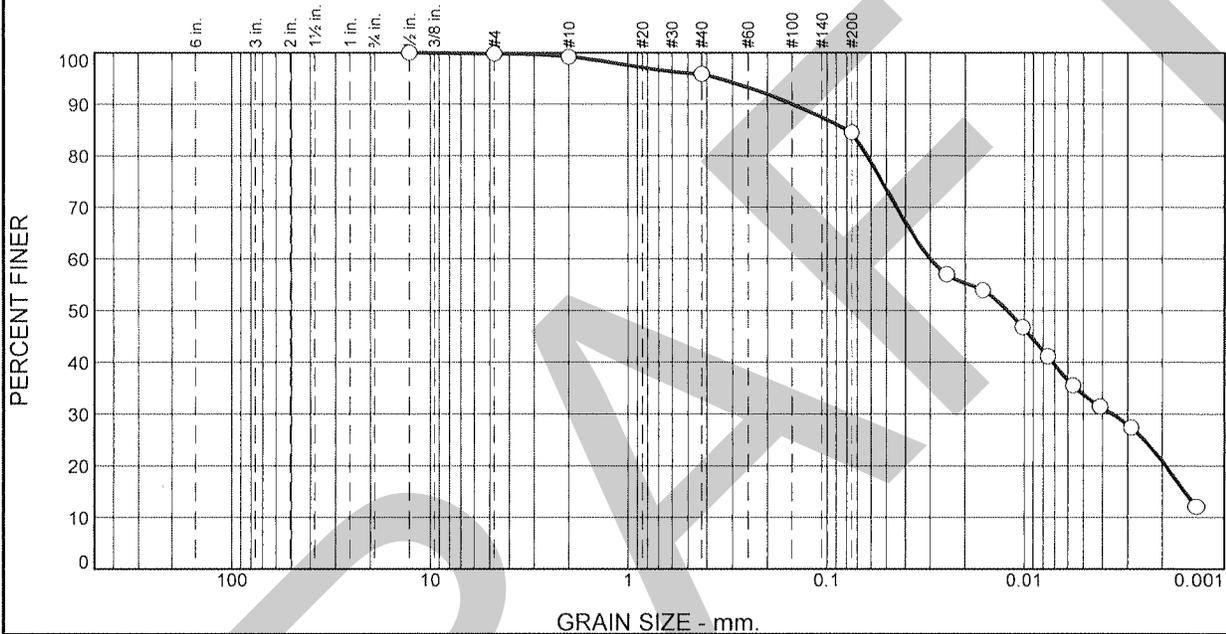
Elev./Depth: 10-12'

% +3"	% Gravel		% Sand			% Fines	
	Coarse	Fine	Coarse	Medium	Fine	Silt	Clay
0	0	0	1	3	11	51	34

SIEVE SIZE	PERCENT FINER	SPEC.* PERCENT	OUT OF SPEC. (X)
1/2"	100		
#4	100		
#10	99		
#40	96		
#200	85

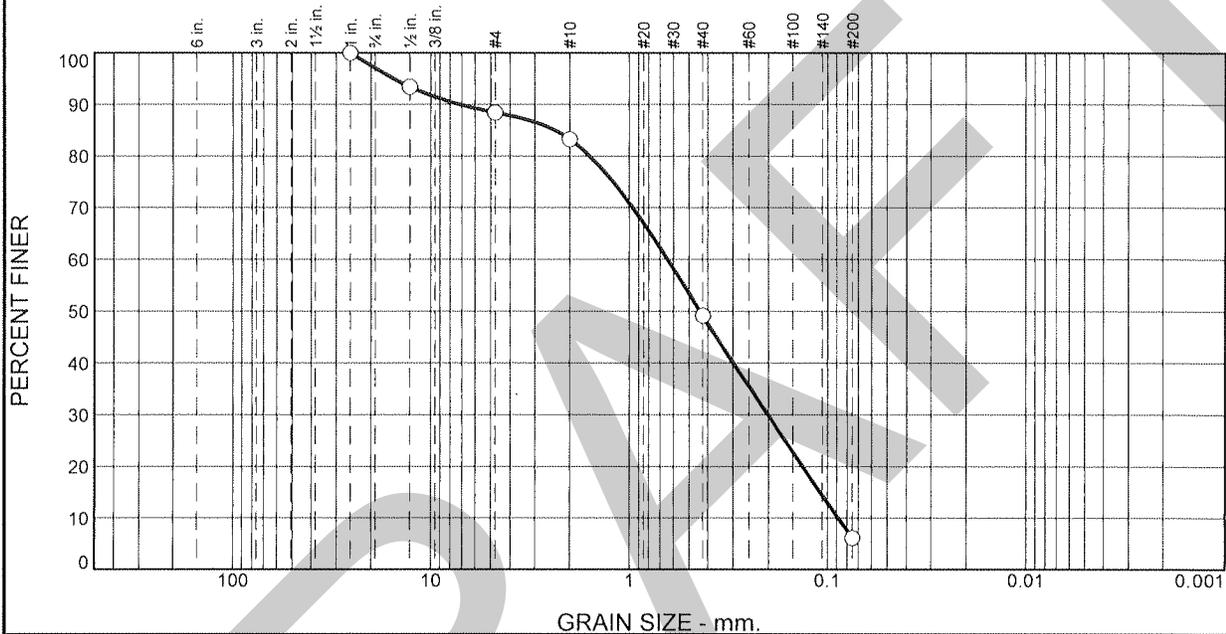
Elev./Depth: 20-22'

% +3"	% Gravel		% Sand			% Fines	
	Coarse	Fine	Coarse	Medium	Fine	Silt	Clay
0	3	9	5	34	43	6

SIEVE SIZE	PERCENT FINER	SPEC.* PERCENT	OUT OF SPEC. (X)
1"	100		
1/2"	93		
#4	88		
#10	83		
#40	49		
#200	6.1

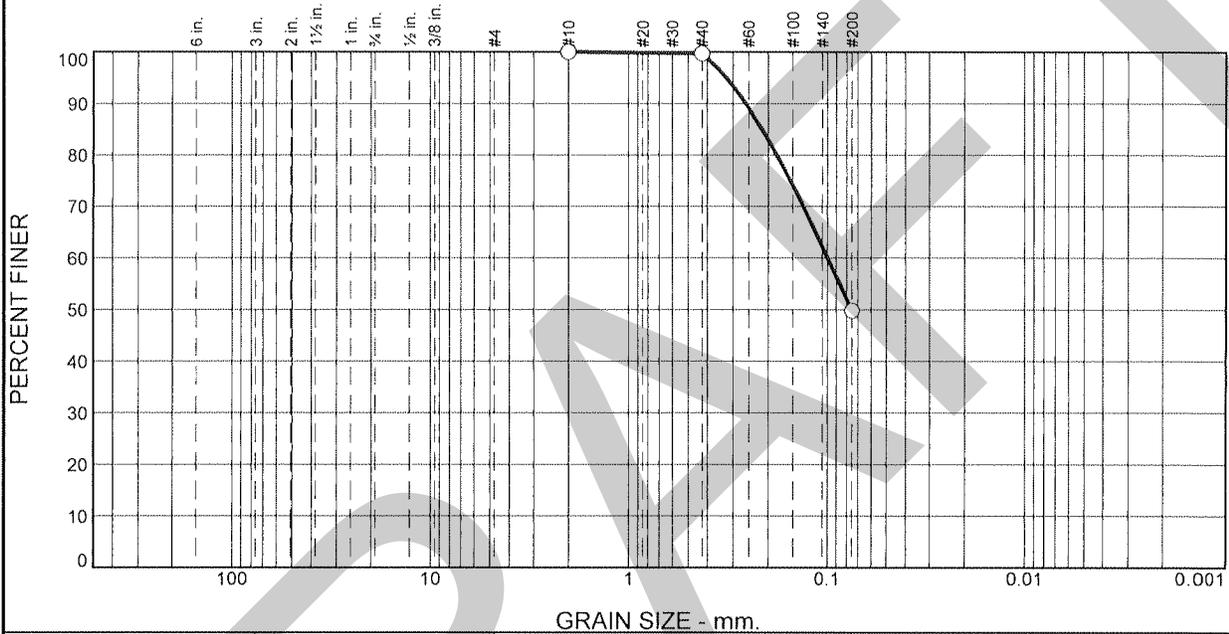
Elev./Depth: 36-38'

% +3"	% Gravel		% Sand			% Fines	
	Coarse	Fine	Coarse	Medium	Fine	Silt	Clay
0	0	0	0	0	50	50

SIEVE SIZE	PERCENT FINER	SPEC.* PERCENT	OUT OF SPEC. (X)
#10	100		
#40	100		
#200	50

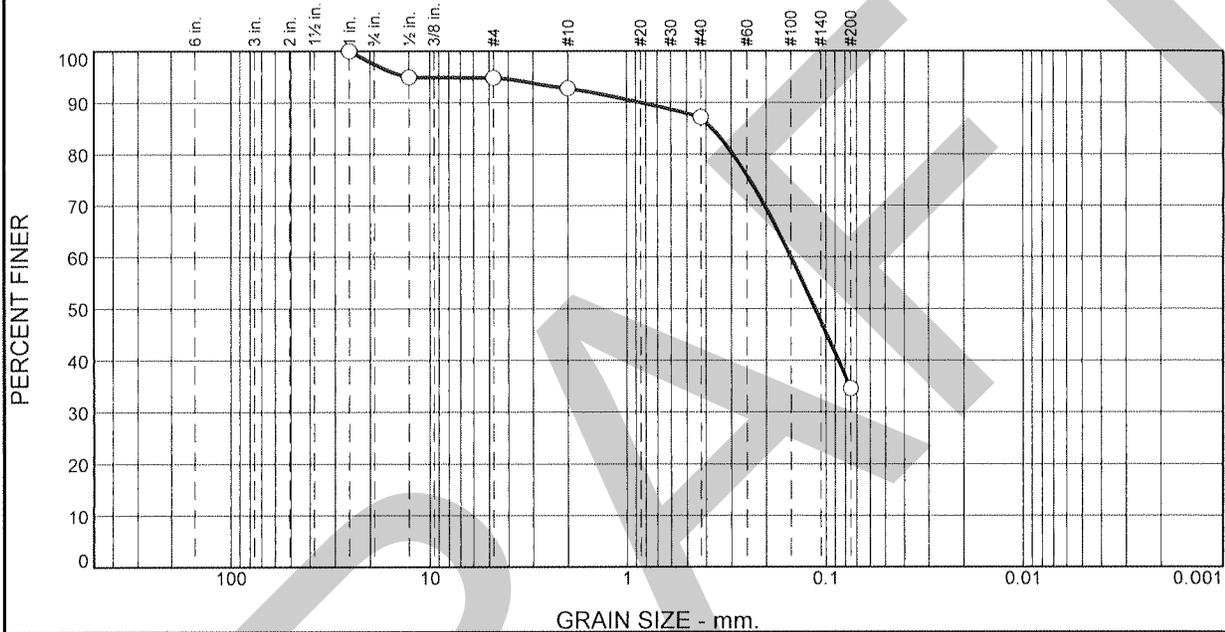
Elev./Depth: 38-40'

% +3"	% Gravel		% Sand			% Fines	
	Coarse	Fine	Coarse	Medium	Fine	Silt	Clay
0	3	2	2	6	52	35

SIEVE SIZE	PERCENT FINER	SPEC.* PERCENT	OUT OF SPEC. (X)
1"	100		
1/2"	95		
#4	95		
#10	93		
#40	87		
#200	35

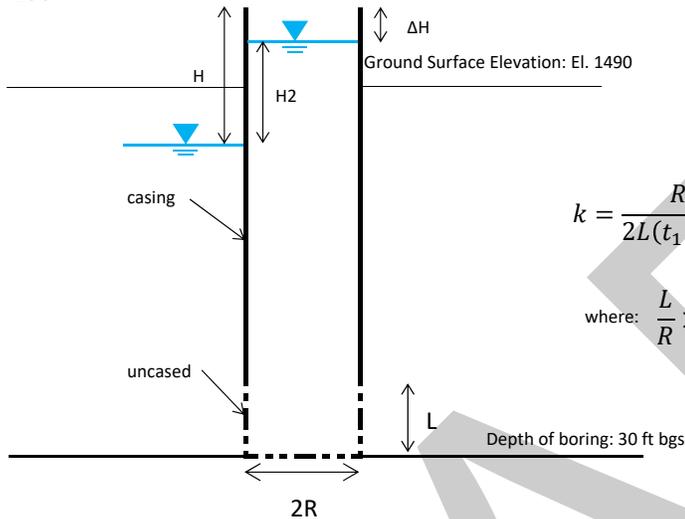
Boring No.: B-1A
 Date: 1/4/2018
 Time: 9:00 AM
 Weather: 19°F, Clear

$$k = \frac{R^2}{2L(t_1 - t_2)} \ln \frac{L}{R} \ln \frac{H_1}{H_2}$$

where: $\frac{L}{R} > 8$

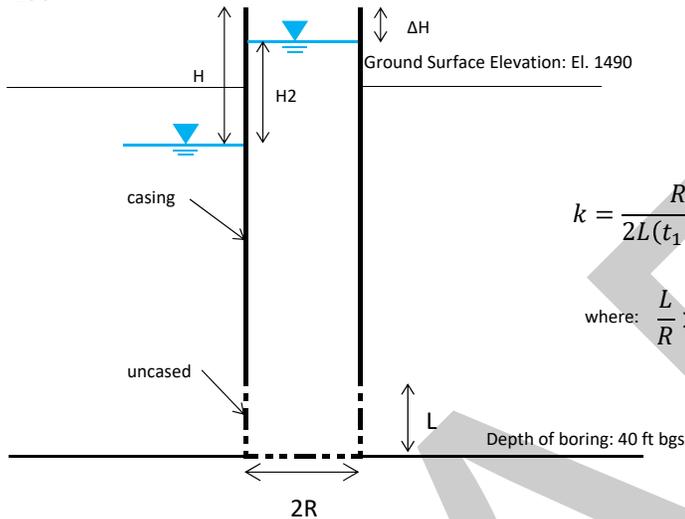
Boring No.: B-1A
 Date: 1/4/2018
 Time: 9:00 AM
 Weather: 19°F, Clear

$$k = \frac{R^2}{2L(t_1 - t_2)} \ln \frac{L}{R} \ln \frac{H_1}{H_2}$$

where: $\frac{L}{R} > 8$

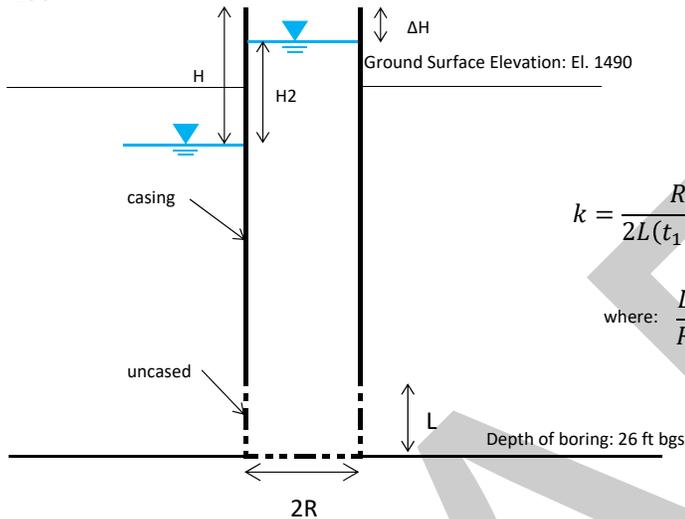
Boring No.: B-4
 Date: 1/8/2018
 Time: 11:00 AM
 Weather: 22°F, Clear

$$k = \frac{R^2}{2L(t_1 - t_2)} \ln \frac{L}{R} \ln \frac{H_1}{H_2}$$

where: $\frac{L}{R} > 8$

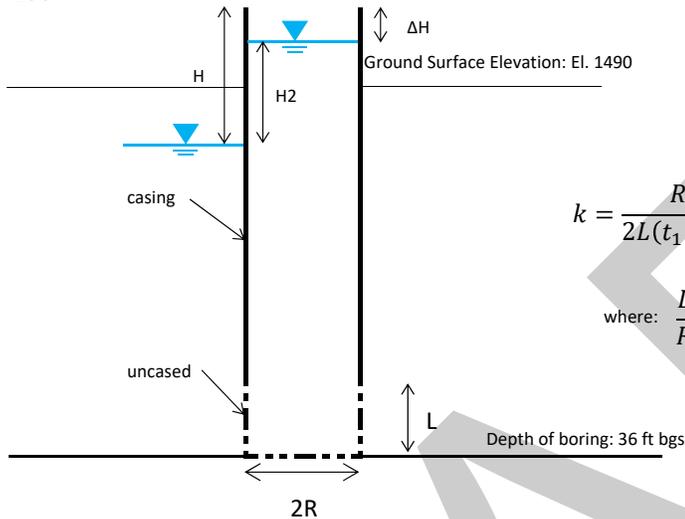
Boring No.: B-4
 Date: 1/8/2018
 Time: 3:30 PM
 Weather: 22°F, Clear

$$k = \frac{R^2}{2L(t_1 - t_2)} \ln \frac{L}{R} \ln \frac{H_1}{H_2}$$

where: $\frac{L}{R} > 8$
