**Three Horizons North C.A.  
Other Components  
*North Miami, FL***

Report #: 38214-1  
Beginning: January 1, 2025  
Expires: December 31, 2025

**RESERVE STUDY  
Update "With-Site-Visit"**

January 24, 2024

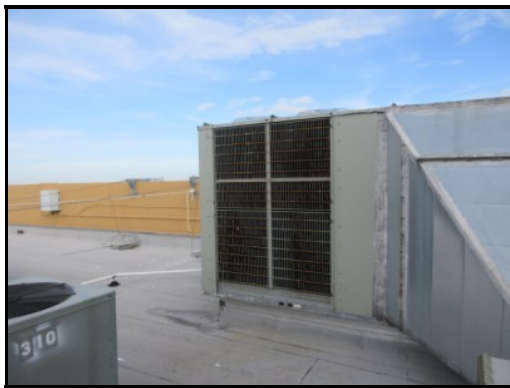
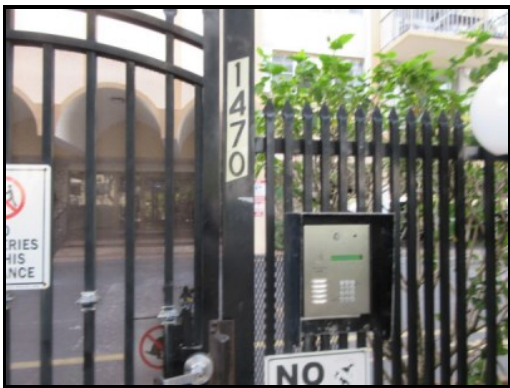
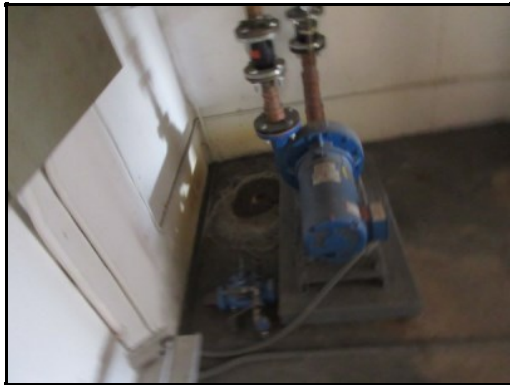
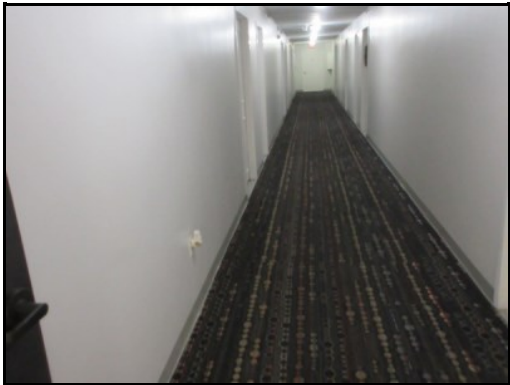
**Site Inspection Notes**

During our site visit on 12/12/2023, we visually inspected all common areas, amenities, and other components that are the responsibility of the Client. Please refer to the Component Details section at the end of this document for additional photos, observations and other information regarding each component.

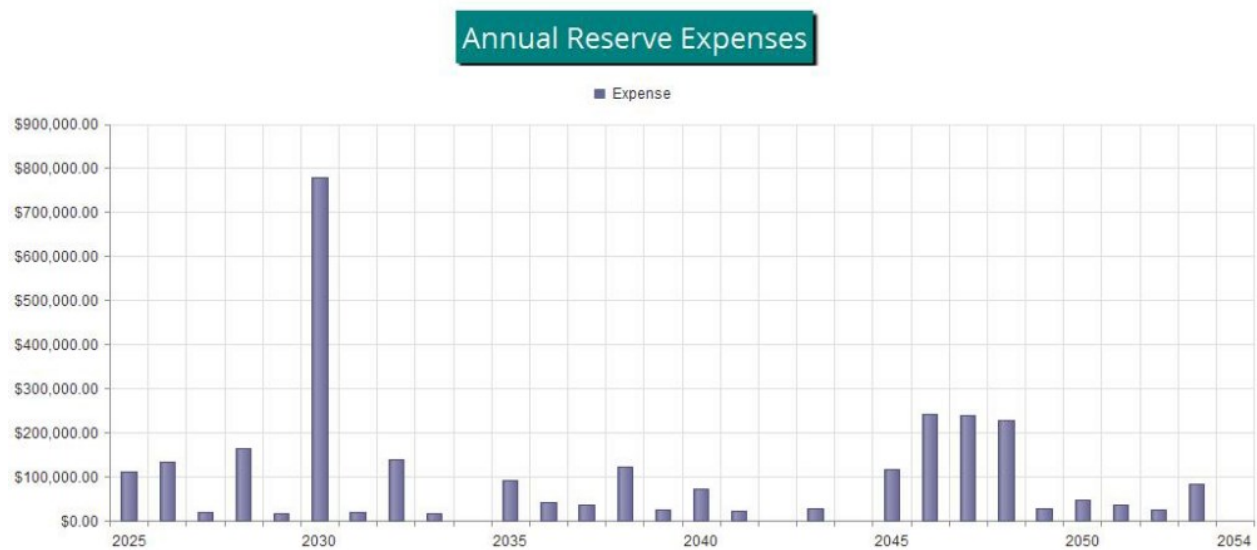
Figure 1

While this Reserve Study looks forward 30 years, we have no expectation that all these expenses will all take place as anticipated. This Reserve Study needs to be updated annually because we expect the timing of these expenses to shift and the size of these expenses to change. We do feel more certain of the timing and cost of near-term expenses than expenses many years away. Please be aware of your near-term expenses, which we are able to project more accurately than the more distant projections. The figure below summarizes the projected future expenses as defined by your Reserve Component List. A summary of these components are shown in the Component Details table, while a summary of the expenses themselves are shown in the 30-yr Cash Flow Detail table.

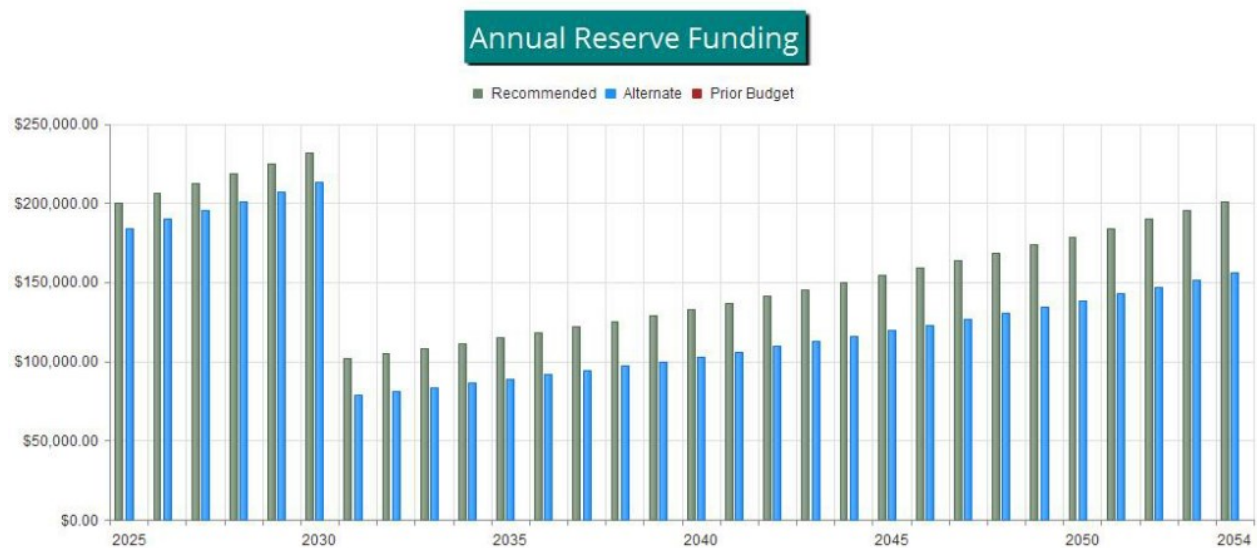
Figure 2

Based on your current Percent Funded and your near-term and long-term Reserve needs, we are recommending budgeted contributions of \$200,000 in the upcoming fiscal year. At minimum, the Association must budget \$184,200 for Reserves in the upcoming year. The overall 30-yr plan, in perspective, is shown below. This same information is shown numerically in both the 30-yr Summary and the Cash Flow Detail tables.

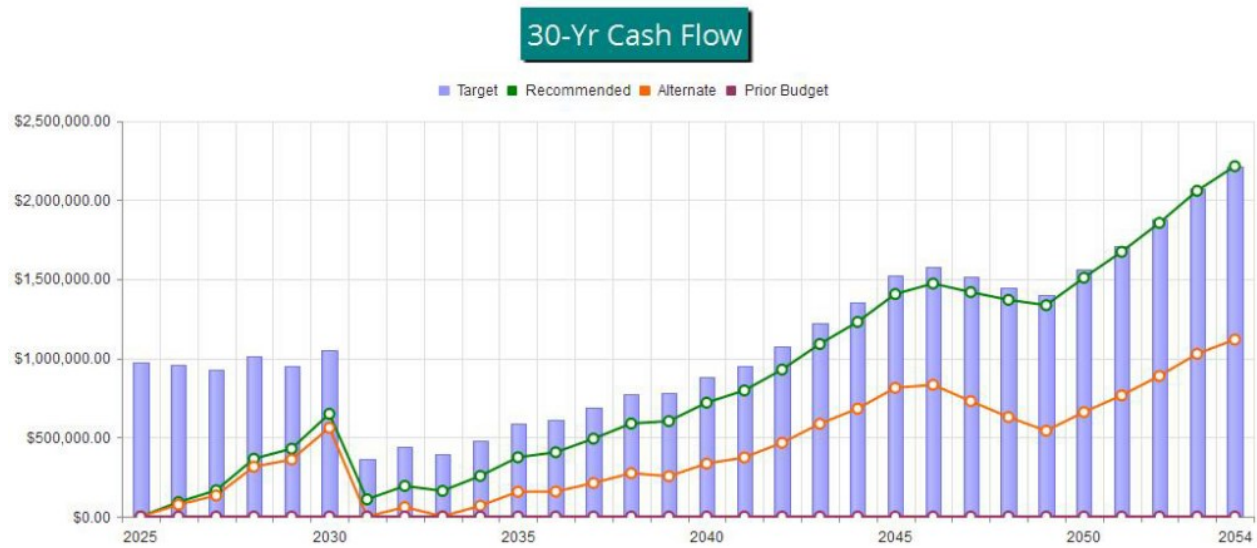
Figure 3

The following chart shows your Reserve balance under our recommended plan, the minimum funding plan and at the Association’s current contribution rate, all compared to your always-changing Fully Funded Balance target.

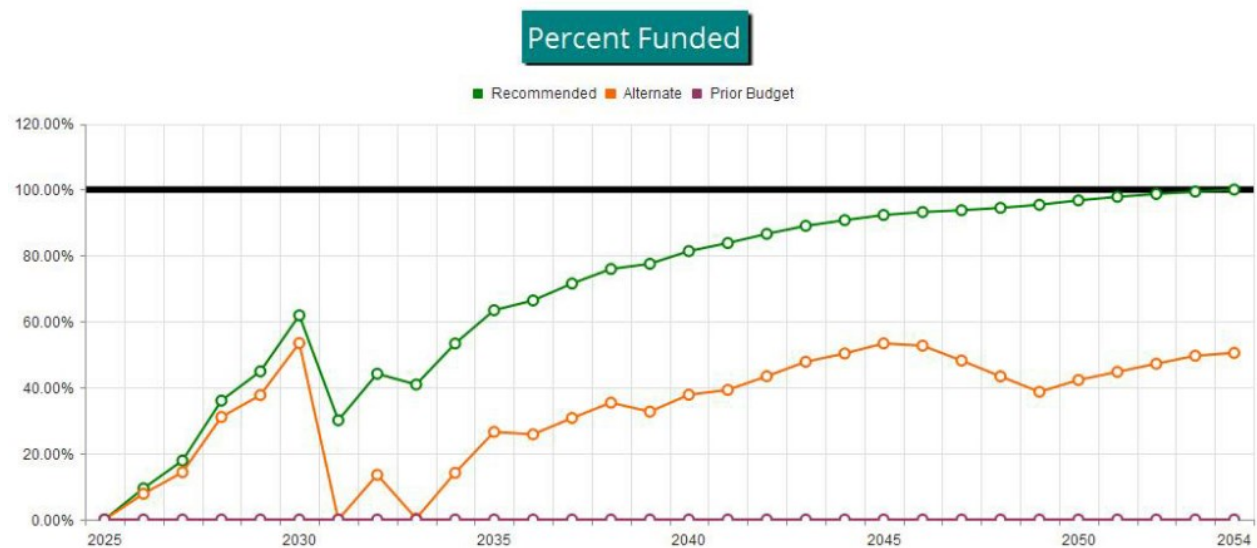
Figure 4

This figure shows the same information described above, but plotted on a Percent Funded scale. It is clear here to see how your Reserve Fund strength approaches the 100% Funded level under our recommended multi-yr Funding Plan.

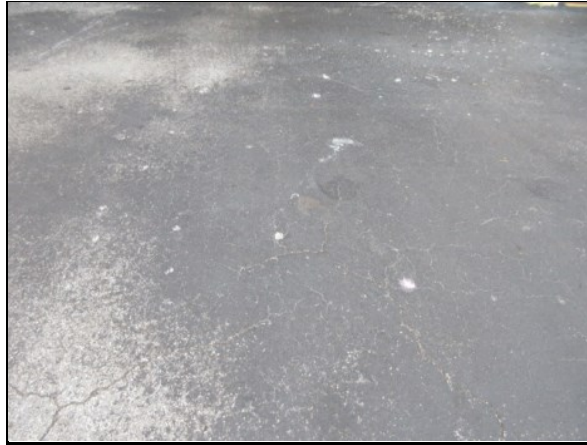
**Comp #: 2123 Asphalt - Seal/Repair****Quantity: Approx 6,840 GSY**

Useful Life:  
4 years

Remaining Life:  
2 years

Best Case: \$ 15,400

Worst Case: \$ 18,800

# Component	Useful Life (yrs)	Rem. Useful Life (yrs)	Current Average Cost
<b>Site and Grounds</b>			
2123 Asphalt - Seal/Repair	4	2	\$17,100
2125 Asphalt - Resurface	20	1	\$130,000
2137 Site Fencing (Metal) - Replace	25	5	\$58,950
2145 Entry/Exit Gates - Replace	25	5	\$44,950
2175 Site Pole Lights - Replace	20	5	\$22,550
<b>Building Exteriors</b>			
2305 Garage Lights - Replace	24	7	\$5,400
<b>Mechanical/Electrical/Plumbing</b>			
2501 Intercom/Entry System - Replace	15	0	\$7,605
2509 Gate Operators - Replace	15	0	\$26,250
2513 Elevators - Modernize	25	5	\$520,000
2517 Elevator Cab - Remodel	25	5	\$26,000
2522 HVAC (Elevator) - Replace	15	7	\$9,500
2522 HVAC (Hallways) - Replace	15	7	\$90,400
2522 HVAC (Lobby) - Replace	15	7	\$8,500
2532 Exhaust Fans - (1/4) Replace	4	0	\$14,000
2543 Surveillance System-Upgrade/Replace	10	0	\$50,550
2567 Water Heater 1 (Laundry) - Replace	15	0	\$11,750
2567 Water Heater 2 (Laundry) - Replace	15	12	\$11,750

#	Component	Current Cost Estimate	X	Effective Age	/	Useful Life	=	Fully Funded Balance
<b>Site and Grounds</b>								
2123	Asphalt - Seal/Repair	\$17,100	X	2	/	4	=	\$8,550
2125	Asphalt - Resurface	\$130,000	X	19	/	20	=	\$123,500
2137	Site Fencing (Metal) - Replace	\$58,950	X	20	/	25	=	\$47,160
2145	Entry/Exit Gates - Replace	\$44,950	X	20	/	25	=	\$35,960
2175	Site Pole Lights - Replace	\$22,550	X	15	/	20	=	\$16,913
<b>Building Exteriors</b>								
2305	Garage Lights - Replace	\$5,400	X	17	/	24	=	\$3,825
<b>Mechanical/Electrical/Plumbing</b>								
2501	Intercom/Entry System - Replace	\$7,605	X	15	/	15	=	\$7,605
2509	Gate Operators - Replace	\$26,250	X	15	/	15	=	\$26,250
2513	Elevators - Modernize	\$520,000	X	20	/	25	=	\$416,000
2517	Elevator Cab - Remodel	\$26,000	X	20	/	25	=	\$20,800
2522	HVAC (Elevator) - Replace	\$9,500	X	8	/	15	=	\$5,067
2522	HVAC (Hallways) - Replace	\$90,400	X	8	/	15	=	\$48,213

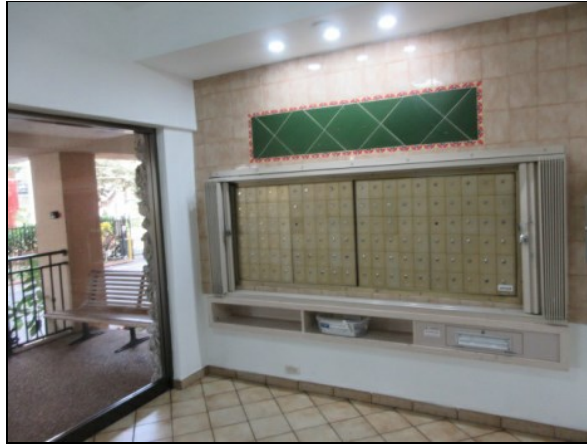
**Comp #: 2721 Mailboxes - Replace**

Comments: (120) boxes and (1) outgoing box noted at time of inspection.

Poor condition: Mailboxes determined to be in poor condition typically exhibit more advanced signs of wear and age, and in some cases, issues with boxes not closing and locking properly. Even if physical conditions are satisfactory, severely outdated types should be considered for replacement for aesthetic reasons.

Clean and inspect regularly, change lock cylinders, lubricate hinges and repair as needed from Operating budget. Metal mailbox structures located inside protected interior areas can have very long life expectancies. In our experience, it is prudent to expect replacement at the approximate interval shown below in order to maintain good appearance consistent with other interior areas. Timing of replacements is ultimately subjective. Best practice is to coordinate with other interior projects such as lobby remodeling or replacement of other FF&E.

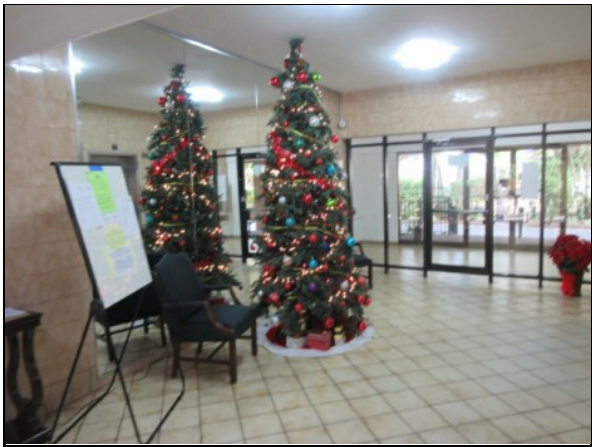
Location: Main entry to building  
Funded?: Yes.  
History: Lobby mirror added in 2017 for \$1,669.20 according to information provided.  
Comments: Painting and tile components are listed separately. This component allows for replacement of furnishings in the lobby. At time of inspection, (2) chairs, (1) stand, and (1) large mirror present. Chairs appeared to be in older condition.

Poor condition: Lobbies determined to be in poor condition typically exhibit an overall decline in aesthetics, due to actual physical deterioration of assets in some cases, but more often due to a generally outdated appearance/style that is no longer adequate for the standards of the property.
