## **Featured Technical Topic Summary** **FGI Monthly Members Meeting** **Friday, May 4, 2023**

### **TOPIC: Leak Testing of Mechanical Attachments & Pipe Boots**

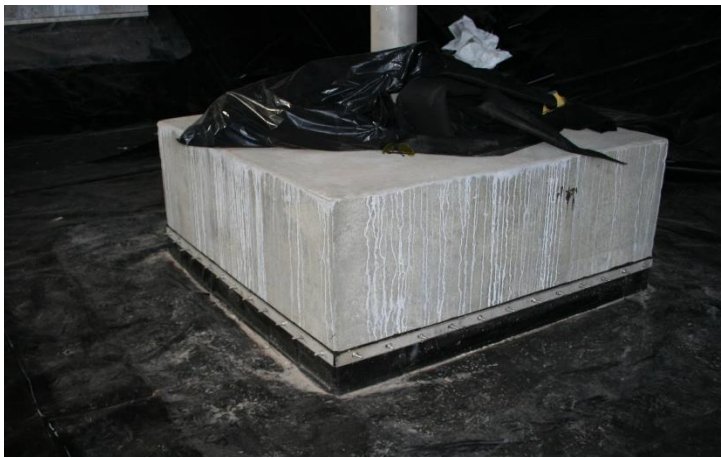
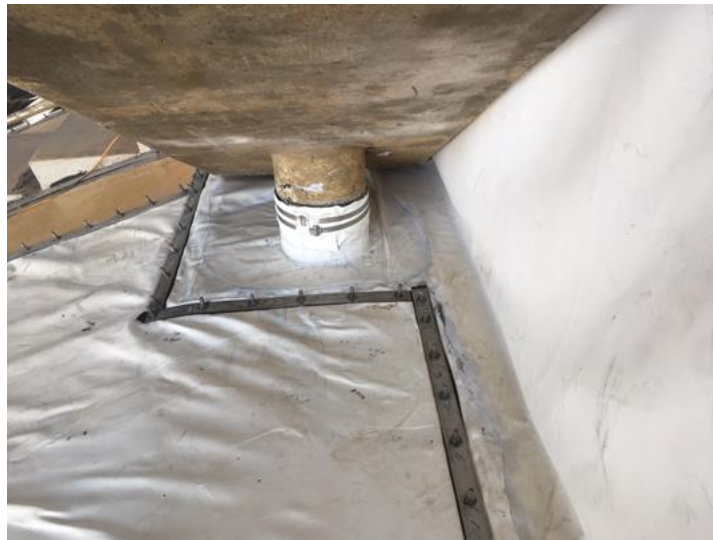
**Figure 1. Photographs of mechanical attachments and pipe boot.**

1. Leak testing mechanical attachments and pipe boots is difficult and a common leak point (see **Figure 1**). This White Paper summarizes the responses to the testing of mechanical attachments and pipe boots during and after installation.
