BRIDGE FAILURES

Nabil Al-Bayati, MAsC., P.Eng

Structural and Bridge Engineer

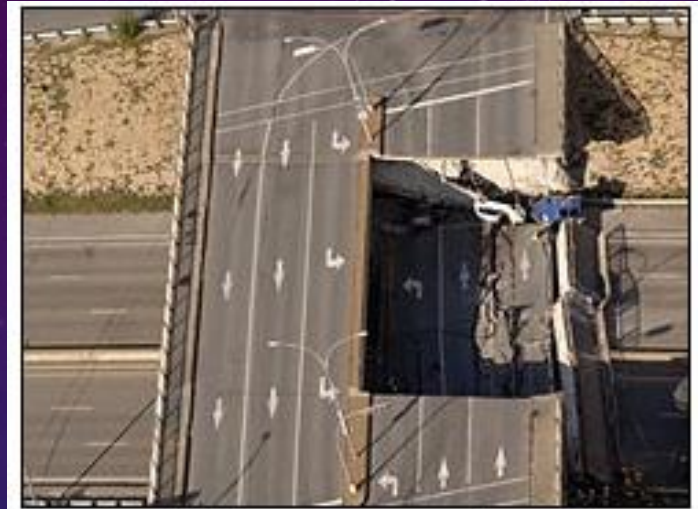
A section of highway overpass collapsed in Laval, Quebec, outside Montreal, Saturday, September 30, 2006. Five people were killed and six people were injured. (AP Photo)

1. The collapsed span is a highway overpass, with three lanes of 65 ft span, built on 1970.
2. The inquiries concluded construction company did not properly secure the concrete beams
3. It was the second serious overpass collapse in Laval in the last six years
4. Transport Quebec spokes woman Josee Seguin said the department heard about an hour before the accident that some pieces of concrete were falling off the overpass
5. Most of the experts refer to the huge amount of CORROSION and low resources for maintenance as a direct reason for these bridge failures.

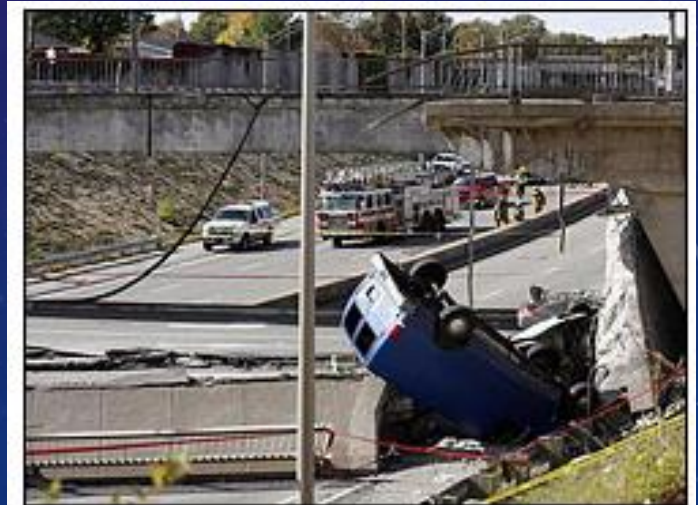
Rescue workers survey the site of an overpass that collapsed onto Highway 19 in Laval, Canada, Saturday, Sept. 30, 2006. (AP Photo/CP, Ryan Remiorz)

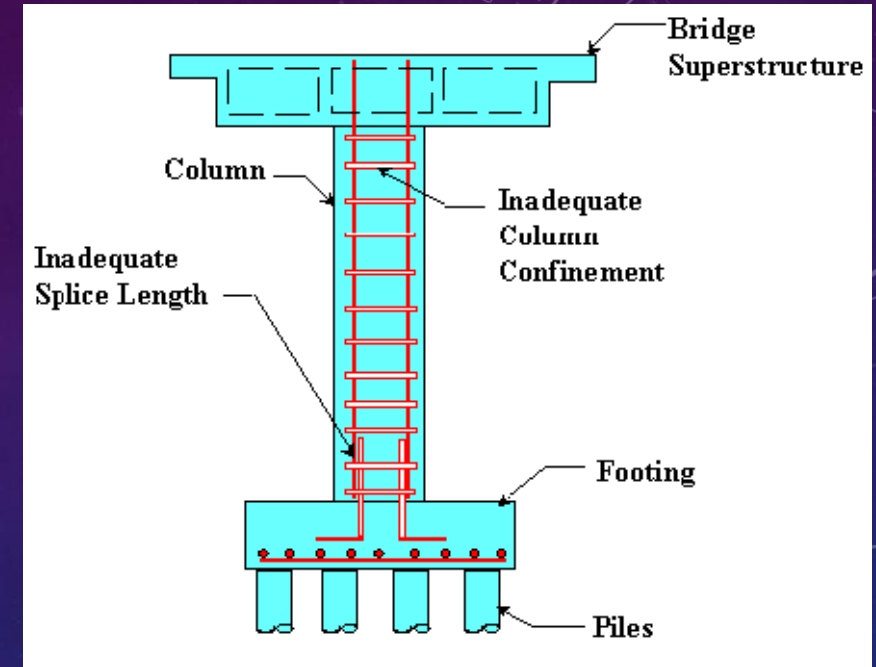
TYPICAL COLUMN DEFICIENCIES

1. Inadequate confinement reinforcement for main longitudinal reinforcing steel in concrete columns.
2. Inadequate splice length of main longitudinal column reinforcing to footing dowels.
3. Inadequate development length of footing dowels (footing embedment).
4. Absence of reinforcement in the tops of footings.
5. Inadequate footing support capacity.

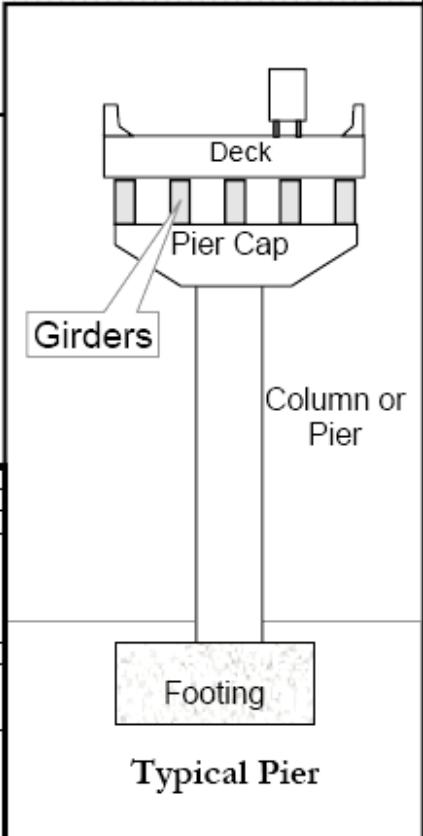
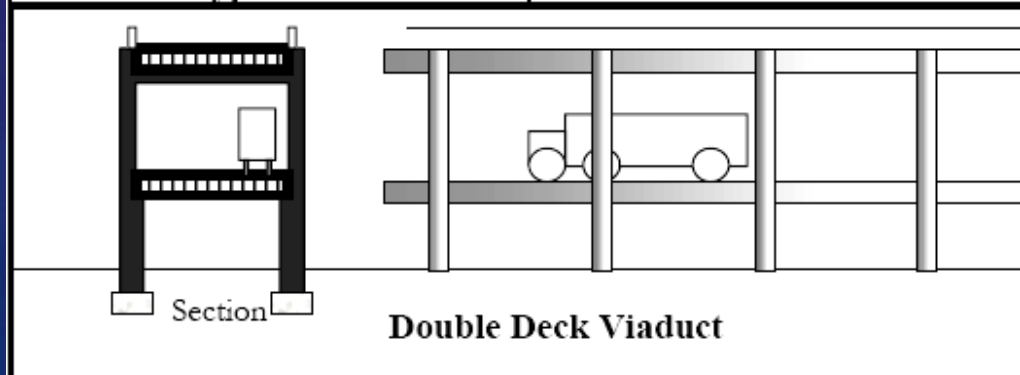
BRIDGE BASICS

The information on this page represents the basic components of bridges.
No Scale

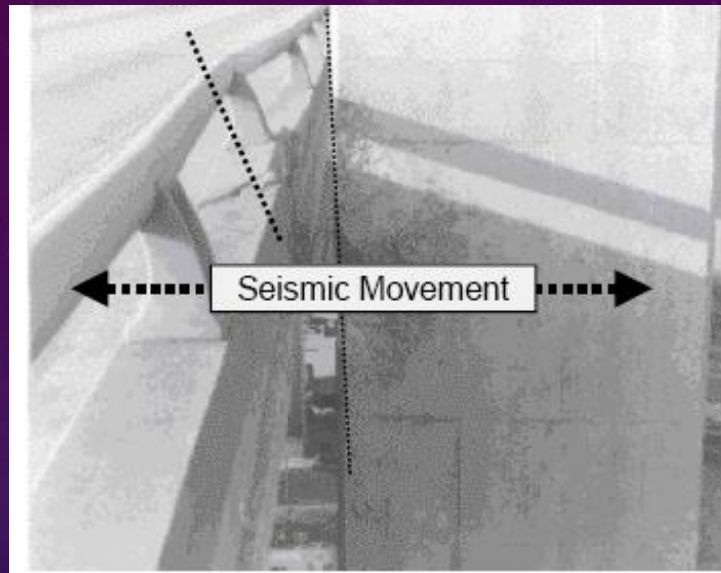
1989 Loma Prieta – Interstate 280 San Francisco , banging damage, roadway hitting column

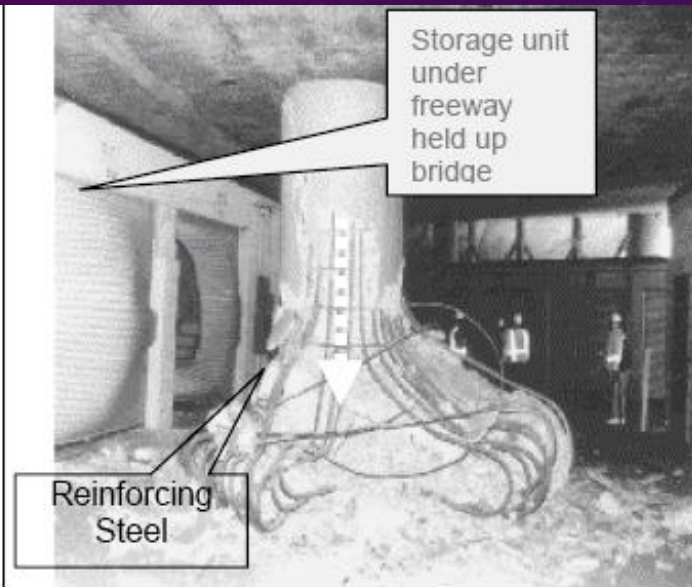
1994 Northridge - Interstate 10 Los Angeles, La Cienega U.C. Concrete column damage

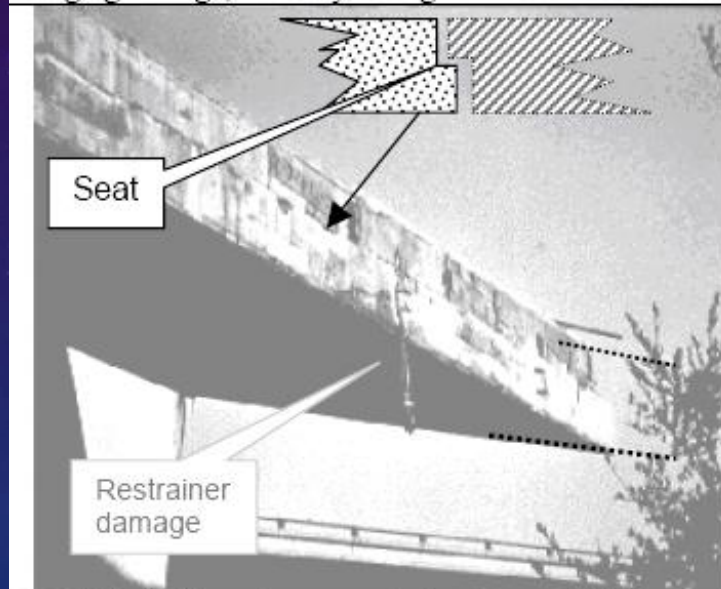
1994 Northridge – Interstate 5, San Fernando Valley, Galvin Canyon crossing. Adjacent span collapse due to unseating .

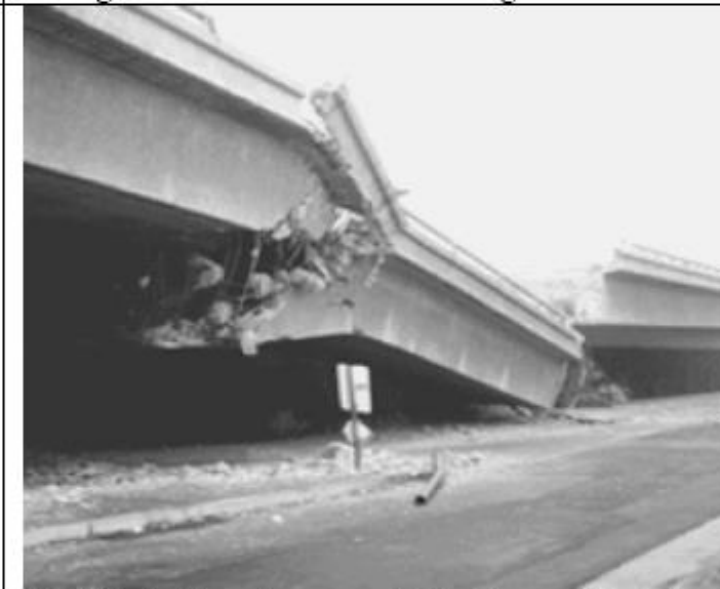
1994 Northridge – Interstate 10, La Cienega Bl. Column failure, bridge collapse

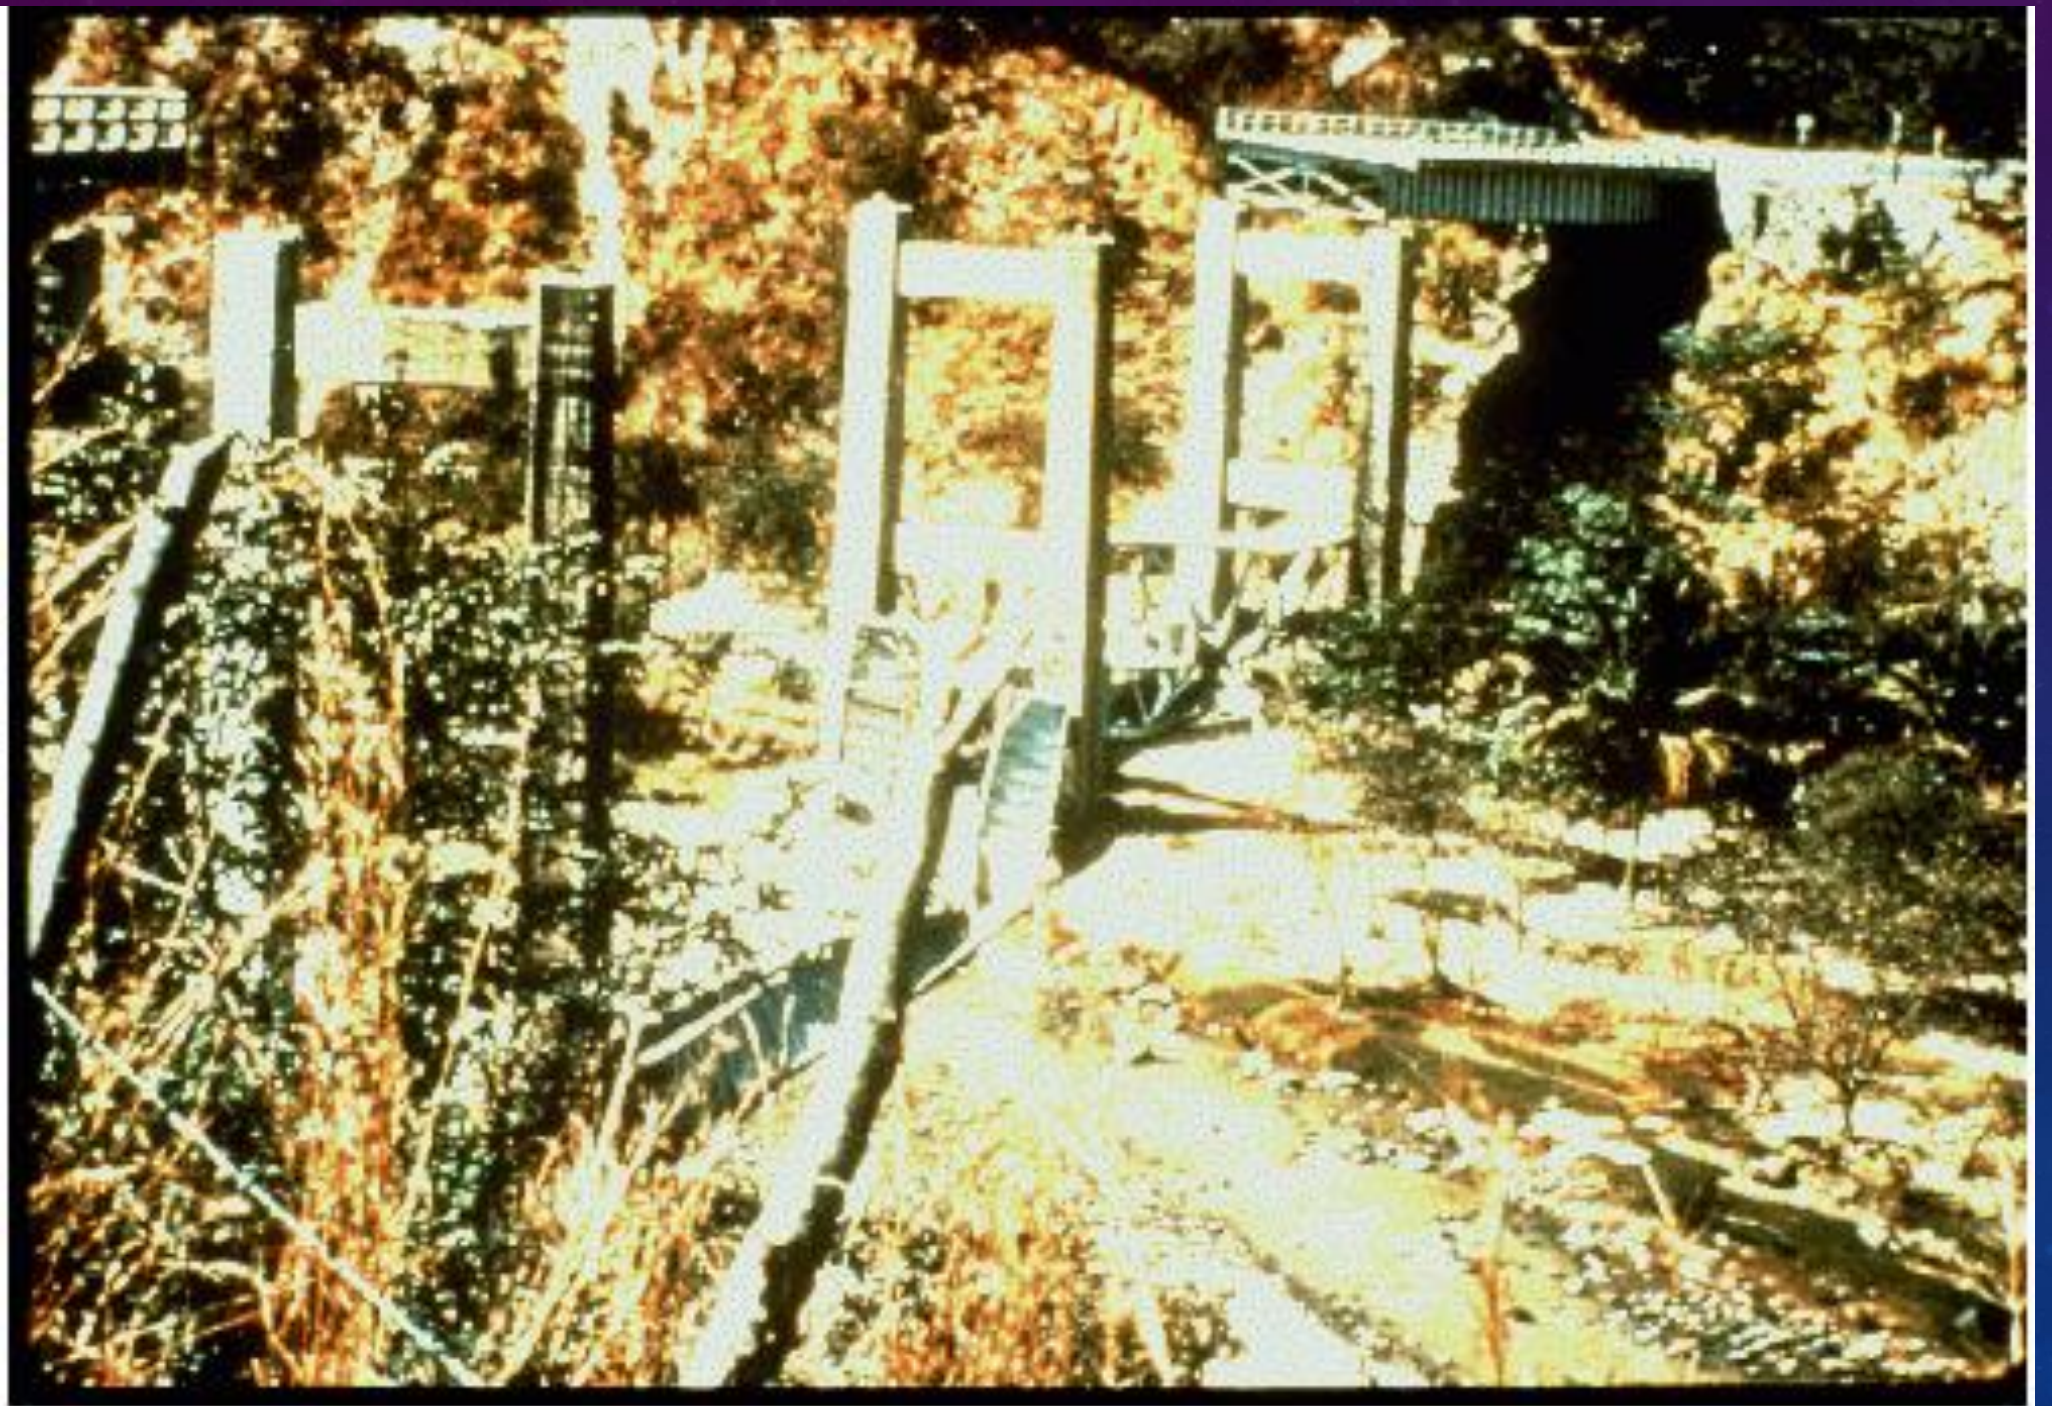
**Collapse of Spans
on Bridge Due to
1976 Earthquake
in Guatemala**

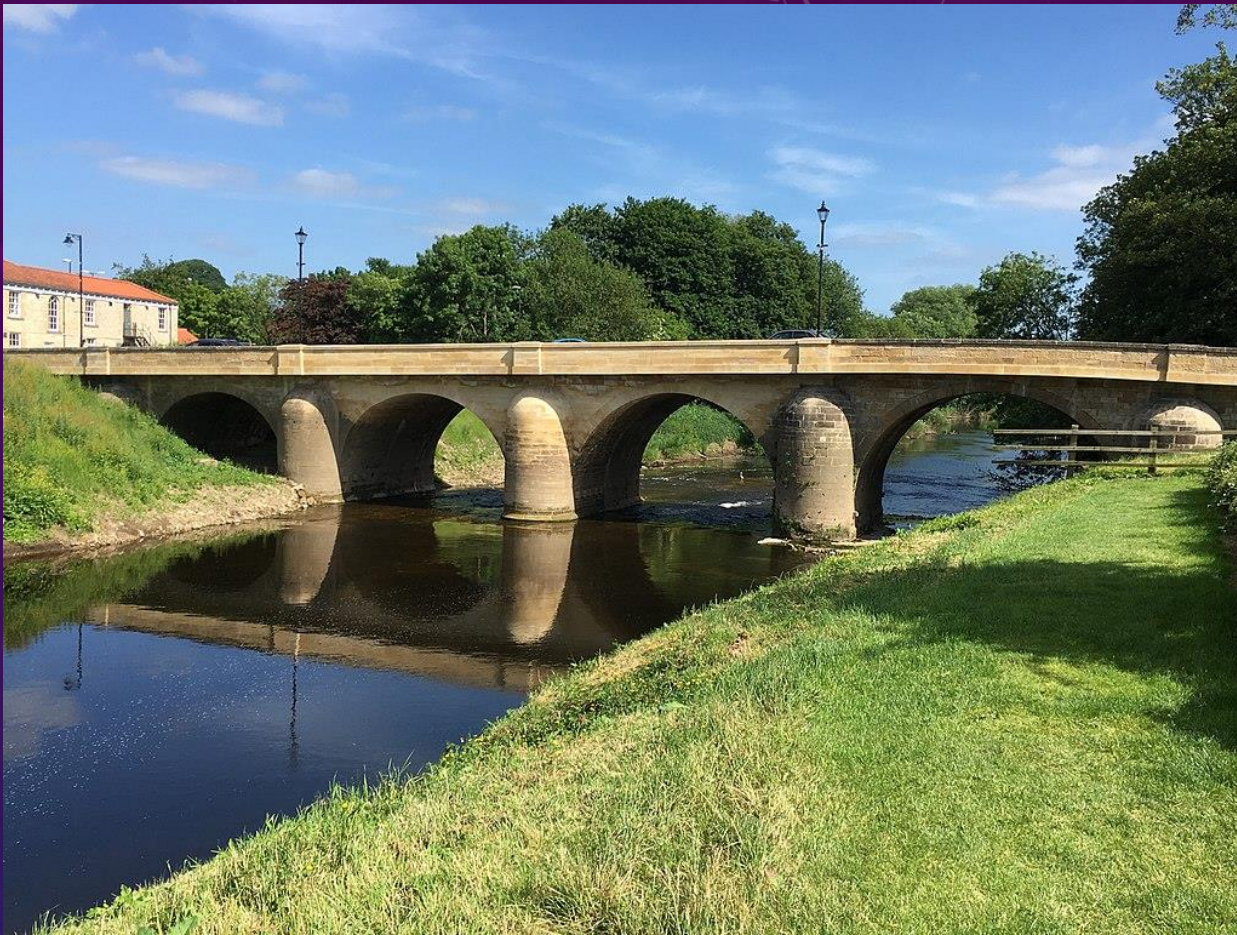
Tadcaster Bridge 2018, North Yorkshire, England, U.K, 300 year old Stone Bridge Grade II Listed on July 12, 1985

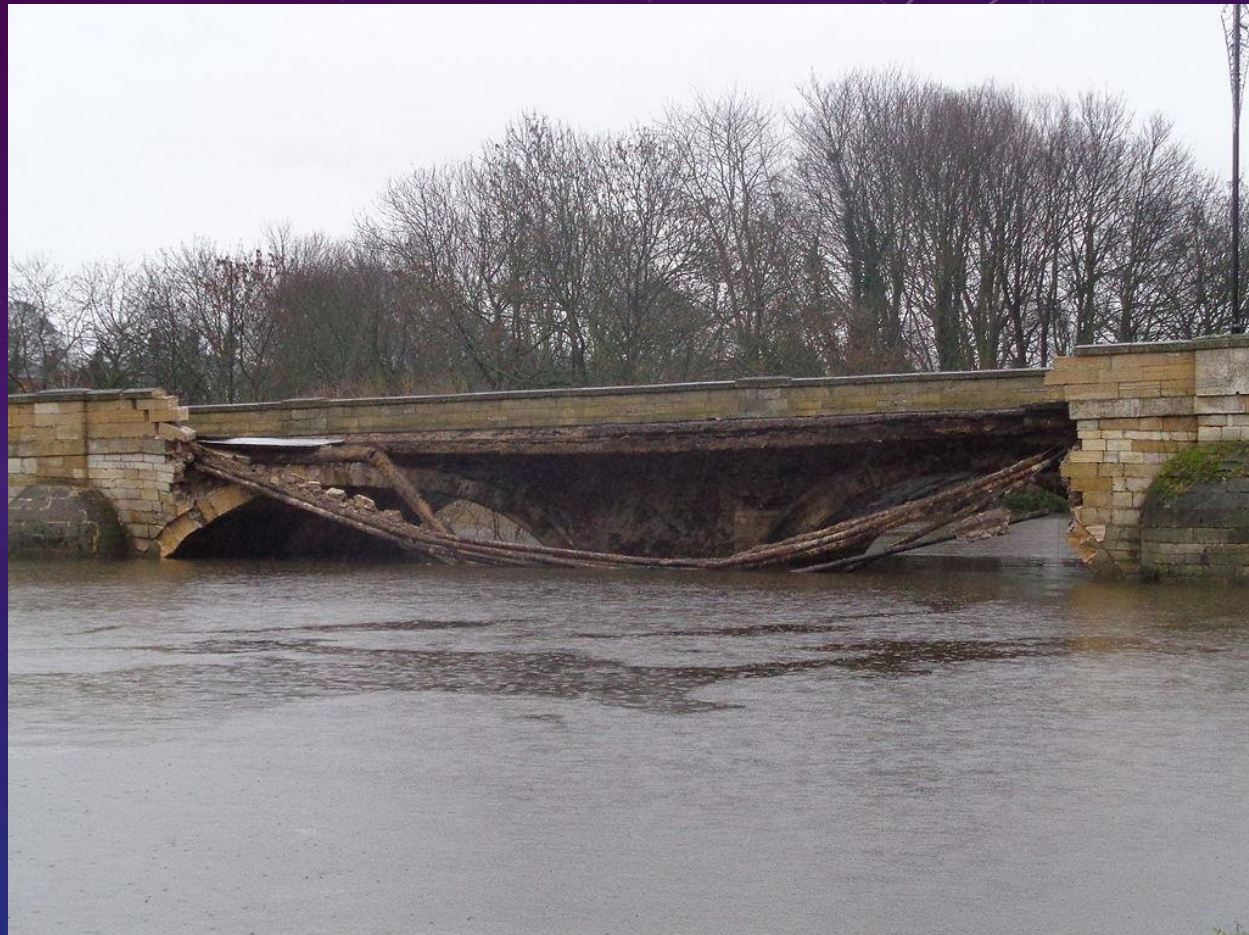
Partially collapsed Tadcaster Bridge (30th December 2015)
The bridge on the day after the collapse. This collapse also caused a substantial gas leak

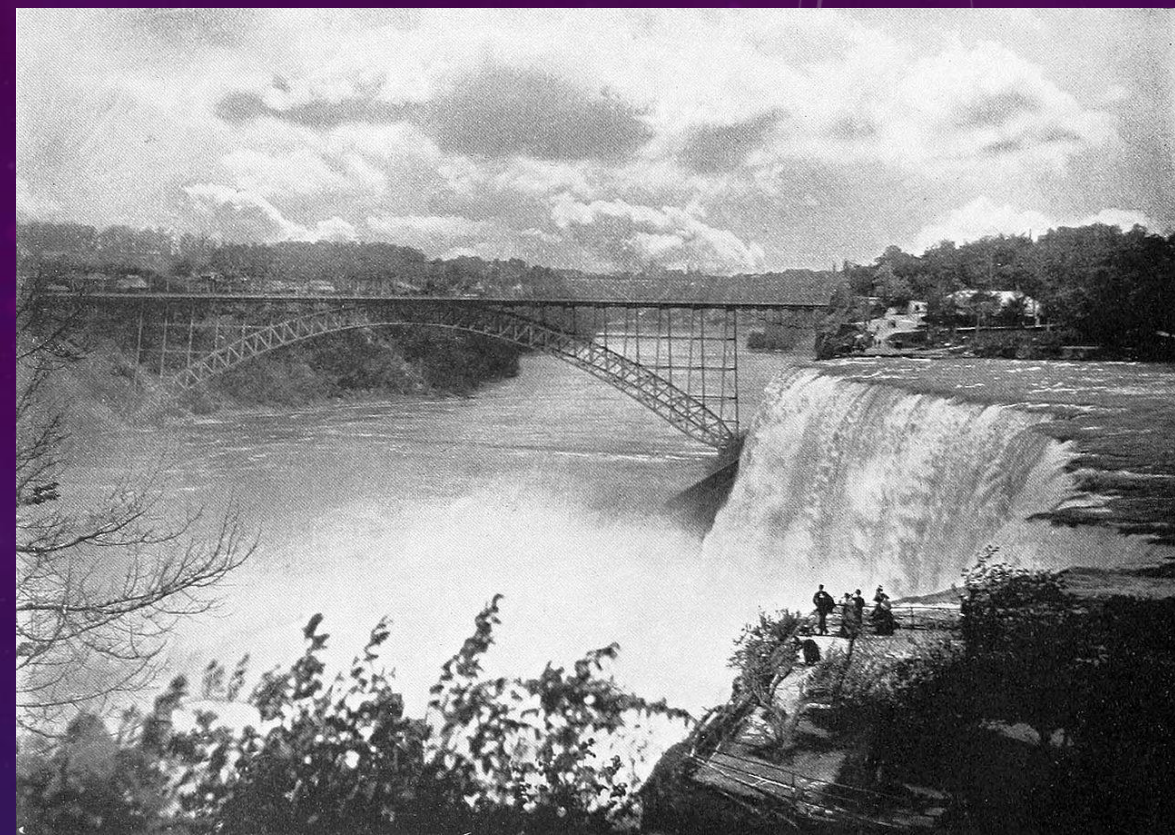
Honeymoon Bridge (Upper Steel Arch Bridge) located in Niagara Falls, Built in 1897–98, and collapsed on January 27, 1938

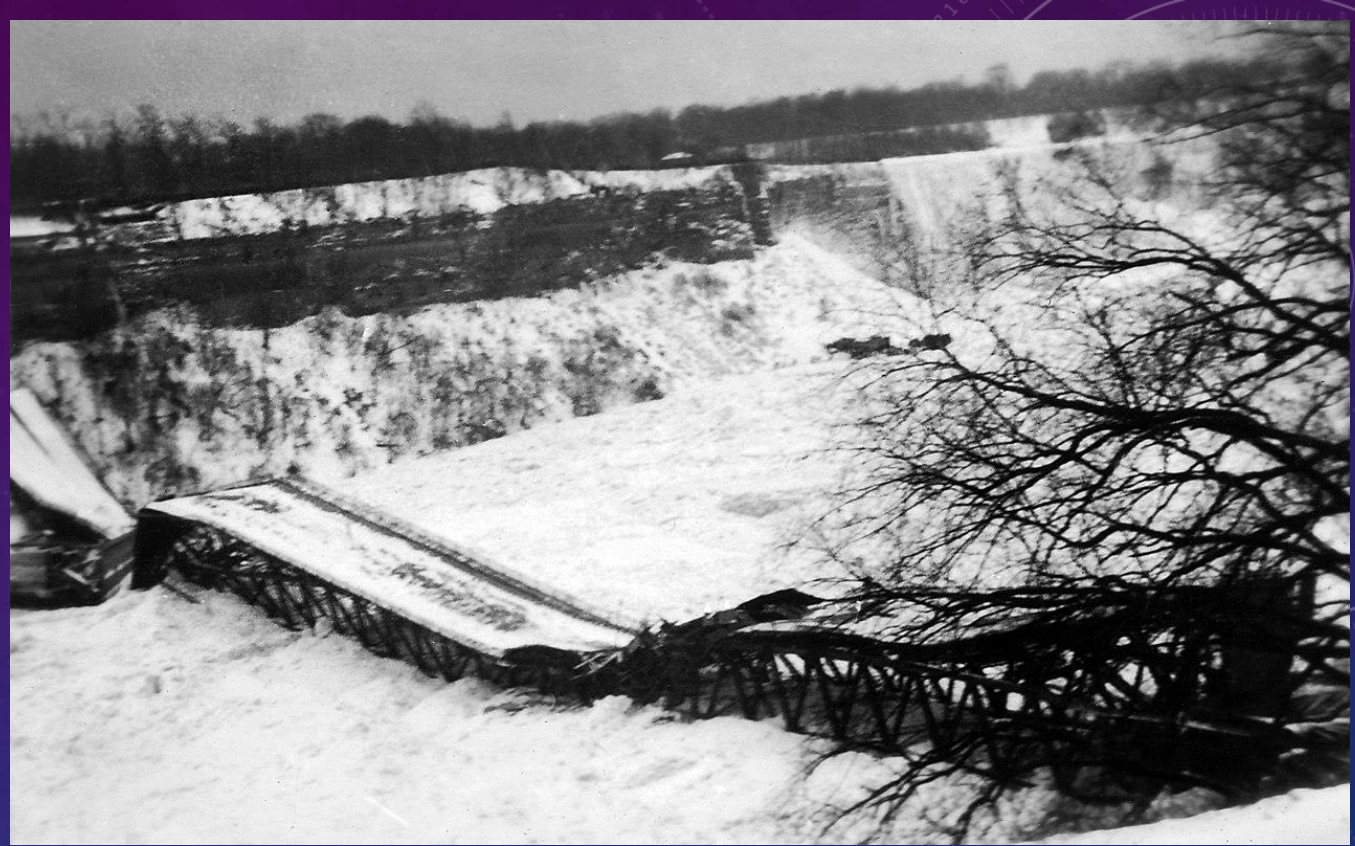
A sudden wind storm on Lake Erie sent a massive amount of ice over the falls, resulting in nearly 100 ft (30 m) of ice pushing against the bridge.

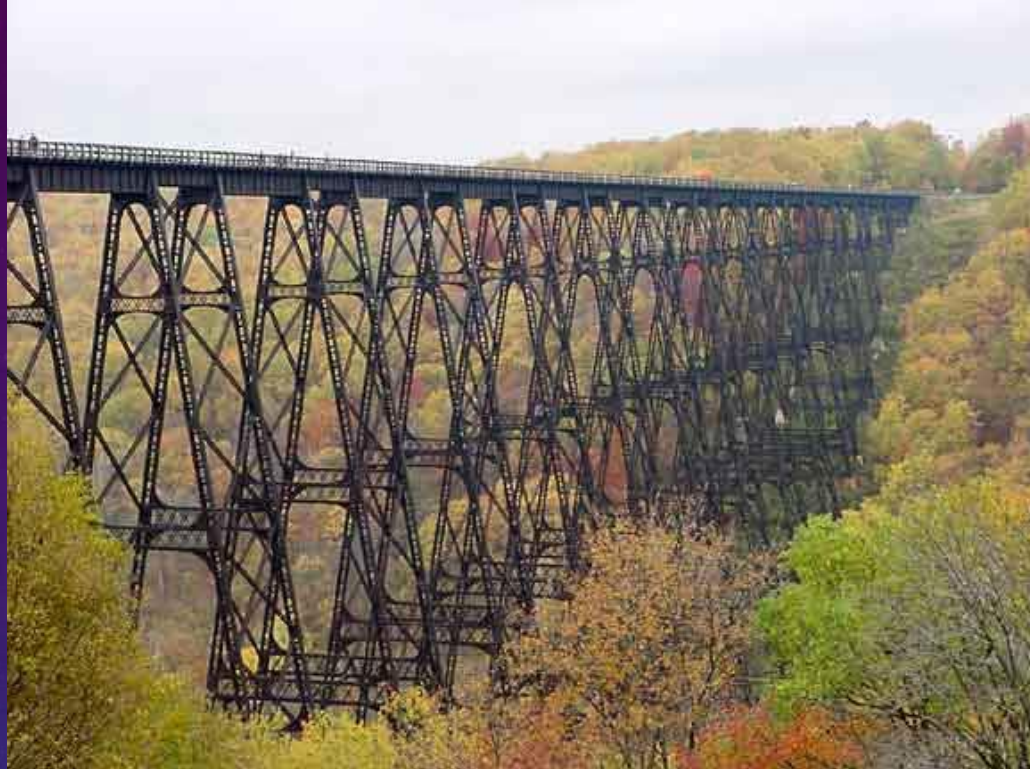
2003: Kinzua Bridge Collapse

Tornado blew Kinzua Viaduct down

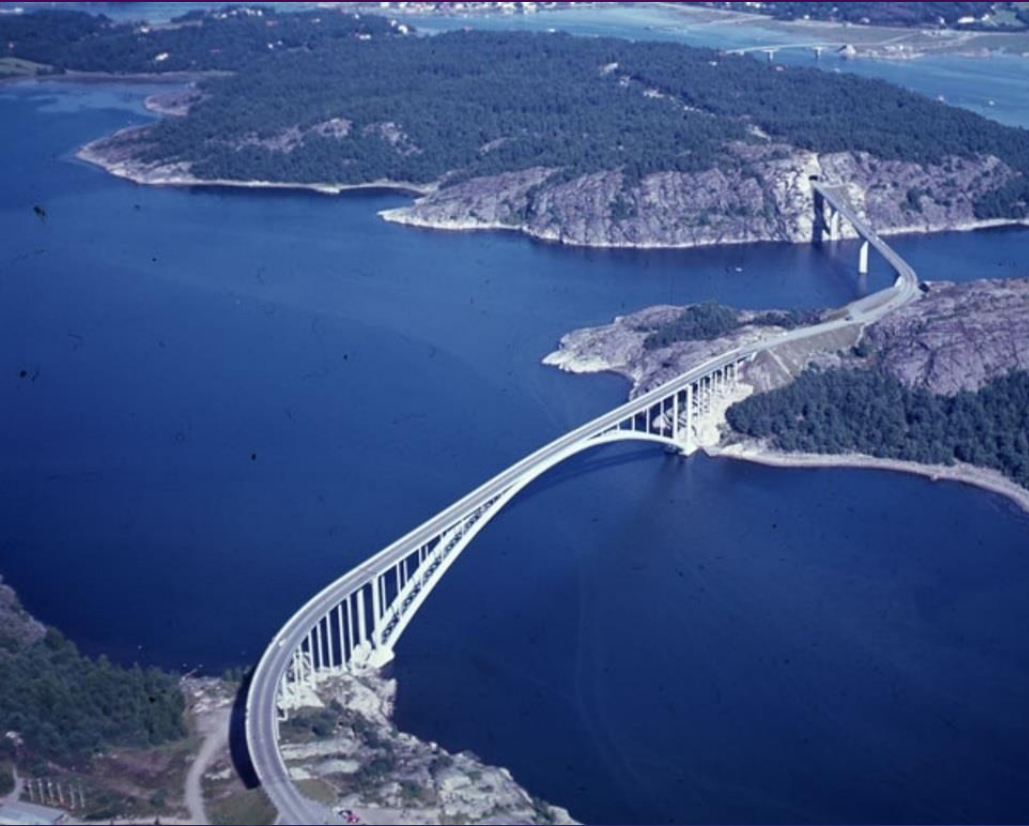
The Almö Bridge in 1962, Stenungsund, Sweden, 18 January 1980, Steel arch bridge

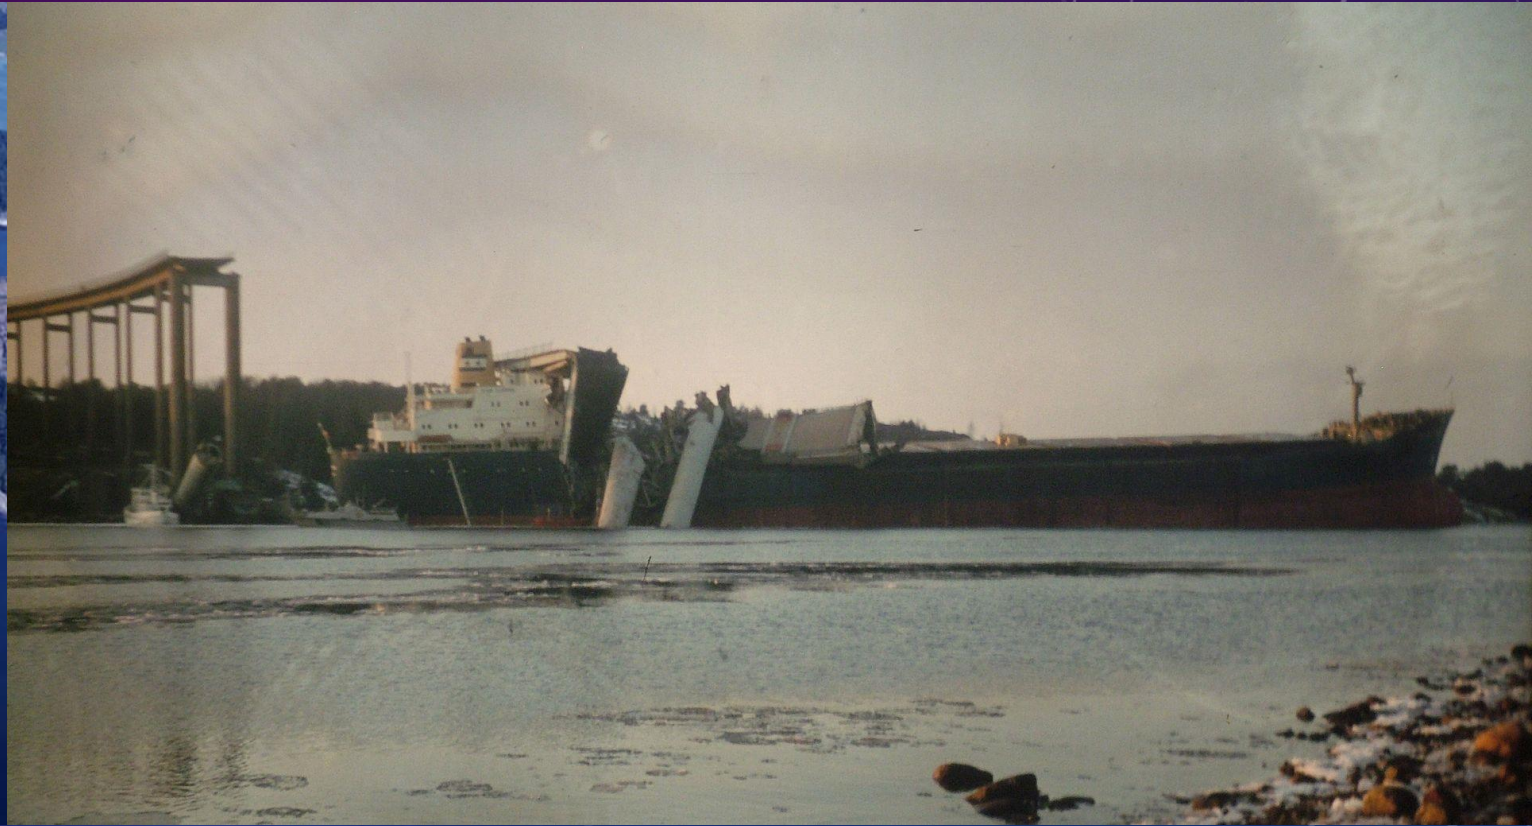
The collapsed bridge and MS Star Clipper Ship collision during bad visibility (mist)

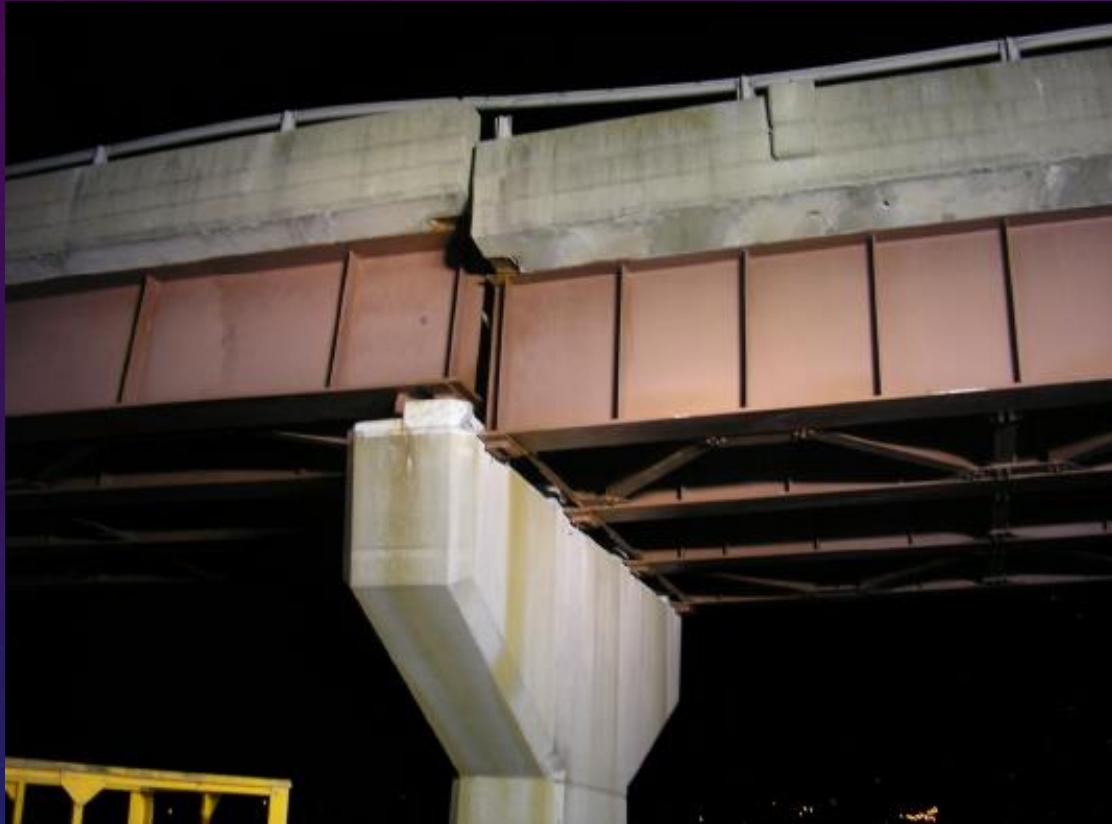
Partial Failure Pier 11, East Fascia

1. Lack of Expansion or contraction support area:

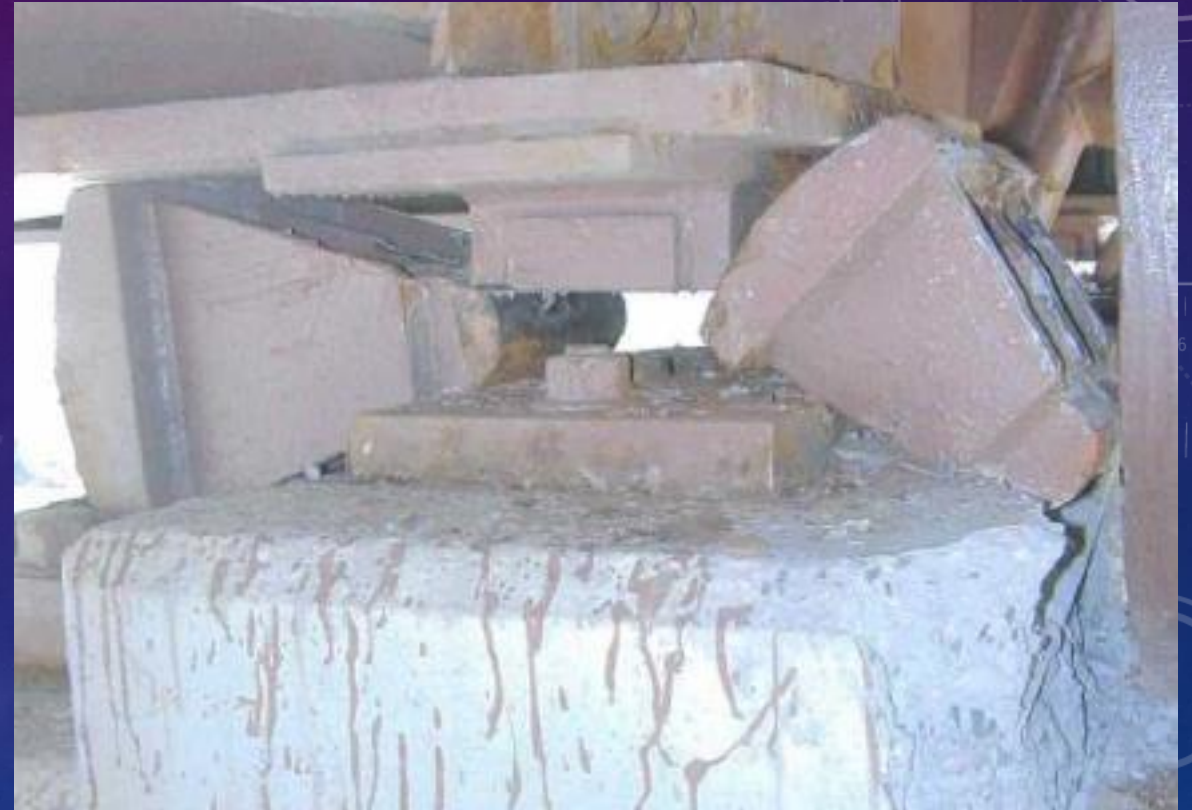
Failed Condition at East Fascia

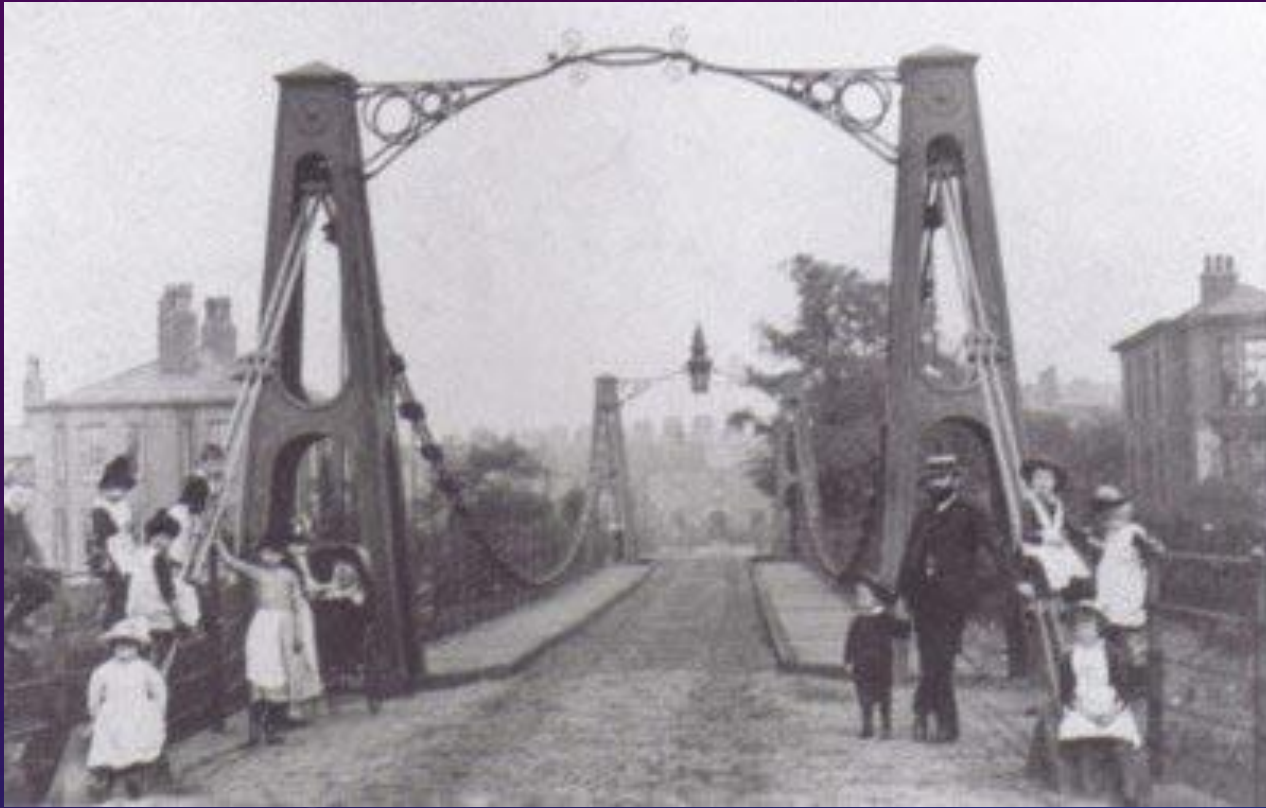
Broughton Suspension Bridge built in 1826, located in Manchester, England. On 12 April 1831, the bridge collapsed, reportedly due to mechanical resonance induced by troops marching. As a result of the incident, the British Army issued an order that troops should "break step" when crossing a bridge

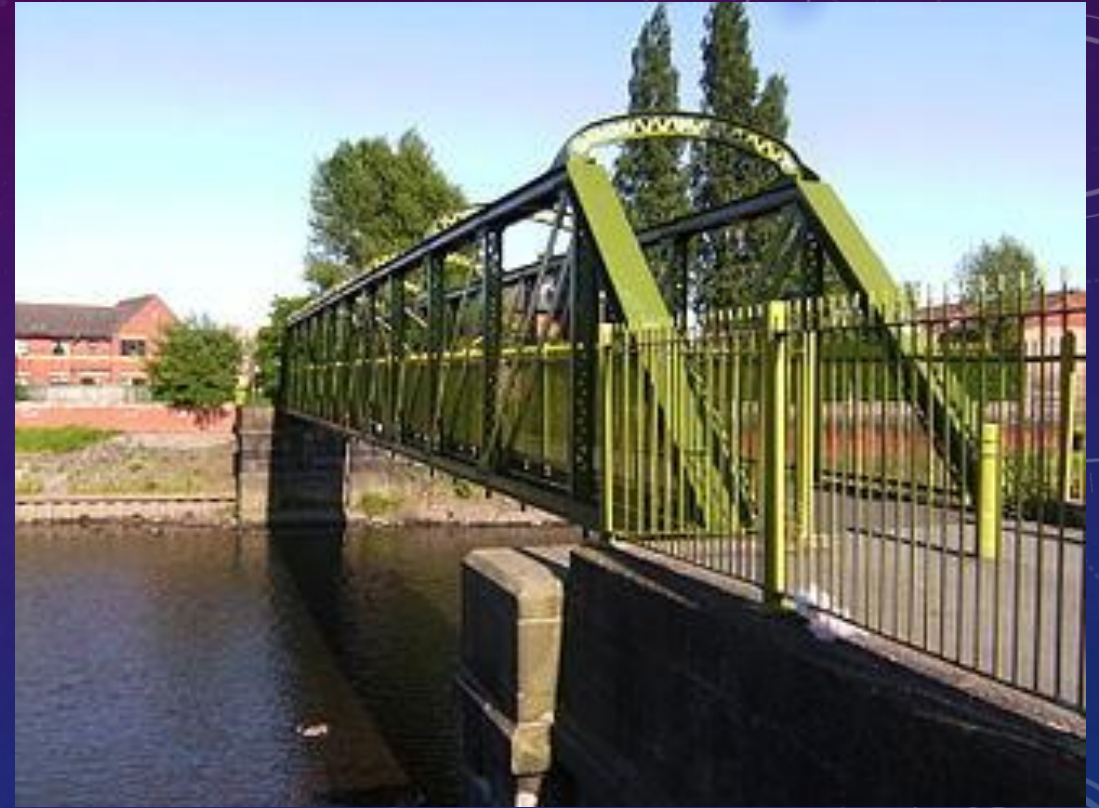
In 1924 it was replaced by a Pratt truss footbridge, still in use

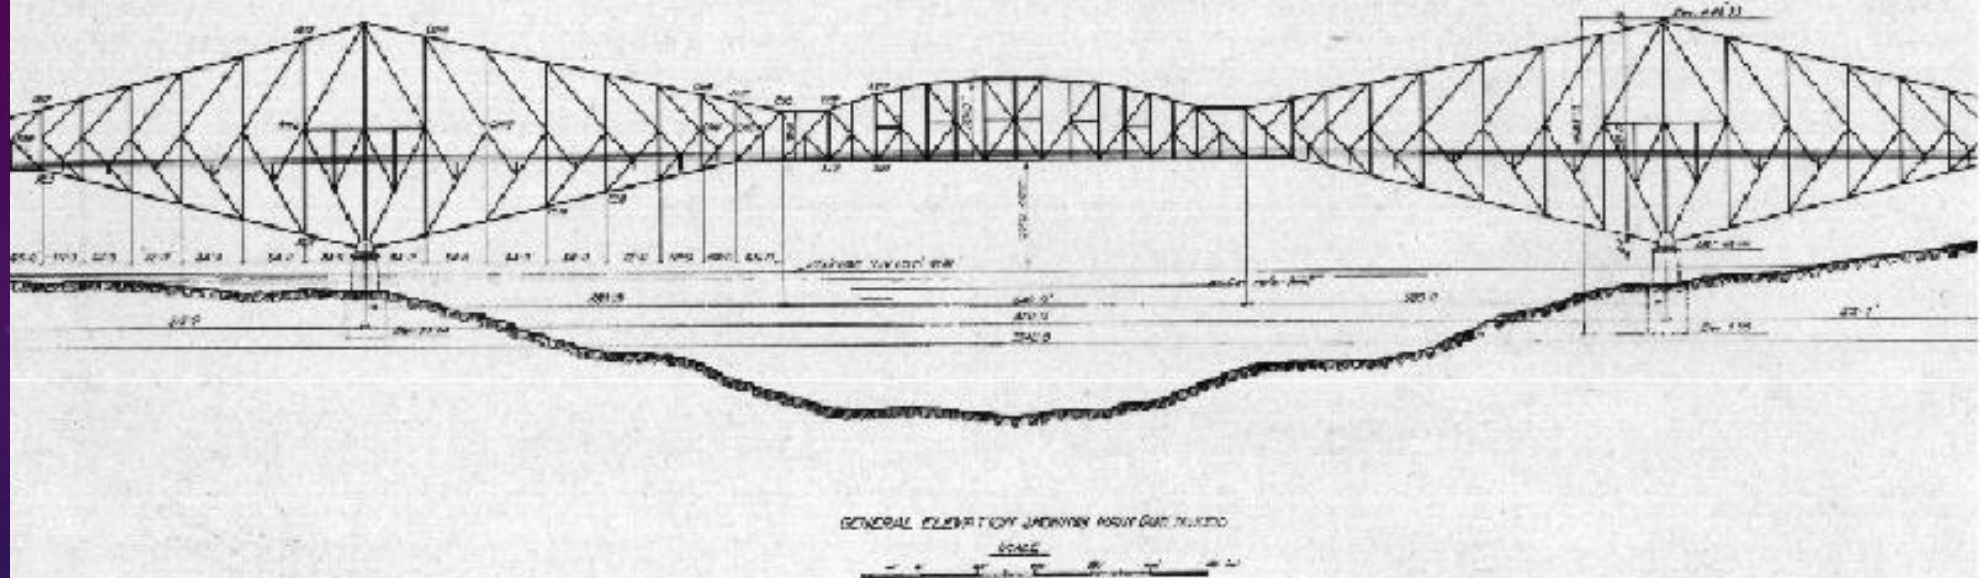
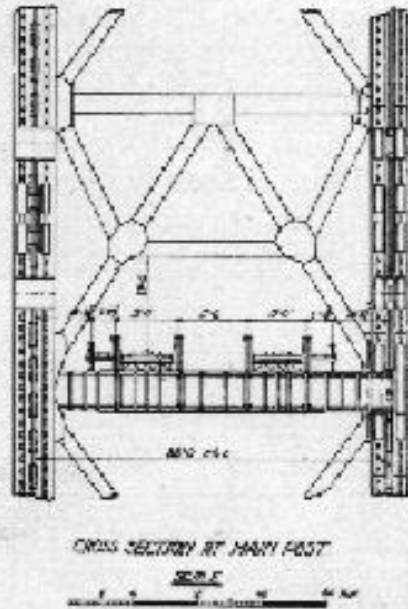
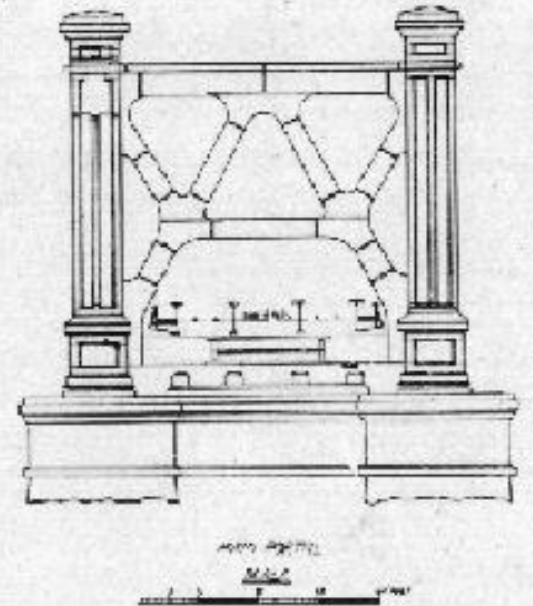
Quebec Bridge /
August 29, 1907

The Original Design:

1. Cantilever
superstructure with
two main supports
placed 1600 feet apart

2. Weighed a total of
62 million pounds

1. Before construction was to begin Cooper lengthened the span from 1600 ft to 1800 ft
2. He also modified specifications that would allow for higher unit stresses
3. There was no preliminary tests or research studies conducted to check these design changes
4. Cooper visited the site only 3 times, this left a lack of authority on the construction site
