BRIDGE FAILURES

Nabil Al-Bayati, MAsC., P.Eng

Structural and Bridge Engineer

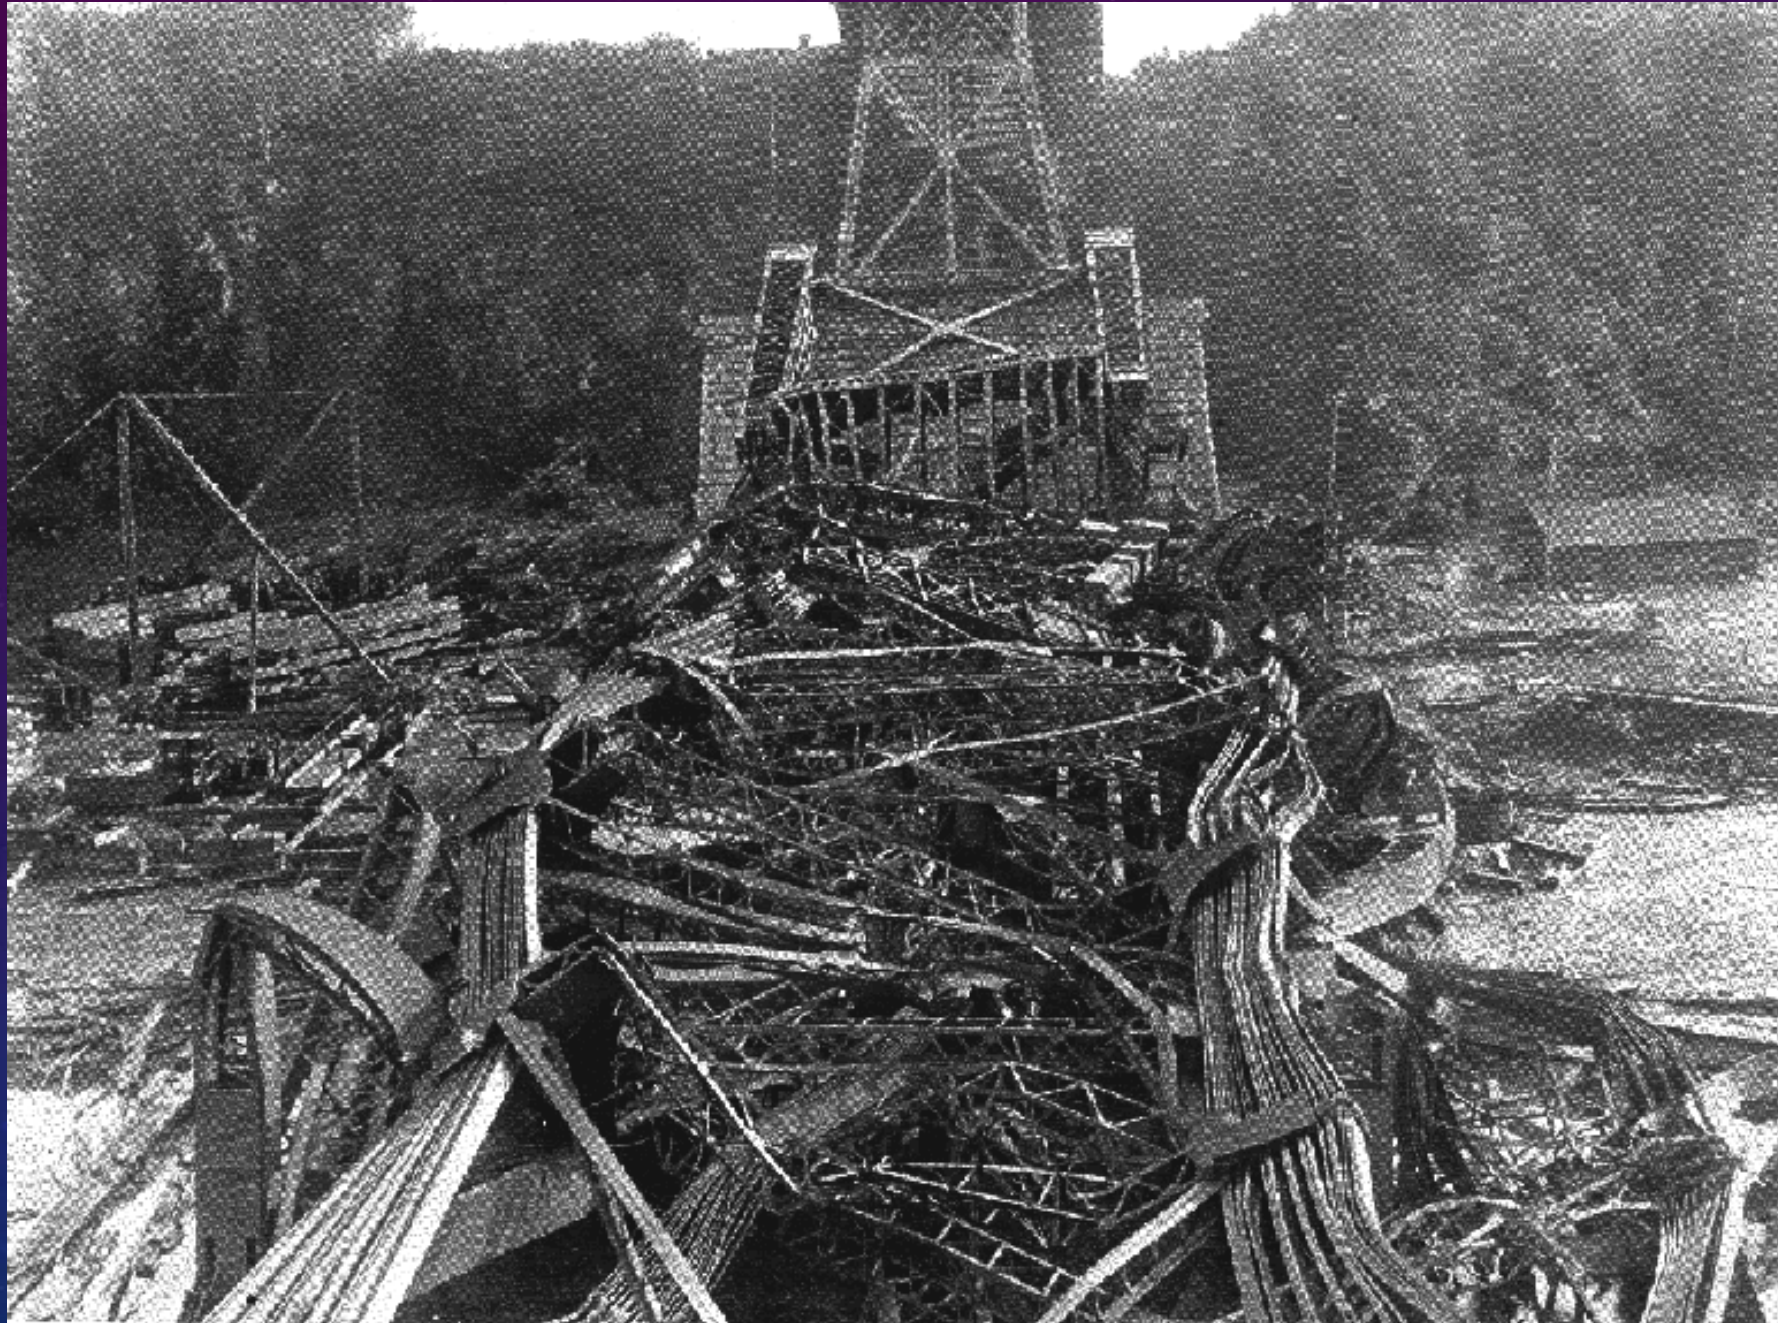
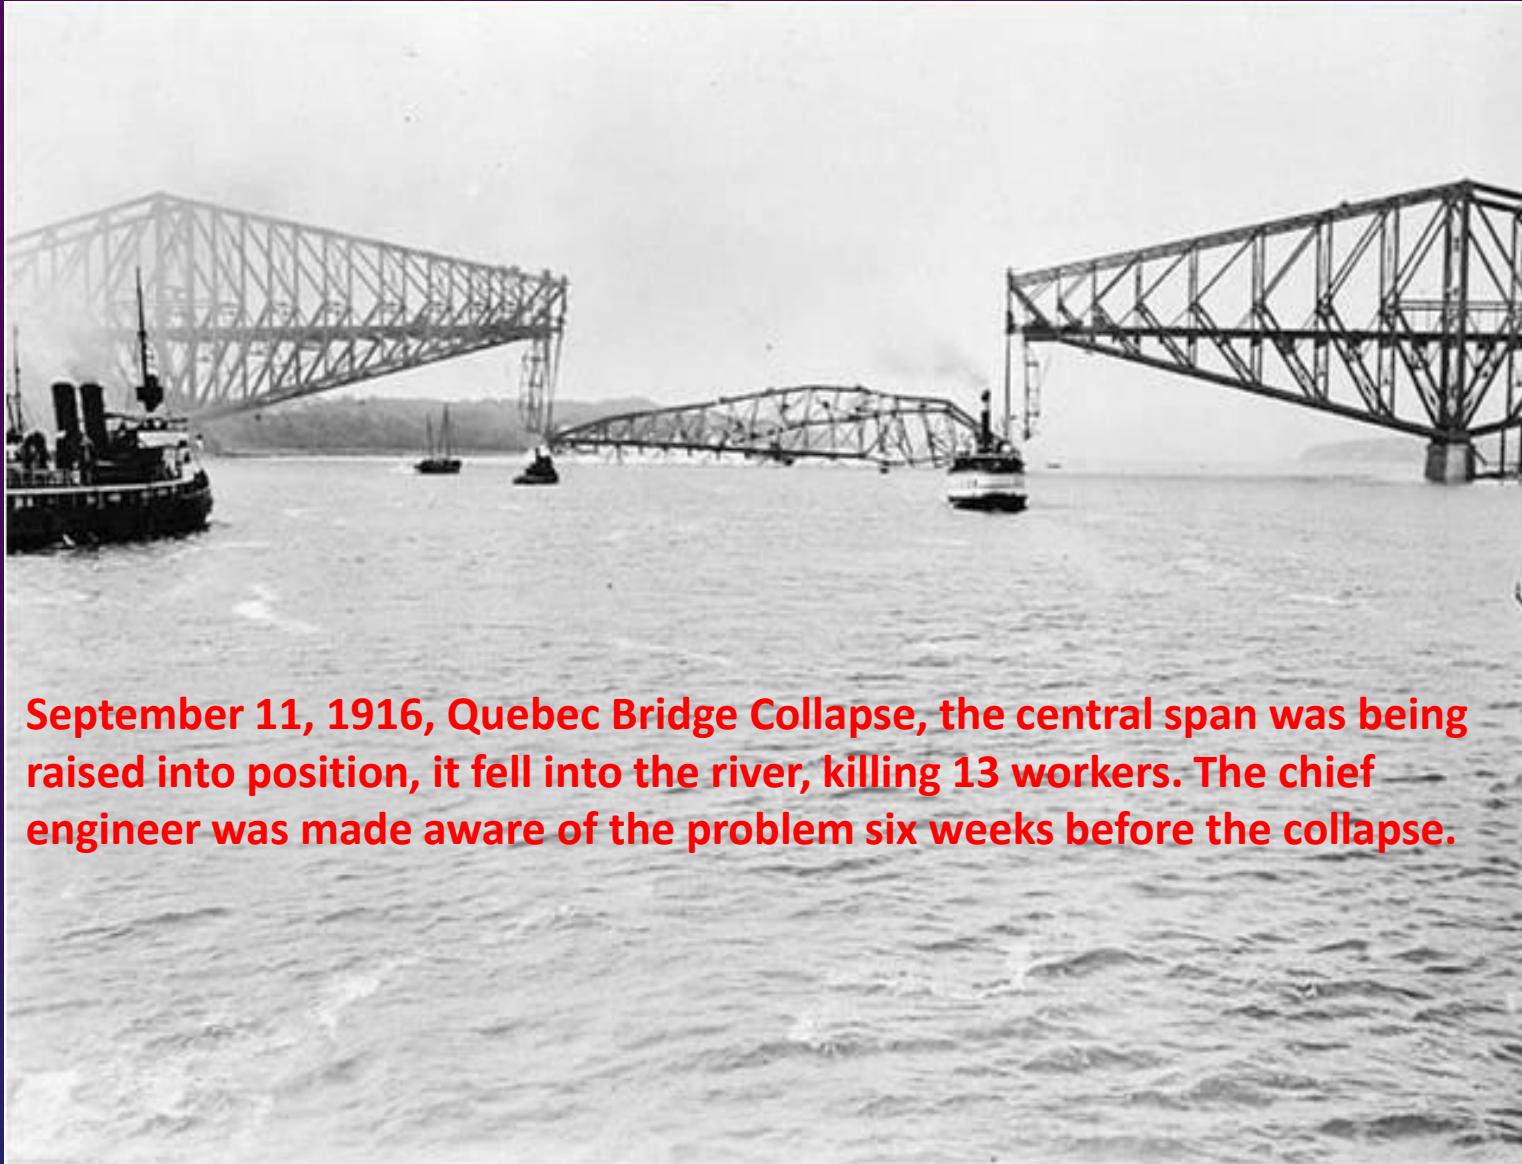
The Collapse at August 29, 1907

September 11, 1916, Quebec Bridge Collapse, the central span was being raised into position, it fell into the river, killing 13 workers. The chief engineer was made aware of the problem six weeks before the collapse.

1. The actual weight of steel put into the bridge had far exceeded the original weight
2. Compressive chords 7-L and 8-L of the south cantilever arm were bent
3. On August 27, 1907, it was reported that the deflection in chord 9-L had increased from three-quarters of an inch out of line to two and one-quarter inches in just a weeks time
4. Yet construction continued!!
5. For the Inaccurate theoretical estimates of the bridge's weight and the Unchecked changes
At August 29, 1907 the

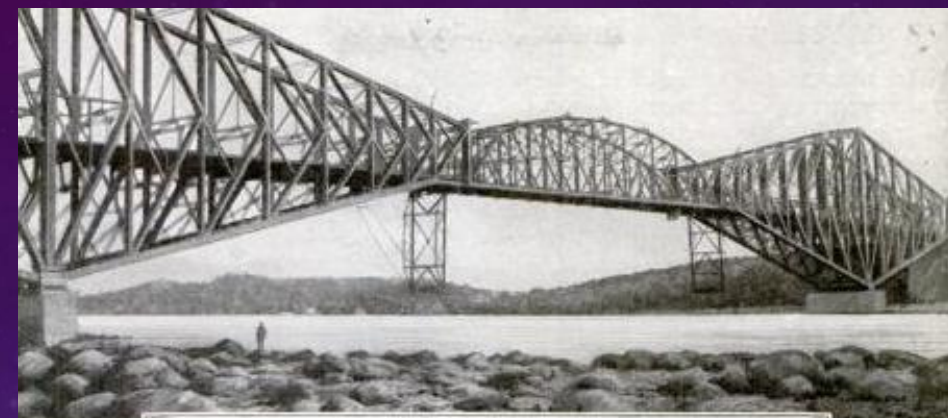
COPYRIGHT, INTERNATIONAL FILM SERVICE
The 640-Foot Central Span of the Mighty Quebec Bridge in Place: Undismayed by Tragic Failures in 1907 and 1916, the Builders have at Last Achieved One of the Greatest Triumphs in the History of Bridge Building

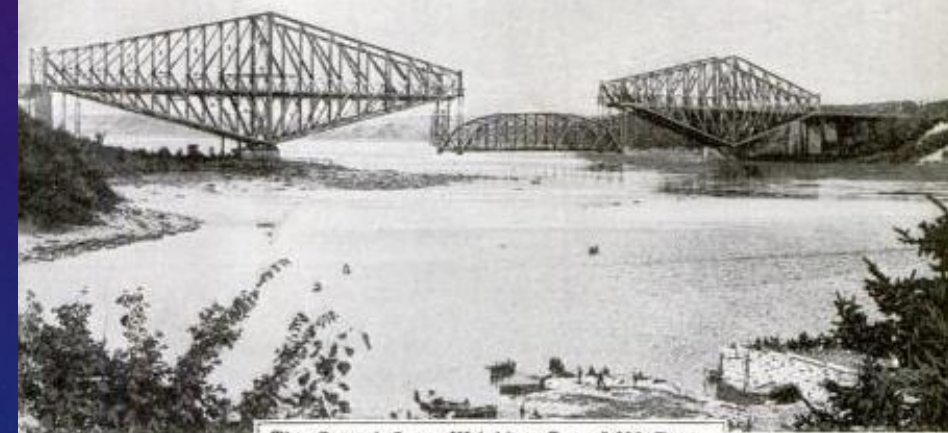
The Central Span, Weighing Over 5,000 Tons, being Raised by Practically the Same Method as was Employed Last Year, with Certain Added Precautions

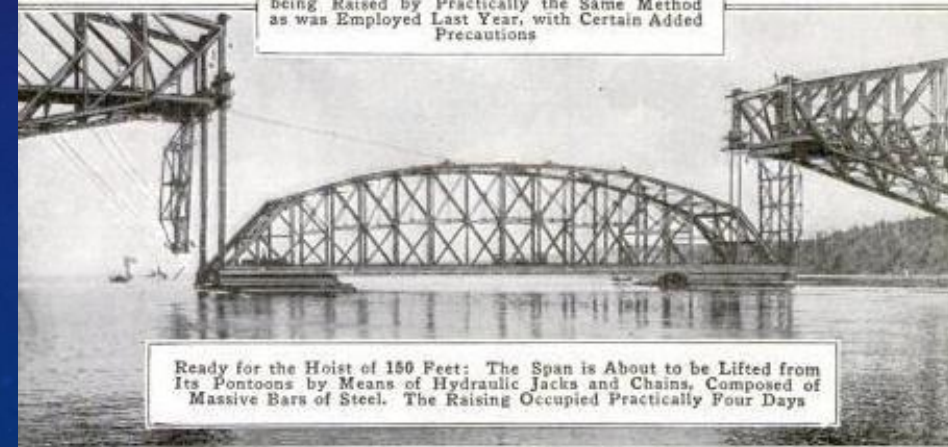
Ready for the Hoist of 150 Feet: The Span is About to be Lifted from its Pontoons by Means of Hydraulic Jacks and Chains, Composed of Massive Bars of Steel. The Raising Occupied Practically Four Days

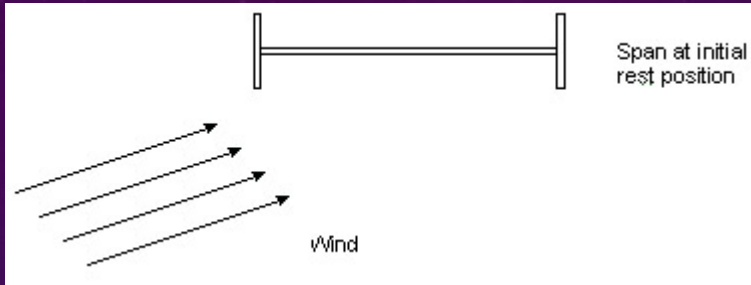
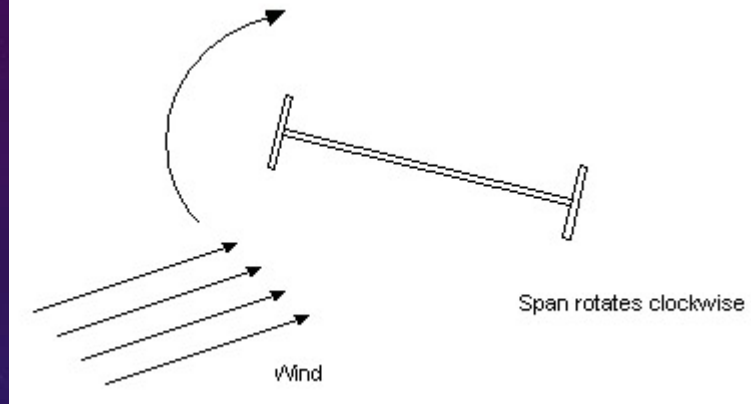
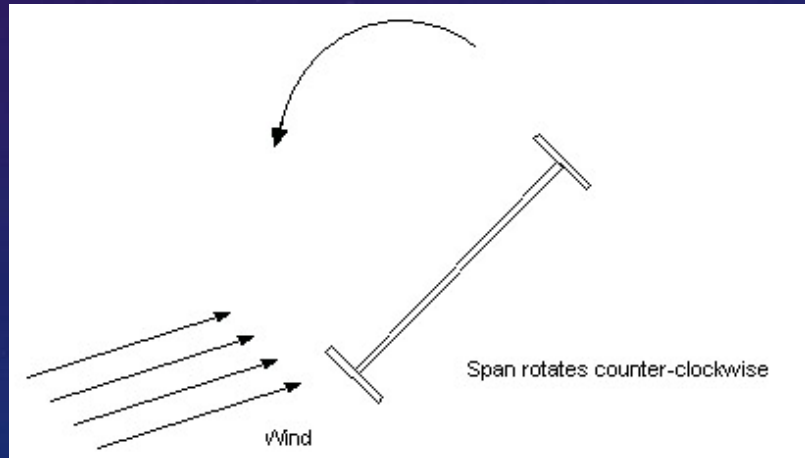
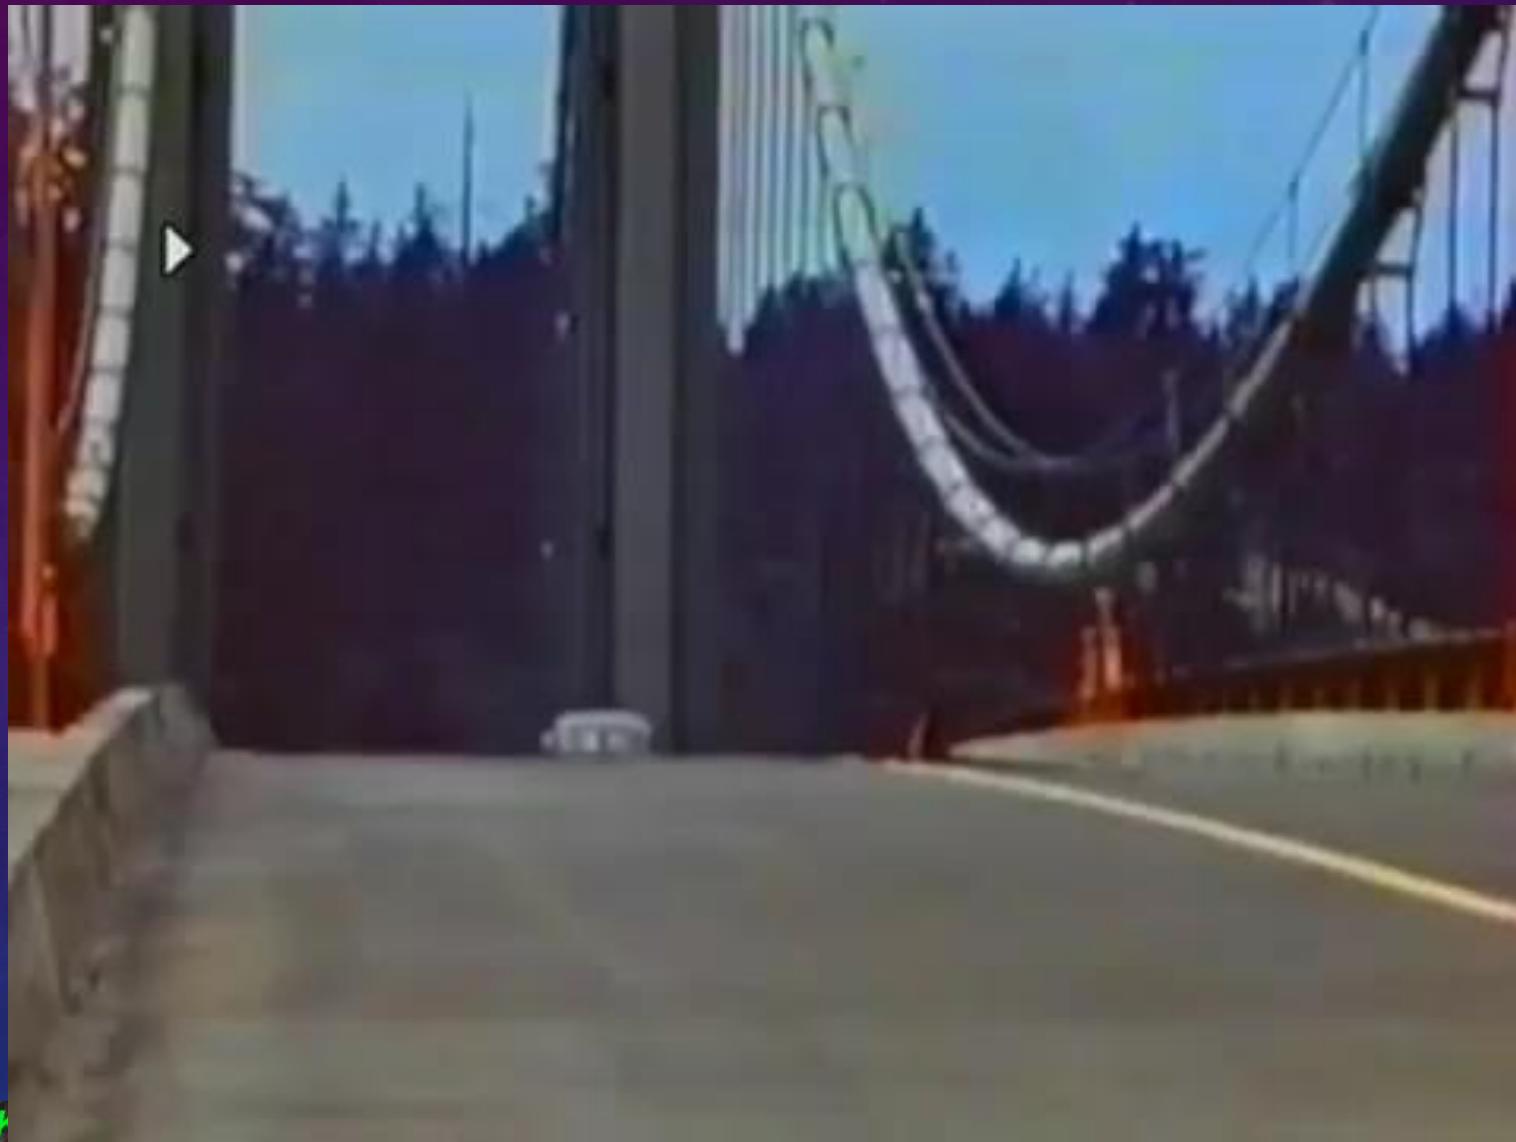
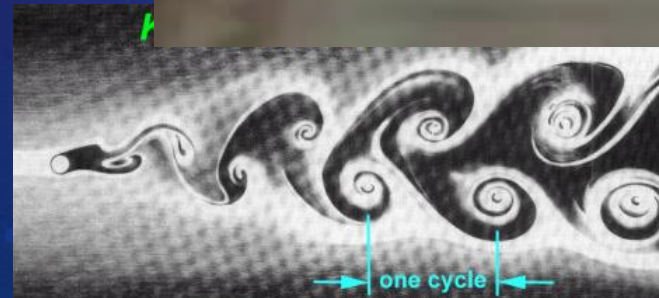
Tacoma Narrows Bridge

Aerodynamically poor design resulted in aeroelastic flutter, opened on July 1, 1940 then collapsed on November 7, 1940

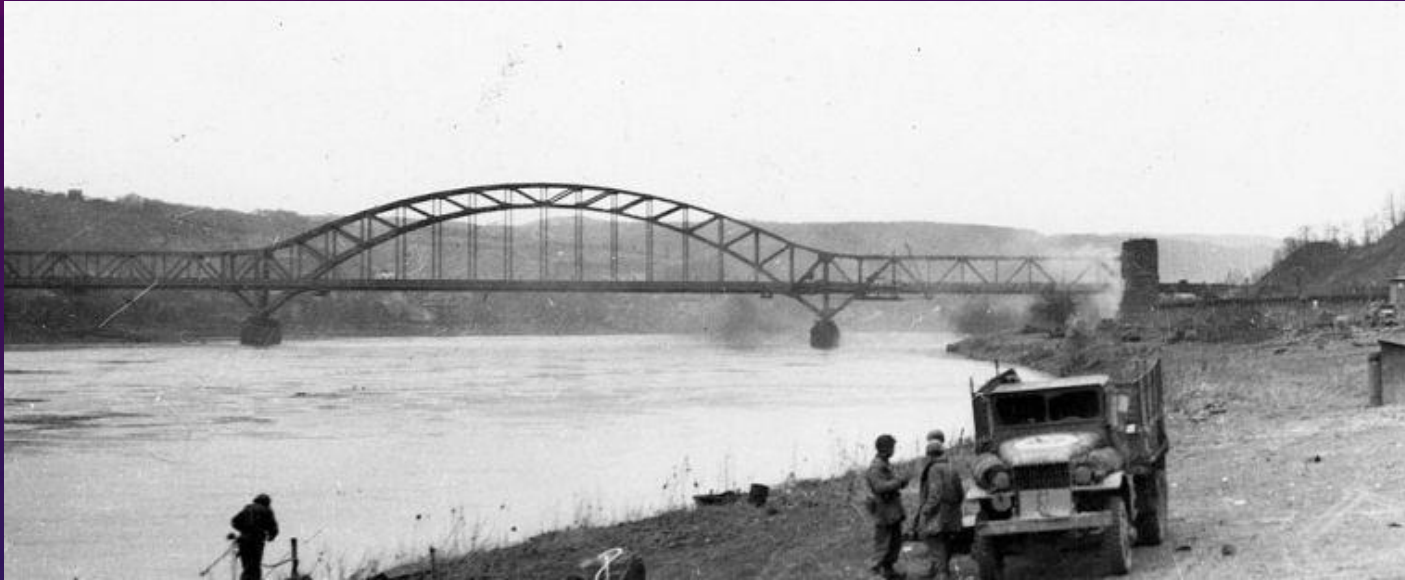
Ludendorff Bridge (Remagen Bridge) side view
Germany

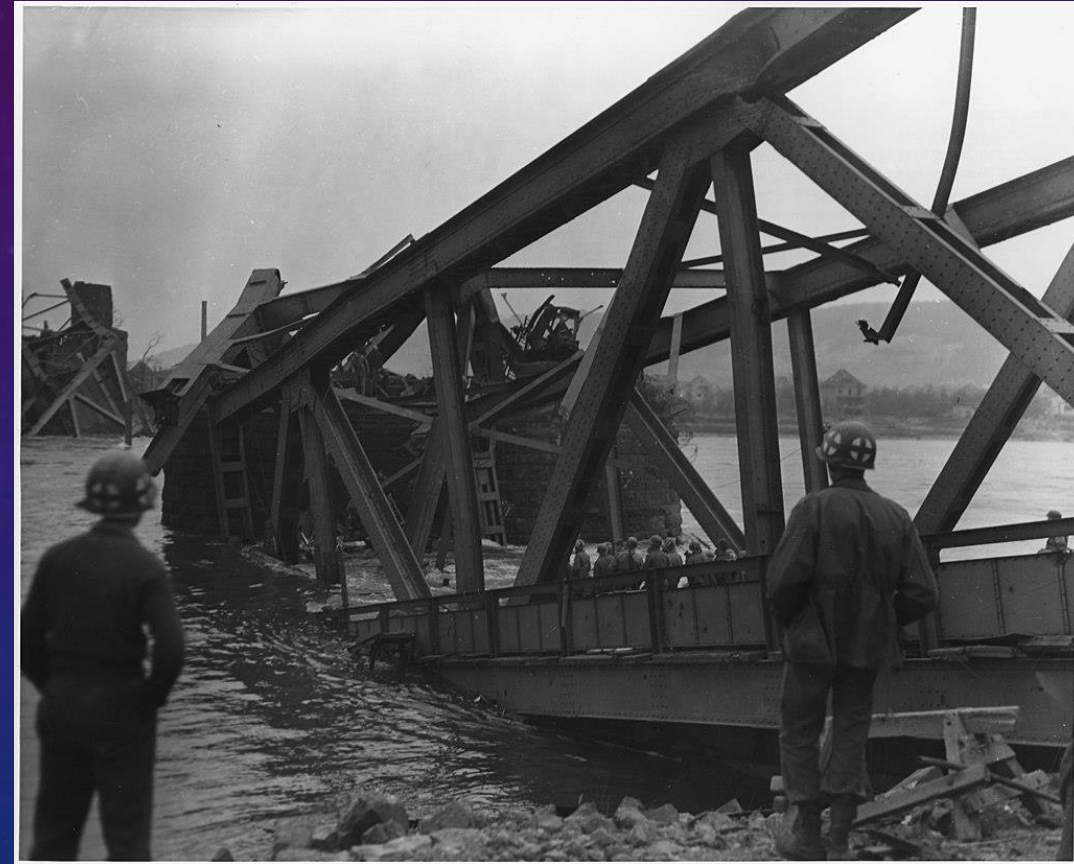
Ludendorff Bridge on March 17, 1945 after the collapse, Collapse due to previous battle damage incurred 7 March 1945
