## INSPECTION

### 1. INSPECT TIMING BELT

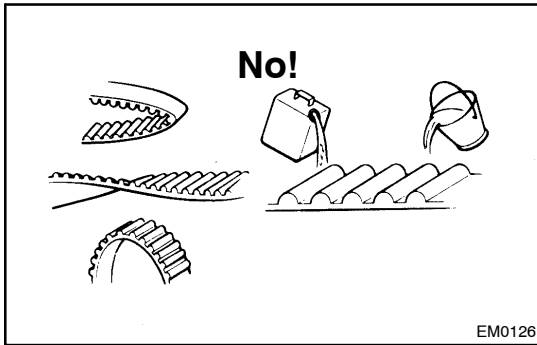
If there are any defects, as shown in the illustrations, check the following points.

- Premature parting
  - Check for proper installation.
  - Check the timing cover gasket for damage and proper installation.
- If the belt teeth are cracked or damaged, check to see if either camshaft is locked.
- If there is noticeable wear or cracks on the belt face, check to see if there are nicks on the side of the idler pulley lock.
- If there is wear or damage on only one side of the belt, check the belt guide and the alignment of each pulley.
- If there is noticeable wear on the belt teeth, check timing cover for damage and check gasket has been installed correctly and for foreign material on the pulley teeth.

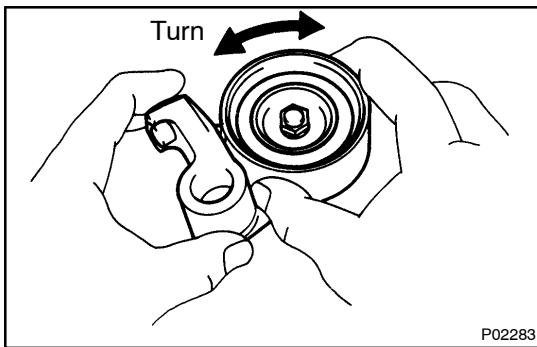
### 2. INSPECT IDLER PULLEY

- Visually check the seal portion of the idler pulley for oil leakage.

- Check the turning smoothness of the idler pulley.

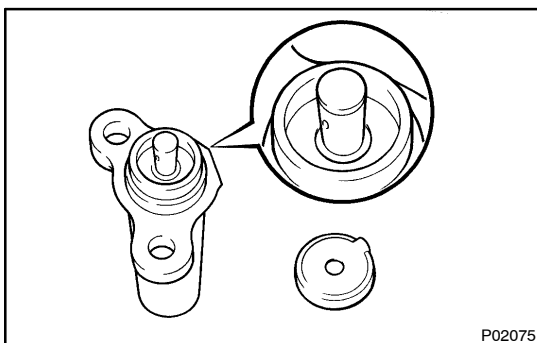
### 3. INSPECT DRIVE BELT TENSIONER

Check the turning smoothness of the tensioner.

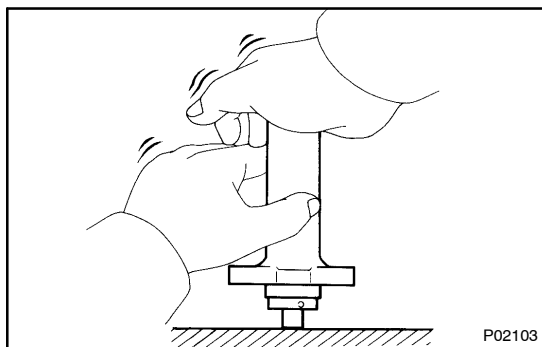
- Visually check tensioner for oil leakage.

If there is only the faintest trace of oil on the seal on the push rod side, the tensioner is all right.

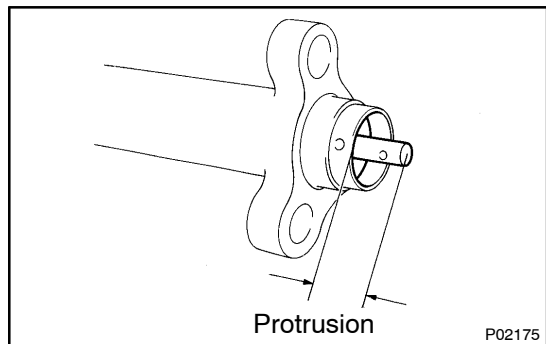
- (b) Hold the tensioner with both hands and push the push rod strongly against the floor or wall to check that it doesn't move.

If the push rod moves, replace the tensioner.
