# HABITAT EVALUATION AND RECOMMENDATIONS for WATER STREET GARDEN AND PARK

Submitted to Waterville Community Land Trust by Janet McMahon, Ecologist

October 2020 WCLT acknowledges with gratitude funding by the Fund for Maine Land Conservation and the Roger N. Heald Fund of the Maine Community Foundation

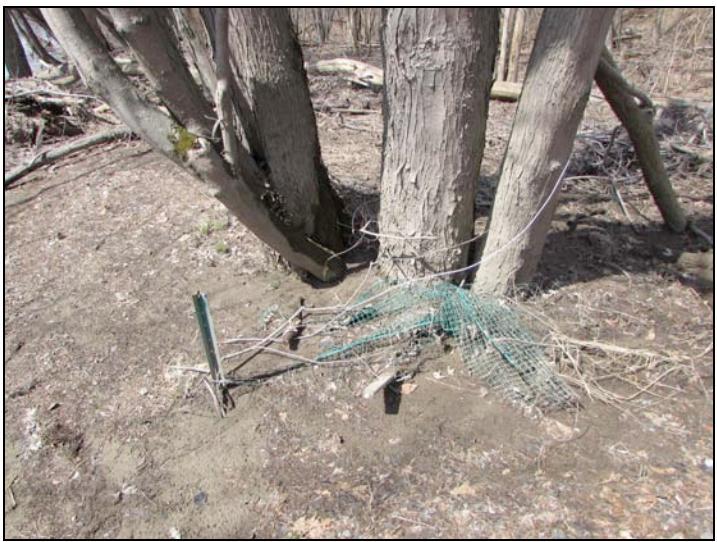
Green stake and old fencing near southerly line of property, April 22, 2020

The property has not been surveyed and the northern and southern boundaries are not clearly marked on the ground. The abutting landowner to the south claims to own land marked as WCLT's on the tax map. Old fencing and some green metal stakes extend from the uplands to the river near this line, which borders a right of way shown on tax map 33 as a "Passway" and on the CAI Technologies location map prepared for WCLT in 2017 (see Appendix A).

The northerly and southerly property boundaries are currently unclear and unmarked, and a survey has not been done. It is difficult to know when you are on the property. Clearly marked boundaries are necessary for future management, i.e., invasive species removal and control, clearing vistas, locating trails, etc.). It would also be helpful to know who owns the right-of-way or "passway" that borders the south line. This area is currently filled with debris and an old bottle dump. A boundary survey of the north and south lines is recommended, or, at a minimum, a boundary agreement with the abutter to the south (Map 33 Lot 94) who claims to own land that the tax map shows in WCLT ownership.

- Complete a boundary survey for the property.
- Once surveyed, using standard boundary marking procedures, blaze and paint property lines or mark with small aluminum markers indicating the land is owned and maintained by WCLT.
- Once marked, inspect boundaries yearly and remark as necessary (in general, painted boundaries should remain visible for about 10 years).
- Determine who owns the right-of-way that parallels the south line.

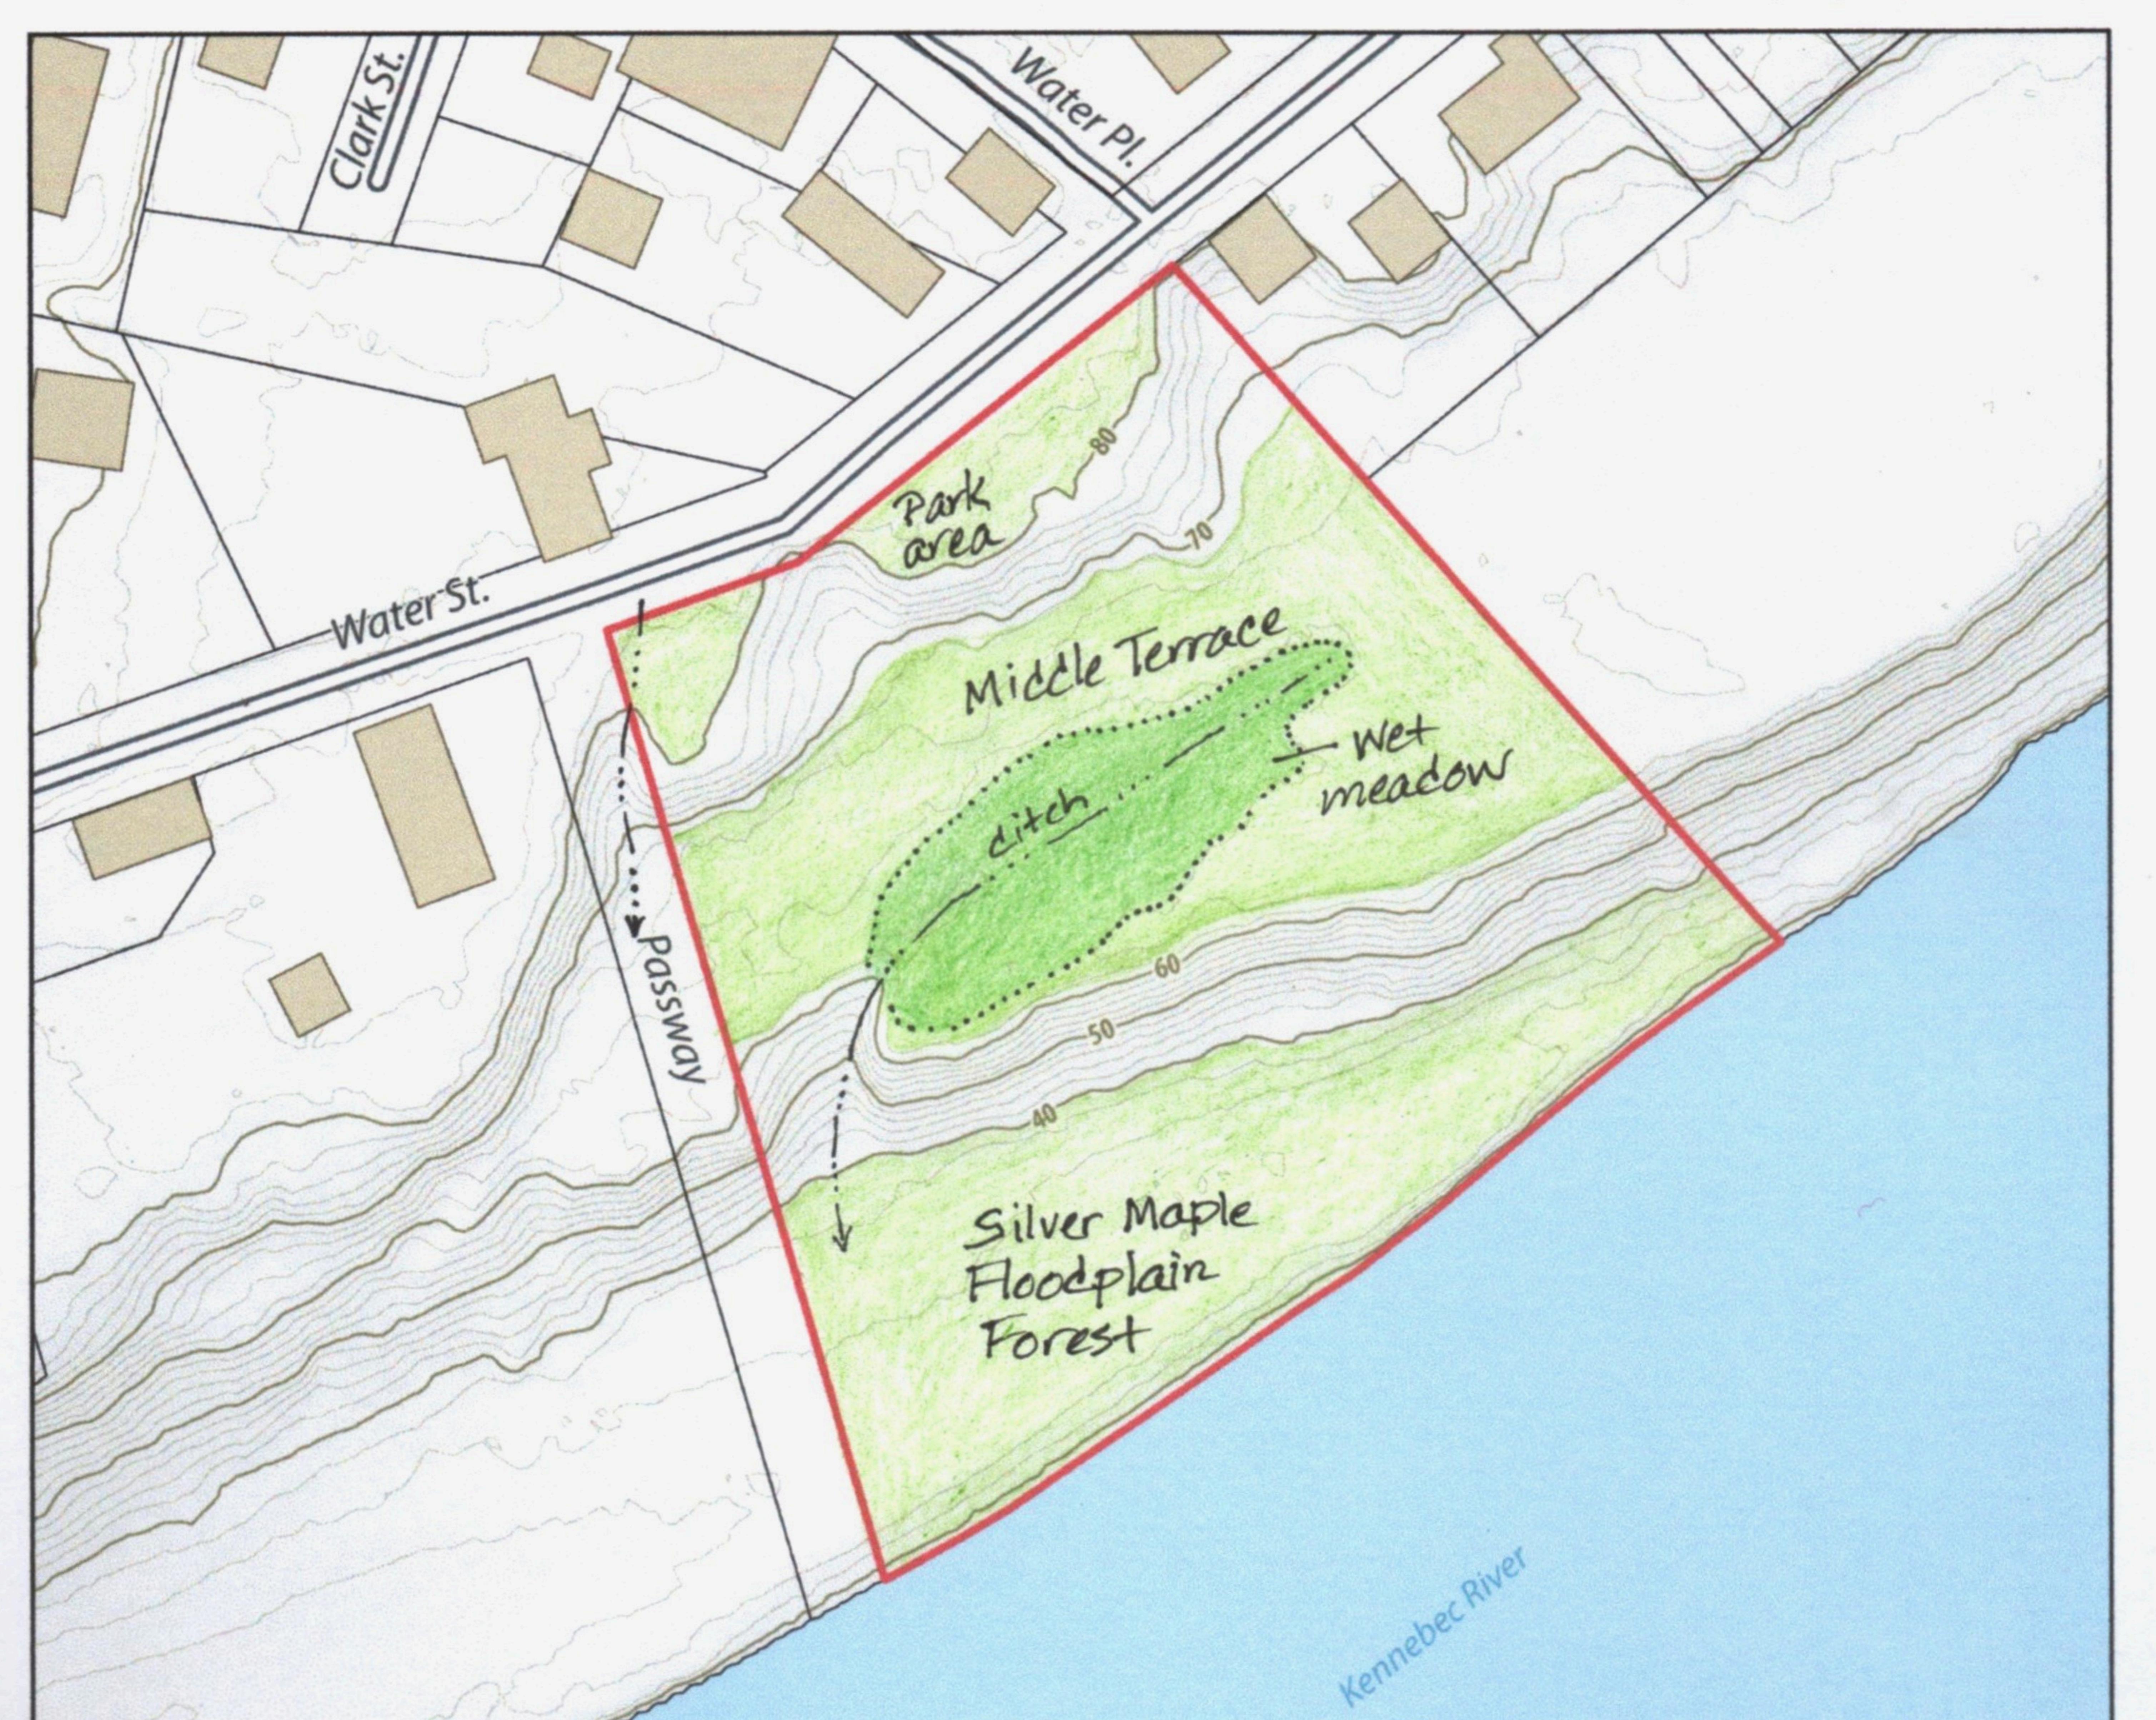
1":100' | Topographic Map

# Water Street Garden and Park

The topography of Water Street Garden and Park is complex. It has three tiers, including the cleared park area along Water Street, a level wet area that was once cleared farmland, and the floodplain along the Kennebec River. The land between these three levels drops steeply, with slopes varying from 30 to 50%. Elevation above sea level ranges from about 82 feet at Water Street to 30 feet at the Kennebec River. The land slopes to the southwest.

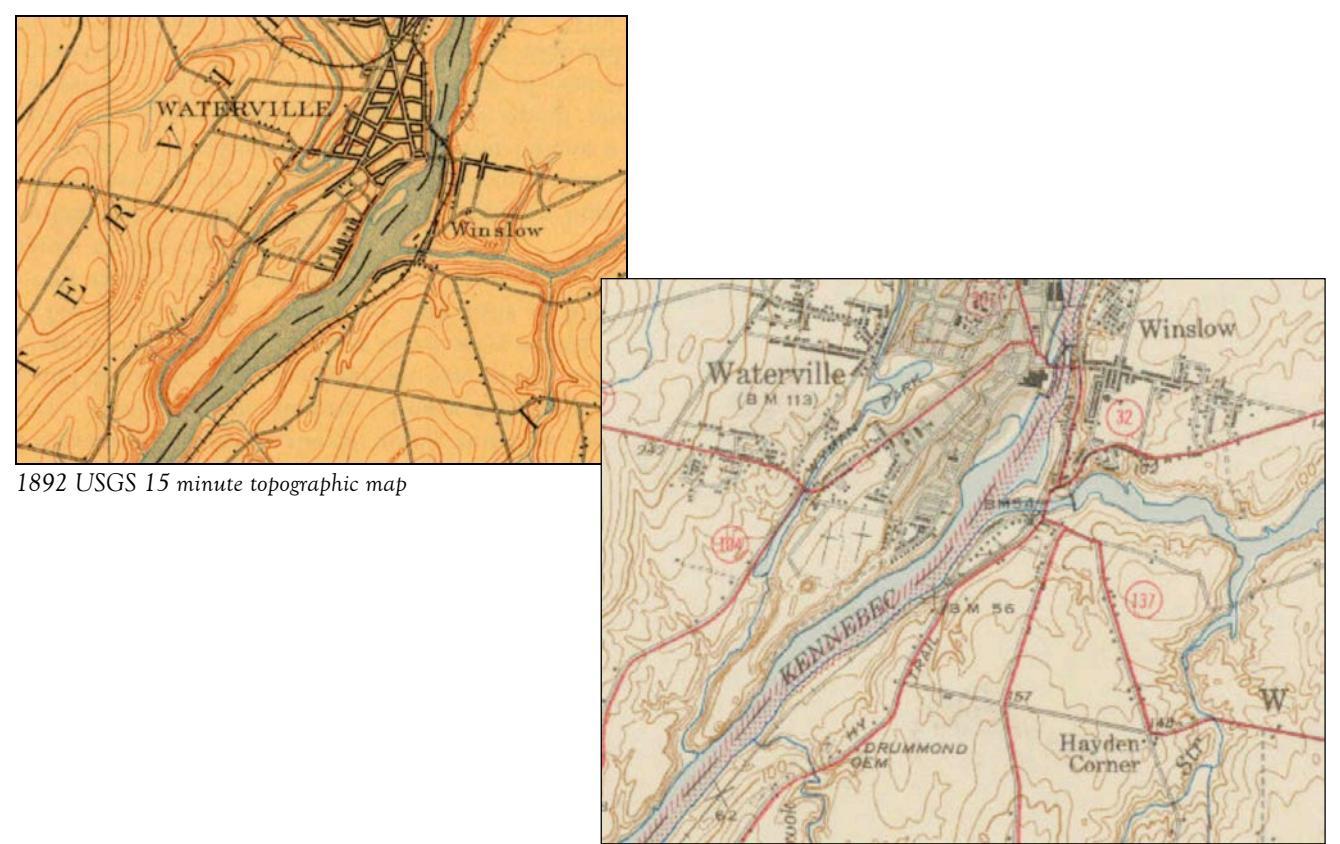
The post-European settlement history of the area is pieced together from maps and old aerial photos, and a close look at the land itself. An early 1856 map shows sparse settlement on the Waterville side of the Kennebec, with more structures concentrated on the Winslow side. A grid of roads in the Water Street area and a small cemetery where Pine Grove Cemetery is located today were already in place. The fairgrounds area shown below and other land has since been added to the Cemetery. The floodplain from the Park southeast to the mouth of the Messalonskee was undeveloped until the land was acquired by the Kennebec Sanitary Treatment District in 1949. The passway that is delineated on tax maps may have been provided access to a landing for a ferry that traveled between Waterville and Augusta (Nancy Williams, personal communication).

From 1856 map of Kennebec County, Maine

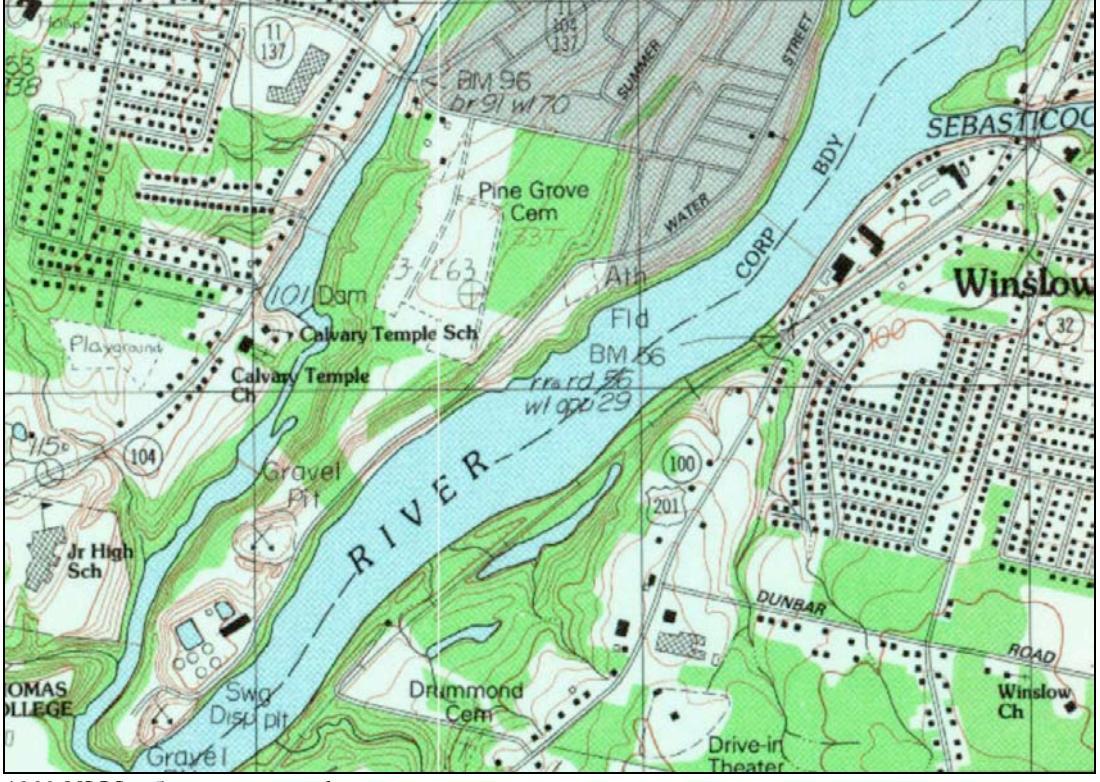
The sequence of topos on the following page show the progression of development in the area. The 1982 topo shows the sewage treatment plant and associated gravel pits and dump areas.

1943 USGS 15 minute topographic map

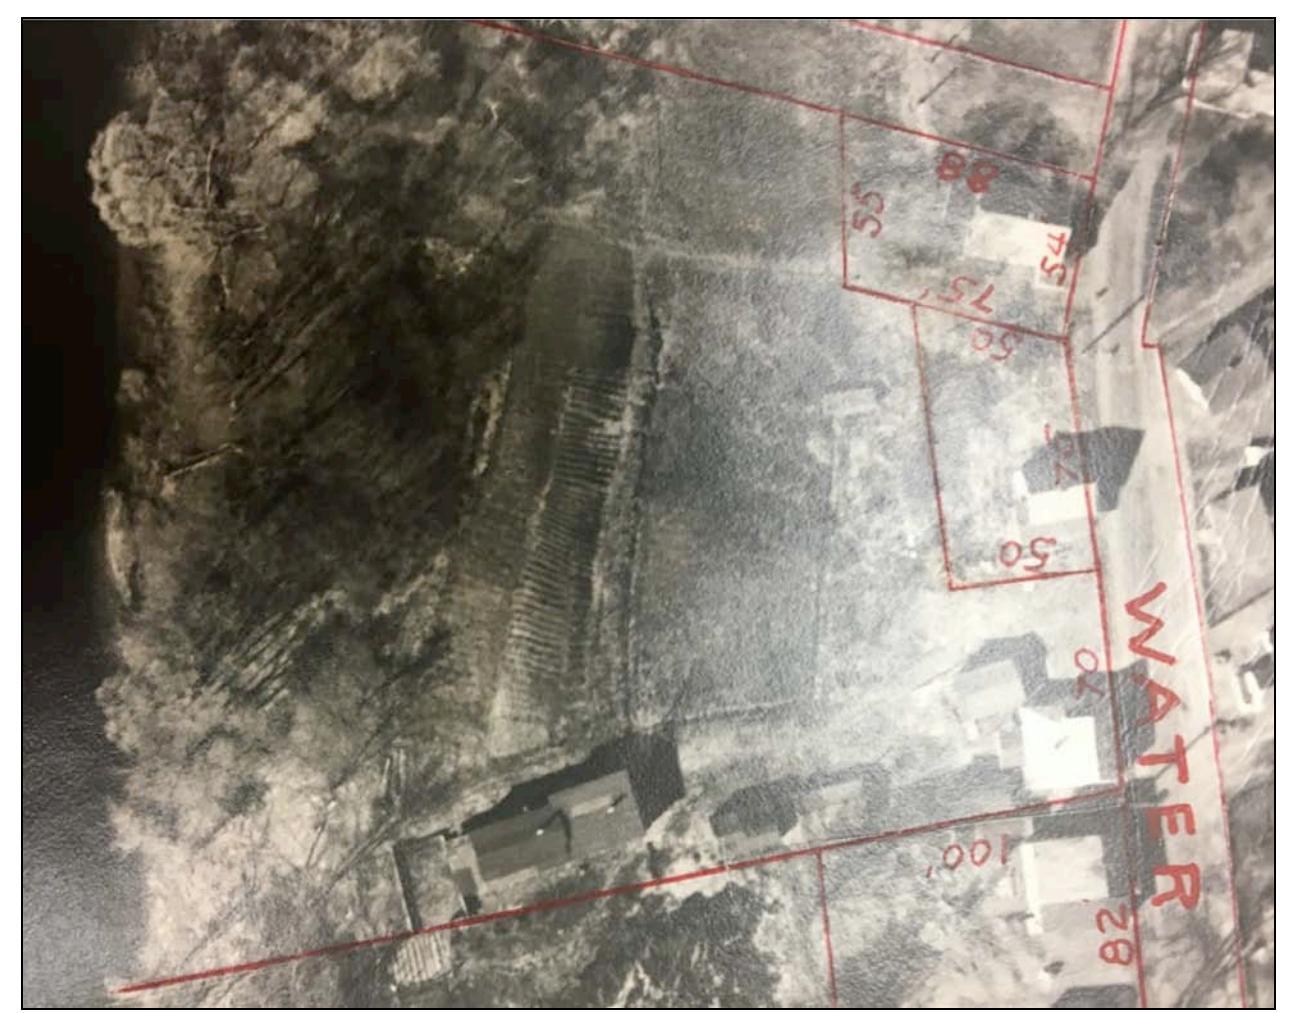
A house and smaller structure were located on the property when it was acquired by WCLT. These have been removed. The 1959 aerial photo below reveals that the entire upper level and middle terrace were cleared for pasture and row crops. A small shed is visible in the pasture area. Fencing is visible in the pasture area and there is a drainage ditch between the area with row crops and the pasture area. The cleared area and ditch are still apparent on the 2018 leaf-off aerial on page 3, although the clearing is much smaller in extent and the ditch has partially filled in. Much of the middle terrace has since reverted to a small sedge meadow. Note that the flood plain was forested except for a wide band of marsh vegetation along the shore which likely existed due to higher water levels from the Edwards Dam impoundment.

1959 US Soil and Water Conservation District aerial photo provided by WCLT

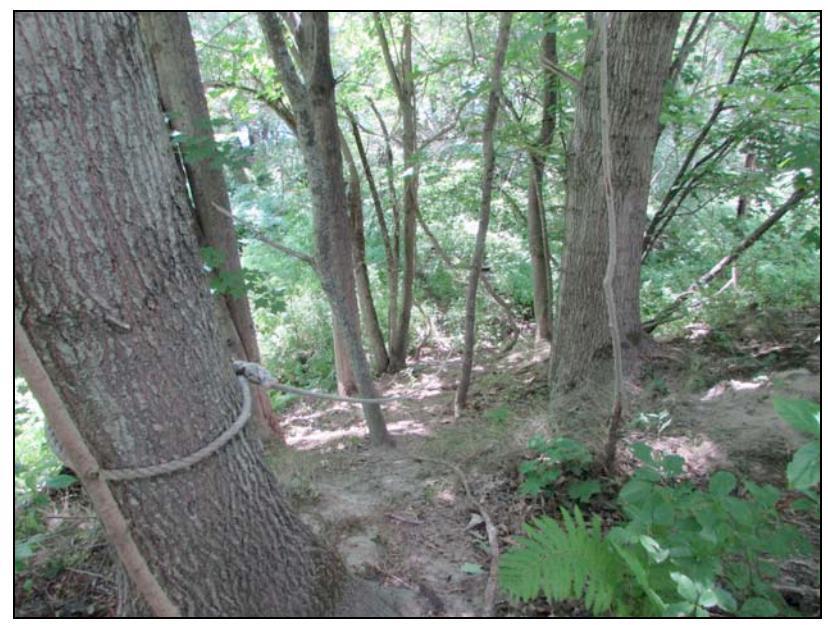
Hand rope on slope bellow middle terrace

Current use of the property is light, in part because the Park is new, and because there is little to draw people to it. The steep slopes and soft soils separating the property's three levels will make access to the property's most notable feature – the silver maple floodplain – problematic. Creating a trail here could result in too much use and would conflict with the property's wildlife habitat value. In addition, trail maintenance would require significant volunteer time to remove debris from the annual spring freshet and other flood events.

Recreational use of the middle terrace and floodplain would require installation of stairs or

steps, and deep posts due to the softness of the soil. The middle terrace could be accessed where there is a gentler grade perpendicular to the slope near the bench area (which is occassionally used now), but ADA requirements could be difficult to meet. The first step for WCLT, after determining boundaries on the ground, will be to explore and define appropriate uses.

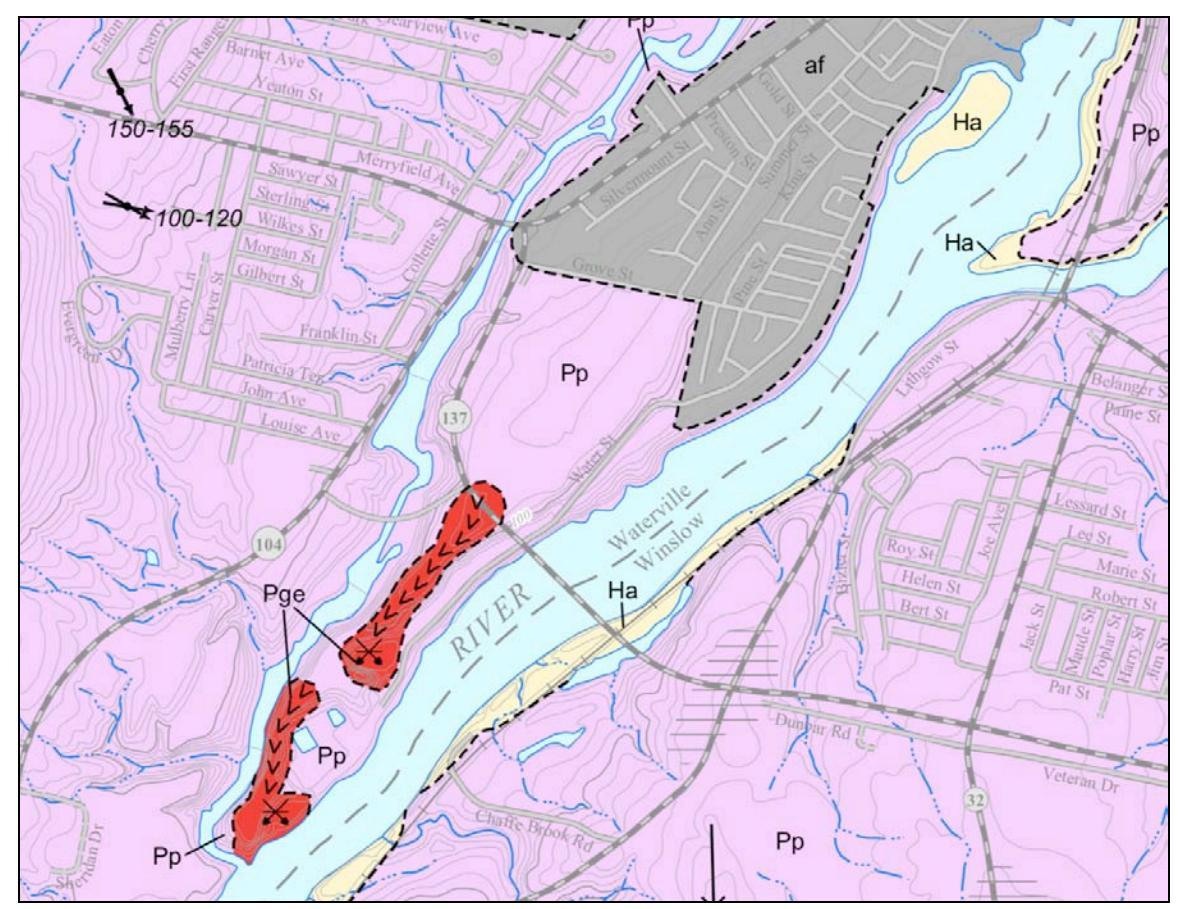
deposits originated during the most recent Ice Age as glaciers retreated from the area around 13,000 years ago. The weight of the ice had pushed down the land surface so that, as the glacier retreated, ocean waters extended far up into the Kennebec valley depositing vast amounts of silt, clay and sand over all of Waterville and as far inland as Bingham, Maine. These deposits, known as the Presumpscot Formation, have since been eroded into the "layers" of sediment that define the topography of Water Street Garden and Park today. Stream deposits laid down annually during spring freshets occur along the Kennebec floodplain. These are referred to as stream alluvium by surficial geologists. Also of interest are the sand and gravel esker deposits to the south on Waterville Sewerage District land. These "rivers of sediment" formed from meltwater streams that flowed under the glacier as it melted and are shown in red on the surficial map below.

Surficial geology of the area, from Weddel and Eckert 2016. Pp = Presumpscot Formation marine clays and silt; Ha = stream alluvial deposits; Pge = esker deposits. The borrow pit symbols indicate sand and gravel mines.

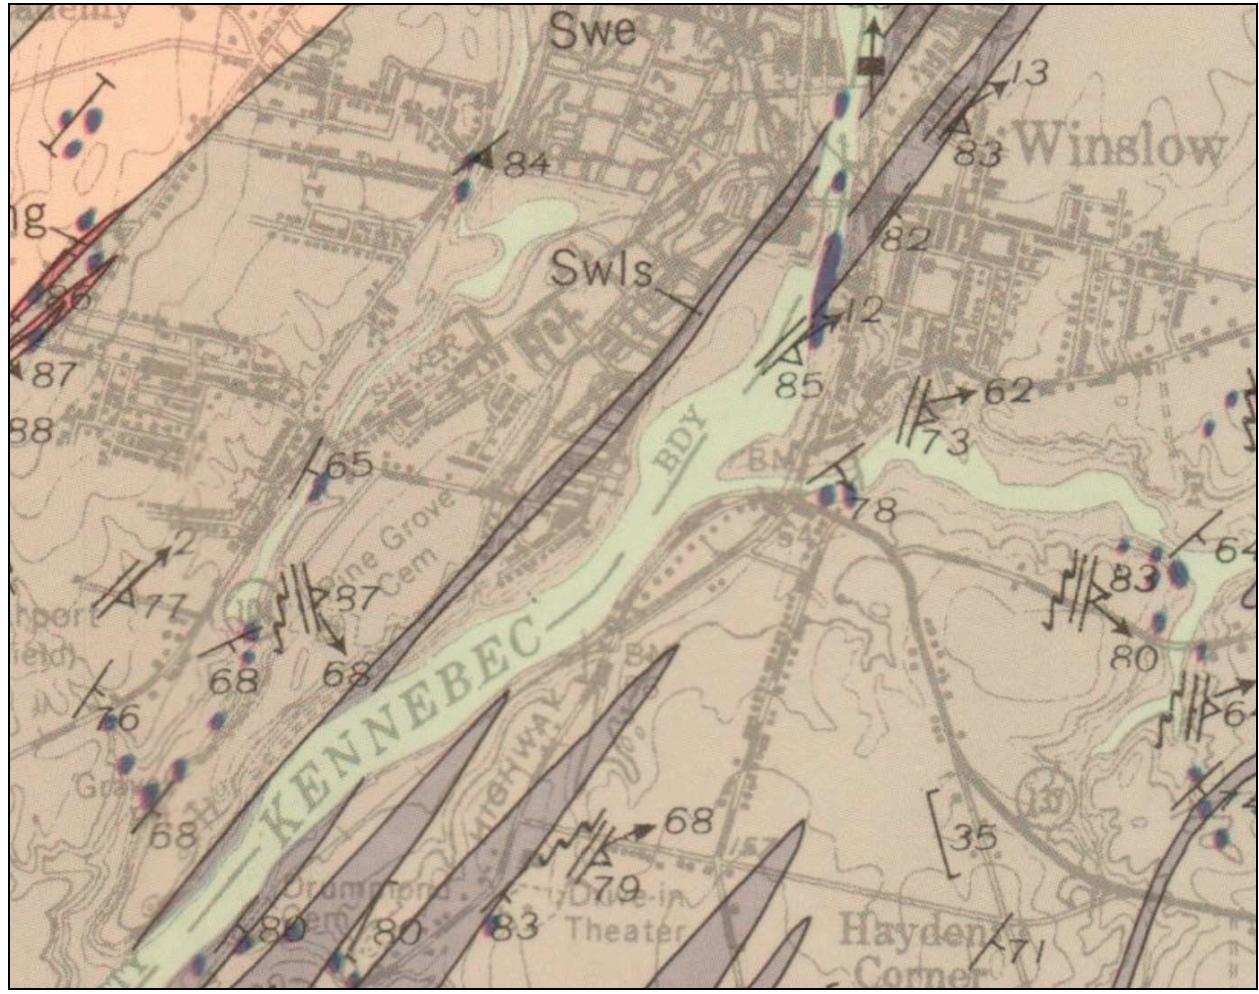
Bedrock lies far below the surface. The two bedrock types underlying the deep marine sediments on the property are part of the Waterville Formation (Osberg 1968). This formation includes thin beds of alternating greenish grey pelite (also called mudstone or shale) and micacious quartzite, a metamorphic rock. Interbedded with these are narrow bands of phyllite. Phyllite is a metamorphic rock that is intermediate between slate and schist (see bedrock map on the following page). The presence of mica crystals give it a silky sheen. No outcrops were observed on the property. Some ledge outcrops are exposed offshore in the Kennebec River during periods of low flow.

Bedrock geology of the area, from Osberg 1968. Lighter purple (Swe) is composed of alternating bands of pelite and micarich quartzite; darker purple (Swls) is composed of limestone and phyllite.

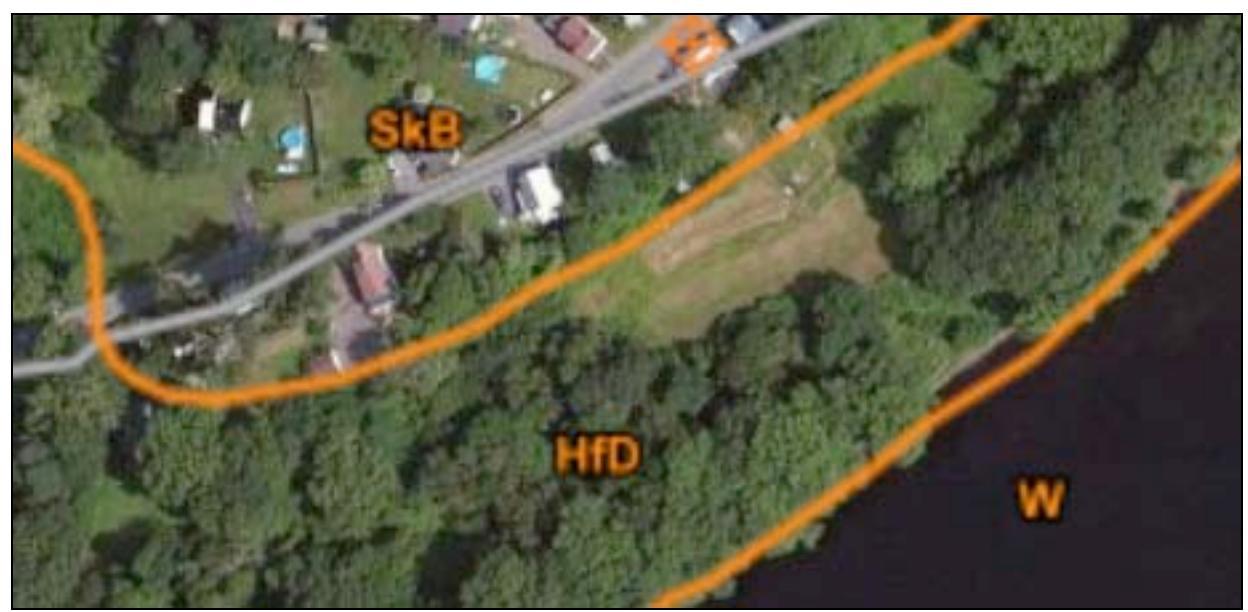
Glacial sediments form the parent material for the soils of Water Street Garden and Park. Two soil types – Hartland and Scio – are mapped on the property (USDA 1978). Hartland soils (HfD) are very fine sandy loams on 15-25% slopes. These are very deep, stone-free, well drained soils that formed on marine sediments that were laid down in the wide Kennebec River valley as the last glaciers retreated. Scio soils (SkB) are very fine sandy loams, on 3-8% slopes that typically occur on terraces adjacent to streams (possibly laid down on an old floodplain of the Kennebec, when water levels were higher). Scio soils are deep, stone-free, moderately well drained, and gently sloping to sloping. Both soil types are considered excellent for forest growth. Soils in the planted area along Water Street are composed of fill that has been brought in.

Both Hartland and Scio soils have a high potential for frost action and steeply sloping Hartland soils are described as having a severe erosion hazard and, as a result, are not considered suitable for roads or trails. The following Soil Conservation map shows the rough boundaries of the two soil types. Note that the soils map shows structures on the property that have since been removed as well as the former cleared area.

Soil type maps are considered approximate. This one does not show the wet soils on the middle terrace of the property. The soils on much of this terrace are mucky and black, and remain saturated through all or most of the growing season.

USDA Soil Conservation soils map (HfD = Hartland soils; SkB = Scio soils)

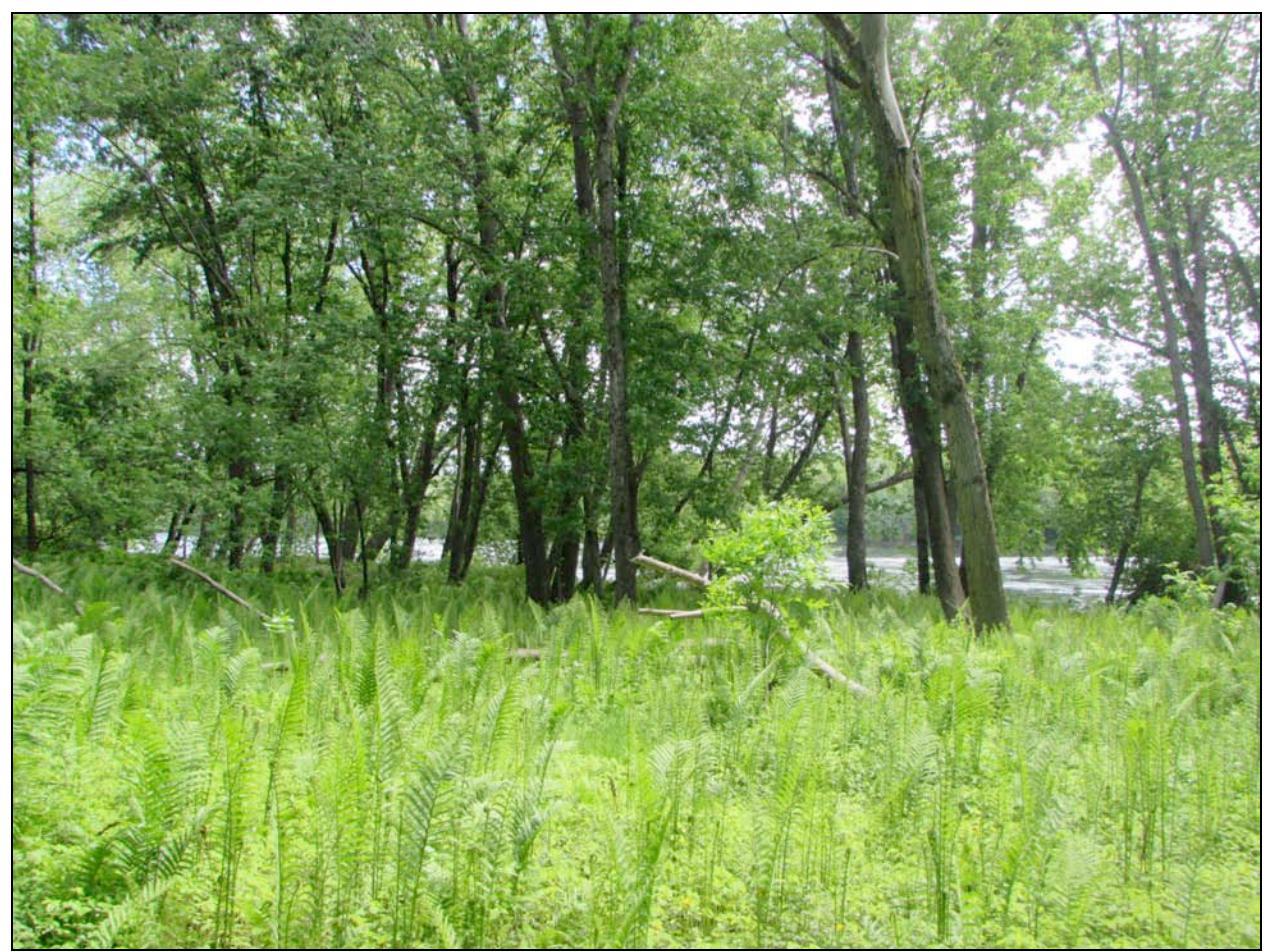
The floodplain of the Kennebec River supports a classic example of a silver maple floodplain forest community. This natural community type<sup>4</sup> occurs in a narrow band along the Kennebec River and is dominated by silver maple, with white ash scattered throughout. The silver maples are widely spaced, many with multiple trunks, giving the area a park-like feeling. The canopy is mostly closed with trees arching over the river in places. The understory is open and, except for patches of invasives, shrubs are sparse. A lush carpet of herbs changes from spring ephemerals to a dense cover of ostrich and sensitive fern in early summer to ferns, jewelweed, and false nettle later in the growing season. Other typical species present are blue joint, tall meadow rue, and common blackberry. One potentially rare species – hollow-stemmed joe-pye weed (*Eupatorium cf. fistulosum*) – was observed along the upland edge of the northerly end of the floodplain. I observed it late in the growing season when the flowers had mostly gone by. It did have a hollow stem. This species is ranked as S2 and is considered a species of Special Concern by the Maine Natural Areas Program (Maine Natural Areas Program 2012).

Silver maple floodplain with ostrich fern in foreground, on June 1, 2020

- Allow floodplain forest to continue to evolve into a mature uneven-aged condition to create more structural diversity, snags, course woody debris, and natural openings, with no future harvesting.

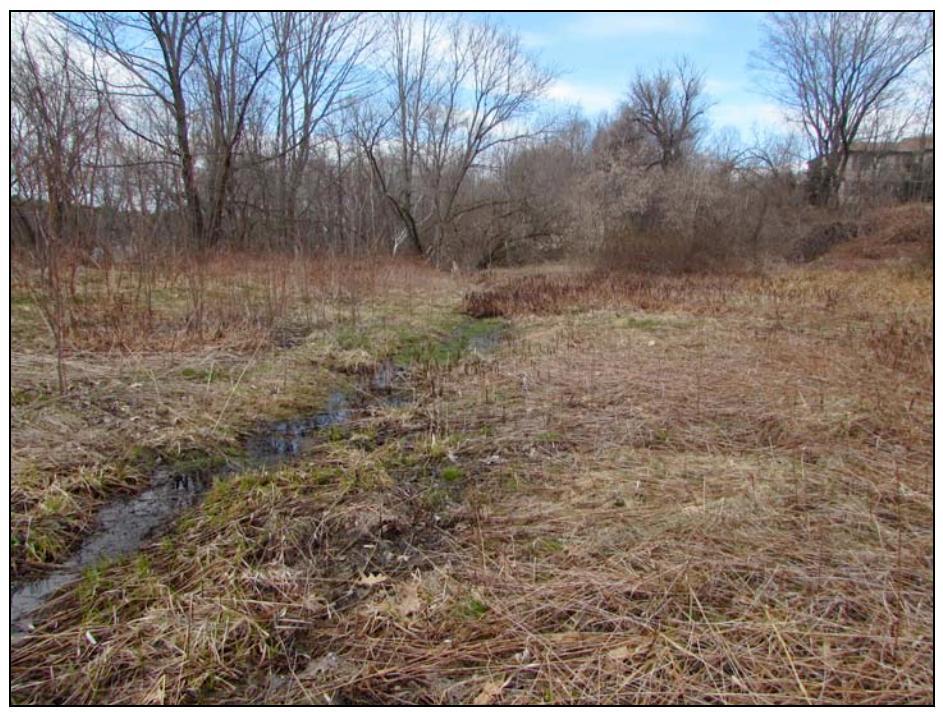
Small sedge meadow on middle terrace showing drainage ditch, April 22, 2020

A small sedge meadow occurs on the middle terrace of the property. This small marsh has been impacted by past cultivation and drainage, but still contains a suite of species associated with wet meadows, including tussock sedge, sensitive fern, bluejoint, as well as other grasses, sedges, rushes, and a few shrubs. Other typical plant species include sensitive fern, common St. Johnswort, flat-topped white aster, and wool grass. The terrain is hummocky. Soils are a combination of organic material and muck and are typically saturated year-round, with standing water present through much of growing season. This was the case, even during the exceptionally dry summer and

early fall of 2020. The source of water is likely groundwater flow from higher ground. If the ditch that drains the area were plugged, the sedge meadow area would likely expand and include small areas of open water that could function as vernal pools. This meadow area is surrounded by dense thickets of invasive shrubs, including multiflora rose and Japanese bamboo, as well as scattered black locust, box elder and Norway maple trees.

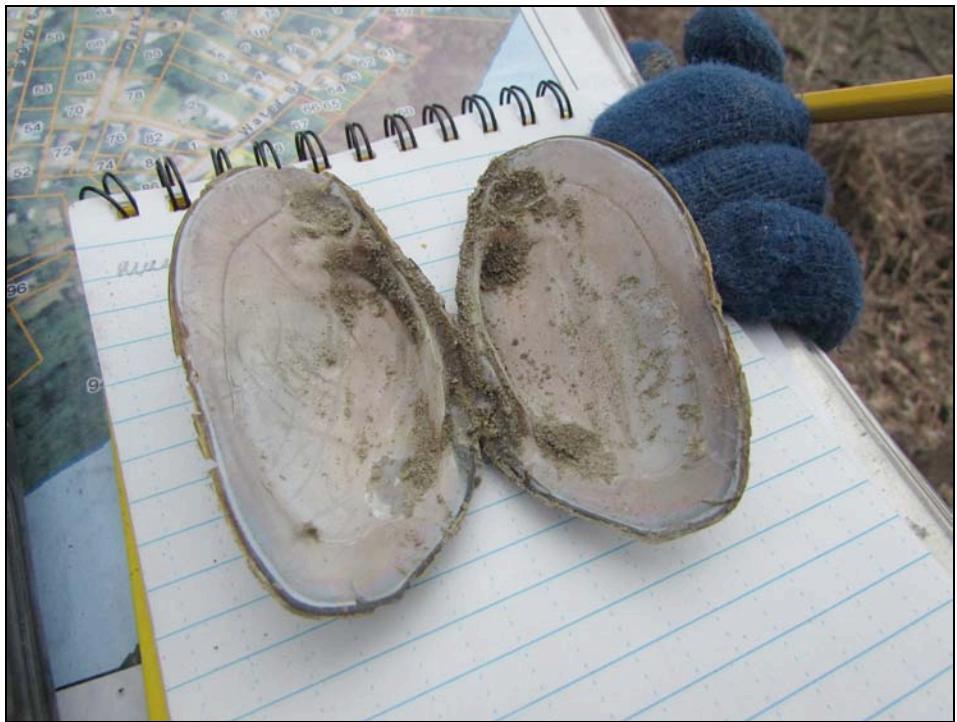
This portion of the Kennebec River, the Sebasticook River and Messalonskee Stream support 9 of Maine's 10 species of freshwater mussels, including four that are rare. While no rare species were observed on the property, shells of two common species – eastern elliptio and eastern floater – along with many raccoon tracks, were abundant on the shore. Rare species documented in the vicinity include yellow lampmussel and triangle floater in Messalonskee Stream, the Sebasticook and Kennebec Rivers, and tidewater mucket and brook floater in the Sebasticook River (Nedeau et al. 2000).

Freshwater mussel shells, a common sight on the floodplain

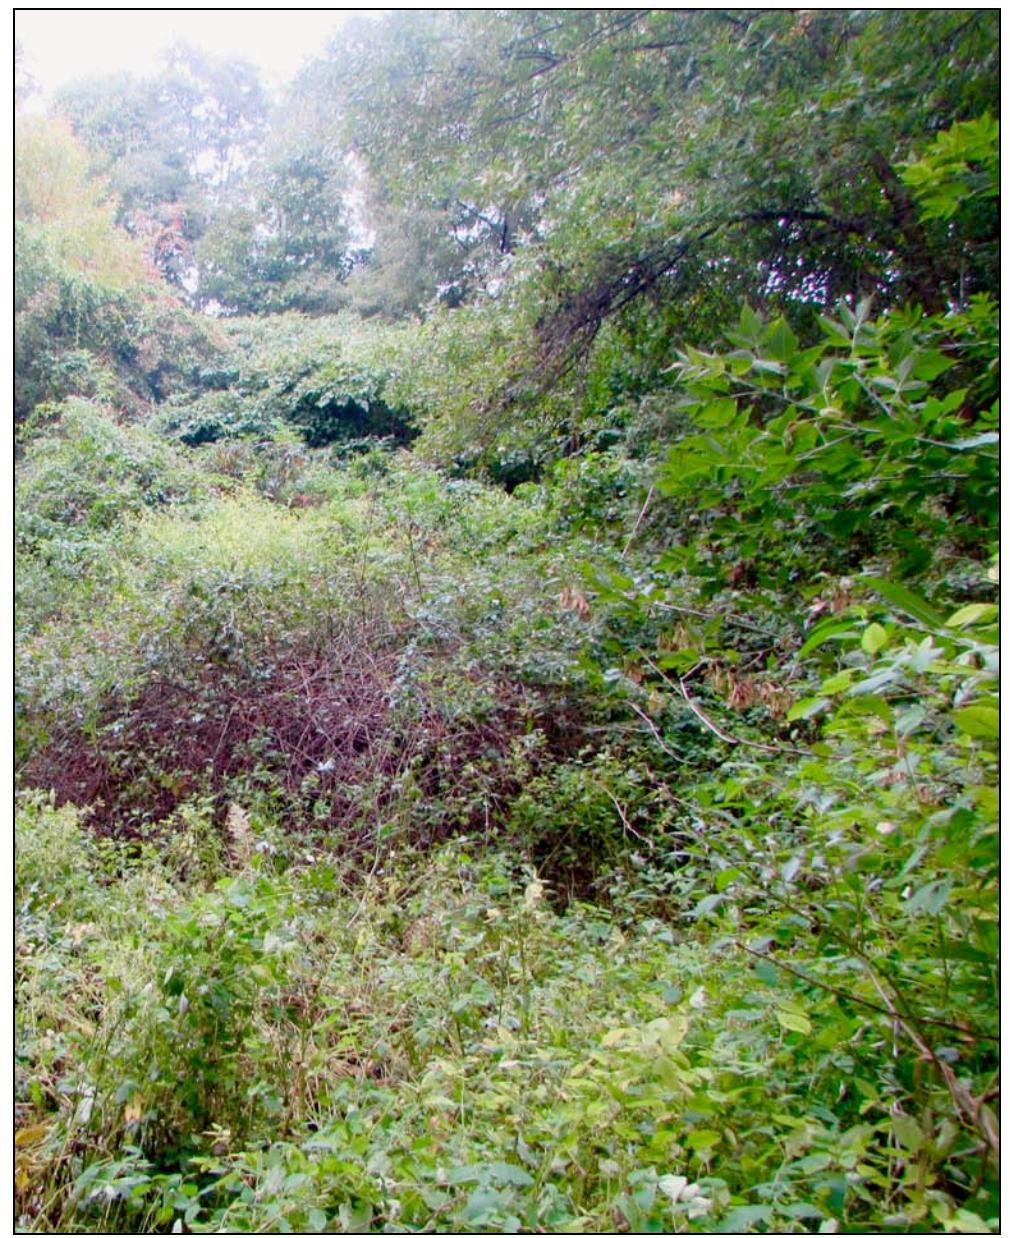
Seven species listed on Maine's official invasive species list were observed on the property as well as two other species that can aggressively colonize disturbed areas – box elder and coltsfoot. Three invasive tree species – Norway maple (Acer platanoides), box elder (Acer negundo), and black locust (Robinia psuedoacacia) occur at the edge of the cleared park area and around the edges of the wet meadow. Box elder and Norway maple are also present in the silver maple floodplain. These species occur as seedlings, saplings and in the canopy and are fast-growing. The most widespread invasive shrubs are multiflora rose (Rosa multiflora), Japanese bamboo (Fallopia japonica), and oriental bittersweet (Celastrus orbiculatus). Multiflora rose and Japanese bamboo form dense thickets and have likely displaced native shrub species, especially in the old field/wet meadow area on the middle terrace and on the steep slopes above and below it. Japanese bamboo thrives on river floodplain, primarily as individual younger plants. Some large vines were climbing trees bordering the uppermost level of the property. Autumn olive (Elaeagnus umbellate), bush honeysuckles (Lonicera morrowii and possibly Lonicera japonica) were found in smaller isolated patches. Most, if not all of these species occur on neighboring land as well.

Invasive species thrive on disturbed soils and are often difficult to eradicate. Clearing along streets and fields, movement of fill for road maintenance, parking areas and the like, and flooding along the river create an environment conducive to invasives. Most species prefer sun and open or edge habitats, but will tolerate some shade. Many species reproduce by seed and vegetatively (through suckers, rhizomes, above ground runners, and even, in the case of multiflora rose, rooting from twig tips). Seeds of most species are eaten and dispersed by birds and mammals, and black locust and multiflora rose seeds can persist in the soil for years. Recent research suggests that some species, such as bush honeysuckles, are expanding with warmer temperatures and higher atmospheric carbon dioxide concentrations (MNAP 2019).

Thickets of multiflora rose and other invasives on the slope above middle terrace

multiflora rose. Invasive plants are displacing native biodiversity, changing soil chemistry, and can pose a hazard to visitors. Eight invasive species were observed on the property during this evaluation, five of which are widespread. In addition, on the floodplain, naturalized species, such as moneywort, are supplanting native ones. Eradicating invasives is a multi-year endeavor, typically involving repeated cutting or burning of sprouts and roots, or applications of herbicides. The MNAP invasive species guide outlines various control methods and Maine Natural Areas Program staff can provide additional information and guidance.

- Develop a time table and strategy for invasive species removal and monitoring. Multiflora rose can be pulled or cut in any season, but recommend doing so before plants set fruit to prevent further spread. Recommend cutting trees when ground is frozen to minimize soil disturbance.

- Recruit a volunteer invasive species 'patrol' to eradicate and manage invasives.
- Once under control, annually monitor property for invasive plant species. If populations are small, they can be pulled by hand or with a weed wrench, and burned (if in flower). The best time to monitor is in early October, when most herbacious and shrubby plants have dropped their leaves. Invasives tend to keep their leaves longer and most leaves turn a bright yellow-orange color in the fall and are easiest to see then.

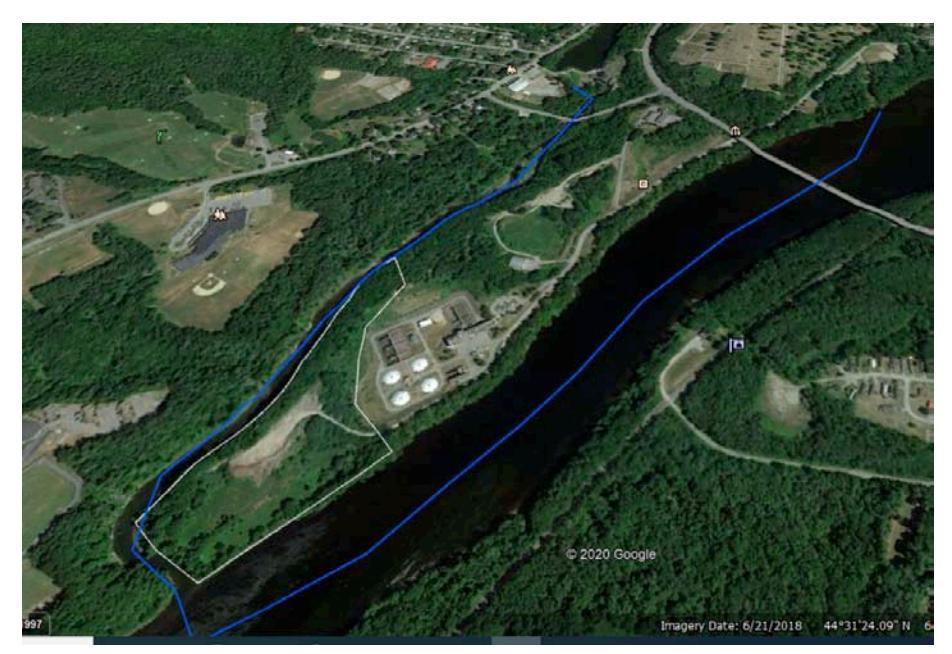
City-owned land along confluence of Messalonskee Stream and Kennebec River outlined in white (map prepared by WCLT).

This land is owned by the City and connects to the esker that is on Kennebec Sanitary Treatment District land. If the city dump area could be closed, this area would provide not only important wildlife habitat, but scenic views. It is also worth exploring its archaeological significance and collaborating with Wabanaki tribal members to find out if they have an interest in the area.
