# **PRELIMINARY ROOST ASSESSMENT FOR PRESENCE OF BAT ROOSTS:**

The New Fleurs Club, 2 Portmanmoor Road, Cardiff, CF24 5FX

Date of Survey: 12<sup>th</sup> August 2024 & 21<sup>st</sup> August 2024

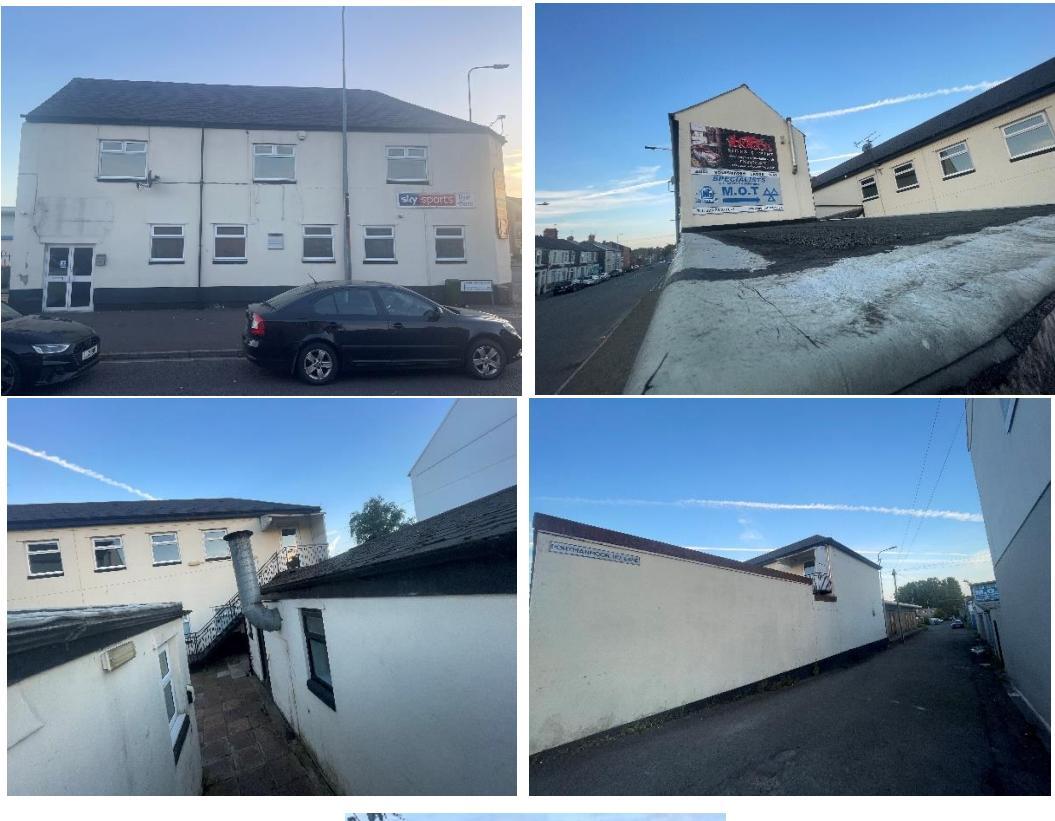
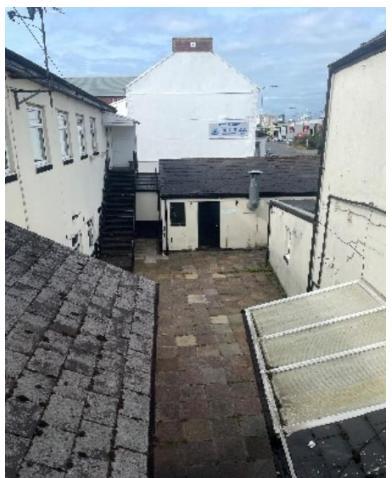
Figure 1: Pictures of the Exterior of the Property

1.0.2. The property comprises a ground floor and first floor for the main building and single story for the outbuildings. The roof covering is concrete slate effect tiles underlaid with a plastic woven membrane. The walls, roof, soffits and fascia appear to be in good repair and weather tight.

Whilst the majority of roof surfaces were too high to inspect at close hand, good sight lines were achieved for the inspection using high-powered focusable lenses and a high-powered torch. The visible tiled roof coverings on the property appear to be well maintained and weather tight, with no cracked, lifted or missing tiles. No PRFs were noted on the main aspects of the roof covering.

The fascia were too high to allow inspection at close hand but were inspected utilising high-powered focusable lenses and a high-powered torch. All the installed fascia and are of a wooden design fitted tight to the external walls, in a good state of repair and appear to be weather tight with no access potential to the fascia. **No significant PRFs were noted within the fascia complex**.

The external surfaces of the walls appear to be in good repair, There was two vertical cracks of the rendered external surface which were no deep enough to support individual bats or a roost. **No PRFs were noted on the external surfaces of the walls.**

No evidence of bats was recorded within or emerging from the surveyed structure. However, due to the constraints in surveying the roof slope visible from the lane, it is proposed, following the precautionary principle, that the dwelling should be subjected to a **destructive search of the roof covering and structure (before demolition commences) under the supervision of a licensed bat ecologist.**
