## 'My Biggest Problem Case and How I Solved It'

## How to Block Out Understructures When Using Translucent Zirconia

By Jack Marrano, CDT

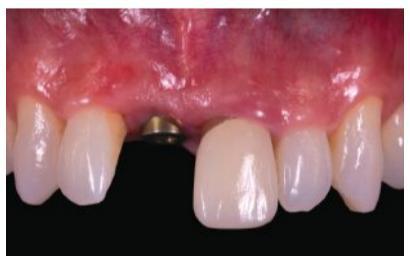
#### Figure 1

Before: the patient presented with site #8 integrated and ready to restore.

The 30-year-old male patient presented with a lost central incisor (#8) and a discolored incisor (#9) previously treated with a cast metal post and core; implant site #8 was integrated and ready to restore. Surrounding dentition exhibited beautiful shade and translucency (see Figures 1-3).

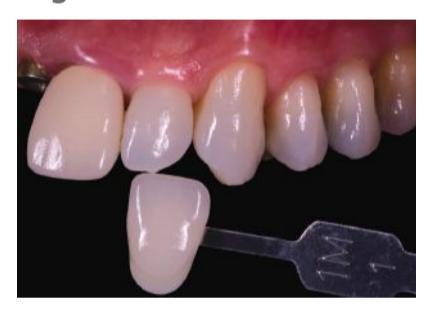
Figure 2

The esthetic challenge was presented by a post and core on #9 and custom abutment on #8.

• Next, I addressed the issue of the underlying custom abutment and metal post and core. This posed one of the greatest challenges of this case and required careful consideration to avoid a poor esthetic result.

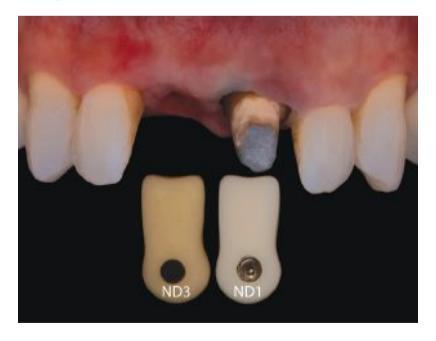
#### Figure 3

The patient's natural teeth had a beautiful translucency.

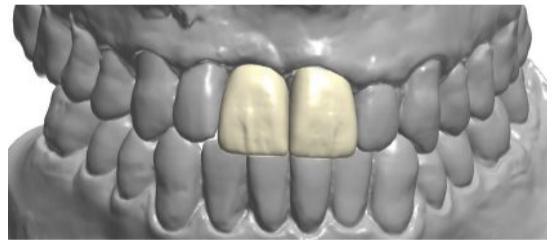
#### Figure 4

The case was designed to full contour in 3Shape's design software.

• I scanned the case and designed to full contour in 3Shape's design software *(see Figure 4)*.

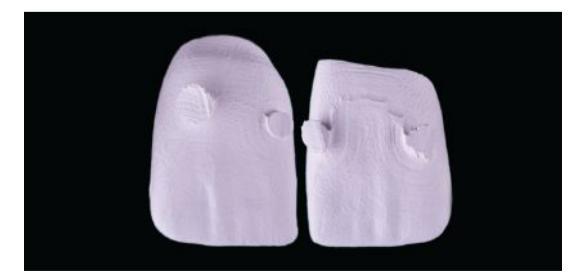
#### Figure 5

ArgenZ STML after milling.

• The final design files were sent for milling in a Roland DWX 52DC (see Figure 5).

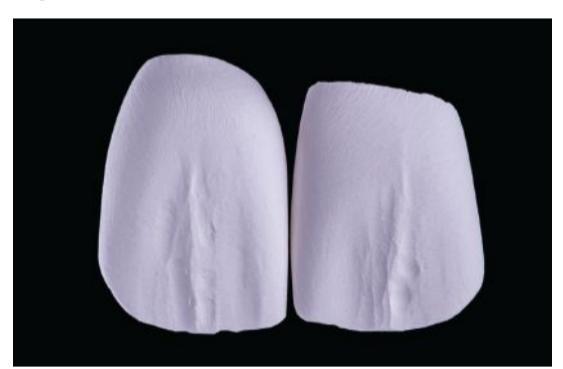
#### Figure 6

After green stage finishing.

• After milling, I used Brasseler diamonds, carbides and rubber wheels to finish the pre-sintered zirconia to establish final contour, surface texture and anatomy *(see Figure 6)*.

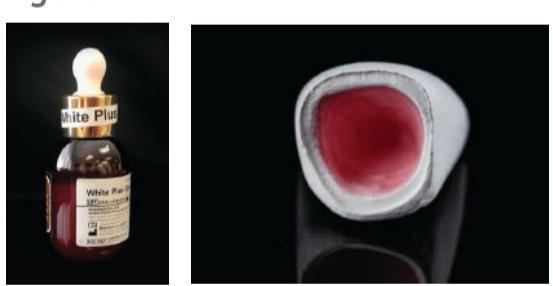
#### Figure 7

Before sintering, I applied White Plus (left).

• I decided to use a product called White Plus from DMAX essentially, it's a zirconia opaque, and is applied to pre-sintered zirconia (see Figures 7-8). After sintering, the underlying structure whether it's a custom abutment or dark stump—is completely blocked out. White Plus is especially useful with today's zirconia due to the increased translucent properties. • After sintering (see Figure 9),

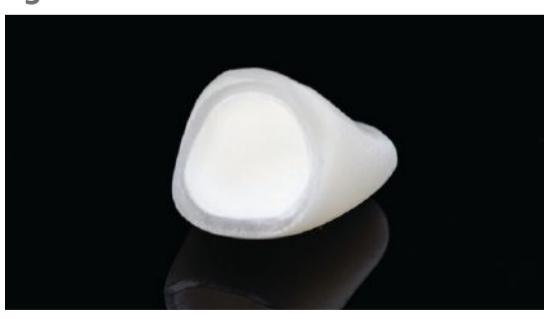
#### Figure 8

White Plus essentially acts as a zirconia opaque (shown after sintering).

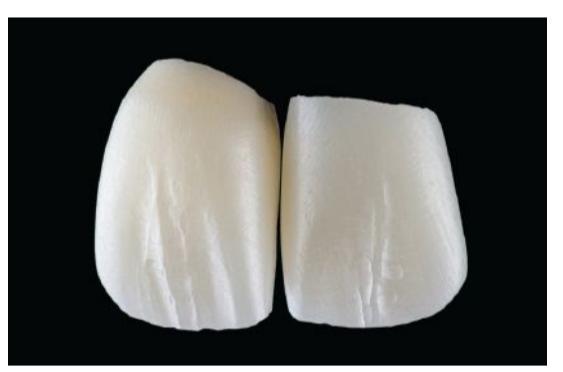
#### Figure 9

The restorations post-sintering.

I made final adjustments and checked the restorations for accuracy on the master cast.

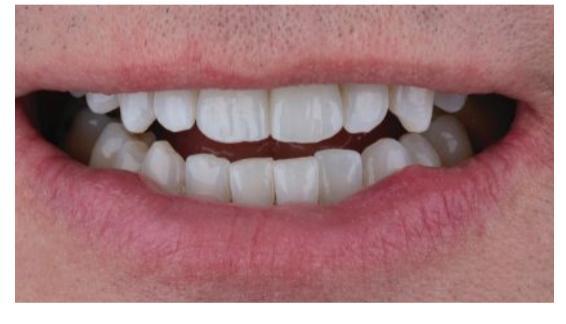
#### Figure 10

The final result after staining and glazing.

• Once the restorations were verified as accurate, I used a simple stain-and-glaze technique to achieve individual characterization.

The final restorations exhibited esthetics and translucency. Using White Plus, I was able to eliminate one of the greatest challenges this case presented: blocking out the underlying structure while not adversely affecting the final look of the restorations (see Figure 10).
