## INTRODUCTION

## 2021 EWM MANAGEMENT AND MONITORING STRATEGY

## LATE-SUMMER EWM PEAK-BIOMASS SURVEY RESULTS

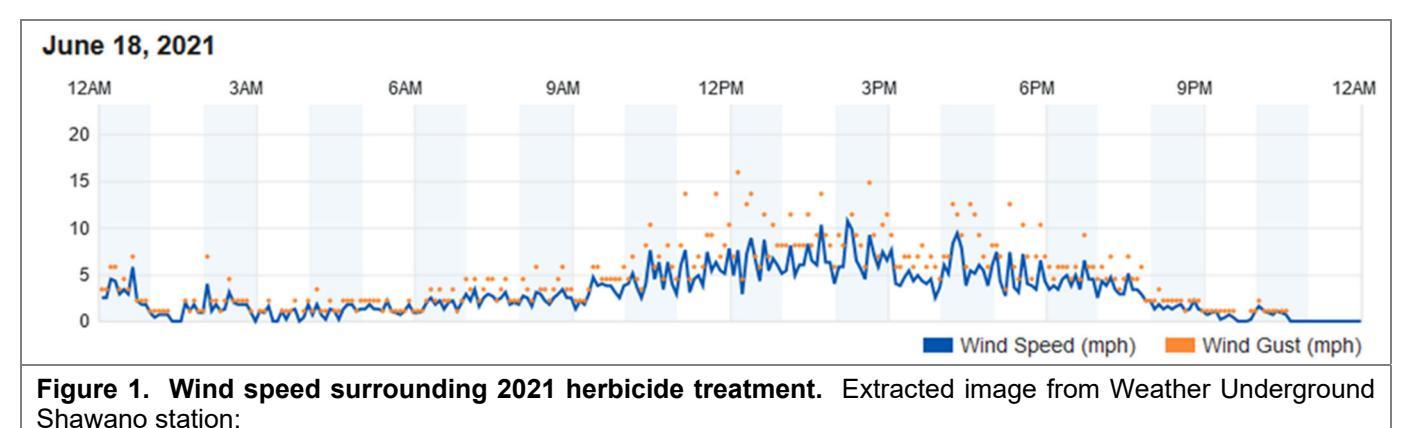
The herbicide application was completed on June 18, 2021 between 5:15 and 6:30 am by Schmidt's Aquatic, LLC. The applicator noted light winds (2-3 mph) and a surface water temperature of 74°F at the time of the treatment. Wind speed and wind gust data were accessed from the nearest station in Shawano, WI, which is approximately 30 miles to the south. Wind speeds increased around 10 am with wind gusts of 10-15 mph reported.

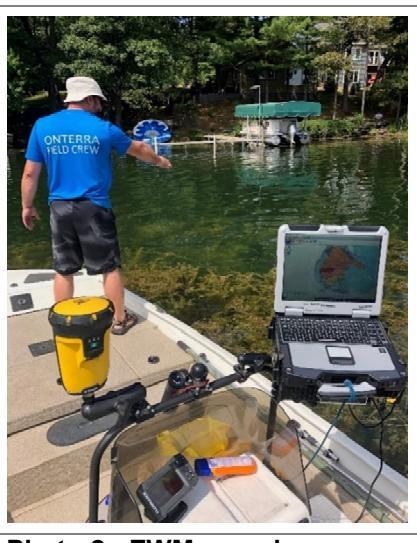
Photo 2. EWM mapping survey on a Waushara County, WI lake. Photo credit Onterra.

Onterra conducted a 2021 Late-Summer EWM mapping survey to assess the effectiveness of the herbicide treatment during the *year-of-treatment*. The EWM mapping survey offers a full account (census) of where a particular species exists in the lake. During the EWM mapping survey, the entire littoral area of the lake is surveyed through visual observations from the boat (Photo 2). Field crews supplement the visual survey by deploying a submersible camera along with periodically doing rake tows. The EWM population is mapped using sub-meter GPS technology by using either 1) point-based or 2) area-based methodologies. Large colonies >40 feet in diameter are mapped using polygons (areas) and are qualitatively attributed a density rating based upon a five-tiered scale from *highly scattered* to *surface matting*. Point-based techniques were applied to AIS locations that were considered as *small plant colonies* (<35 feet in diameter), *clumps of plants*, or *single or few plants*.

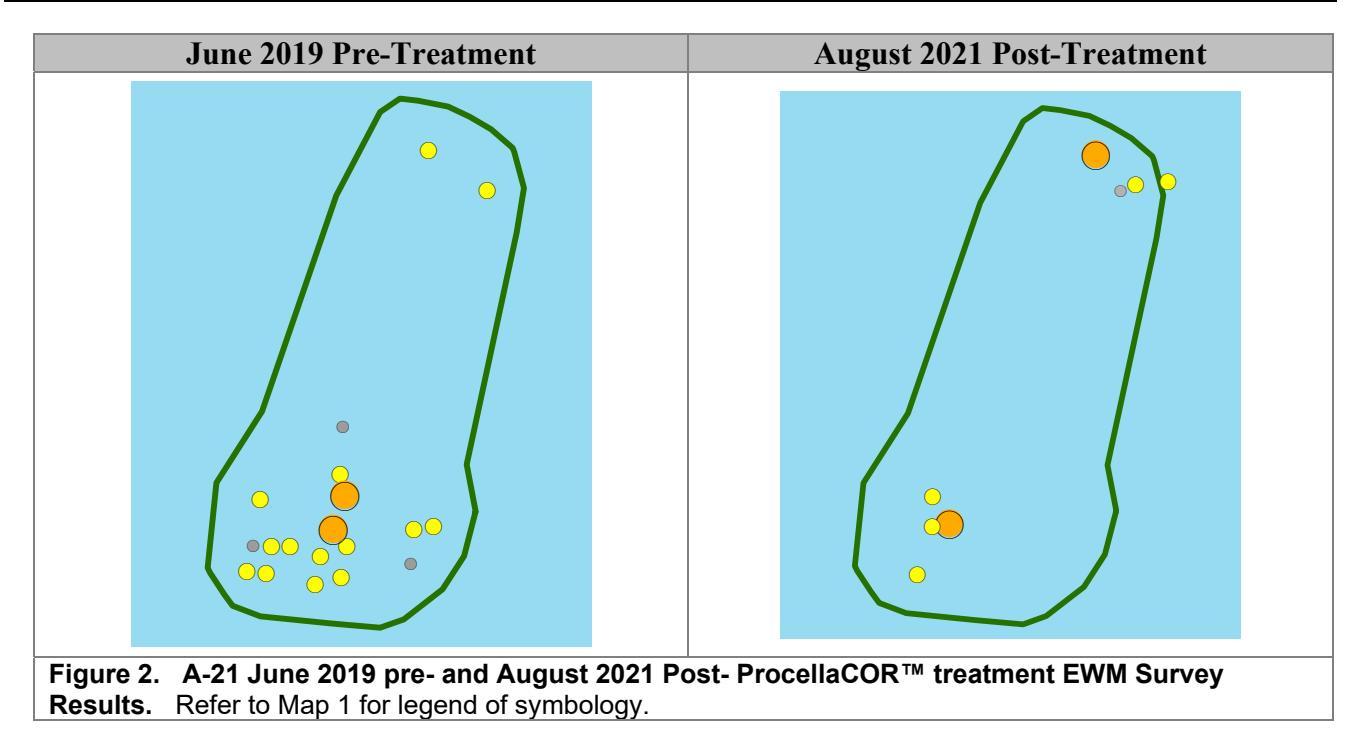
Site A-21 contained numerous *clumps* of EWM as well as a couple *single or few plants* and *small plant colonies* during the June 2019 survey (Figure 2, left frame). After the 2021 ProcellaCOR<sup>TM</sup> treatment, a decrease in EWM was observed within the site in the late-summer survey with a few *clumps of plants* identified in the site, one *single or few plants*, and two *small plant colonies* (Figure 2, right frame).

The results of the late-summer survey are displayed on Map 1, with the majority of the EWM being located within the treatment site A-21 and in front of the Echo Valley Resort boat landing. Figures 1 and 2 display a comparison of the two 2021 treatment sites from before treatment (June 2019) to after treatment (August 2021).

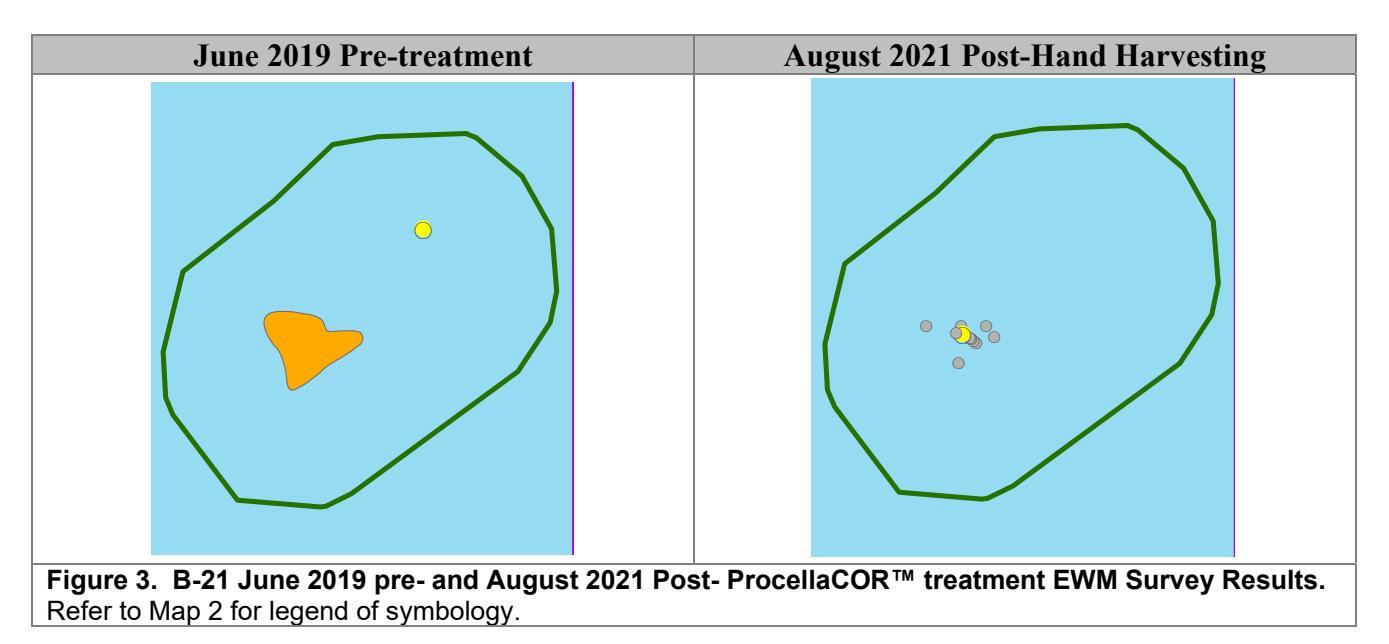
A *clump of plants* and a small *highly dominant* colony was located in site B-21 in the early-summer 2019 survey (Figure 3, left frame). Following the 2021 ProcellaCOR<sup>TM</sup> treatment during the summer of 2021, several *single or few plants* and one *clump of plants* remained present in the site at the time of the 2021 late-summer survey (Figure 3, right frame).
