File
Jaime M. Colby, P.E., SWMB, NHDES
Leachate Spill on May 3, 2021 Communications Week of May 3, 2021
North Country Environmental Services, Inc. North Country Environmental Services, Inc. Landfill 581 Trudeau Road, Bethlehem, NH Permit No. DES-SW-SP-03-002
May 20, 2021

Date: 05/03/2021	Town: Bethlehem	
	Site # 198704033	
SITE INVESTIGATION		
	SUMMARY REPORT	
Site Name: North Country Environmental Services		
Location: 581 Trudeau Rd.		
NHDES Investigator(s): A. Madison		
Personnel Present / Affiliations:		
1. Kevin Roy, Foreman

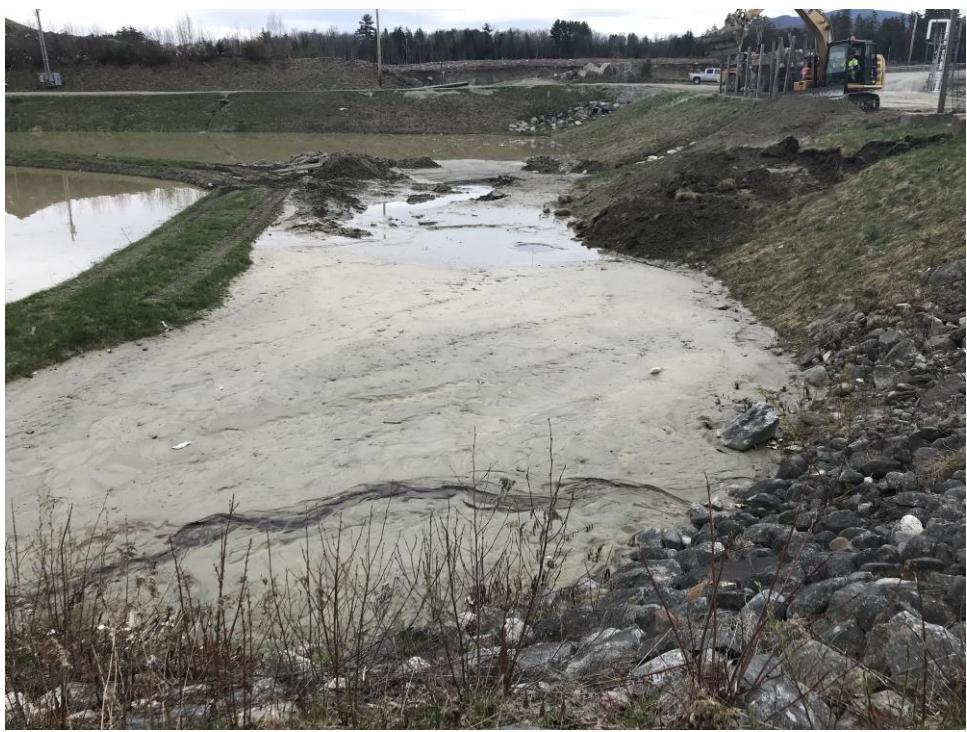
Sediment and leachate in retention basin, note the construction of the ramp to the right of the photo.

The retention pond had a substantial amount of sediment, which appeared to have been transported via the same route as the leachate. Mr. Roy informed me that they were in the process of constructing an earthen ramp down into the retention pond in order to access and remove the sediment in the retention pond, some of which may have been transported during heavy rainfall over the weekend. Mr. Roy informed me that the UST is being pumped out and trucked off site for treatment and disposal, and that a consultant was en route to sample water within the pond, and in a stream nearby, however he had no reason to believe that leachate had left the storm water system. I asked Mr. Roy how much leachate was released, he said he wasn't sure, it could be as little as 500 gallons, or as much as a thousand. I was also informed that the pumping system was shut down until the necessary repairs could be made. I then advised Mr. Roy to consult with the Solid Waste Management Bureau for further instruction and to coordinate further activities. I then discussed my observations from the site with Jaime Colby of the SWMB over the phone, and then departed the scene.

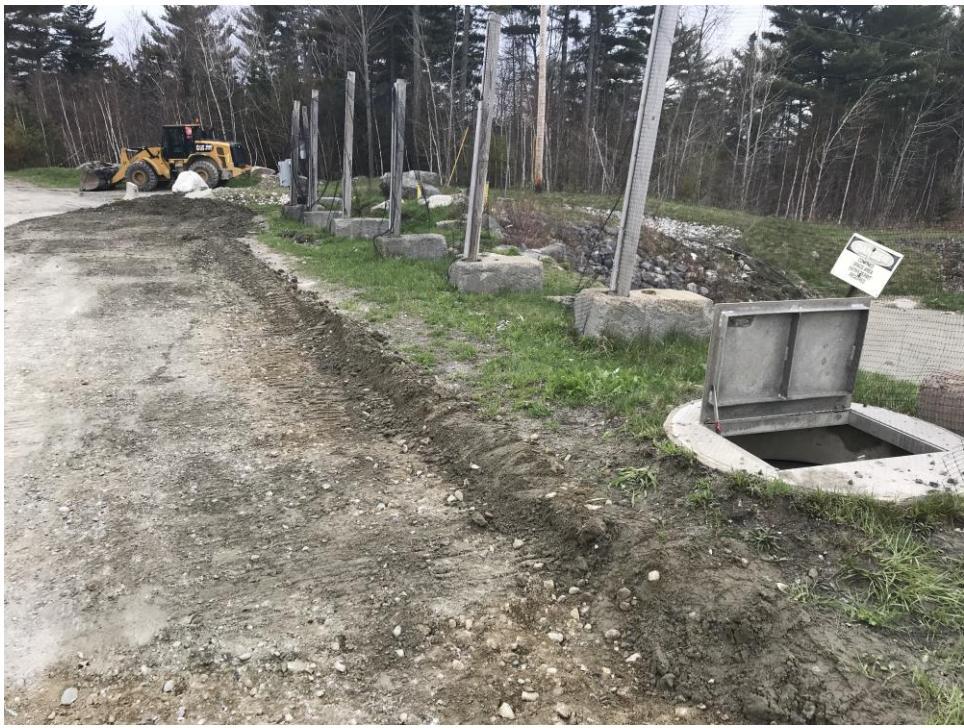
Overland route leachate followed to the retention pond. Contaminated soil was scraped and removed. Drainage ditch leading into the pond is behind the loader in the photo. Manhole where the release originated is behind and to the left of the viewer.

I arrived on-scene at the North Country Environmental Services in response to a report of a release of leachate from an overfilled UST at the NCES Landfill in Bethlehem. I reported to the facility office and introduced myself to the Forman, Kevin Roy. Mr Roy and I then drove to the site of the release, which was located at the back of the property. When we arrived at the location of the UST in question, Mr. Roy explained what happened over the weekend. He explained that during the weekend, an alarm that would normally stop the leachate pump when the UST was full had failed, and allowed leachate to flow into the UST. This caused the UST to overfill, which allowed leachate to flow out of an access cover, over the ground and over a dirt road, and then into a storm water retention pond.
