# Existing Lighting and Utility Poles Are Not Fit for 5G, But Composite Poles Are

## By David Kilmer

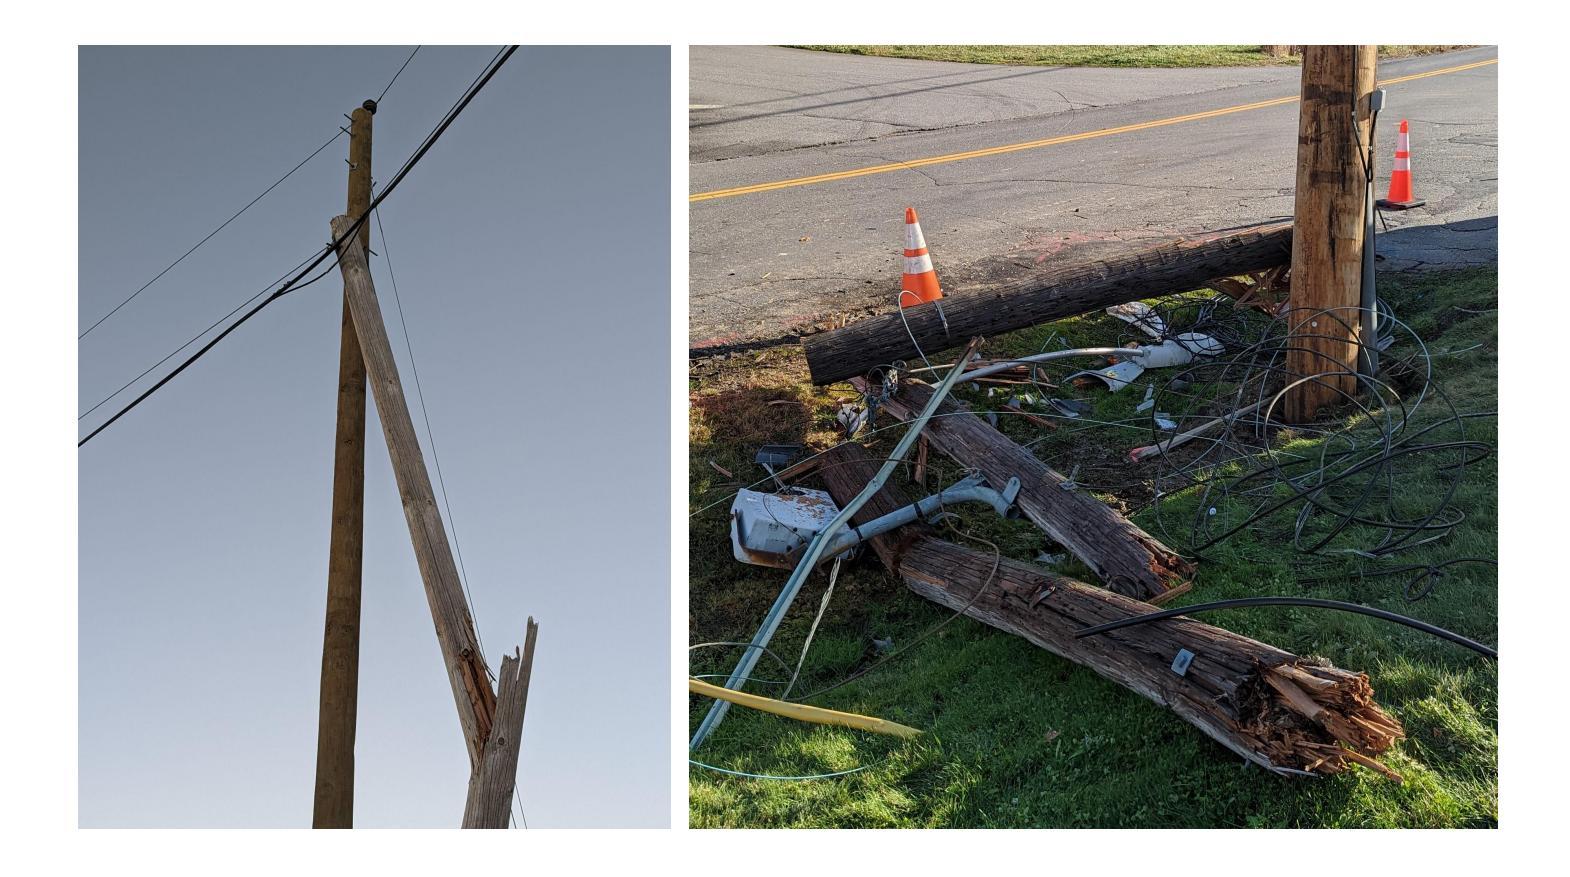
Serious wood pole damage and failure in Maine in the fall of 2022, which was initiated by a truck that backed into a pole outside of the local convenience store. When the pole cracked, it caused the lines to sag, and a separate tractor trailer struck the catenary. The incident broke all power and communications lines, including fiber, and it pulled down two other wood poles on the other side of the highway.

Jim McKenna, CEO of Redzone Wireless, has demonstrated the hazards of wood poles breaking near his home in Maine in late fall of 2022. "The damage at the intersection was initiated by a truck that backed into a pole outside of the local convenience store," McKenna says. "When the pole cracked, it caused the lines to sag, and a separate tractor trailer struck the catenary. The truck driver broke all power and communications lines, including fiber, and it pulled down two other wood poles on the far side of route 131."

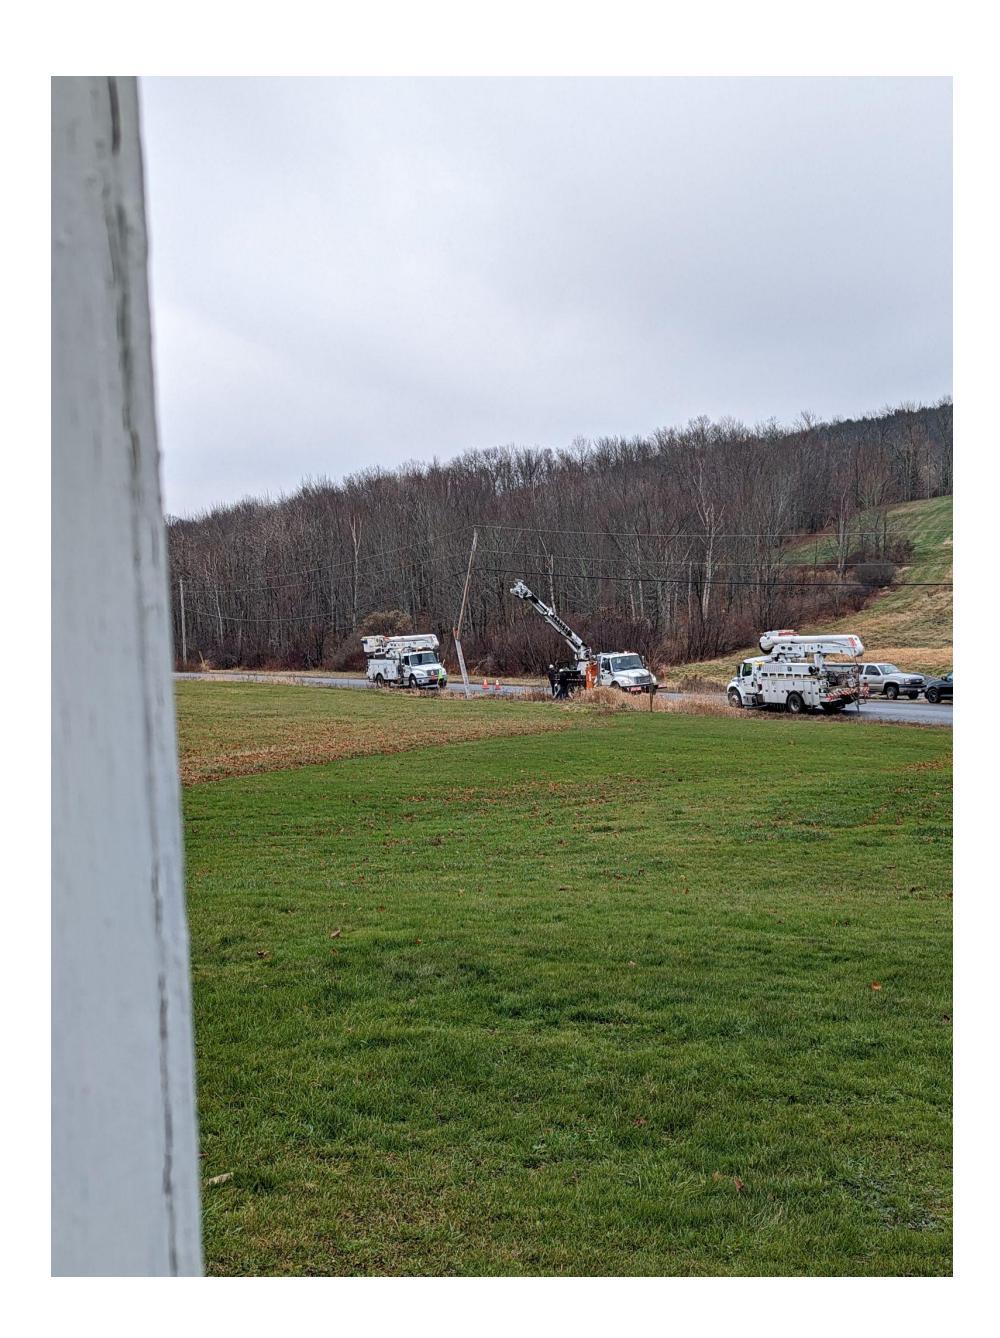
In a separate incident in the fall of 2022, located outside a residence in Maine, this wood pole failed not from ice, wind, snow or storm, but in clear weather from no apparent cause other than age and overloading stress.

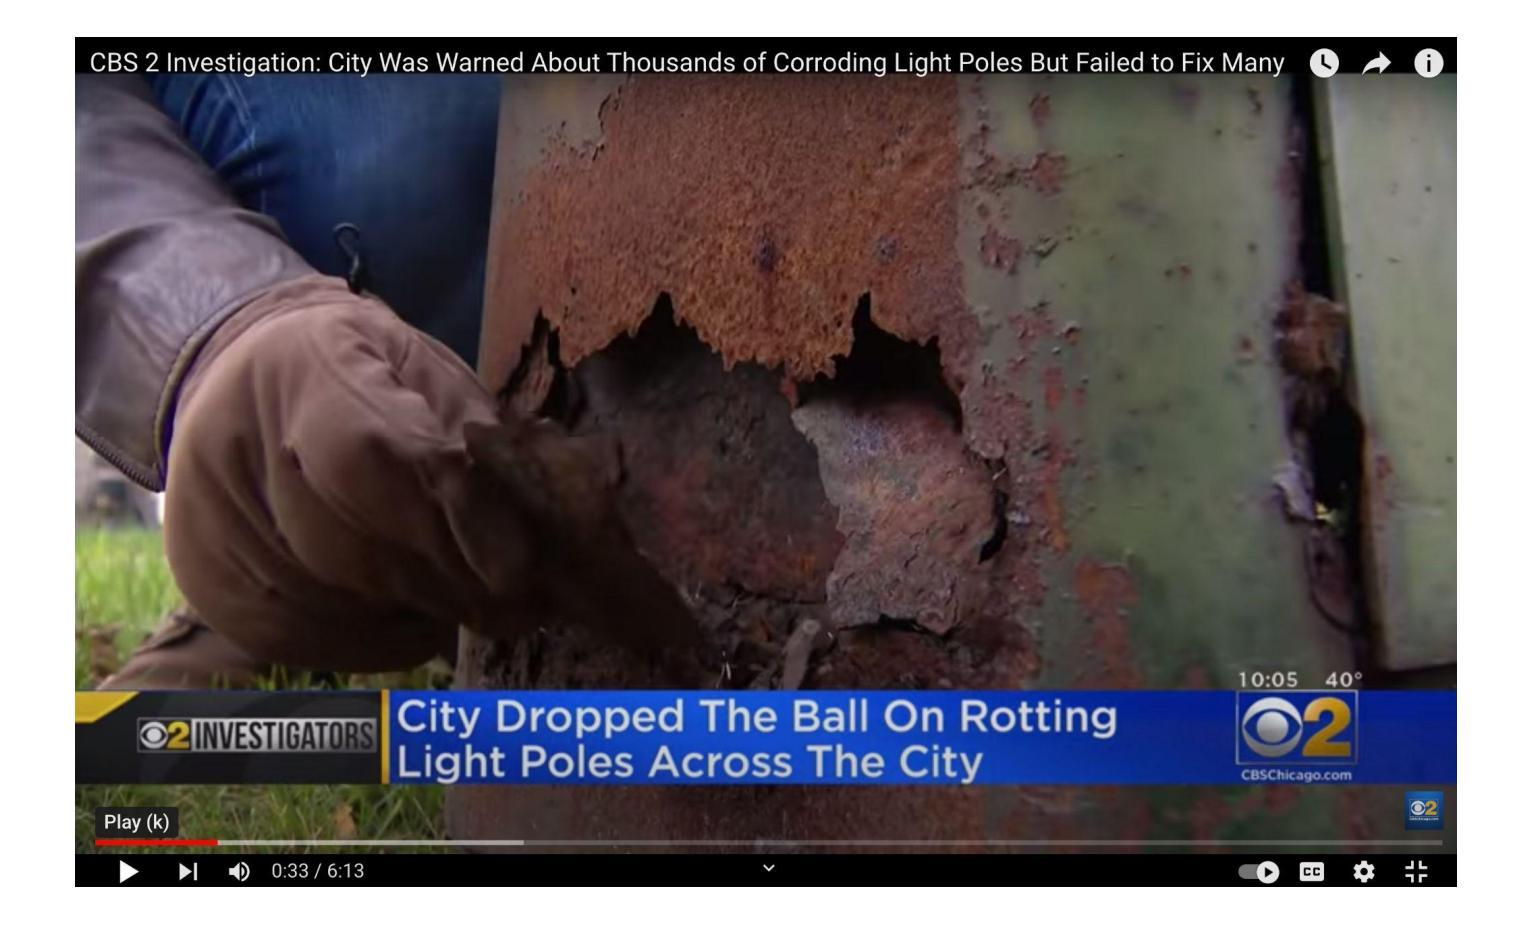
A CBS News investigation discovered that at least 10 percent of the metal light poles in Chicago were dangerously corroded, and failures to this infrastructure have caused severe injuries.

Of the 330,000 light poles in the city, more than 33,000 poles, or 10 percent, were graded as having some sort of serious issue across all four of the major categories, a CBS data analysis found.

He said rust is often a key indicator of a deeper problem with the integrity of the pole. More than **22,000** poles were rated as having a concerning amount of rust, the data shows.

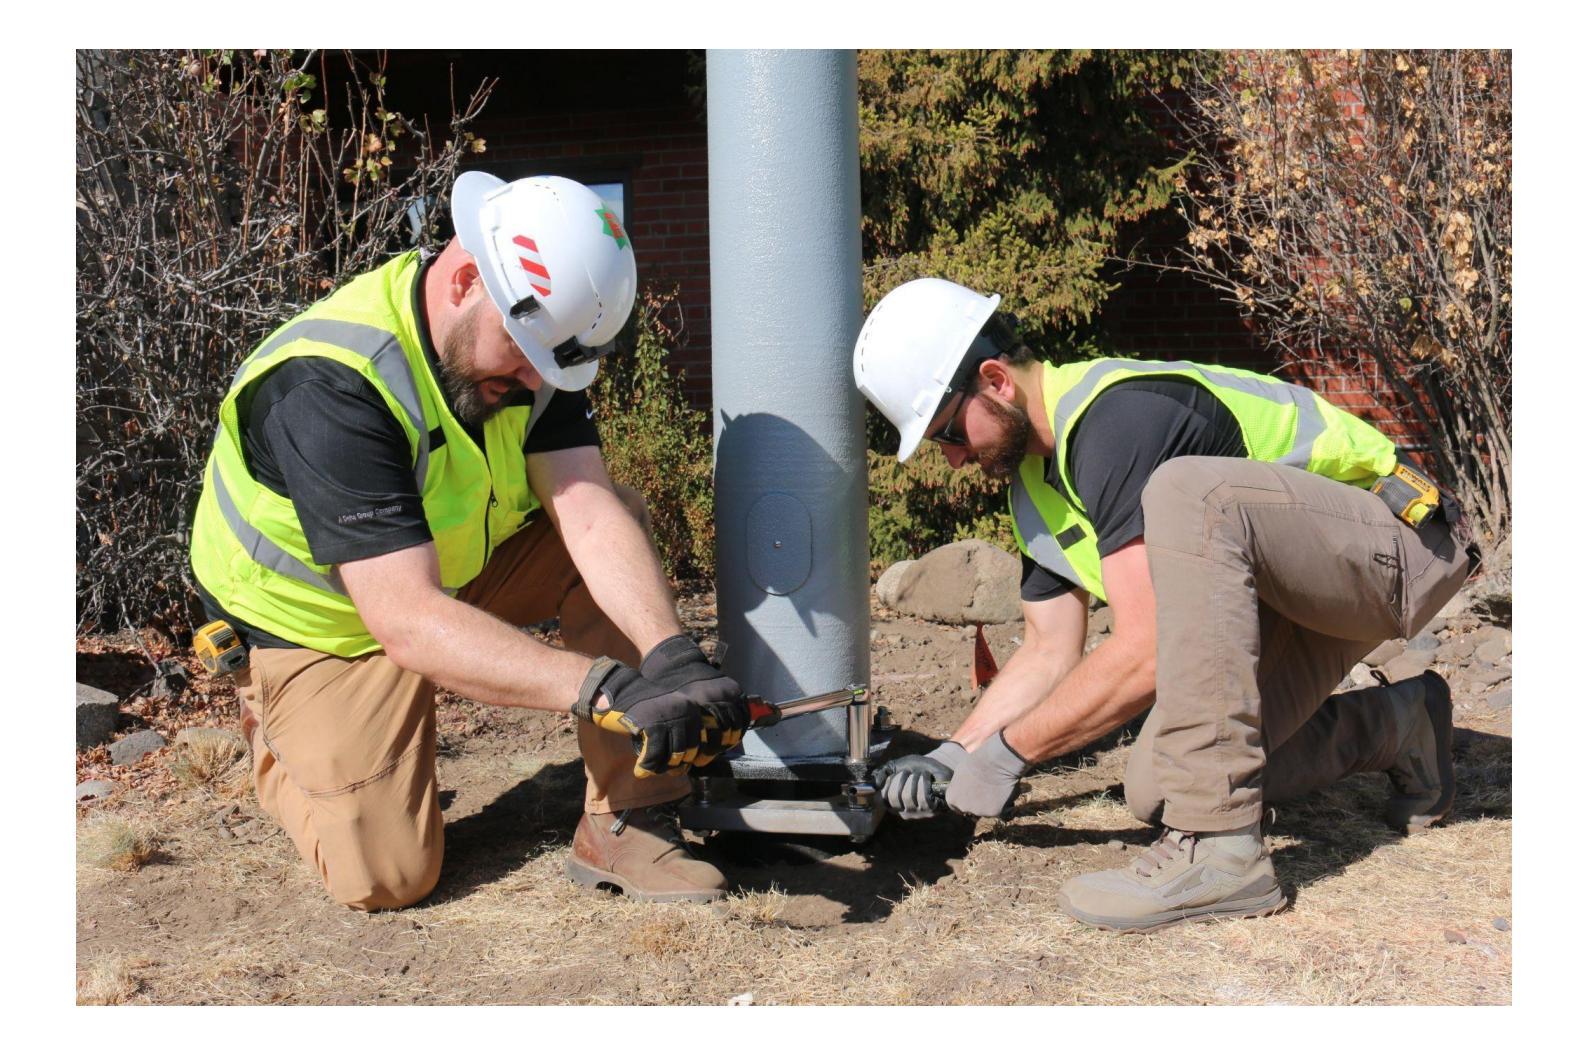
Field technicians from EasyStreet Systems install a composite pole which is non-corroding, ultra-lightweight and strong. Composite poles have low conductivity properties; and resist corrosion, rot, UV rays, water absorption, insects and woodpeckers. In addition, composite poles do not lose strength as they age.

Composite poles are one of those alternatives. They are lightweight, strong and have low conductivity properties. They also resist corrosion, rot, UV rays, water absorption, insects and woodpeckers. Composite poles do not lose strength as they age, so maintenance is minimal. Engineers also appreciate the electrical properties of composite poles and their ability to withstand heavy wind loads and impacts.<sup>23</sup>

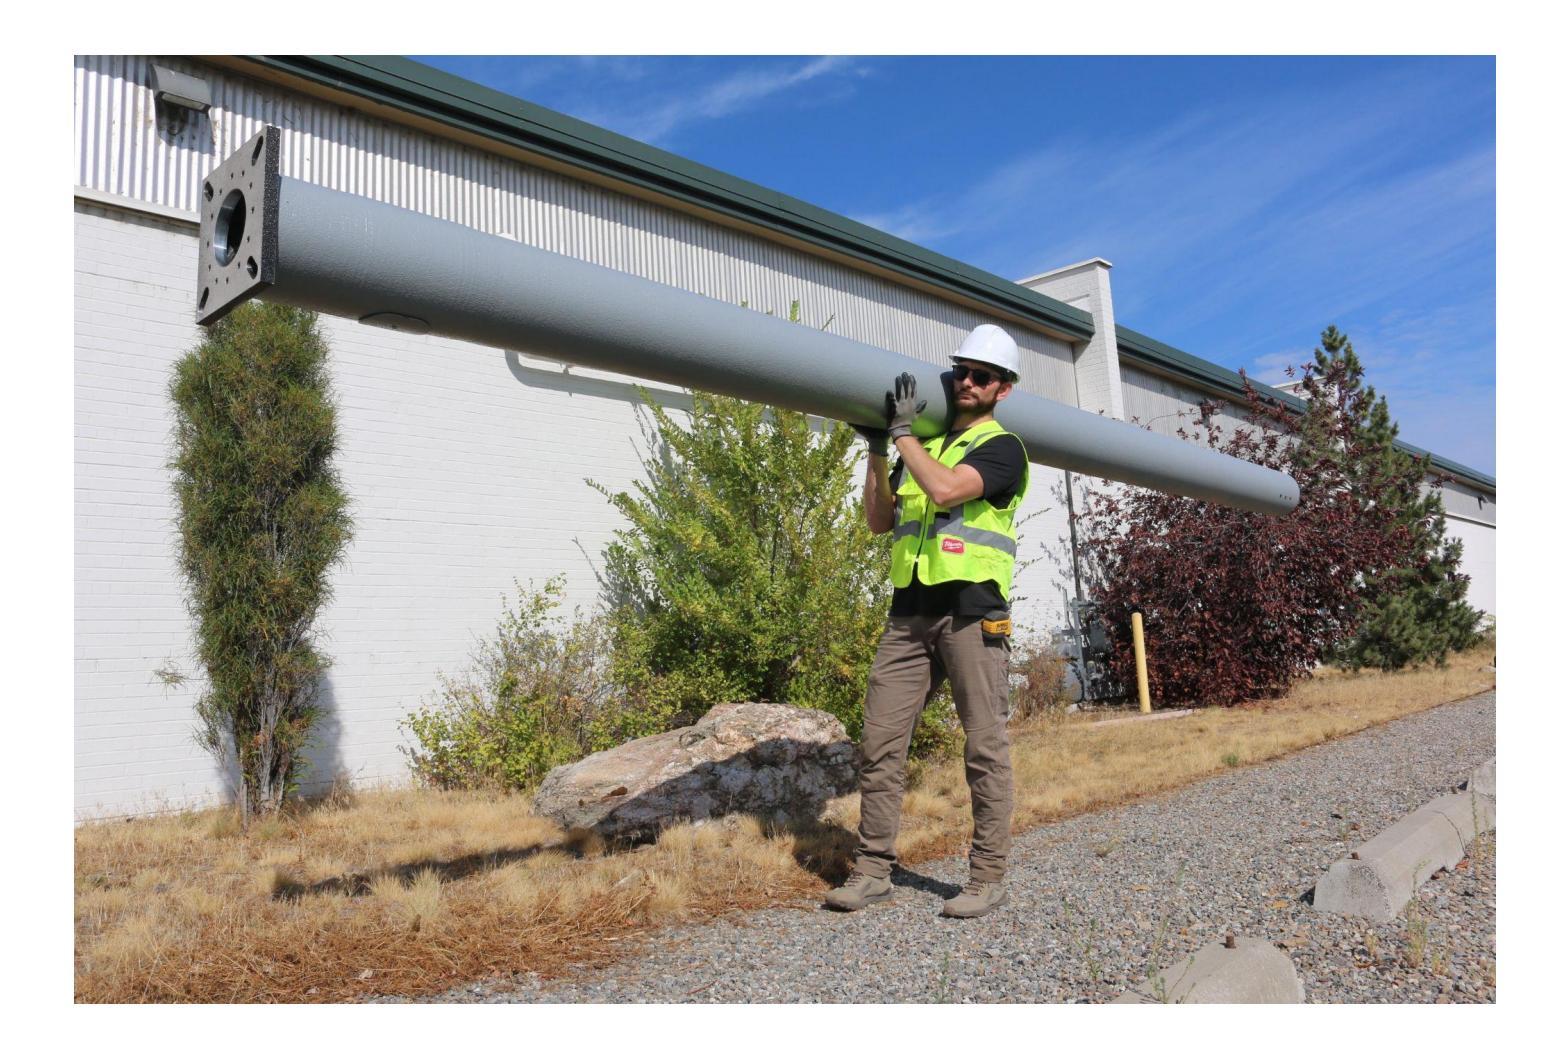
Ultra-lightweight composite poles, seen carried here by a single technician, support these uses and more: 5G and Internet of Things, wind power, solar power, EV charging, lighting, transportation and security.
