The Piano Owner's Heads-Up Guide to Important Piano Maintenance

Focus On: Polishing Capstans

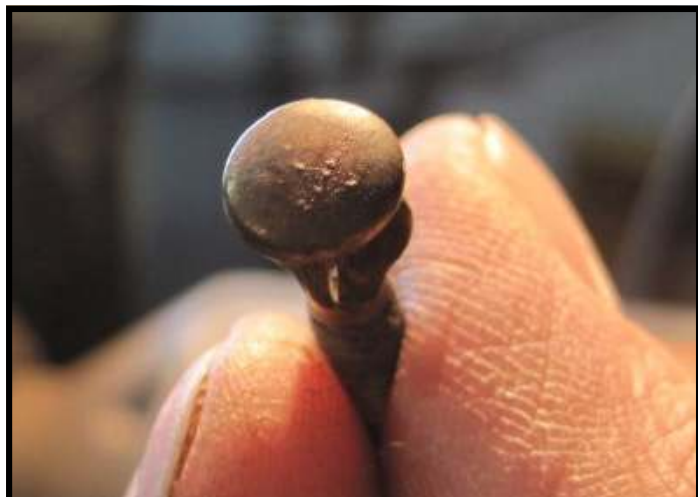
When the surface of the capstans are polished to a shine, practically no energy is lost in this transfer of motion. However, if they become badly tarnished or corroded (see photo above), the drag produced may diminish the power of the action. Excessive wear and tear on the felt located at the underside of the wippen may also result.

The capstans of your piano are either tarnished or corroded to the point where a professional polishing is in order.

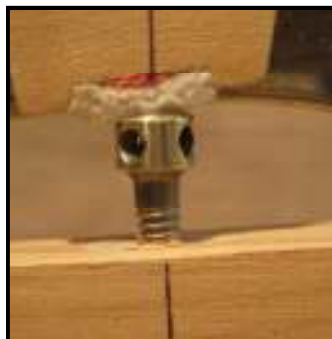
Note at rest

The above photos show why wear and tear on the felt cushion at the bottom of the wippen occurs when brass capstans become corroded. As a note is played the back end of the key rises up with the capstan transferring the power to the wippen. While the motion is primarily up and down, there is at the same time a front to back motion as well as the felt cushion slides over the capstan (note reference line). When the surface of the brass is tarnished or corroded, the felt will gradually be worn thin. This will decrease performance and throw essential adjustments off.

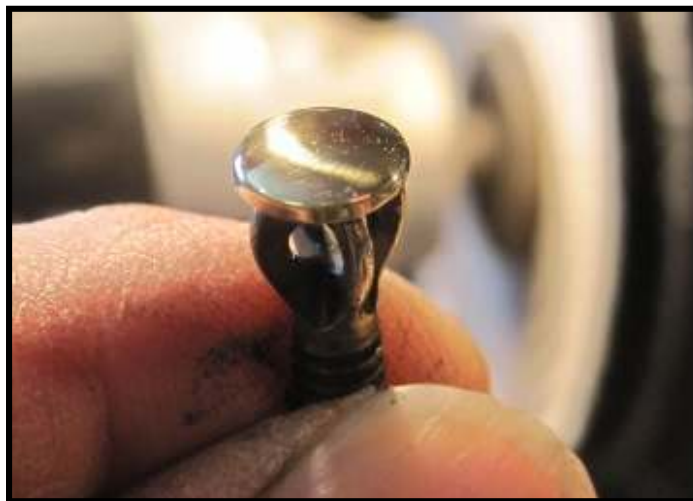
With the capstans of your piano polished as in the above photo, wear and tear on the corresponding felts will be at a minimum, and performance will be at a maximum.
